# Long-Term Evaluation of the Acoustic Emission Weld Monitor

Report No. FHWA-TS-88-021

Kentucky Transportation Research Program  
University of Kentucky  
533 South Limestone Street  
Lexington, Kentucky 40506

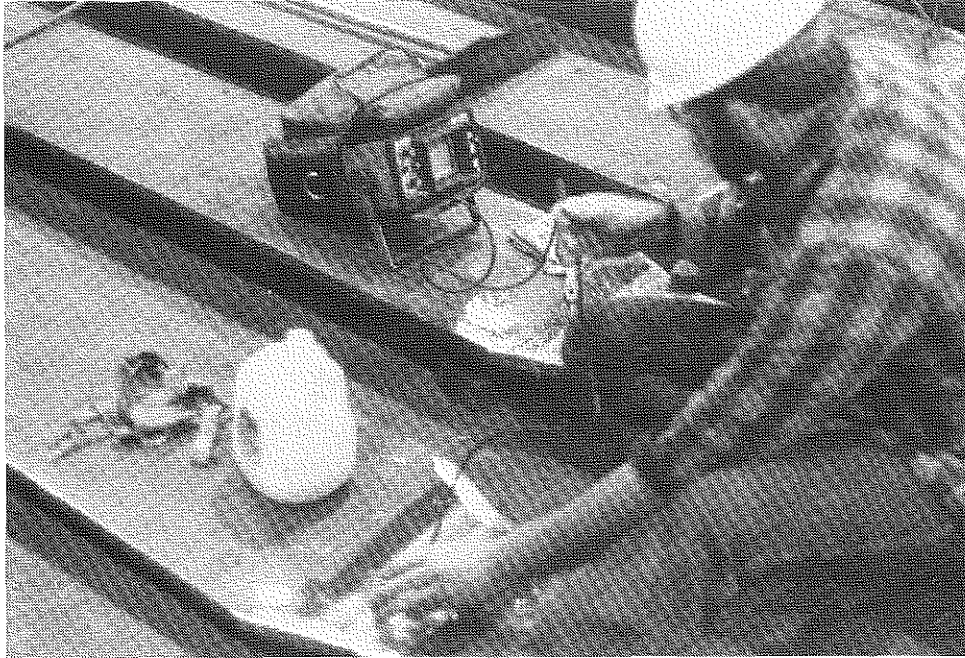
Figure 1. Ultrasonic Inspection of Flange Weld.

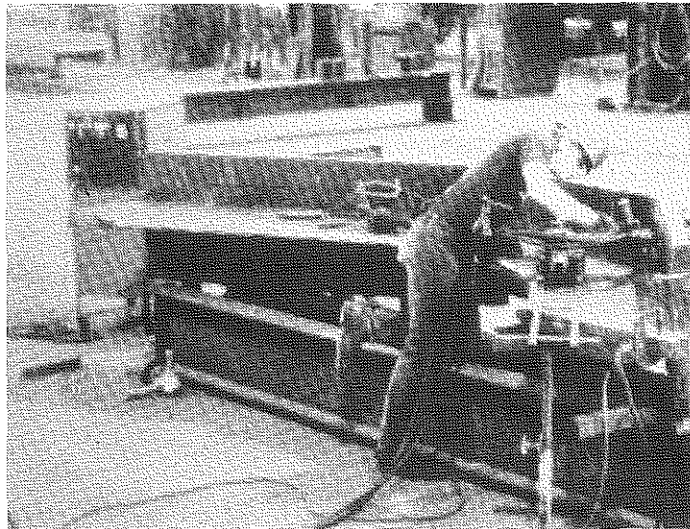
Figure 2. Use of the AEWM to Inspect Large Weldment (at Phoenix Steel Inc., Eau Claire, Wisconsin, September 1986).

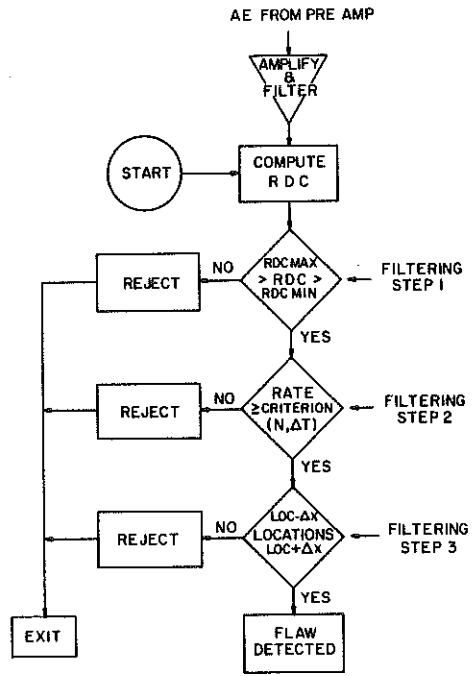
Figure 3. AEWM Processing Flow Chart for Flaw Detection.

The functional operation of the AEWMM has been discussed in other reports and will be explained only briefly herein (1, 2). The AEWMM performs weld flaw detection in real time. It employs pattern recognition to discriminate between normal background AE noises created by welding processes and AE events due to the formation of flaws such as slag inclusions or cracks. The AEWMM pattern-recognition process subjects each AE event to a series of sequential tests. The flaw detection model requires a three-step testing process as shown on the flow chart in Figure 3. After computing an AE ringdown count (RDC) for each separate AE event, the first test is applied. If the ringdown count lies within preset limits (usually 100 to 1,000 counts), an event is passed to the second test for AE event rate. This test requires that some number of AE events, which have passed the RDC test, occur within a preset time interval (usually 1 to 2 seconds). The final test determines whether all the events that have passed the previous two tests originated from the same location or at least within a predetermined location tolerance (usually  $\pm 1$  inch). The AEWMM also subjects the AE events to frequency spectra analyses for flaw characterization. Indications with high-frequency components are categorized as crack-related. Others with lower-frequency components are categorized as unclassified flaws.

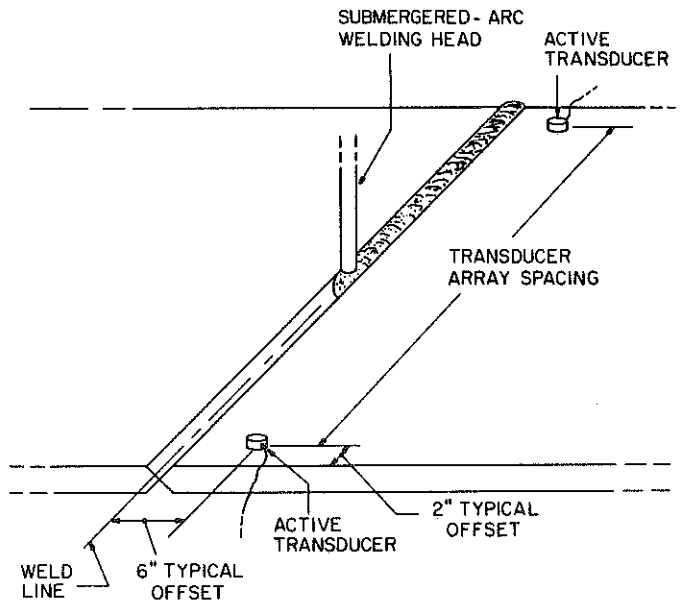
Figure 4. Schematic of Typical Butt-Weld Showing Normal Transducer Placement.

A procedure was formulated whereby the Number 1 transducer of the array was always placed at the starting point of the welding operation. However, it was necessary to determine where the weld was started in relation to the initial weld side (or "A face") of the plate. In some cases, it was possible for the welder to begin welding on the backside (or "B face") from either end of the weld in relation to the starting point of the pass on the "A face" of the plate. This was noted by circling the arrow shown on the schematic and indicating it was the welding direction for the "A face" and then noting the starting point of the back side ("B face") weld in relation to the "A face" weld. This allowed determination of defect location if one was encountered on either side of the plate in relation to the transducer placement.

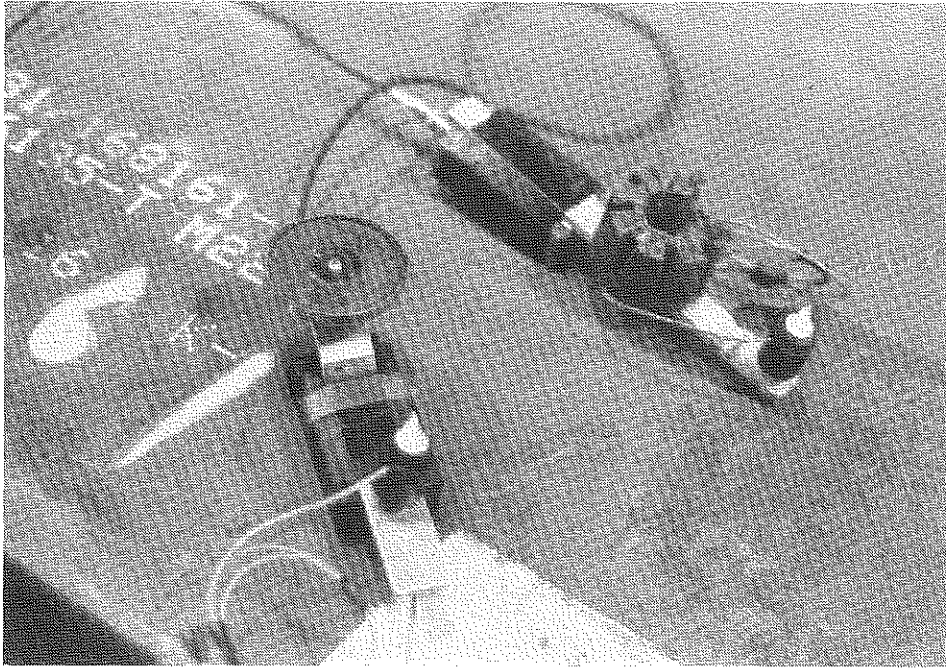
Figure 5. Magnetic Hold-Down Assemblies Housing the Preamplifiers and Transducers (Note the silicone couplant on faces of transducers).

Transducer placement and AEWM calibration required about 5 to 10 minutes. This did not substantially interfere with welding operations. The transducers were mounted in hold-down assemblies that also incorporated preamplifiers (Figure 5). Since those assemblies were housed in a single pre-connected unit, they could be quickly attached to the weldment saving much time compared to handling separate components. The technician applied a silicone couplant on the wear faces of the two transducers and then attached them on one side of the weldment adjacent to the weld line (Figure 6). After the technician had determined the plate width and established the transducer spacing, he calibrated the AEWM and prepared for monitoring (Figure 7).

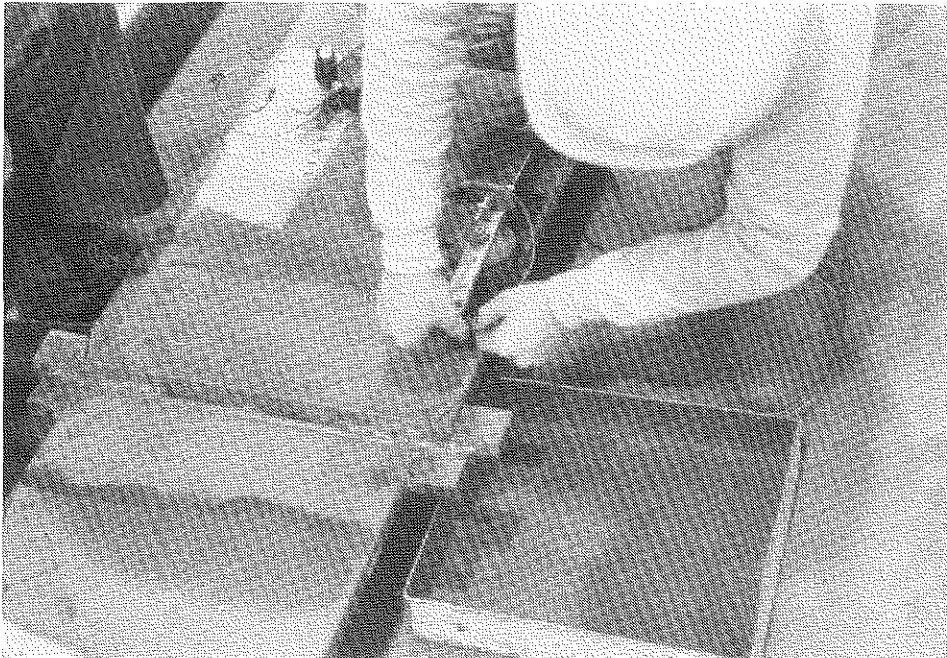
Figure 6. Attaching Transducer to Flange Weld.

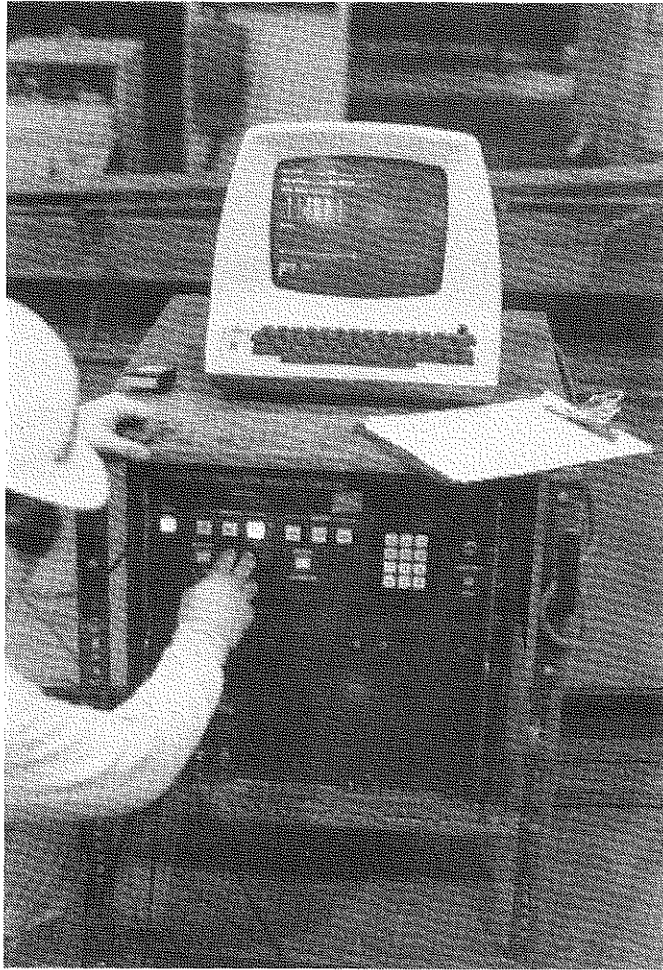
Figure 7. Calibrating the AEWM Prior to Monitoring Weld.

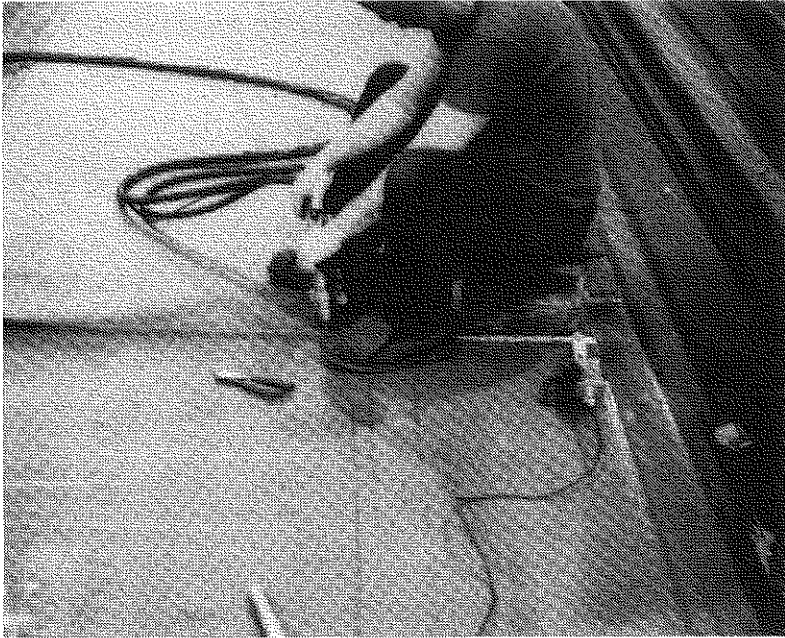
Figure 8. Welder Performing Semi-Automatic Submerged-Arc Weld on Web (Note AE transducers located near edge of plate).

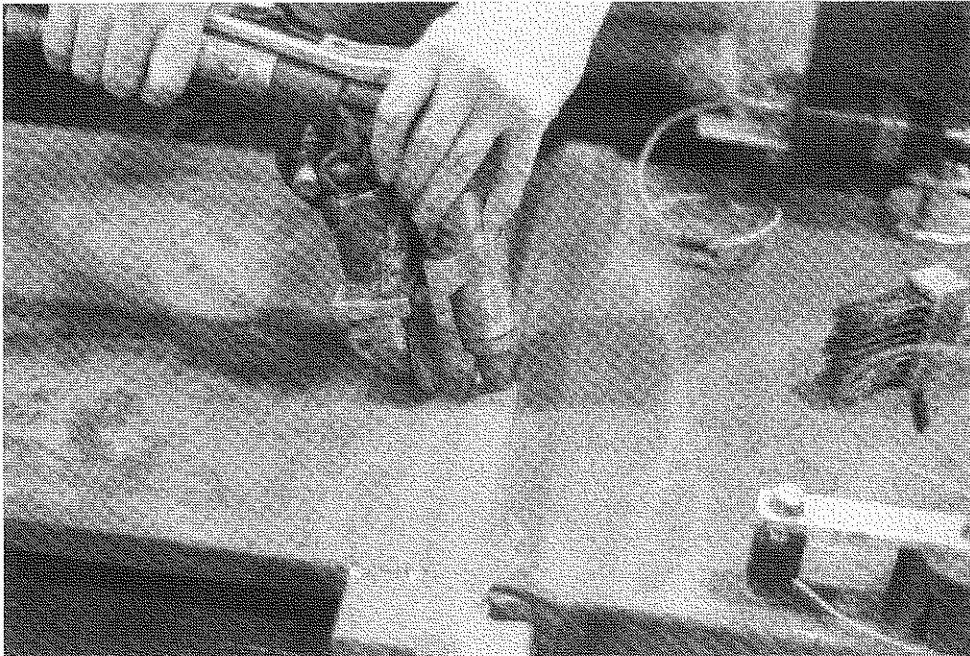
Figure 9. Semi-Automatic Submerged-Arc Welding Gun Depositing "A" Face Weld on Beveled Side of Flange.

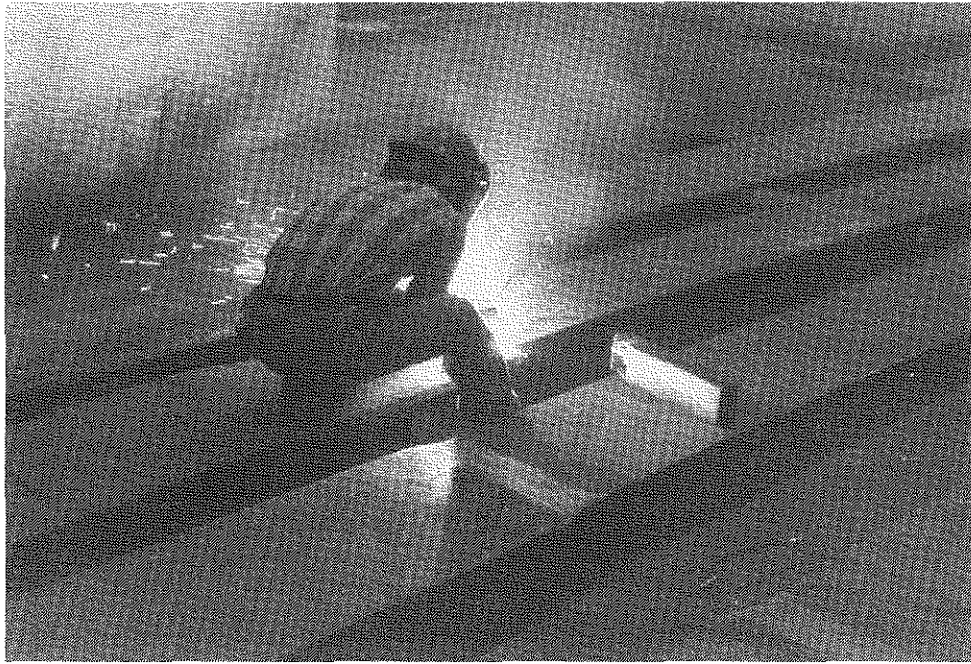
Figure 10. Carbon-Air Arc Backgouging on Back Side of a Flange Weld.

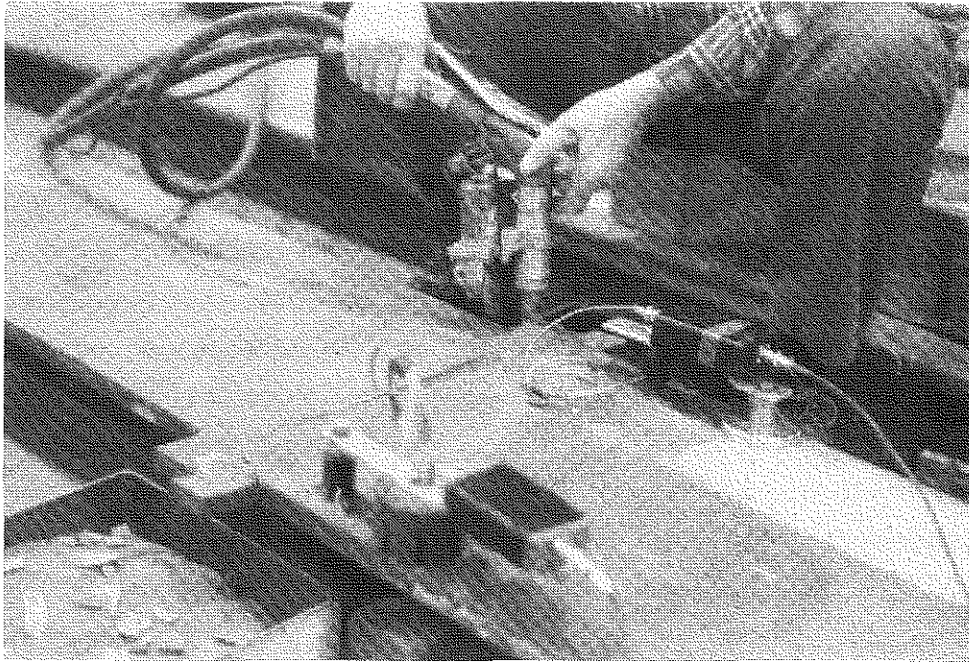
Figure 11. Depositing Weld on Flange (Note magnetic hold-down assemblies that contain preamplifiers and transducers).

During the initial flange tests, GARD personnel questioned whether the PAC transducers were suitable for use with the AEW due to their high resonant frequency (500 kHz). The required AE signal frequency for operation of the AEW is around 200 kHz. The PAC transducers were shipped to the GARD laboratory in Niles, Illinois, and subjected to a helium-jet (white-noise) source to determine their resonant frequencies. The transducers were found to contain resonant frequency peaks within the operating range of the AEW and therefore, were satisfactory for use. Concurrently, properly fitting transducer receptacles were fabricated. The transducers and new receptacles were delivered to the KTRP technician in September 1987 and were used successfully thereafter (Figure 11).

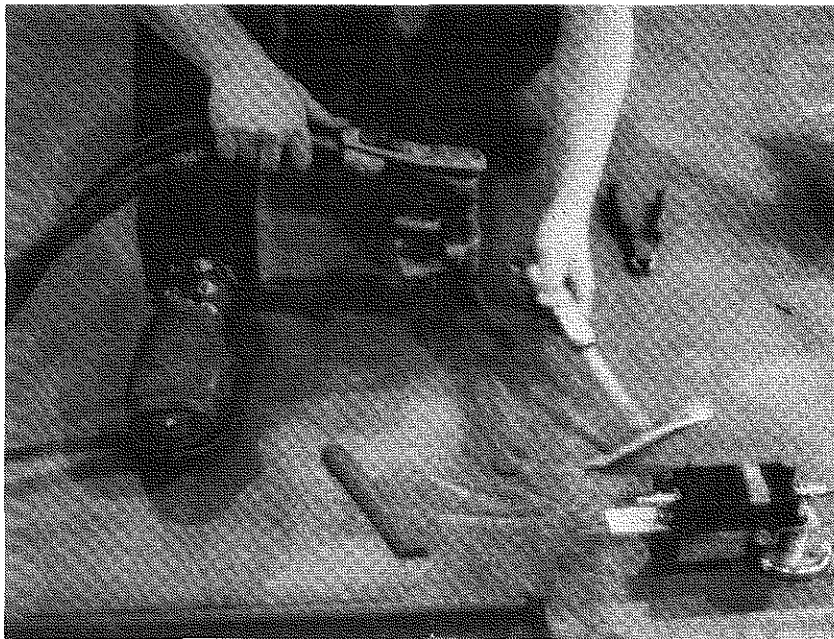
Figure 12. Welder Chipping Flux during Welding Operation.

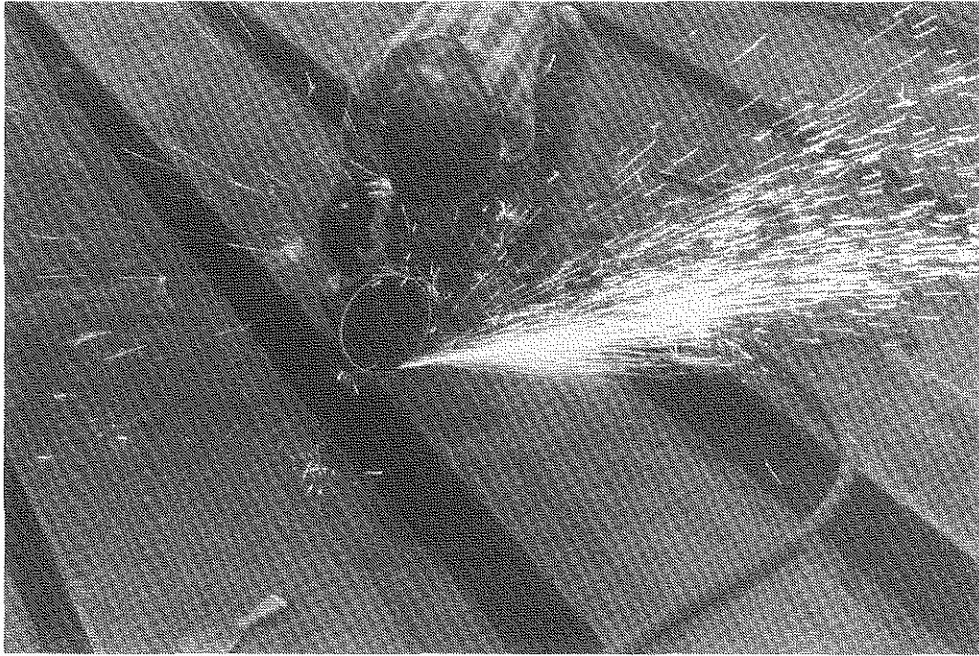
Figure 13. Grinding a Surface Blemish Prior to Depositing a Succeeding Weld Pass.

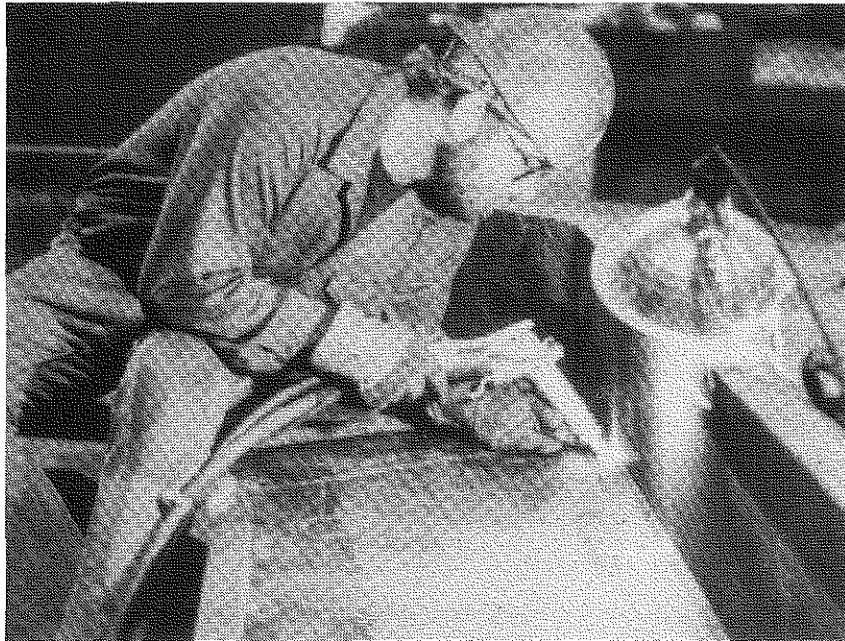
Figure 14. Manual Submerged-Arc Weld Repair of Large Weldment.

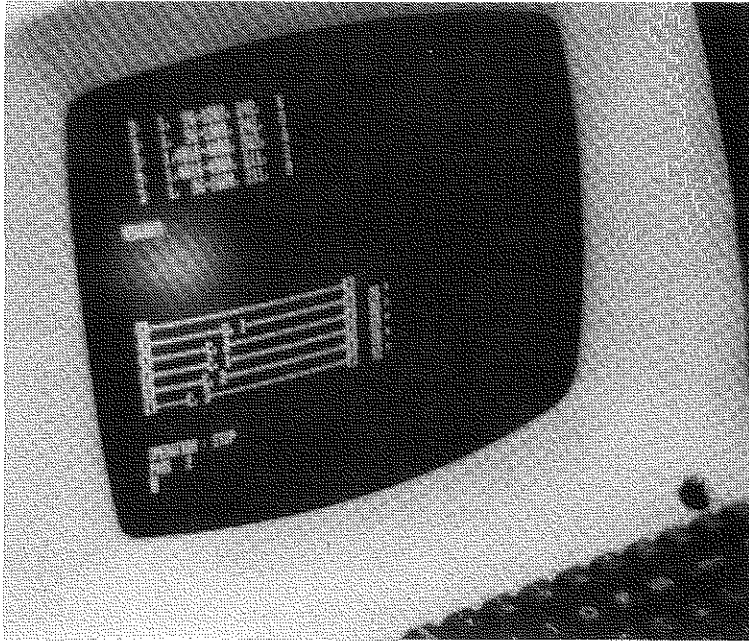
Figure 15. AEWM Flaw Indication from Web Welding Operation.

The most persistent type of flaws are slag inclusions (Figures 15 and 16). Oftentimes, slag inclusions are created during the deposition of a root pass or by formation of what is termed a "roll." "Rolls" are caused by the improper positioning of the welding gun to one side of a groove bevel during welding. That causes molten weld metal to roll over the flux during the deposition, possibly trapping some slag (Figure 17). "Rolls" associated with slag inclusions were readily detected by the AEWM (Figure 18). Sometimes, rolls did not create slag inclusions. In those cases, the AEWM did not indicate flaws. When visually inspected, both cases appear similar. Typically, welders ground "rolls" out prior to depositing the next weld pass. However, several welders just welded over them.

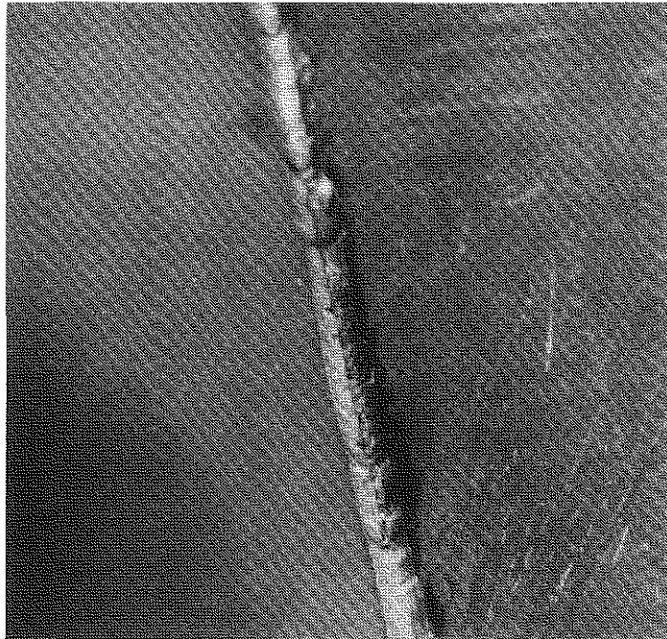
Figure 16. Slag Stringer (Figure 15) Revealed after Backgouging.

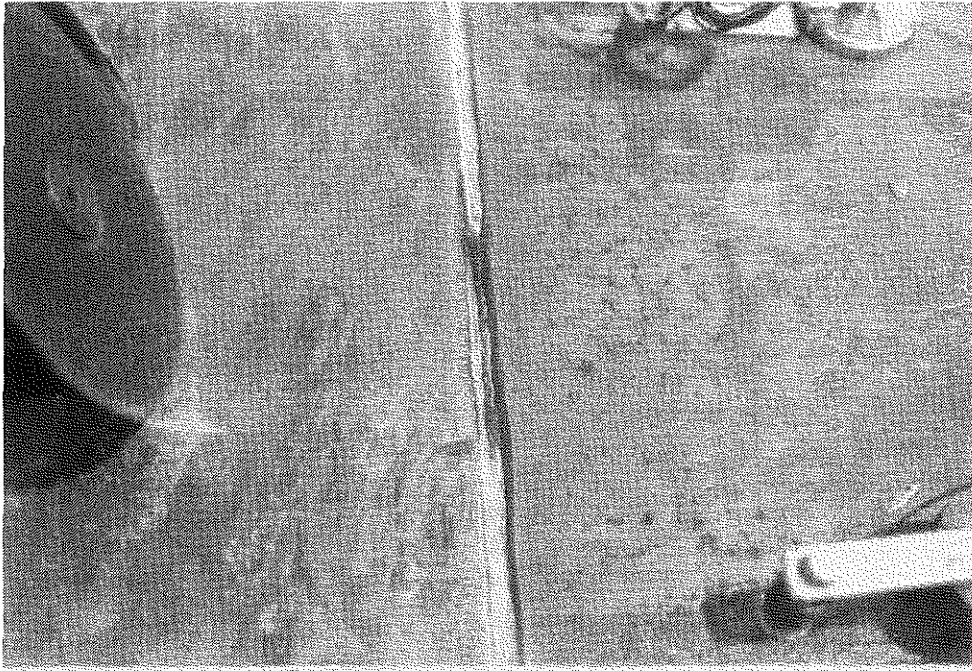
Figure 17. Weld "Roll" in Flange Weld (Detected by the AEWB).

Occasionally, the AEWM detected welding irregularities that might affect the quality of a completed weld. Typically, those irregularities were related to simple problems such as loss of flux (Figure 19) or depletion of welding wire (Figure 20). On several occasions, poor weldment fit-up caused burn-throughs or slag-related problems on the root pass (Figure 21).

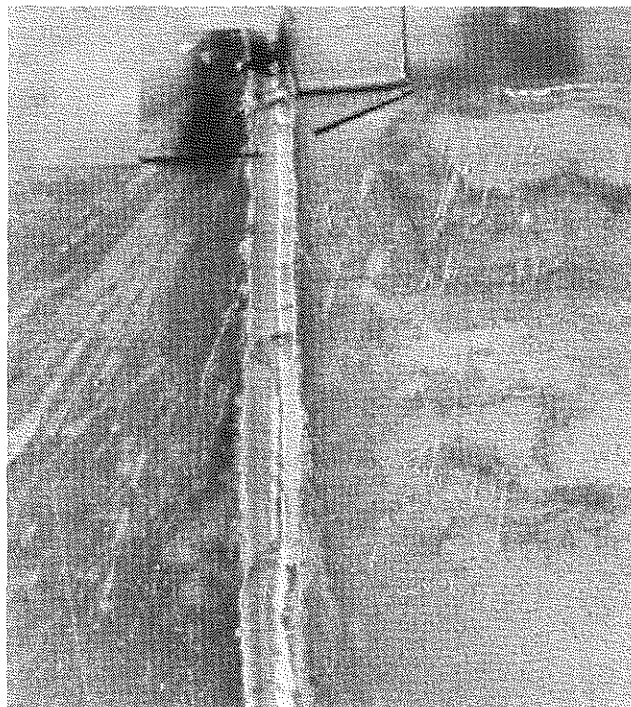
Figure 18. Slag Inclusion in Weld (Figure 17) Revealed by Backgouging.

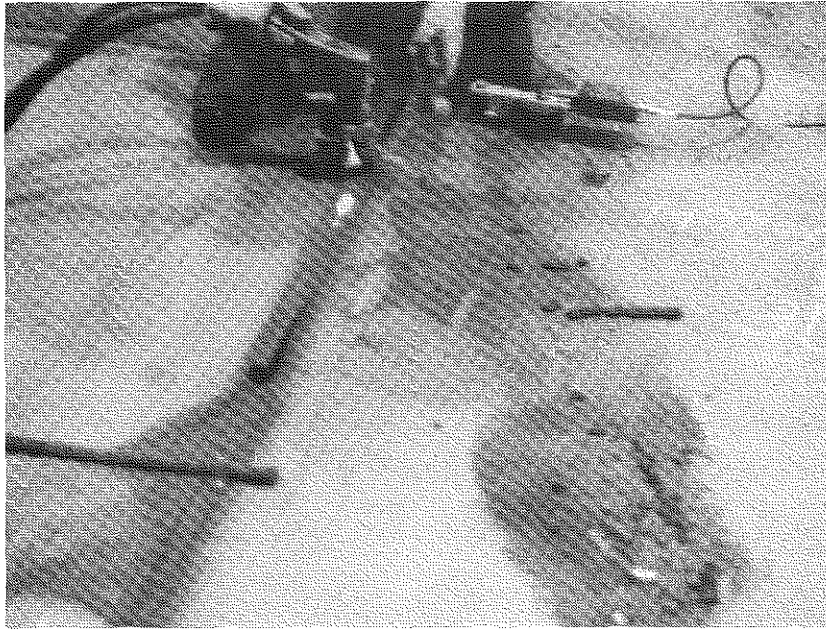
Figure 19. Weld Irregularity Caused by Temporary Loss of Flux.

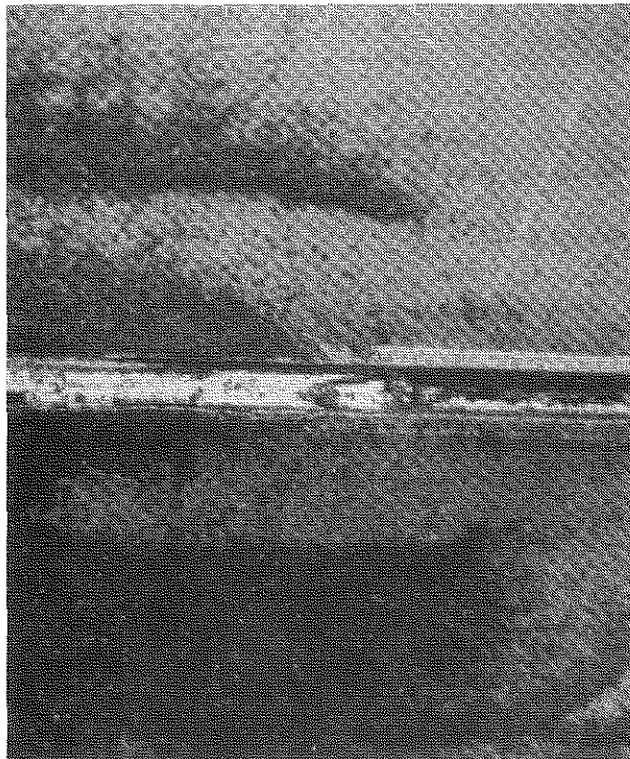
Figure 20. Flaw at Weld Termination (Slag and Porosity) Detected by AEW.

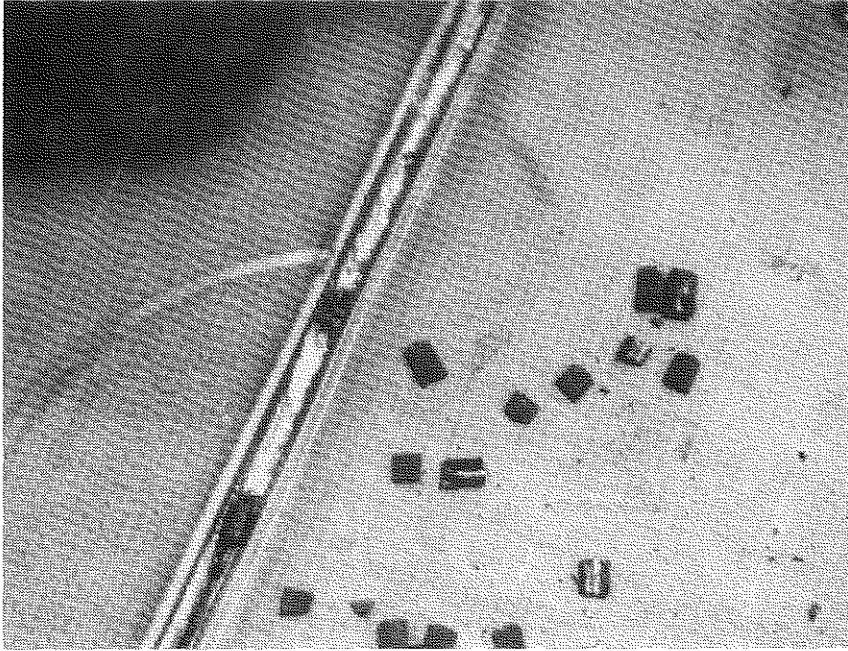
Figure 21. Trapped Surface Weld Slag Detected by AEWM during Root Pass Weld and Subsequently Repaired by Grinding.

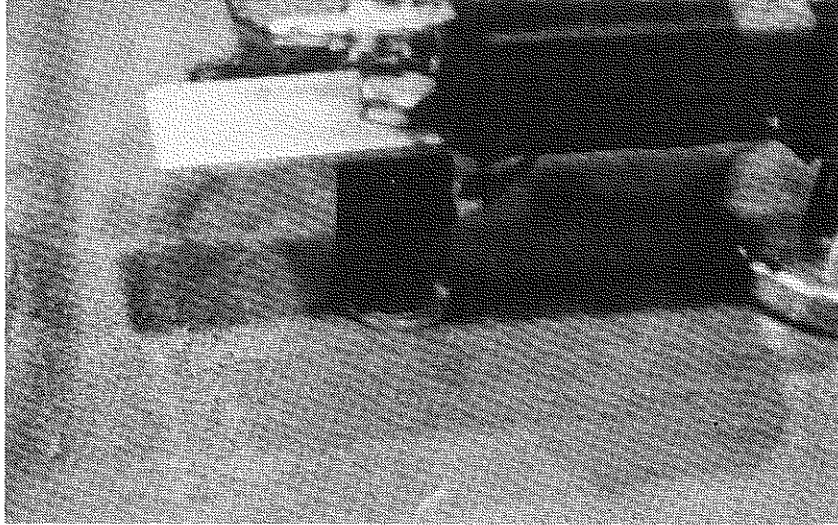
Figure 22. Transducer Assembly Coupled to Weldment (Note the flux near point of attachment and extruded clear couplant around the base of the transducer).

Currently, a major AE monitoring problem area is in the sensing of AE activity. The main problem concerns coupling of transducers to steel plates. Improper coupling is usually due to flux that gets between the transducer and the plate surface weakening sound transmission (Figure 22). Also, extremely

high temperatures may affect the viscosity of a couplant, changing the transmission quality of AE signals across the transducer/plate interface during a test (especially when monitoring flange welds). Another potential problem occurs when a transducer is bumped or a transducer lead wire is moved, causing the transducer to slide along a plate. This occurs even when using heavy magnetic-based hold-down units that attach the transducer to the steel with high force. That is one reason to have an audible confirmation during the test to indicate to a welder the unit is detecting AE activity.
