1. Report No. UKTRP-86-4		2. Government Accession No.		3. Recipient's Catalog No.	
4. Title and Subtitle Delineation of Horizontal Curves				5. Report Date March 1986

Research Report  
UKTRP-86-4

DELINEATION OF HORIZONTAL CURVES

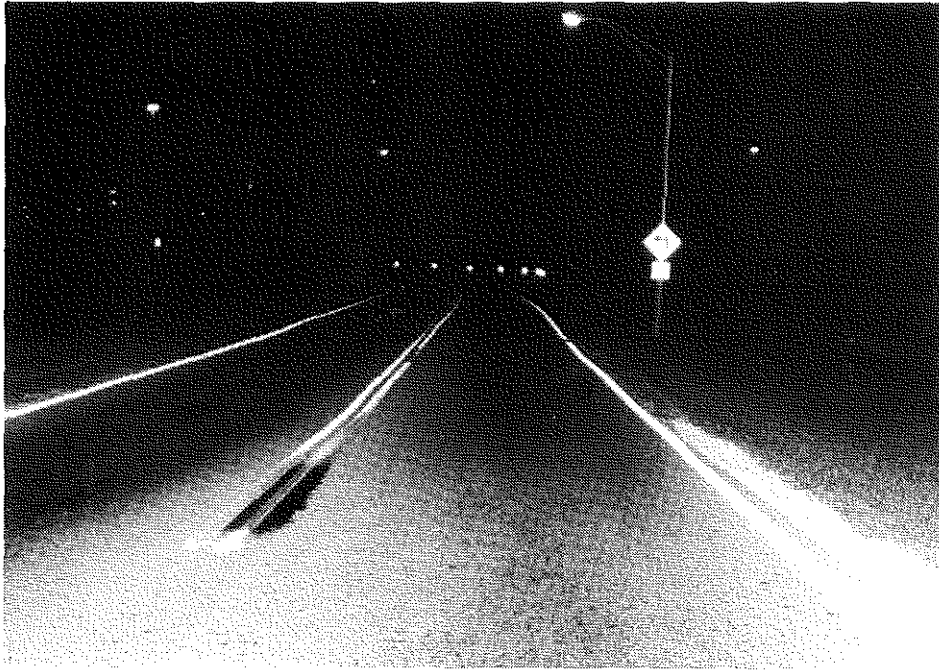
Figure 5. STD Configuration, 300 Feet from Start of Curve.

Delineators were placed at the different configurations, using portable stands, at a roadway curve, and nighttime photographs were taken. The photographs were taken at distances of 100, 300, and 500 feet from the beginning of the curve, which was where the first delineator was placed. The photographs of all configurations were then placed on a display and labeled as Configurations 1 through 11. The questionnaire shown in Figure 4 was then given to a sample of licensed drivers to determine if they perceived any difference in the configurations. Photographs of each configuration, taken at the 300-foot distance from the start of the curve, are shown in Figures 5 through 15.

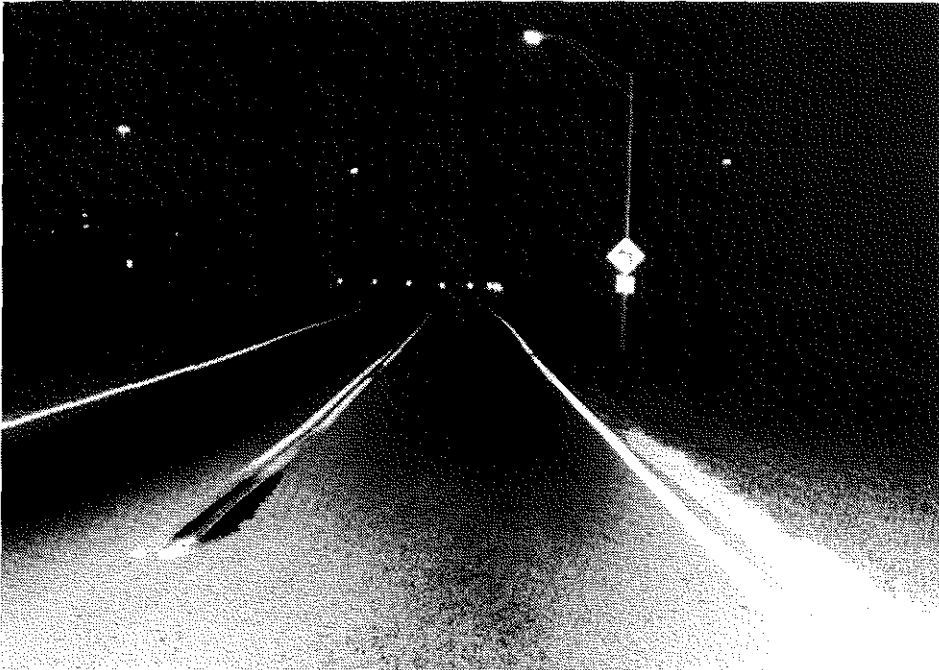
Figure 6. EIO Configuration, 300 Feet from Start of Curve.

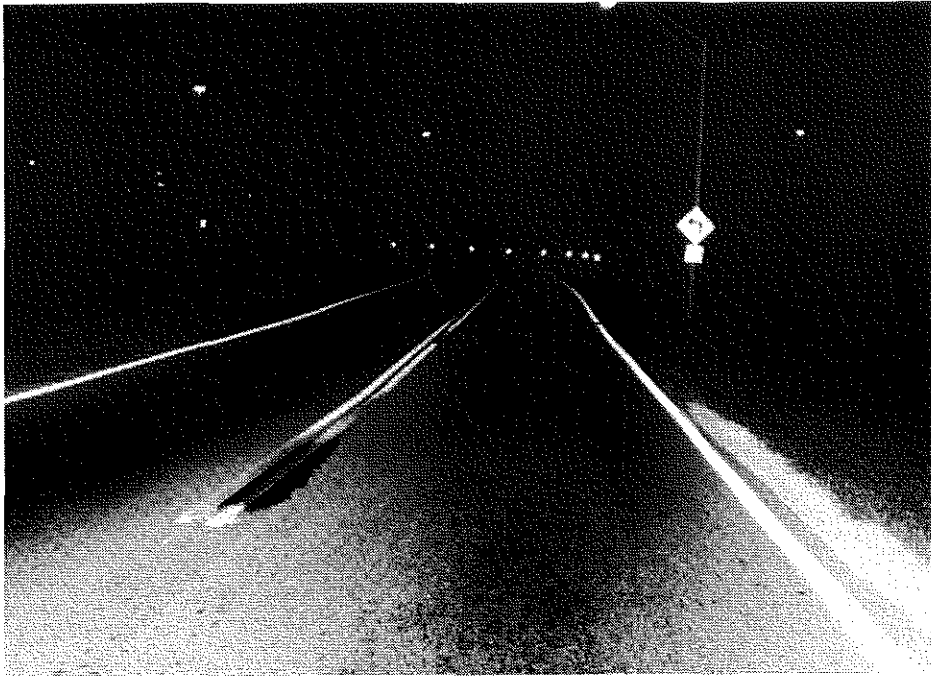
Figure 7. EOI Configuration, 300 Feet from Start of Curve.

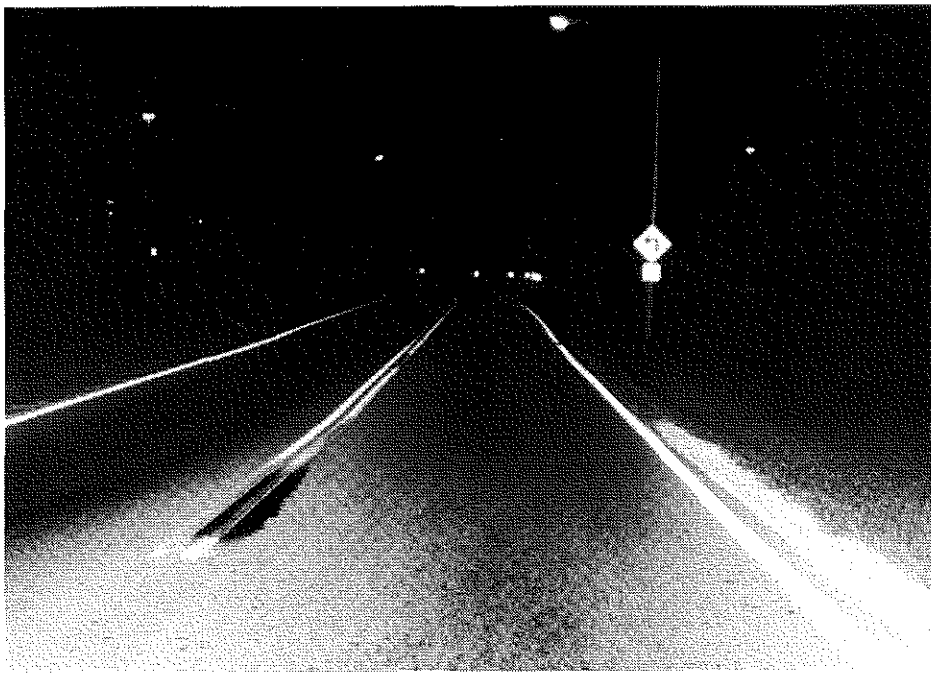
Figure 8. IS Configuration, 300 Feet from Start of Curve.

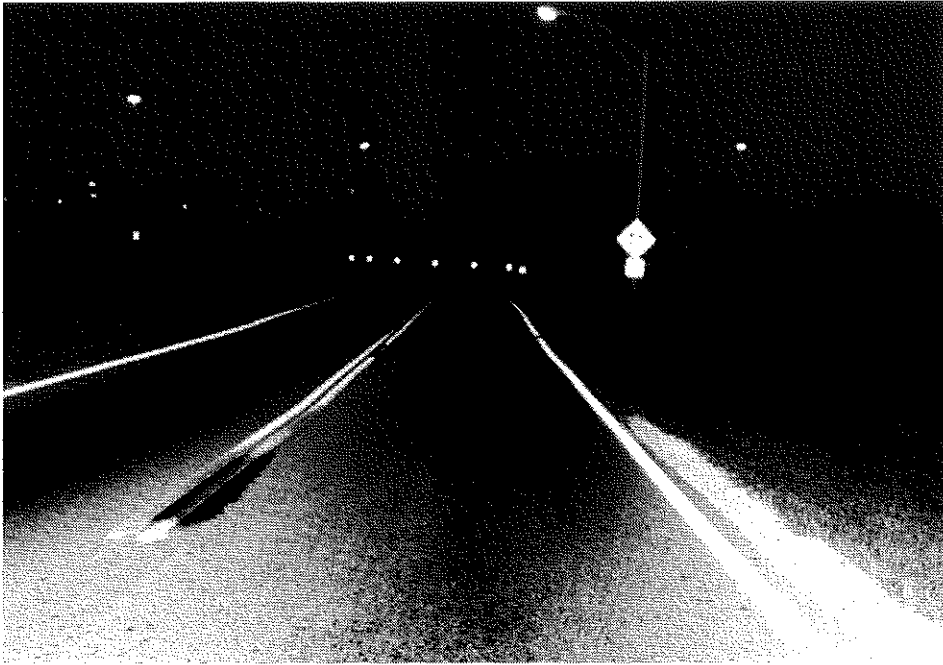
Figure 9. DS Configuration, 300 Feet from Start of Curve.

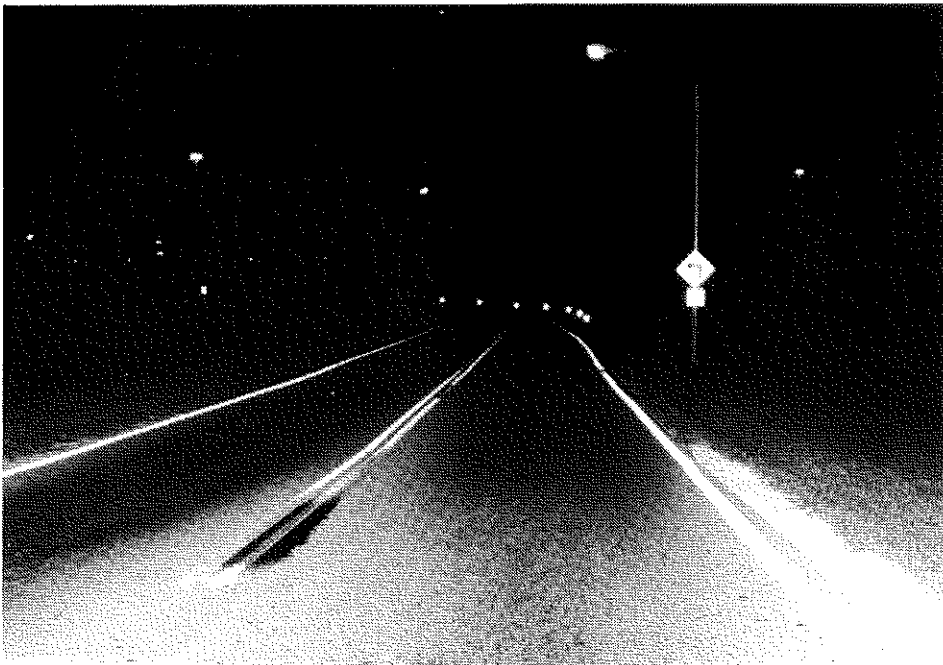
Figure 10. AE Configuration, 300 Feet from Start of Curve.

The AE configuration, in which the distance from the post to the pavement edge and the post spacing remained constant while the height of the delineator on the post increased, was ranked number one by a large margin. Both the second and third ranked configurations involved increasing the height of the delineator on the post while also increasing or decreasing the distance the post was placed from the roadway shoulder.

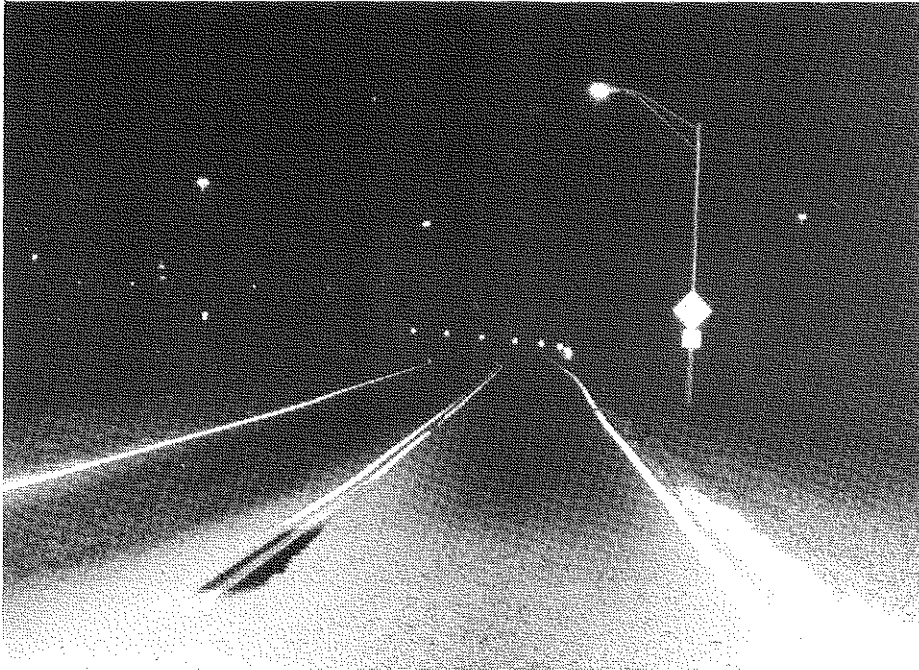
Figure 11. AIO Configuration, 300 feet from Start of Curve

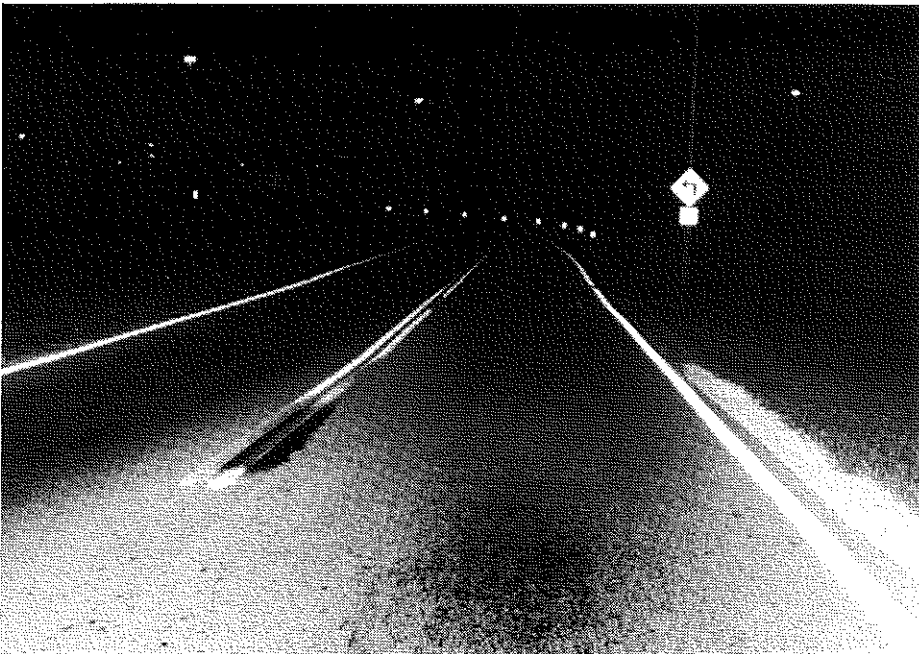
Figure 12. AOI Configuration, 300 Feet from Start of Curve

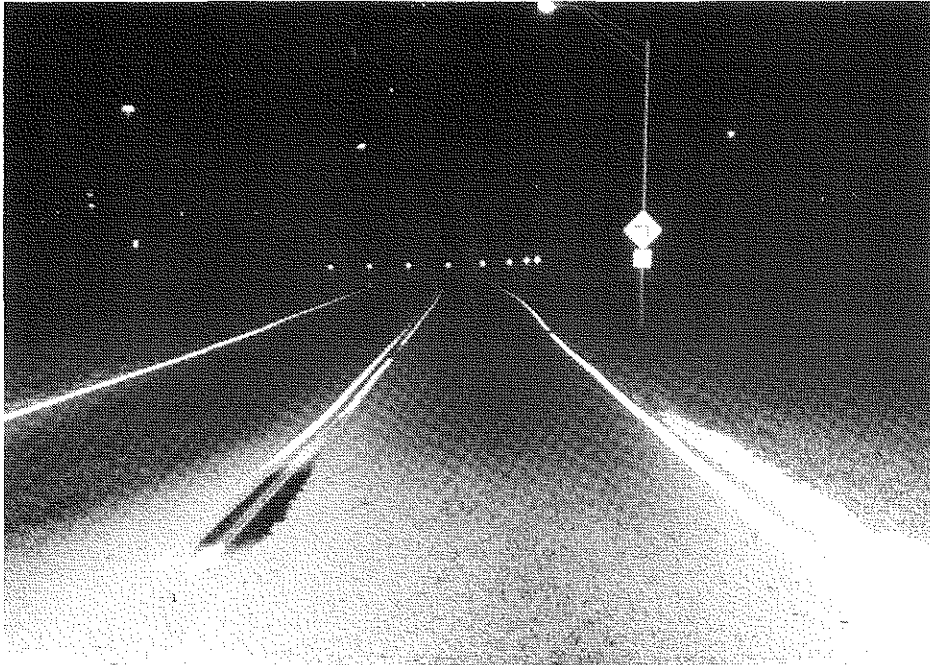
Figure 13. DOI Configuration, 300 Feet from Start of Curve.

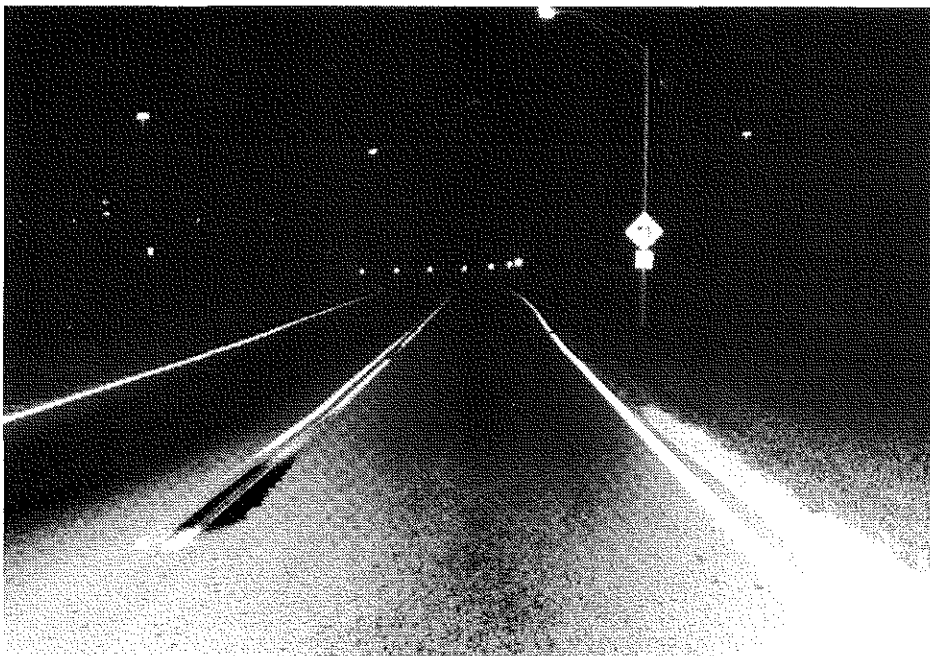
Figure 14. DIO Configuration, 300 Feet from Start of Curve.

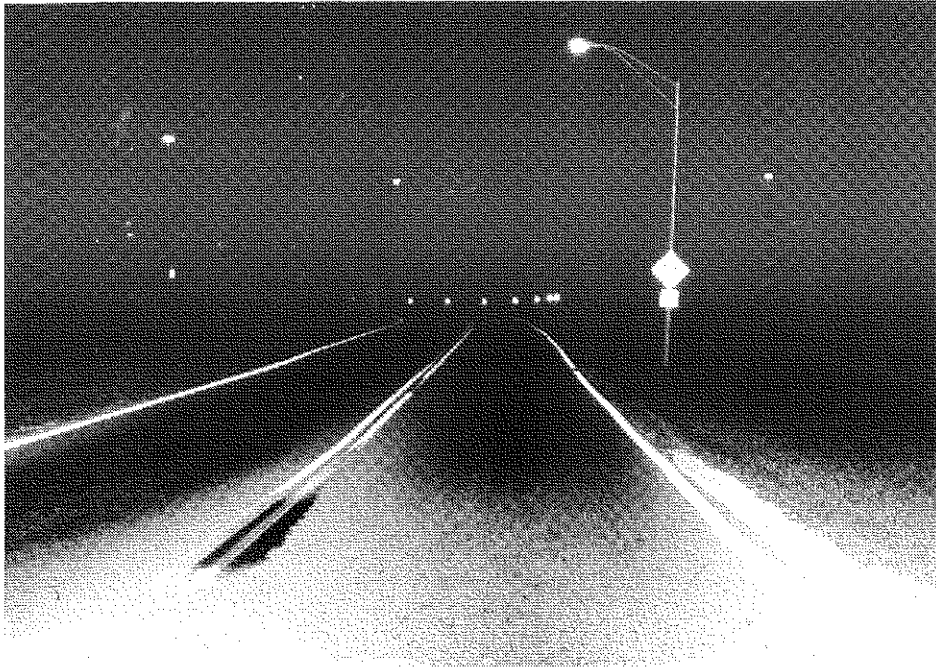
Figure 15. DE Configuration, 300 Feet from Start of Curve.

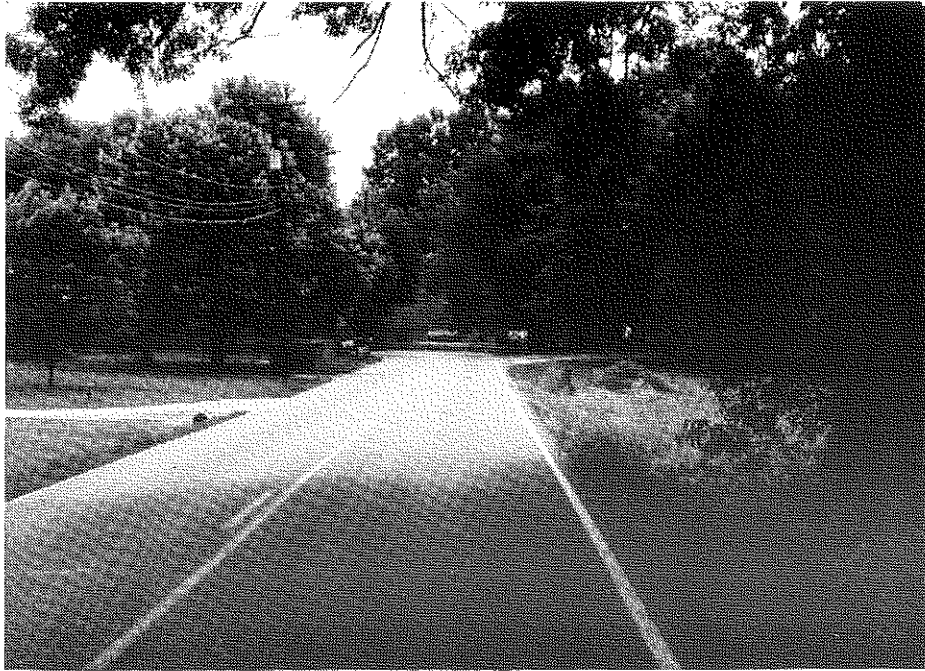
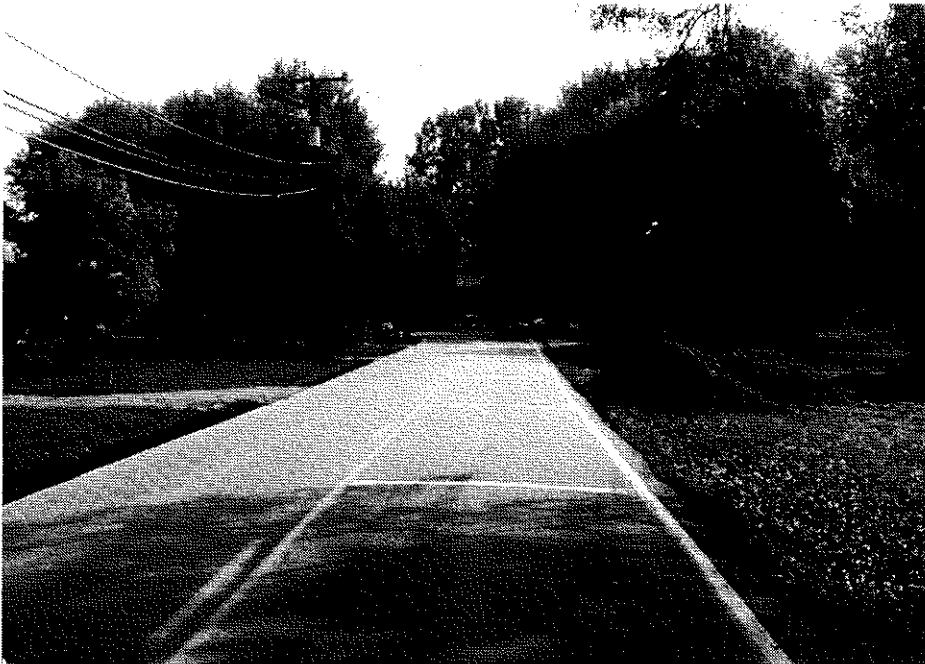
**Figure 16. Daytime Photographs of Lower Hunters Trace Eastbound Approach Before and After Addition of Transverse Stripes and Raised Pavement Markers.**

Daytime and nighttime photographs showing the eastbound approach of the Lower Hunters Trace location before and after the addition of transverse stripes and raised pavement markers are shown in Figures 16

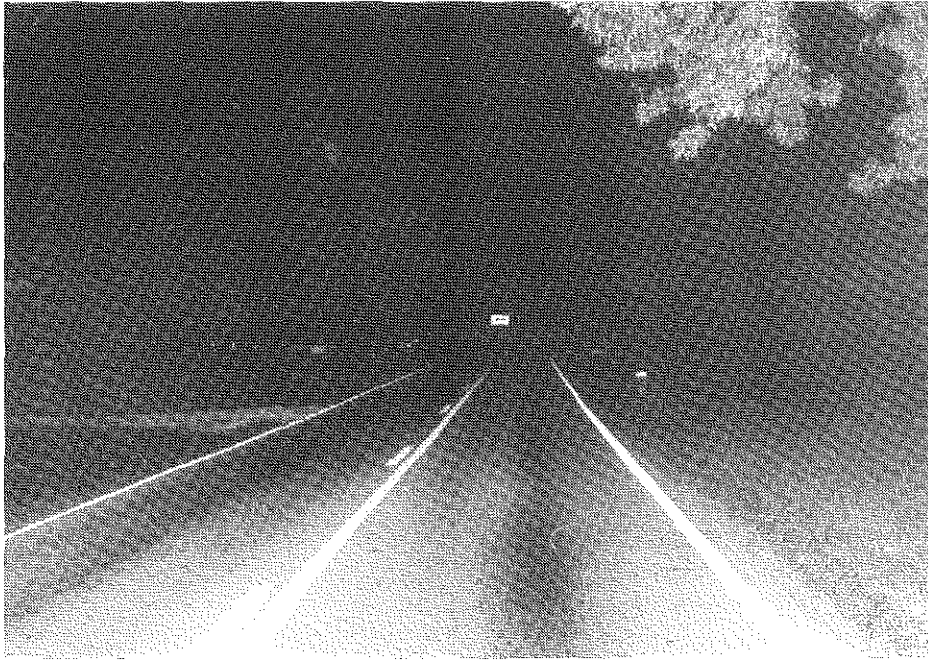
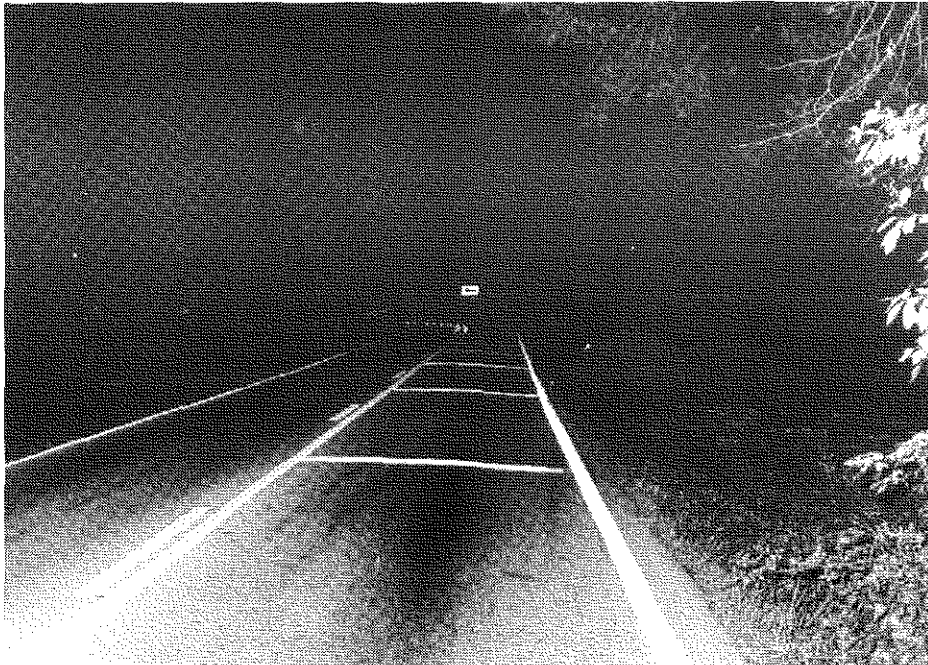
Figure 17. Nighttime Photographs of Lower Hunters Trace Eastbound Approach Before and After Addition of Transverse Stripes and Raised Pavement Markers.

and 17, respectively. Daytime and nighttime photographs showing the westbound approach of the Lower Hunters Trace location before and after the addition of rumble strips and raised pavement markers are shown in Figures 18 and 19, respectively. Nighttime photographs of the Cooper Chapel Road location before and after the addition of raised pavement markers and rumble strips are shown in Figure 20. Nighttime photographs of installation of raised pavement markers at the Blanton Lane and Fegenbush Lane locations are shown in Figures 21 and 22, respectively.

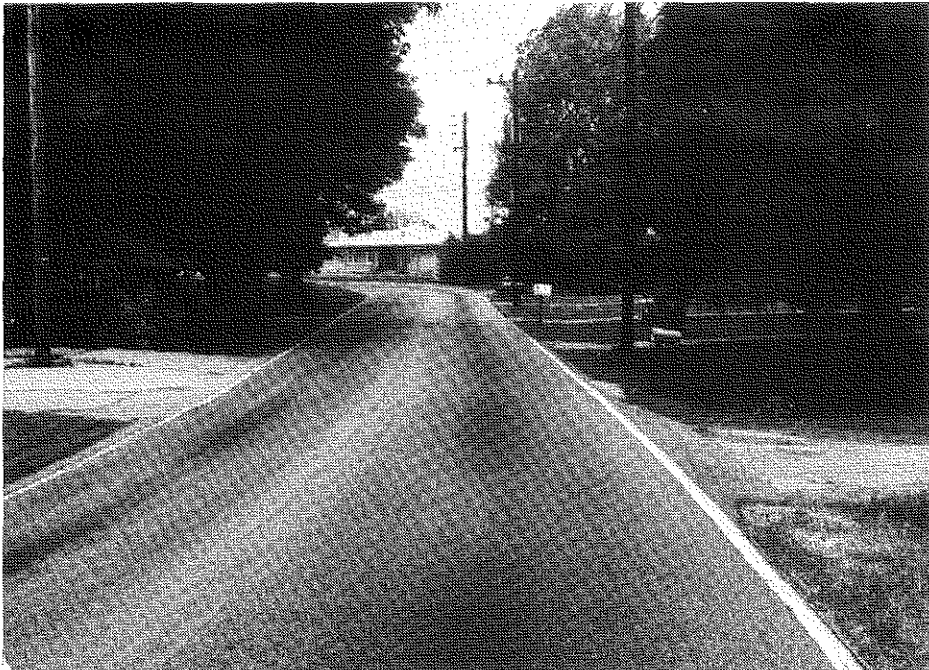
Figure 18. Daytime Photographs of Lower Hunters Trace Westbound Approach Before and After Addition of Rumble Strips and Raised Pavement Markers.

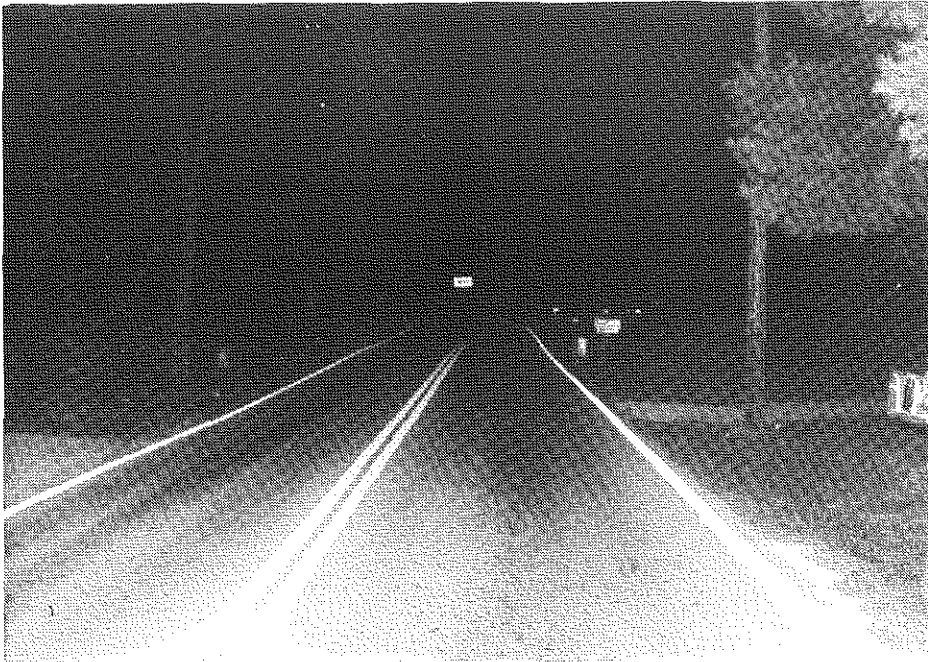
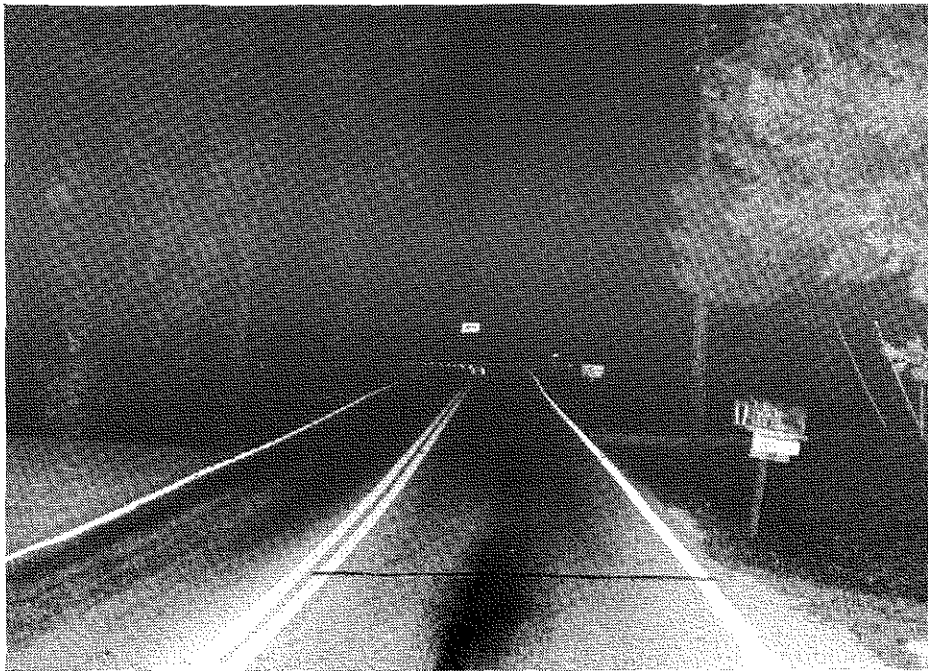
Figure 19. Nighttime Photographs of Lower Hunters Trace Westbound Approach Before and After Addition of Rumble Strips and Raised Pavement Markers.

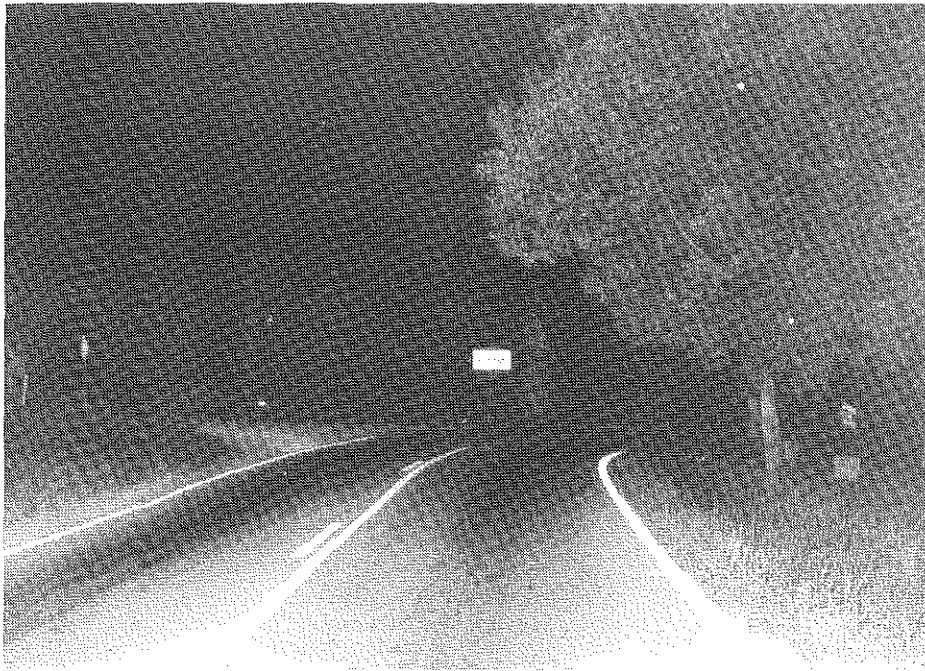
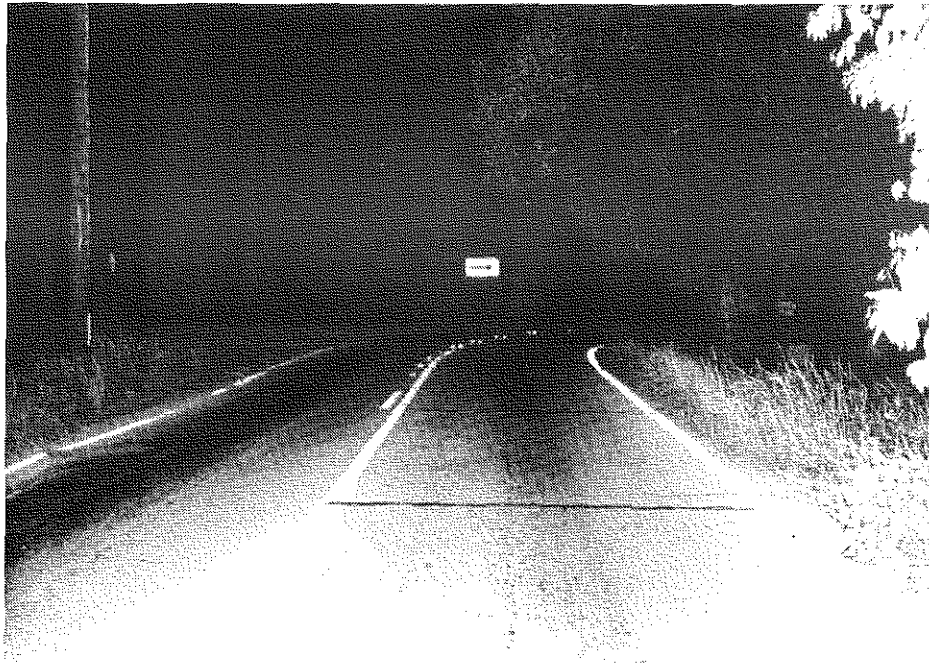
Figure 20. Nighttime Photographs of Cooper Chapel Road Southbound Approach Before and After Addition of Raised Pavement Markers and Rumble Strips.

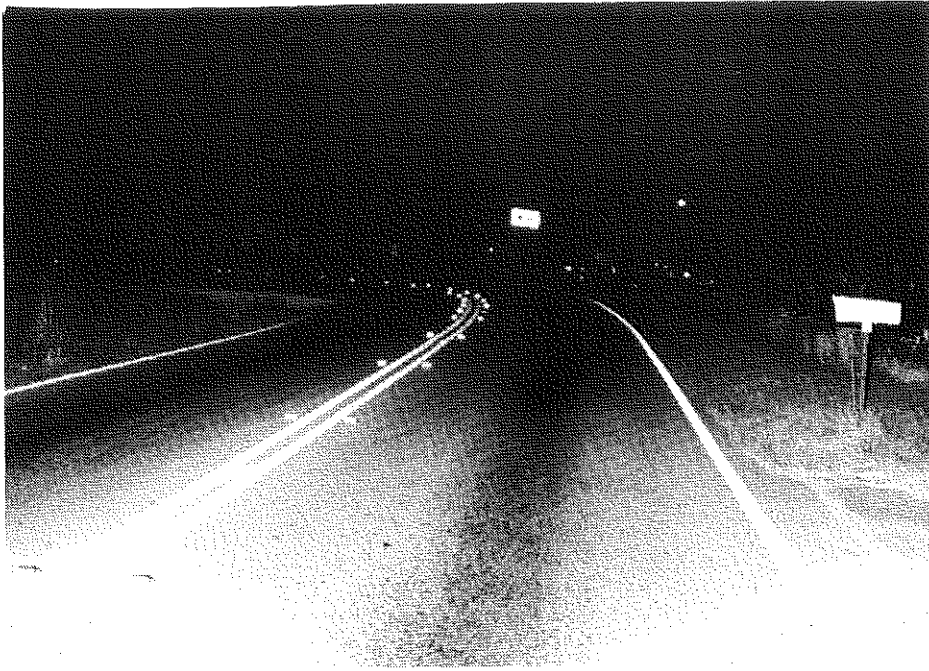
Figure 21. Nighttime Photograph of Blanton Lane After Installation of Raised Pavement Markers.

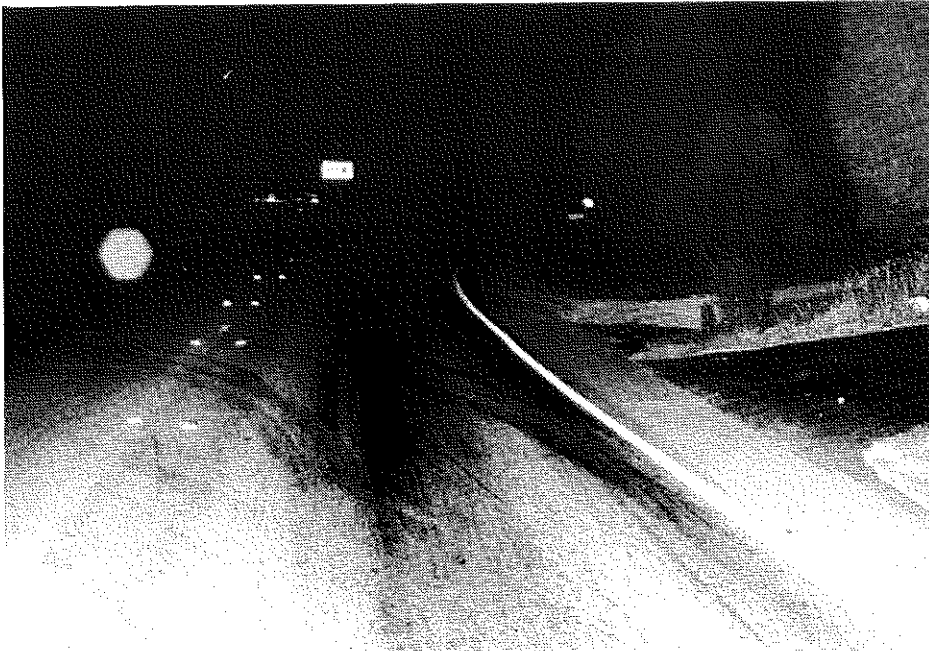
Figure 22. Nighttime Photograph of Fegenbush Lane After Installation of Raised Pavement Markers.

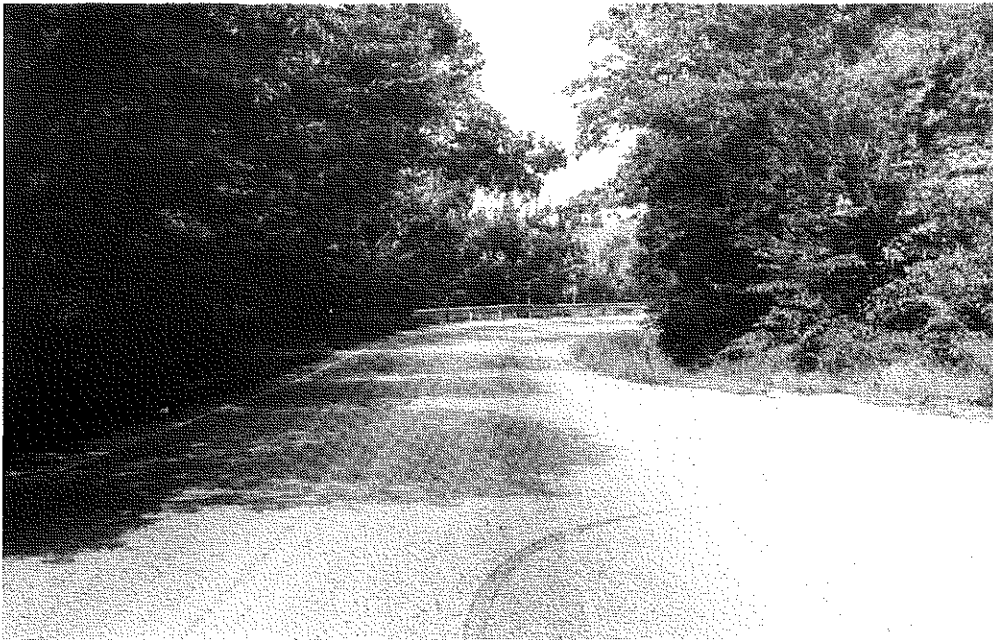
Figure 23. Daytime and Nighttime Photographs of US 421 Location with No Added Delineation.

Daytime and nighttime photographs of the US-421 location with no added delineation are given in Figure 23. The nighttime delineation provided by post delineators placed in a standard configuration (at a 30-foot spacing) and in an ascending even (AE) configuration (nine delineators placed from 1.5 feet to 5.5 feet above the roadway surface at 0.5-foot increments) is shown in Figures 24 and 25, respectively. Daytime and nighttime photographs of the chevron signs placed in a standard configuration (at a 60-foot spacing) and in an ascending even (AE) configuration (four signs placed at 2.0, 2.5, 3.0, 3.5 feet above roadway surface) are shown in Figures 26 and 27, respectively. Daytime and nighttime photographs of the US-62 location with no added delineation are given in Figure 28. Nighttime delineation provided by post delineators placed in a standard configuration (at a 50-foot spacing) and in an ascending even pattern (eight delineators placed from 1.5 to 5.0 feet above the roadway surface at 0.5-foot increments) is shown in Figures 29 and 30, respectively. Daytime and nighttime photographs of the chevron signs placed in a standard configuration (at a 100-foot spacing and in an ascending even configuration) are shown in Figures 31 and 32, respectively.

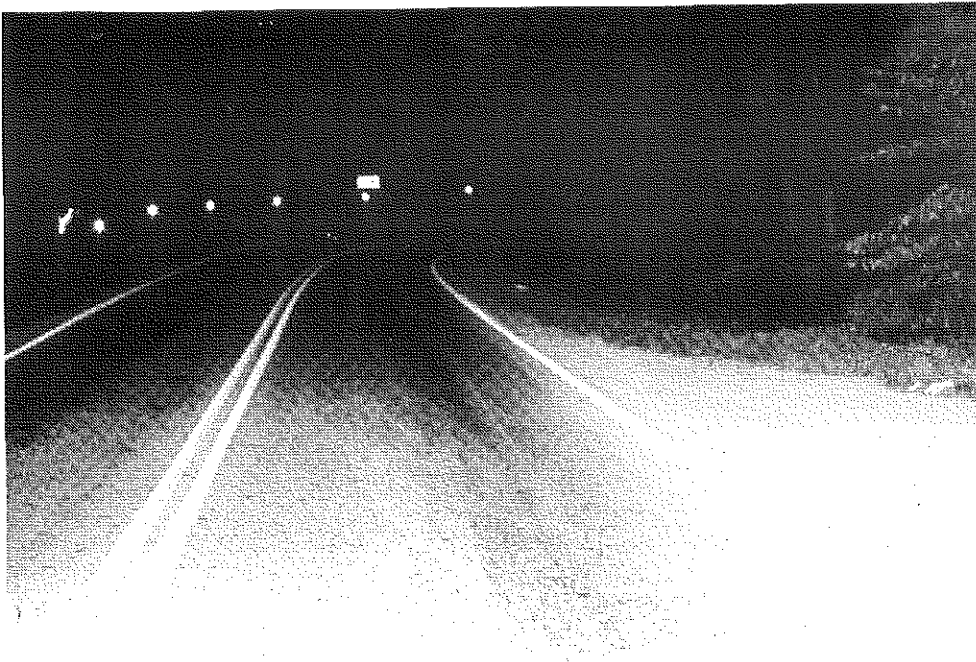
Figure 24. Nighttime Photograph of Post Delineators at US 421 Location Placed in a STD Configuration.

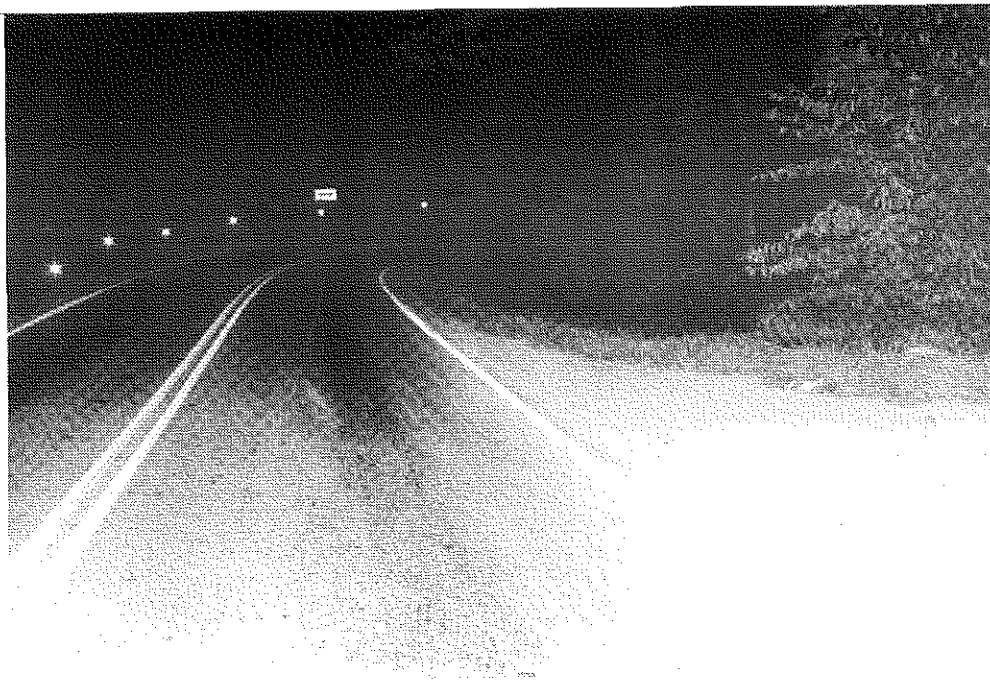
Figure 25. Nighttime Photograph of Post Delineators at US 421 Location Placed in an AE Configuration.

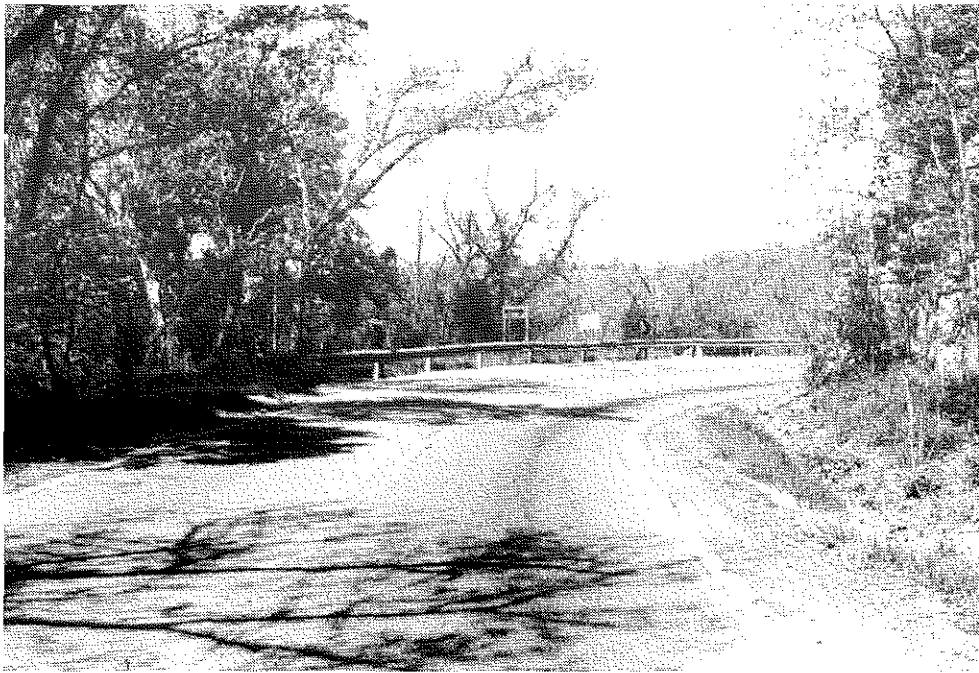
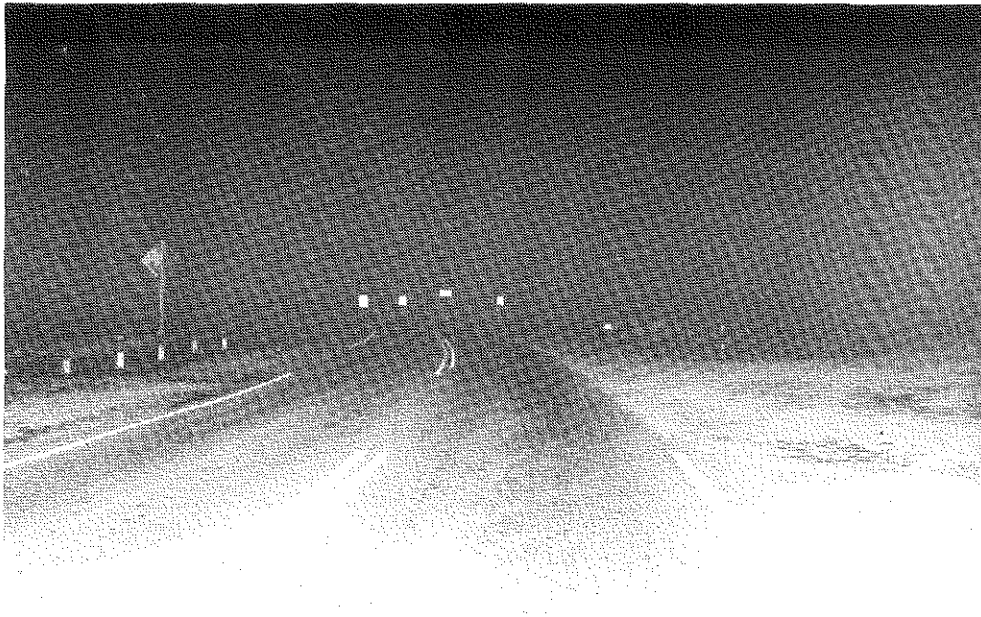
Figure 26. Daytime and Nighttime Photographs of Chevron Signs at US 421 Location Placed in a STD Configuration.

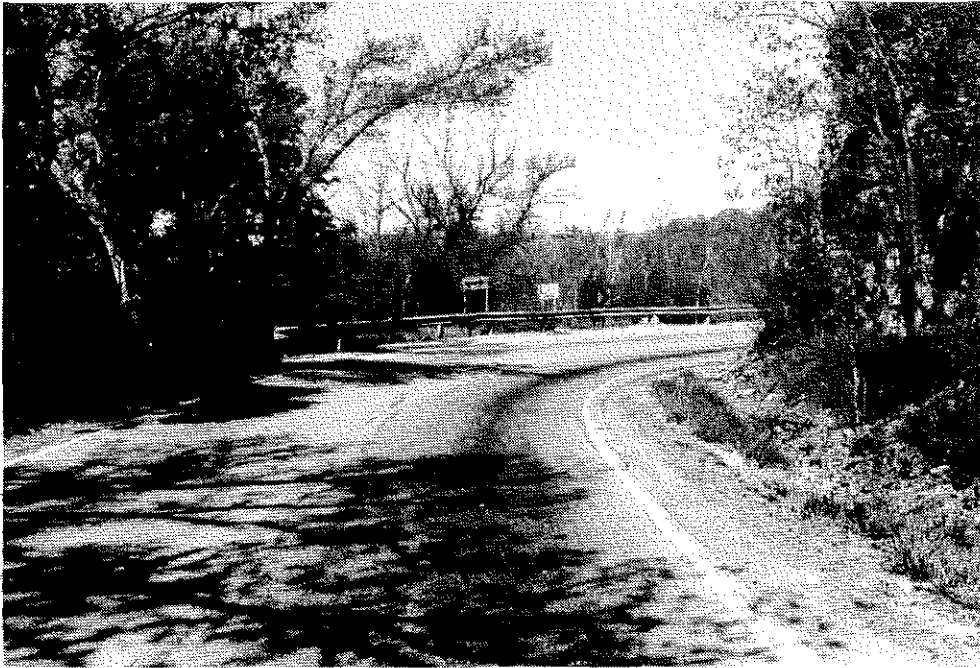
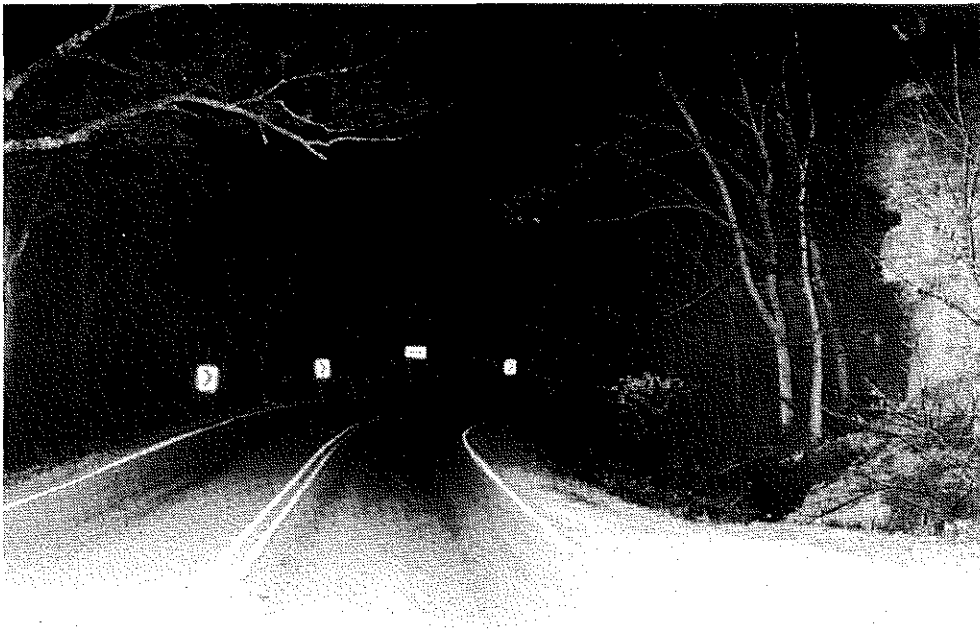
Figure 27. Daytime and Nighttime Photographs of Chevron Signs at US 421 Location Placed in an AE Configuration.

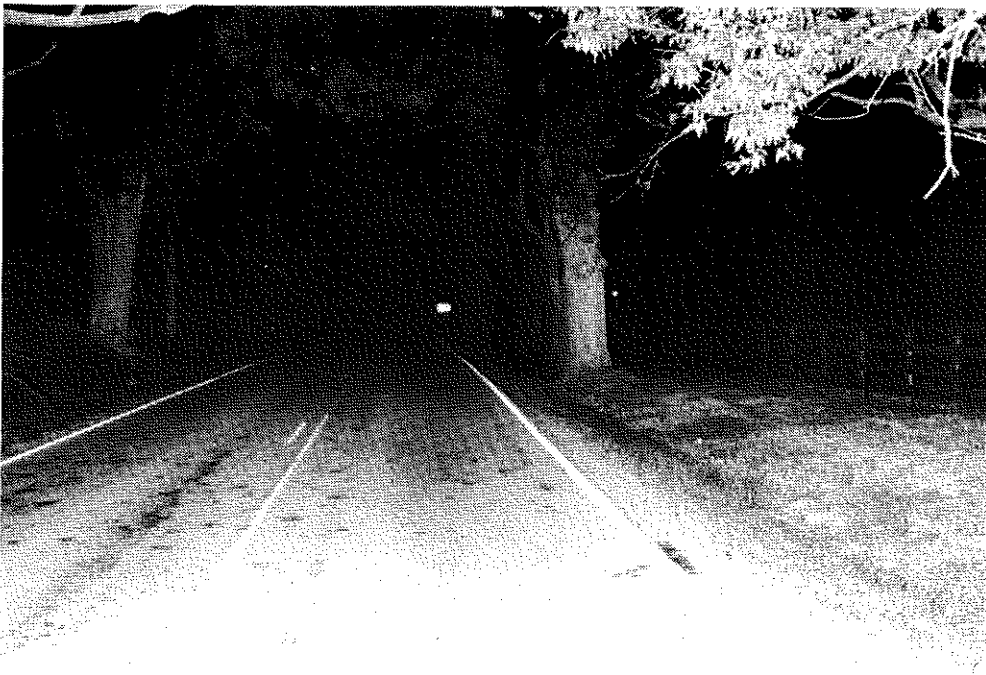
**Figure 28. Daytime and Nighttime Photographs of US 62 Location with No Added Delineation.**

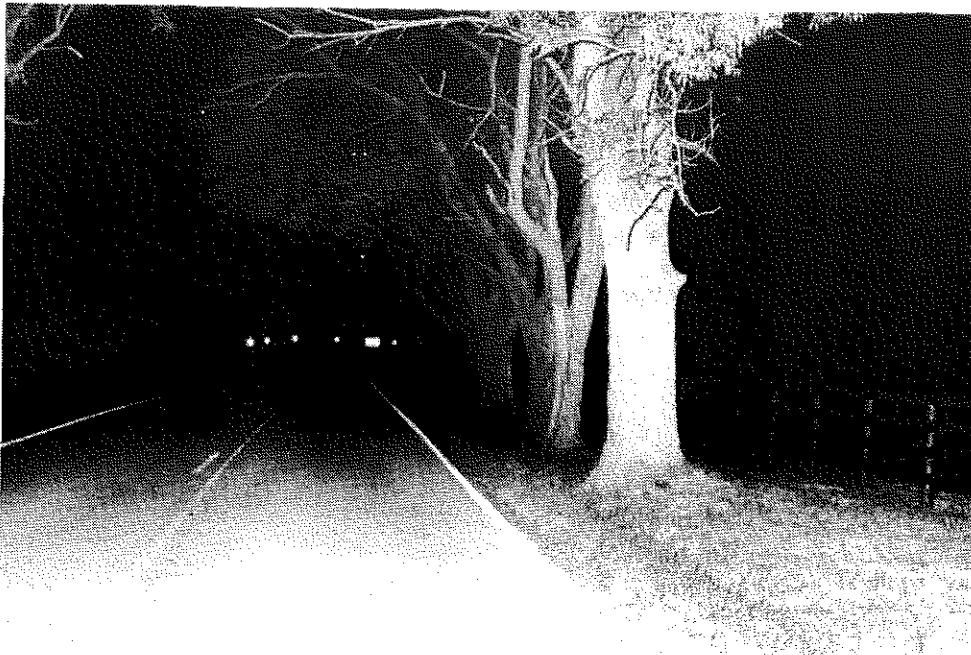
Figure 29. Nighttime Photograph of Post Delineators at US 62 Location Placed in a STD Configuration.

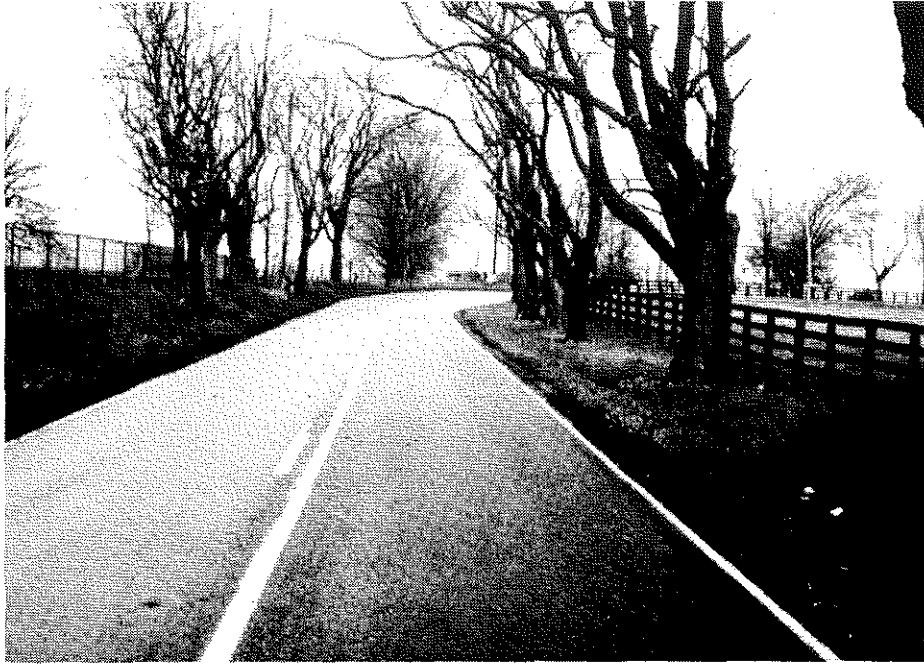
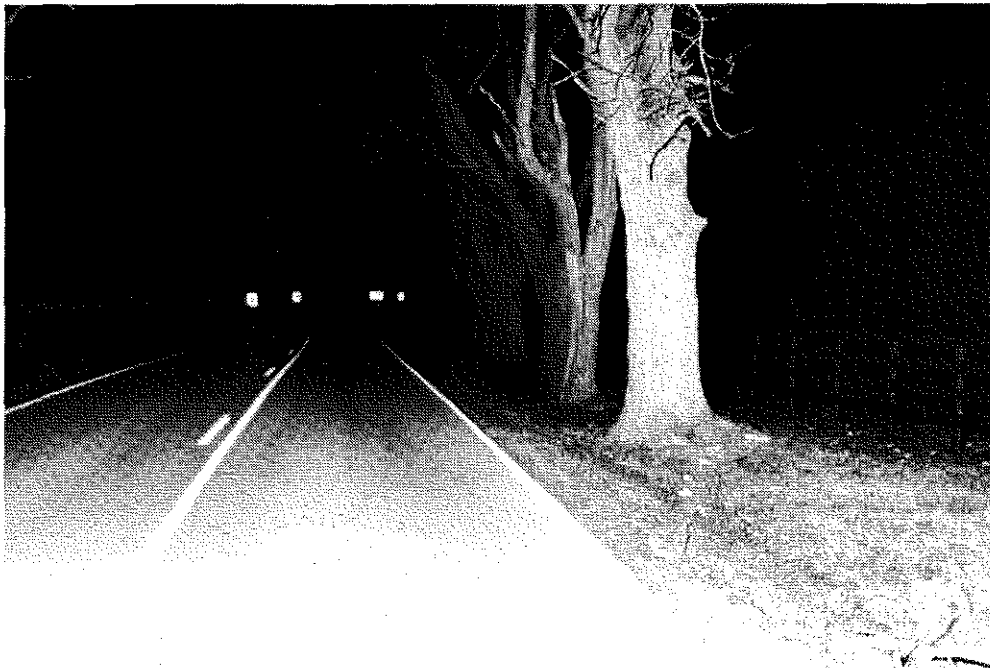
Figure 31. Daytime and Nighttime Photographs of Chevron Signs at US 62 Location Placed in a STD Configuration.
