1. Report No. UKTRP-86-4		2. Government Accession No.		3. Recipient's Catalog No.	
4. Title and Subtitle Delineation of Horizontal Curves				5. Report Date March 1986

Research Report  
UKTRP-86-4

DELINEATION OF HORIZONTAL CURVES

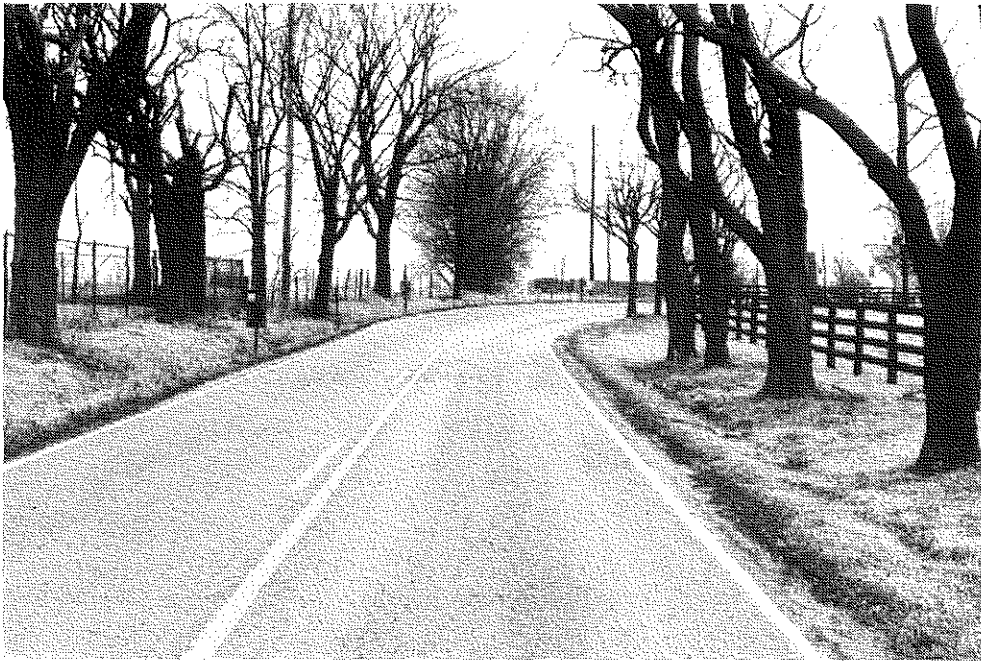
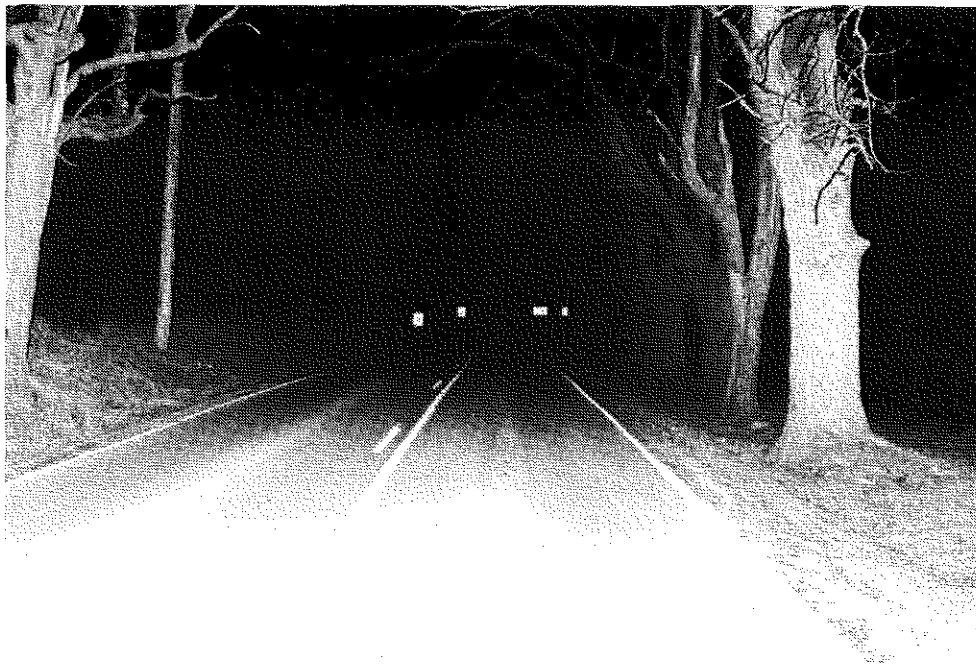
Figure 32. Daytime and Nighttime Photographs of Chevron Signs at US 62 Location Placed in an AE Configuration.

Daytime and nighttime photographs of the US-421 location with no added delineation are given in Figure 23. The nighttime delineation provided by post delineators placed in a standard configuration (at a 30-foot spacing) and in an ascending even (AE) configuration (nine delineators placed from 1.5 feet to 5.5 feet above the roadway surface at 0.5-foot increments) is shown in Figures 24 and 25, respectively. Daytime and nighttime photographs of the chevron signs placed in a standard configuration (at a 60-foot spacing) and in an ascending even (AE) configuration (four signs placed at 2.0, 2.5, 3.0, 3.5 feet above roadway surface) are shown in Figures 26 and 27, respectively. Daytime and nighttime photographs of the US-62 location with no added delineation are given in Figure 28. Nighttime delineation provided by post delineators placed in a standard configuration (at a 50-foot spacing) and in an ascending even pattern (eight delineators placed from 1.5 to 5.0 feet above the roadway surface at 0.5-foot increments) is shown in Figures 29 and 30, respectively. Daytime and nighttime photographs of the chevron signs placed in a standard configuration (at a 100-foot spacing and in an ascending even configuration) are shown in Figures 31 and 32, respectively.
