Research Report
UKTRP-82-14

SNOW-MELTING SYSTEM, 9th STREET AND I 64, LOUISVILLE

September 1982

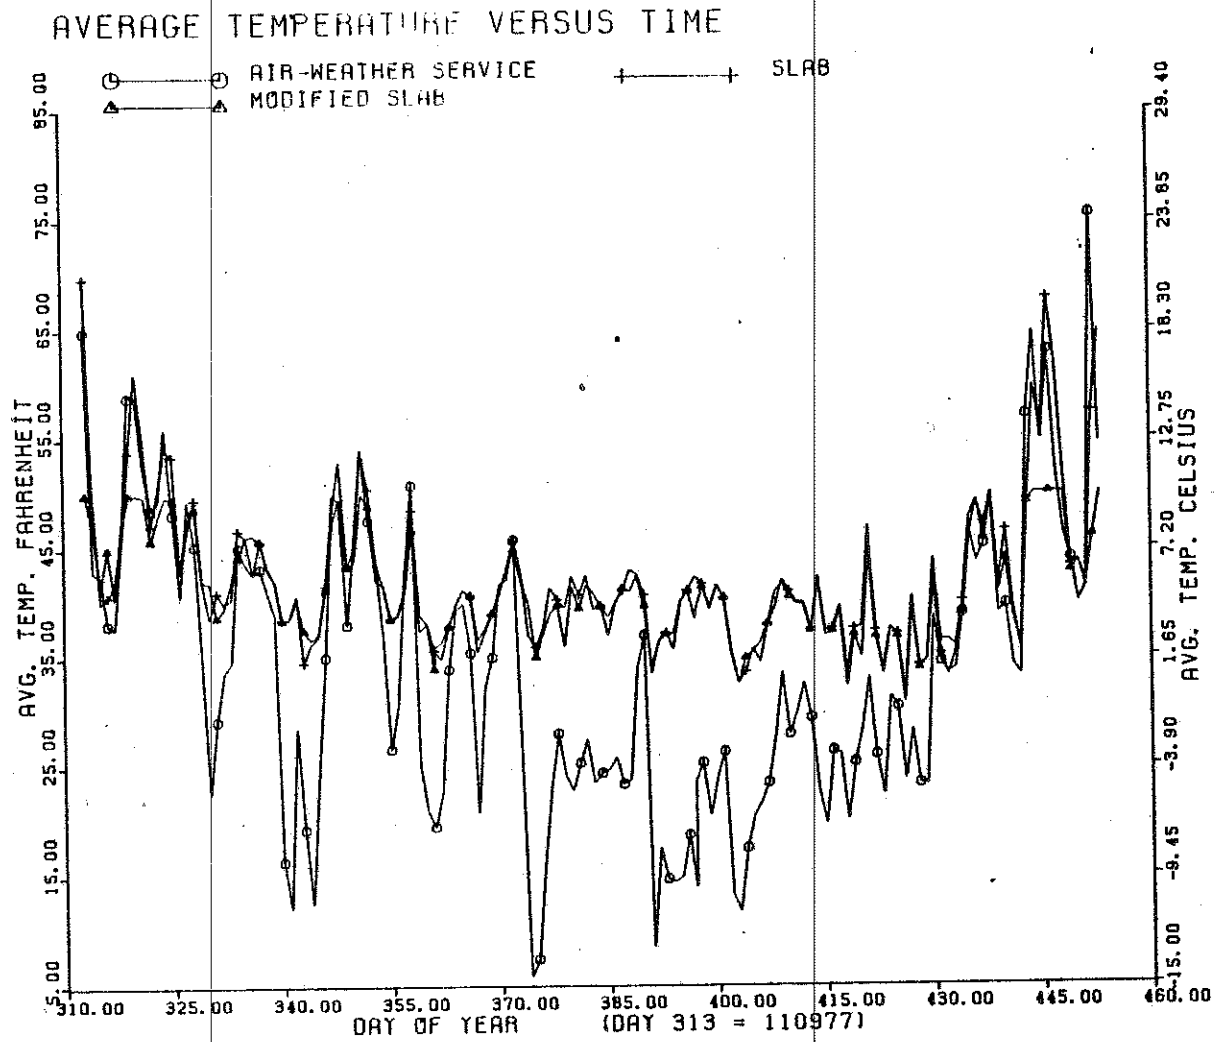
Figure 4. Average Temperatures; 1977-1978.

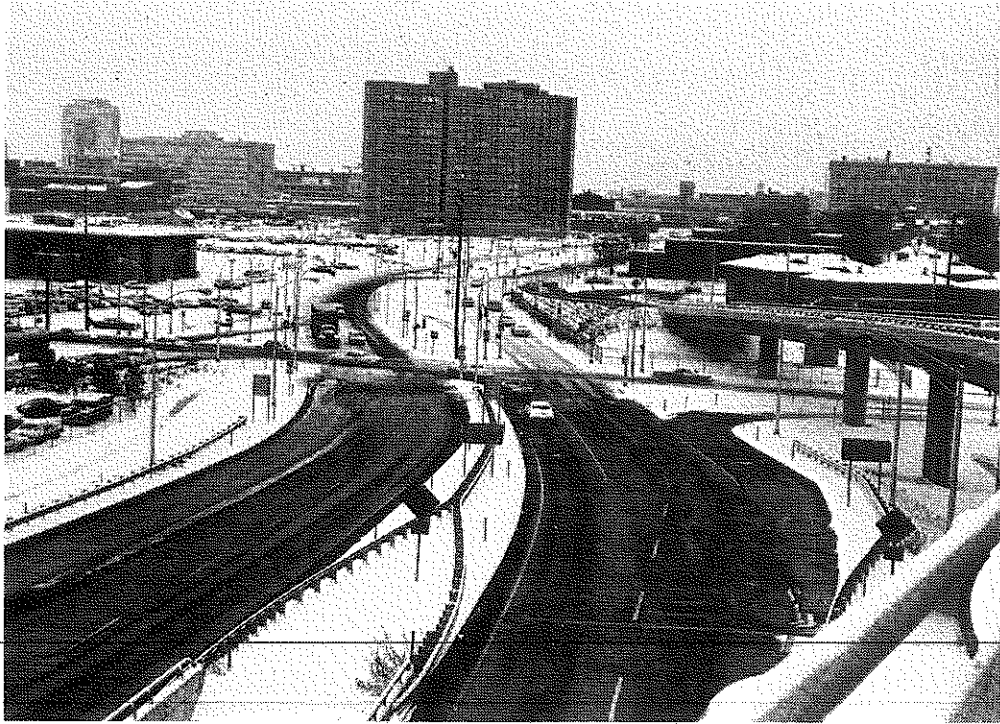
Figure 5. Snow Melting; March 14, 1978.

persisted during severe weather conditions. The snow- and ice-melting capabilities of the heating system performed beyond expectations. Operating expenses were high but seemed justified as the public grew accustomed to a "clear roads policy" at the interchange. The winter of 1977-1978 was the harshest on record for the Louisville area. Yet, during periods with as much as 10+ inches (280+ mm) of snow cover, the interchange remained clear and safe (Figure 5 and 6).

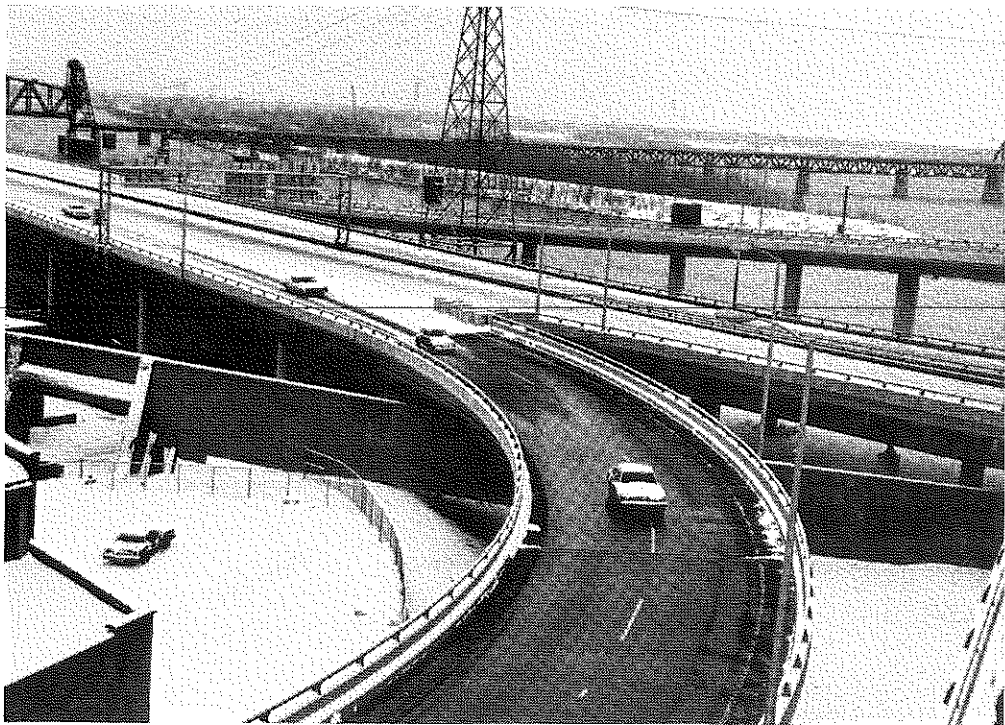
Figure 6. Snow Melting; March 14, 1978.

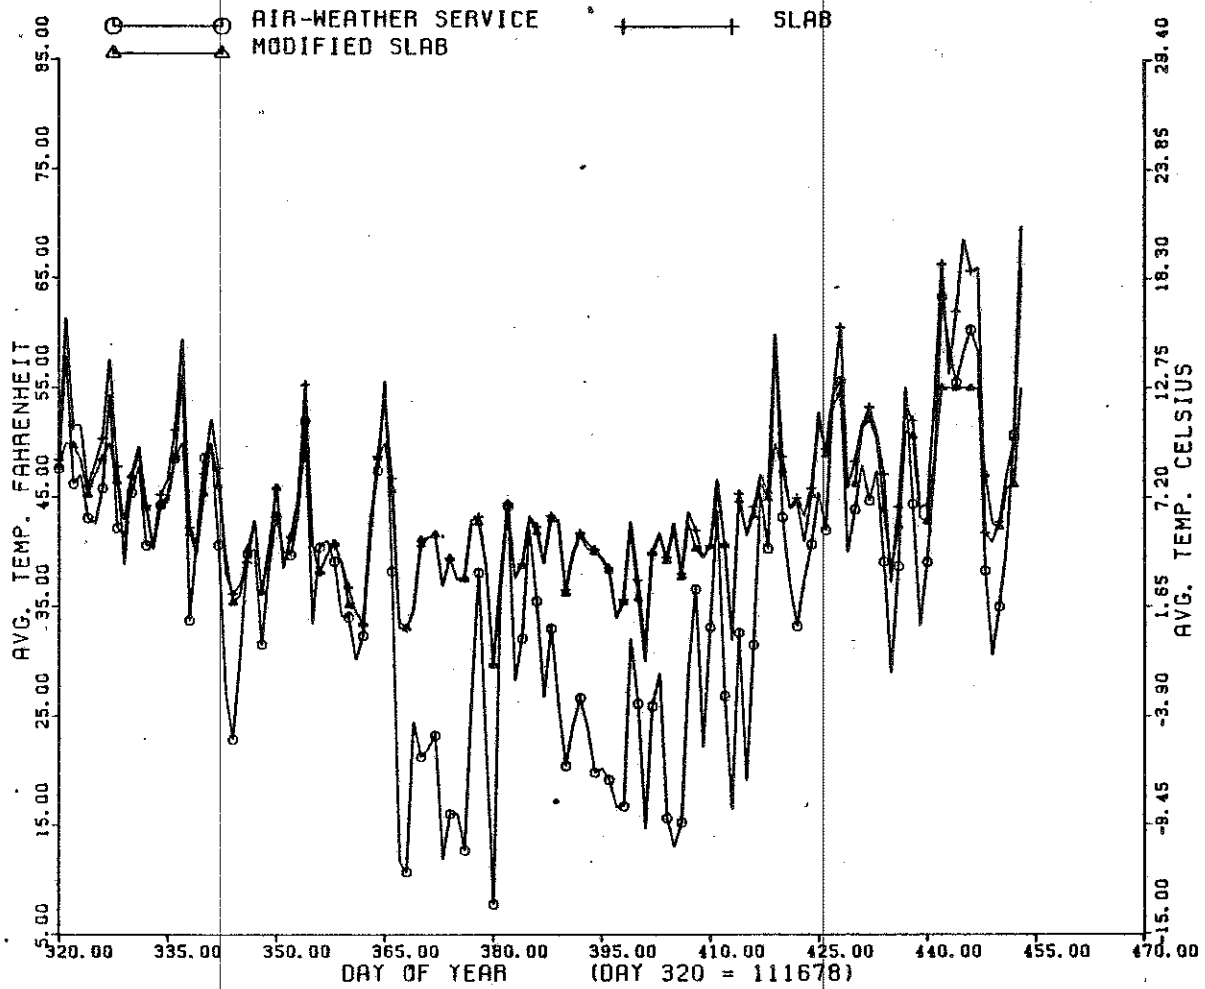
Figure 7. Average Temperatures; 1978-1979.

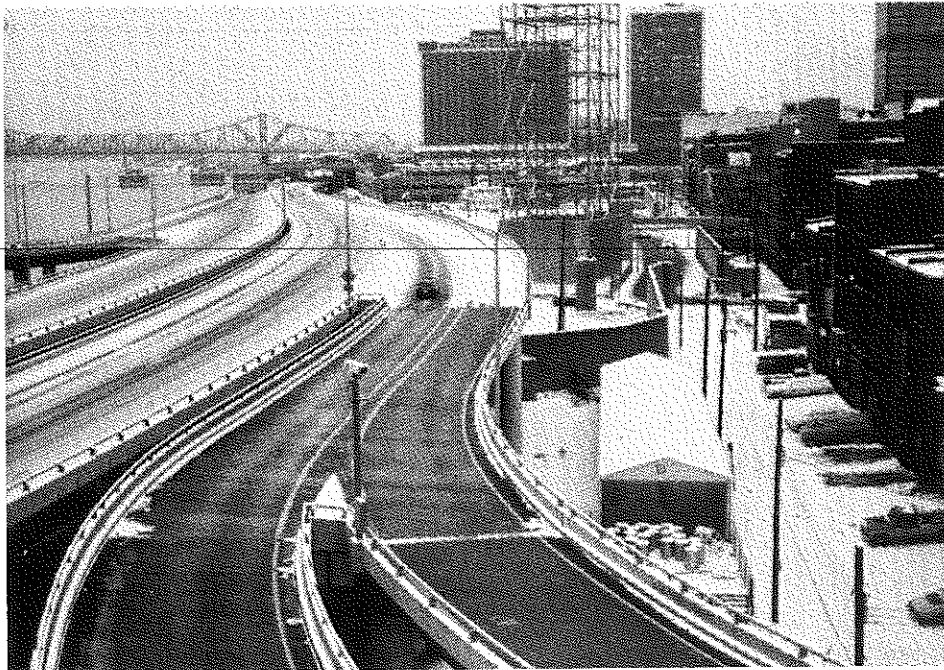
Figure 13. Inoperative Heating Cable (left curb); January 13, 1982.

Of the 201 separate heating circuits, 16 are inoperable due to low resistance. Three circuits have been rewired with two-pole breakers to utilize two of the three circuits which are of sufficient resistance. Five of the 16 inoperable circuits are on on-grade ramps; the remainder are on bridge ramps. Moisture intrusion in or around the heating cables lowers their resistance to ground and renders them inoperable. Figures 12, 13, and 14 show sections where cables have been turned off. Periodic energizing of the system is necessary to minimize intrusion of moisture. A circuit that has become inoperable due to low resistance (moisture intrusion) may be rejuvenated with repeated energizing to "dry out" the circuit.
