Research Report  
494

**HEATING BRIDGE DECKS  
BY ELECTRICAL RESISTANCE**

## HEATING BRIDGE DECKS BY ELECTRICAL RESISTANCE

James H. Havens, W. Vernon Azevedo, Assaf S. Rahal, and Robert C. Deen, Kentucky Department of Transportation

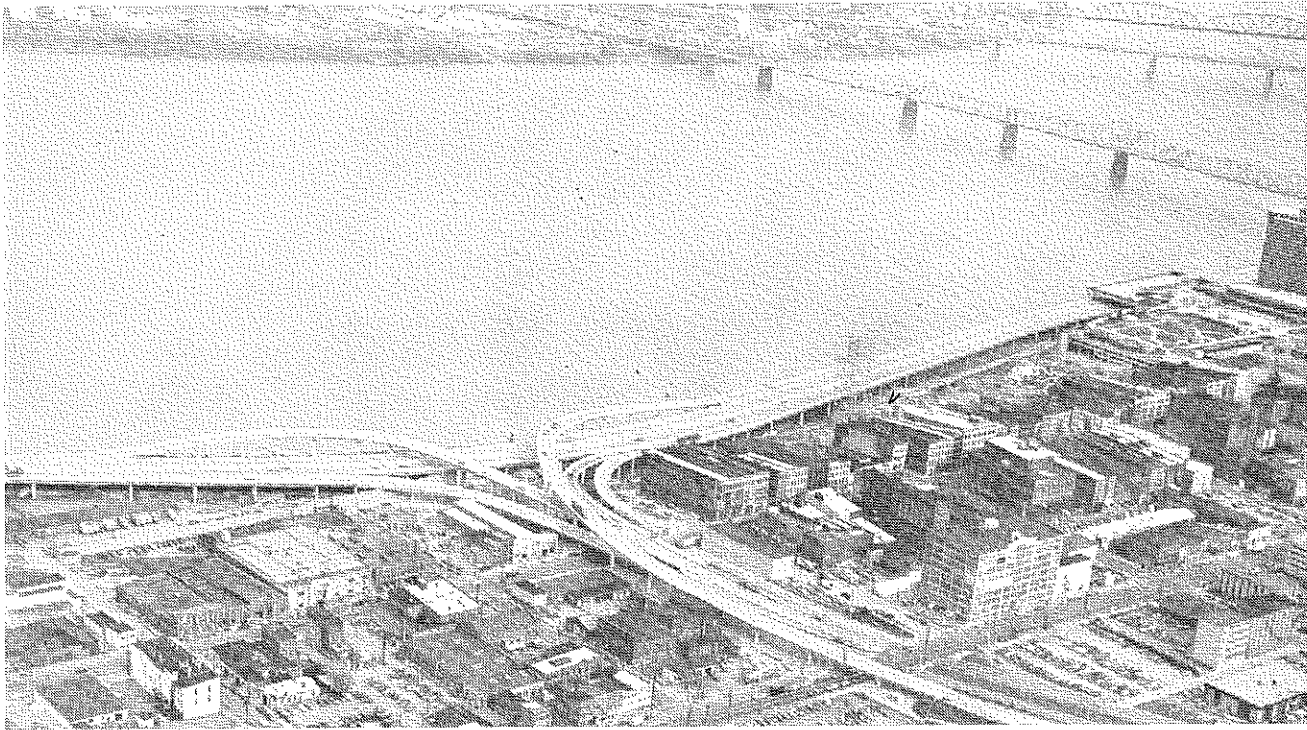
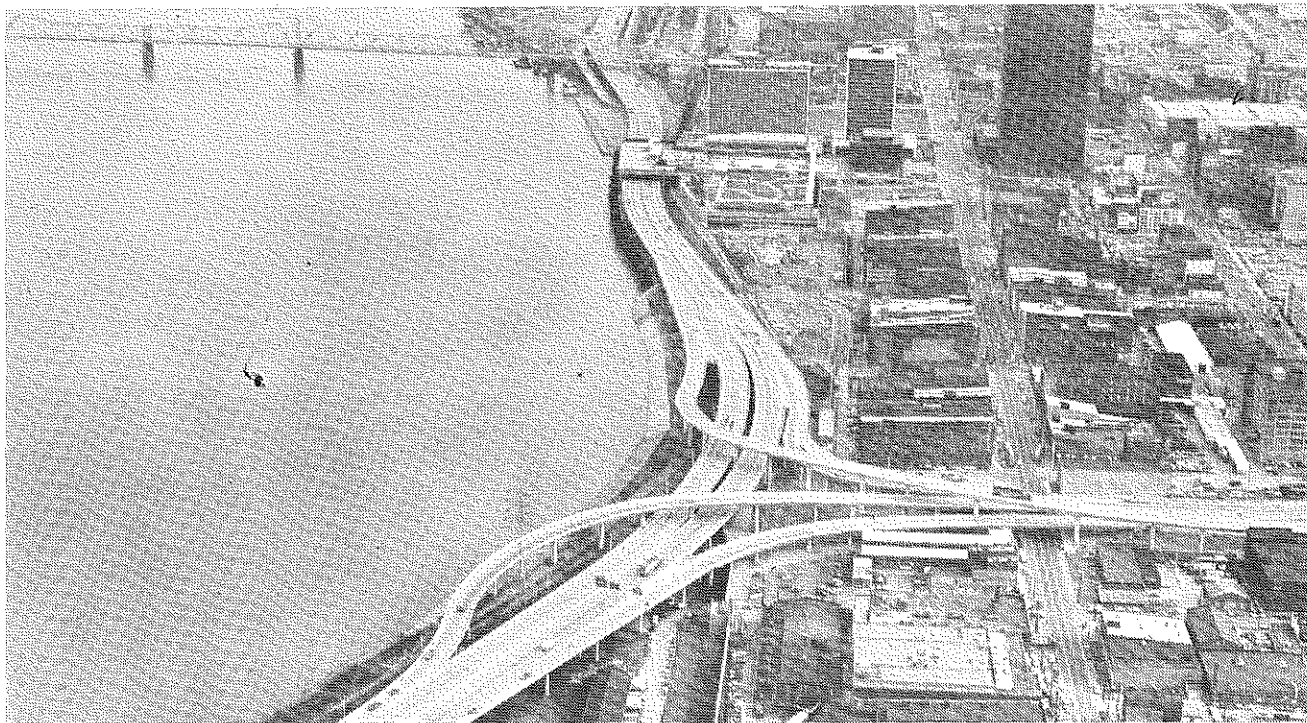
megohms. As concreting continued, the damaged cable was removed from the fresh concrete and a replacement cable was installed in its place. The replacement cable was tied at irregular intervals with copper wire. The concrete was replaced around the new cable and floated by hand. No re-vibration of the concrete occurred. The completed interchange is shown in two aerial photos taken December 2, 1977 (Figures 11 and 12).

Figure 11. 9th-Street Interchange, Looking toward River.

Figure 12. 9th-Street Interchange, Looking Upstream.

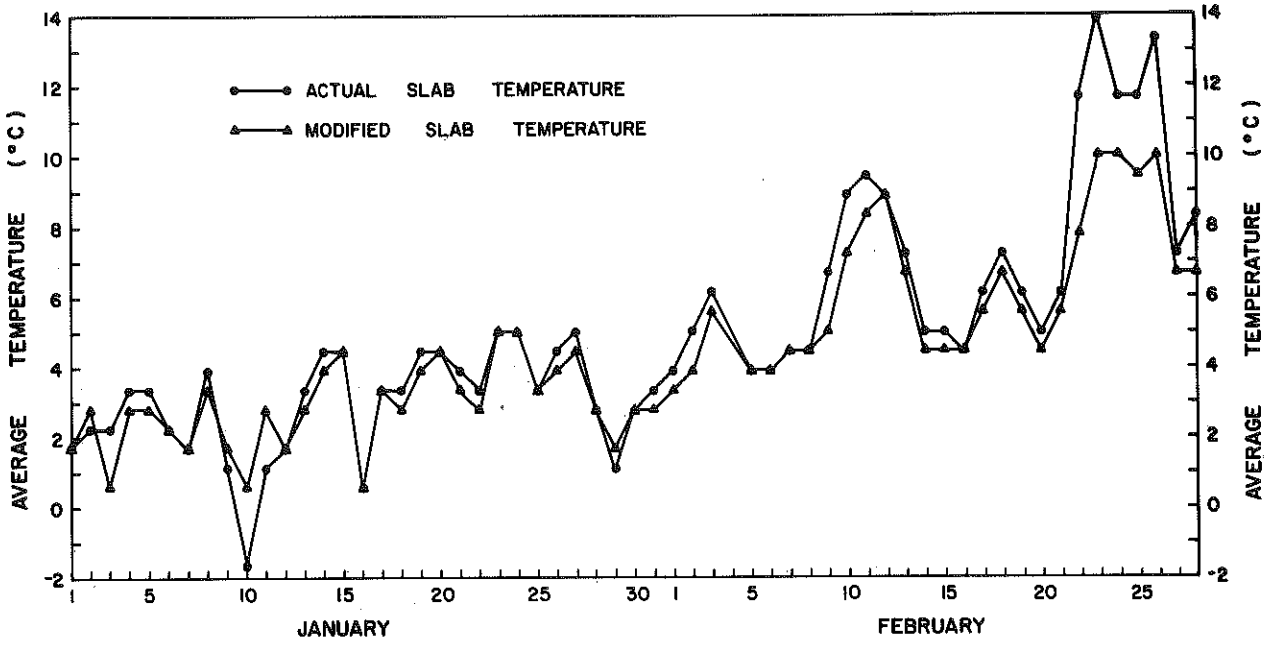
Figure 18. Average Temperature Versus Time (January and February).

Heating the 9th-Street interchange on the probability of snow appears to be an advantage over other roadway heating systems. Such an approach does not require "catch-up" time after a snowfall to clear a pavement but rather keeps the interchange clear as the snow falls. Figures 18 and 19 show the actual slab temperature compared to the modified slab temperature as computed by the master controller for the period January 1, 1977, to April

16, 1977. The average modified slab temperature is slightly lower than the average actual slab temperature throughout this period because the heating system is based on the probability rather than the actual occurrence of bad weather. In Figures 18 and 19, any average modified slab temperature above  $10^{\circ}\text{C}$  ( $50^{\circ}\text{F}$ ) is recorded as  $13^{\circ}\text{C}$  ( $55^{\circ}\text{F}$ ).
