Research Report  
481

**KENTUCKY'S  
PAVEMENT MANAGEMENT  
SYSTEM**

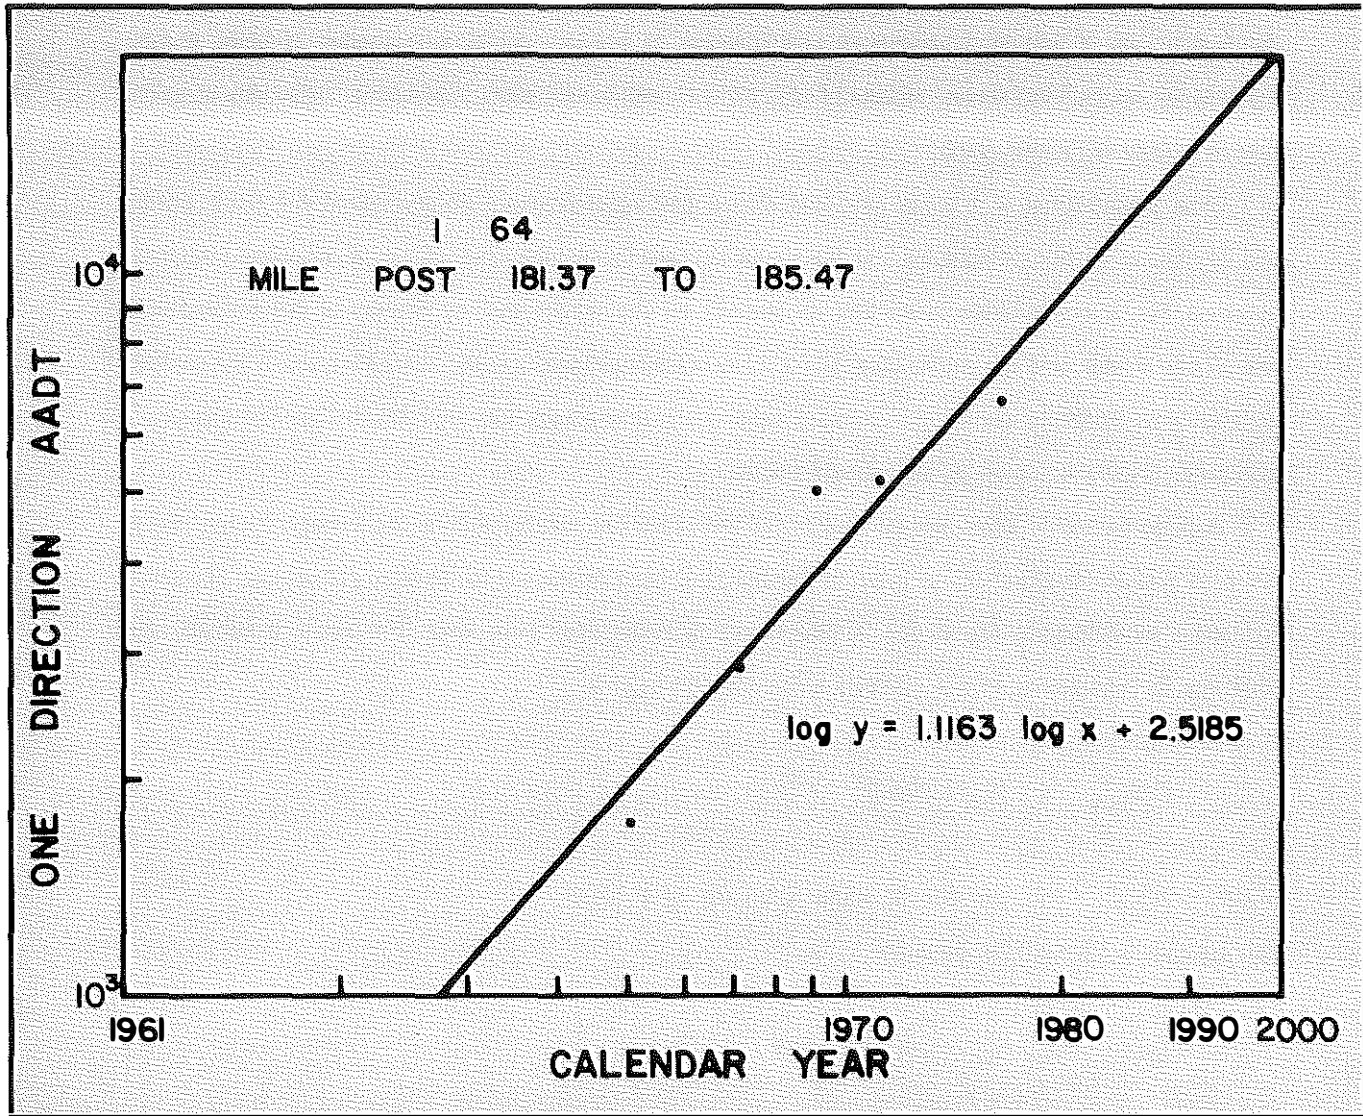
Figure 3. AADT versus Calendar Year.

3 had to be applied in two stages where the AADT had already approached the capacity and could not sustain the same growth rate through 1995. This procedure was applied to each interchange-to-interchange length.

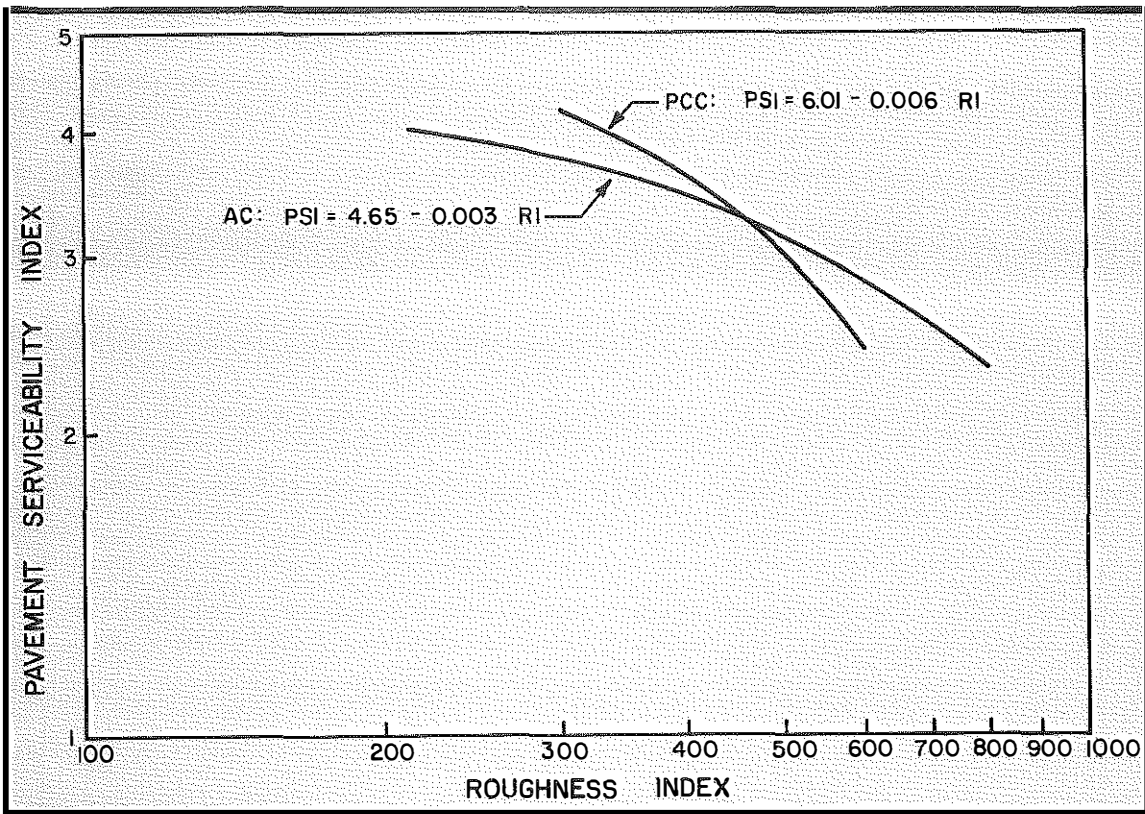
Figure 14. Serviceability Index versus Roughness Index.

Roughness measurements indicated a relatively low serviceability index (Figure 14) and corresponded to different levels of deterioration. Weaker areas were analyzed using Road Rater readings as entrance values to appropriate portions of Figure 12 and the equivalent structure was determined to be approximately 5 inches (125 mm) of AC on 14 inches (355 mm) of DGA. Such analyses permitted the development of Figure 15.

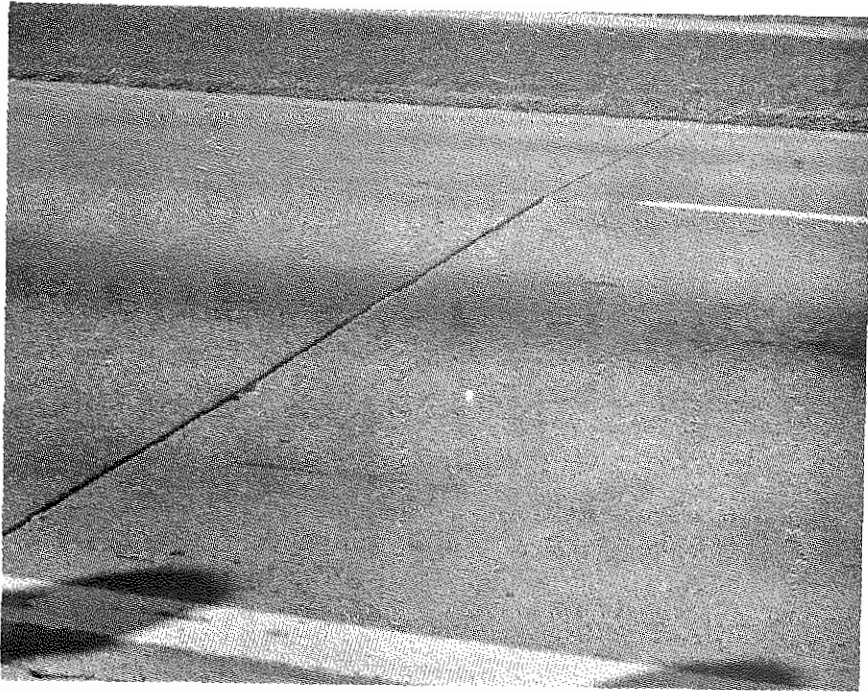
Figures 17 and 18 show deterioration mechanisms which were unanticipated in design but which emerged after the half-life stage. In Figure 17, frozen or misaligned dowel bars prevented the normal function of a contraction joint. The joint in the inside lane (in the background) remains locked; that joint in the outer lane is faulted (upthrust, creating a drop-off). Figure 18 shows a severe faulted crack following and between dowelled-but-locked (non-functioning) contraction joints. Successive or intermittent occurrences of this defect suffices to render a pavement unserviceable (as having a low PSR).

**Figure 17.    Faulting of a Sawed, Doweled, Contraction Joint; Outer Lane.**

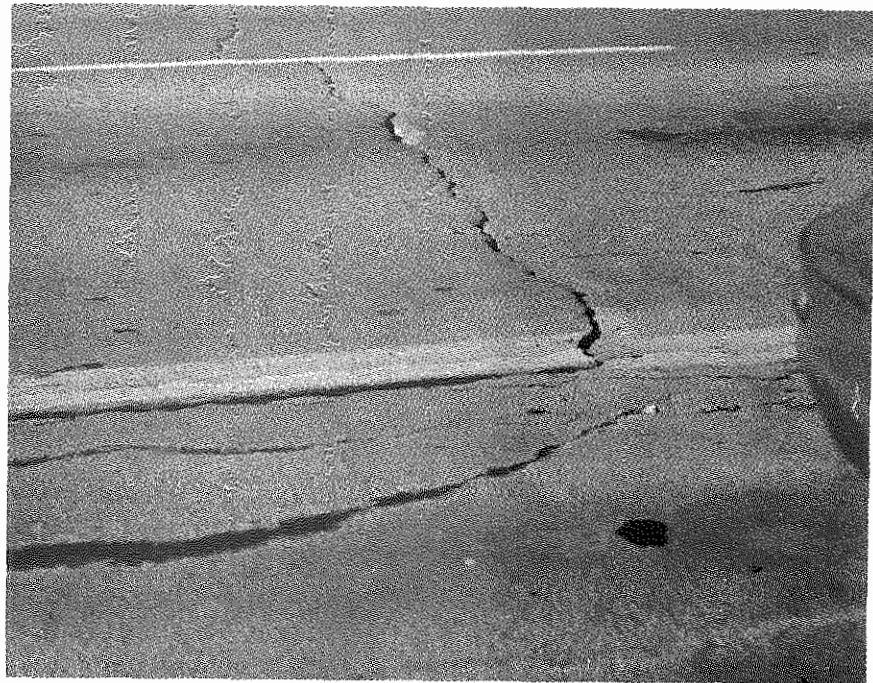
**Figure 18.    Severe Faulting of a Crack Midway between Non-Functioning Contraction Joints.**

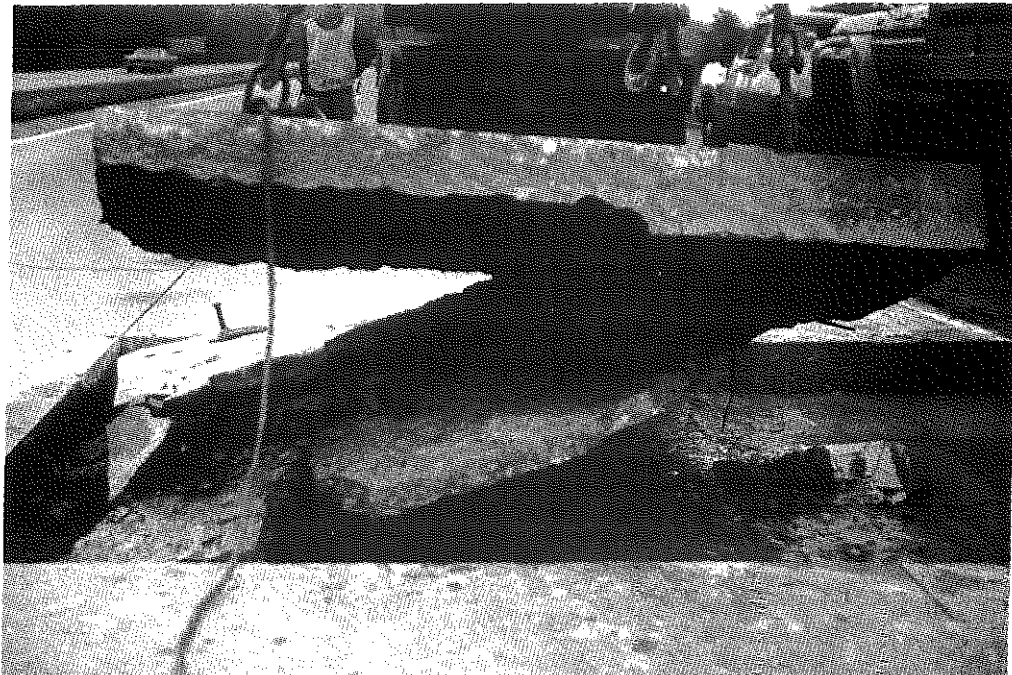
Figures 19 and 20 show similar deterioration at a joint advancing in both lanes and near-horizontal splitting of the slabs. The pavement as shown in Figure 19 has been sawed preparatory to lifting the section for examination (18).

**Figure 20.** Exposed Joint and Surrounding Concrete; Same Site as Shown in Figure 19.

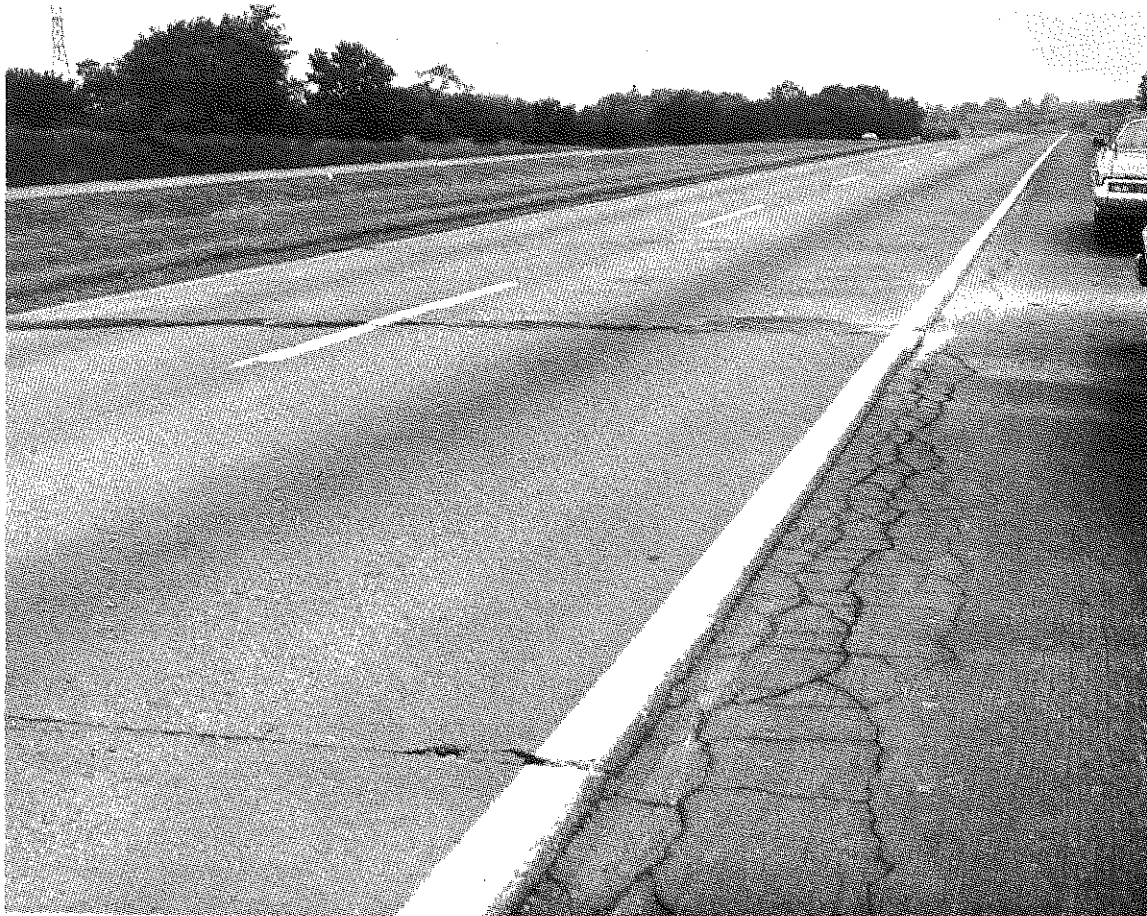
Figures 21 and 22 show progressive deterioration arising from severe temperature compression in a PCC pavement designed with sawed (reduced-section-type) contraction joints only (i.e., expansion joints were not provided). The interval between upheavals (small blowups) depends greatly on the strength of the concrete and the amount and regularity of deterioration at each joint. The greater interval ranges between two-tenths mile and a mile (0.3 kilometer and 1.6 kilometers). Minor deterioration is evident in the foreground of Figure 21; the blowup type is in the middleground. In Figure 22, the deterioration progressed from so-called D-cracking (18).

**Figure 21. Progressive Deterioration, Arising from Temperature Compression; Sawed, Doweled, Contraction Joints.**

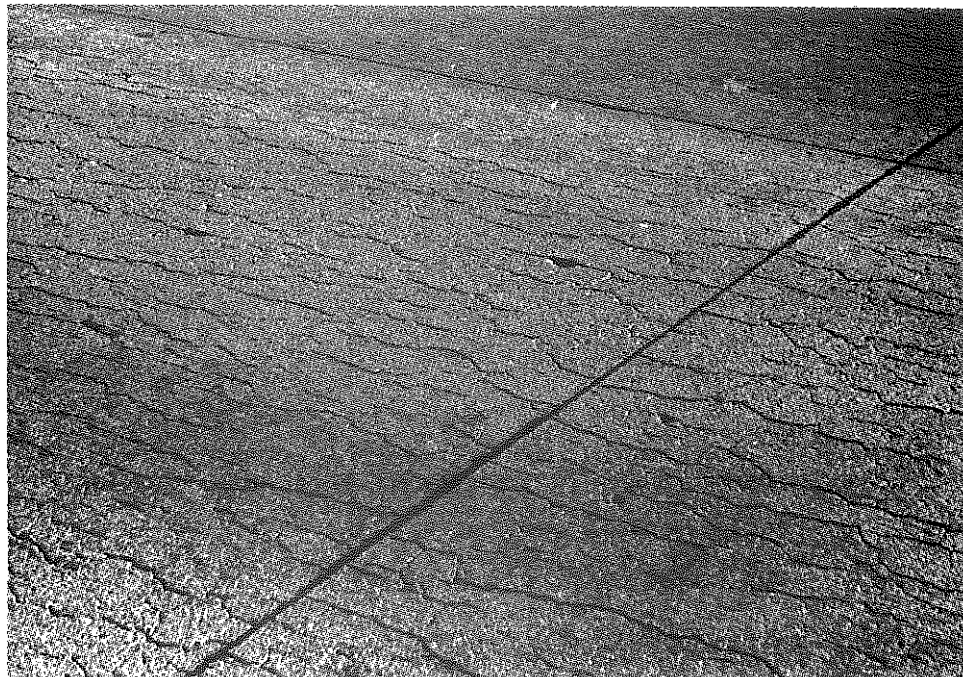
**Figure 24. Surface Cracking, Symptomatic of Expansive Aggregate.**

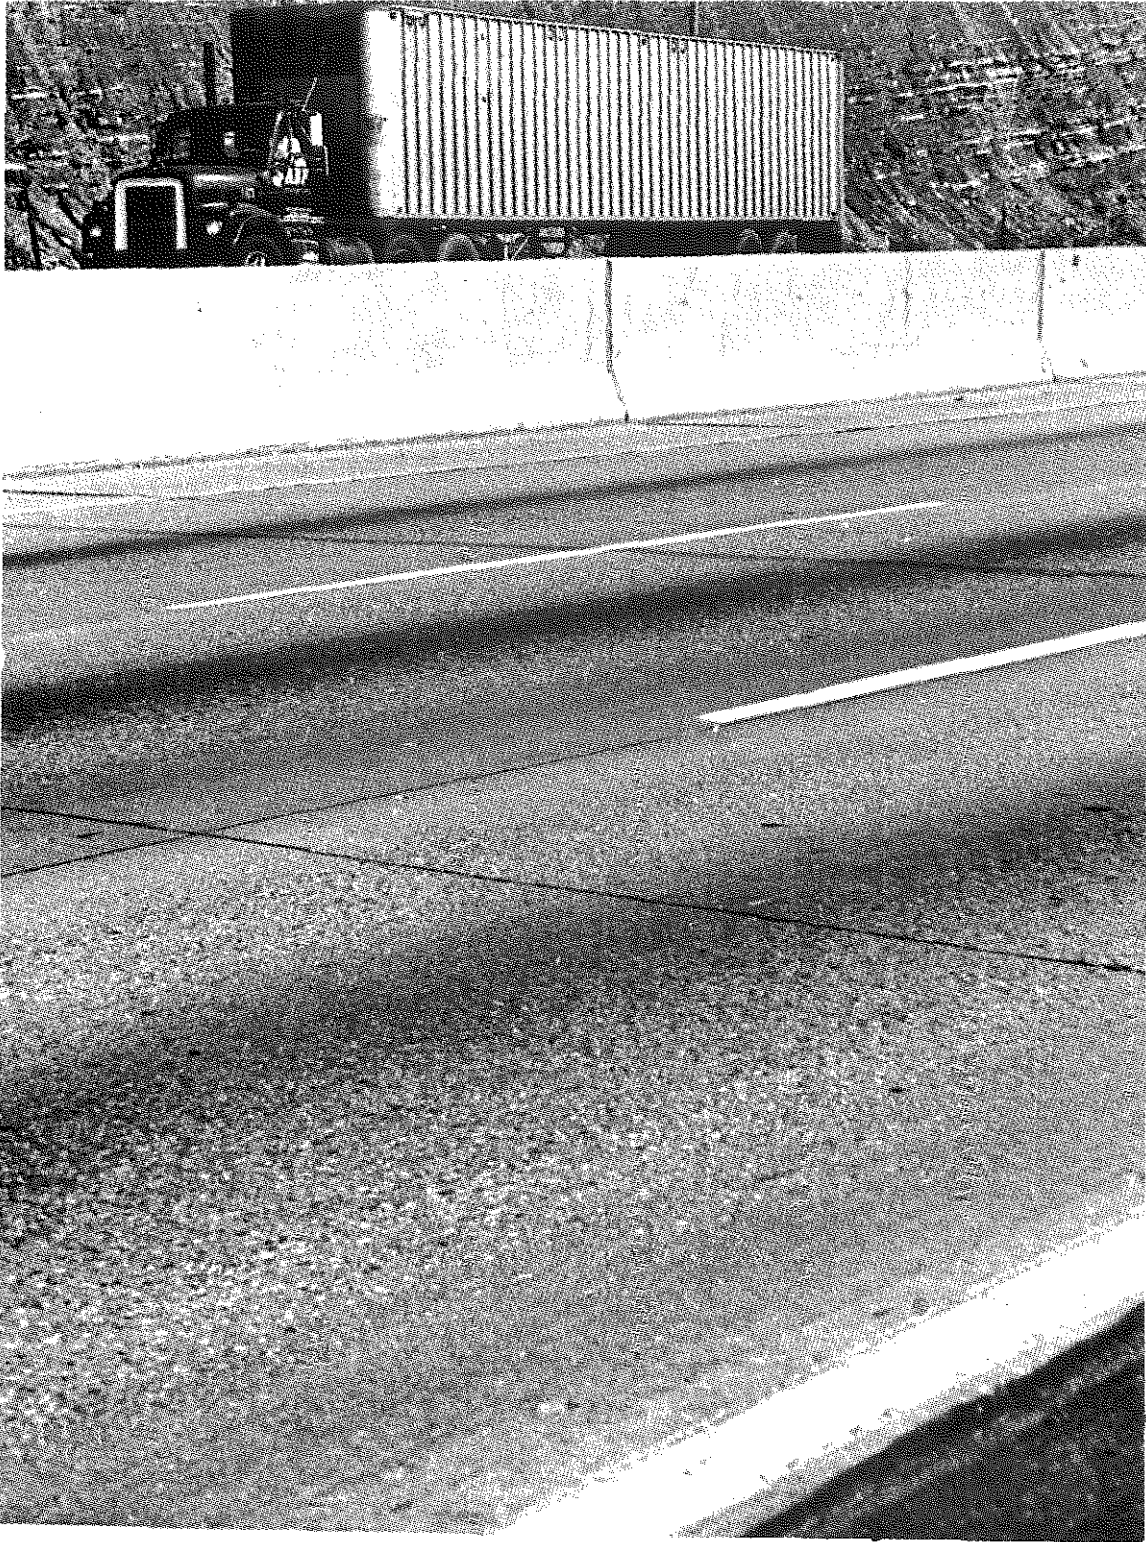
Figure 25 illustrates the now-common problem of wear and rutting caused by studded tires running on PCC-type pavements. Because of slipperiness and channelized flow of water in the ruts, this section

Figure 25. Wear and Rutting, Attributed to Studded Tires.

of pavement was overlaid (See Appendix, I 75, Covington, MP 190, approximately). A thin leveling course of asphaltic concrete and an open-graded friction course were applied. Traffic was maintained. The surface course raveled -- but remains unrepaired (a deferred action).

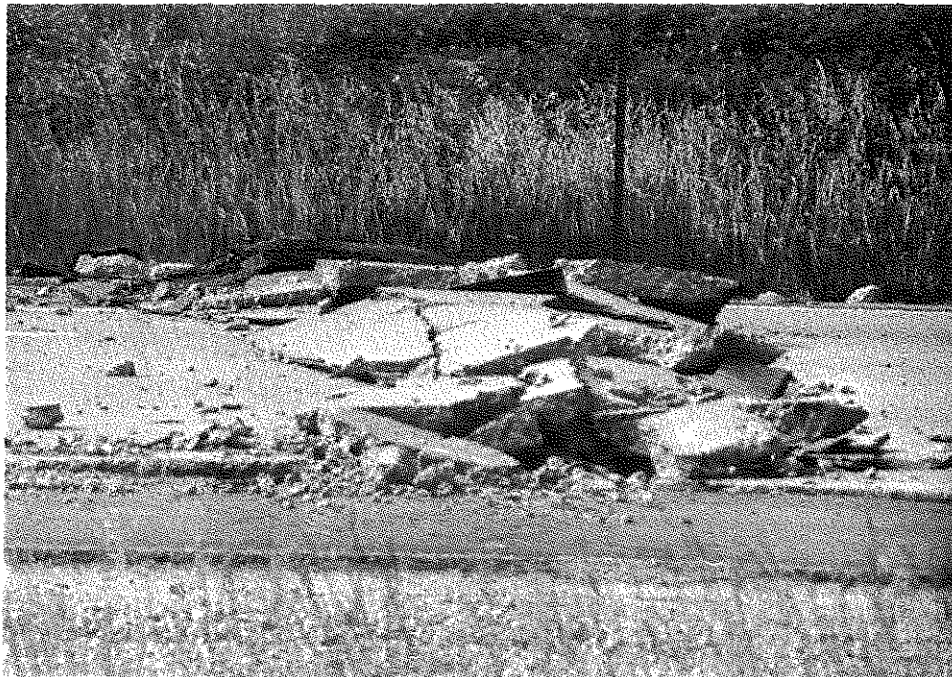
Figure 27. Explosive Upheaval in a CRC-Type Pavement.

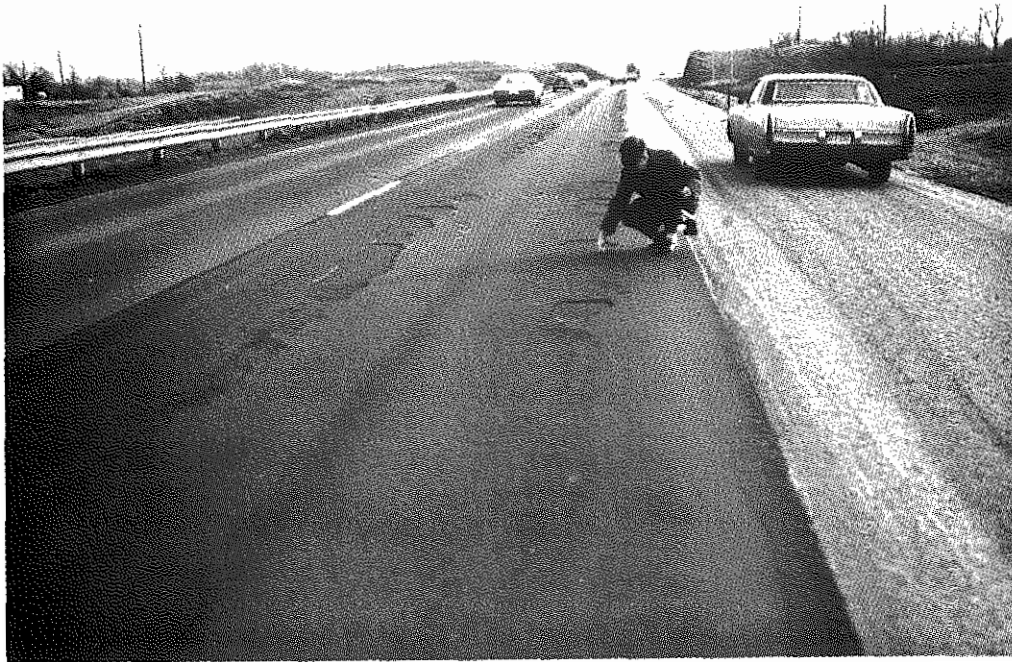
Figure 28 shows a section of Interstate 75 which was overlaid (eligible for extension of service life to 1984) with bituminous concrete; traffic was maintained; bleeding and slickness developed; it was overlaid again with a sand-asphalt -- which proved to be unstable and scaled in the manner shown. This is a typical failing of low-stability, lean sand-asphalts and is traceable through the 1920's and 1930's and through the long history of Kentucky Rock Asphalt. The portion of the road shown was surfaced again (lastly) with bituminous concrete.

Figure 28. Scaling of an Unstable Sand-Asphalt.

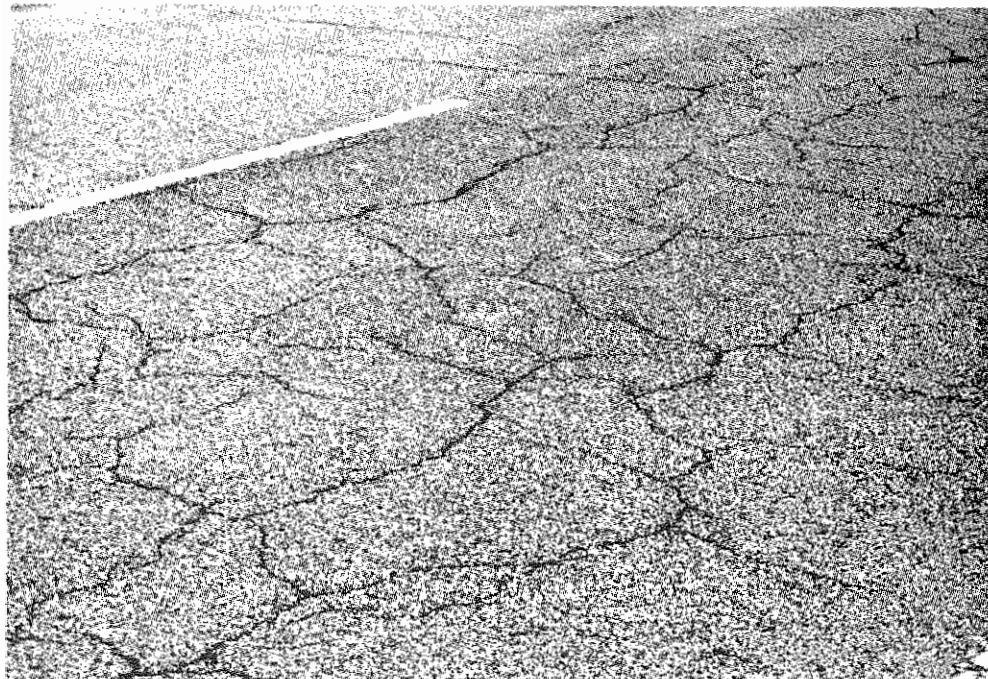
Figure 29 illustrates an unfortunate type of cracking in a relatively low-volume section of Interstate 64. Opinions differed as to the cause. The core in Figure 30 shows the typically shallow depth of the cracks (in surface course only). Roller marks persisted and were visible on the surface until it was overlaid. The possibility remained that the cracks had been induced by the compaction equipment (roller) at the time of construction and merely became evident after weathering and surface erosion. Figure 31 further illustrates an unfortunate tendency for glazing to occur in wheelpaths following bituminous resurfacing when traffic is maintained (no curing or setting time provided).

Figure 29. Cracking in an Asphaltic Concrete Surface Course.

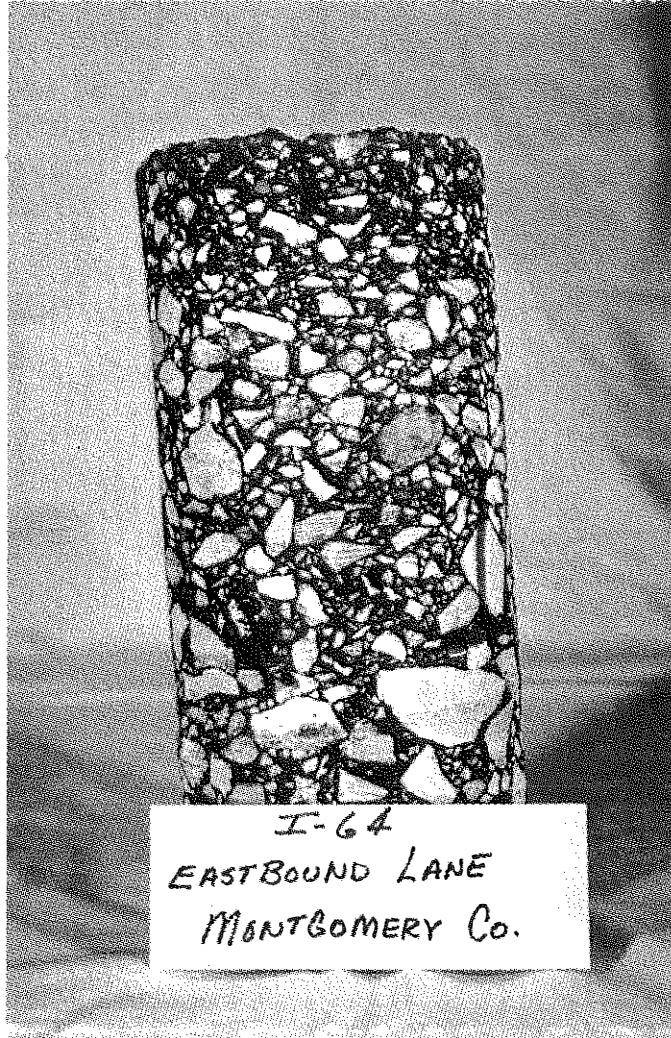
Figure 30. Core Showing Shallow Cracking; Surface Course.

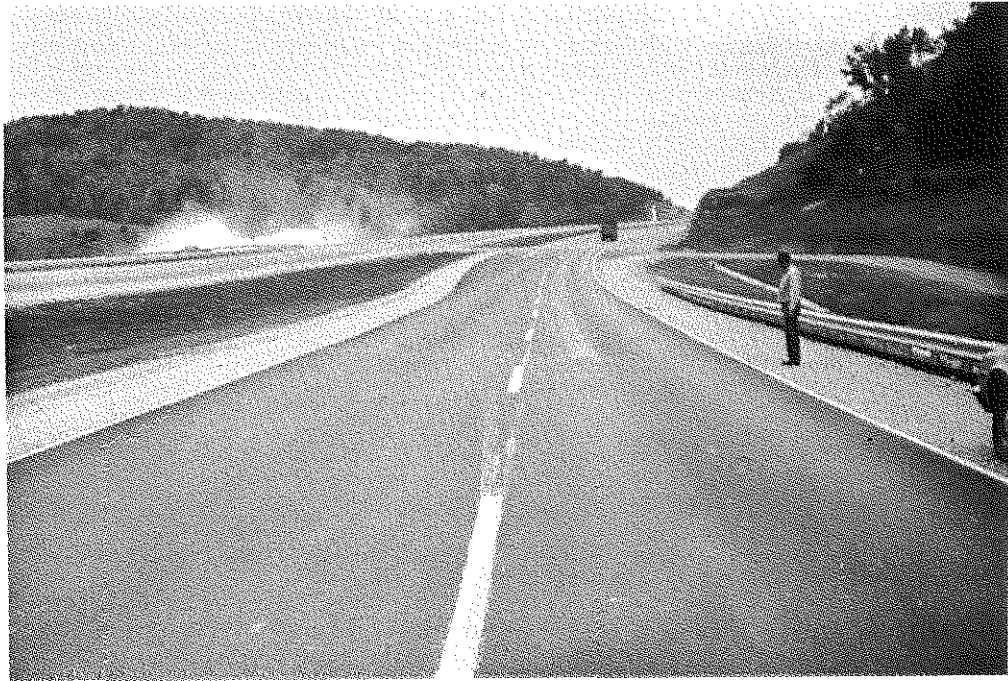
**Figure 31. New Asphaltic Concrete Surface Constructed under Traffic; Tendency for Glazing and Apparent Bleeding Shown in Background.**

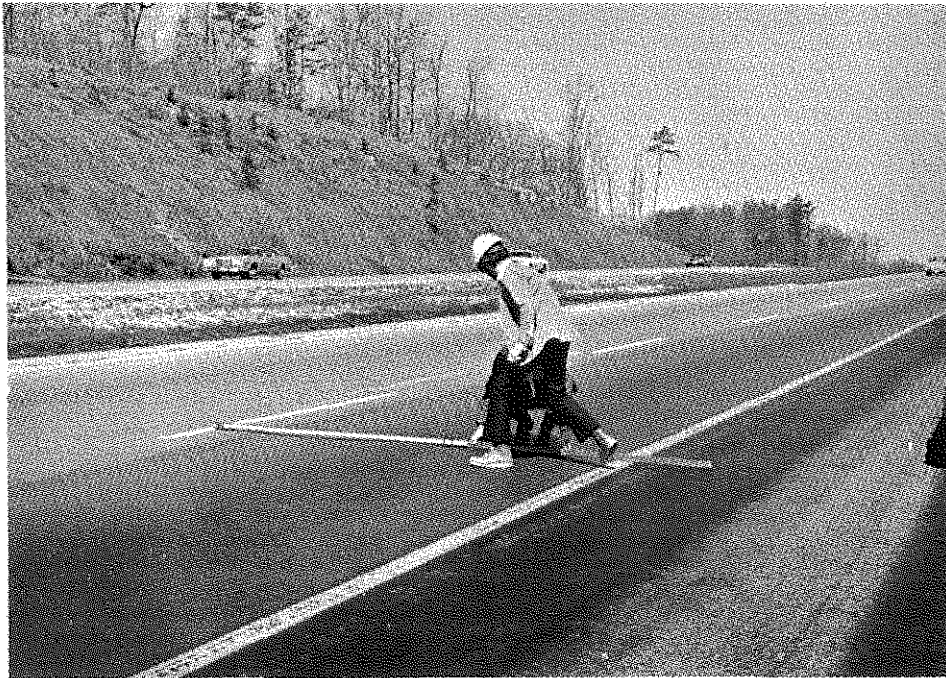
**Figure 32. Tendency toward Rutting in Asphaltic Concrete Pavements Carrying Heavy Traffic.**

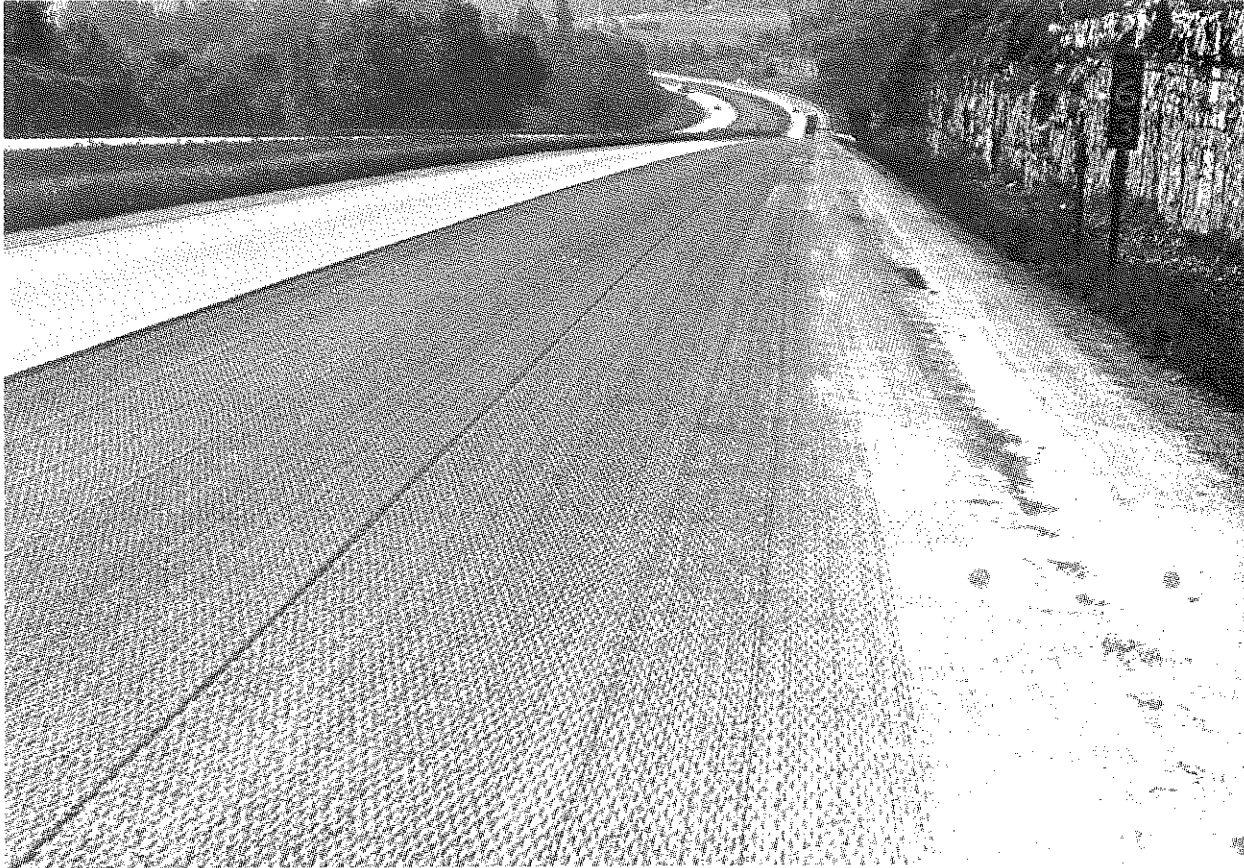
**Figure 33. Texture Produced by Planing Rutted Asphaltic Concrete Pavement; CMI Roto-Mill.**

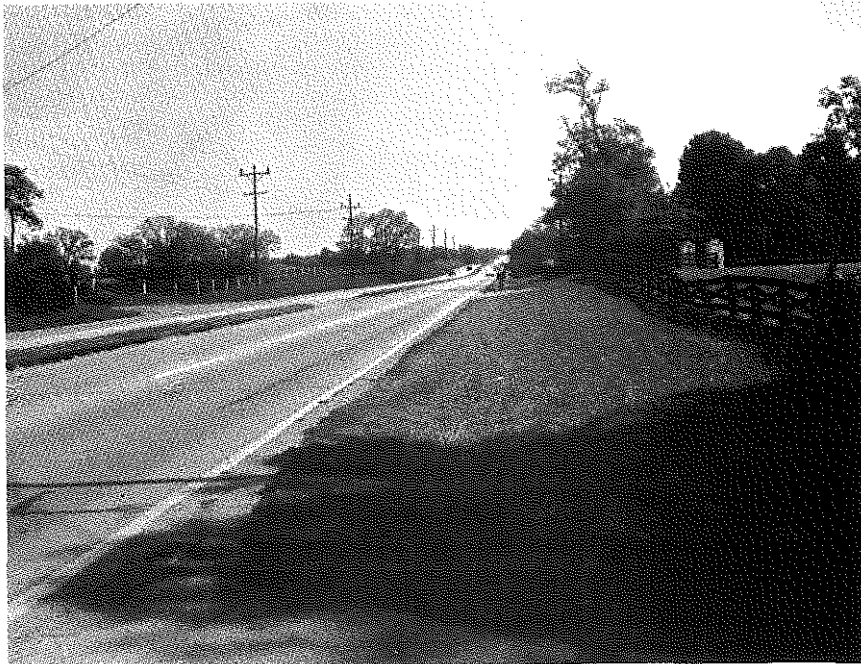
Fayette-Woodford Counties; US 60; From Lexington to Versailles; Widened and Overlaid in 1965; Recent Photo.

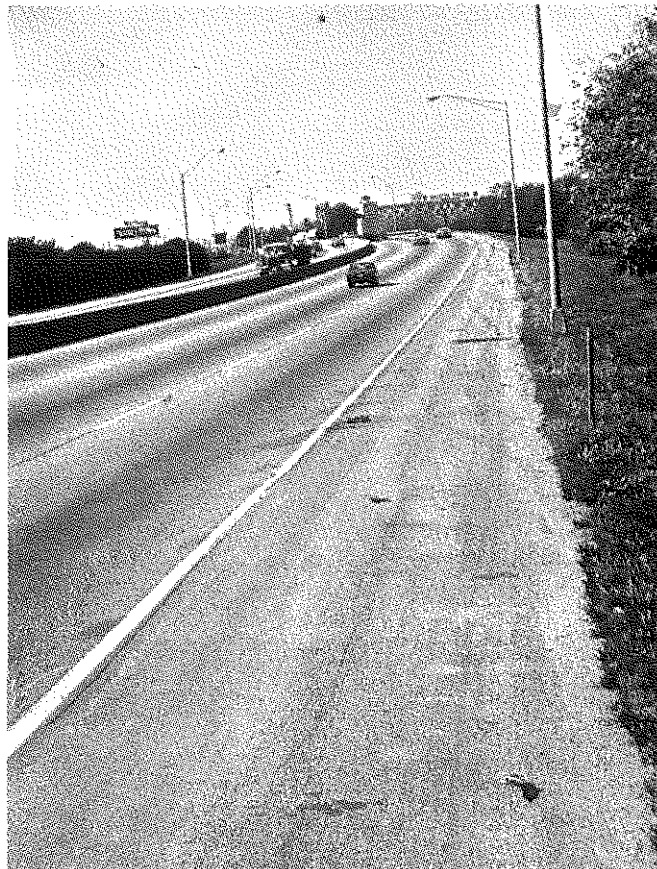
Jefferson County; I 65; North-South Expressway; From Watterson Expressway to Woodbine; Inside Lanes, Median Barrier, and Overlay Added in 1970; Recent Photo.

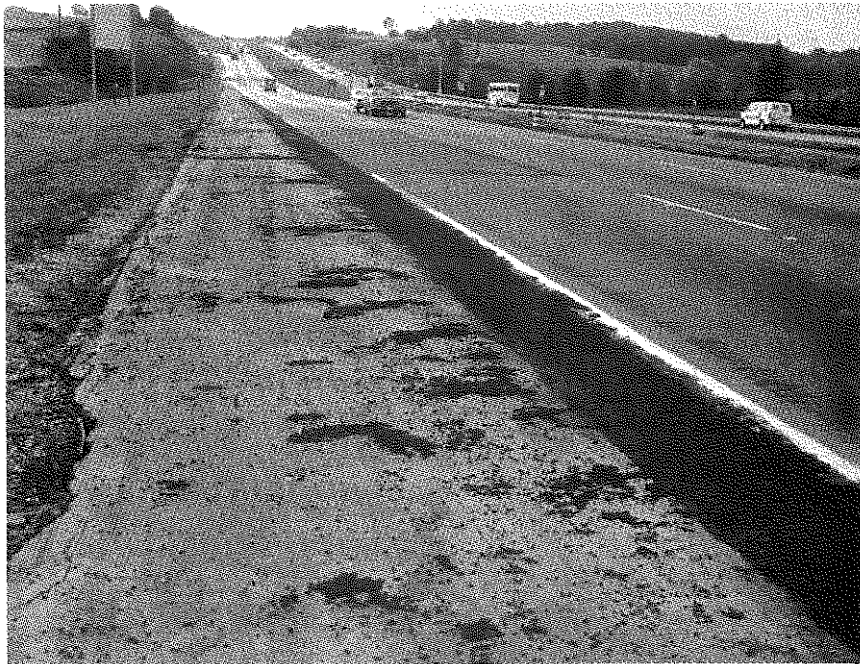
**Boone County; I 75; From I 71 to US 42; Shows R-R-R Work in Progress; Lane-wide Patch Covers Area Fragmented after Proof-rolling; Narrow Patch Covers New, Plastic Drain Pipe; Inner Lane and Concrete Barrier Will Be Added.**

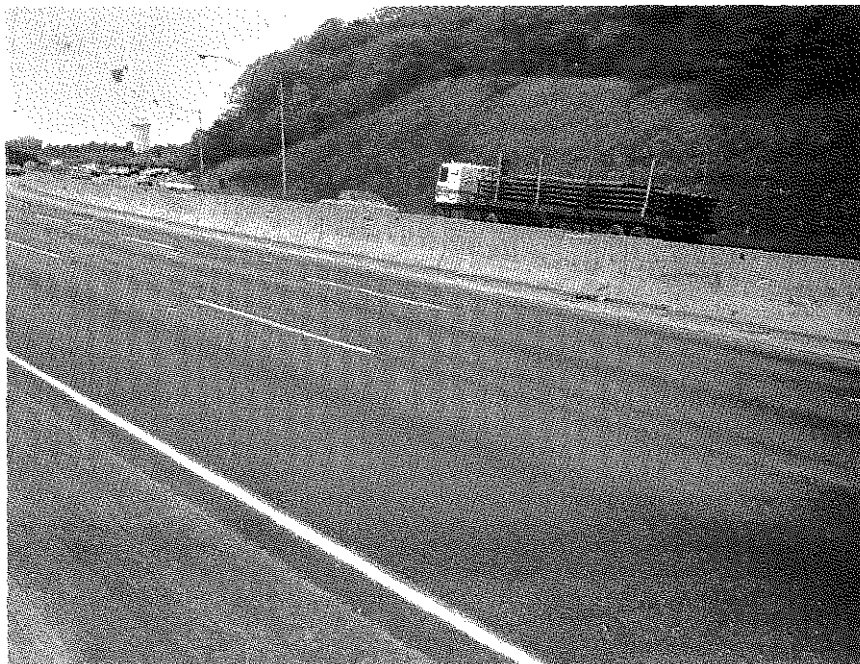
Kenton County; I 75 From US 25 - US 42 Interchange to the Ohio River; Revised in 1969; Recent Photo. Companion Photo Shows Open-graded Overlay Added to Northbound Lanes in 1976.
