Research Report
433

**TRANSVERSE, PAVEMENT MARKINGS FOR SPEED
CONTROL AND ACCIDENT REDUCTION**

KYP-72-40, HPR-PL-1(11), Part III-B

Kenneth R. Agent
Research Engineer Senior

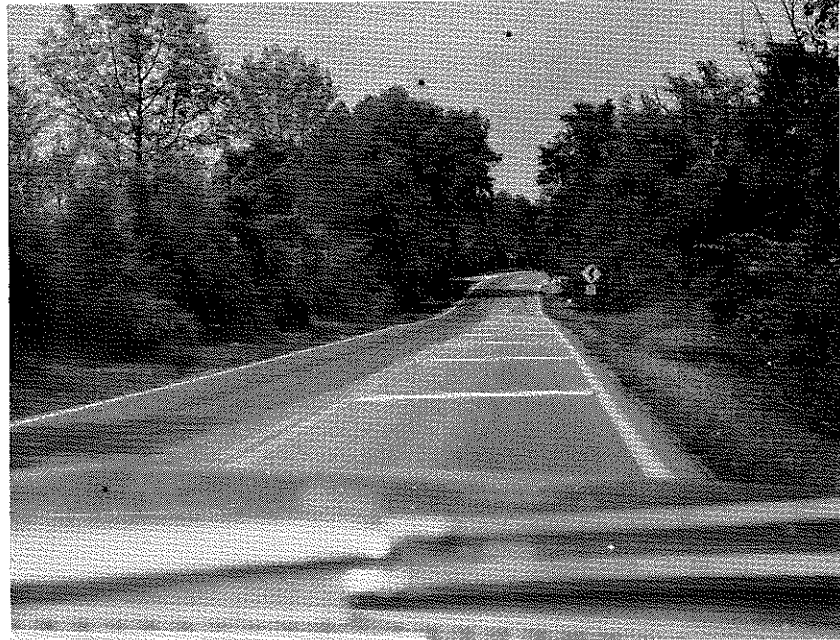
Figure 6. Guardposts Connected with Cable at the Curve.

The high severity of accidents at the curve resulted from inadequate containment provided by guardposts connected with cable (Figure 6) which are placed to prevent an errant vehicle from going over a steep embankment. The errant vehicle went over or through the guardposts in 17 of 25 collisions.
