SUBJECT: Research Report No. 382; "The Creep Response of Cohesive Soils: A Method of Design Using Rheological Strength Parameters;" Final Report; KYHPR-65-38; HPR-1(9), Part II

1. Report No.		2. Government Accession No.		3. Recipient's Catalog No.	
4. Title and Subtitle The Creep Response of Cohesive Soils: A Method of Design Using Rheological Strength Parameters			5. Report Date December 1973

Research Report  
382

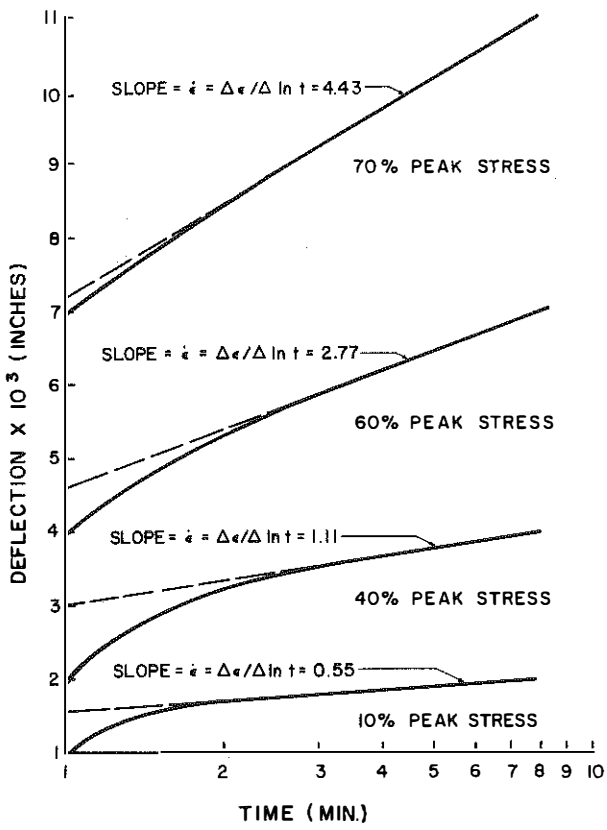
Figure 1. Example Creep Curves.

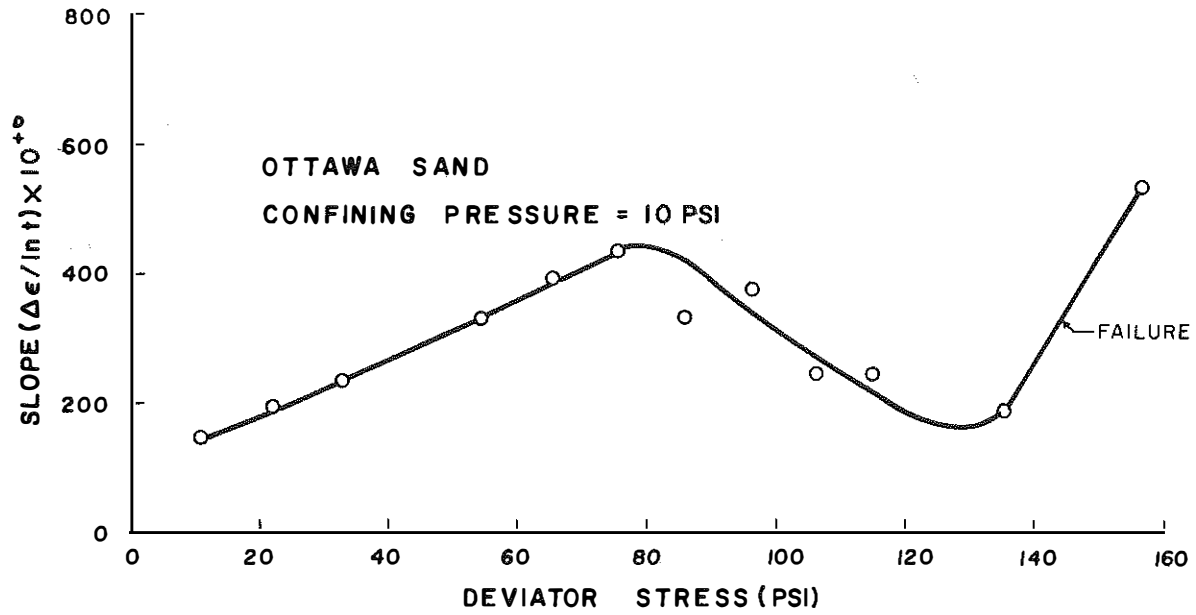
Figure 9. Viscosity Diagram - Ottawa Sand.

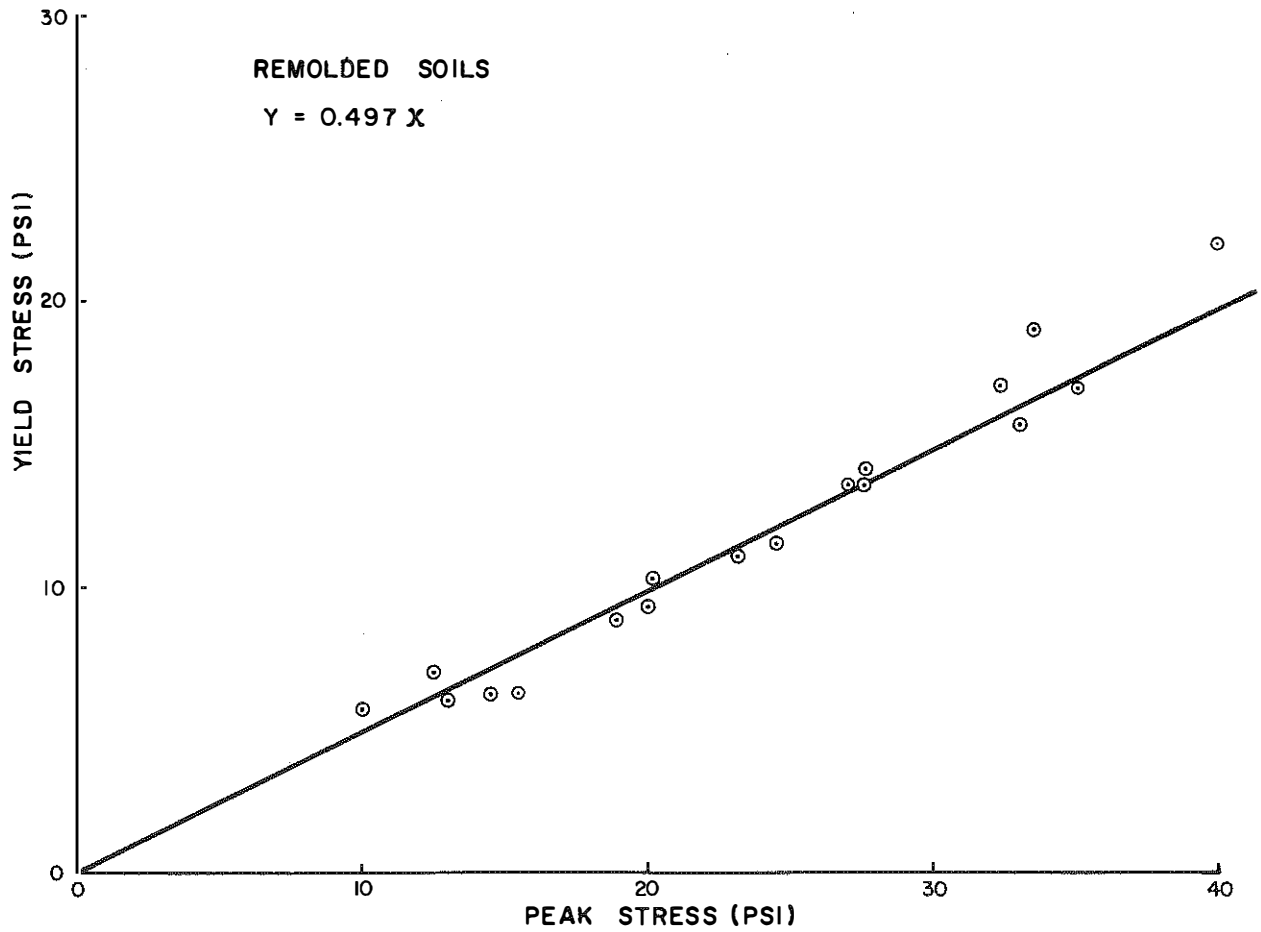
Figure 10. Yield Stress as a Function of Peak Stress - Remolded Soils.

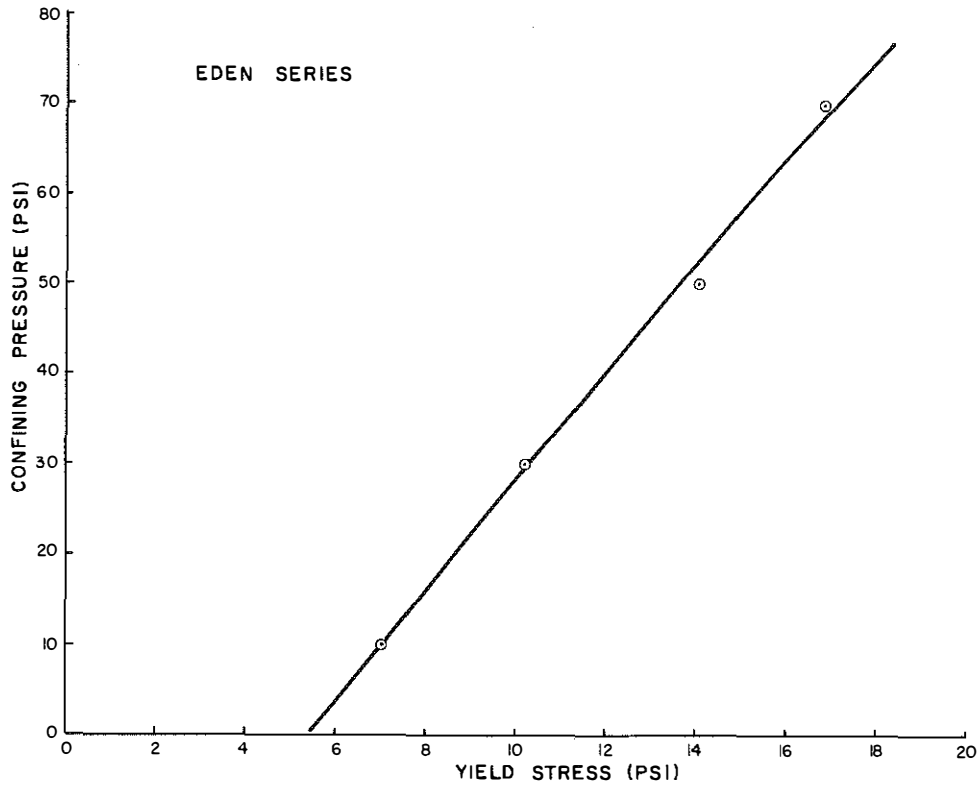
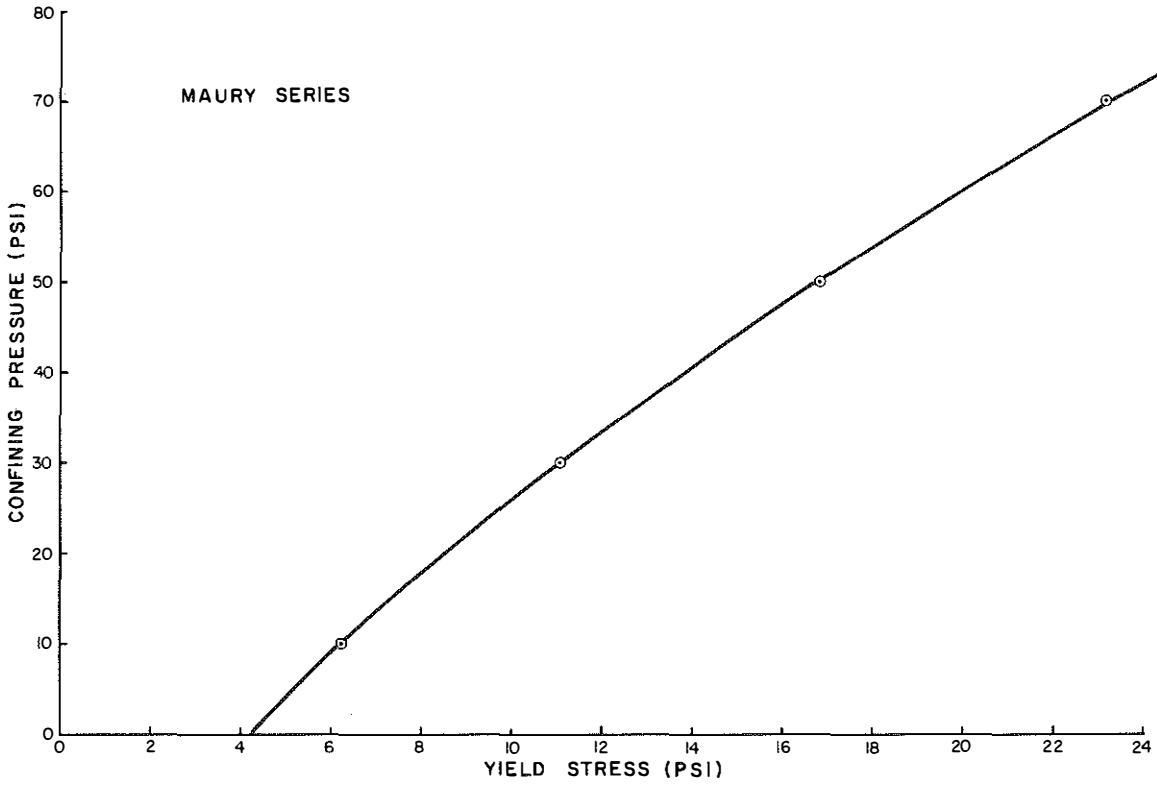
Figure 14. Relationship between Confining Pressure and Magnitude of Yield Stress.

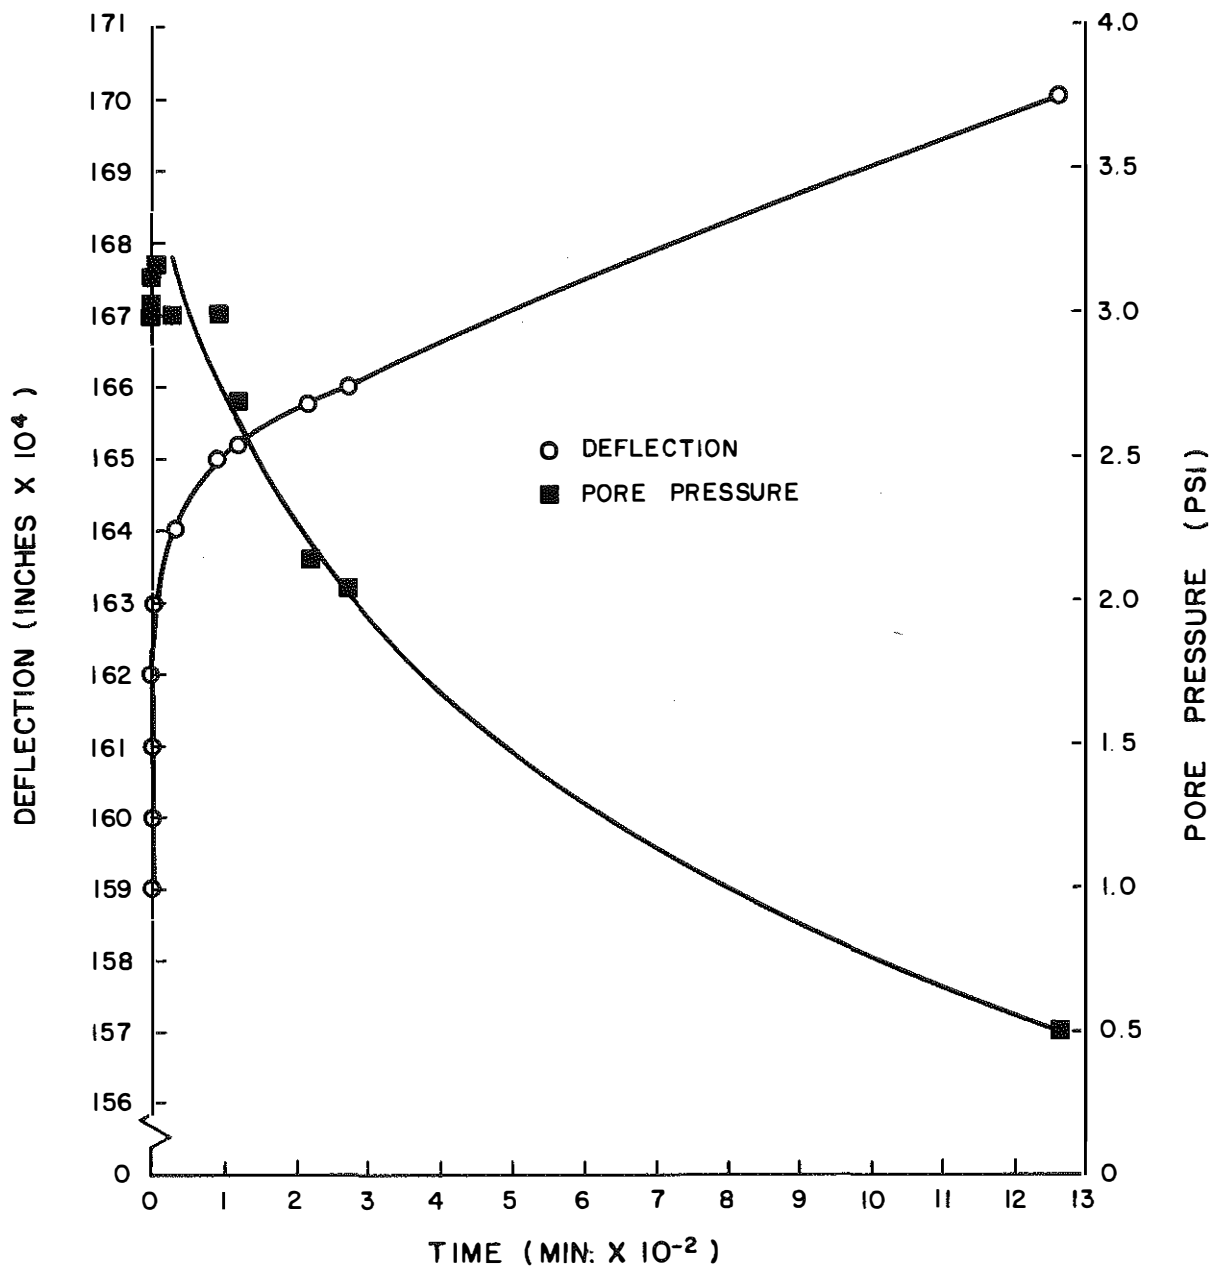
Figure 15. Relationship of Pore Pressure and Deflection to Time.

Roscoe and Schofield (10, 19) predicted there should be a constant ratio between pore pressure increment and deviatoric strain increment. Walker (11) and Arulanandan, et al (12) have published data supporting this idea. However, Arulanandan states further this probably holds true for undisturbed soils only. Arulanandan presents data for remolded kaolinite samples that show the pore pressure reaches a peak shortly after loading and then decreases to zero over long periods of time. This difference in behavior between remolded and undisturbed samples in undrained creep tests was attributed to the counterbalancing effects of thixotropic hardening in the remolded soils and the arresting of secondary compression in the undisturbed soils. A more complete discussion of these forces is given in Arulanandan's paper.

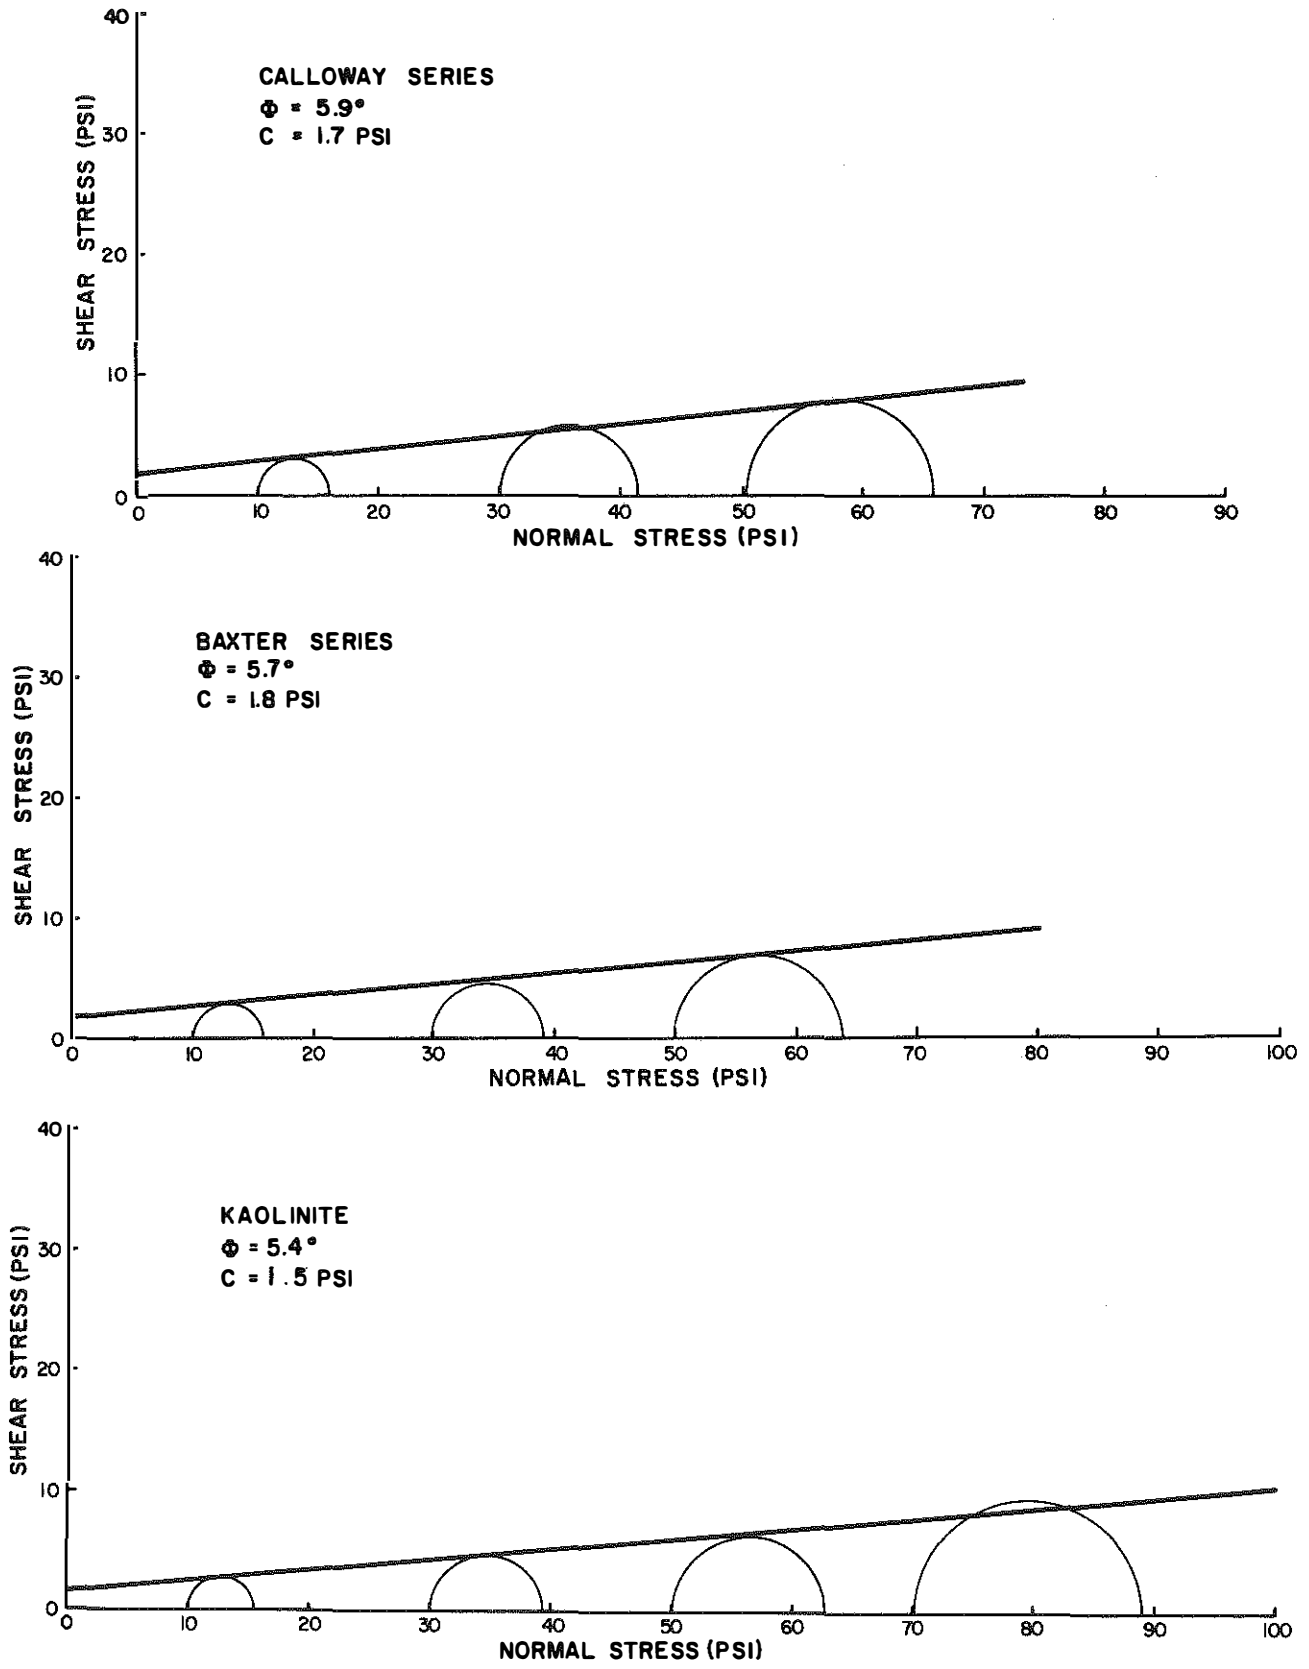
Figure 16. Failure Envelope Using Yield Stress.

Mohr's failure envelopes were constructed using the yield stress values and the results are shown in Figures 16 and 17. It was intended that effective strength parameters be used in this analysis. However, the 24-hour pore pressure readings were used (zero psi), making the analysis, in effect, one of total stress. The internal friction angles,  $\phi$ , were very low, ranging from 4.5° to 5.9°. The cohesion values varied from 1.6 to 2.6 psi.

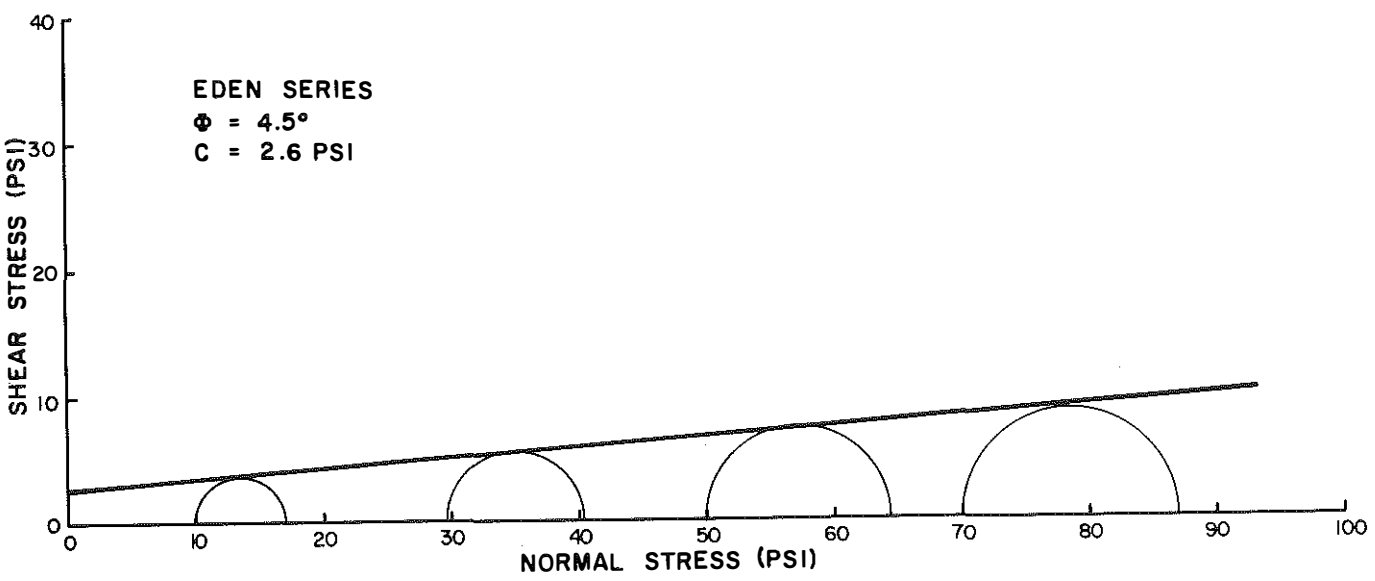
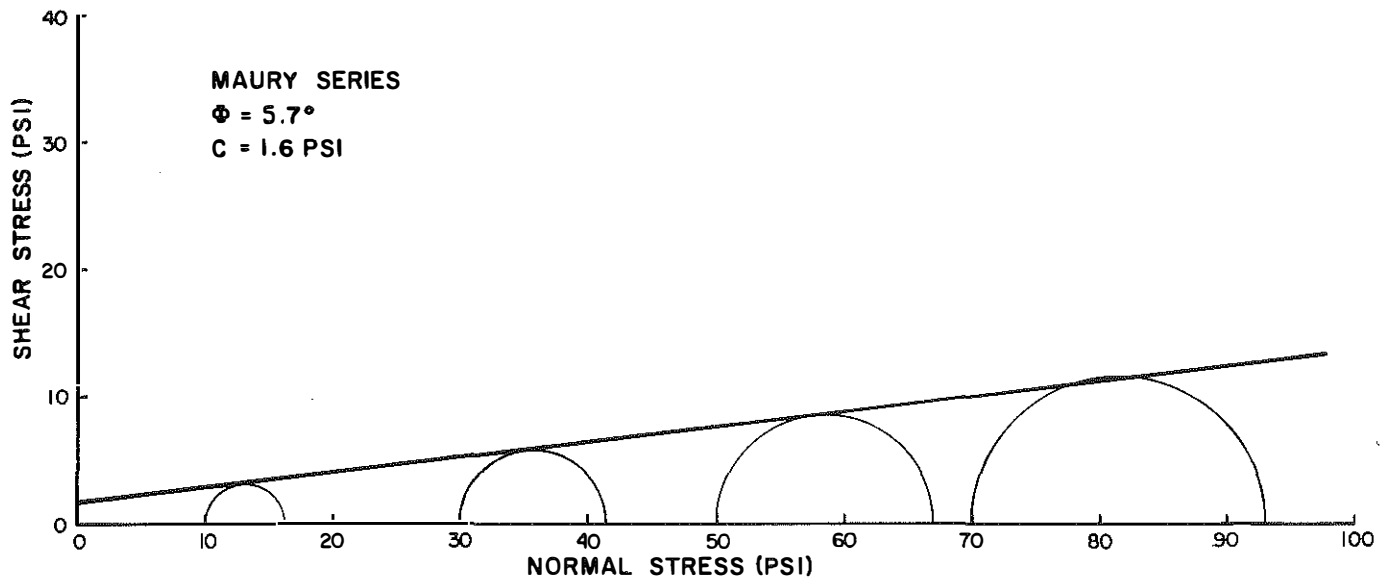
Figure 17. Failure Envelope Using Yield Stress.

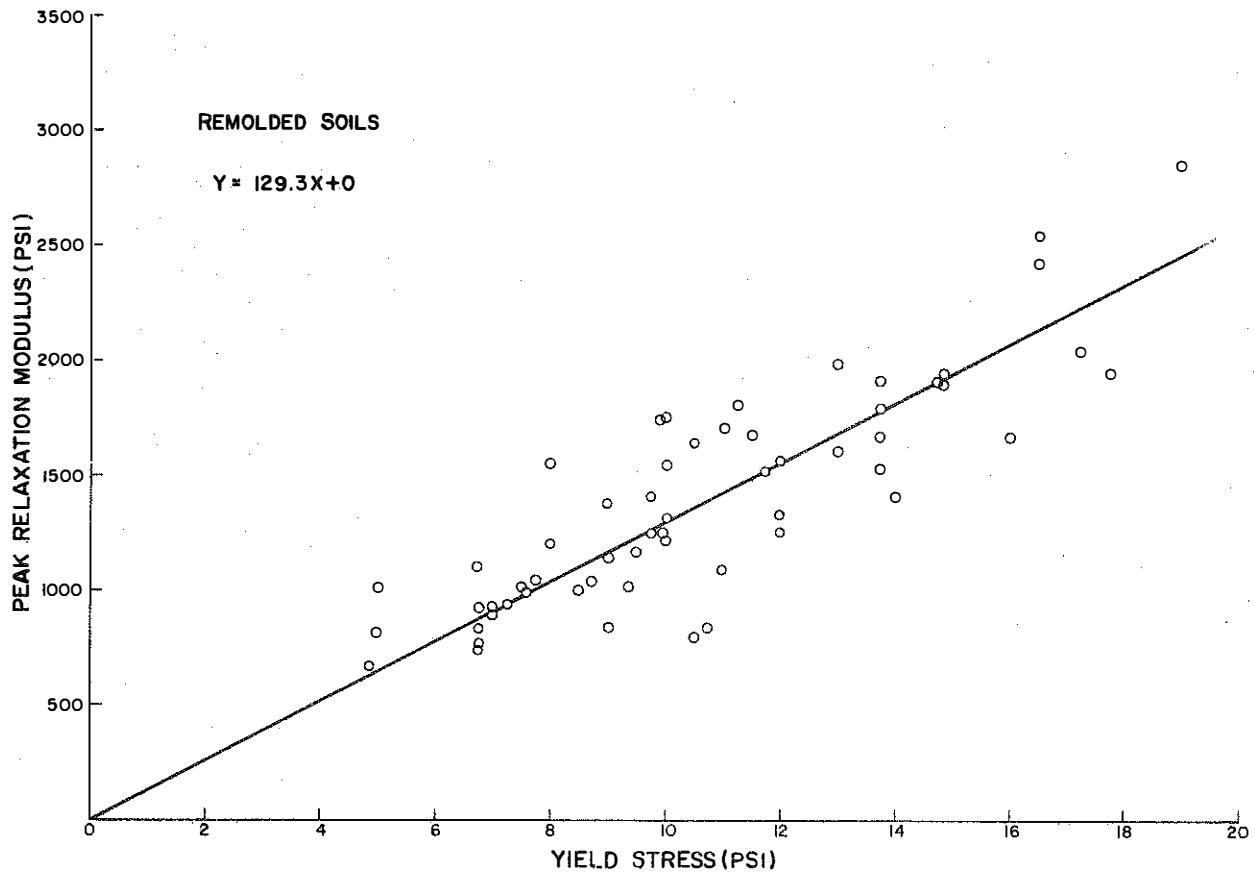
**Figure 18. Peak Relaxation Modulus as a Function of Yield Stress.**

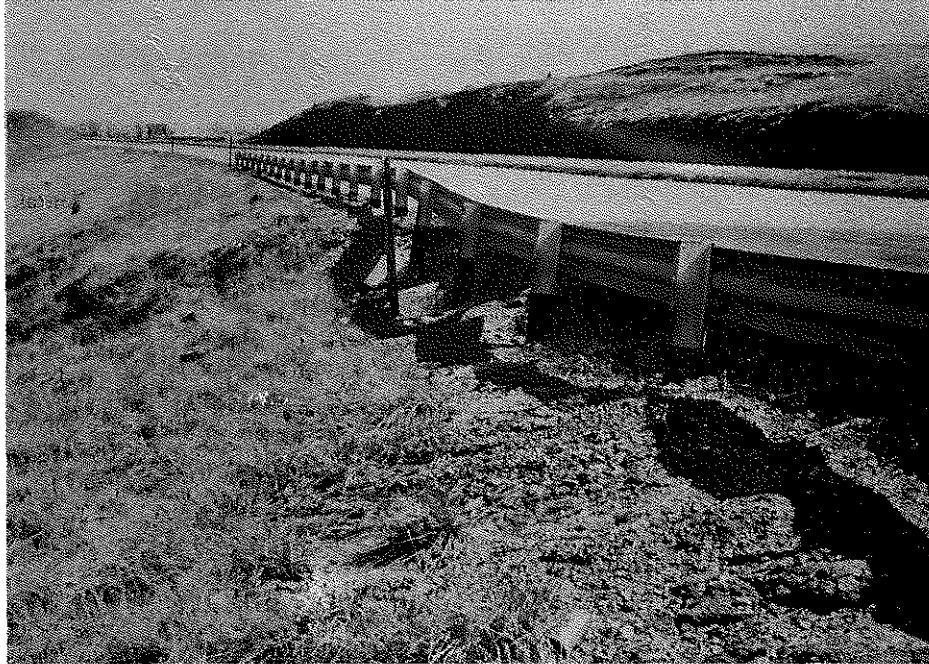
**Figure 20.** View of Surface Break of Westbound Lanes of Western Kentucky Parkway at Station 6922 + 50.

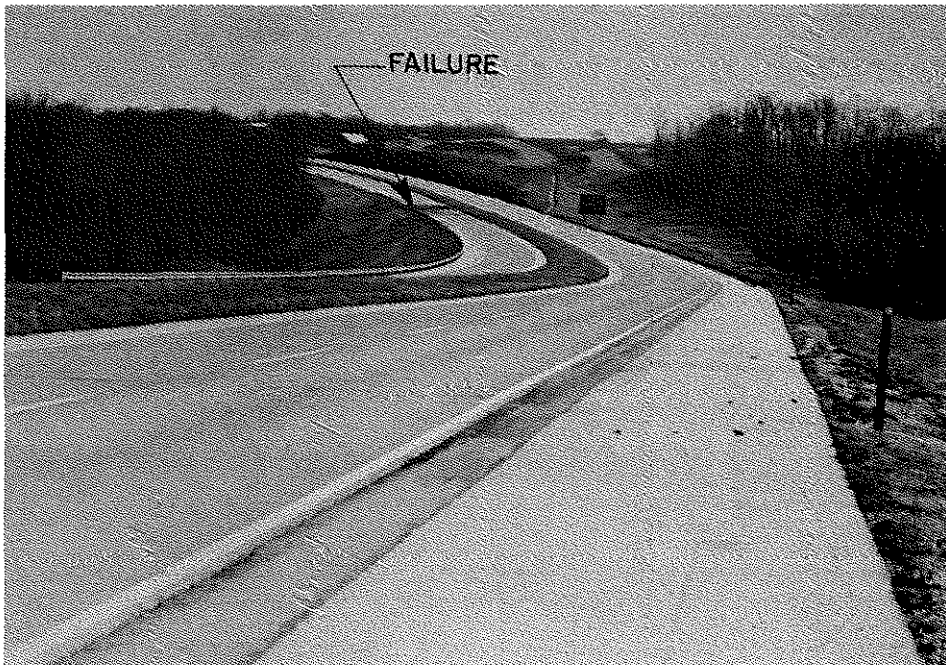
**Figure 21.** General View of Slide Area on Western Kentucky Parkway near Milepost 96.

The unstable area is located in the westbound lanes. Travelling west, the roadway emerges from a cut section to a fill at Station 6924+00. The unstable mass is located in the fill, constructed on a 1°00' curve and a grade of -3.9 percent. Figure 21 is a view of the slide area as it appears from the west.

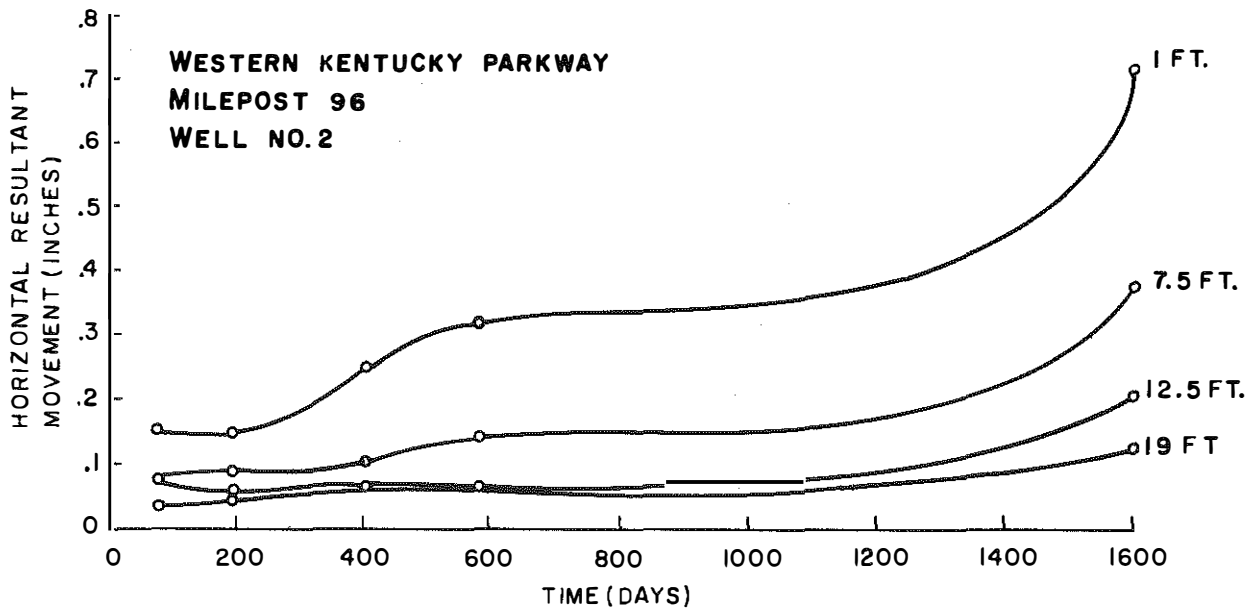
Figure 24. Slope Inclinometer Results, Well No. 2, Western Kentucky Parkway.

Slope inclinometer data presented in Figures 23 and 24 indicate the well at the top of the embankment (Inclinometer 1) has moved in a northeasterly direction and the top of the casing has moved a total of 5.8 in. Inclinometer 2, at the toe of the embankment is moving northwesterly. The top of the casing has moved approximately 0.7 in. Figure 34 is a plan view of the slide showing the directions of thrust of the moving mass. From visual observations and slope inclinometer data, the failure surface at Station 6922+50 is located in the foundation at 27.5 ft under the shoulder and at 9.0 ft under the toe and intersects the roadway in the middle of the driving lanes. There is no visible break at the toe.

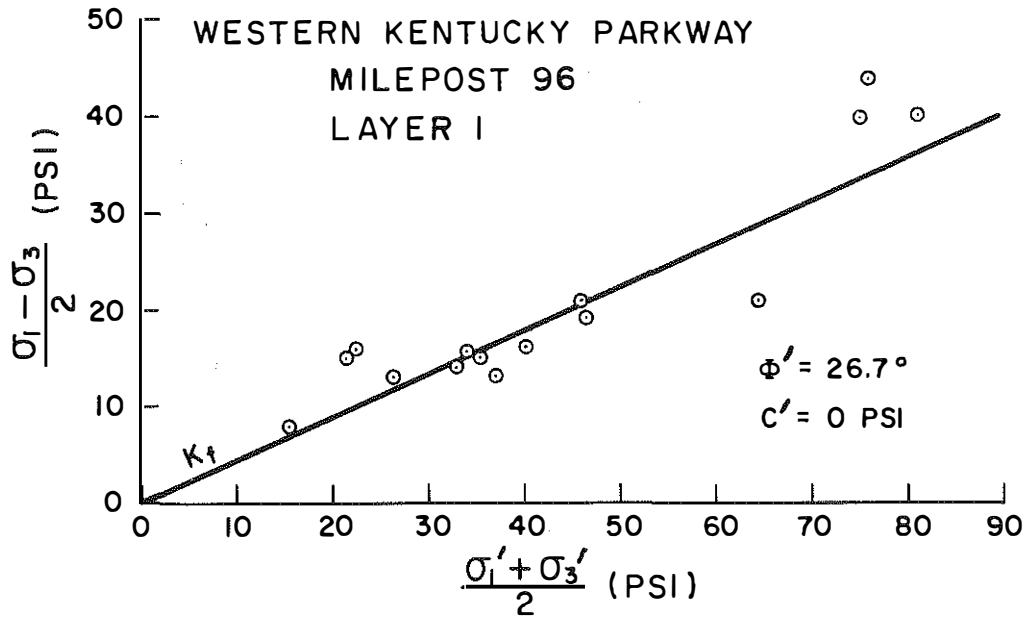
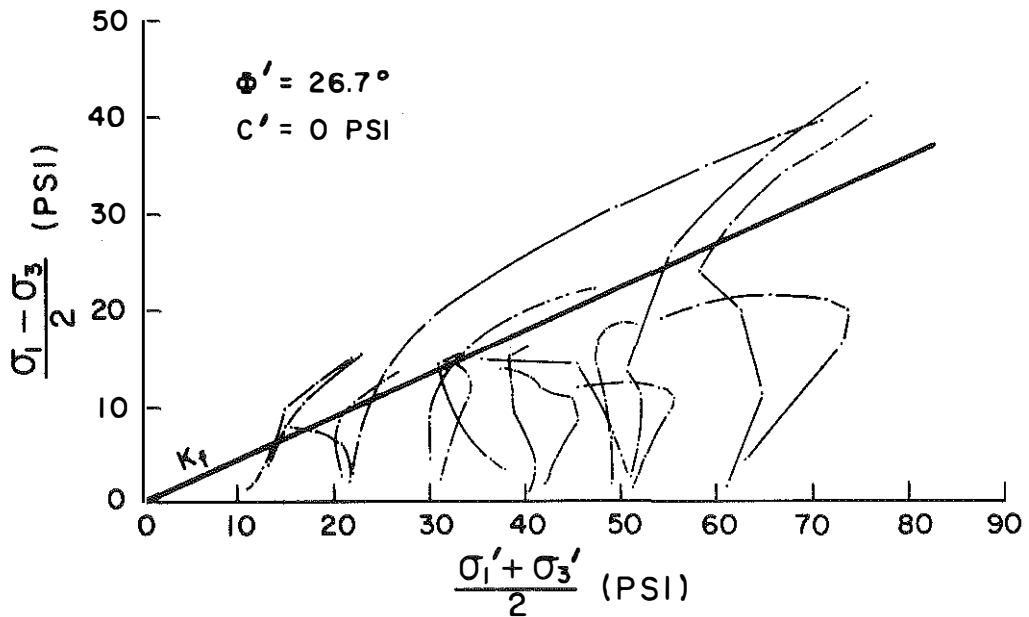
Figure 25. Consolidated, Isotropic, Undrained Triaxial Test Results, Layer 1 (Embankment) - Western Kentucky Parkway.

Results of the CIU triaxial tests for Layers 1 and 2 are plotted on a "P-Q diagram" in Figures 25 and 26. Figures 25a and 26a are the same as Figures 25b and 26b except only the peak deviatoric stress points are plotted. The method of least squares was used to construct the failure curve ( $K_f$  line) through the peak deviatoric stress points. The effective internal friction angle,  $\phi'$ , and the effective cohesion,  $c'$ , for Layer 1 were  $26.7^\circ$  and zero, respectively.  $\phi'$  and  $c'$  for Layer

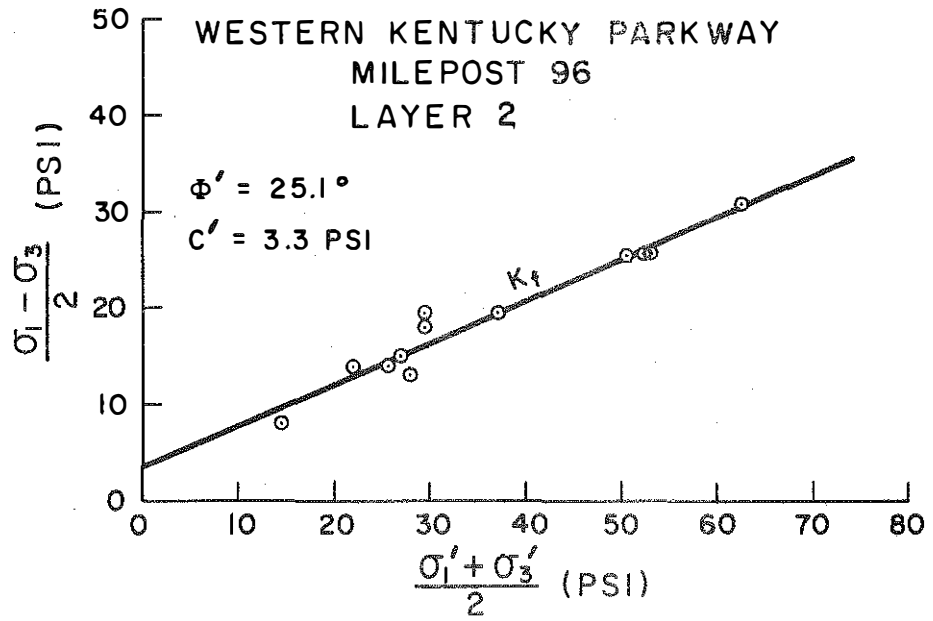
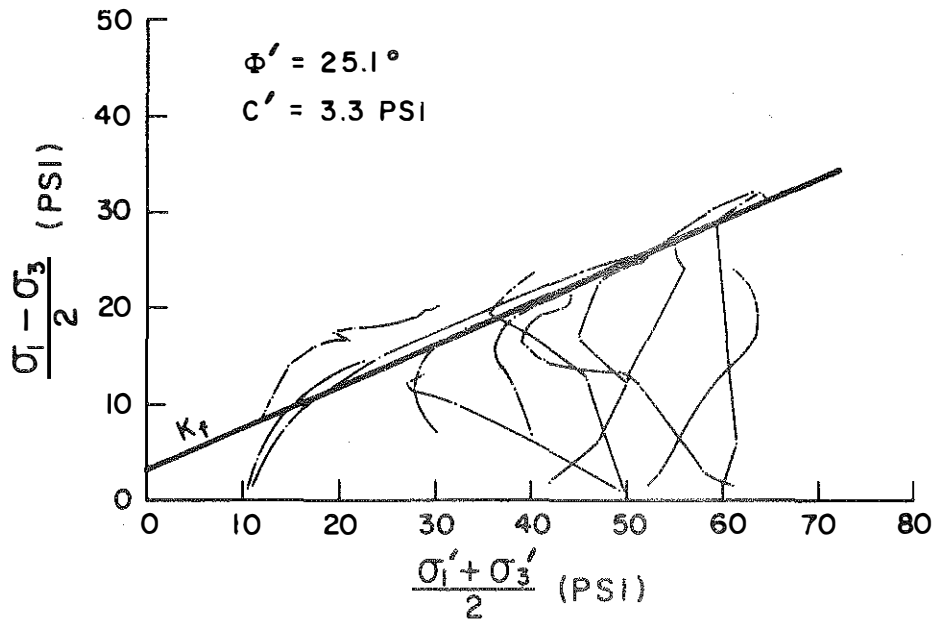
Figure 26. Consolidated, Isotropic, Undrained Triaxial Test Results, Layer 2 (Foundation) - Western Kentucky Parkway.

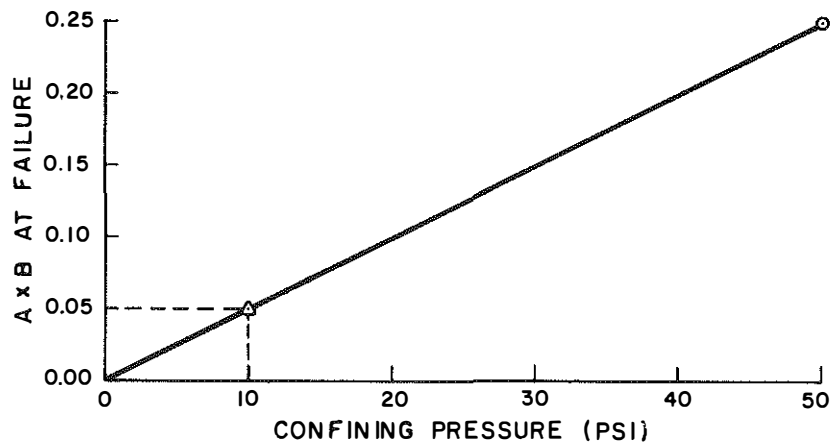
Figure 28. Shear Strength Results from Special Relaxation - Triaxial Test Using One Specimen, Layer 2 (Foundation) - Western Kentucky Parkway.

Scott (14) proposed a number of methods for constructing Mohr's failure envelopes solely from information gained from two or three relaxation tests and one triaxial test performed on a single sample. One of these was used in this case history. In this method a sample was set in the triaxial chamber and consolidated overnight under 10-psi confining pressure. A relaxation test was performed the next morning and the confining pressure was then increased to 50 psi. After again consolidating overnight, a second relaxation test was performed. A regular triaxial test was then performed at the end of the second relaxation test. The peak relaxation modulus at 50-psi confining pressure was plotted against peak stress from the triaxial test and a line was drawn through the point (0, 0). The peak stress at 10-psi confining pressure was found by extrapolating horizontally the value of the peak relaxation modulus at 10 psi until it intersected the straight line already constructed. From that intersection point, a line was constructed vertically, intersecting the horizontal axis at the value of the peak stress at 10-psi confining pressure. The stress values thus obtained were used to construct the Mohr's stress circles in Figures 27a and 28a.

The pore pressures were subtracted from the peak stresses (Figures 27b and 28b) to give the values for  $\phi'$  and  $c'$  in Figures 27a and 28a.

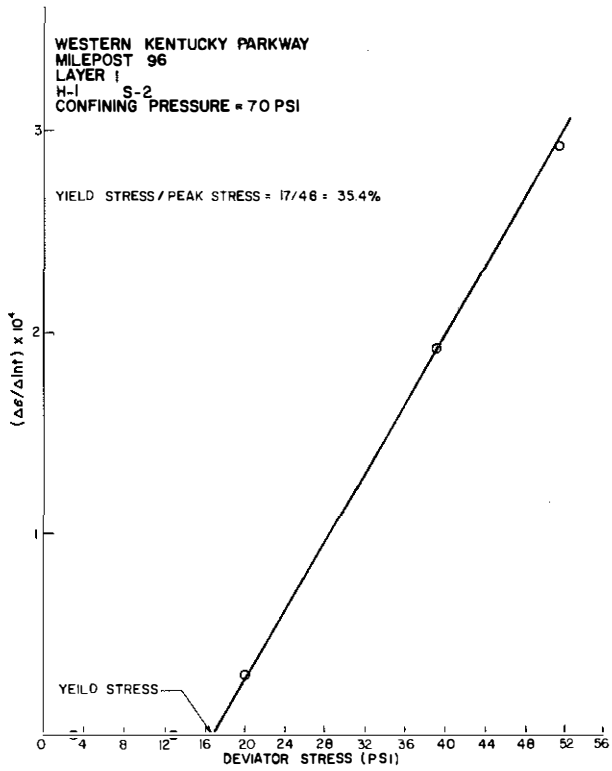
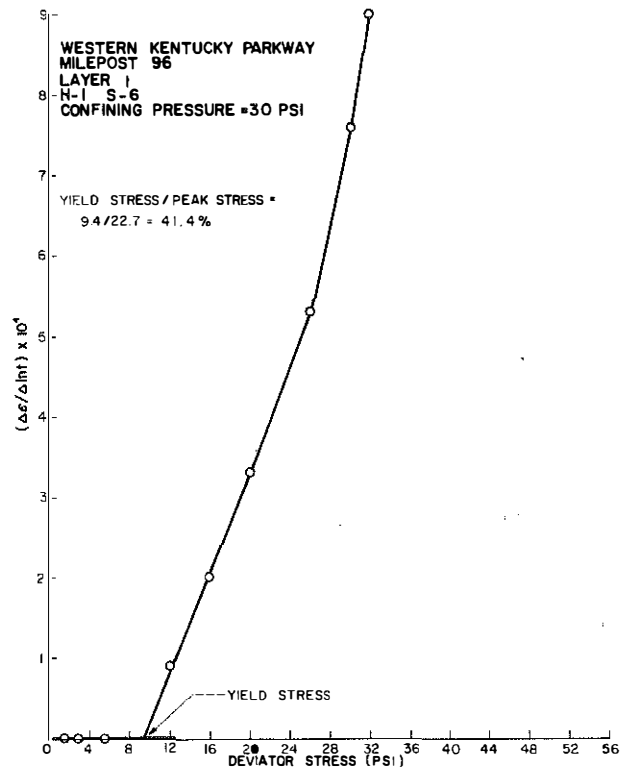
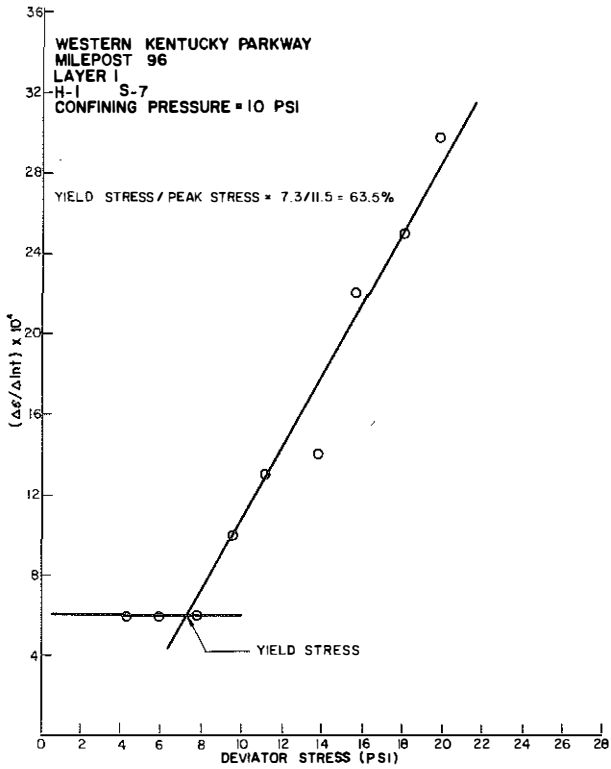
Figure 29. Viscosity Diagrams, Layer 1 (Embankment) - Western Kentucky Parkway.

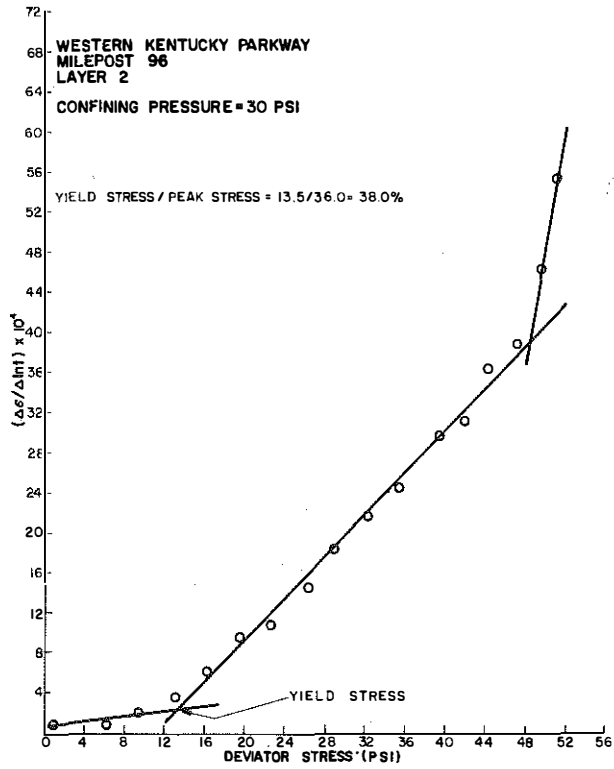
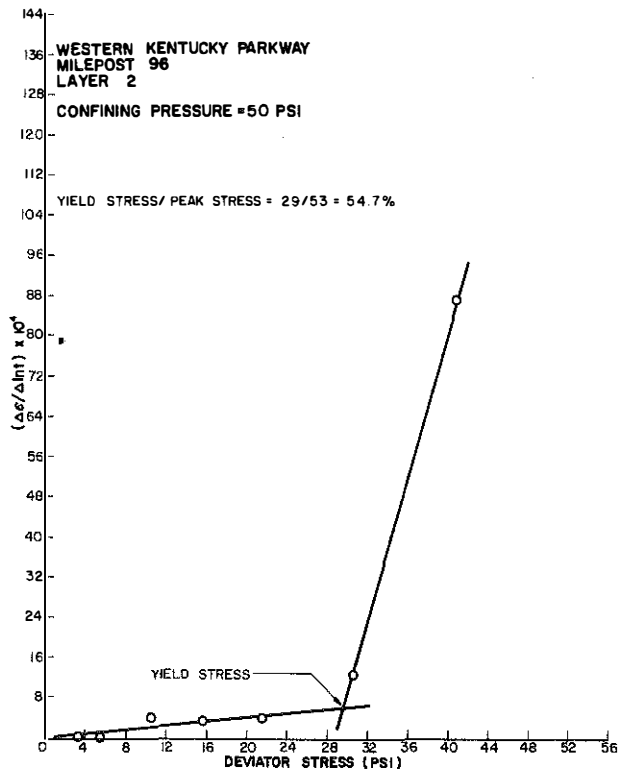
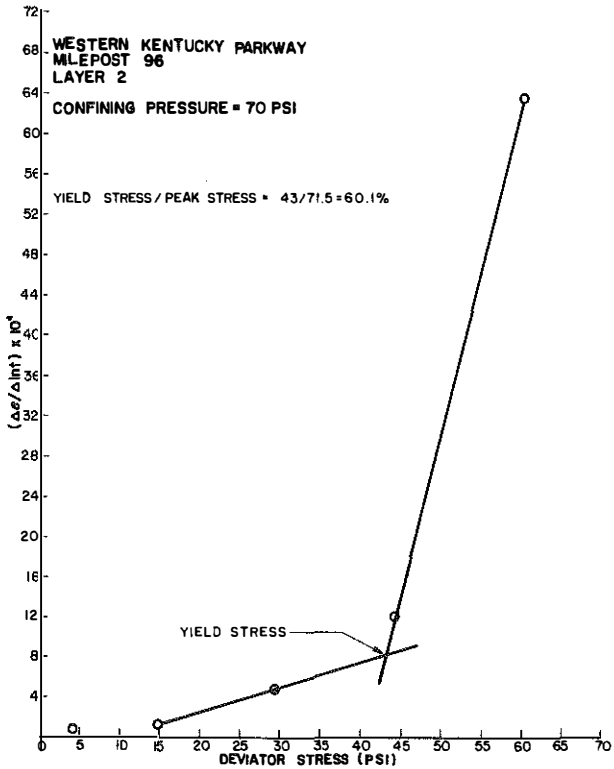
Figure 30. Viscosity Diagrams, Layer 2 (Foundation) - Western Kentucky Parkway.

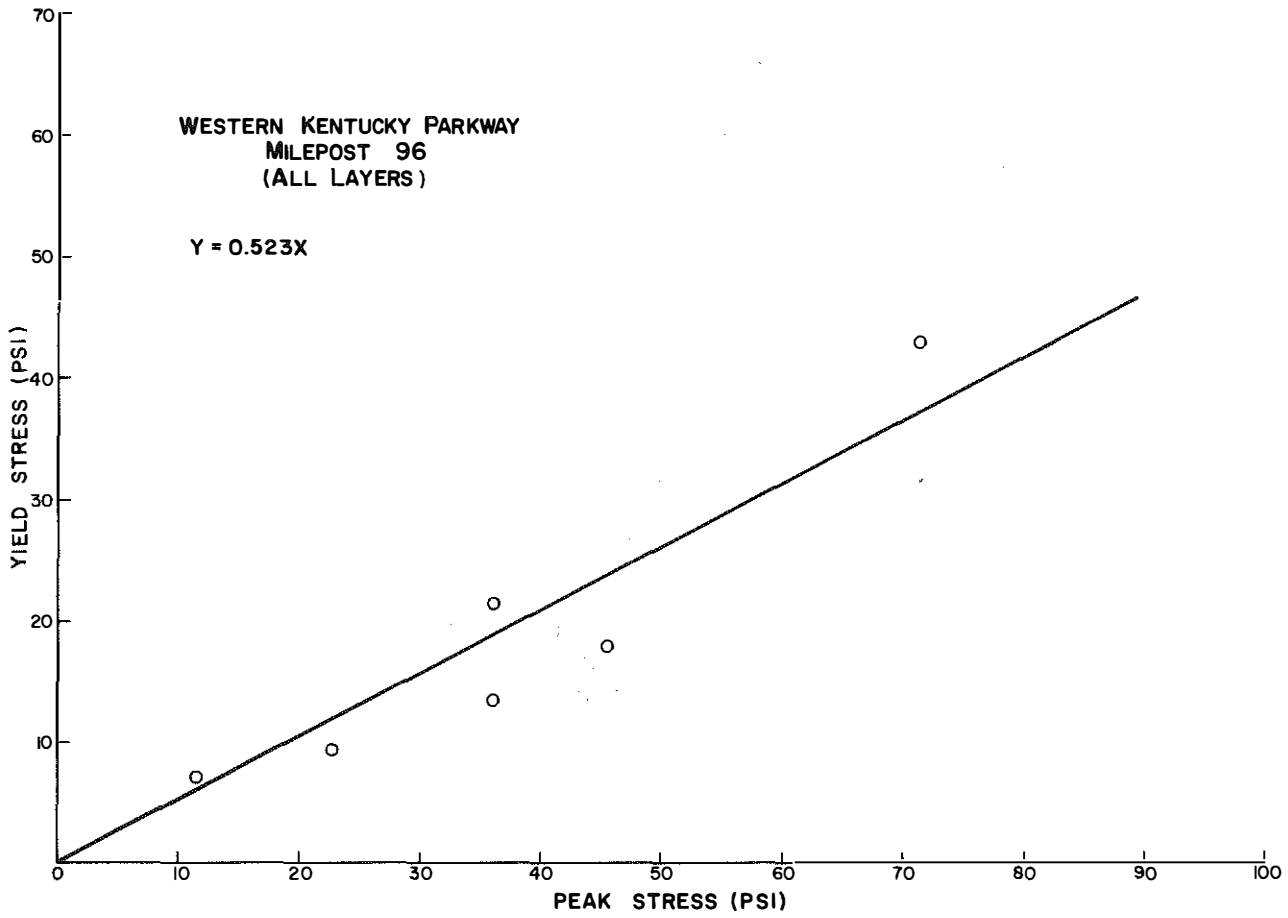
Figure 31. Yield Stress as a Function of Peak Stress, All Layers, Western Kentucky Parkway.

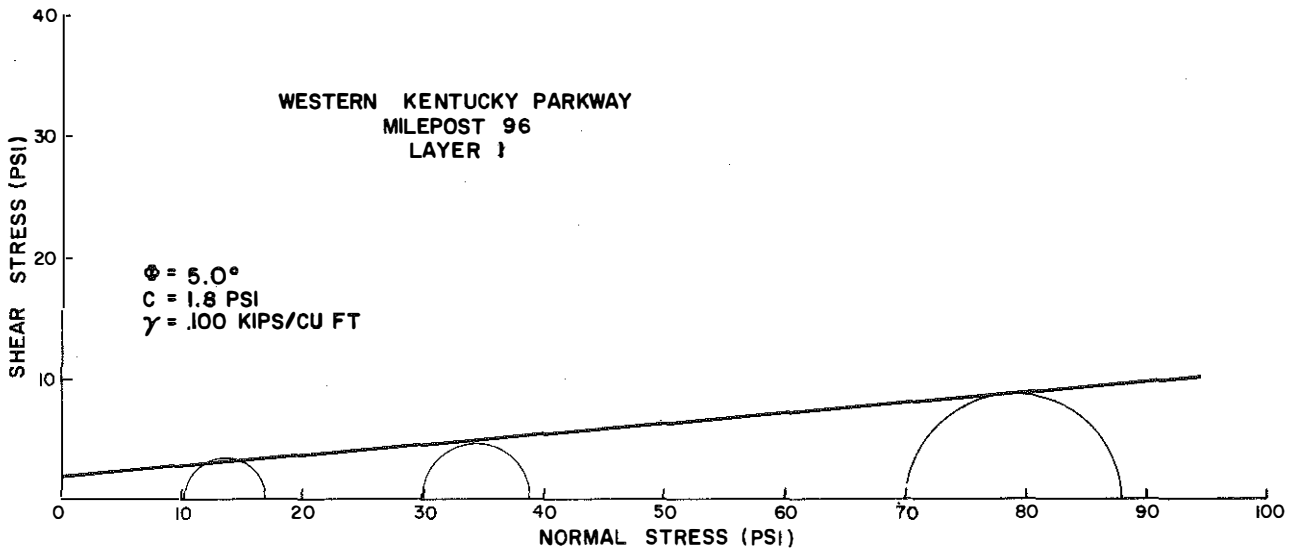
Figure 32. Failure Envelope Using Yield Stress, Layer 1 (Embankment) - Western Kentucky Parkway.

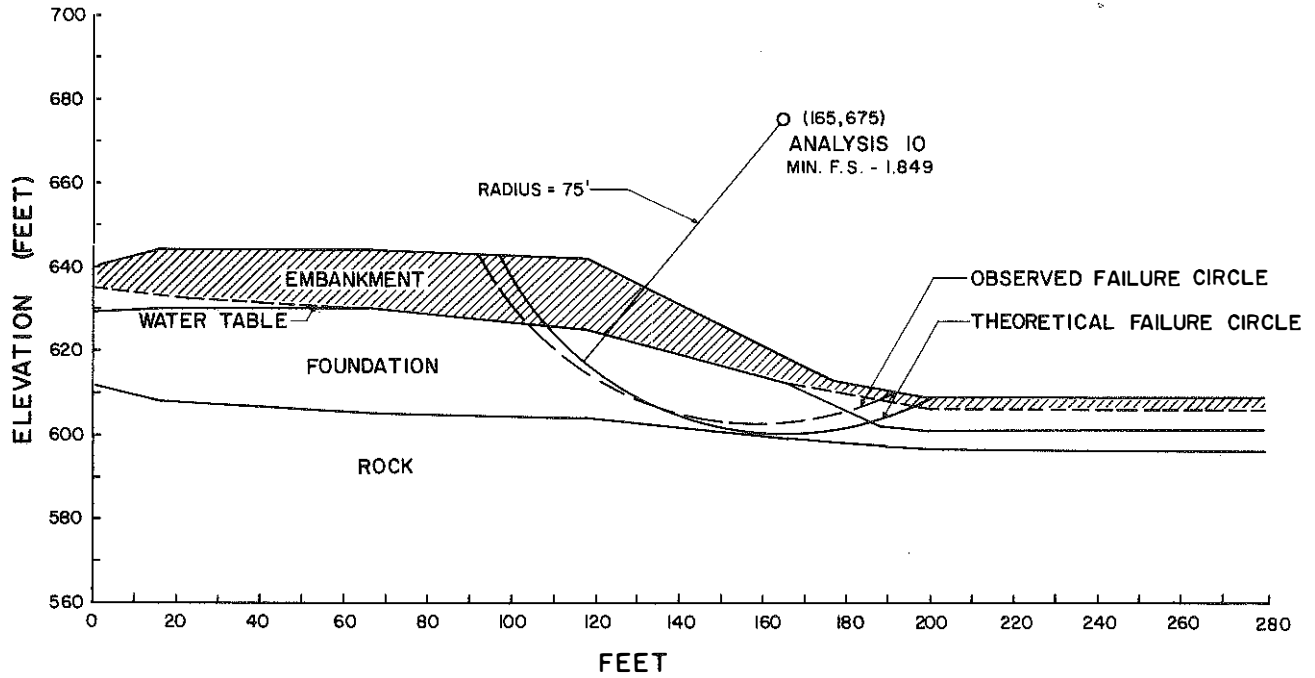
Figure 35. Stability Analysis Results, Analysis 10 - Western Kentucky Parkway.
