SUBJECT: Research Report No. 382; "The Creep Response of Cohesive Soils: A Method of Design Using Rheological Strength Parameters;" Final Report; KYHPR-65-38; HPR-1(9), Part II

1. Report No.		2. Government Accession No.		3. Recipient's Catalog No.	
4. Title and Subtitle The Creep Response of Cohesive Soils: A Method of Design Using Rheological Strength Parameters			5. Report Date December 1973

Research Report  
382

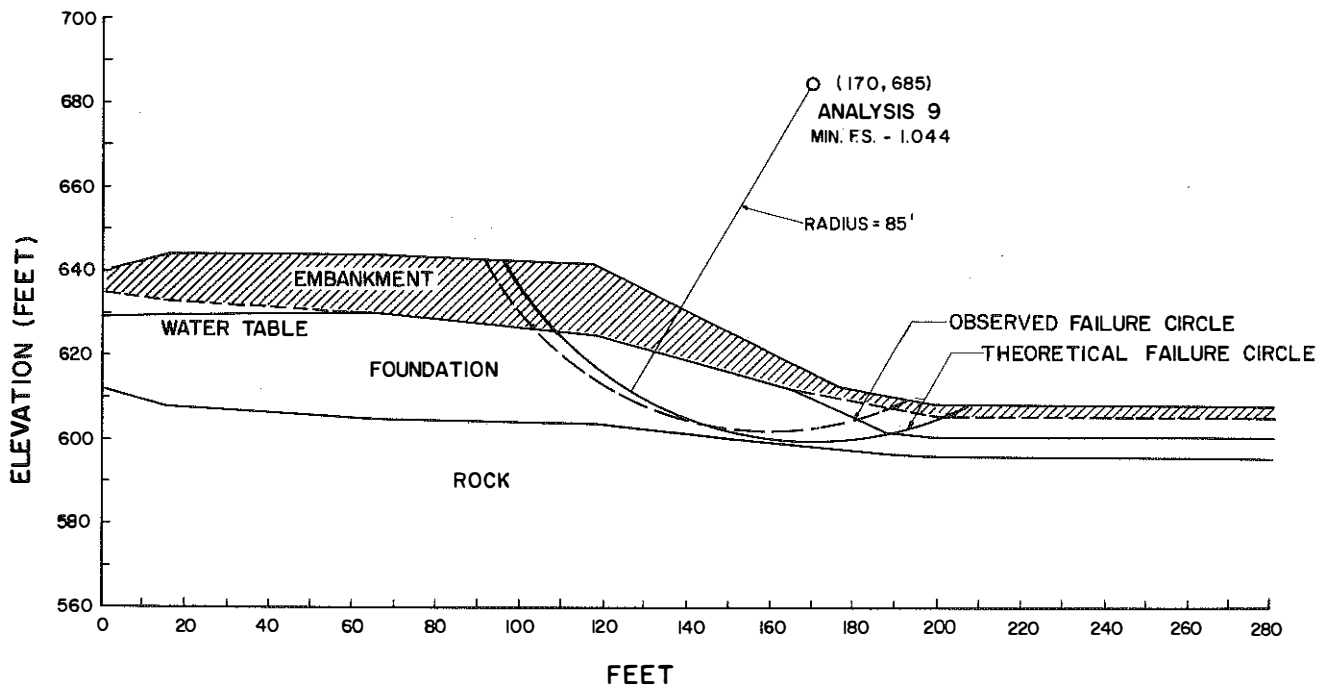
Figure 36. Stability Analysis Results, Analysis 9 - Western Kentucky Parkway.

function with time and that it eventually becomes zero, then the long term factor of safety would be 1.044 (Analysis 9, Table 4). This analysis (labeled "Residual" in Table 4) was made assuming high watertable and excess pore pressures due to seepage (Figure 36). It would appear, therefore, that a decrease in cohesion was indeed the case and, consequently, contributed to failure.

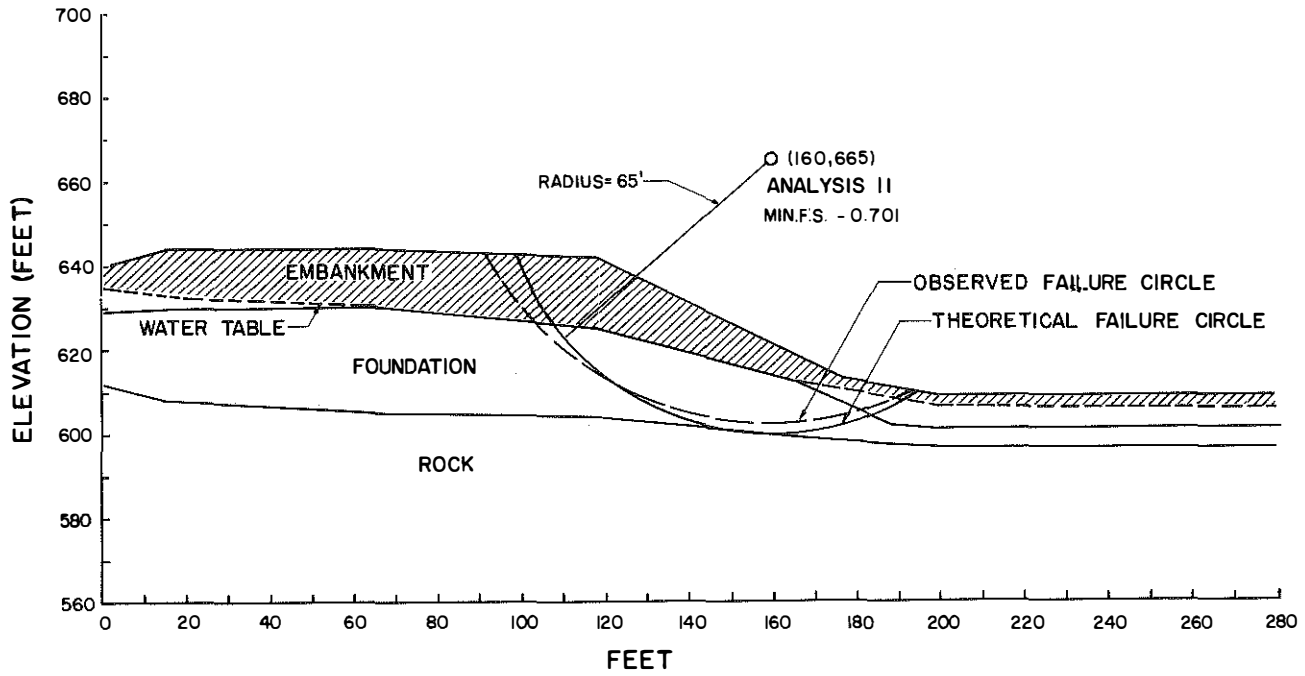
Figure 37. Stability Analysis Results, Analysis 11 - Western Kentucky Parkway.

Analysis 11 in Table 4 was made using creep strength in conjunction with the high watertable. The minimum factor of safety was 0.701. There was excellent agreement between the observed and theoretical failure surfaces (Figure 37). However, the failure surface in the creep analysis was deeper at the toe than the observed failure surface.

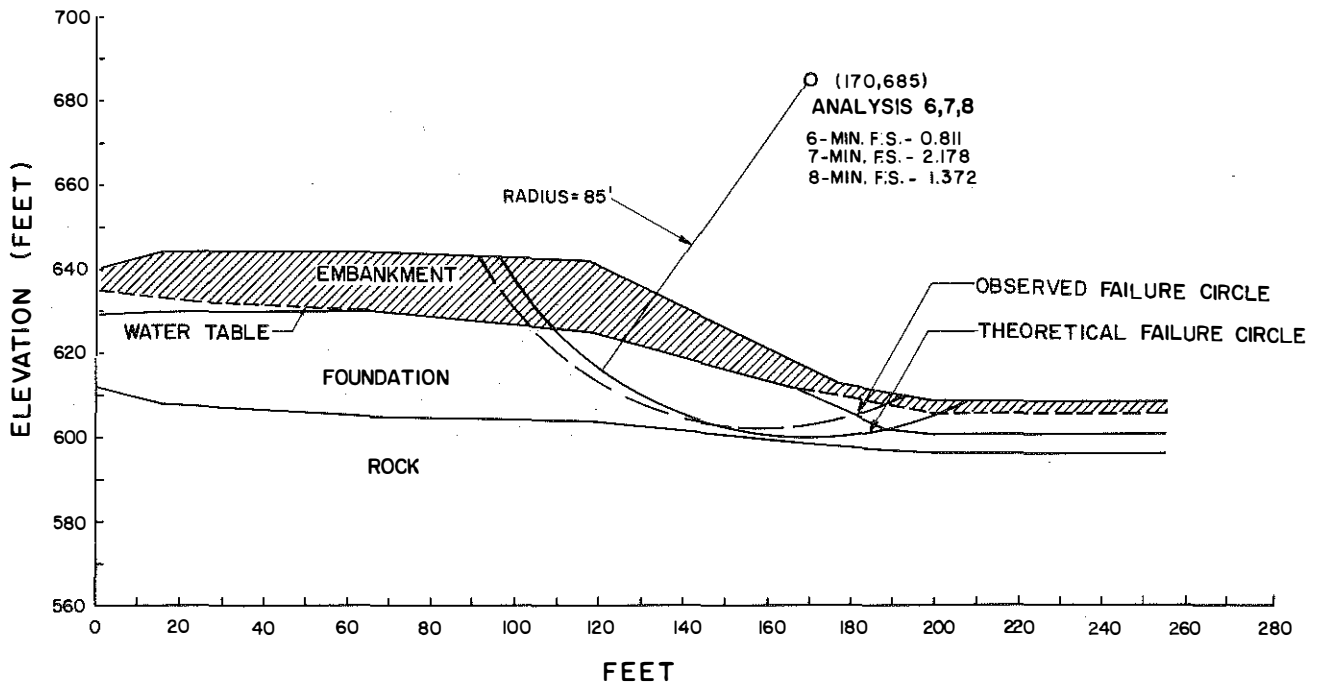
Figure 38. Stability Analysis Results, Analysis 6, 7, and 8 - Western Kentucky Parkway.

Three different remedial designs were analyzed. The first was a change in the side slope from 2:1 to 3:1. Analysis 7, using peak parameters and a high watertable with seepage, yielded a factor of safety of 2.178 with the slope change. "Residual" strength (Analysis 8), using the same water conditions, gave a factor of safety of 1.372. However, creep strength (Analysis 6) had a factor of safety of only 0.811 for the slope change. Figure 38 shows the theoretical failure surfaces for these three analyses.

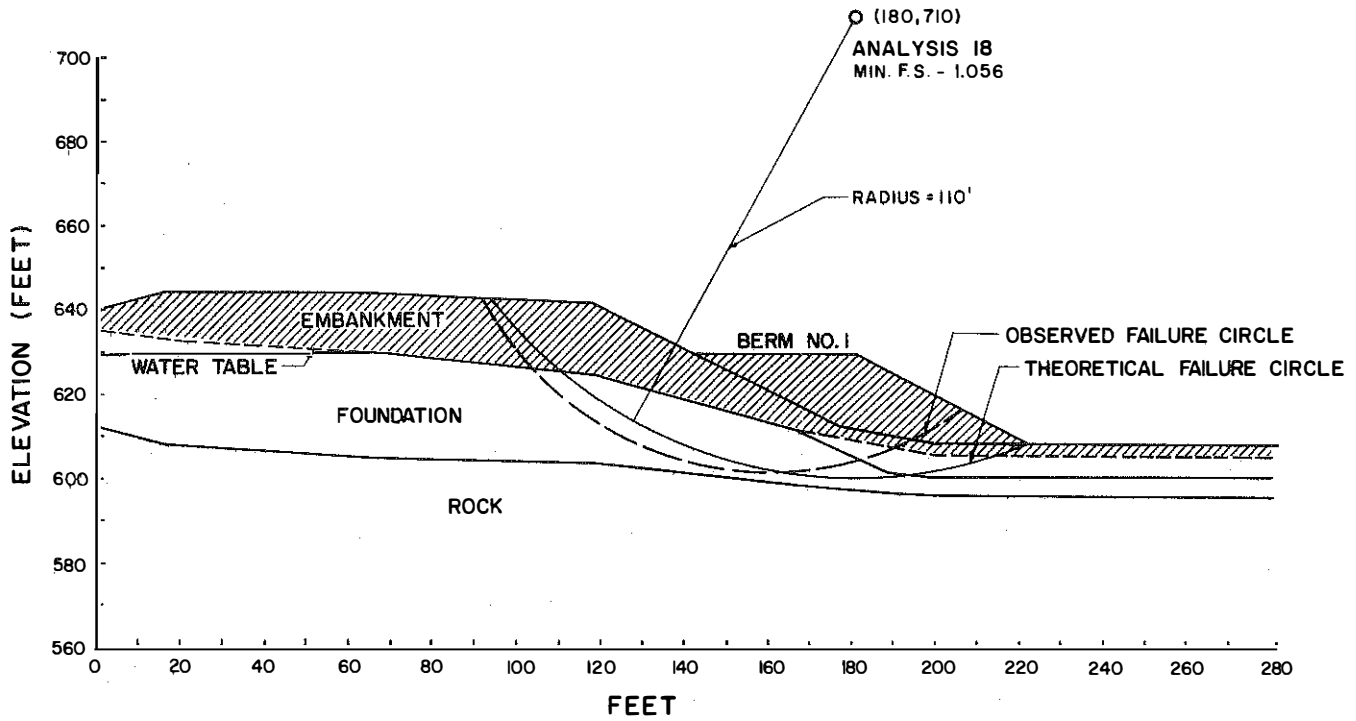
Figure 39. Stability Analysis Results, Analysis 18 - Western Kentucky Parkway.

In the second design, a berm 40 ft wide and approximately 25 ft high (Berm 1, Figure 39) was used. Again, using a high watertable with seepage conditions, the factors of safety for peak, "residual", and creep strengths were 3.601, 2.527 and 1.056, respectively. This is obviously an overdesign if one considers only peak or "residual" strength; however, this would be strictly a minimal design if creep strength were the governing factor in design.

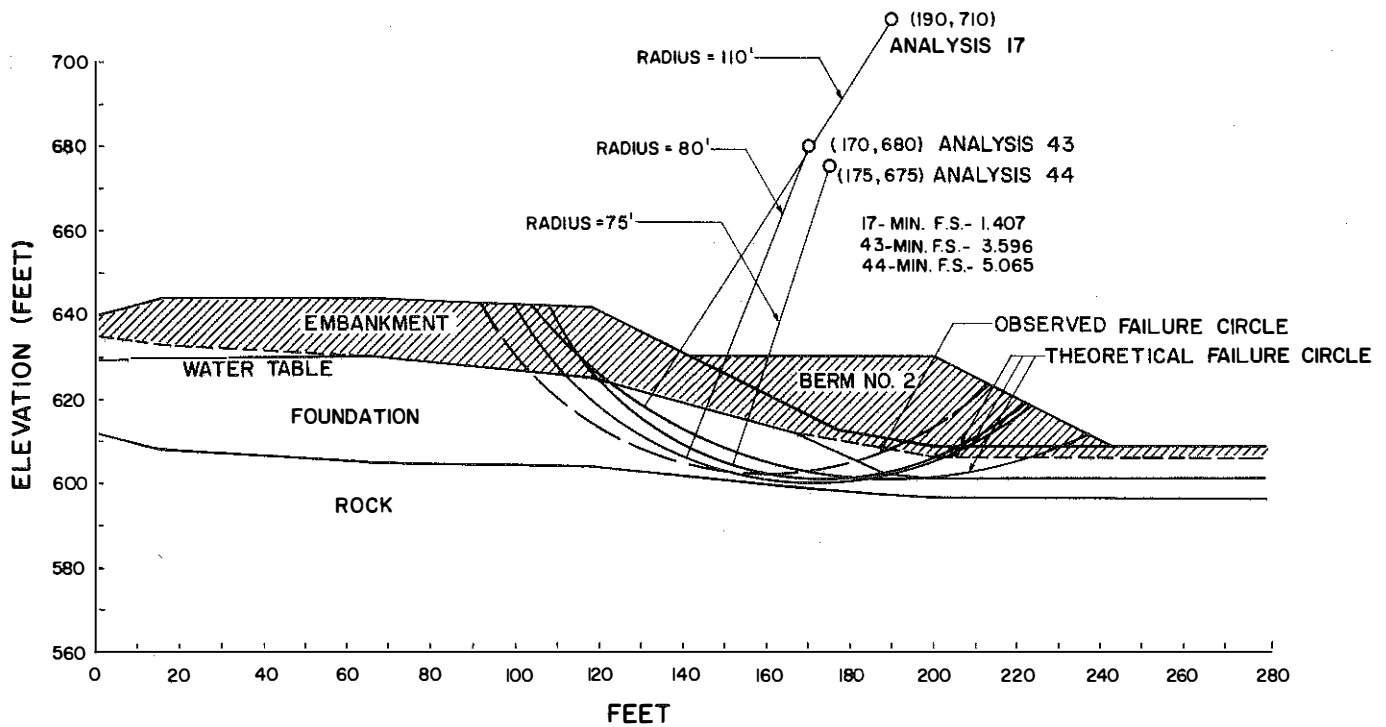
Figure 40. Stability Analysis Results, Analysis 17, 43, and 44 - Western Kentucky Parkway.

To insure a better design that would provide a greater margin of safety against soil creep, the width of the berm was increased to 60 ft (Berm 2). In this analysis (Analysis 17), designing with creep strength gave a factor of safety of 1.407, which was considered an adequate design to insure against large strains resulting from soil creep. Peak and "residual" strength analyses yielded factors of safety of 5.065 and 3.596, respectively, for this case, shown in Figure 40.

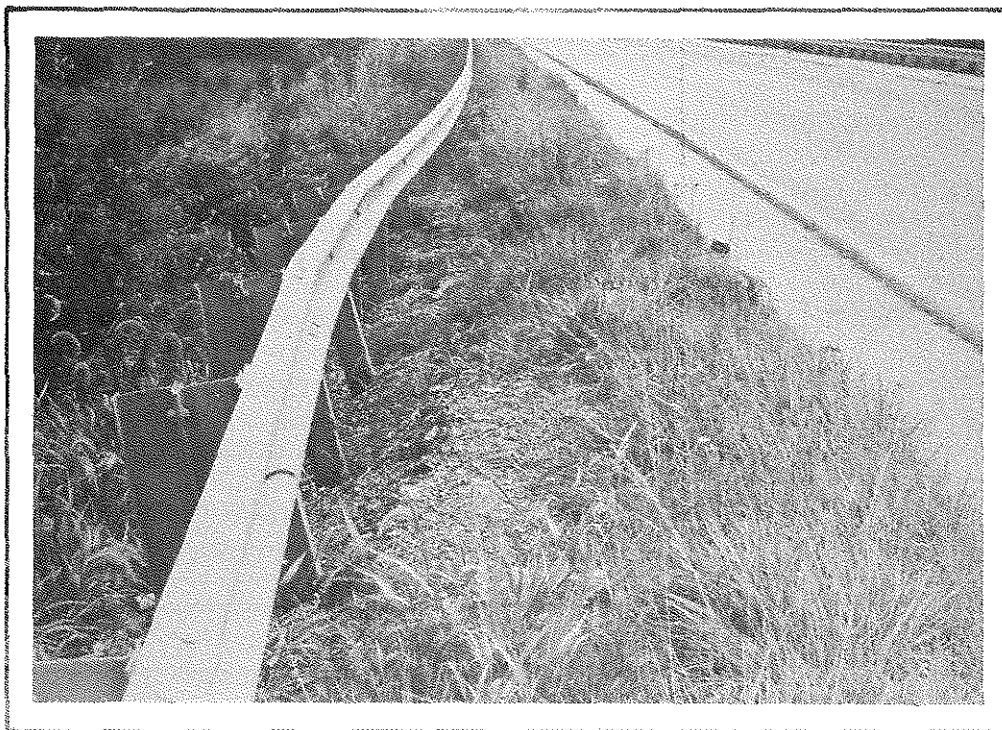
**Figure 41. View of Surface Break at Inside Shoulder of Eastbound Lanes on I 64 at Station 1865 + 50.**

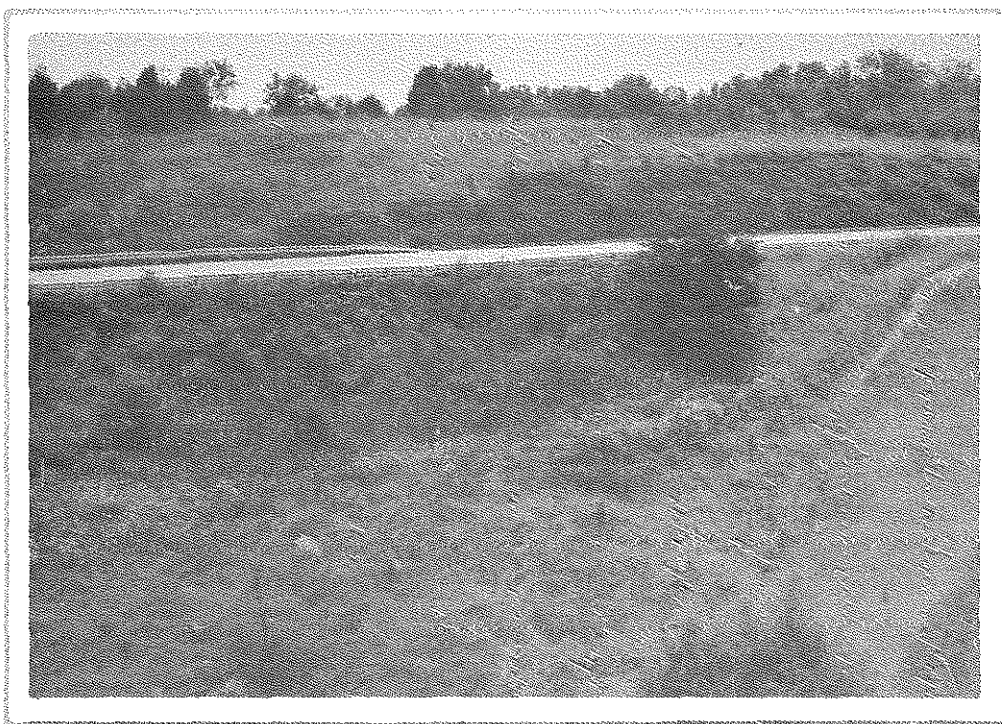
**Figure 42. General View of Slide Area, Looking South, on I 64 Near Milepost 44.**

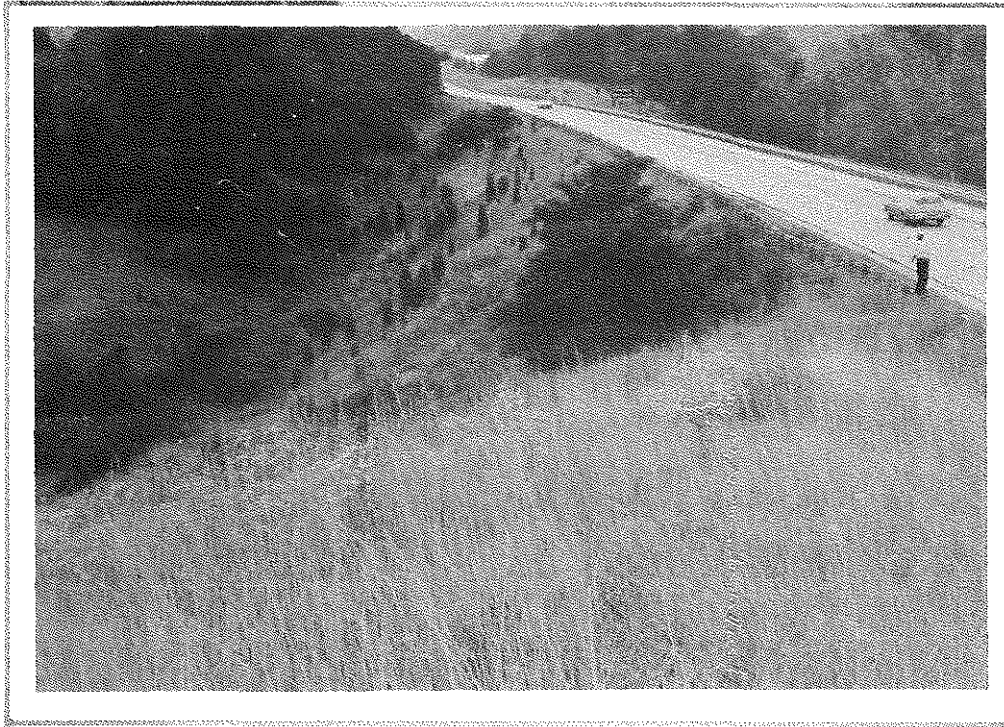
Figure 43. General View of Slide Area, Looking East, on I 64 Near Milepost 44.

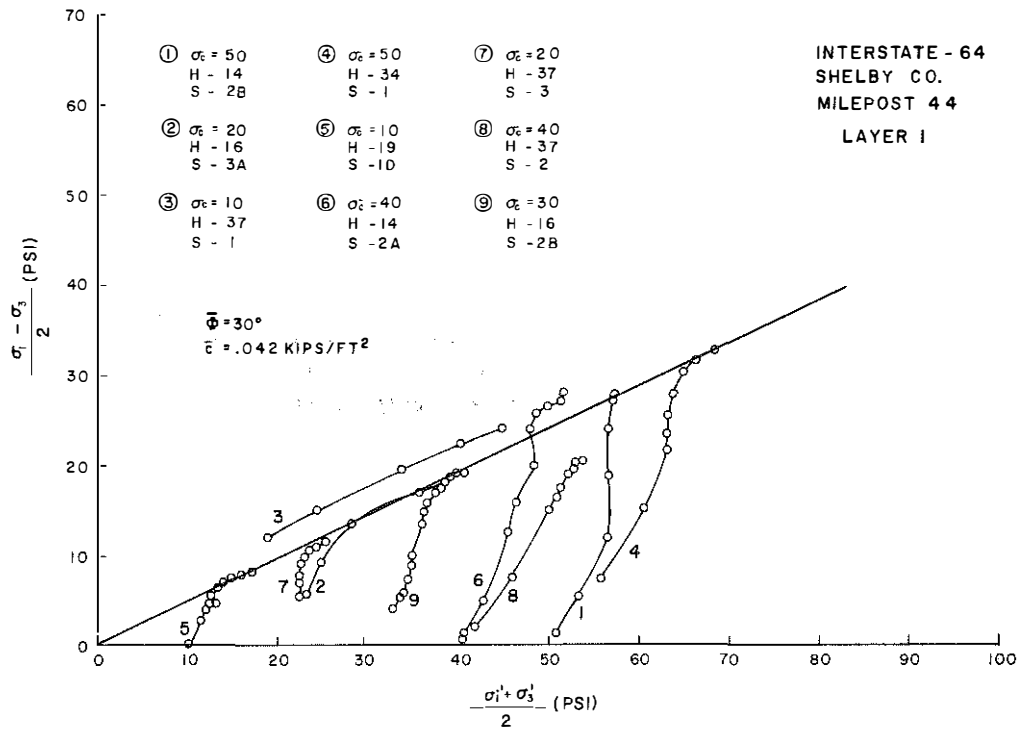
Figure 44. Consolidated, Isotropic, Undrained Triaxial Test Results, Layer 1 (Embankment) - I 64.

The "P-Q diagrams" for embankment and foundation are presented in Figures 44 and 45. The shapes of the stress paths indicated that the material in both layers was overconsolidated (16). The effective strength parameters for the embankment were 30° for  $\phi'$  and 42 psf for  $c'$ . The foundation had a smaller  $\phi'$  of 24.2° but a higher  $c'$  of 474 psf.

Using the effective peak strength parameters from the CIU triaxial tests (Figures 44 and 45), the "as built" factor of safety was 1.010 (Analysis 31, Table 5). This was made using the highest observed water table and also assuming excess pore pressures were present due to seepage. To determine the effect of watertable fluctuations on stability, the line of seepage was dropped to its lowest observed elevation (Analysis 43, Table 5). This increased the factor of safety 40 percent to 1.409, thus indicating water may have been a contributing factor to instability. Figure 55 shows the observed and theoretical failure surfaces for these two cases.

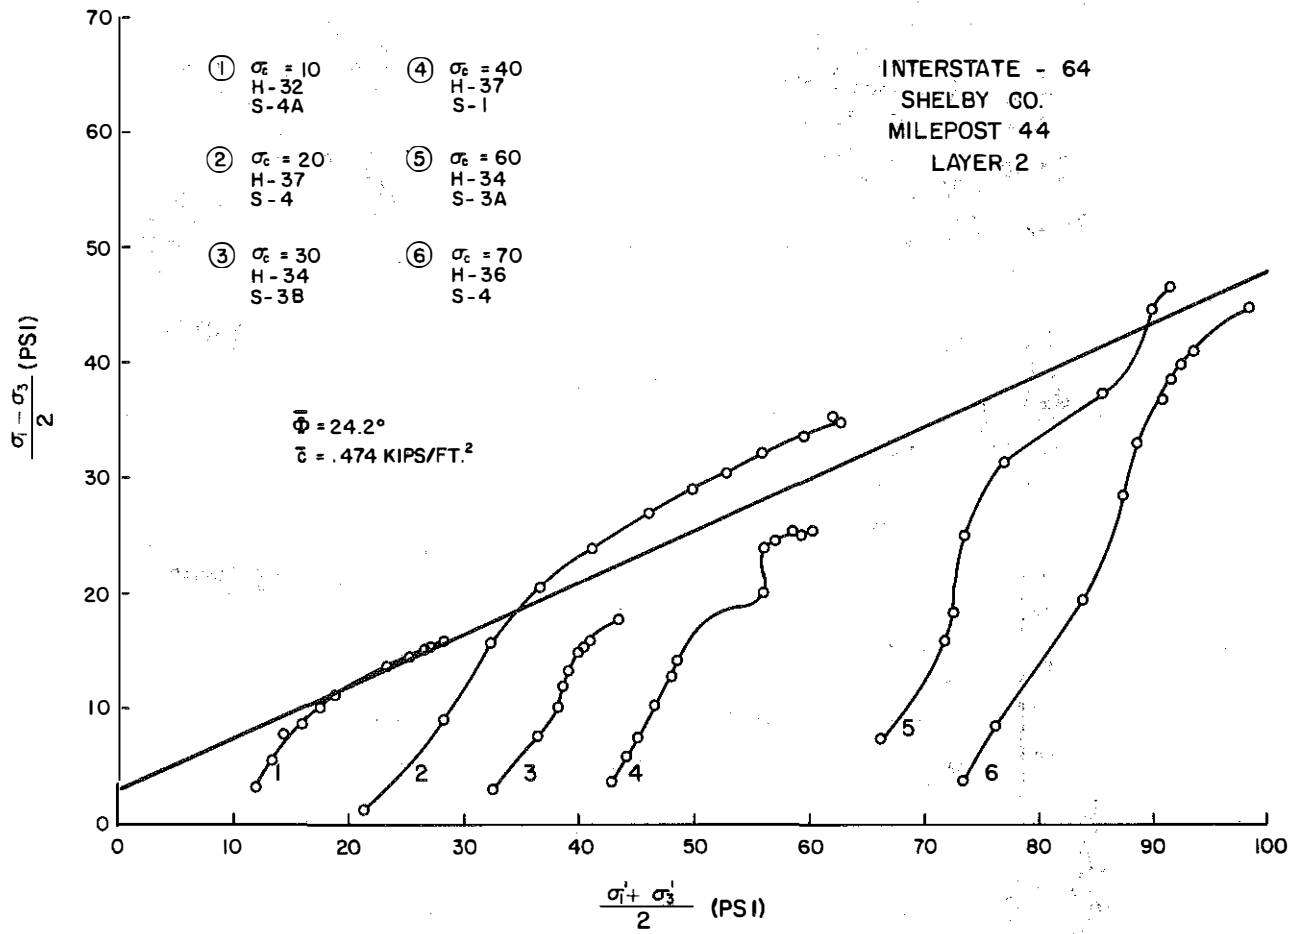
Figure 45. Consolidated, Isotropic, Undrained Triaxial Test Results, Layer 2 (Embankment) - I 64.

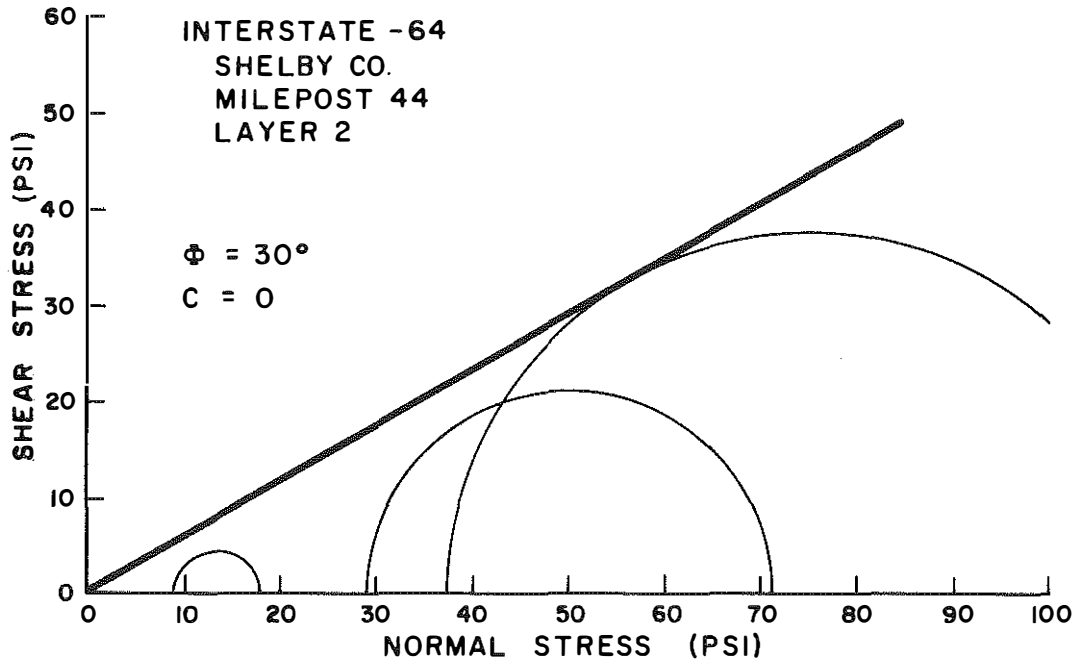
Figure 47. Shear Strength Results from Special Relaxation - Triaxial Test Using One Specimen, Layer 2 (Foundation) - I 64.

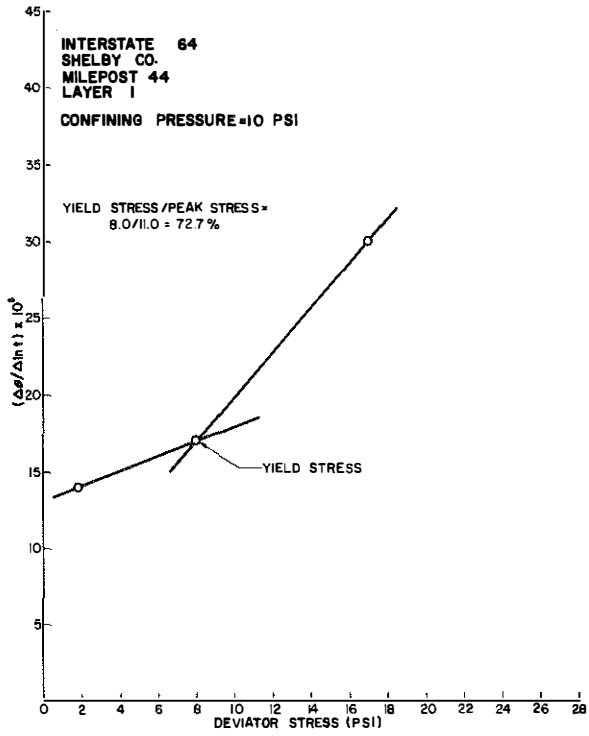
Figure 48. Viscosity Diagrams, Layer 1 (Embankment) - I 64.

The results of the creep tests are given by the "viscosity diagrams" in Figures 48 through 50. Two creep tests were run on a third layer that was not in the immediate slide area (Figure 50) and was not used in the stability analysis but are presented for record. Analysis of yield stress as a function of peak stress is given in Figure 51. Regression analysis indicated the yield stress was equal to 47.5 percent of the peak stress.

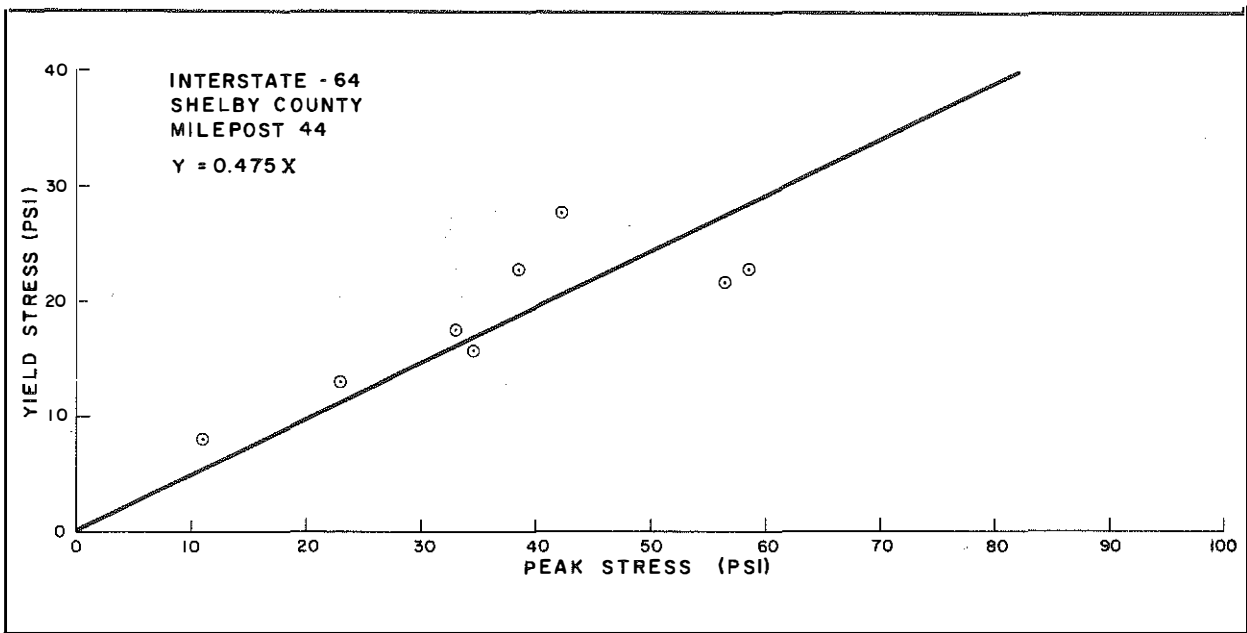
Figure 51. Yield Stress as a Function of Peak Stress, All Layers - I 64.

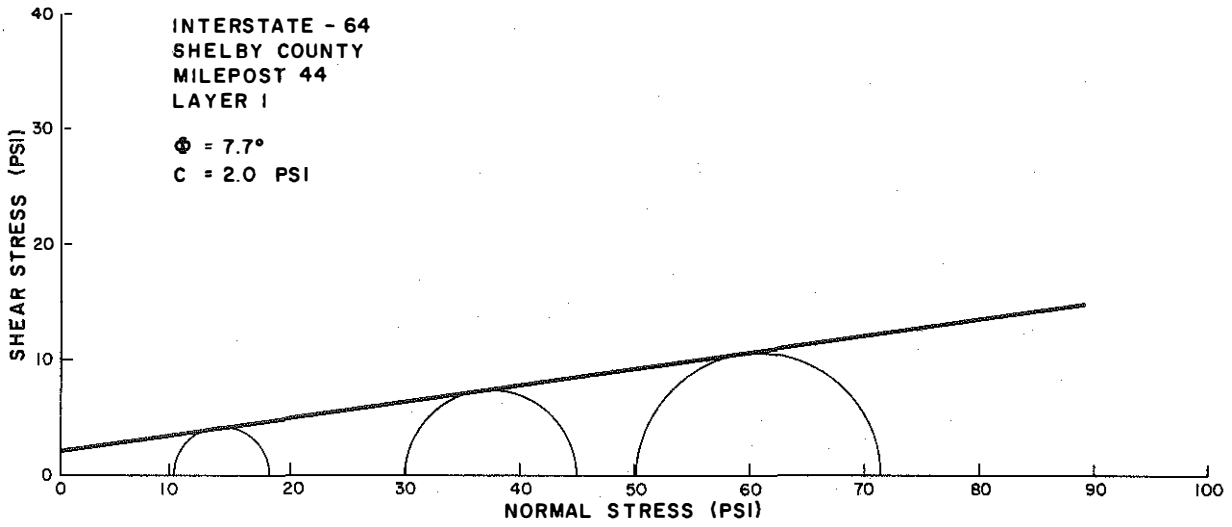
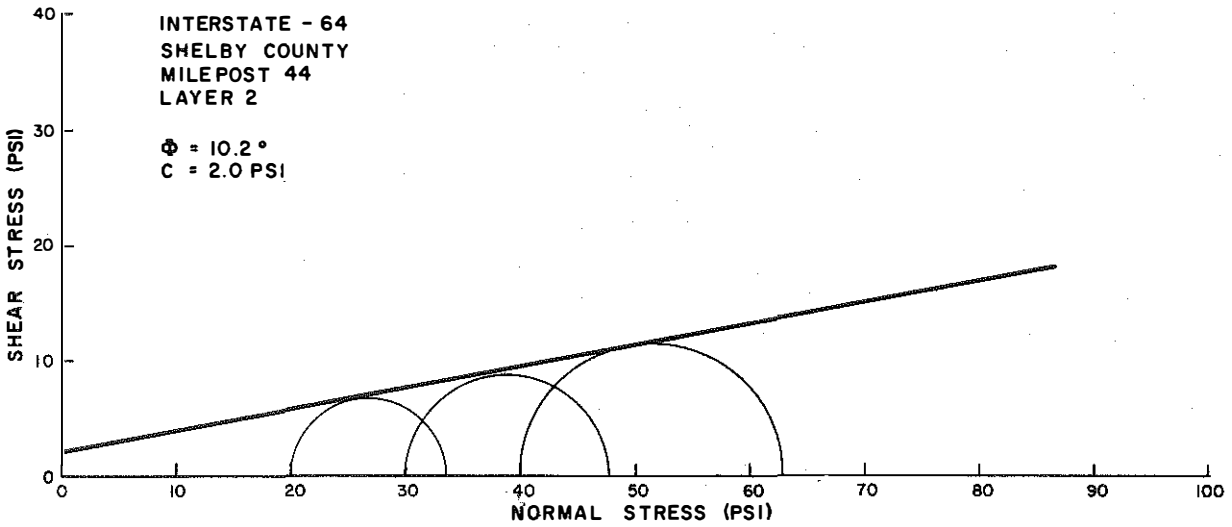
Figure 52. Failure Envelope Using Yield Stress,  
 Layers 1 and 2 - I 64.

Strength parameters for the embankment, using yield stress, were  $7.7^\circ$  for  $\phi$  and 2.0 psi for  $c$ . The foundation had a higher  $\phi$  of  $10.2^\circ$ , but cohesion was equal to that of the embankment (Figure 52).

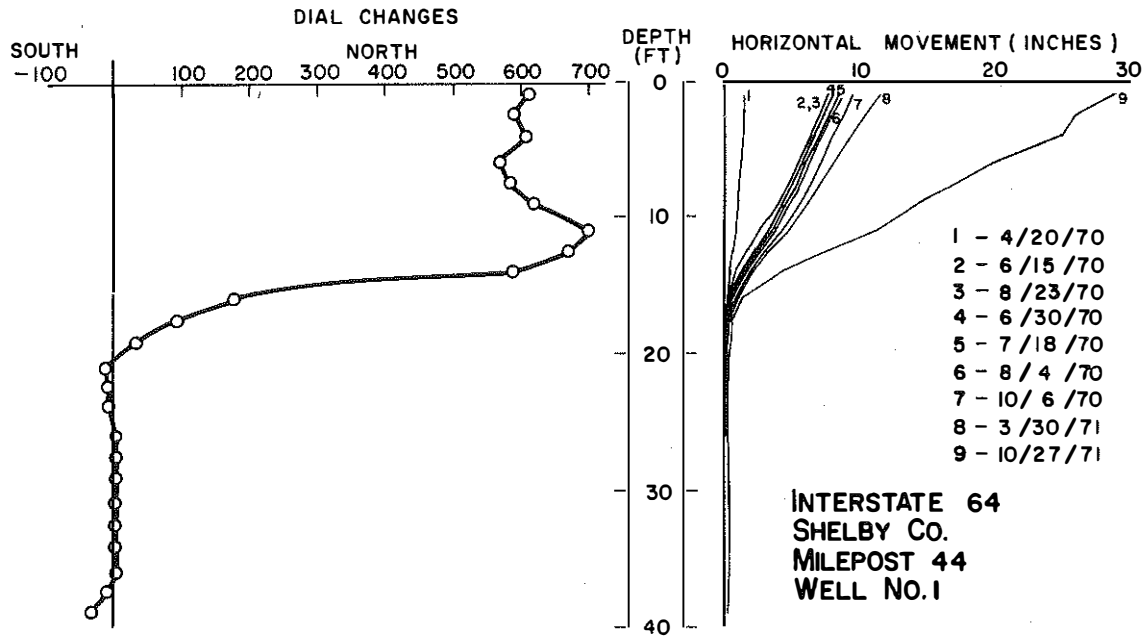
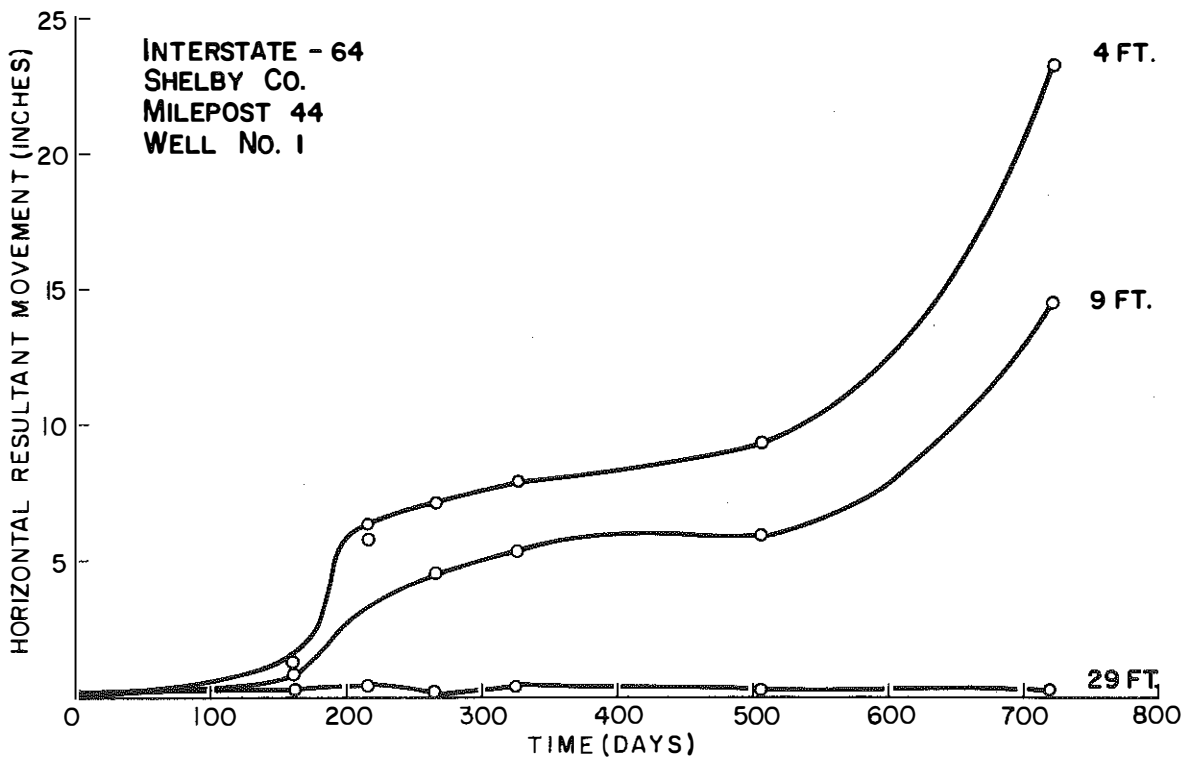
Figure 53. Slope Inclinerometer Results, Well No. 1 - I 64.

The inclinometers near Station 1866+00 indicate the failure surface is approximately circular and is at a depth of about 15 feet (Figures 53 and 54). Inclinometer No. 2 shows a second shear zone about 5 ft below the surface. This zone was probably initiated as a result of the deeper shear zone. The horizontal movement versus time plot in Figure 53 shows the movement began to accelerate at Well No. 1 between 500 and 700 days. Shortly after 700 days, complete failure occurred closing the well. In spite of repairs at this site, Well No. 2 is open and the reading taken at 1300 days appears to indicate movement has accelerated between 700 and 1300 days (Figure 54). However, it is suspected that most of this movement occurred when the embankment failed, which would probably cause a discontinuity in the curves shortly after 700 days. Sufficient readings were not taken to verify this.

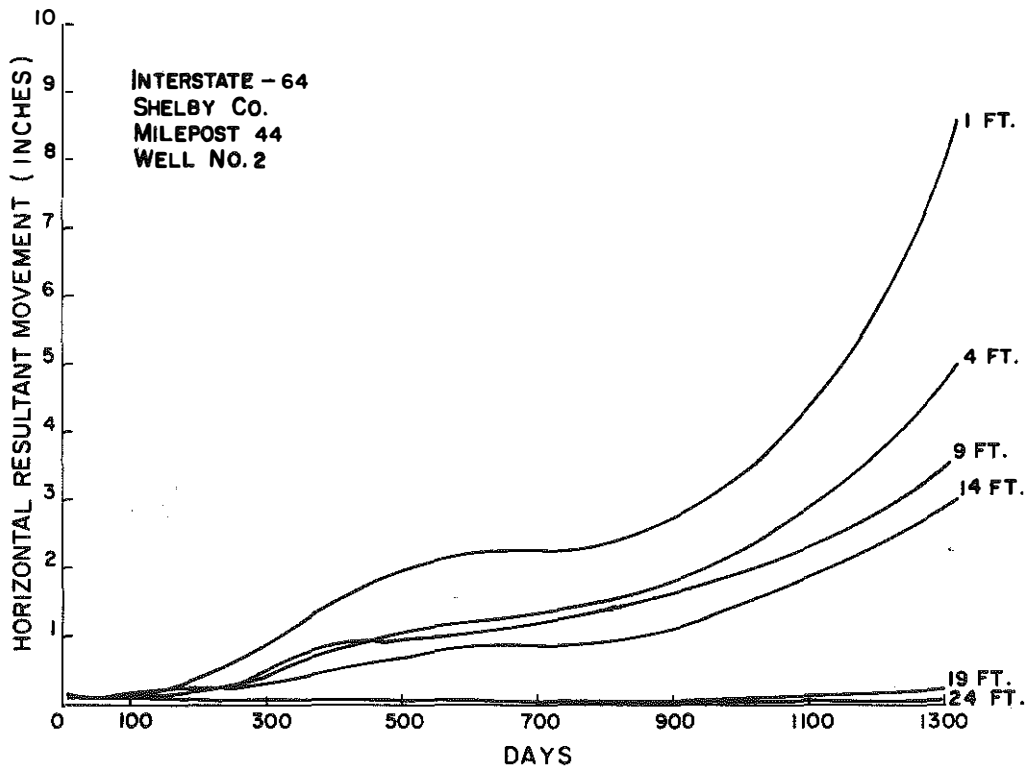
Figure 54. Slope Incliner Results, Well No. 2 - I 64.

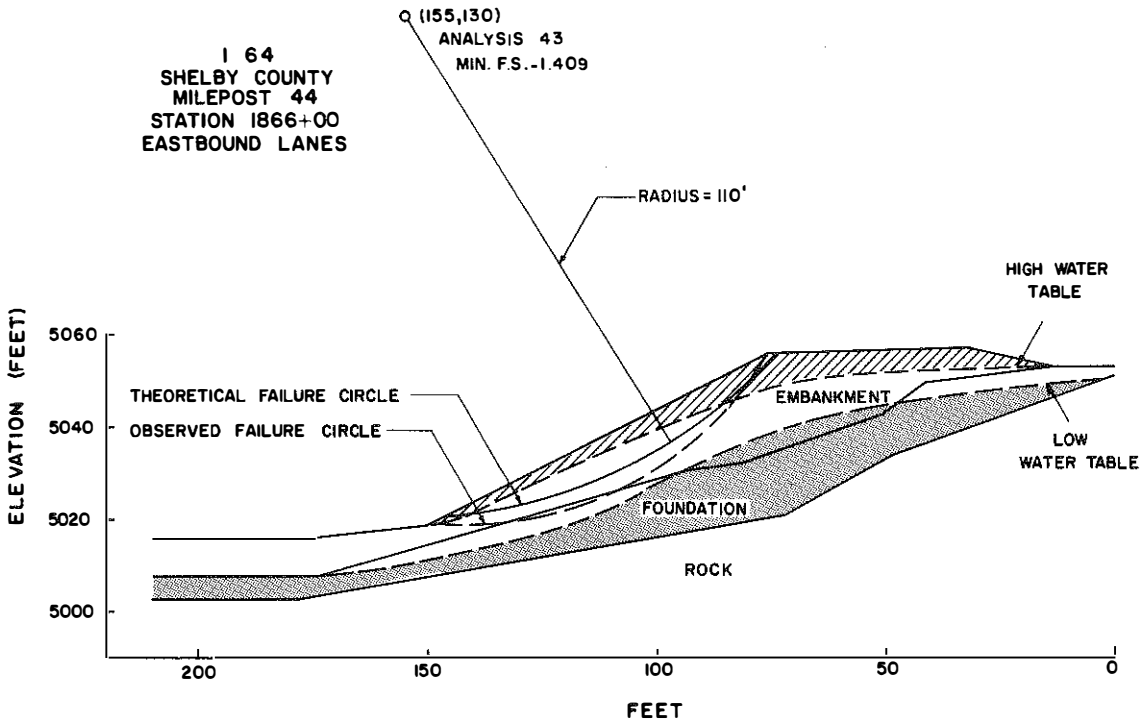
Figure 55. Slope Stability Analysis Results, Analysis 43 - I 64.

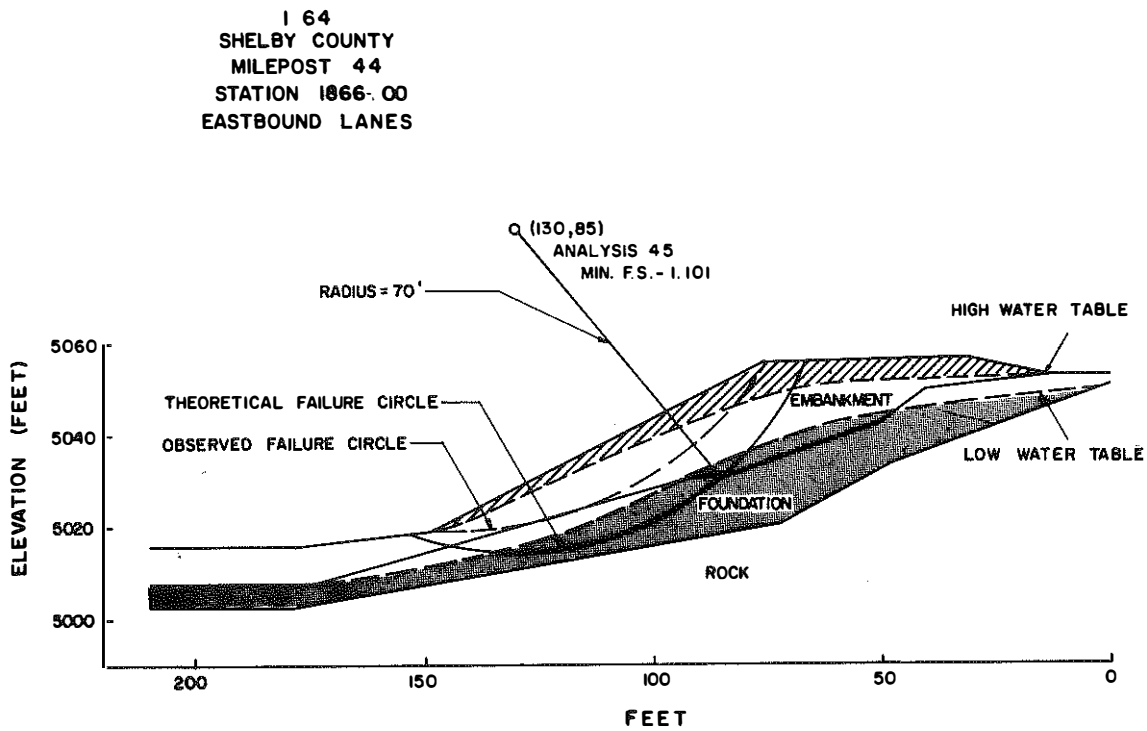
Figure 56. Slope Stability Analysis Results, Analysis 45 - I 64.

To consider the effect of loss of shear strength on stability because of decreasing cohesion, Analysis 39 was made assuming no cohesion and using  $\phi'$  angles determined from the CIU tests (labeled "residual" strength in Table 5). Using the highest elevation of seepage, this case yielded a factor of safety of 0.719. However, using the lowest observed seepage line (Analysis 45), the "residual" parameters predicted 1.101 (Figure 56).

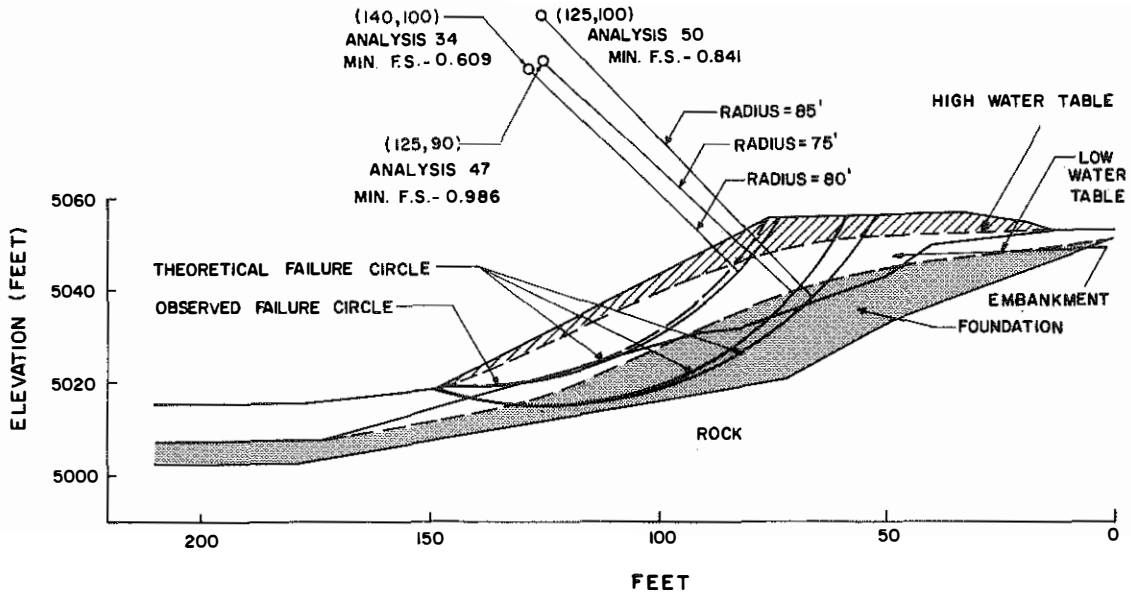
Figure 57. Slope Stability Analysis Results, Analysis 34, 47, and 50 - I 64.

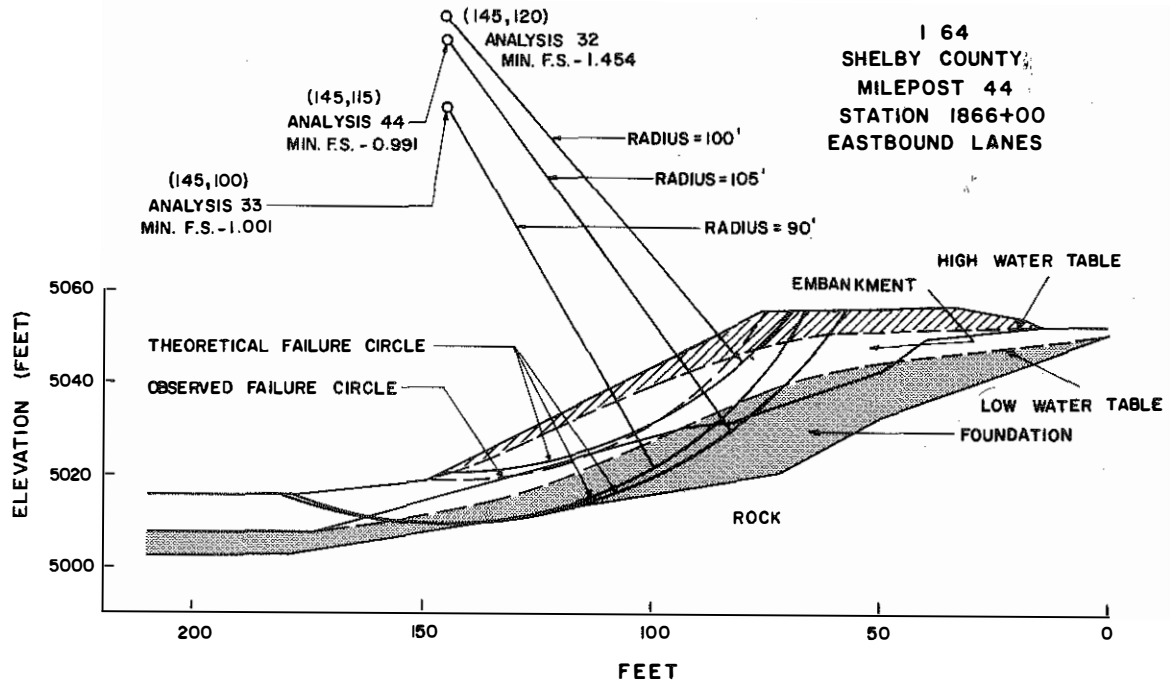
Figure 58. Slope Stability Analysis Results, Analysis 32, 33, and 44 - I 64.

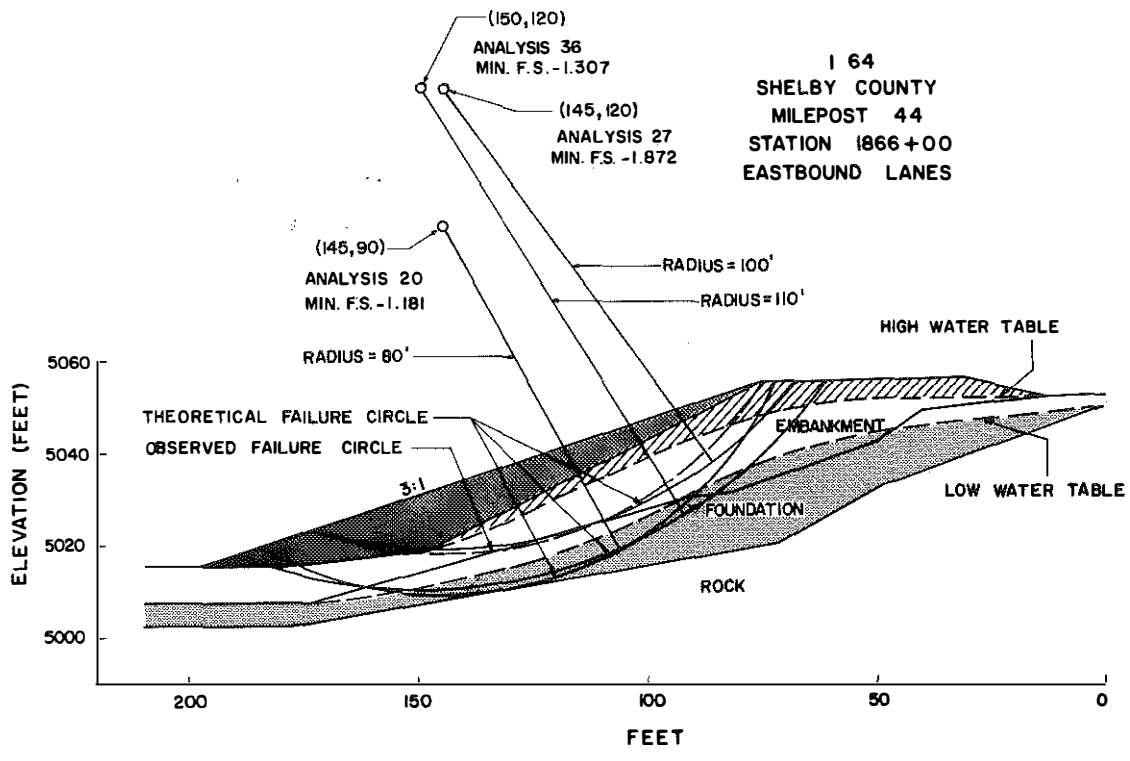
**Figure 59. Slope Stability Analysis Results, Analysis 20, 27, and 36 - I 64.**

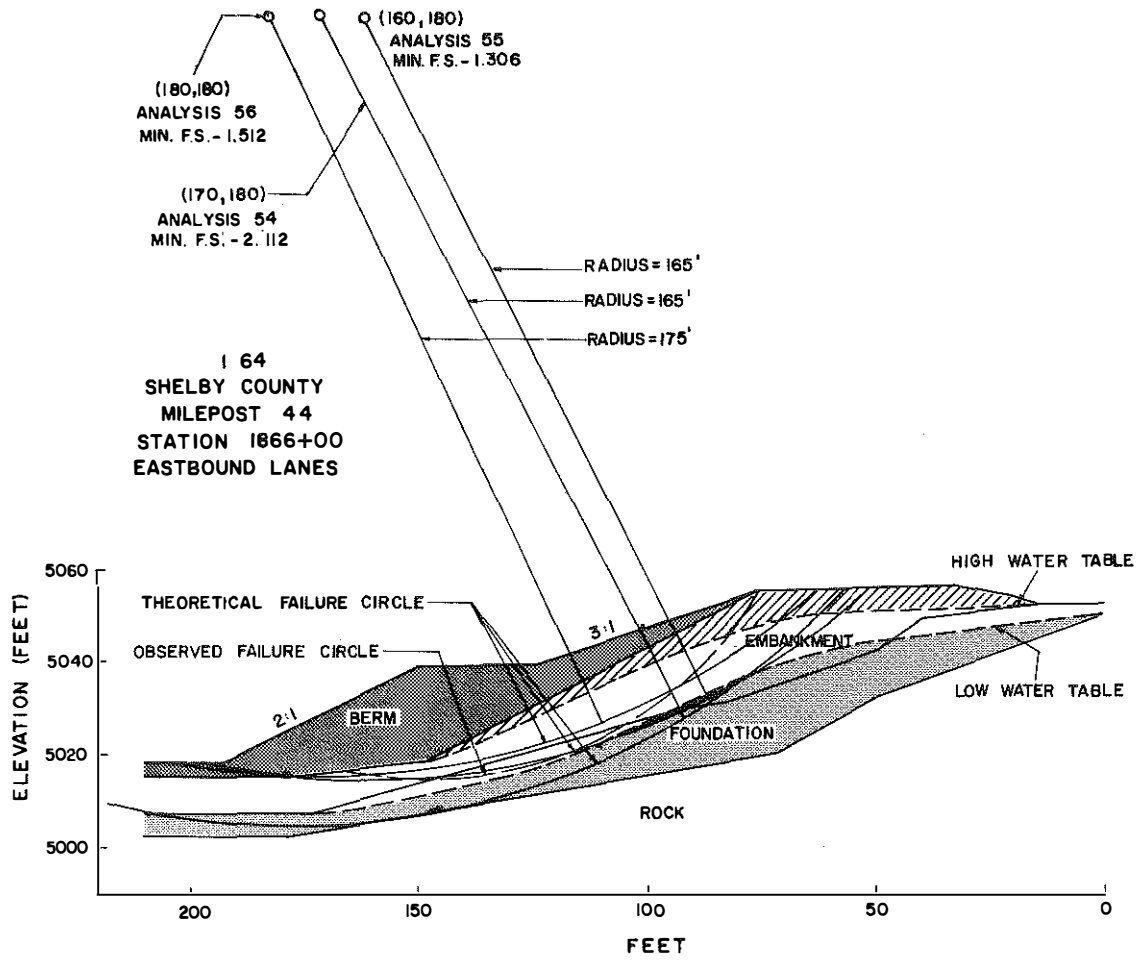
Figure 60. Slope Stability Analysis Results, Analysis 54, 55, and 56 - I 64.

In an effort to increase the factor of safety from a marginal design of 1.181 and to provide better insurance against large creep deformations, a berm 33 ft wide and approximately 25 ft high was analyzed (keeping the slope above the berm at 2:1). This provided adequate security against deep failures; the minimum factor of safety would be approximately 1.30. However, this design would not prevent small failure surfaces from passing through the slope above the berm as there were several circles with factors of safety very close to 1.0. To prevent these shallow failures, the embankment slope was changed to 3:1 and a small 24-ft wide berm was added (Figure 60). Analysis indicated this was a good remedial design inasmuch as shallow failures were not critical and the factors of safety against deep failures using peak, "residual", and creep parameters were 2.112 (Analysis 54), 1.512 (Analysis 56), and 1.306 (Analysis 55), respectively.

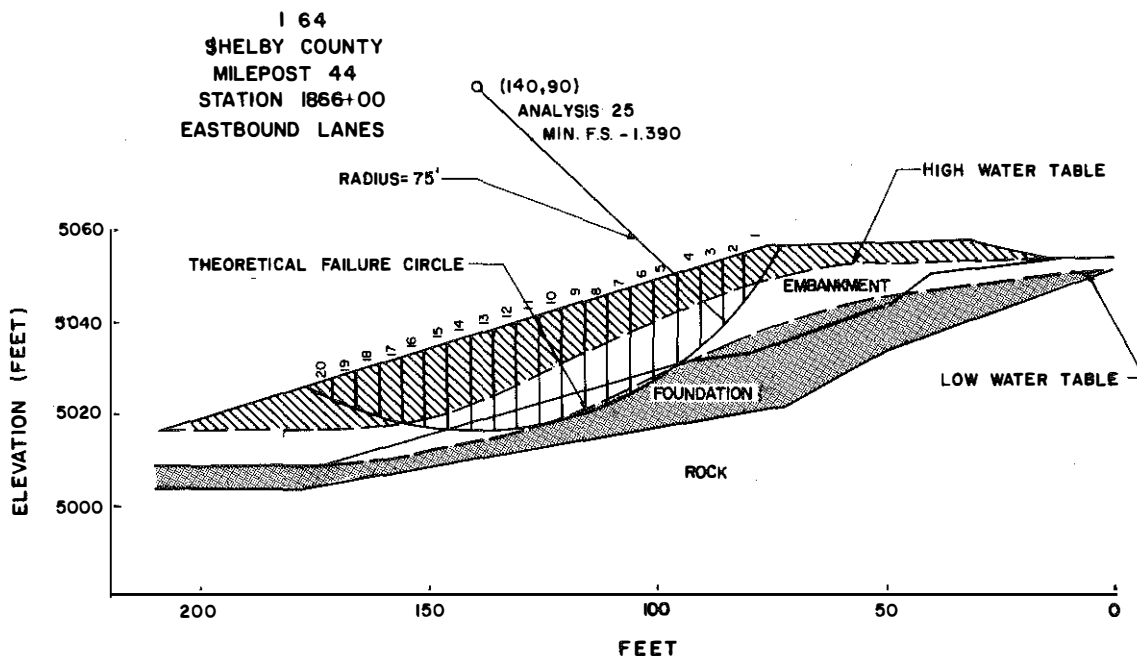
Figure 61. Slope Stability Analysis Results, Analysis 25, Showing Division of Soil Mass into Individual Slices - I 64.

The stability analysis program developed by Yoder and Hopkins (20) will provide a detailed printout of all forces on each slice for any given failure circle. An example printout is shown in Figure 61 (Analysis 25). Column eight lists the available shear strength for each slice, and column nine lists the shear stress on each slice. In making remedial designs, special attention was paid to the balance of these two forces for each slice. In each design analyzed, there was a minimum of four or five slices in the upper portion of the slope which was overstressed. In the case of Figure 61, there were eight slices overstressed. In attempting to remedy this, a
