SUBJECT: Research Report No. 382; "The Creep Response of Cohesive Soils: A Method of Design Using Rheological Strength Parameters;" Final Report; KYHPR-65-38; HPR-1(9), Part II

1. Report No.		2. Government Accession No.		3. Recipient's Catalog No.	
4. Title and Subtitle The Creep Response of Cohesive Soils: A Method of Design Using Rheological Strength Parameters			5. Report Date December 1973

Research Report  
382

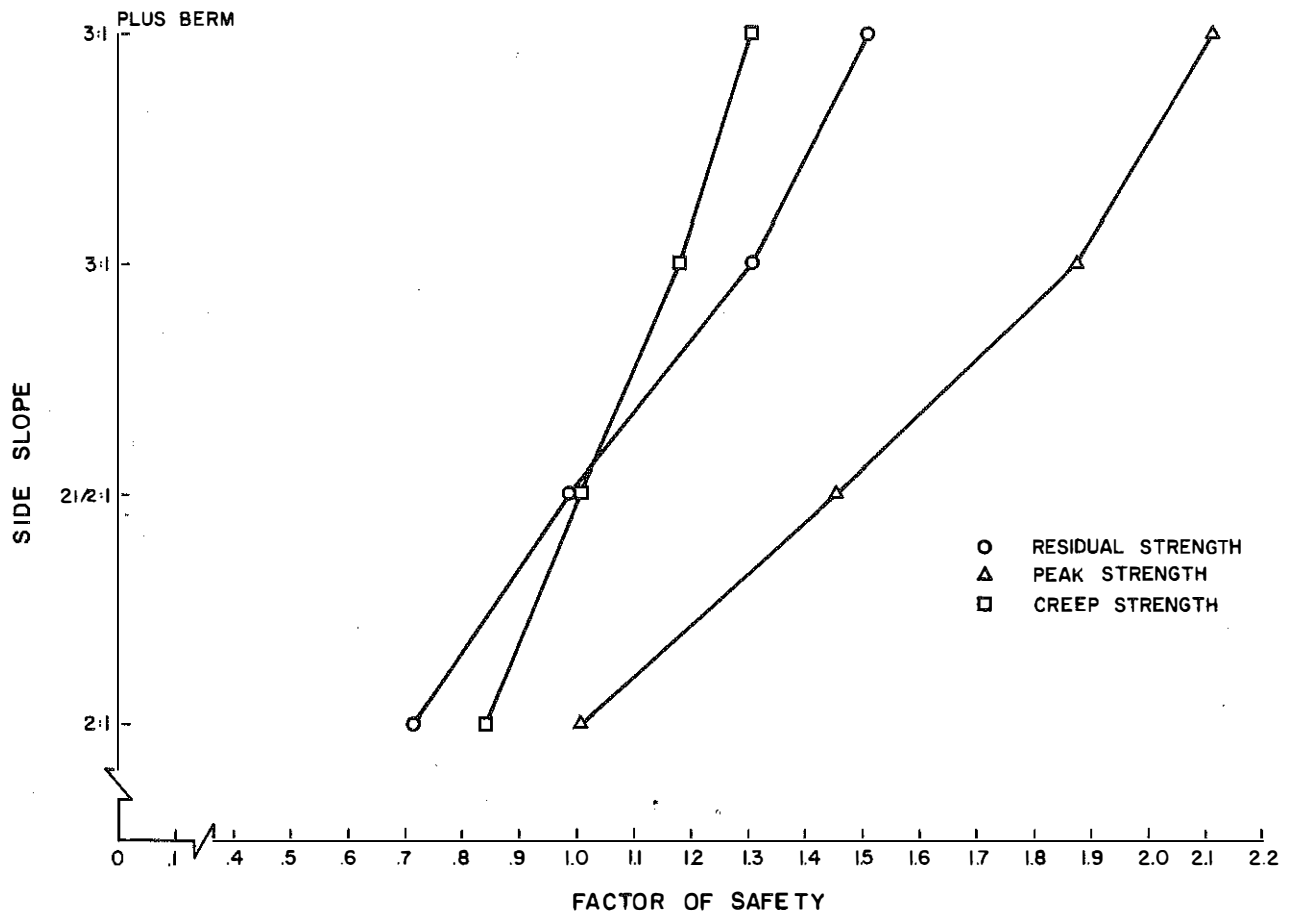
**Figure 62. Factor of Safety as a Function of Side Slope Configuration - I 64.**

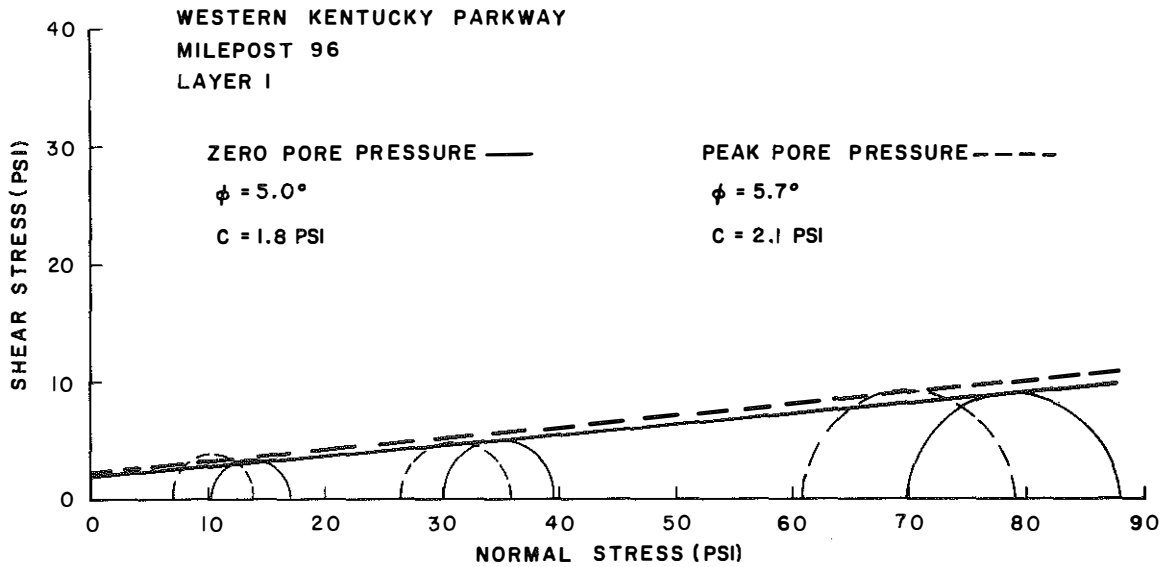
Figure 63. Relationship between Failure Envelopes Using Total Stress Analysis and Effective Stress Analysis, Layer I (Embankment), Milepost 96 - Western Kentucky Parkway.

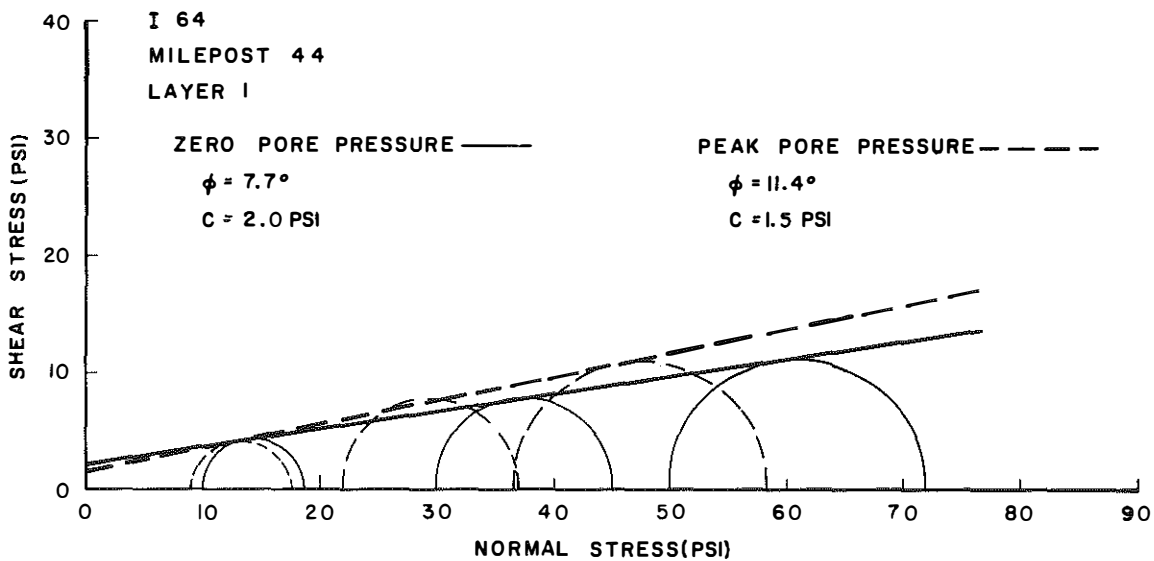
Figure 64. Relationship between Failure Envelopes Using Total Stress Analysis and Effective Stress Analysis, Layer I (Embankment), Milepost 44 - I 64.

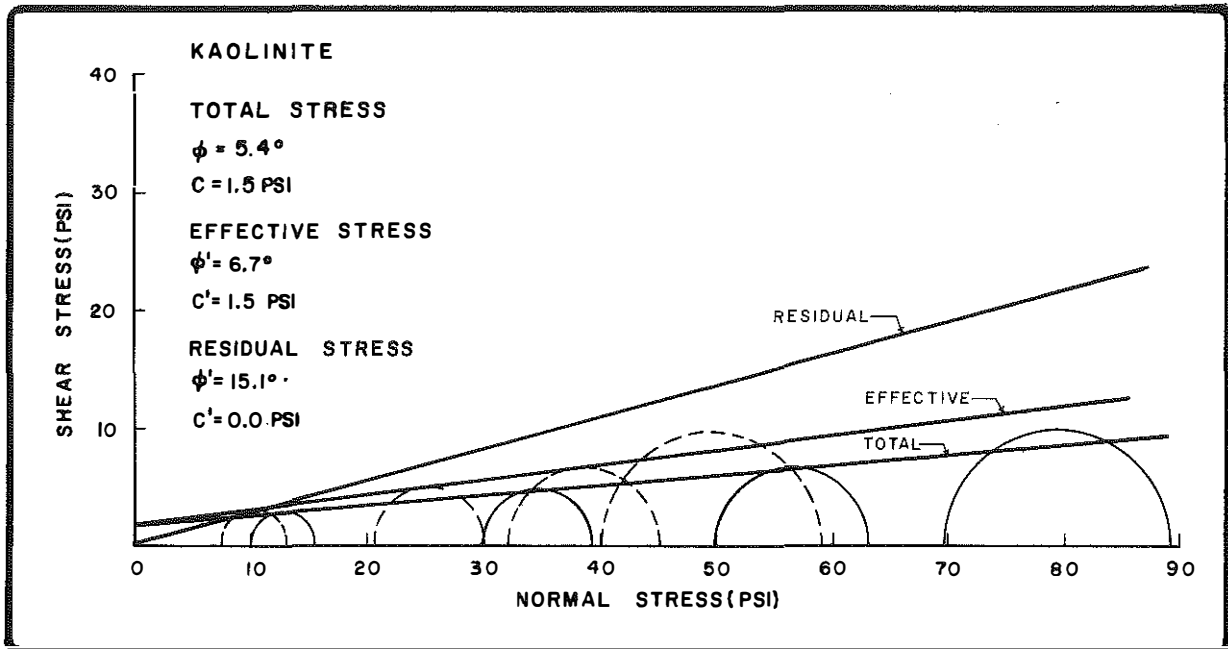
Figure 65. Comparison of Shear Strength Parameters Using Residual, Effective, and Total Stresses Kaolinite Series.
