SUBJECT: "Expansive Limestone Aggregate in a Concrete Pavement;" I 65, Warren-Simpson  
Counties; KYP-56; HPR-1(7), Part III-A.

**EXPANSIVE LIMESTONE AGGREGATE  
IN A CONCRETE PAVEMENT**

I 65-1(13)13, MP 114-263-E  
Warren - Simpson Counties

April 1972

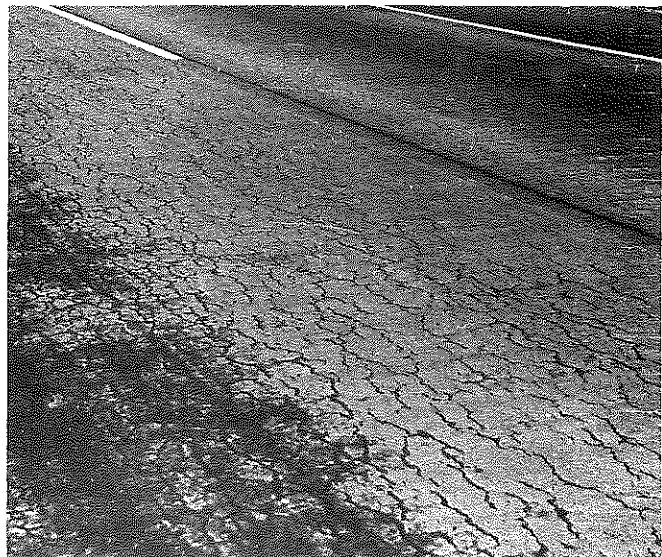
**Figure 3.** I 65, Crack Pattern Made Obvious by Moisture after a Rain; October 1967.

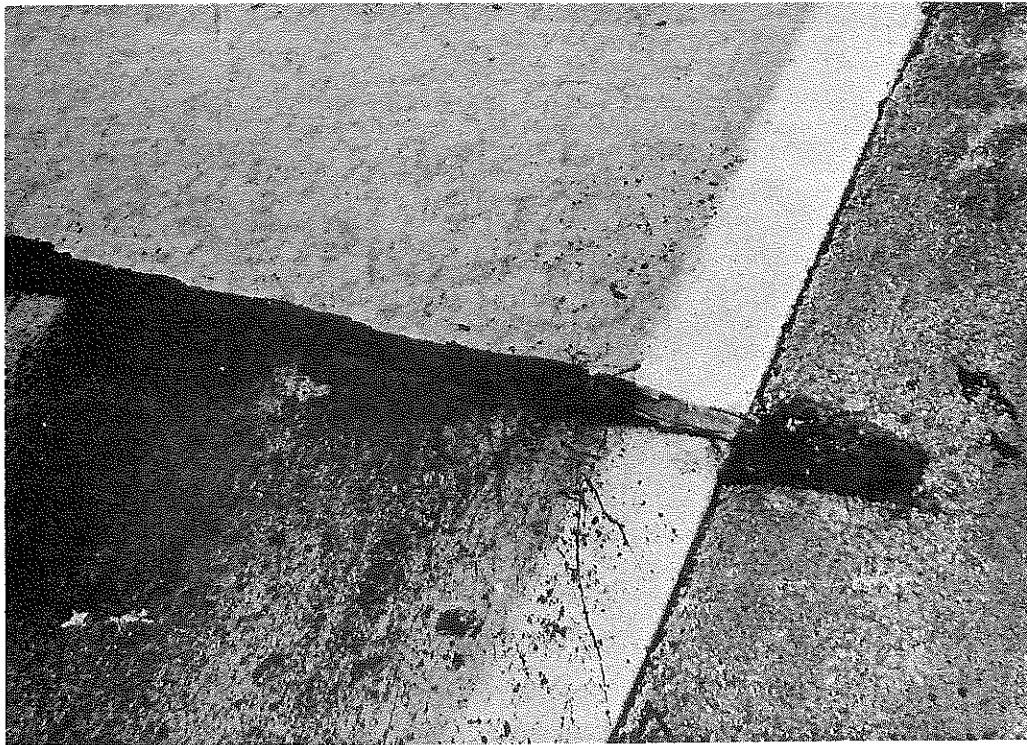
**Figure 5. Closure of Relief Joint, Station 707+75 NB; July 15, 1968.**

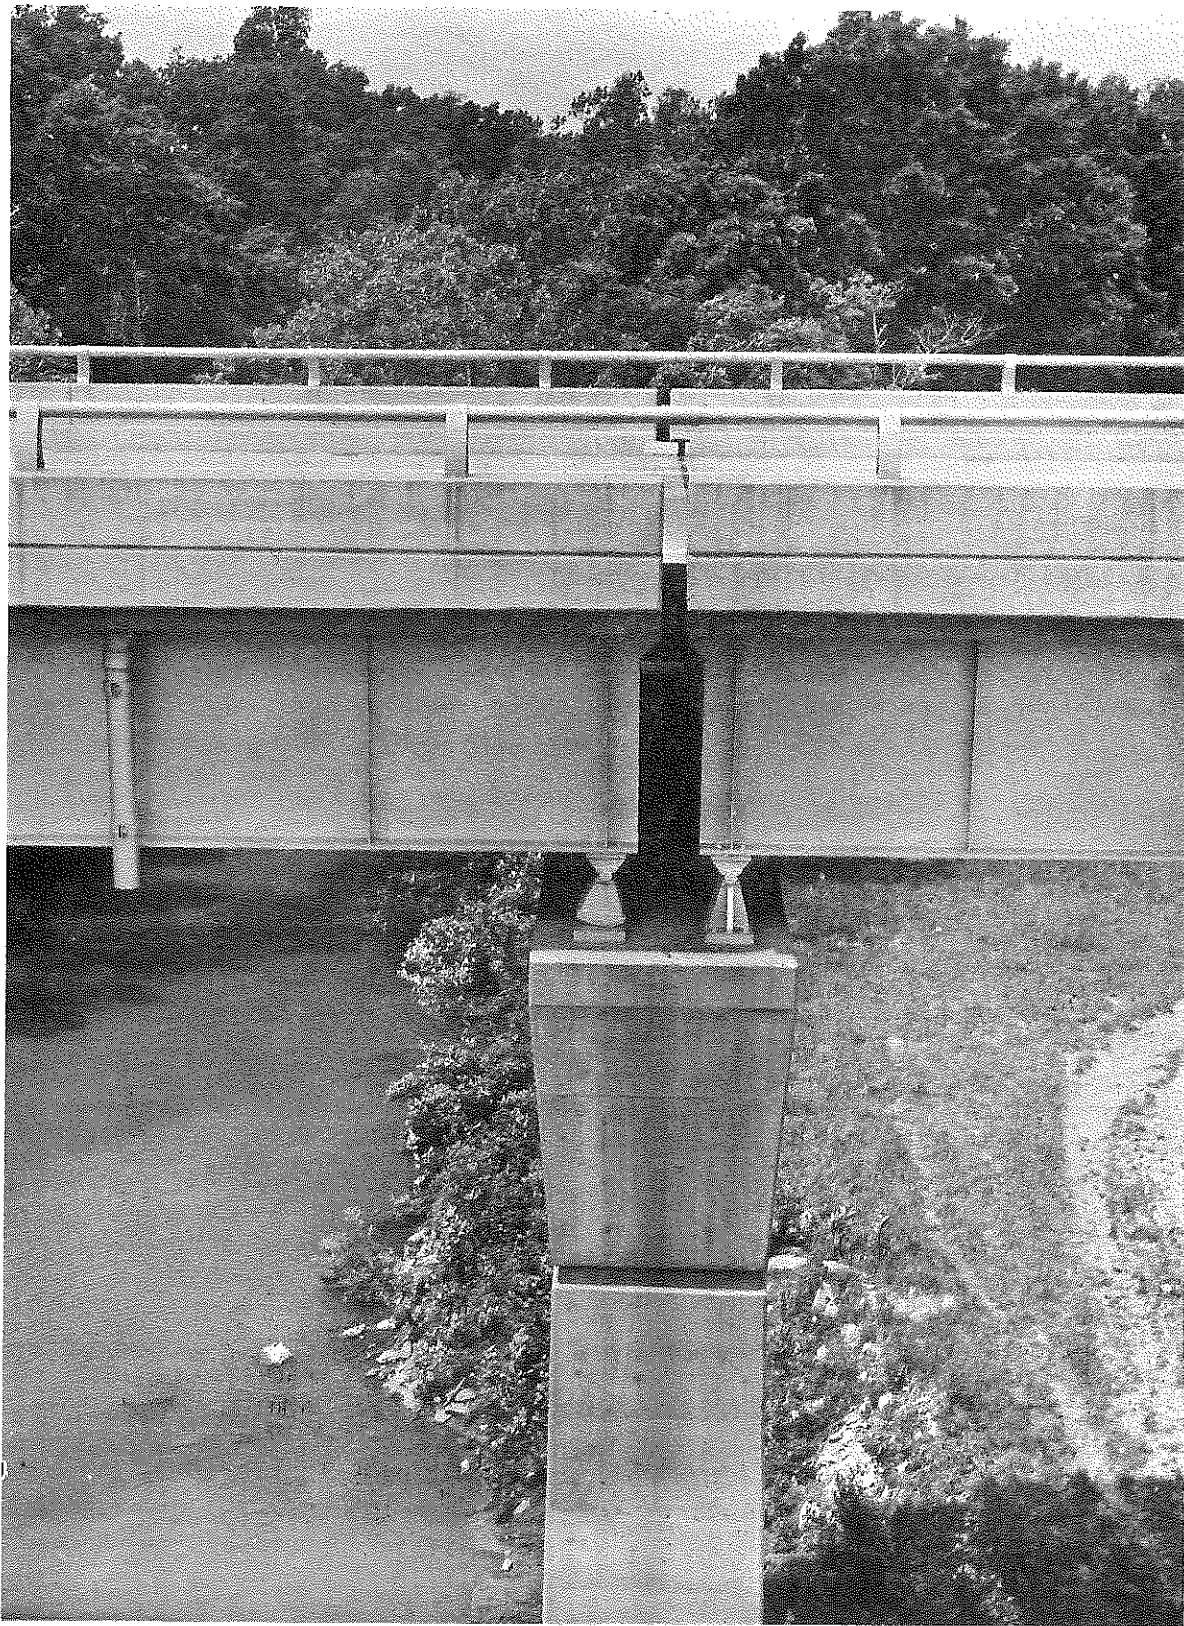
**Figure 6.** Bridge over Drakes Creek, I 65-1(8), Showing Northward Thrust of South Abutment and Closure at Center Pier. South abutment wall sheared, subsequently repaired; damage attributed in large part to expansion of pavement south of bridge.

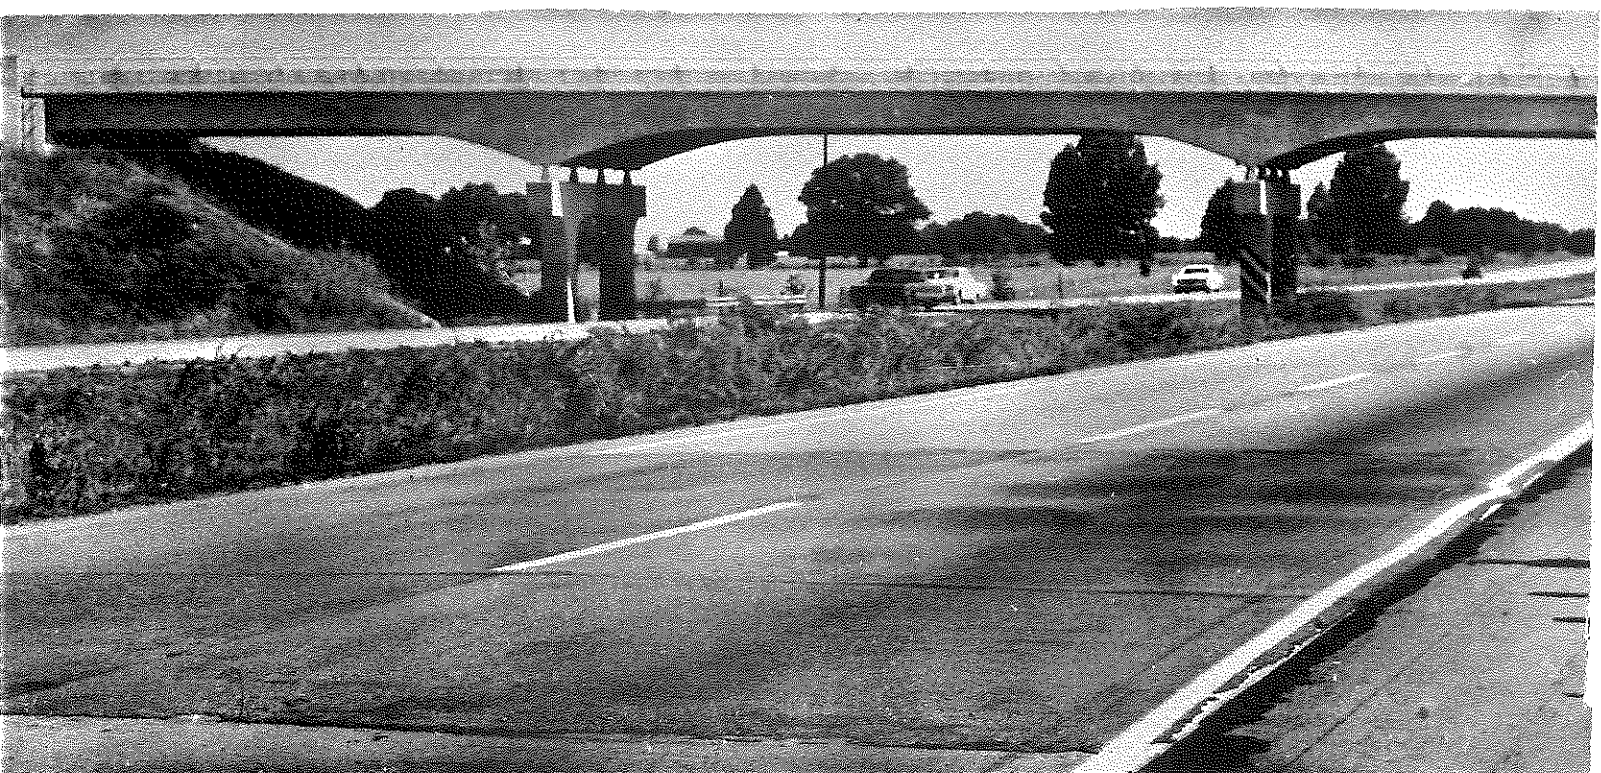
**Figure 8.** Same Site as above with Bituminous Patch, Station 280+75 NB; July 17, 1970.

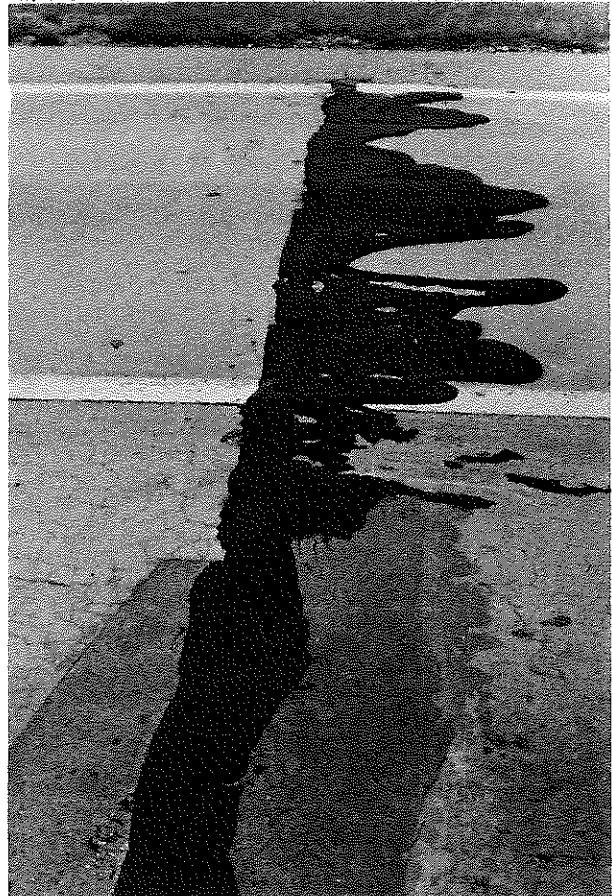
**Figure 12.** Rubberized Asphalt Filler Extruded from Relief Joint, near Drakes Creek, Due to Closure; March 7, 1972.

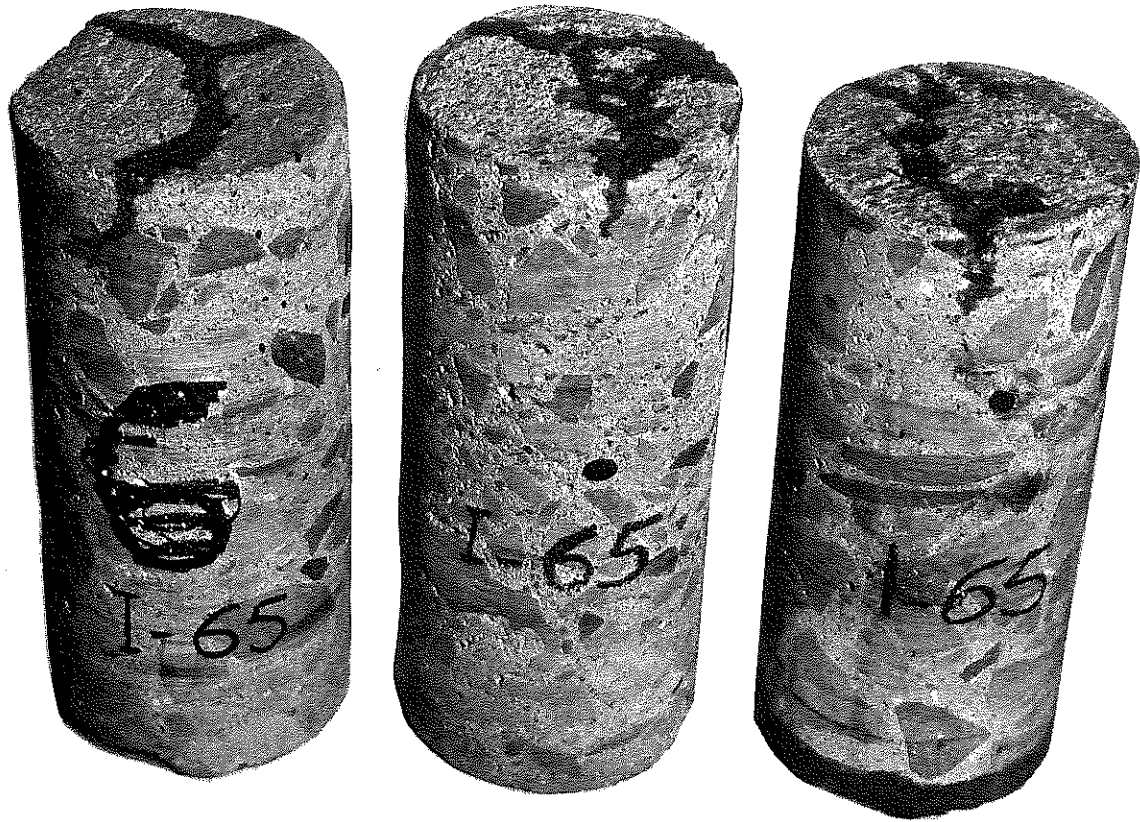
Figure 14. Cores Showing Cracks at Surface and Depth. Cracks have been wetted. Note indentation in surface of core at right; these appear to be finger imprints and suggest that someone recognized the crack before the concrete hardened. Note too that this crack is directly over a strand of steel (blackened).

These cores were kept to illustrate the nature of the cracking. No tests were performed on them. Two were forced apart along the crack to determine (visually) the possibility of deeper, latent, or formative crack

fronts. Each one split in a nearly horizontal direction and exposed fresh surfaces in the horizontal plane. Core 6 had "dimples" in the surface; these were in line with a crack; they appeared very much like finger prints.

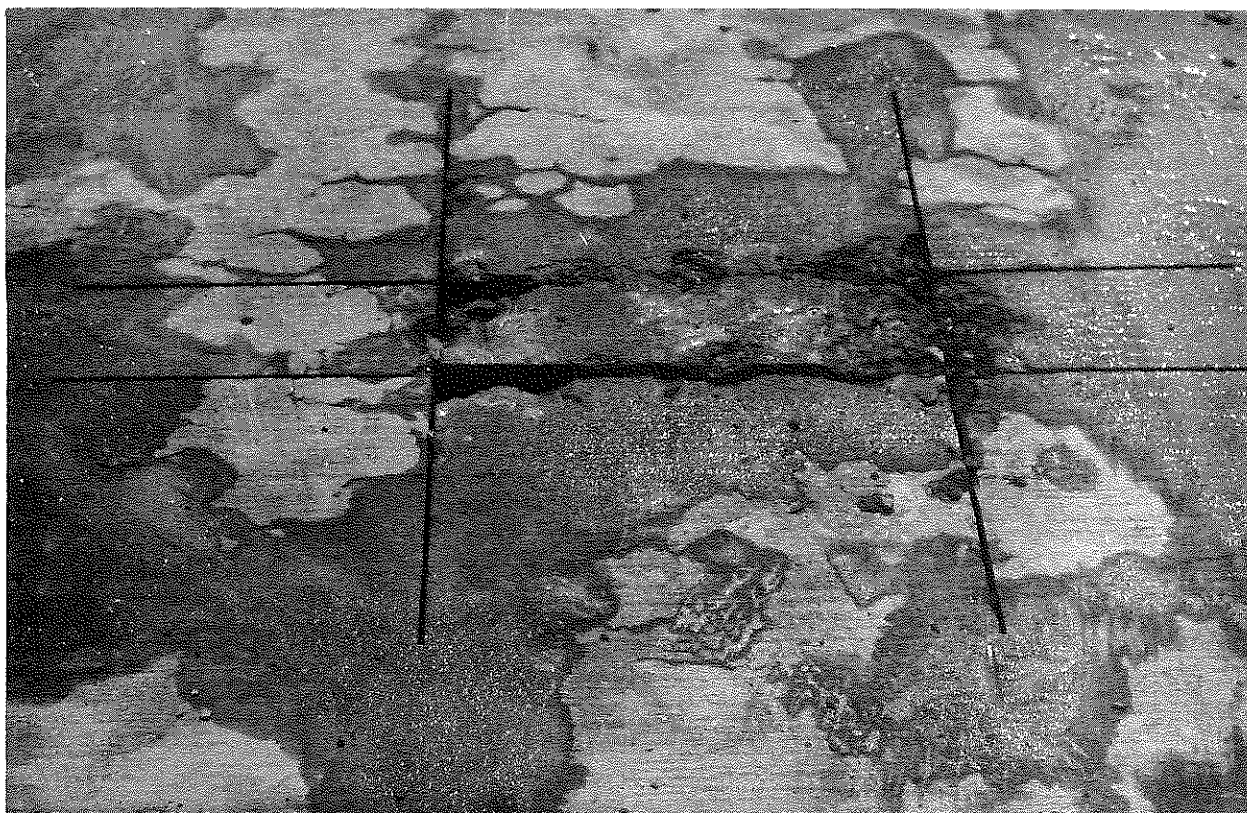
**Figure 15.** Gage Points Set in Pavement, Measured, then Block Sawed Free. Change in length between gage points -- due to relaxation -- was used to compute stress. Note cracking in lower photo (Station 226+00 SB).

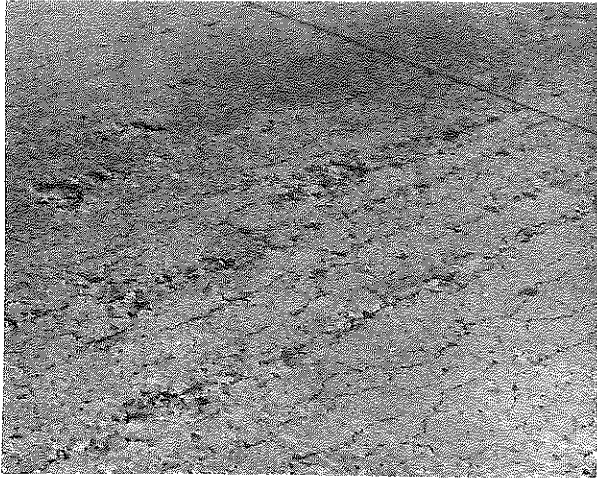
Figure 32. Advanced Cracking, I 65, MP 22, NB; March 7, 1972.

On March 7, 1972, remnant specimens of aggregate particles were extracted from "popout sockets" in the pavement in the vicinity of Milepost 22 (NB). The advanced stage of cracking at the site is shown in Figure 32. Photomicrograph shown in Figure 33 definitely associates the particles with Ledges 1, 4, or 5 in the quarry.

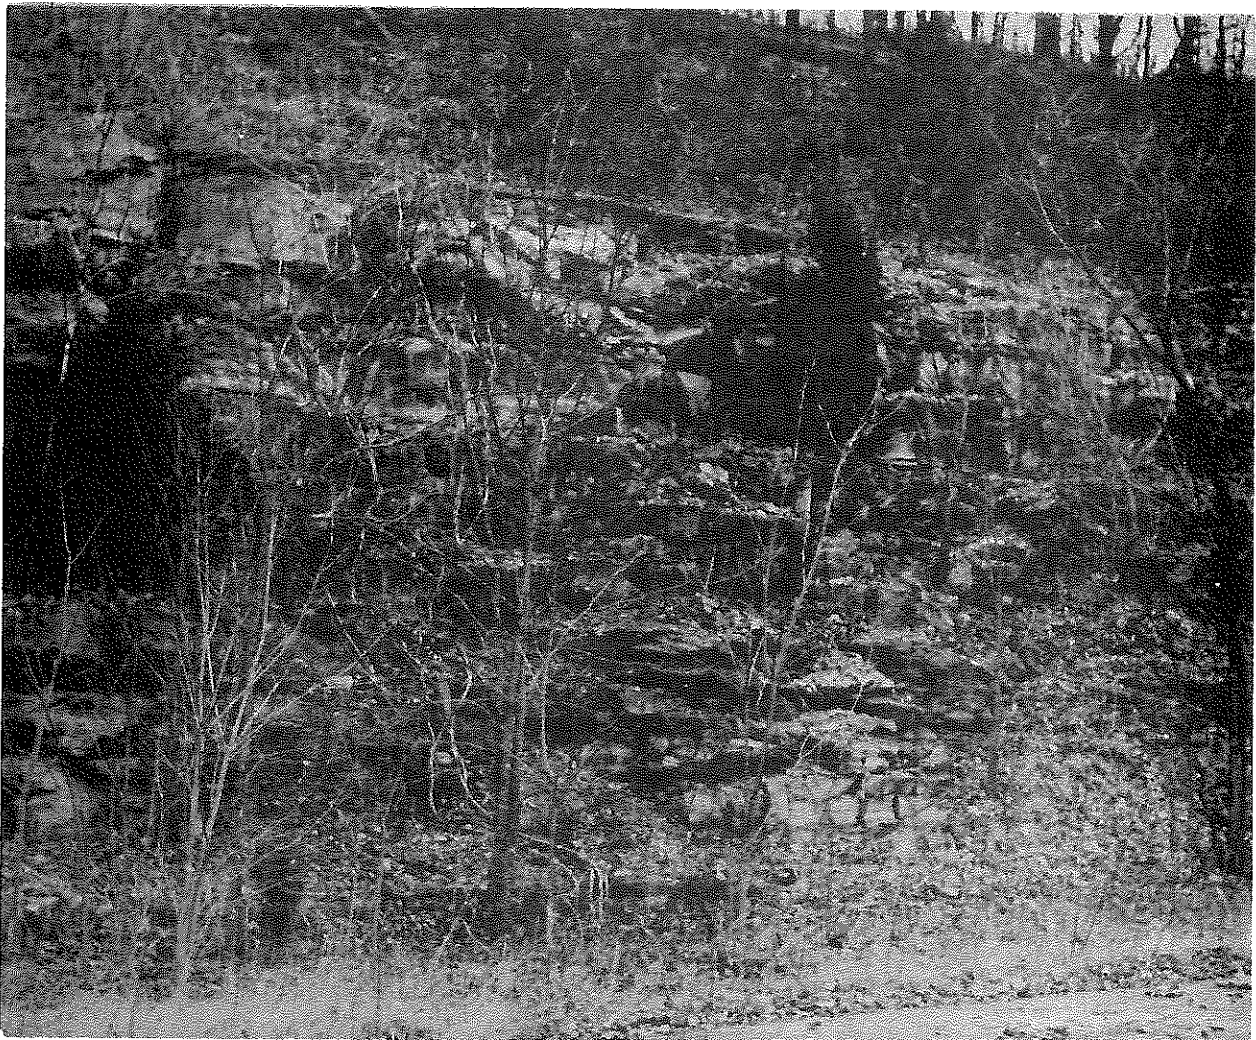
Figure 34. Quarry at Prices Mill, Southwest Simpson County; March 7, 1972.

Branson (3) mentions a quarry in the St. Louis at Prices Mill, in the southwestern corner of Simpson County, which was used to construct abutments for a bridge (built in 1958, KY 591 over Red River). No other local history of St. Louis limestone usage has been uncovered. A cursory review of quarries in Kentucky which have been identified geologically indicates that

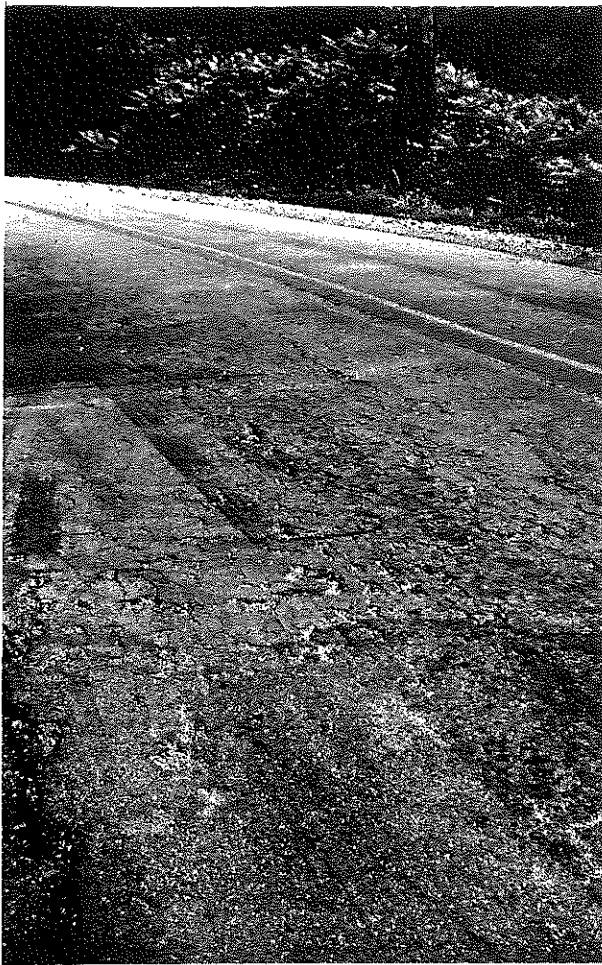
**Figure 36.** Section of US 60 between Olive Hill and Grayson; 1948 (14).

US 60 (5.04 miles, FA-13B), vicinity of Tygarts' Creek, eastward toward Grayson was paved in 1926. About 14 years later, surface cracking and popouts appeared. Figure 36 shows a portion of the pavement as it appeared in 1948. Popouts were caused by a chalky limestone which was distinctly associated with two ledges in the source quarry. The quarry was located just east of Olive Hill (visible rightwardly from present US 60). It was operated by the Codell Construction Company and by Central Rock Company. After World War II, this and three other quarries were studied intensely (12, 13, 14, 15). Rock quality requirements were not well established when this pavement was constructed; however, the quarry was abandoned sometime around 1940 because of difficulties in meeting specifications. In the course of the study (1948), it was observed that rock fragments from the offending ledges had chalked and deteriorated while laying on the floor of the quarry (Figure 37).

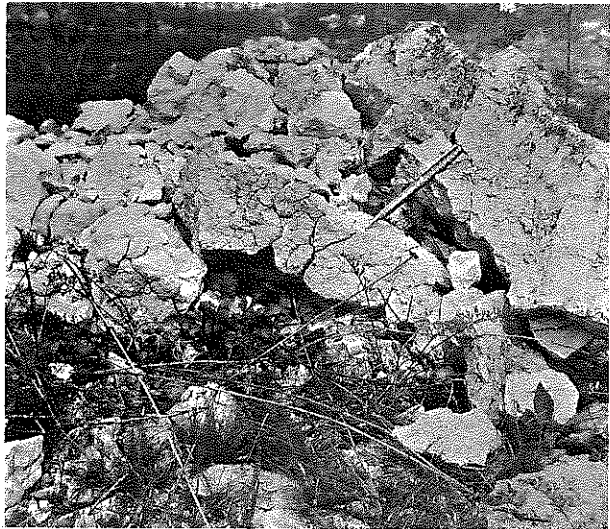
**Figure 37.** Weathered Rock Found in Floor of Olive Hill Quarry in 1948 (14).

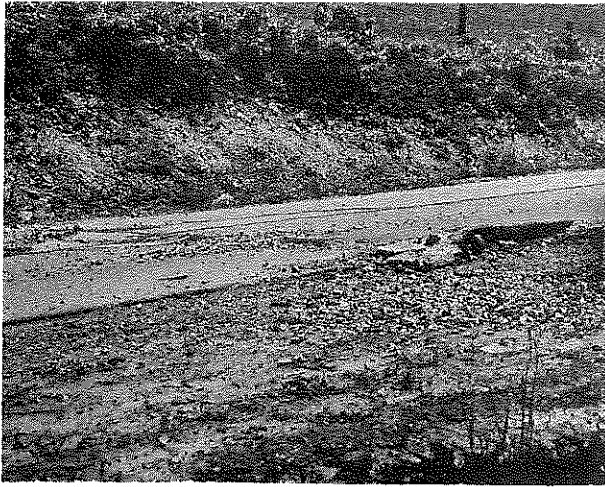
Figure 41. Blowup on KY 32; June 1950.

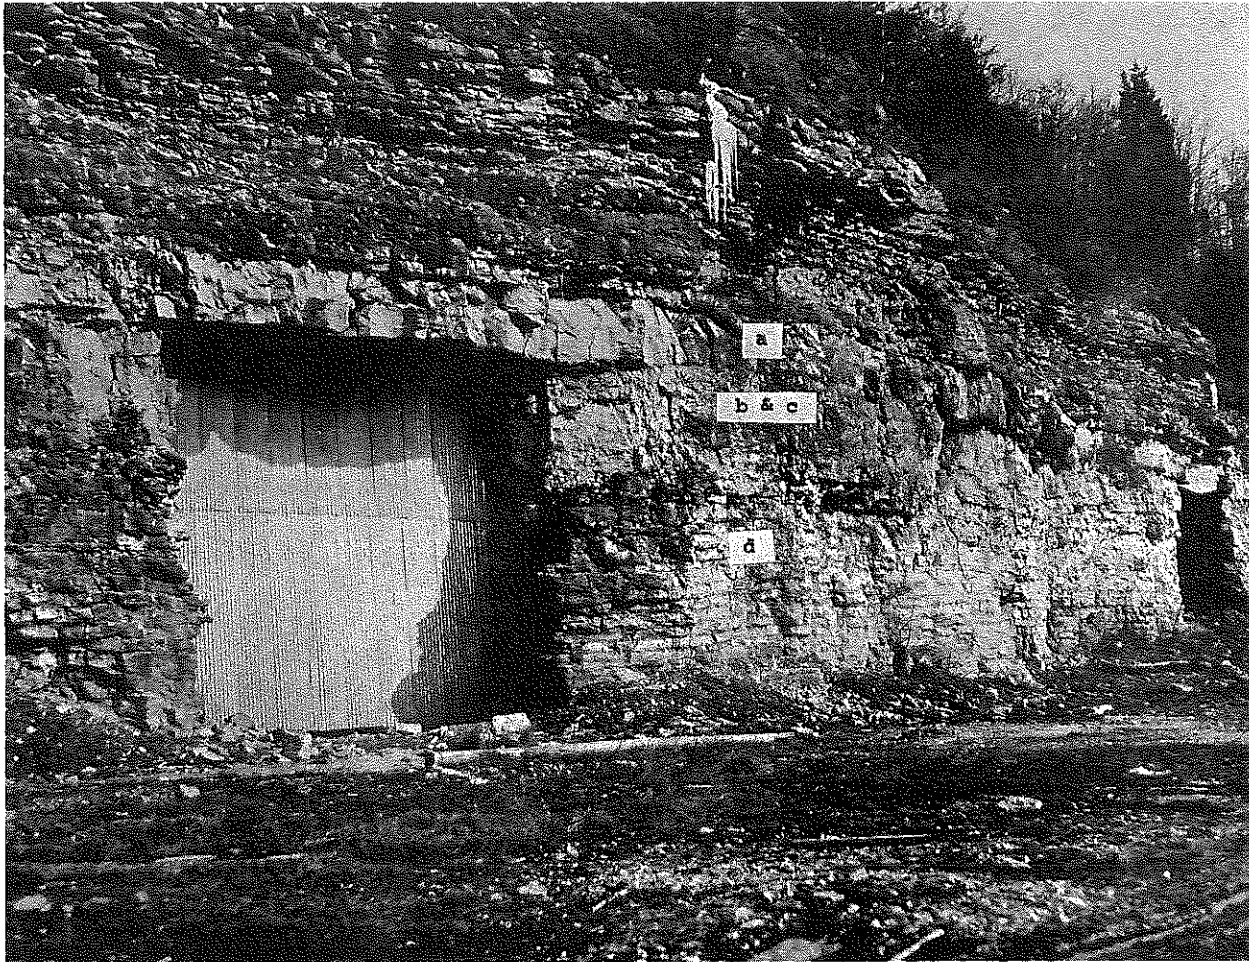
**Figure 46.** Old Tygart Limestone Company's Quarry and Mine at Lawton, Kentucky. Mine is now used to grow mushrooms. Proximity to Olive Hill quarry and poor performance of this aggregate on KY 32 invited investigation; February 10, 1972.

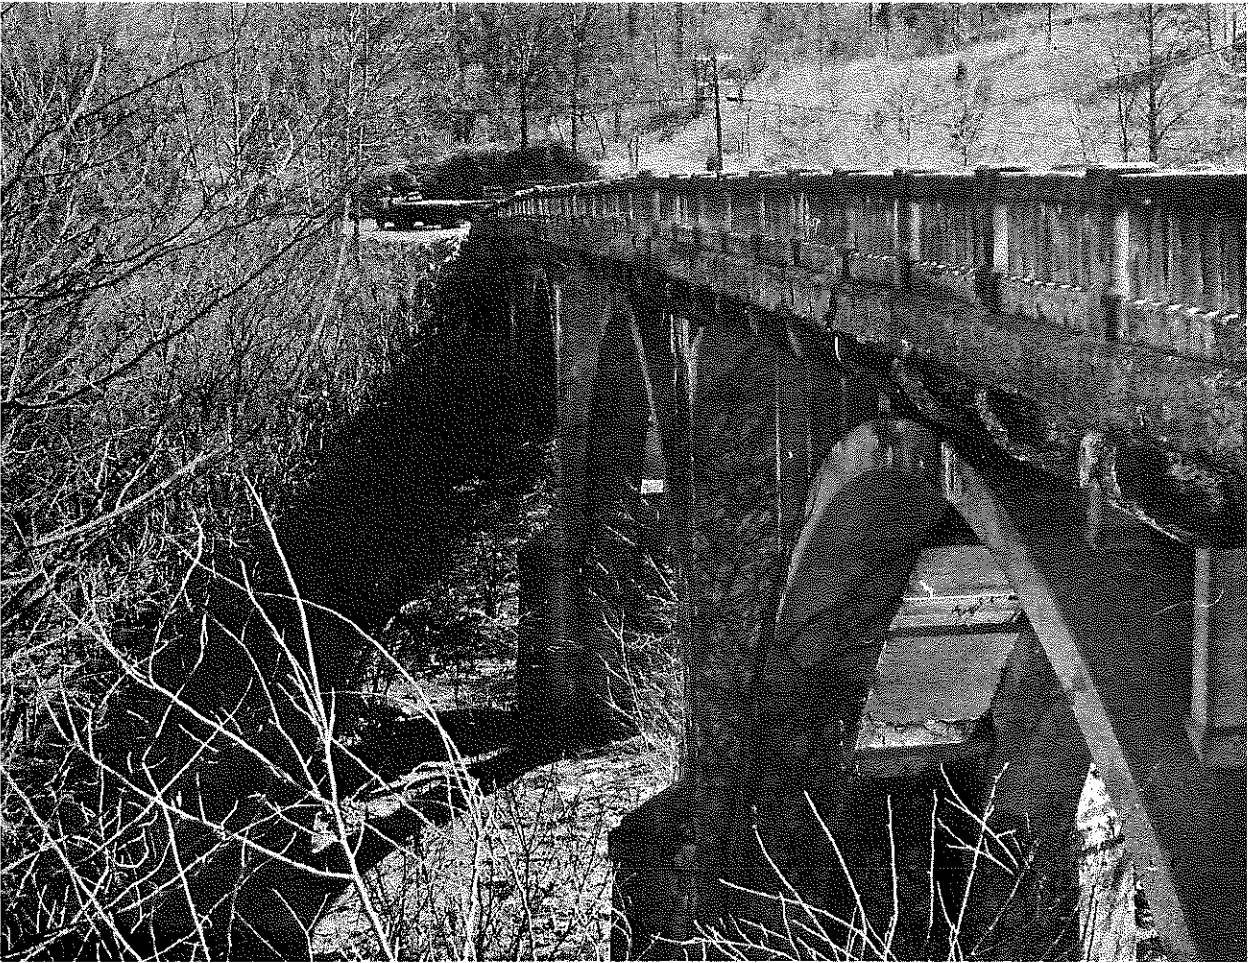
**Figure 48.** Tygart's Creek Bridge, US 60, East of Olive Hill; Built about 1927; March 1972.

Although no specific investigation has been made in regard to the aggregate used in the Tygarts Creek Bridge, deterioration of concrete handrails has been apparent for many years. The source of aggregate has not been identified; but it is likely that it was supplied from the Olive Hill quarry. A recent photograph (Figure 48) is included here as a matter of record.

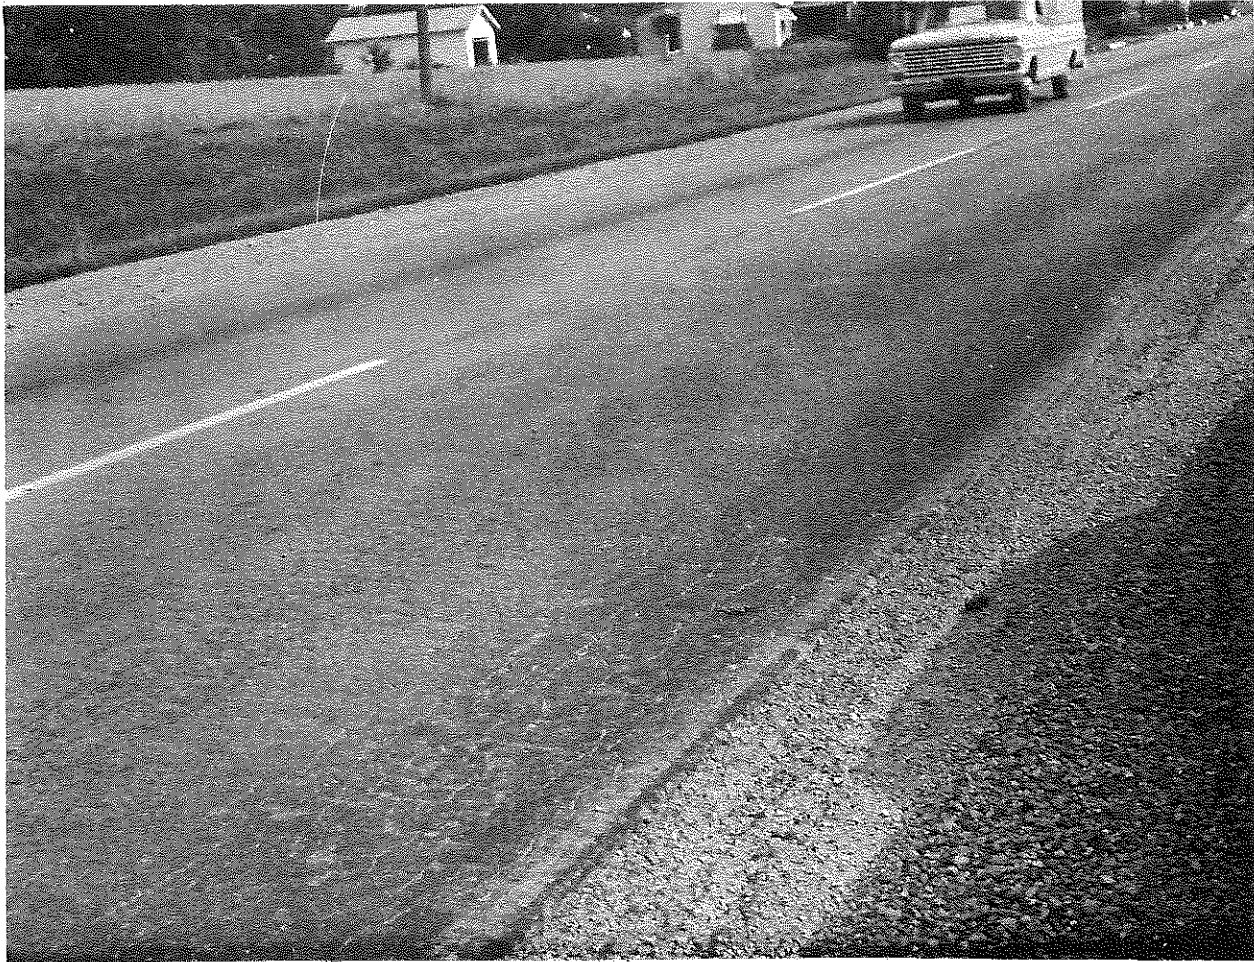
**Figure 49.** US 31 W North of Tennessee Line; Non-Reinforced, 8-inch Slab, No Joints; Built Experimentally in 1949; Carried Heavy Traffic until I 65 Opened; Source of Aggregate Unknown; June 6, 1968.

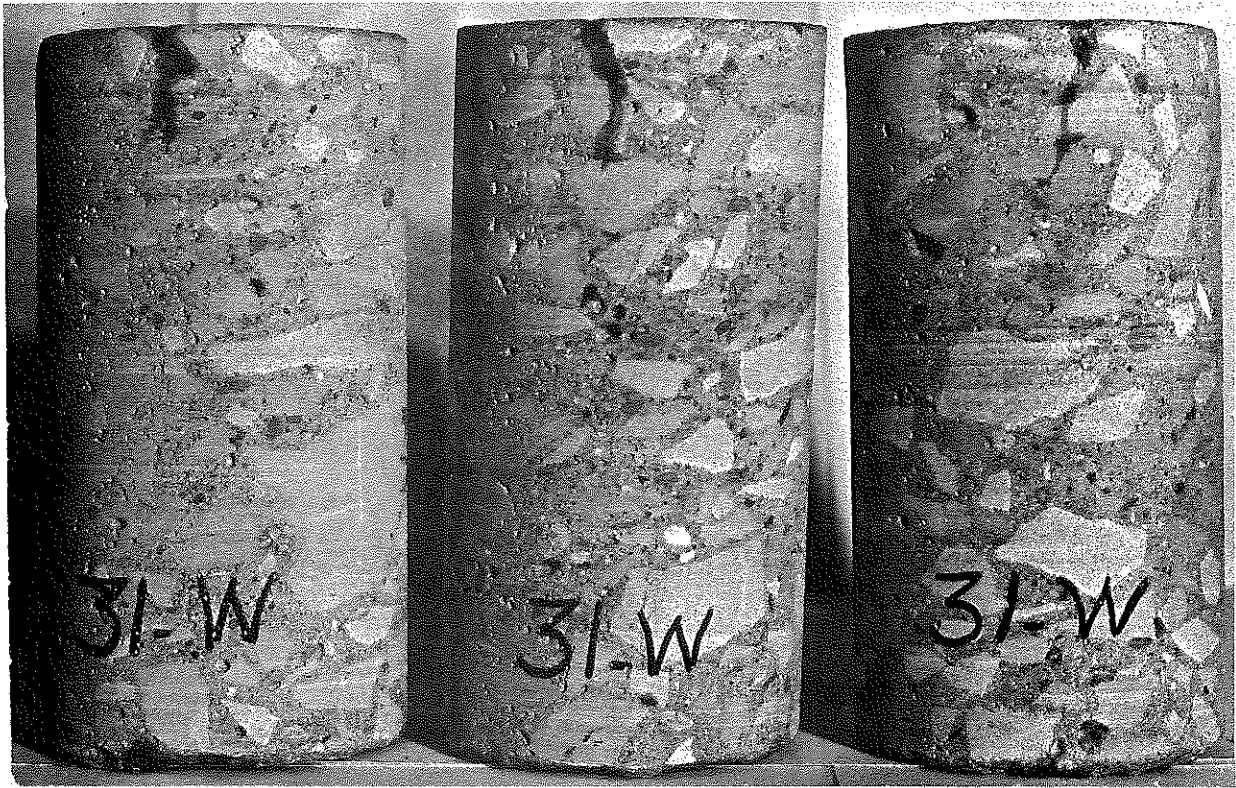
**Figure 50.** Cores from US 31 W North of Tennessee Line. Surface cracks are delineated by wetting. The aggregate is presumed to be from the Ste. Genevieve formations north of Franklin. Pavement was cured with a lacquer-type membrane.

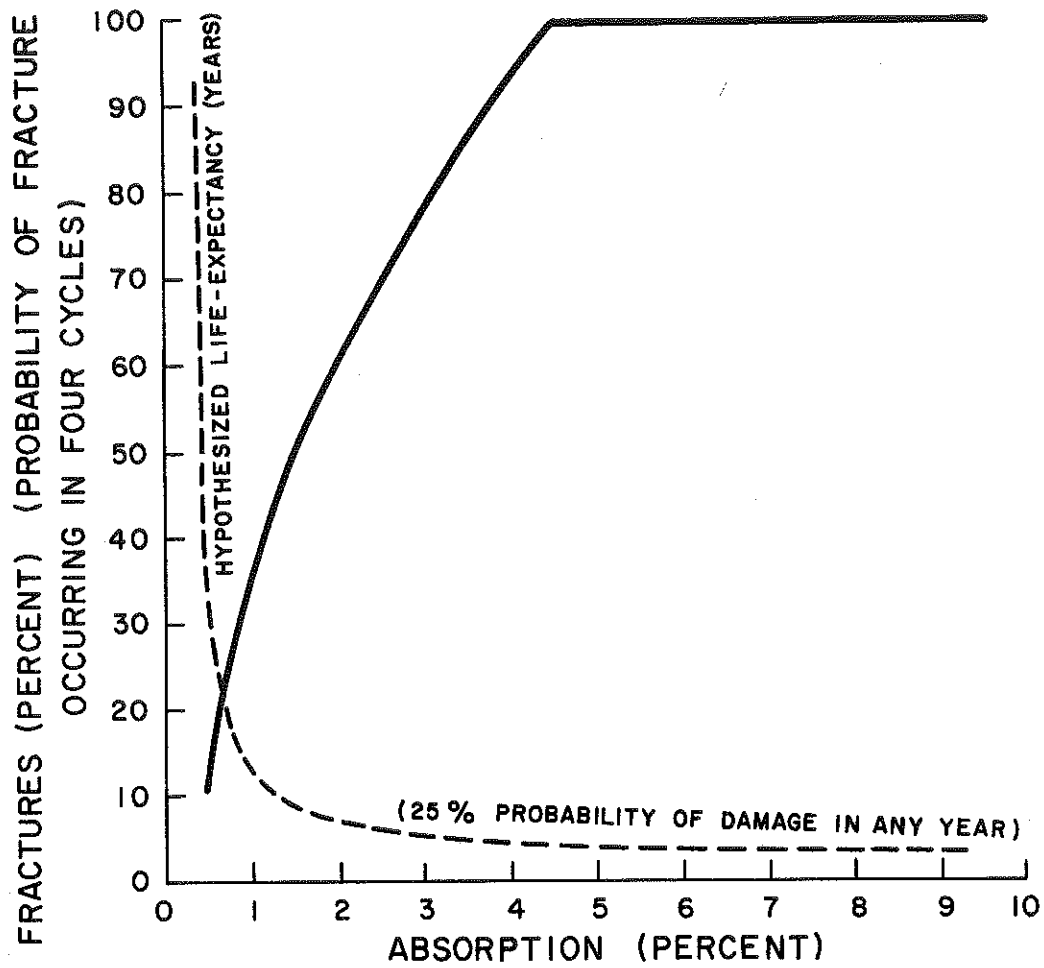
Figure 53. Relationship between Absorption and Percentage of Fractured Particles after Exposure to Four Freeze-Thaw Cycles (also Shows Hypothesized Life Expectancy).
