**COMMONWEALTH OF KENTUCKY**  
**DEPARTMENT OF HIGHWAYS**  
**FRANKFORT, KENTUCKY 40601**

May 5, 1971  
H-264

**SUBJECT:** Research Report, Interim; "Experimental Installations of Impact Attenuation Devices"; KYHPR-71-64; HPR-1 (6), Part II

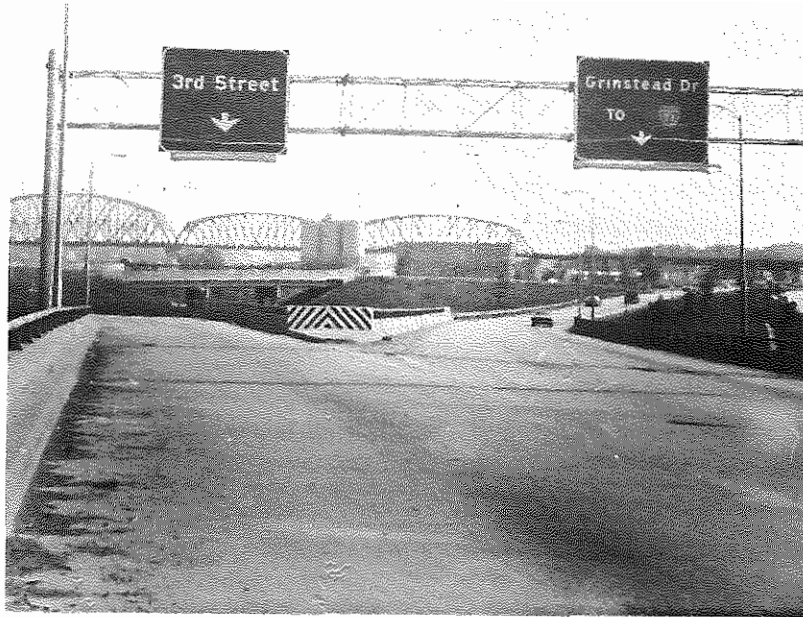
FIGURE 1. Dangerous Gore Configuration

Although designs and signing are being revised, the problem of vehicle encroachment into gore areas remains largely unabated. The design standards to which the above statement alluded have increasingly called for a greater recovery area within the gore to enable an errant driver to survive his mistake. Existing sites are subject to correction. Revised signing and improved visibility have been somewhat effective. However, situations exist which are poorly designed (by current design standards) and for which signing changes have not been the solution. Drivers continue to commit errors, and the result is all too often an accident statistic.

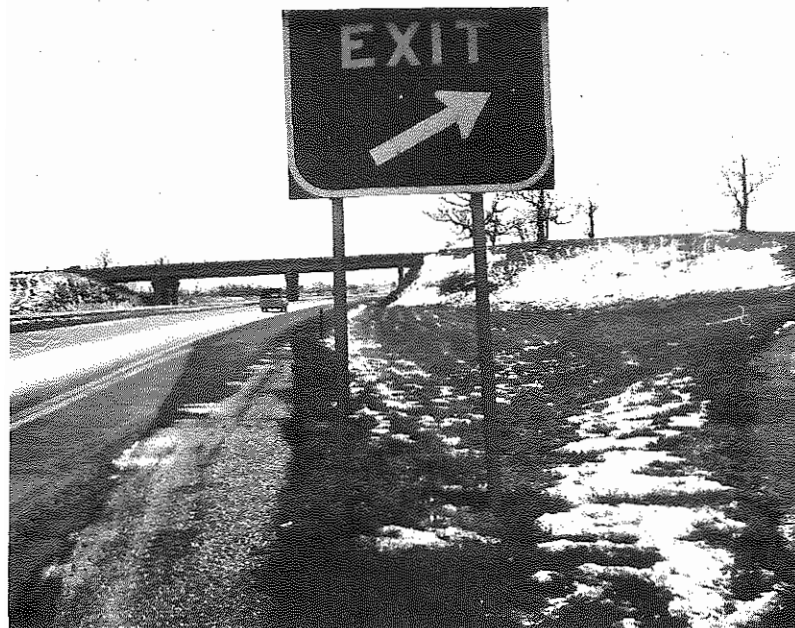
FIGURE 2. Adequate Gore Area

The preferability of a clear gore area, such as is shown in Figure 2, is related to the manifold psychological reactions of a driver to roadway situations. Multilane highway facilities and their attendant features which require driver decision and commitment are sometimes momentarily confusing. Initially, this was attributed to the novelistic quality of the road type. It was hypothesized that as the great body of the motoring public was exposed to these features, drivers would instinctively comply and compensate. Such, however, has not been altogether the case. A report of a special AASHO Traffic Safety Committee, February 1967 (11) (the "Yellow Book"), enumerated 19 considerations pertaining to safety in the design of the roadways.

The site shown in Figure 2 was without noticeable defect. Of all the gores inspected, eight were found at which the installation of a safety barrier was the most satisfactory method of renovation. Those are itemized as follows:

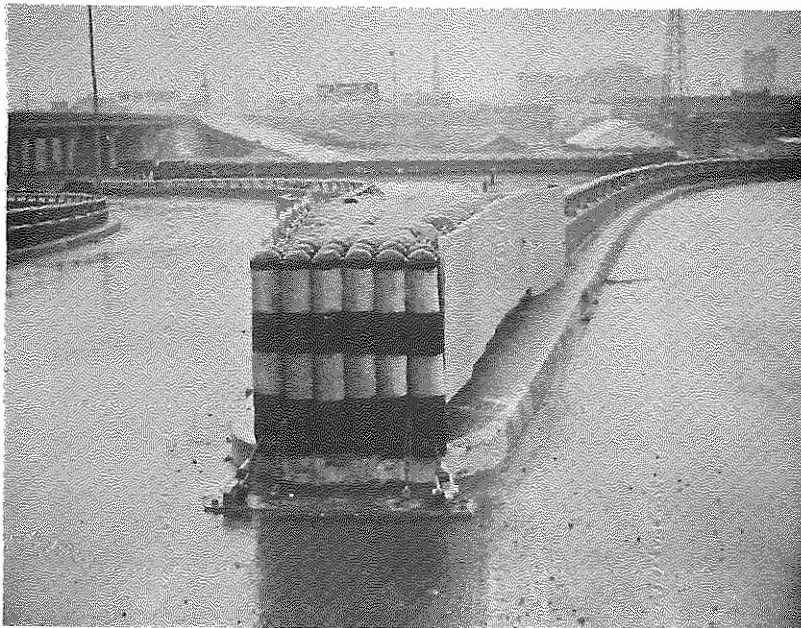
**FIGURE 18. HI-DRO CELL Barrier at Location 3 (a)**

It was the recommendation of this Division that a HI-DRO CUSHION barrier be installed at each of these locations. Preliminary designs had been requested for these gore areas early in 1969, and these were accepted by the Committee. Authorization for the installation of these barriers was requested in January 1970; these are existing locations. In March, a request was sent to the supplier for a firm price quote for the materials. These barriers were installed in early September 1970. Figure 15 shows the gore at the junction of Ramps 4 and 8. The gore between Ramps 3 and 6 was previously pictured in Figure 1. The designs for each of these gores are respectively illustrated in Figures 16 and 17. The actual installations for the gores between Ramps 4 and 8 and Ramps 3 and 6 are pictured in Figures 18 and 19. These gores are also being considered for camera monitoring.

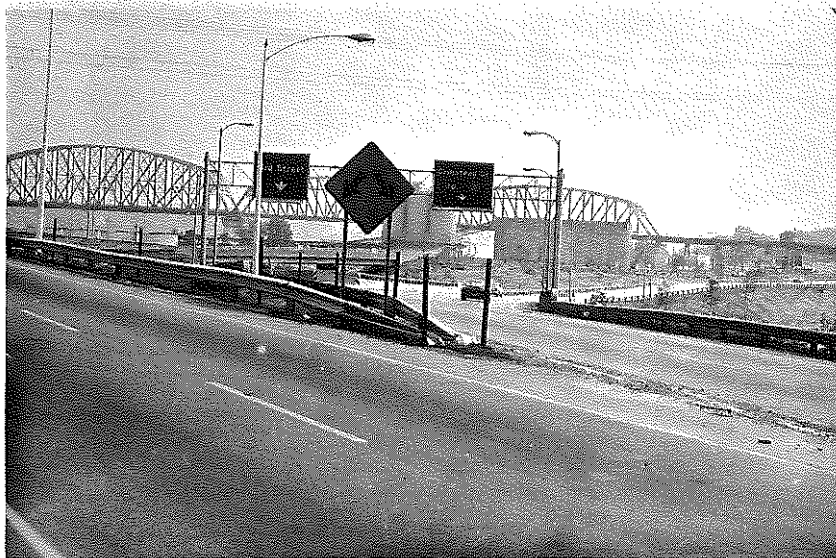
**FIGURE 20. Location 3 (c); Jefferson County, Kennedy Interchange (I 71 - I 64 - I 65), Mainline Exit, Northbound, before Improvements**

Originally, a HI-DRO CELL barrier was planned for this location. The design suggested by the manufacturer was judged to provide insufficient protection at this unusual gore area. Figure 20 pictures this site as it existed until May 1970. This particular gore had a history of many accidents and had an alarmingly high severity rate. The dual guardrail end-treatment shown in Figure 20 had apparently reduced the severity rate of the accidents at this site but not the frequency. It was decided that an increase in the area was needed between the bifurcating roadways. The HI-DRO CELL barrier would have decreased the gore area and thereby would have caused further constriction. The alternate suggestion was to fill the gore area back nearly to the bridge structures, turn the guardrail on a radius, and install a FITCH barrier. This procedure would not only provide a barrier system but would increase the free area by over 100 feet. The gore area was regraded with the assistance of District 5 to a grade as shown in Figure 21. The FITCH barrier system installed at this gore on August 13-14, 1970 is schematically illustrated in Figure 22. Figure 23 shows the barrier as it now appears. This site is currently being monitored by a vehicle-actuated camera system.

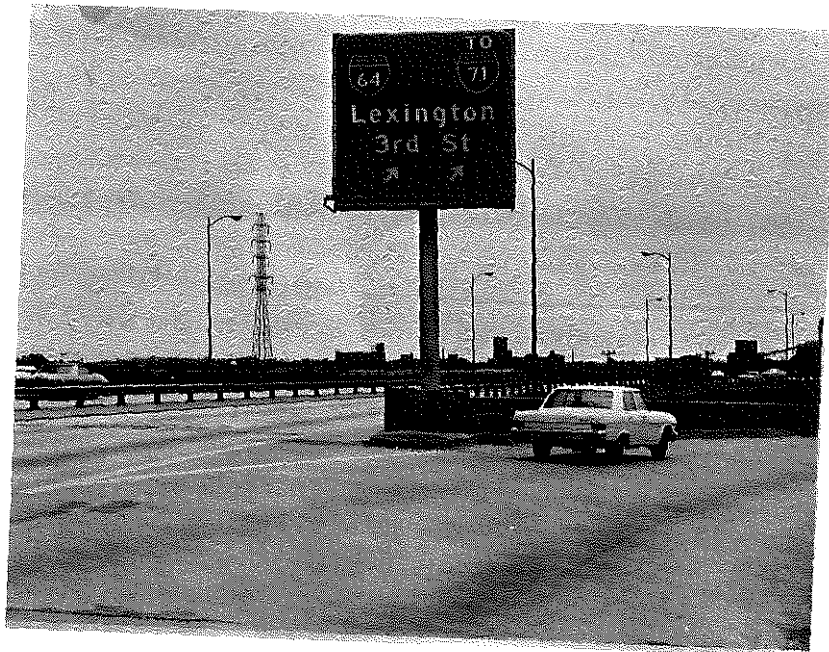
FIGURE 24. Location 3 (d); Jefferson County, Kennedy Interchange (I 71 - I 64 - I 65), Mainline Exit, Southbound

This location, pictured in Figure 24, has been designated for a safety barrier and possibly for a camera monitoring system. No other specific plans concerning this site have been formulated at the present time.

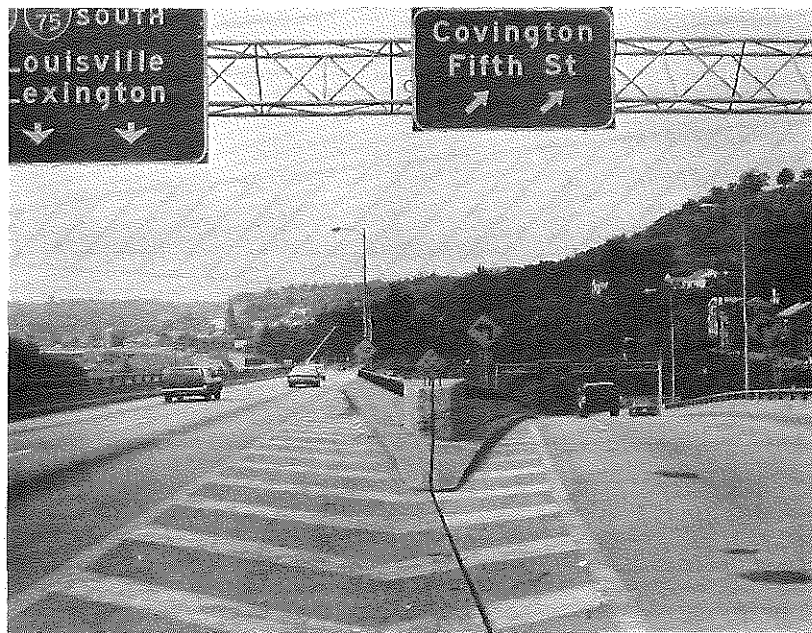
FIGURE 29. Location 7; Kenton County, I 75 - 5th Street Interchange ,  
Gore at Southbound Exit Ramp, before Installation of  
FITCH Barrier

A FITCH barrier was installed at this location on November 5, 1970. The gore prior thereto is shown in Figure 29. A picture of the system as it presently appears and a schematic plan view are shown in Figures 30 and 31. A camera monitoring system is currently planned for this location.

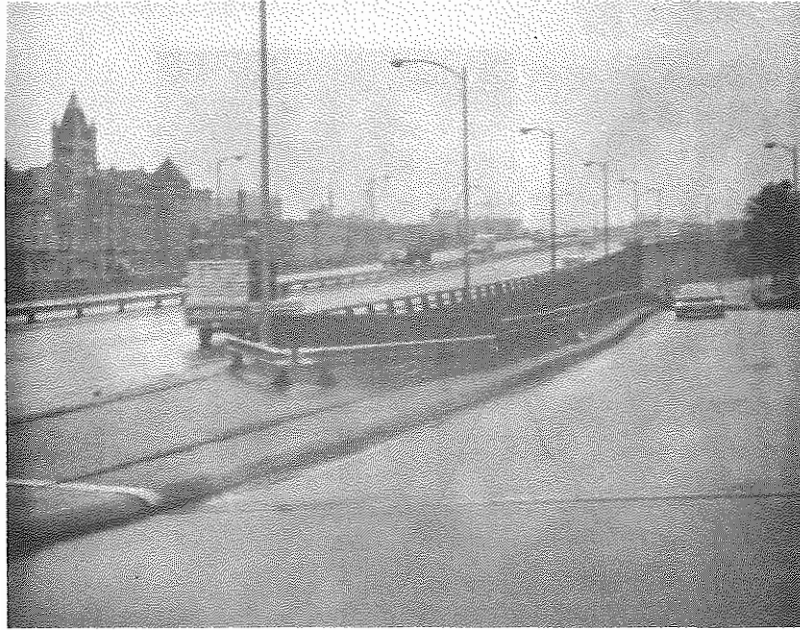
**FIGURE 42.** Location 12; Jefferson County, I 65 - Chestnut Street Interchange, Gore at Northbound Exit from I 65 to Chestnut Street

At the other gore locations enumerated above, no additional action has been taken except to delineate some as possible sites for barrier installations. Figures 36 through 44 illustrate each site. It is anticipated that further action will be forthcoming.

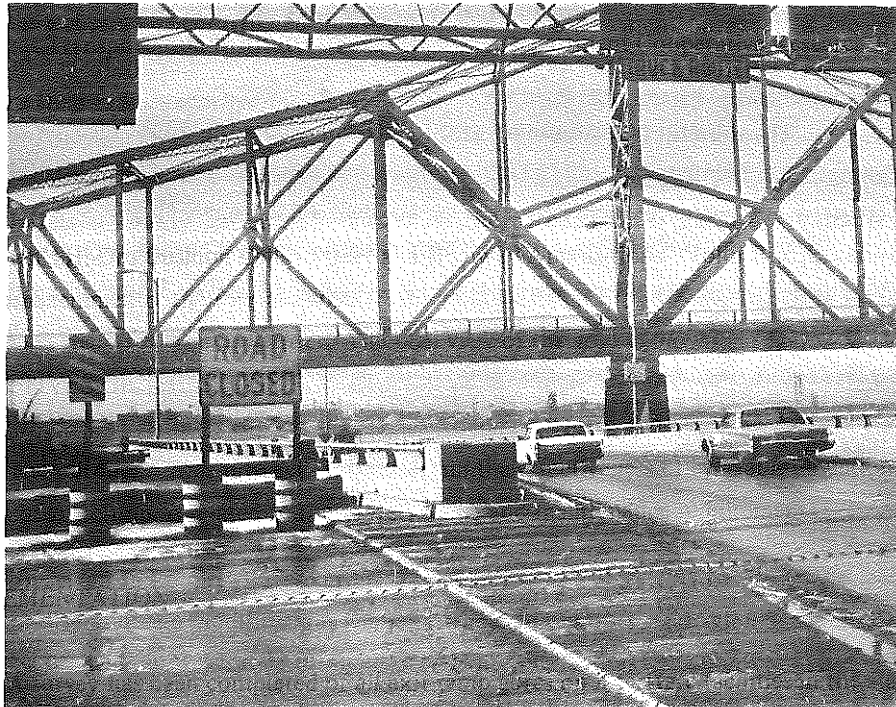
**FIGURE 44.** Location 15; Jefferson County, I 64 - 3rd Street Interchange,  
Gore at Westbound Exit from I 64 to 3rd Street

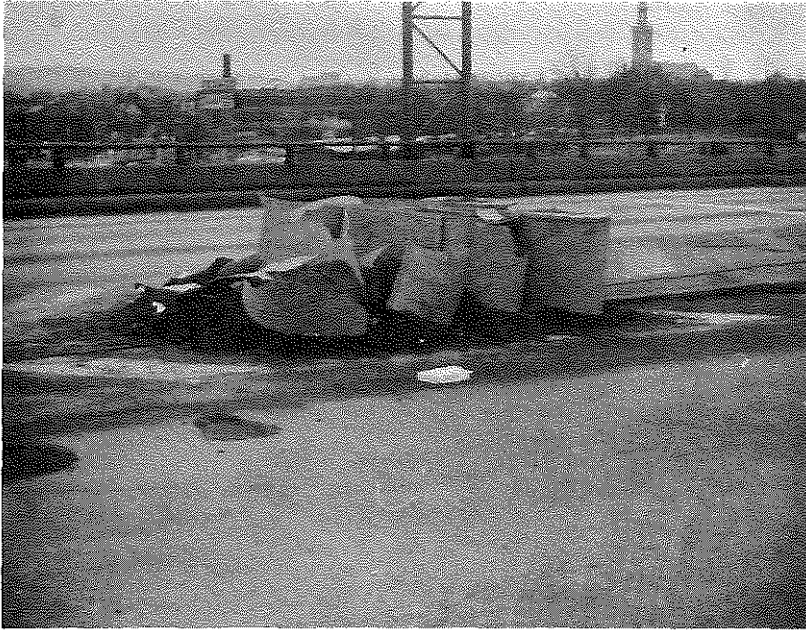
**FIGURE 45. Location 7; Kenton County, I 75 - 5th Street Interchange,  
Gore at Southbound Exit Ramp after First "Hit"**

The first "hit" occurred on January 24, 1971, at 4:05 am at the FITCH barrier on I 75 near Covington. Police were summoned, and an accident report was filed. The driver of the vehicle, a 1964 Chevrolet, stated that he fell asleep and impacted almost head-on but off-center of his vehicle. The impact slowed the vehicle considerably and the driver was able to stop his car as it veered down the exit ramp. The driver estimated his speed to be 40-45 mph, and Research personnel estimated his angle of impact to be 13 degrees. Extent of damage to the vehicle is uncertain since the driver planned to repair the car himself; he estimated the cost of

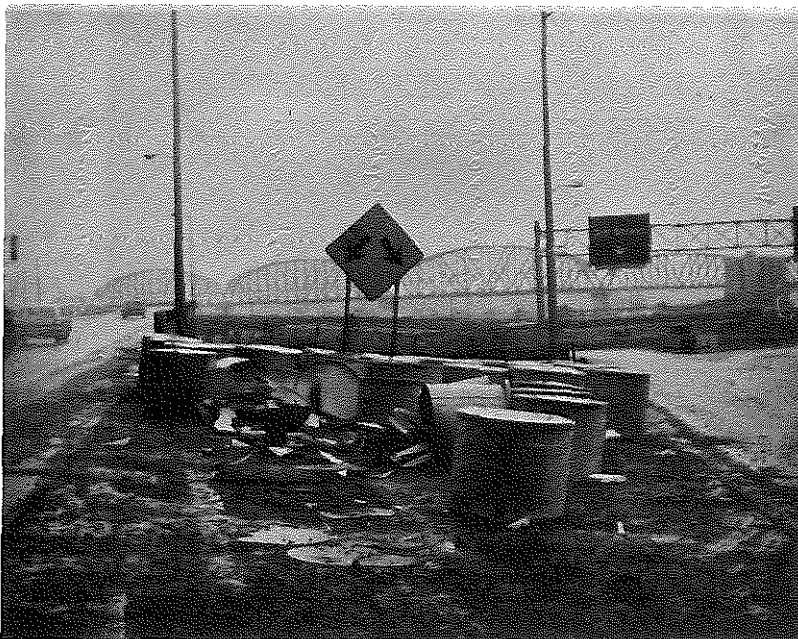
**FIGURE 46. Location 3 (c); Jefferson County, Kennedy Interchange  
(I 71 - I 64 - I 65), Mainline Exit Northbound after  
First "Hit"**

The second hit occurred at the FITCH barrier in Louisville on or about February 11, 1971. Since the driver was able to travel on, there was no police report and no record of the accident. Eight modules were destroyed, and two more were overturned but reusable. The damage done to the barrier is shown in Figure 46. The angle of impact was estimated to be ten degrees. From tire marks in the gore leading to the barrels, it appeared that the vehicle might have struck the bridge wall had the barrier not been installed.

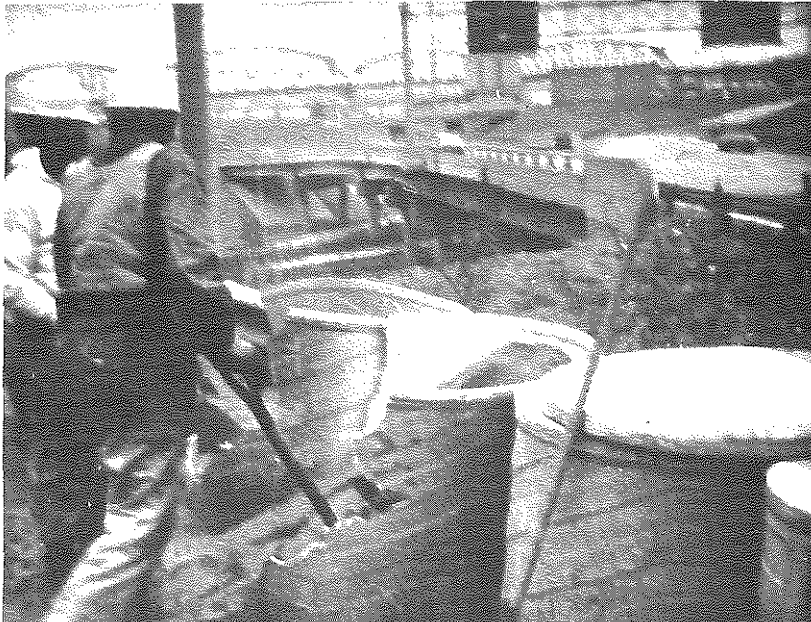
**FIGURE 48. Location 3 (c) after Second “Hit”**

The fourth hit occurred at the FITCH barrier at the Kennedy Interchange (the second hit at this site also) in Louisville on or about February 17, 1971. Two flanking modules to the rear and adjacent to the mainline flow of traffic (I 65N) were shattered -- evidently by a side-swiping hit (Figure 48). Again, the driver and vehicle vanished and no police report was made.
