**A PRELIMINARY EVALUATION OF
MOUNDS TO DIVERT WAYWARD VEHICLES AWAY
FROM RIGID OBSTRUCTIONS**

**Division of Research
DEPARTMENT OF HIGHWAYS
Commonwealth of Kentucky**

August 1969

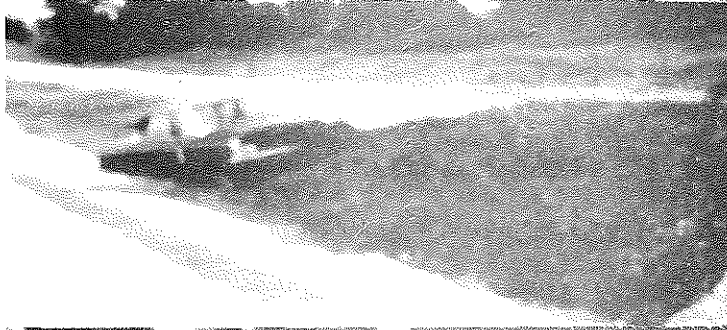
Encroachment Angle: $7 \frac{1}{2}^{\circ}$
Vehicle Speed: 20 MPH

Since the adverse effects of the 15-mile-per-hour test run at 7.5 degrees were not as pronounced as those at 15 degrees, it was decided to make another run at the 7.5-degree encroachment angle and at a speed of 20 miles per hour. Again, the vehicle dug in the wood-chip layer and slid obliquely to the right. At this angle it was surmised that the pier would be hit if the speed were 25-30 miles per hour.

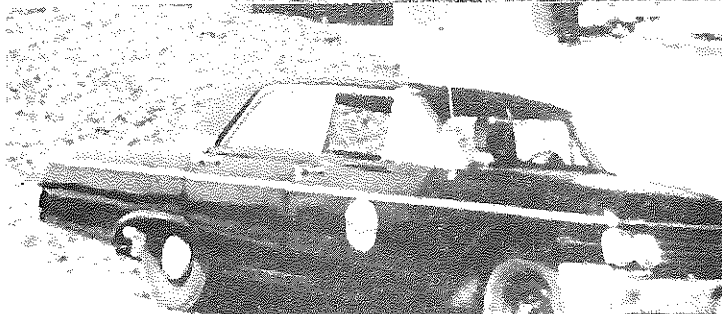
Encroachment Angle: 22°
Vehicle Speed: 10 MPH

Test runs were then made at an angle of 22 degrees and at speeds of 10 and 15 miles per hour. On both runs the test vehicle dug into the slope and slid obliquely to the right. With this steeper encroachment angle, the chances of hitting the pier at 20-25-mile-per-hour speeds seemed to be much greater. However, there is some physical improbability of a high-speed vehicle achieving a high angle of approach (4). The possibility remains that, at some angle and speed and point of approach, a vehicle may impact the pier. A mathematical analysis indicates that, at approach angles of 7.5, 15, and 22 degrees and at approach points 92, 46, and 33 feet from the pier, respectively, such a collision would occur. As the approach angle is decreased, the probability of collision is decreased because the deflecting characteristics of the mound are more likely to be effective.

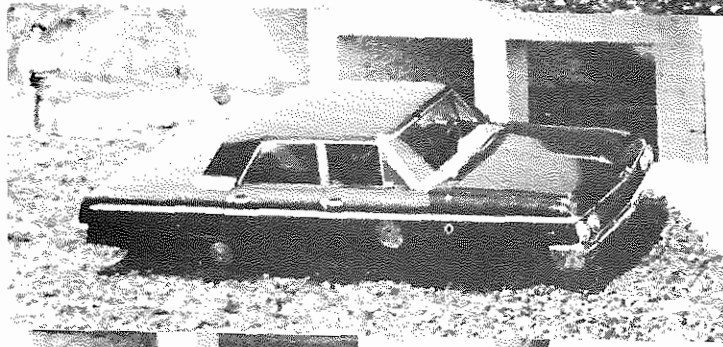
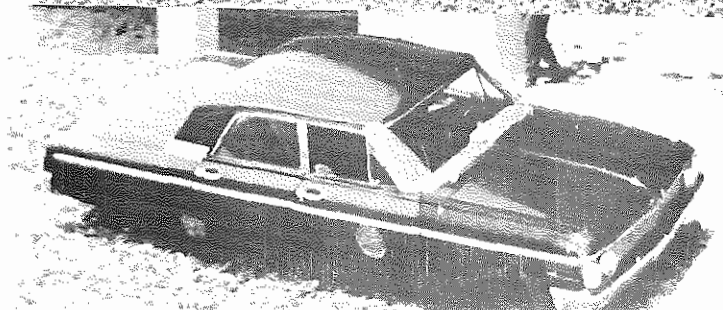
Encroachment Angle: 22°
Vehicle Speed: 15 MPH
