SUBJECT: Landslides: Geological Correlation

Research Report: "The Crab Orchard  
and Osgood Formations," R. C. Deen  
KYHPR-63-16; HPR-1(3), Part II

THE CRAB ORCHARD AND OSGOOD FORMATION  
The Case For Slope Instability  
KYHPR-63-16, HPR-1(3)

KY 52, Estill County  
SP-33-83, S 616(13)

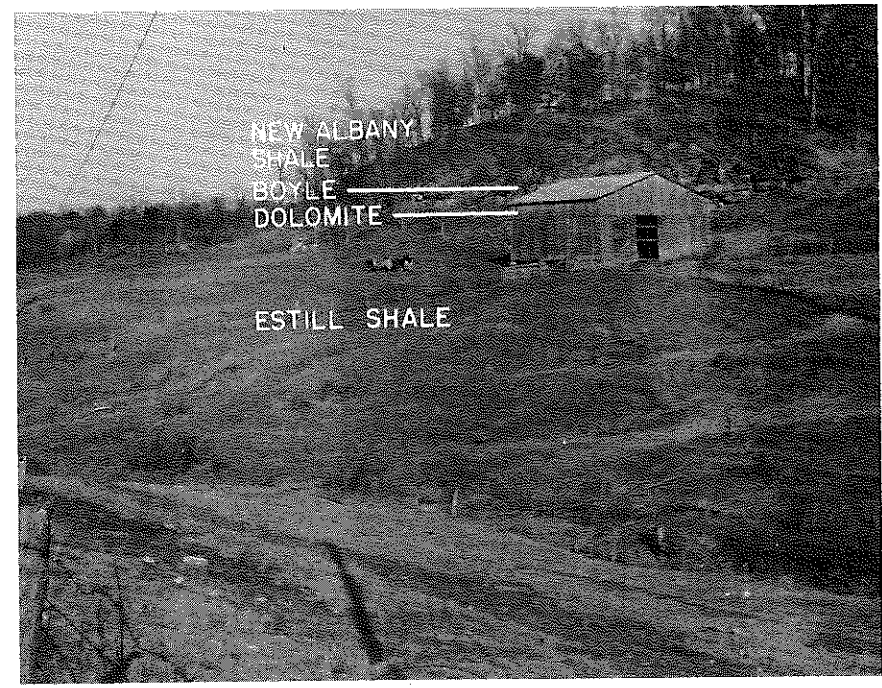
Figure 2. Gentle Slopes in the Estill Shale at the Base of the Boyle Dolomite Escarpments (KY 89, Estill County).

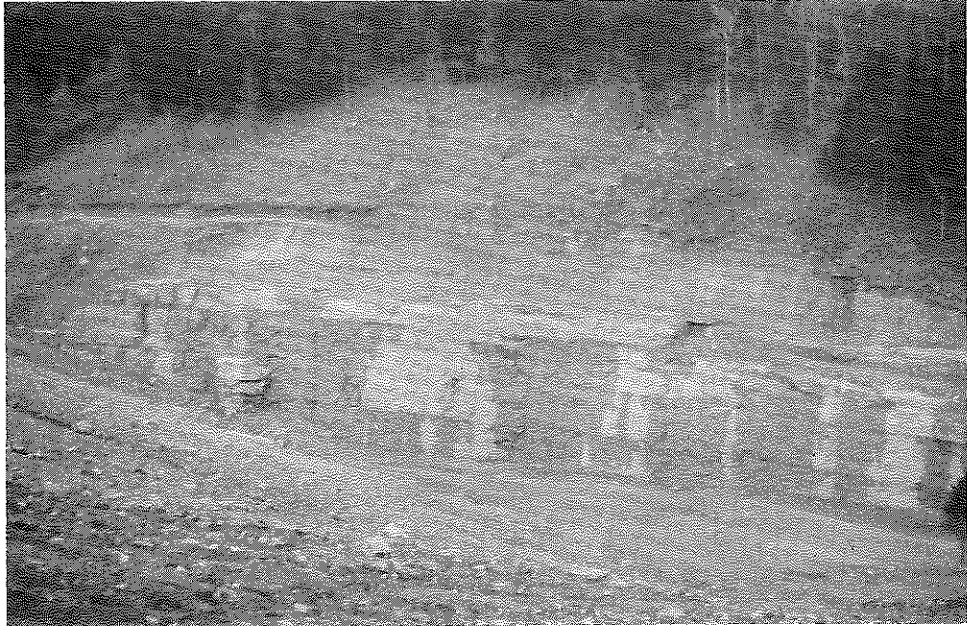
In both Western and Eastern Kentucky, the Crab Orchard and Osgood Formations are underlain by the Brassfield Dolomite (see Figure 4), a deposit of lower Silurian age, ranging between 8 and 30 feet in thickness, being

Figure 4. Brassfield Dolomite (KY 52, Estill County).

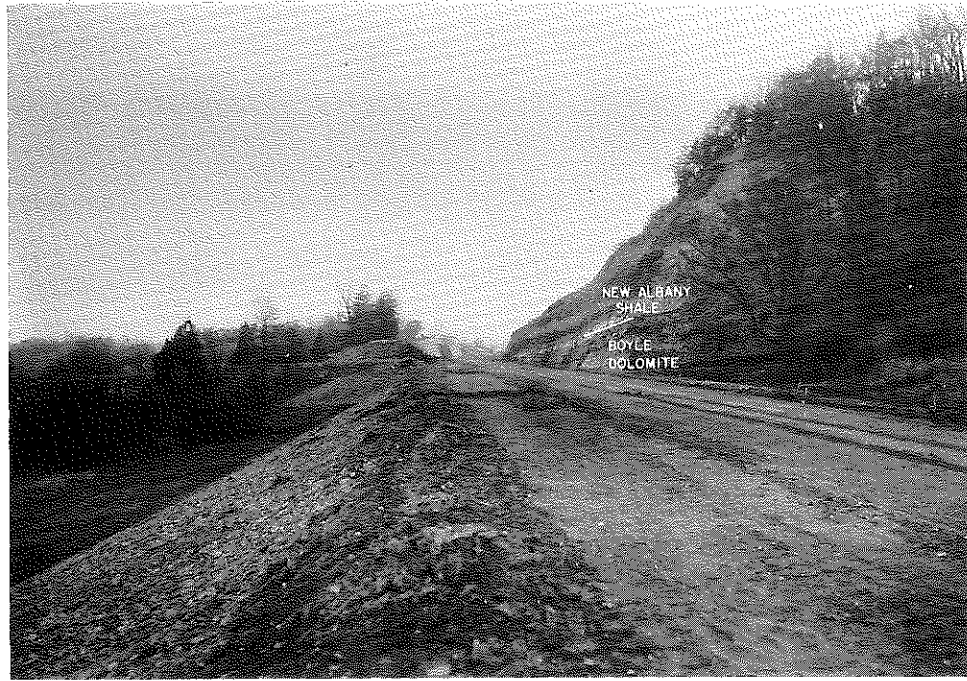
Figure 5. Boyle Dolomite and New Albany Shale (KY 52, Station 230, Estill County).

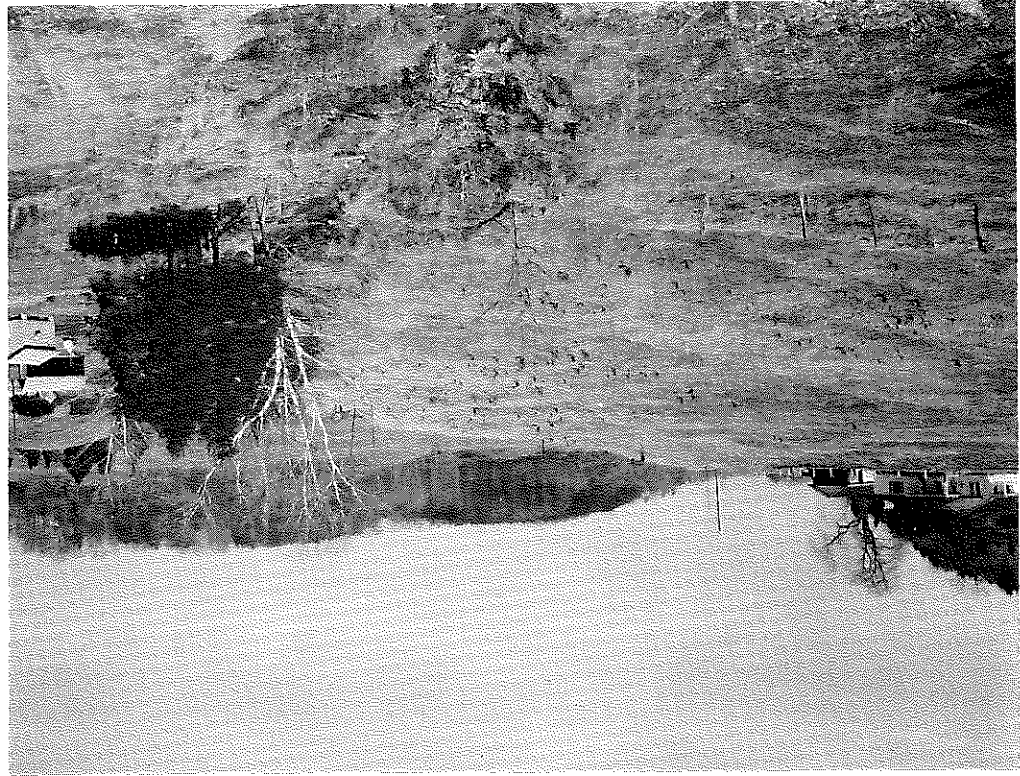
Figure 6. Slumps in Natural Slope in Estill Shale (KY 52, Estill County).

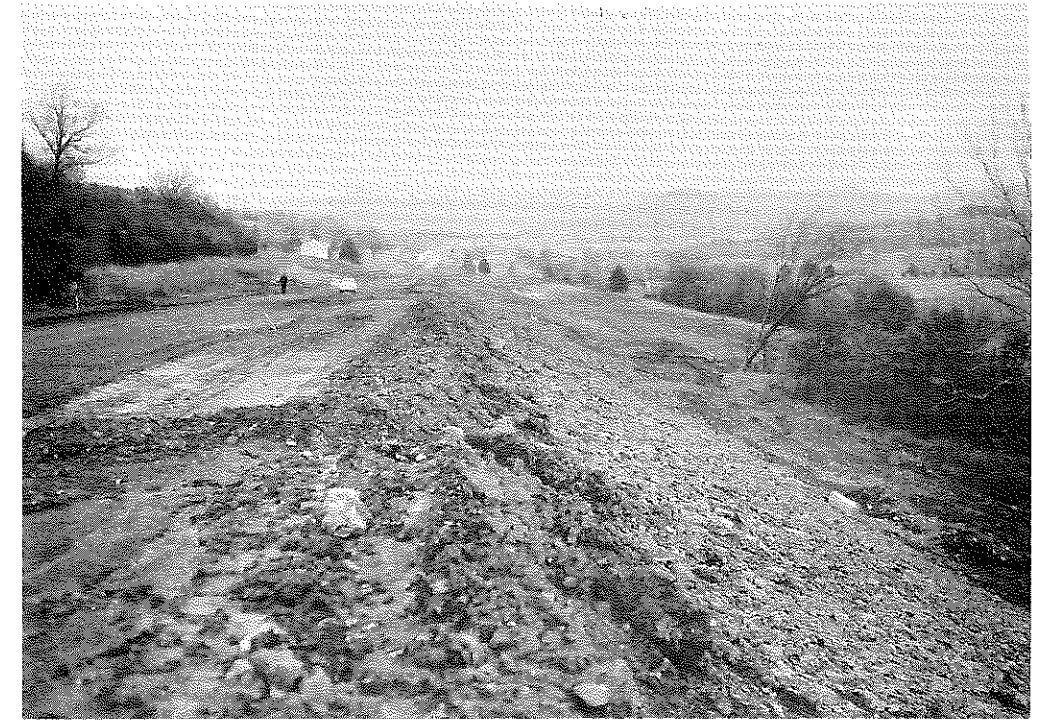
During the 1967 construction season (November, 1967), a slide began to develop near Station 241+00 on a side-hill fill situation. The fill was not particularly high, being only twenty feet at the deepest point (see Figure 7). However, the additional loading due to the fill was sufficient to cause significant movement, first noted in the original ground some 20 or 30 feet below the limits of construction, to develop in the foundation material (see Figure 8). Movement continued and construction in the immediate area was postponed. Movement of the unstable soil mass has continued and the slide now (February, 1968) extends at least from Station 239+00 to 254+00 (see Figures 9, 10 and 11).

Figure 7. View of Landslide Site on  
KY 52, Estill County (December 1967).

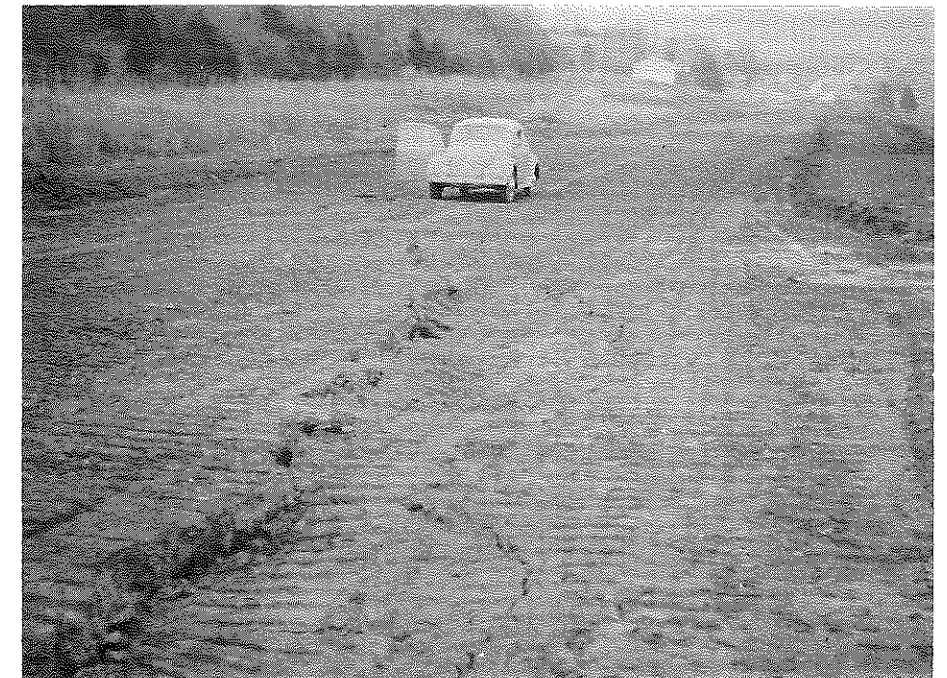
Figure 8. Distress in Embankment on  
KY 52, Estill County (December 1967).

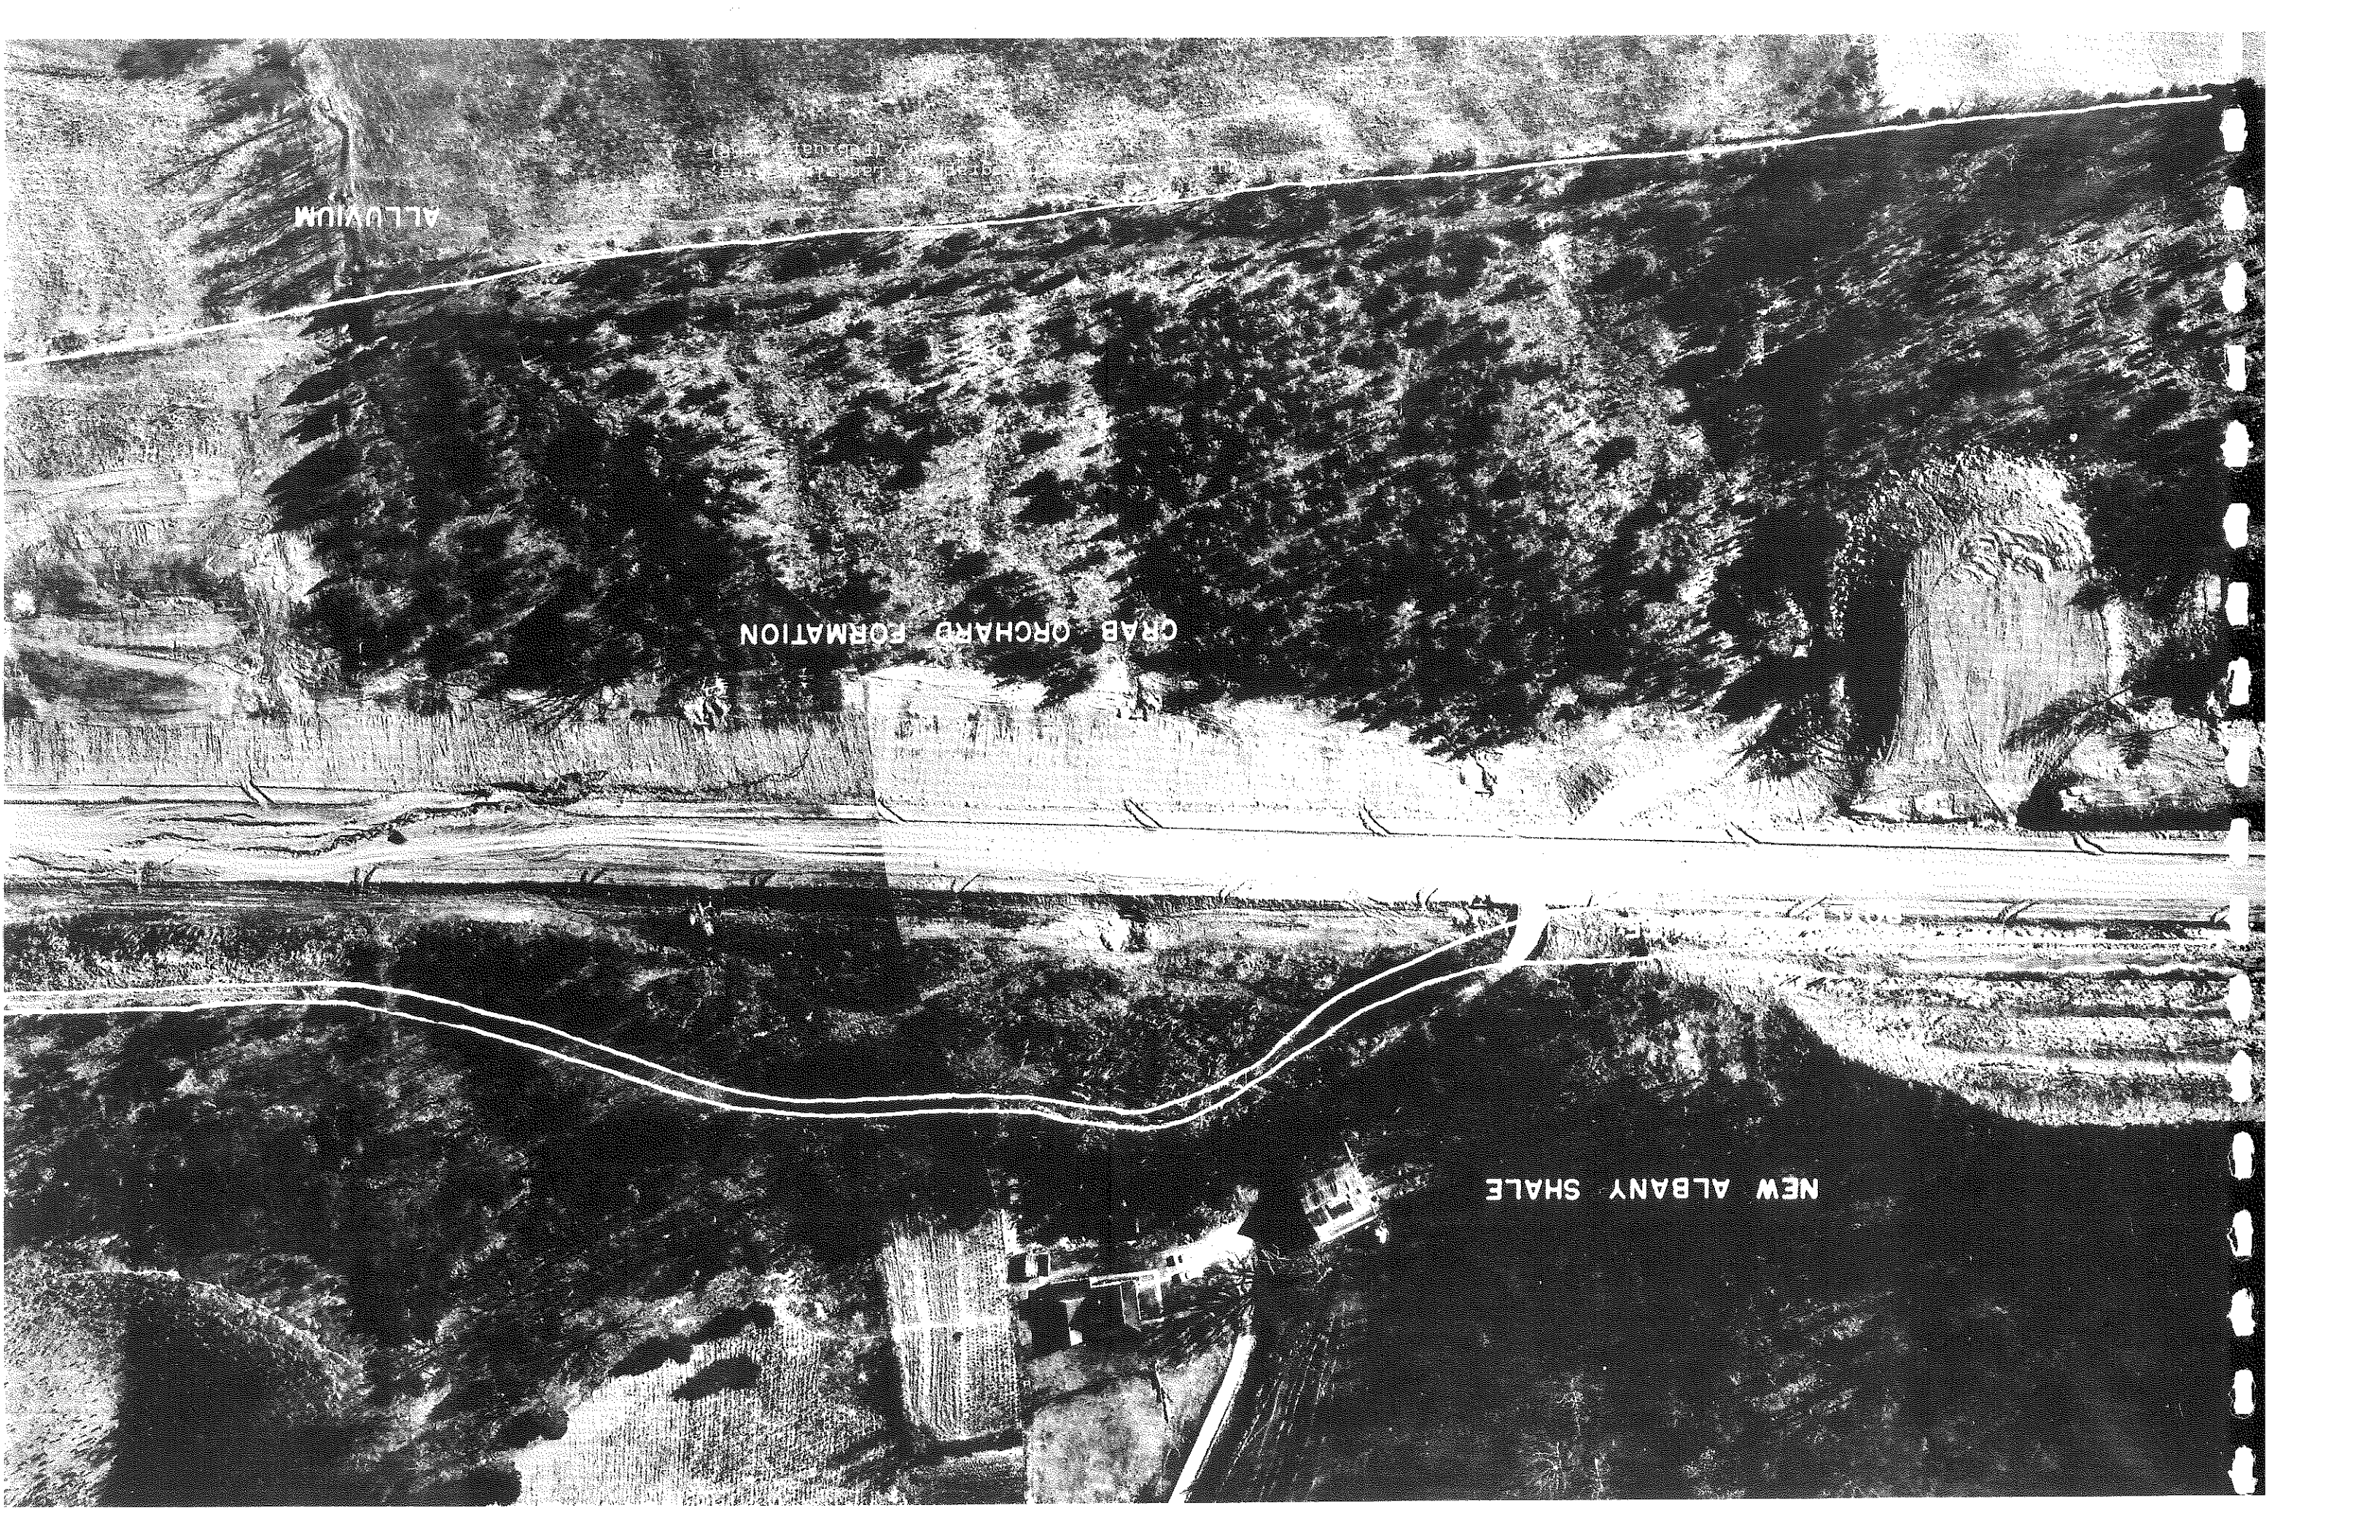
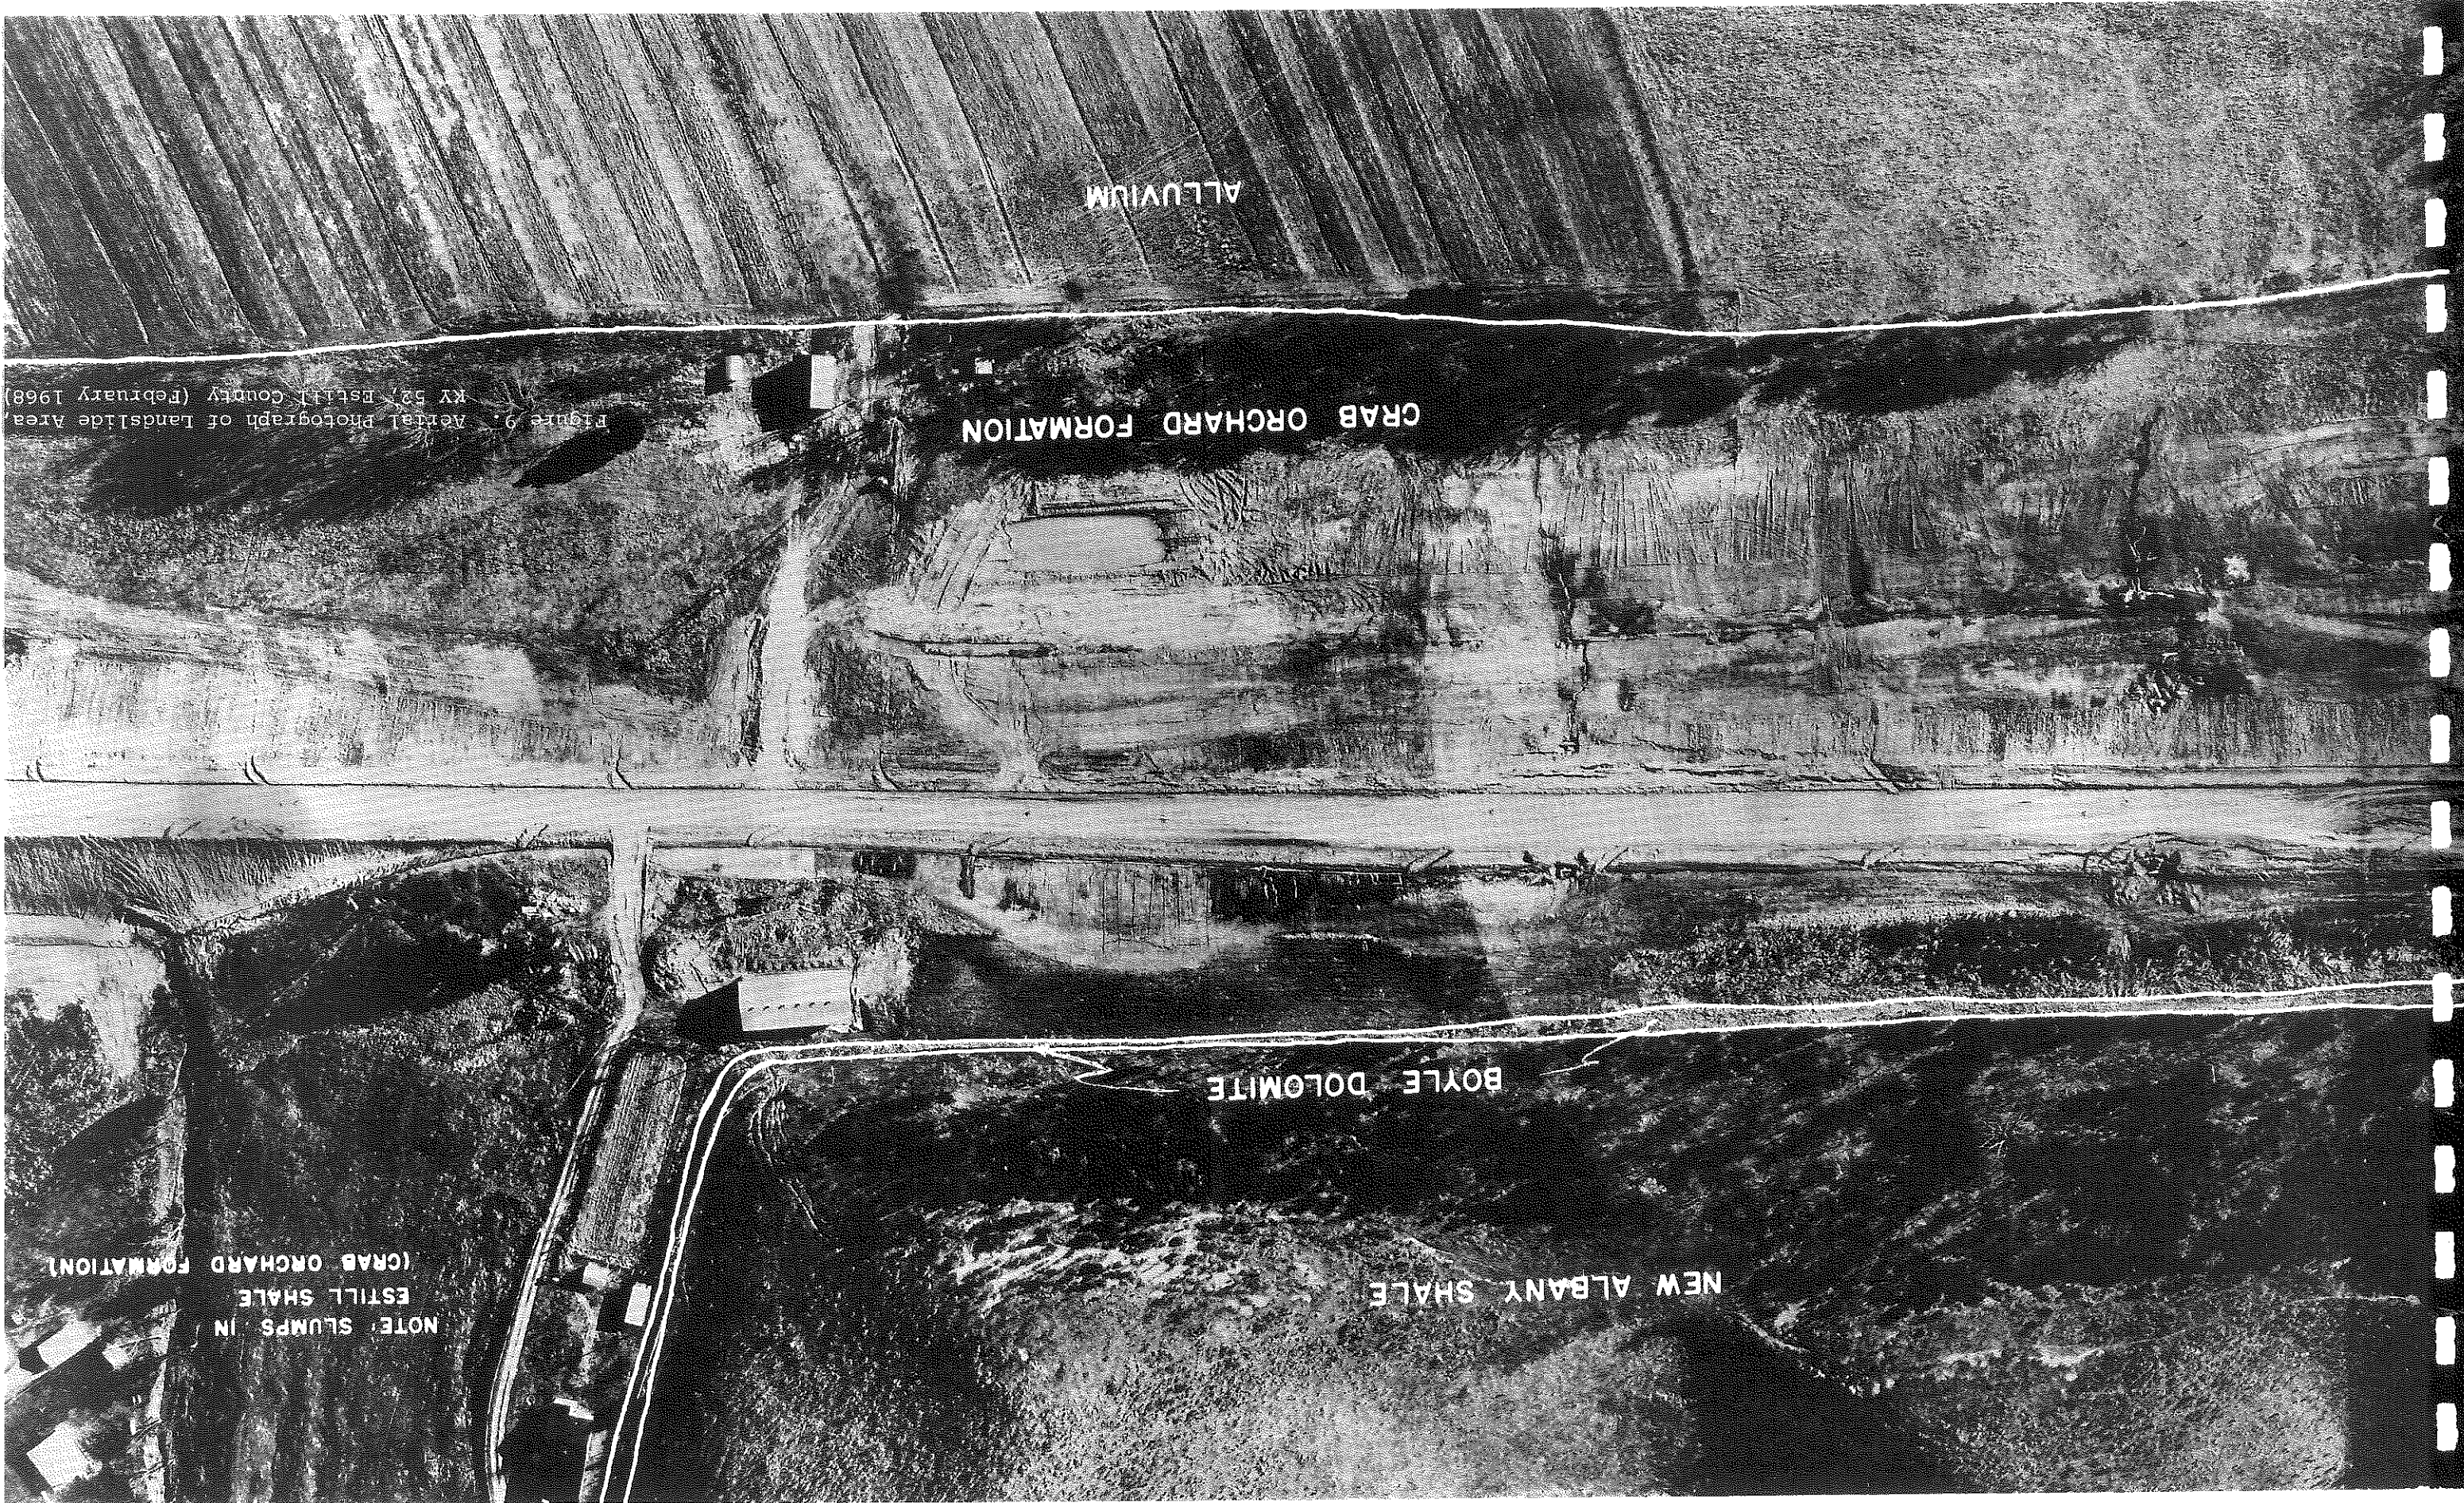
NOTE: SLUMPS IN  
ESTILL SHALE  
(CRAB ORCHARD FORMATION)

Figure 9. Aerial Photograph of Landslide Area  
KY 52, Estill County (February 1968)

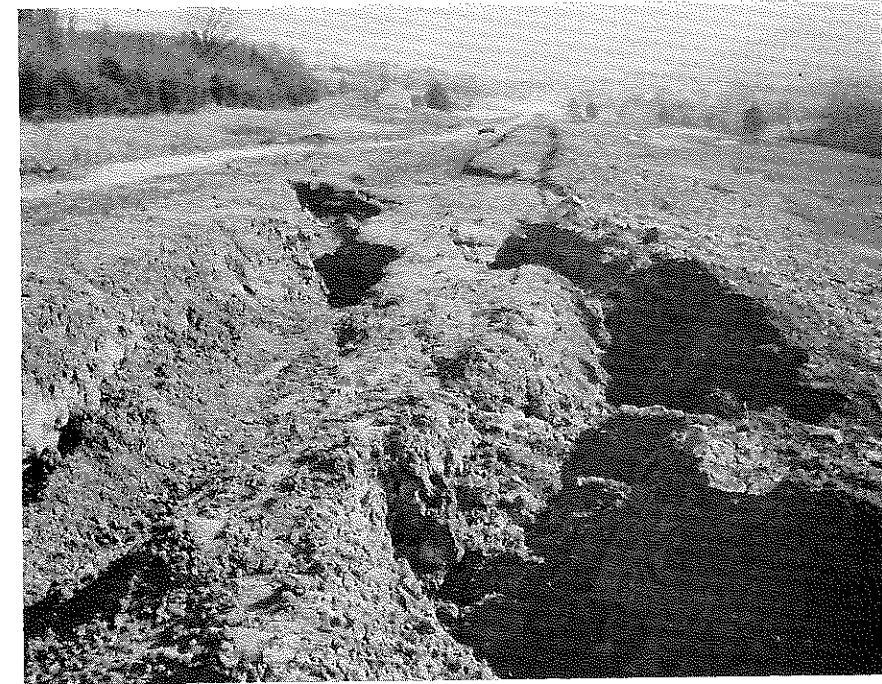
Figure 10. Distress in Embankment on KY 52,  
Estill County (February 1968).

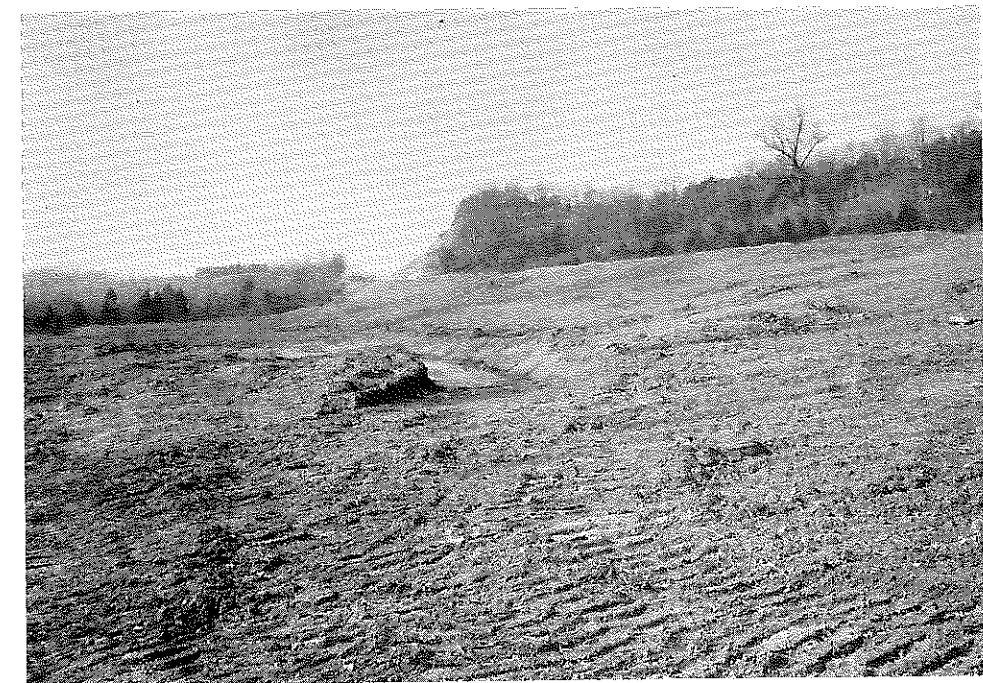
Figure 11. Distress in Embankment on KY 52,  
Estill County (February 1968).

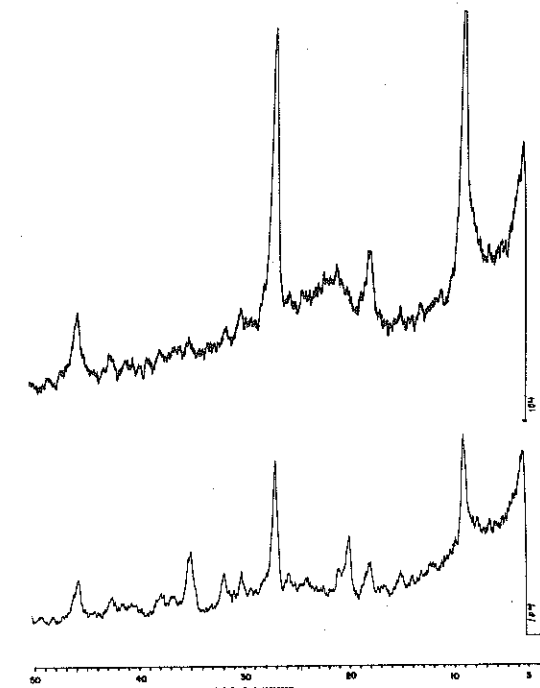
A critical review of geologic maps for the Estill County area and interviews with the U. S. Geological Survey personnel working in that area revealed that the unstable material was a portion of the Crab Orchard Formation. The unstable material involved in the slide at Rice's Station is the Estill Shale Member, a yellowish-green to grayish-olive, thinly and evenly bedded shale which weathers very readily to plastic clays that slump when moist. X-ray analysis (see Figure 12) of the clays from the landslide site and several other points on KY 52 in the general vicinity indicate the presence of illite, chlorite, and some bentonite clays. Table 1 summarizes the engineering characteristics of the Estill Shale clays.

Figure 12. Typical X-Ray Diffraction Patterns of the Estill Shale.

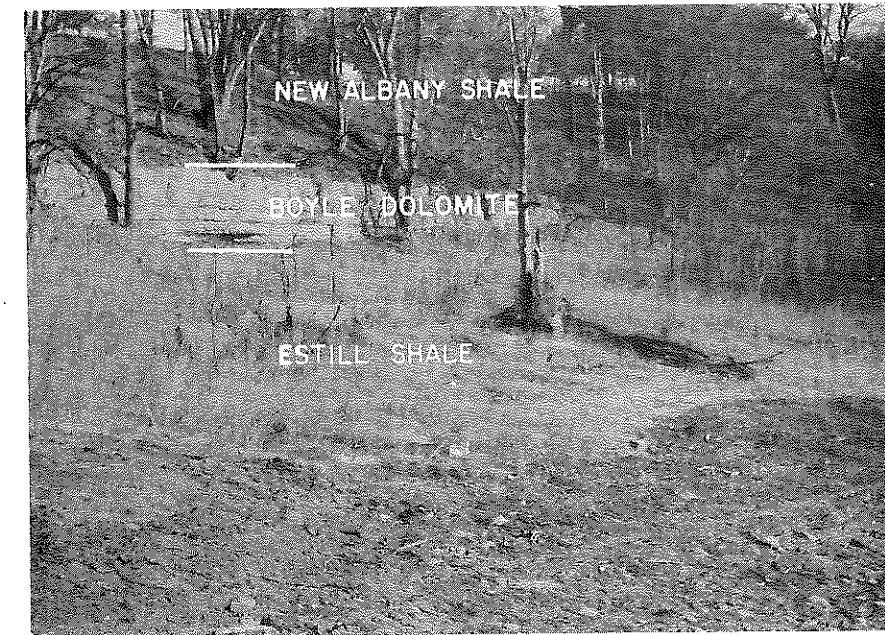
At the landslide site, the Estill Shale is overlain by the Boyle Dolomite. This dolomite can be seen outcropping in a cliff (see Figure 13) just to the north of the roadway construction and is the significant material contributing to the formation of the ridge to the north of the highway. Above the Boyle Dolomite is the New Albany Shale (also known as the Ohio Shale and the Chattanooga Shale), primarily a grayish-black shale 80 to 120 feet thick in the area (see Figure 14). The deep cut (Station 230) just to the west of the landslide site exposes the New Albany Shale and the Boyle Dolomite.

Figure 13. Cliffs of Boyle Dolomite on  
KY 52, Estill County.

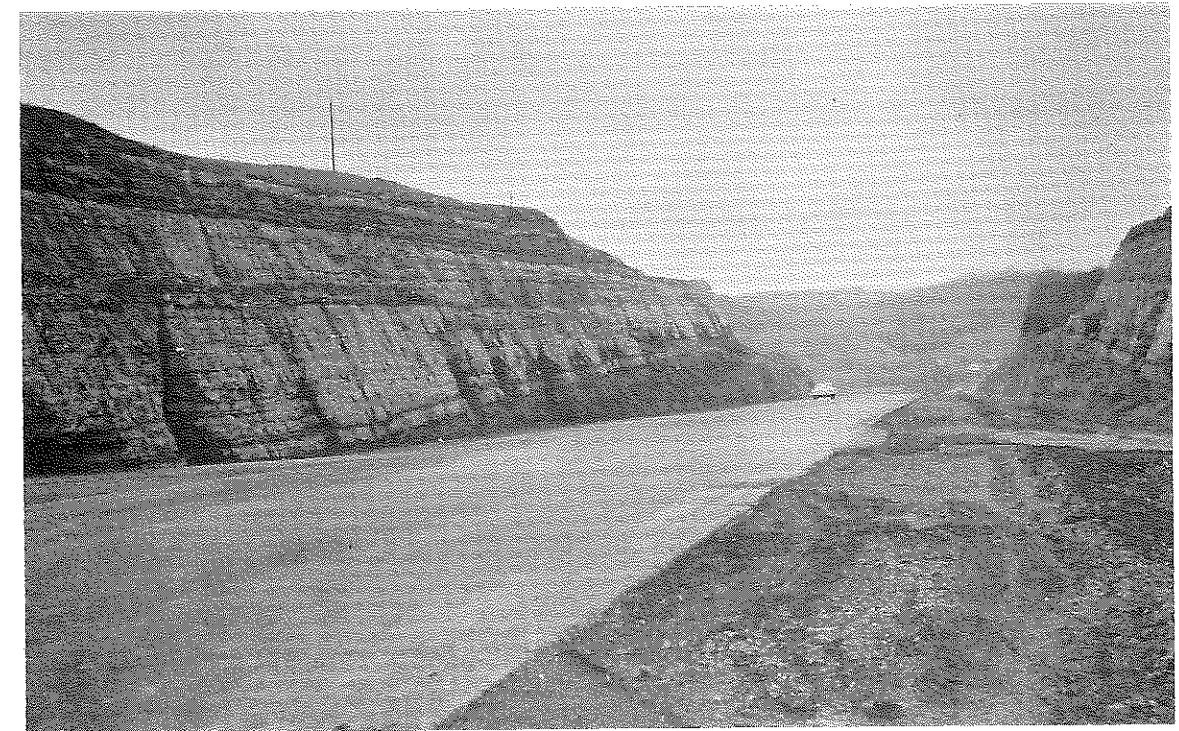
Figure 14. Exposures of Estill Shale, Boyle  
Dolomite, and New Albany Shale  
(Ohio Shale or Chattanooga Shale)  
on KY 52, Estill County.

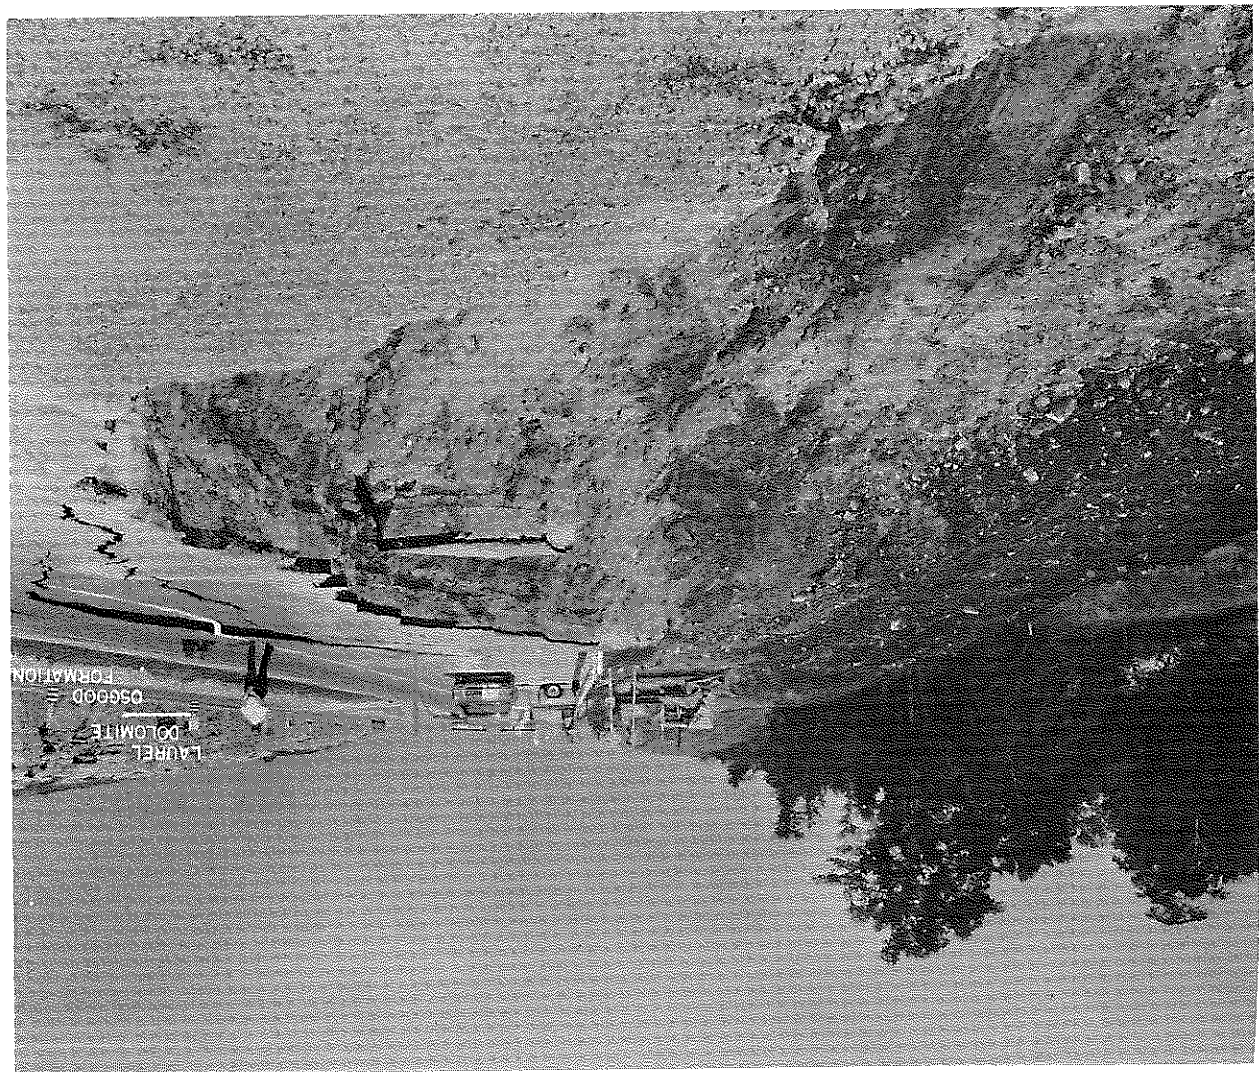
Just prior to the completion of construction, a slide occurred in the eastbound lane of the Bluegrass Parkway approximately 1.5 miles west of the US 31E interchange. The pavement, which was damaged, was patched just before the Parkway was opened to traffic. Movement continued in this area until the eastbound lanes had to be closed to traffic. A detailed discussion of the site and of the corrective measures have been reported previously ("Stability Analyses of Earth Masses" by R. C. Deen, G. D. Scott, and W. W. McGraw, September, 1966).

Figure 15. View of Slide Area, Looking West, at Mile Post 20 in Late July, 1966.

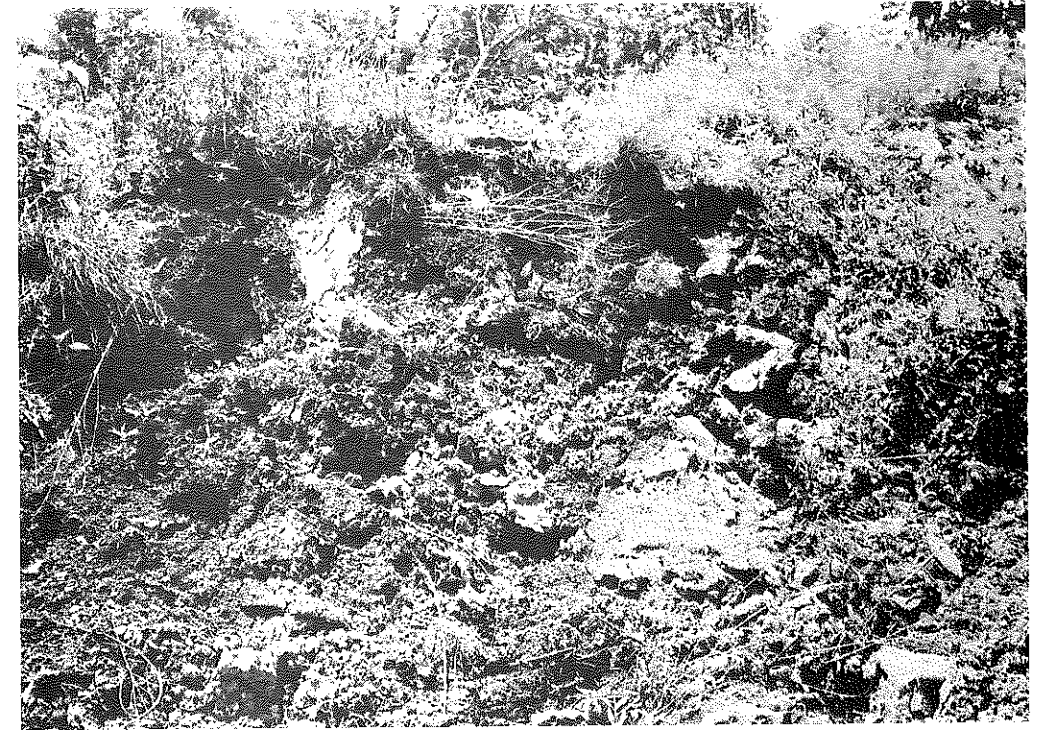
Figure 17. Photograph 1 (See Figure 15) Showing Saturated Slope Material, KY 89, Clark County.

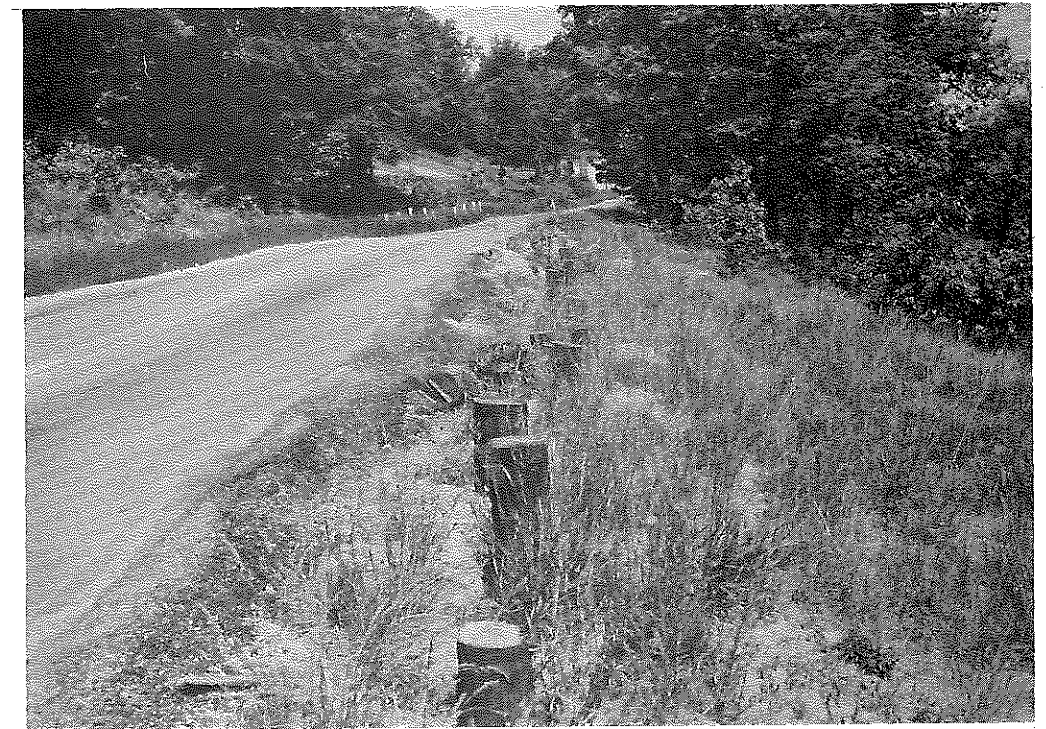
Figure 18. Photograph 2 (See Figure 15) of Slide Area, KY 89, Clark County.

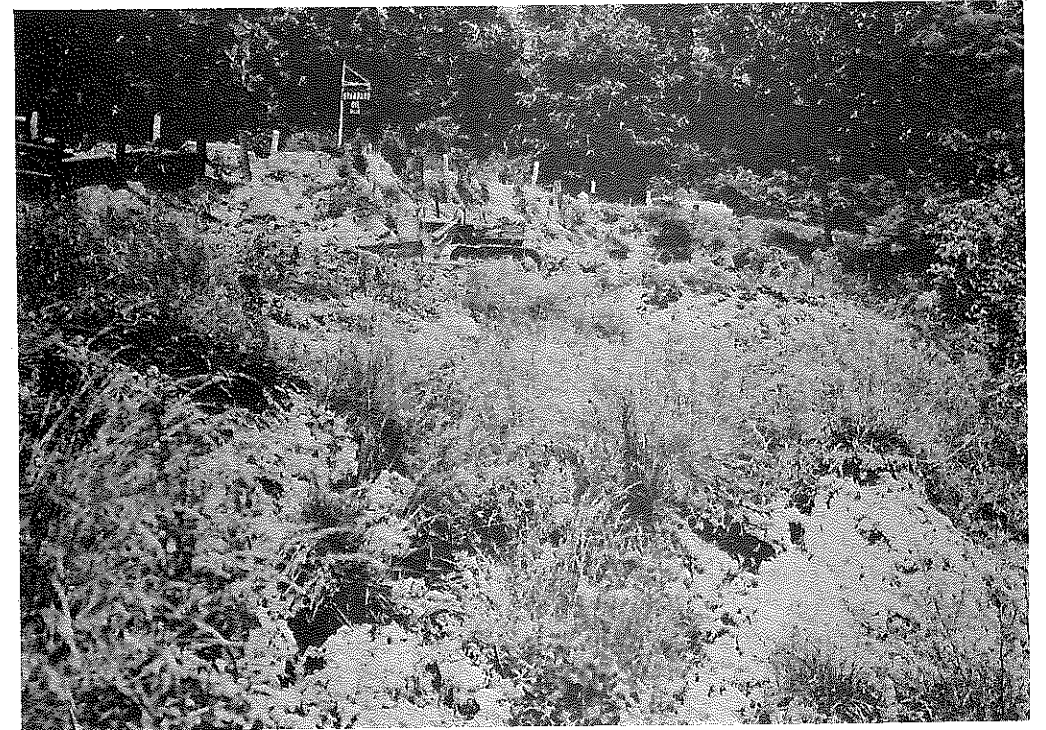
Figure 19. Photograph 3 (See Figure 15) of Slide Area, KY 89, Clark County.

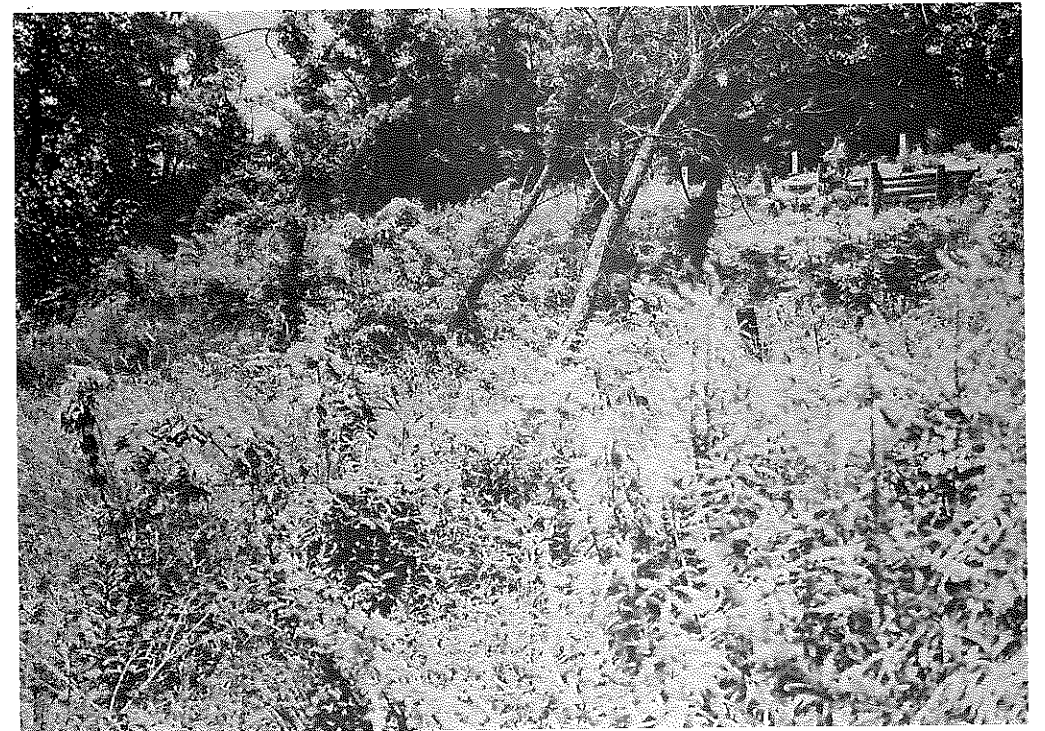
Figure 20. Photograph 4 (See Figure 15) of Slide Area, KY 89, Clark County.

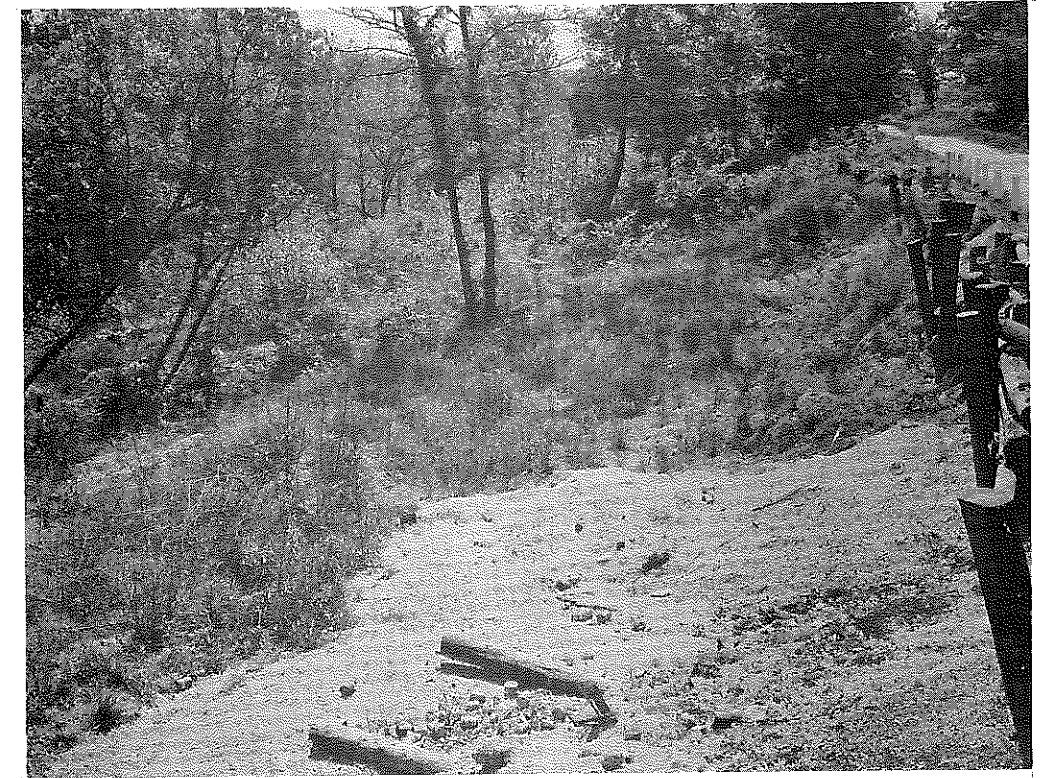
Figure 21. Photograph 5 (See Figure 15) of Slide Area, KY 89, Clark County.

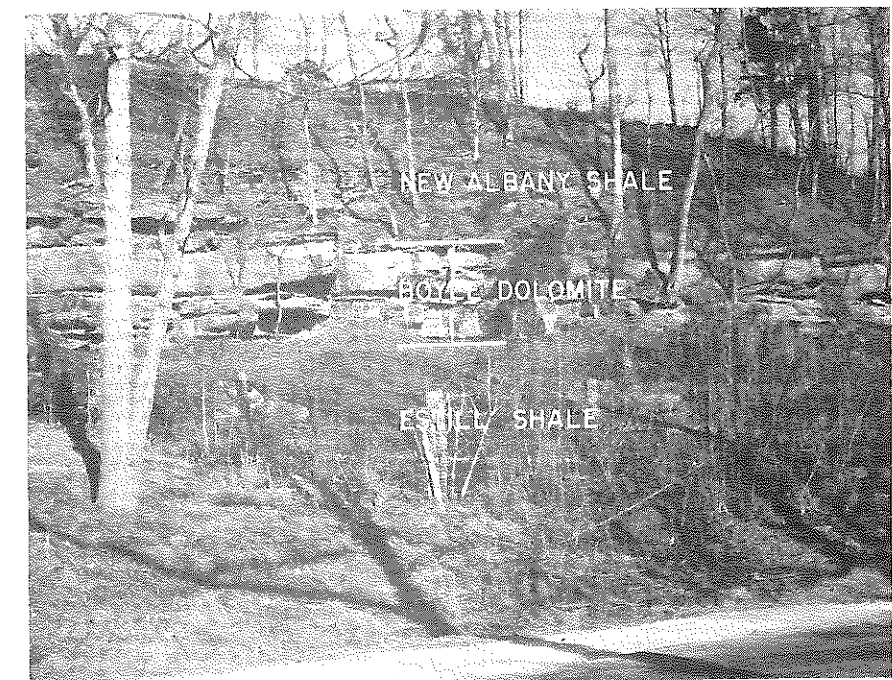
Figure 22. Boyle Dolomite Cliff, KY 89, Clark County, Photograph 6 (See Figure 15).

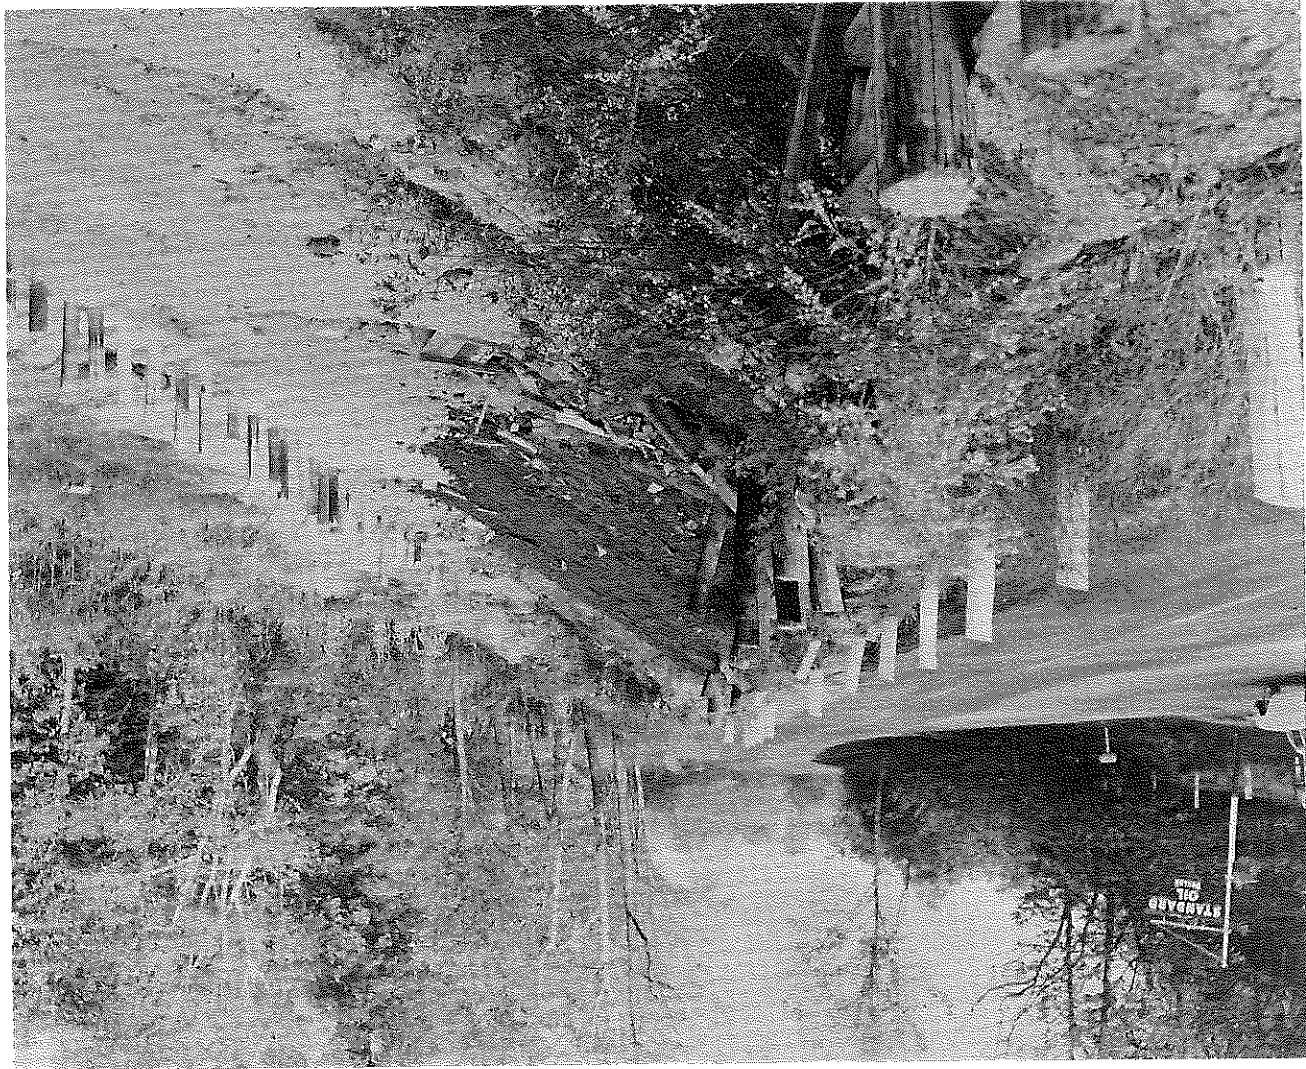
Figure 24. Concrete-Filled Pipe in Place, KY 89,  
Clark County, Photograph 7 (See Figure 15).

In September 1963, the Division of Maintenance installed a number of concrete-filled, 6-inch steel pipe piles in the slide area in Clark County (see Figure 24). These piles were placed to depths of some 60 to 80 feet and apparently penetrated into stable material sufficiently to stabilize the slope. According to comments made by local people in February 1968, there has been no significant movement of the area for a couple of years.
