SUBJECT: Landslides: Geological Correlation

Research Report: "The Crab Orchard  
and Osgood Formations," R. C. Deen  
KYHPR-63-16; HPR-1(3), Part II

THE CRAB ORCHARD AND OSGOOD FORMATION  
The Case For Slope Instability  
KYHPR-63-16, HPR-1(3)

KY 52, Estill County  
SP-33-83, S 616(13)

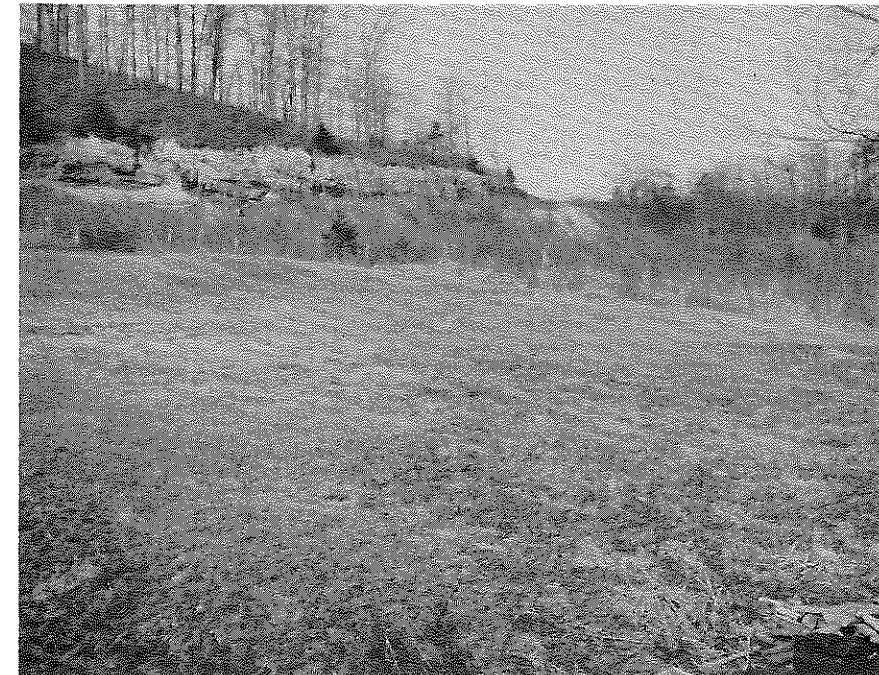
Significant difficulties were encountered with slides during the construction of KY 1840 in the area where it junctions with KY 89, approximately 1-1/2 miles north of Irving. This county road was built along a line parallel to the contours of the ridge and more or less parallel to the outcrops of the Estill Shale. The road was built at the base of the Boyle Dolomite cliff which was overlain by the New Albany Shale (see Figure 25).

Figure 25. Landslide Area, KY 1840, Estill County.

In order to correct the landslide situation, the location of the road was abandoned and relocated in the bottom of the "V" of the small valley between the two ridges. Even though the roadway crossed the Estill Shale, this particular location was the most advantageous. The crossing is made at right angles to the strike of the outcropping and the roadway is "wedged in" the bottom of the small valley. In this manner, the likelihood of a landslide was minimized. To date (February 1968) there has been no significant difficulty with the relocated section of KY 1840 where it crosses the Estill Shale.

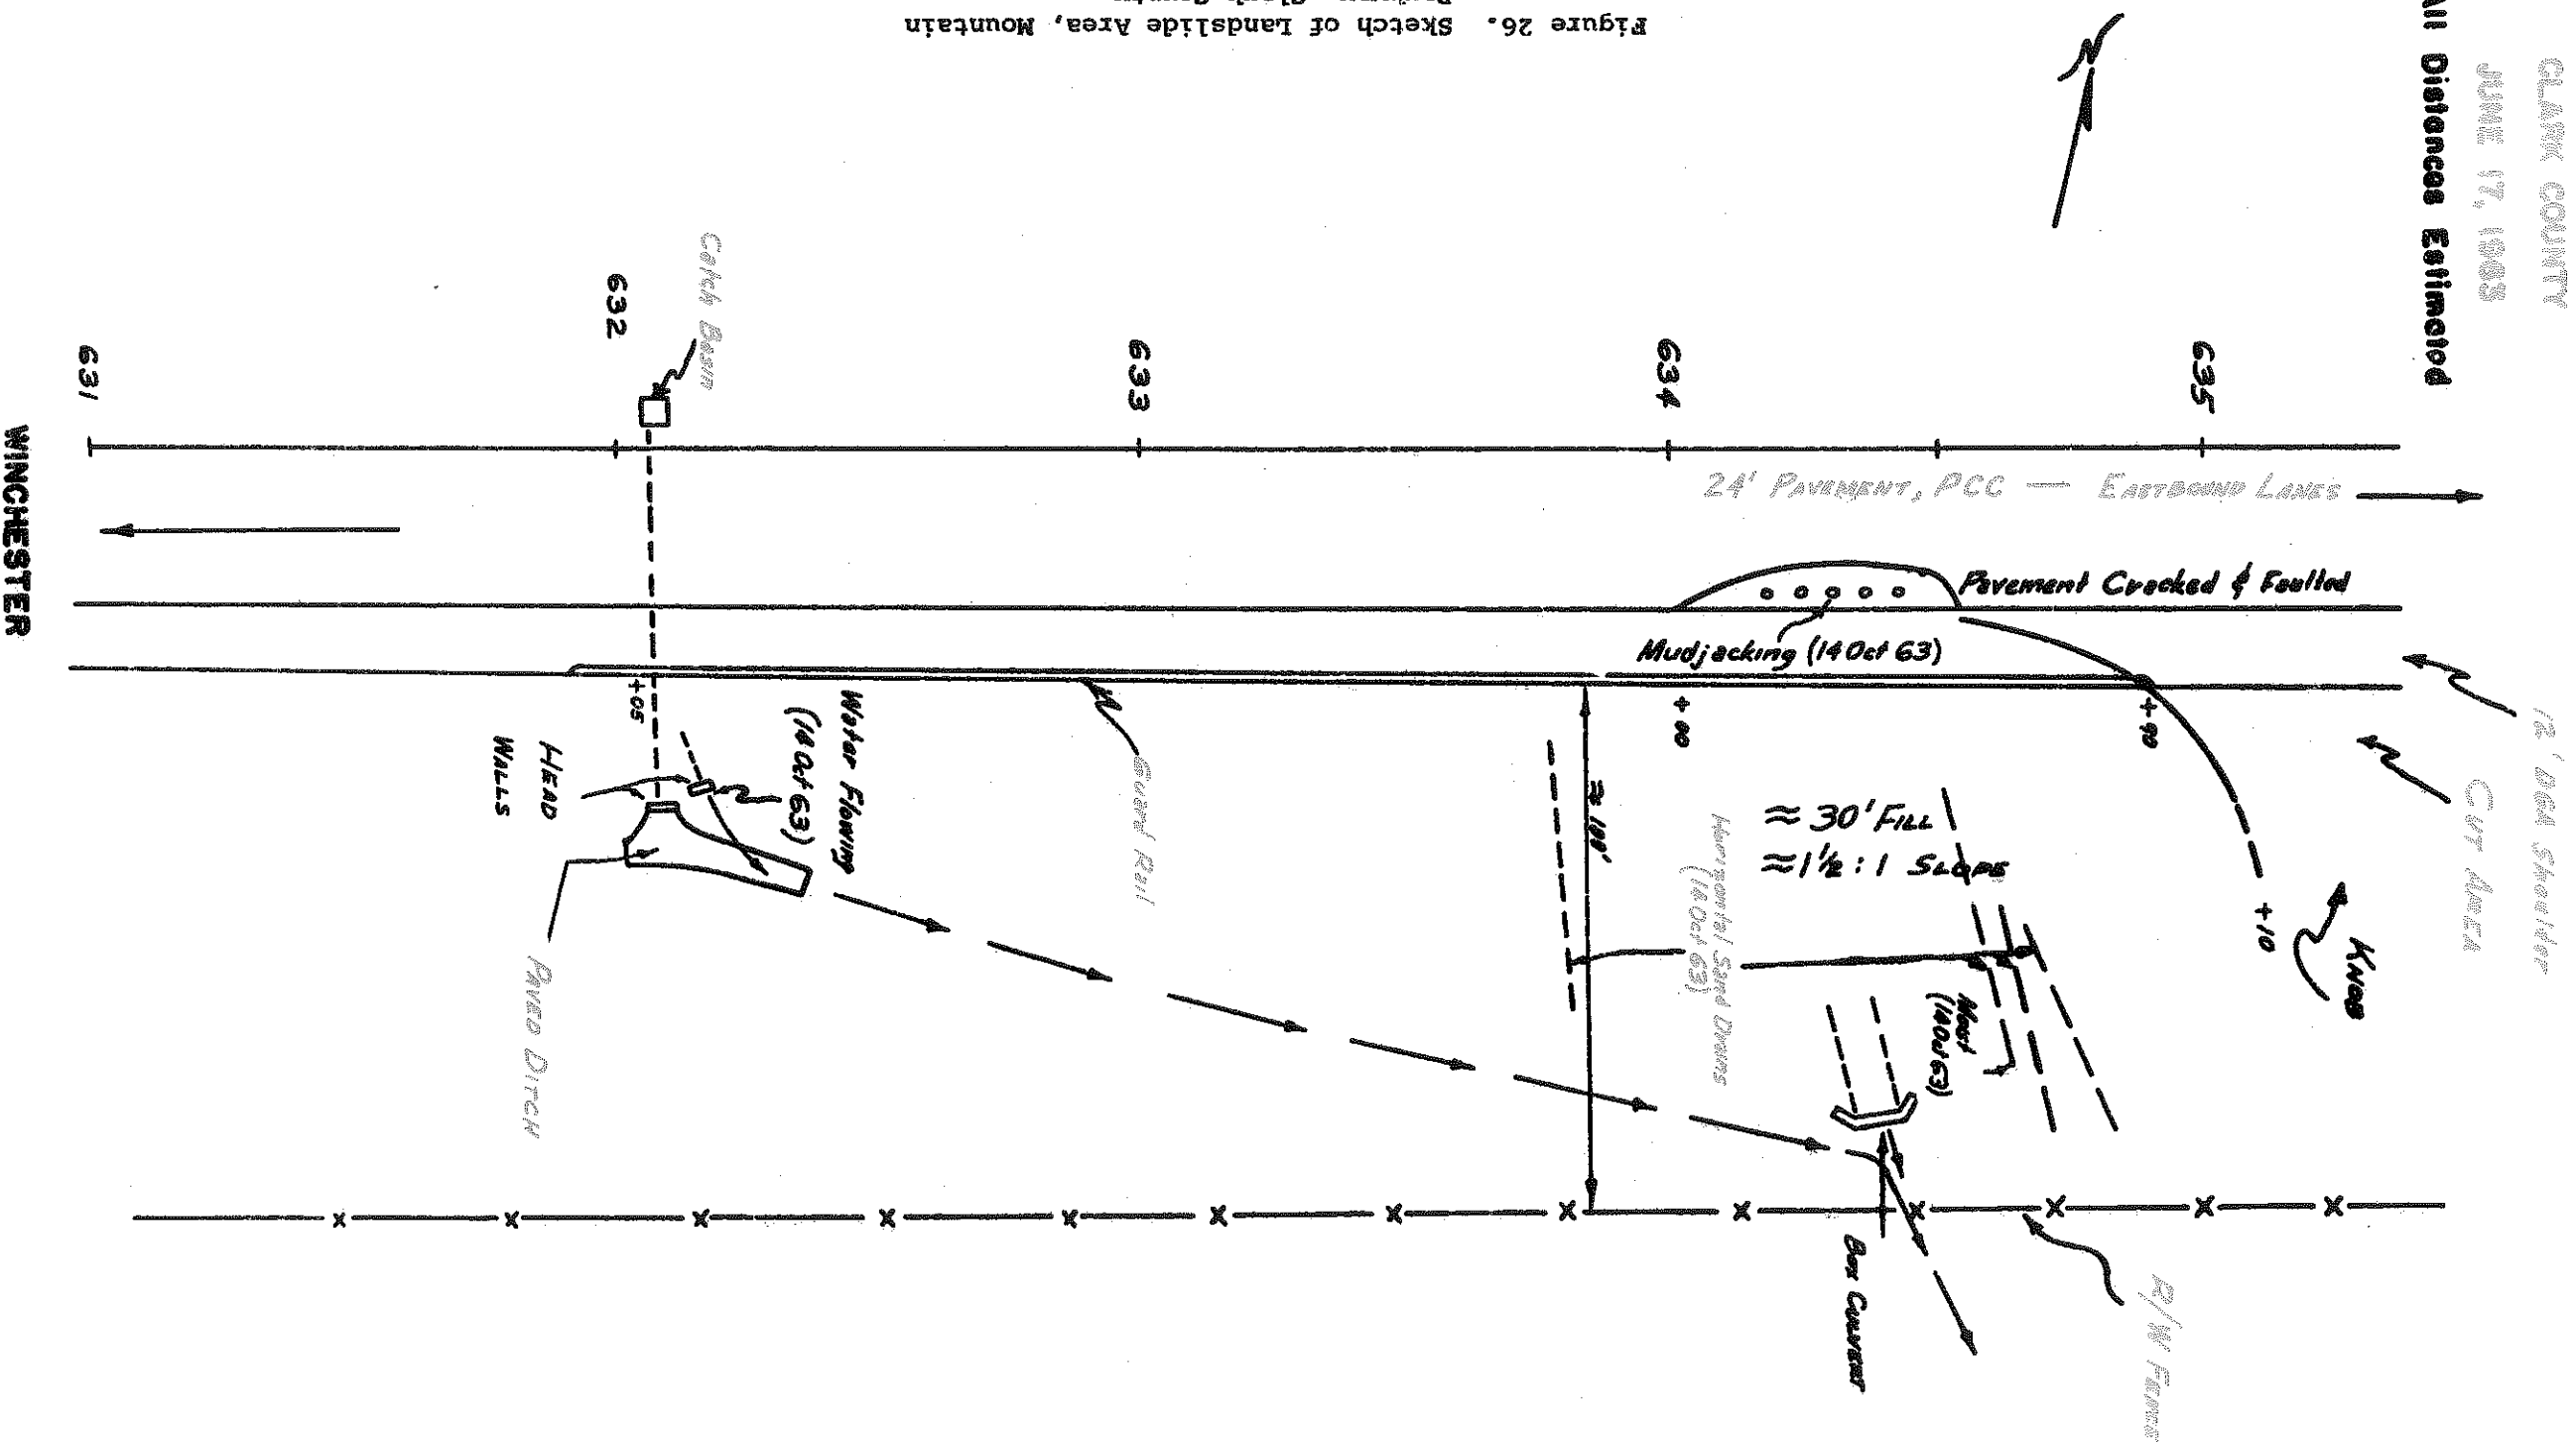
The Division of Research has been observing a slide on the Mountain Parkway in Clark County between Stations 633+00 and 635+00 in conjunction with research on methods of tracing seepage water in unstable slopes. The slide is located on a short fill section near the Powell County line. Soon after the project was opened to traffic, a 50-foot section of the right (eastbound) shoulder subsided slightly (see Figures 26 and 27). Since that time the area of subsidence has increased during periods of wet weather so that both right (eastbound) traffic lanes, and to a lesser extent the left (westbound) traffic lanes, have been involved. Maintenance operations have included mudjacking and patching to maintain the proper grade.

Figure 26. Sketch of Landslide Area, Mountain Parkway, Clark County.

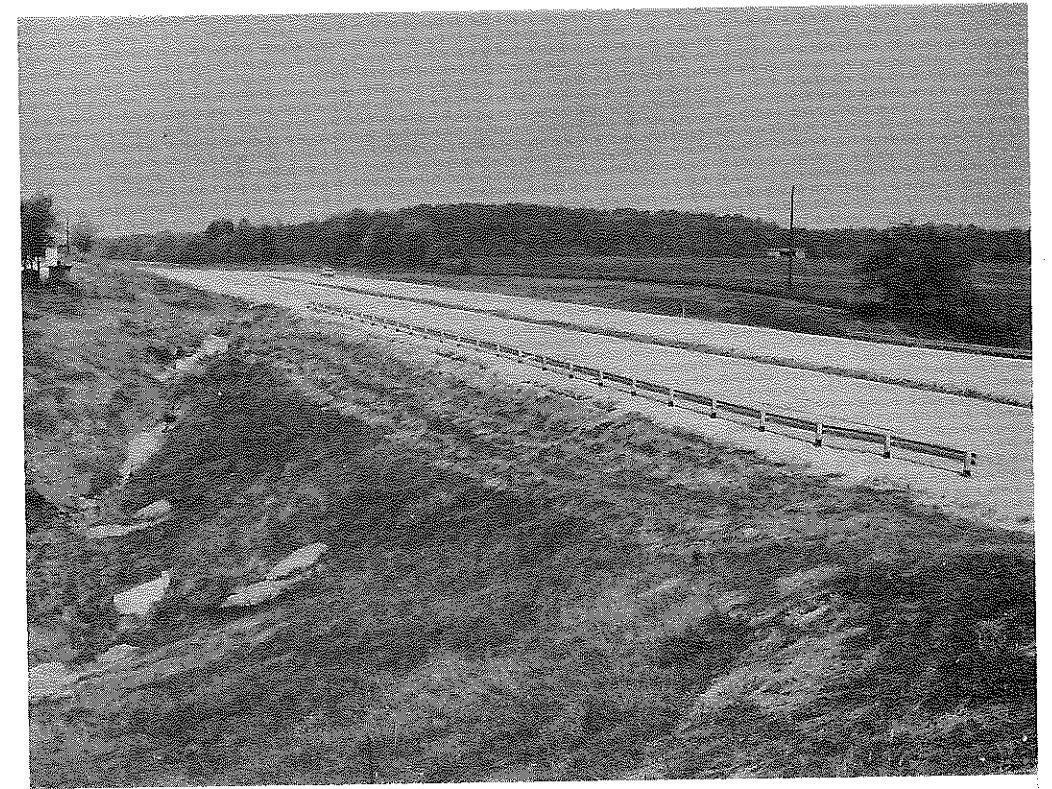
During all the inspections of the landslide site, numerous areas of significant groundwater seepage were noted in the fill area. A suspected source of this water was thought to be water coming down the ditches and rock subsurface through the cut to the west of the site. In September 1966, hydrated lime was placed just below the ground surface at the median inlet and two ditch inlets at Station 625+00, where water was observed disappearing into the ground. Water samples were obtained from drill holes, which had been installed during the summers of 1965 and 1966, at frequent intervals over a period of several months and tested in the laboratory for ph, conductivity, calcium content, etc. Analyses of these water samples did not indicate any change due to the lime, indicating that the suspected source of seepage was not actually a major factor and that this water probably finds its way to the spring box at Station 631+80, which, as indicated by the large flow, is functioning properly. With the most obvious source being eliminated as a prime suspect, observations of water elevations in the drill holes were made at frequent intervals for several months in an effort to detect other possible sources of seepage water into the slide area. The results of this data are presented in the form of water-table contours in Figure 28. These water-table contours show a mound of groundwater between Stations 633+50 and 634+00 and extending the entire width of the roadway. The contours indicate that the water is draining from the embankment in a southerly direction. The groundwater low point is in the eastbound lane at Station 633+00, which places the drainage outlet in the vicinity of the 48-inch concrete culvert. Water was noted to be continually entering the culvert through the tops of open joints, a further indication that the culvert serves as an outlet.

Figure 27. Landslide Area, Mountain Parkway,  
Clark County.

groundwater. Regardless of the ultimate source, it is likely that an interceptor trench about 10 feet deep and extending from approximately Stations 633+50 to 635+00 in the left ditch line would cut off the flow of water to the fill. Such a ditch 10 feet deep would have its bottom near elevation 700 which is well below the top of a green shale, thought to act as a barrier to the vertical seepage.

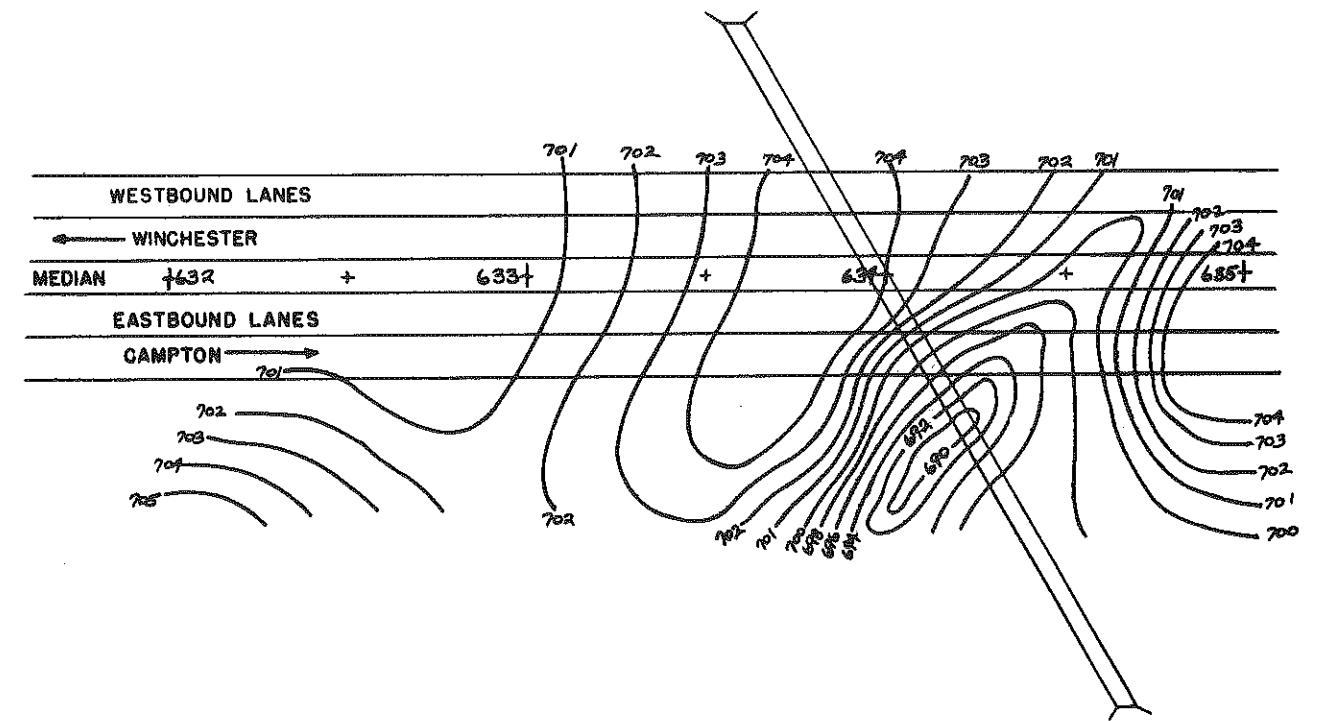
The water appears to be entering the unstable embankment from the east. To the northeast about 100 feet is a pond with water at a normal pool elevation of 705 feet. Thus, the pond is a likely source of seepage and should be drained. It is possible, however, that the pond is not the source of seepage but, rather both the pond and the embankment may be feed by

Figure 28. Water-Table Contour Map of Slide Area, Mountain Parkway, Clark County.

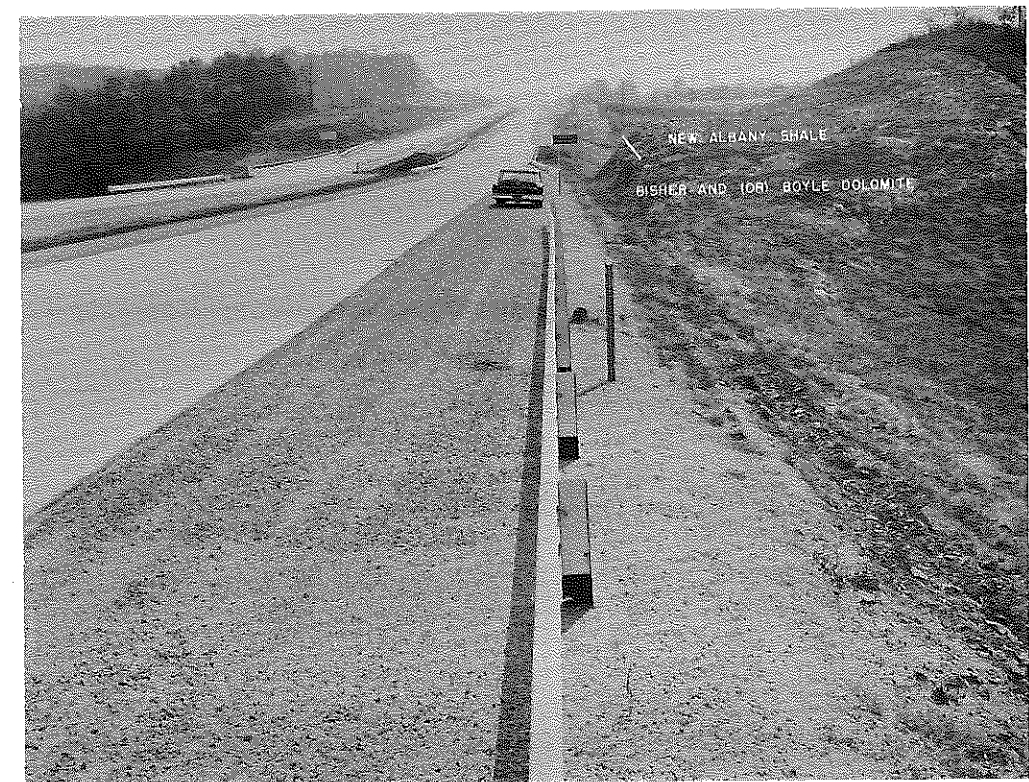
Figure 29. Slide Area, Mountain Parkway, Clark County.

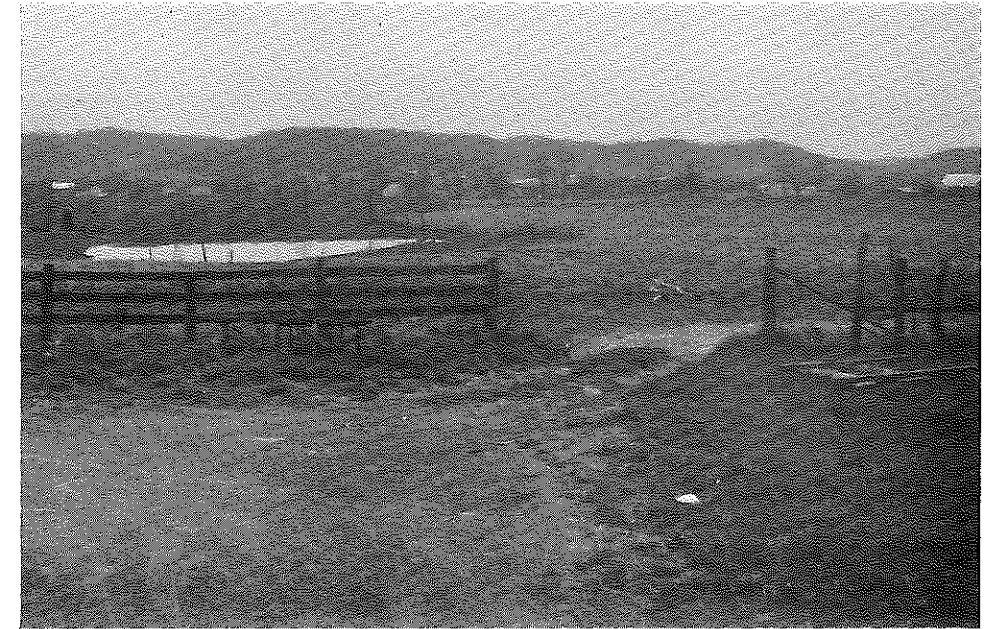
Figure 30. View of Crab Orchard Outcropping in Vicinity of Tollesboro. Note Ohio Black Shale Knobs in Background.

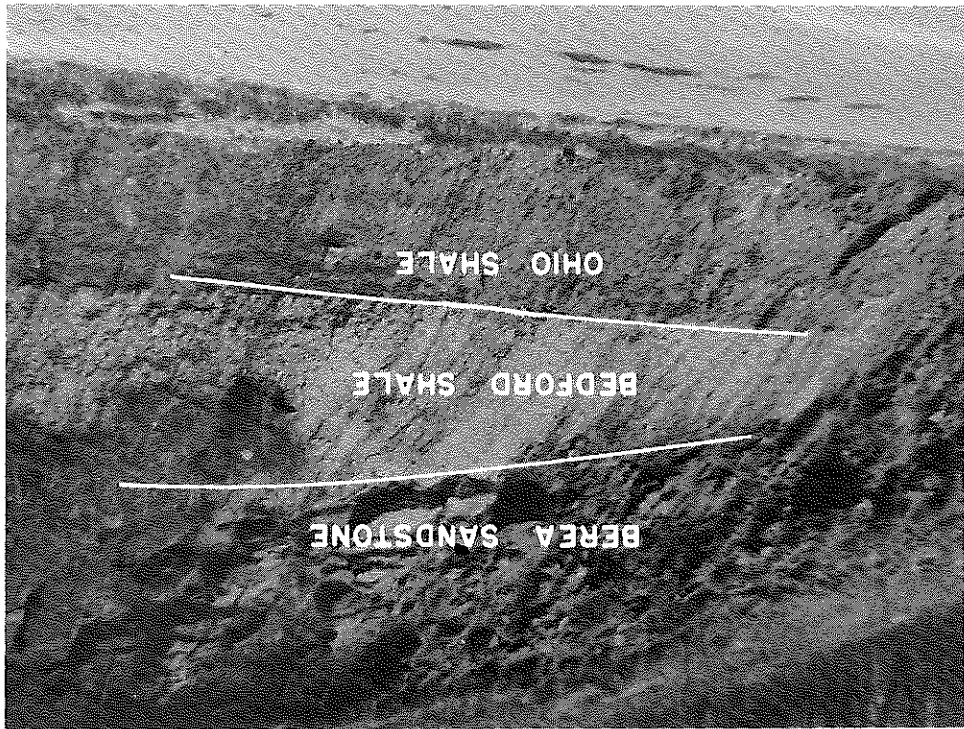
Figure 32. Outcrop of Berea Sandstone at Herron Hill.
