COMMONWEALTH OF KENTUCKY
DEPARTMENT OF HIGHWAYS
FRANKFORT

SUBJECT: Research Report, Interim; "Stability Analyses of Earth
Masses"; KYHPR-63-16, HPR-1(2), Part II; Development
of a Practical Method of Locating and Tracing Seepage
Water in Unstable Slopes.

FOUNDATION AND SLOPE STABILITY
OF HIGHWAY EMBANKMENTS
AND EXCAVATIONS

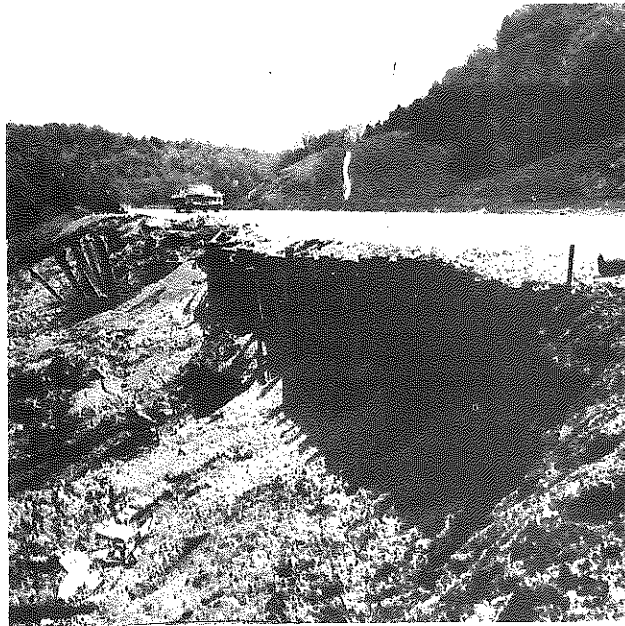
Figure 2-3. Slide at Mile Post 75 Western Kentucky Parkway, in May, 1966.

On the basis of the analysis, it was suggested that three rows of the nominally six-inch diameter piles, which were placed at the site, would be adequate to stabilize the soil above the zone in which the piles are placed. The piles in these three rows would be placed at a spacing of two feet, center-to-center. This recommendation appears to have been verified in the field. In those zones of the slide in which the equivalent of three rows of piles, two feet, center-to-center, were placed, the slide appears to have stabilized (see Figure 2-3). In other zones where

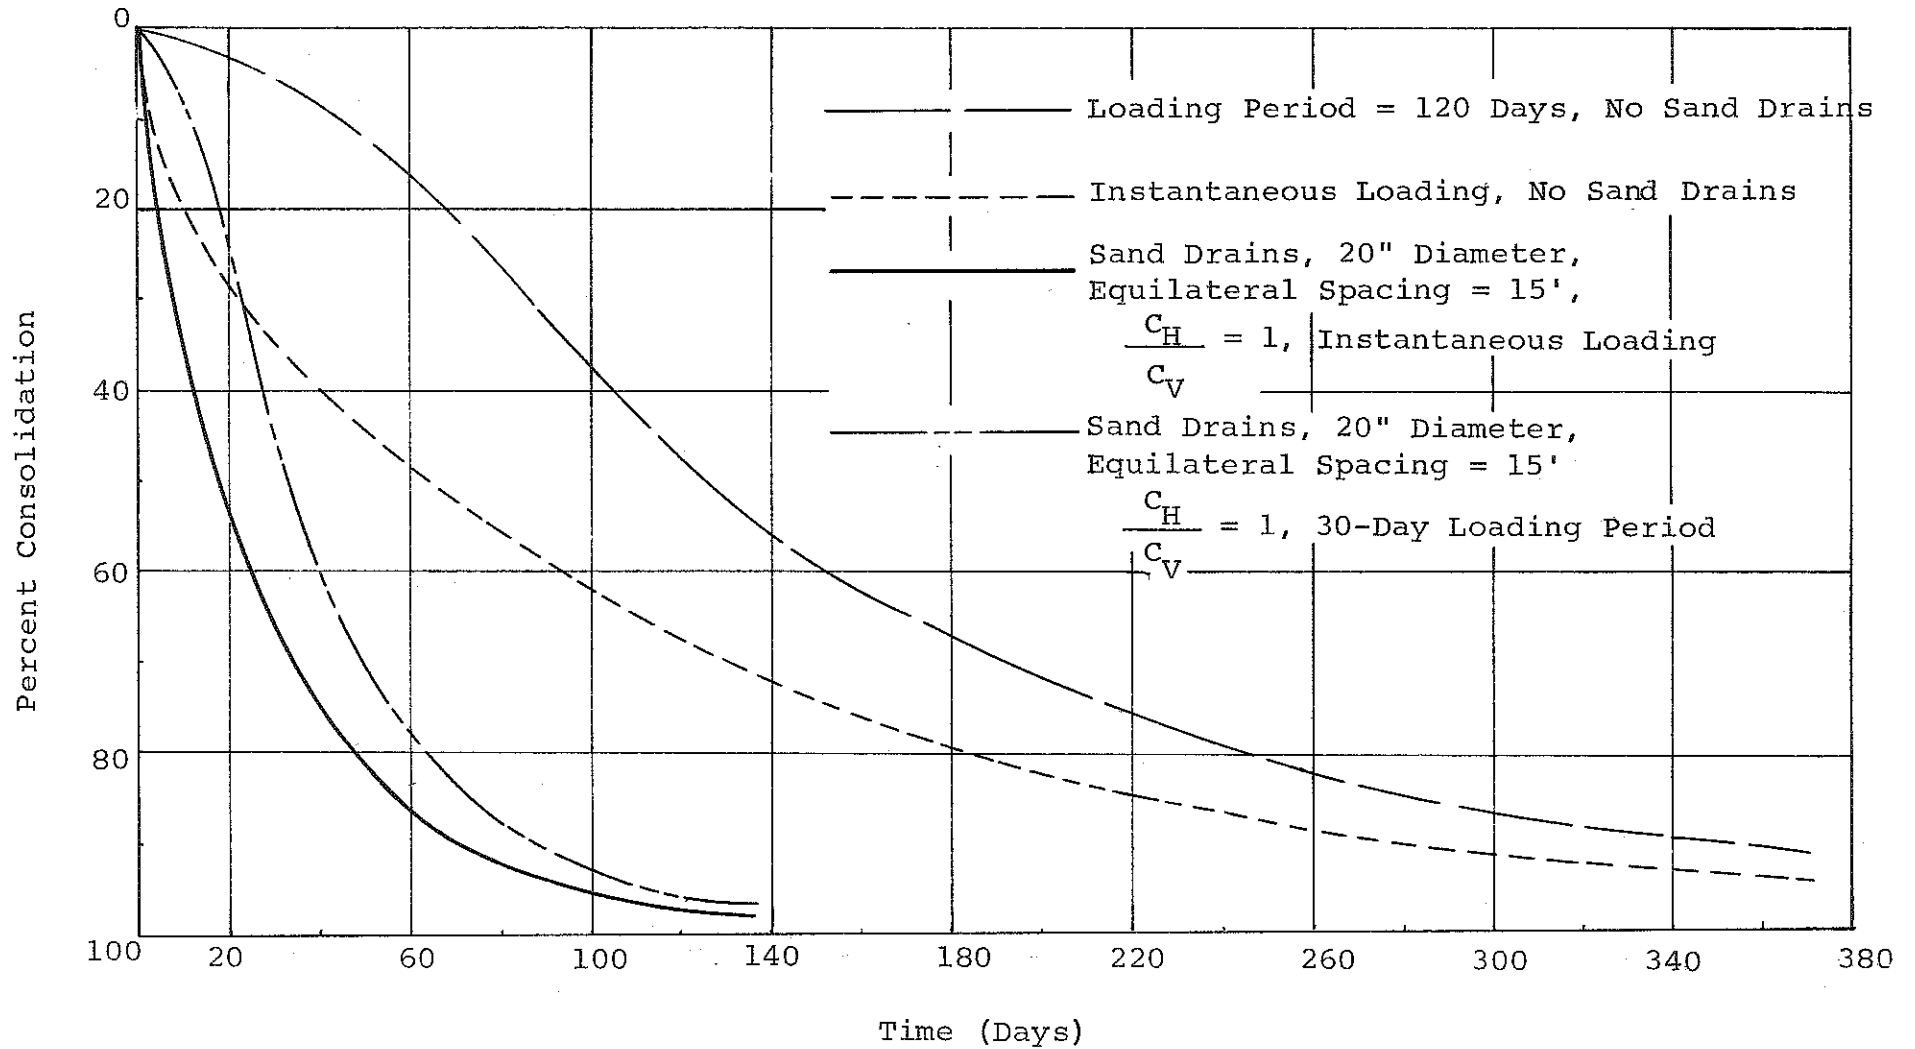
Figure 5-3. Rate of Settlement Curves.

Figure 5-3 shows that the sandy foundation materials consolidates relatively fast, even without sand drains. An extended construction period of approximately 120 days would permit a higher degree of consolidation than would be obtained with sand drains on 15-foot centers in a construction period of 30 days. Thus, there does not appear to be sufficient justification for the installation of sand drains.

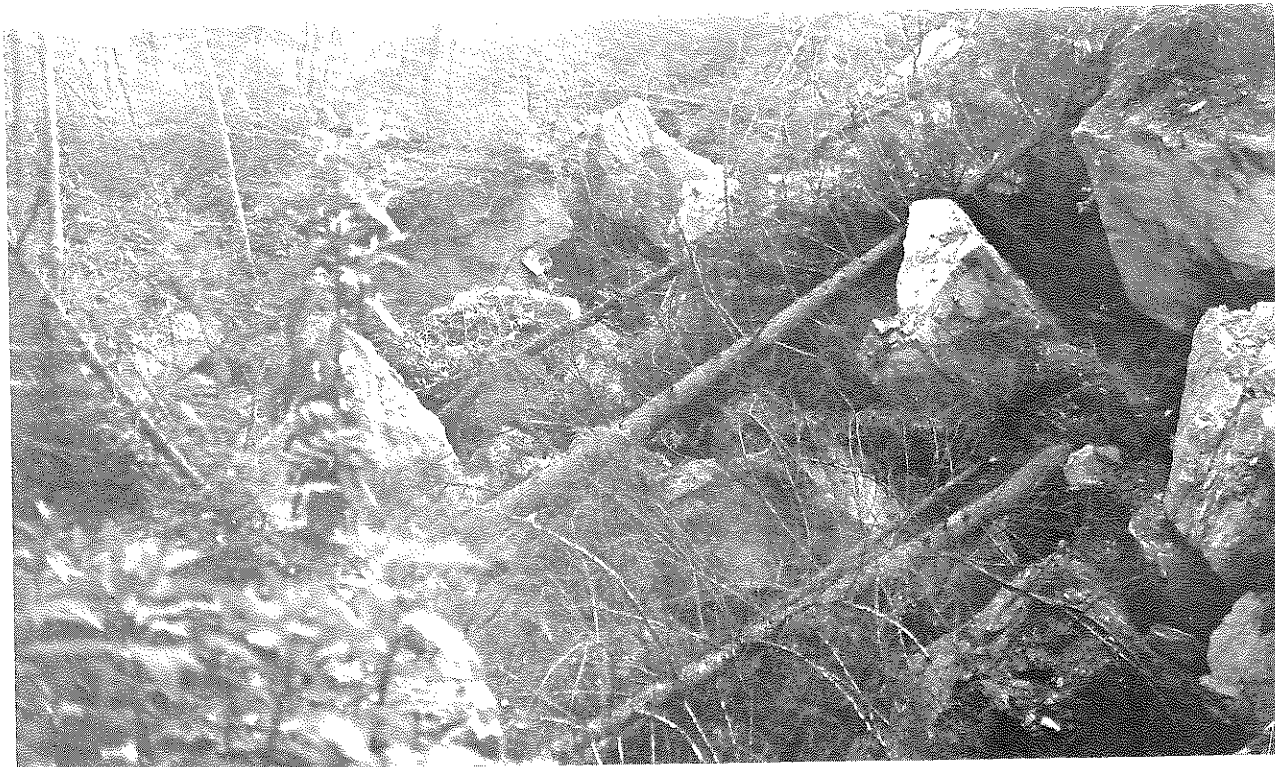
Figure 6-3. View of the Crevasse above the Moving Mass.

An investigation of the site indicates that the slope consists of approximately 18 to 25 feet of sandstone resting directly on a plastic clay approximately one foot thick. A thin coal seam approximately one foot thick lies under the clay. Below this is approximately 60 feet of dark, gray shale and then about 20 feet of light gray, shaley sandstone (see Figure 6-7). The material which is

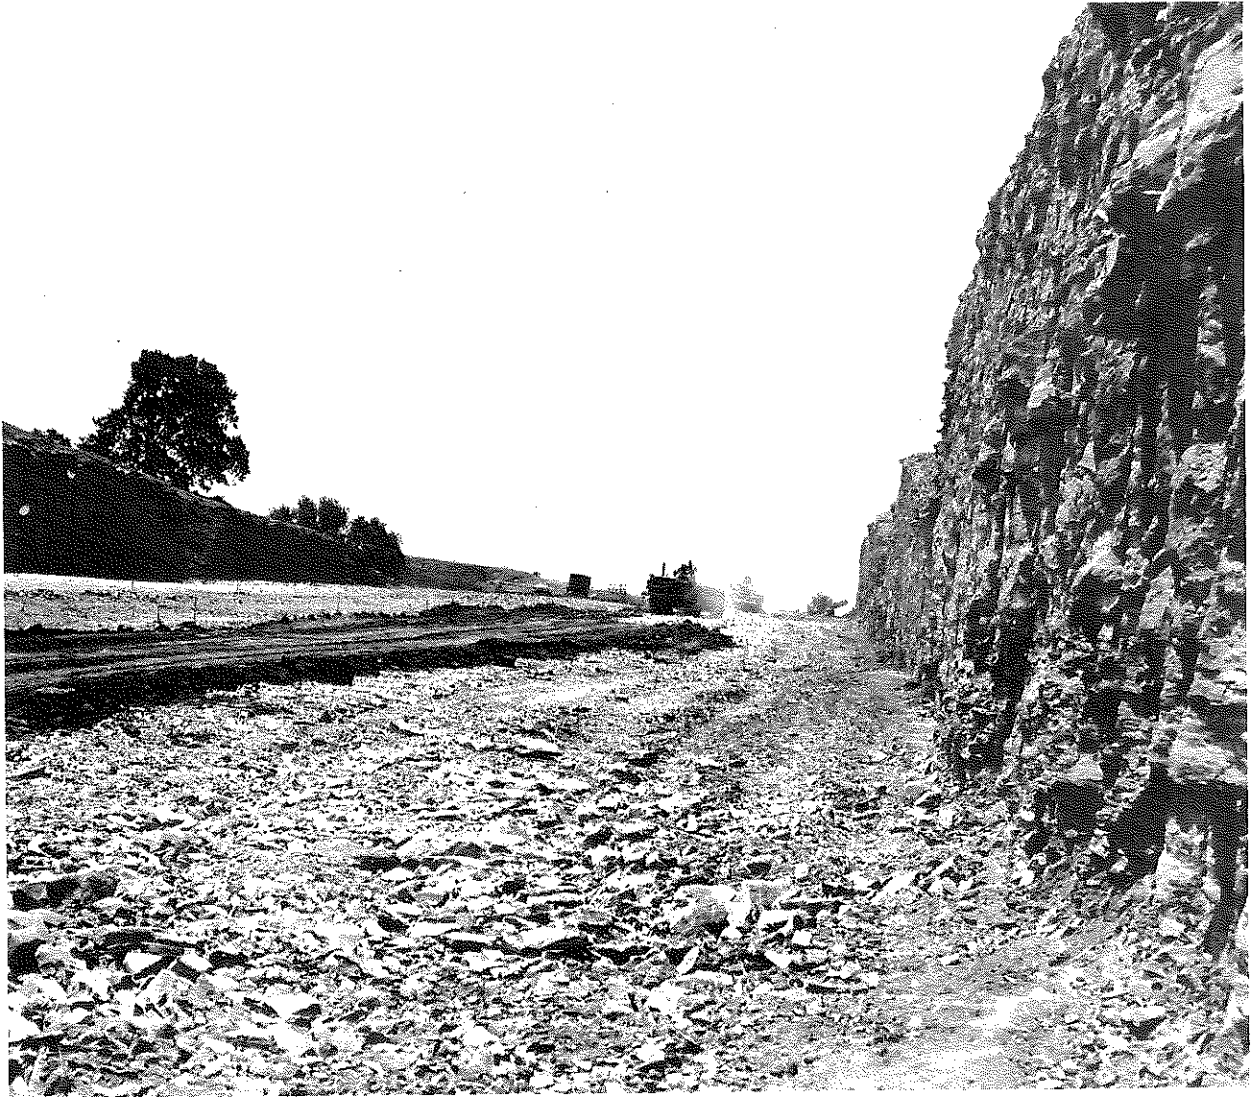
Figure 3. Photograph of Rock Cut Construction on
I 75 Near Richmond, Kentucky.

It is interesting to note that many of the slides which have occurred as a result of the damming effect of a side-hill embankment have been located in the transition zone between full cut and full fill sections. In addition to the natural subsurface waters which may be impounded by the side-hill fill, additional waters from the cut section may be finding a way into the embankment in this transition area. Figure 3 is a photograph obtained from a construction project on I 75 south of the Richmond Bypass. Although specifications require that any depressions requiring refilling to the designated rock line will be
