COMMONWEALTH OF KENTUCKY
DEPARTMENT OF HIGHWAYS
FRANKFORT

MEMORANDUM

SUBJECT: Slurry Seal Maintenance and
Test Applications of 1962

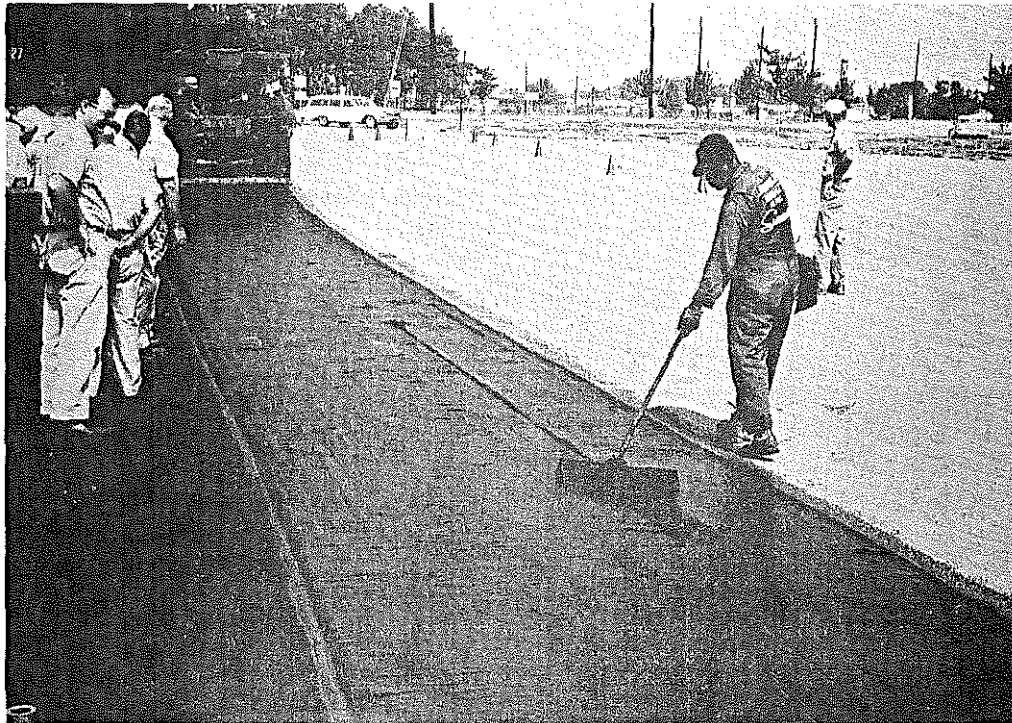
Fig. 4. Kentucky State Fairgrounds. The laborer is smoothing a streak caused by an over-sized aggregate particle. The dark stripe next to the fresh slurry is water from the spray-bar beneath the slurry machine.

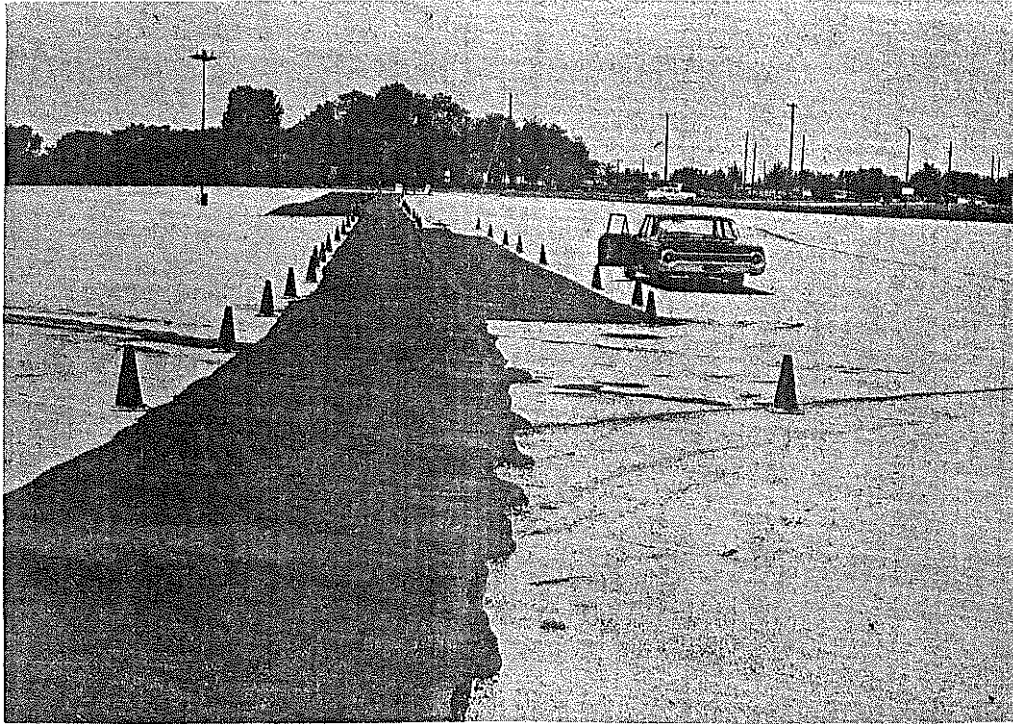
Fig. 10. Kentucky State Fairgrounds. The section containing all limestone aggregate and 16.6 percent SS-lh is on the left in the background. The section composed of blended sand, 1.25 percent portland cement, and 14.0 percent SS-lh is in the background between traffic hats. The section composed of blended sand, 12.0 percent SS-lh, and 2.5 percent portland cement is in the foreground.

slurry containing equal parts of the limestone sand and a medium Ohio River sand, 1.25 percent portland cement, and 14.0 percent SS-1h was laid. A strip was also laid containing equal parts of the sands, 2.5 percent portland cement, and 12.0 percent SS-1h. It was noted that paint stripes reflected through the fresh slurry, due to lower water absorption of the paint stripe surface (Fig. 7). Several times the fresh slurry was streaked by large aggregate particles caught by the squeegee. The slurry which fills deep depressions takes longer to cure or "set up" than the surrounding surface.

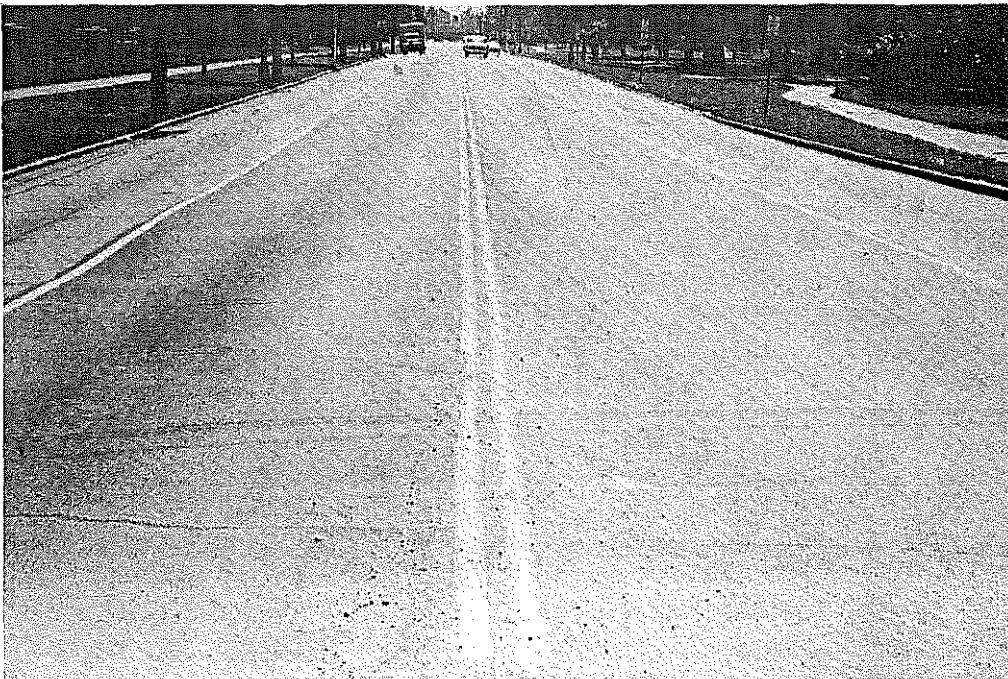
Fig. 15. South Third Street, Louisville. The seal contains silica sand from near Mt. Vernon. Only the two center lanes have been sealed. Note the shrinkage cracks in the old surface.

Prior to sealing the service areas, a section of the Beuchel By-Pass (US 31-E), and a section of South Third Street at the University of Louisville were slurry sealed by the Louisville Asphalt Company (Figs. 15 and 16). The aggregate used in these sections was silica sand from near Mt. Vernon in Rockcastle County. The emulsion was SS-1h. On the Beuchel By-Pass the pavement surface was cracked due to deformation. On South Third Street, the pavement was cracked due to age shrinkage. The total cost of these two sections was \$300.00.
