AN EVALUATION AND SUMMARY OF THE 16-YEAR
PERFORMANCE OF A CONCRETE TEST PAVEMENT

(Project F. A. 366, C1 and C2, Harrison- Pendleton Counties)

Milton Evans, Jr.
Research Engineer

Highway Materials Research Laboratory
Lexington, Kentucky
June, 1958

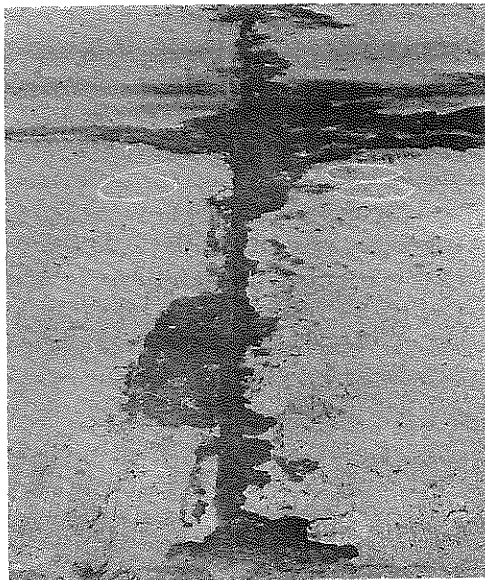
C - Enlarged crack or joint, showing considerable spalling and corner breaking

Fig. 4: Joints Illustrating Typical A, B, C, and D Conditions as Designated in Table 5.

In order to interpret clearly the crack survey data presented in Table 5, an understanding of the designations A, B, C, and D, used to describe the condition of cracks and joints, is necessary. Figure 4 illustrates the difference between an A, B, C, and D crack or joint. An A crack or joint is in like-new condition, a B crack or joint shows more deterioration, a C crack or joint shows further deterioration, and a D crack or joint shows maximum deterioration.

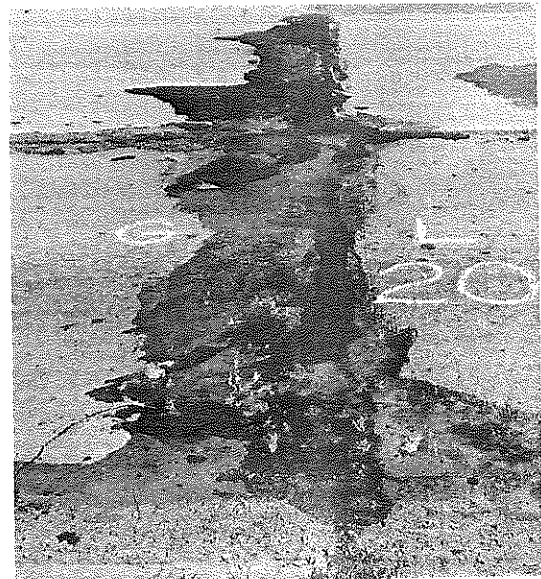
D - Greatly enlarged crack or joint, with excessive spalling and corner breaking
