TEST PROJECT F.A. 366, C1 AND C2,  
HARRISON-PENDLETON COUNTIES

A MEMORANDUM REPORT

March, 1958

SUBJECT: Test Project F.A. 366, C1 and C2,  
Harrison-Pendleton Counties

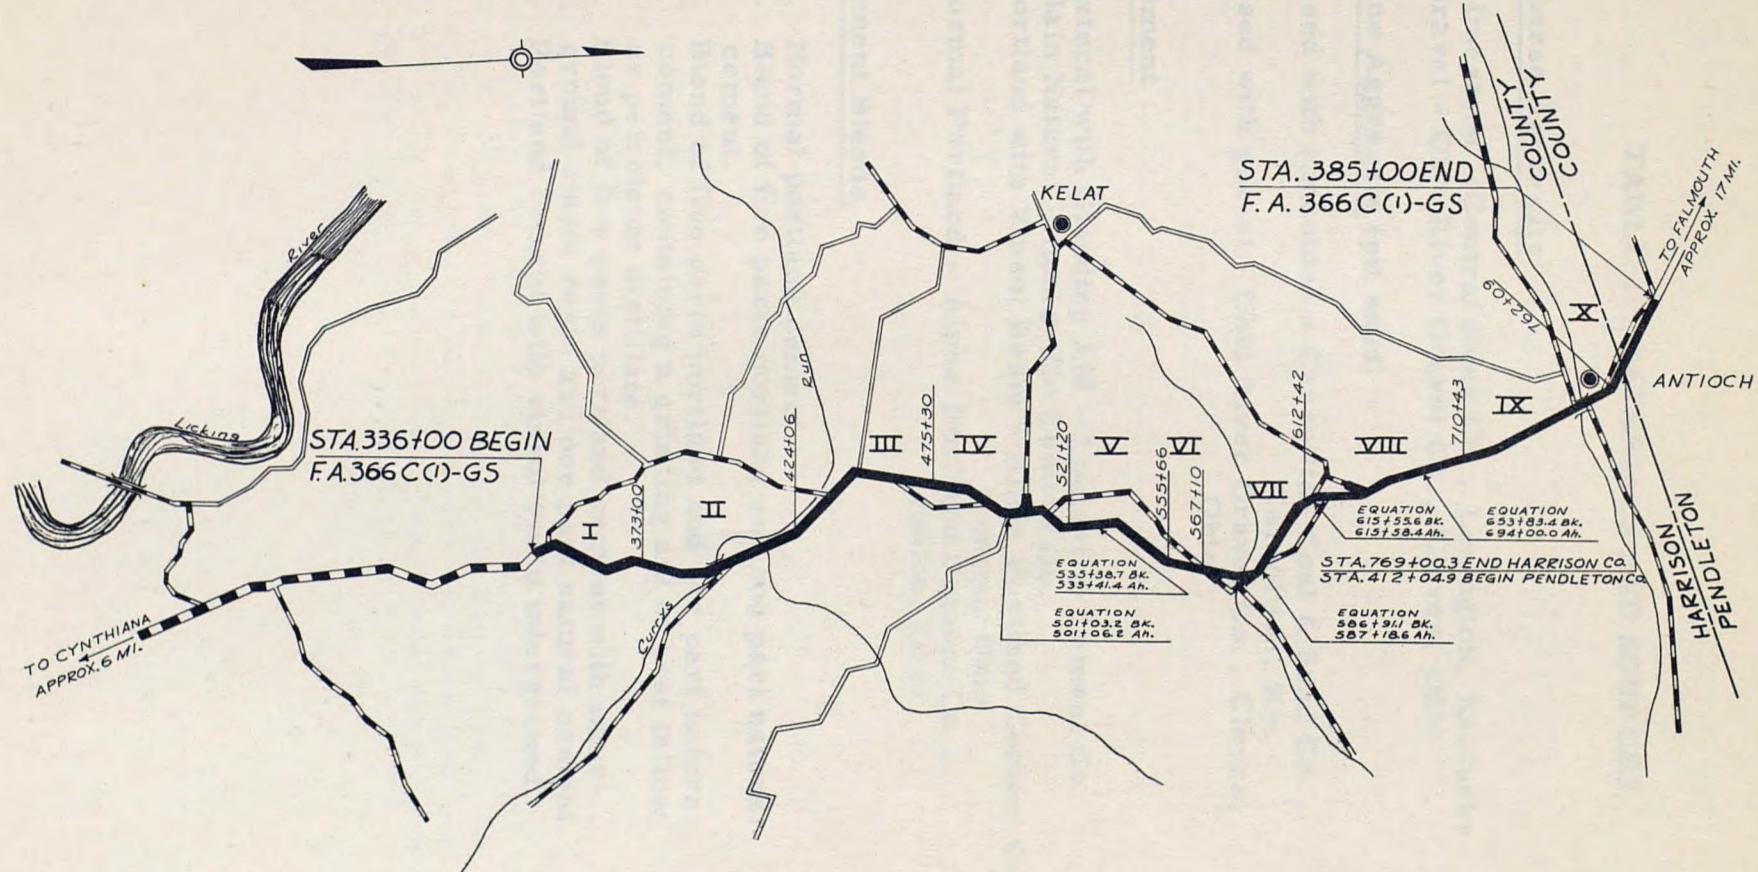
FIG. 1: Layout Map Showing Location of Test Pavement

This project, located on US 27, was designed to provide performance data on concrete durability over a period of years. The pavement, totaling 7.89 miles, was constructed in ten experimental test sections, as shown on the layout map in Figure 1. Five blends of cement, containing portland, natural and two different air-entraining agents, were used with two types of coarse aggregate -- limestone and river gravel. Since the construction of the pavement in the summer of 1941, reports and memoranda have been released dealing with several aspects of the over-all study:

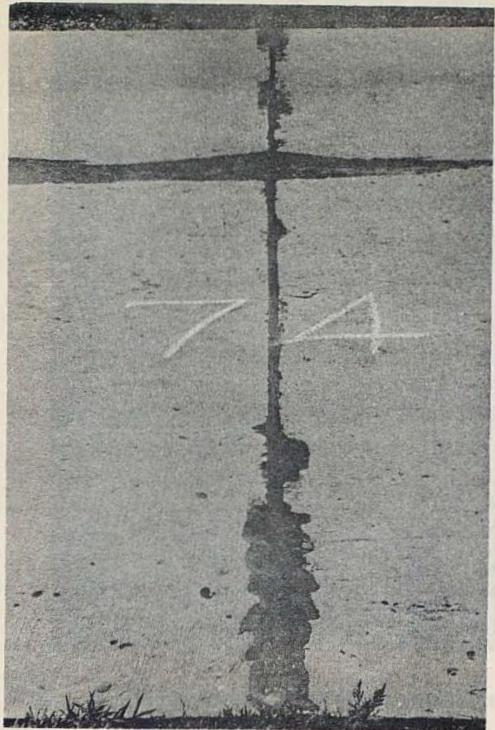
A - Fine crack or normal joint without spalling or other deterioration

\* Crack and joint designations A, B, C, and D are as illustrated in fig. 2.

FIG. 2: Joints Illustrating Typical A, B, C, and D Conditions as Designated in Table 2

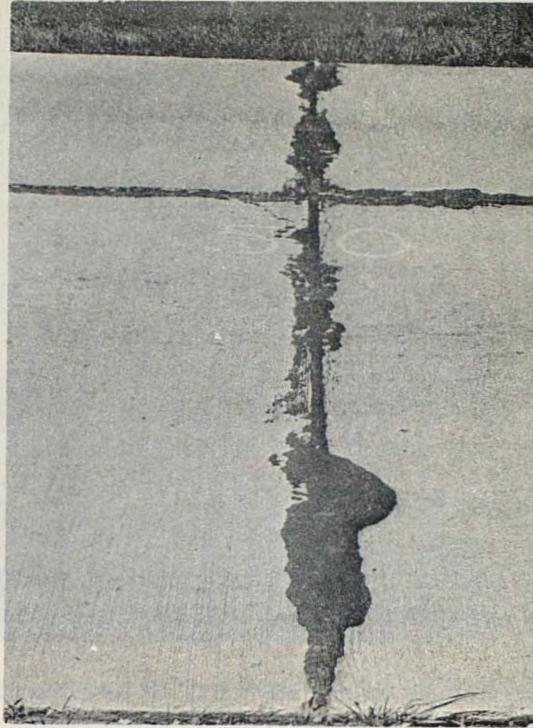
B - Fine crack or normal joint with slight spalling and minor corner breaking

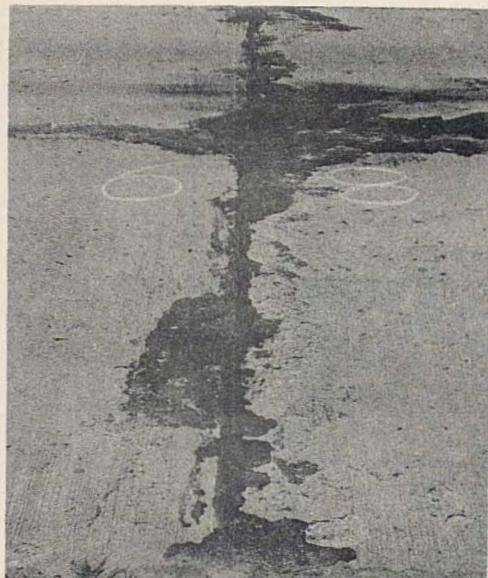
C - Enlarged crack or joint, showing considerable spalling and corner breaking

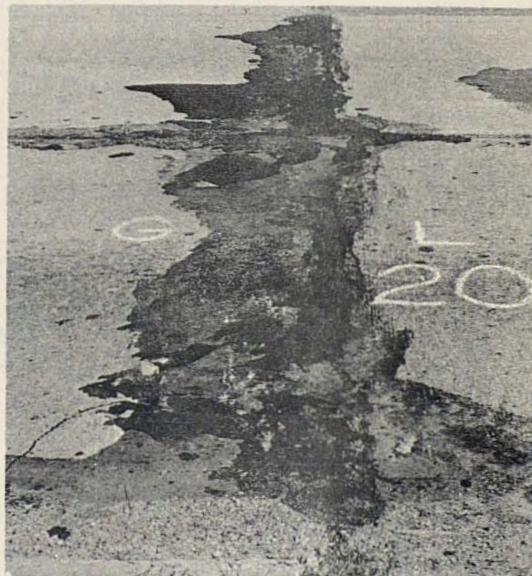
D - Greatly enlarged crack or joint, with excessive spalling and corner breaking

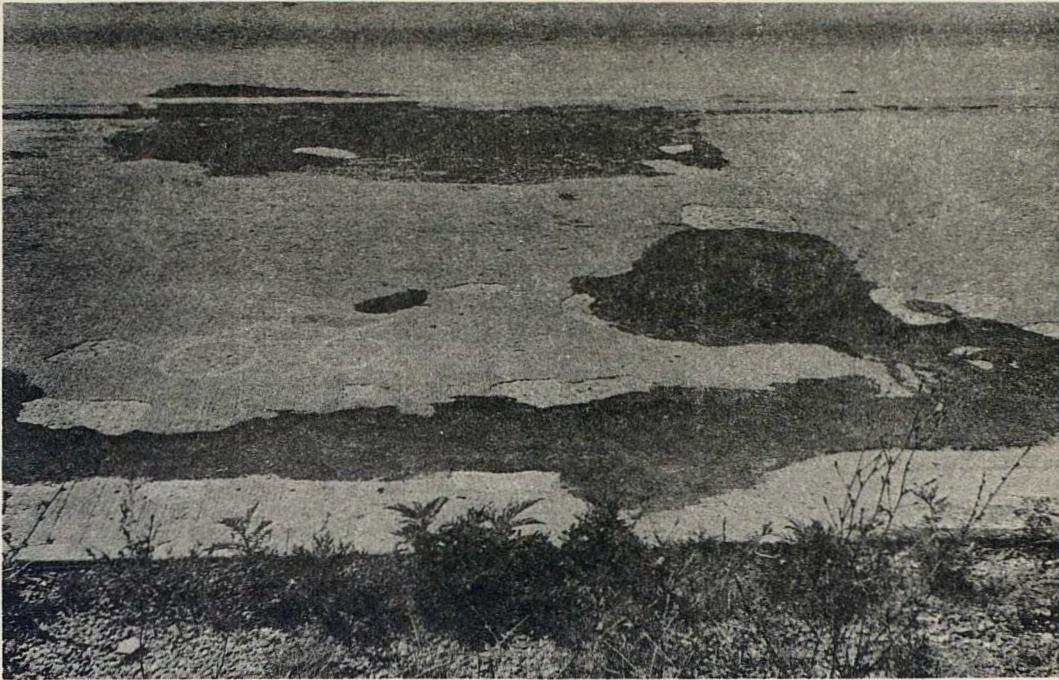
Total Cracks / Slab	0.64	0.57	0.27	0.097	0.22	0.94	0.61	0.81	0.88	0.97
Total Cracks and Joints / Mi.	144.13	140.00	113.35	92.02	110.32	249.21	243.49	311.26	313.85	346.32
Avg. Crack and Joint Spacing	36.63 ft.	37.71 ft.	46.58 ft.	57.38 ft.	47.86 ft.	21.19 ft.	21.68 ft.	16.96 ft.	16.82 ft.	15.25 ft.
Avg. Comp. Strengths of Cores, '57	4714 Psi.	4250 Psi.	4550 Psi.	4888 Psi.	6718 Psi.	7365 Psi.	6428 Psi.	5330 Psi.	6063 Psi.	6045 Psi.
Surface Spalling	None	None	0.76%	20.45%	22.55%	59.35%	1.24%	0.62%	None	None

**FIG. 3: Extensive Surface Spalling Encountered in Test Sections as Indicated in Table 3**

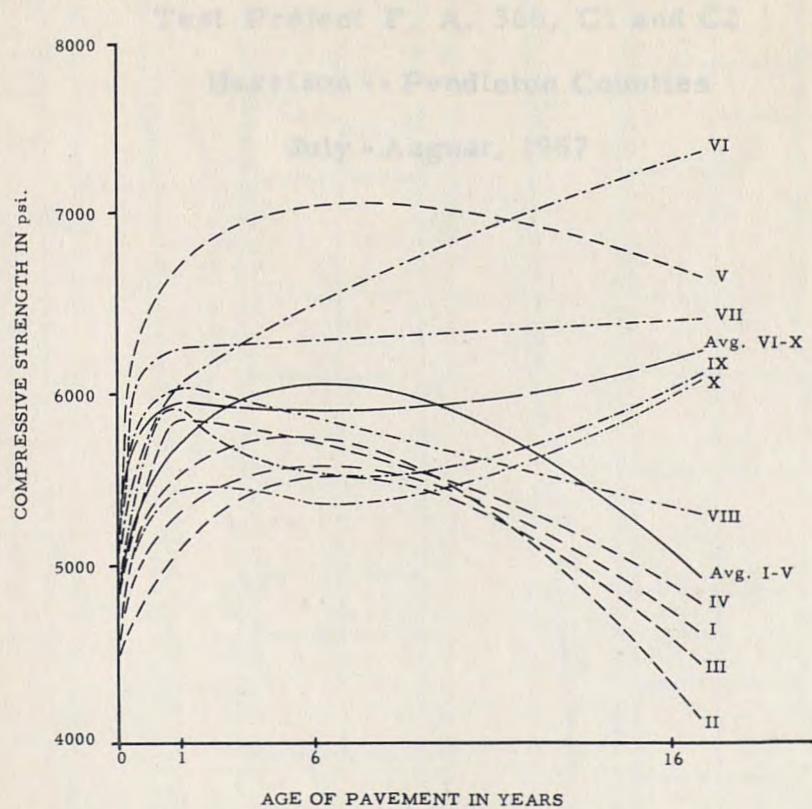
**FIG. 4: Variation in Compressive Strength with Age, by Sections. Data were obtained from tests on cores taken in 1942, 1947, and 1957. Sections I through V contain limestone coarse aggregate; VI through X contain river gravel coarse aggregate.**
