COMMONWEALTH OF KENTUCKY  
DEPARTMENT OF HIGHWAYS  
FRANKFORT

December 13, 1954

SUBJECT: Inspection of Full Depth Modified Dense-Graded Aggregate  
Base, Plant Mixed (Tennessee Project)

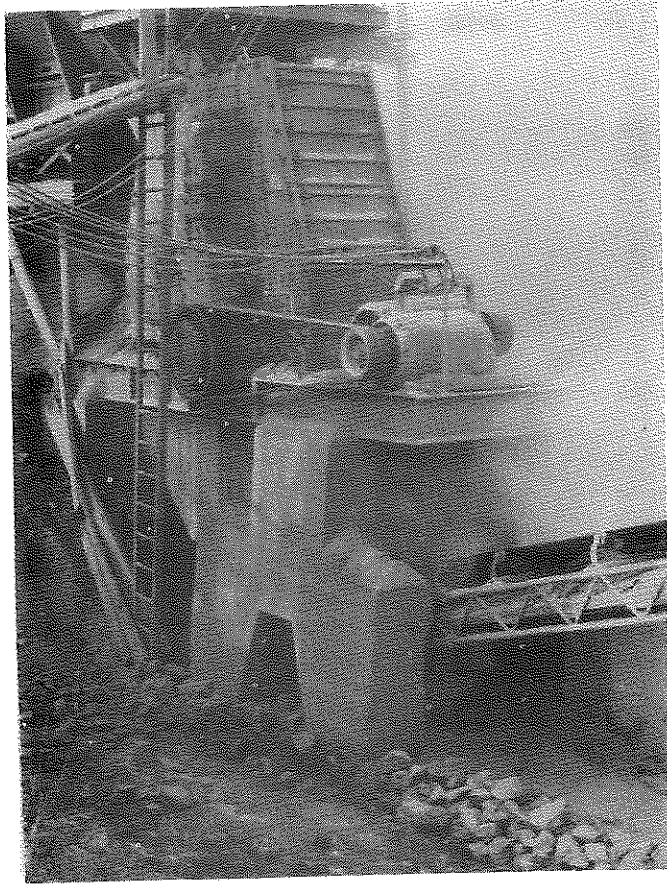
**Fig. 1 - Primary crusher in operation.**  
This unit produced 2000 to 2900 tons  
of stone per day through a 2-in. screen.  
Quarry trucks dumped material into a  
hopper (not shown) just above the crusher.

Limestone was quarried and then crushed through a 2-inch screen with a jaw-type crusher (See Fig. 1). The stone was separated into two bins at the No. 4 screen (See Fig. 2). Two hammer mills were available for controlling the grading in the fine bin. On the date of the inspection only one hammer mill was being used. Since the stone was wet, there was very little loss of fines in dust. All of the stone that was originally put through the jaw crusher was ultimately run through the pug mill and placed on the road.

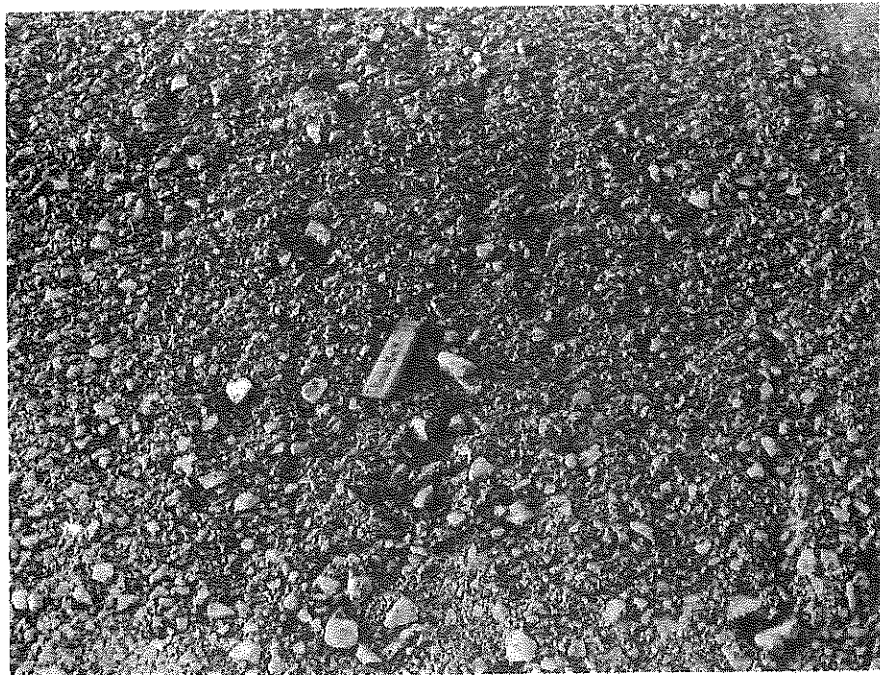
Of primary concern was the effect of the grader on the plus 1-inch stone. However, there was very little evidence that stone was being pulled from the mix by the blade (See Fig. 7). The texture of the completed base is shown in Fig. 8, and it can be seen that the larger stone particles prominent in Fig. 7 had satisfactorily "tied down" during the rolling operation.

**Fig. 7 - Close-up view of base prior to compaction and just after the patrol grader had passed. Note the small amount of segregated stone present.**

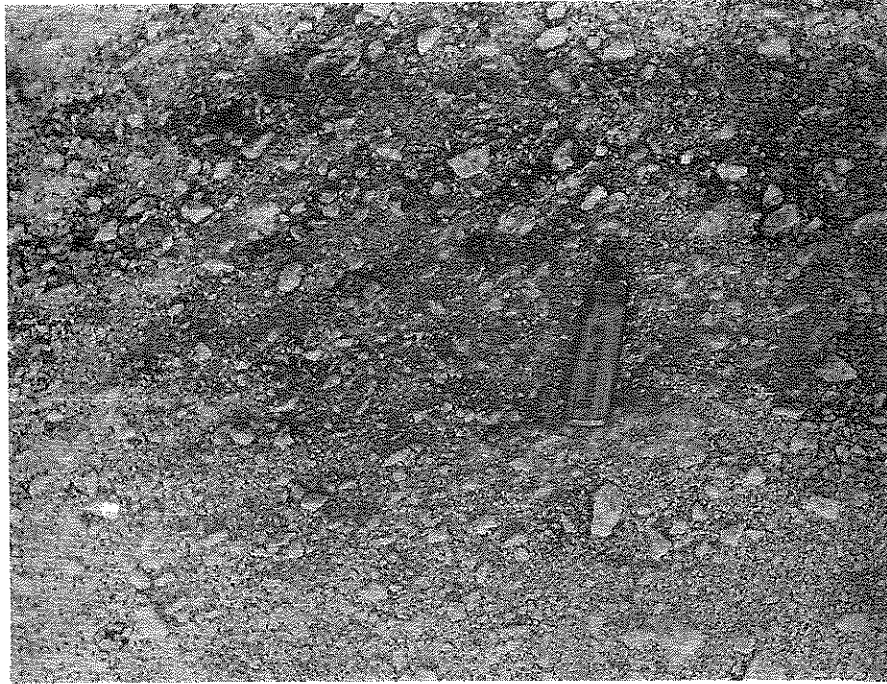
Fig. 8 - Near view of texture of finished base, which appeared firm and stable under the weight of construction equipment.
