A COMBINATION WATERBOUND MACADAM AND DENSE-
GRADED AGGREGATE BASE FOR FLEXIBLE PAVEMENTS

32nd Annual Highway Research Board Meeting

W. B. Drake
Research Engineer

January, 1953

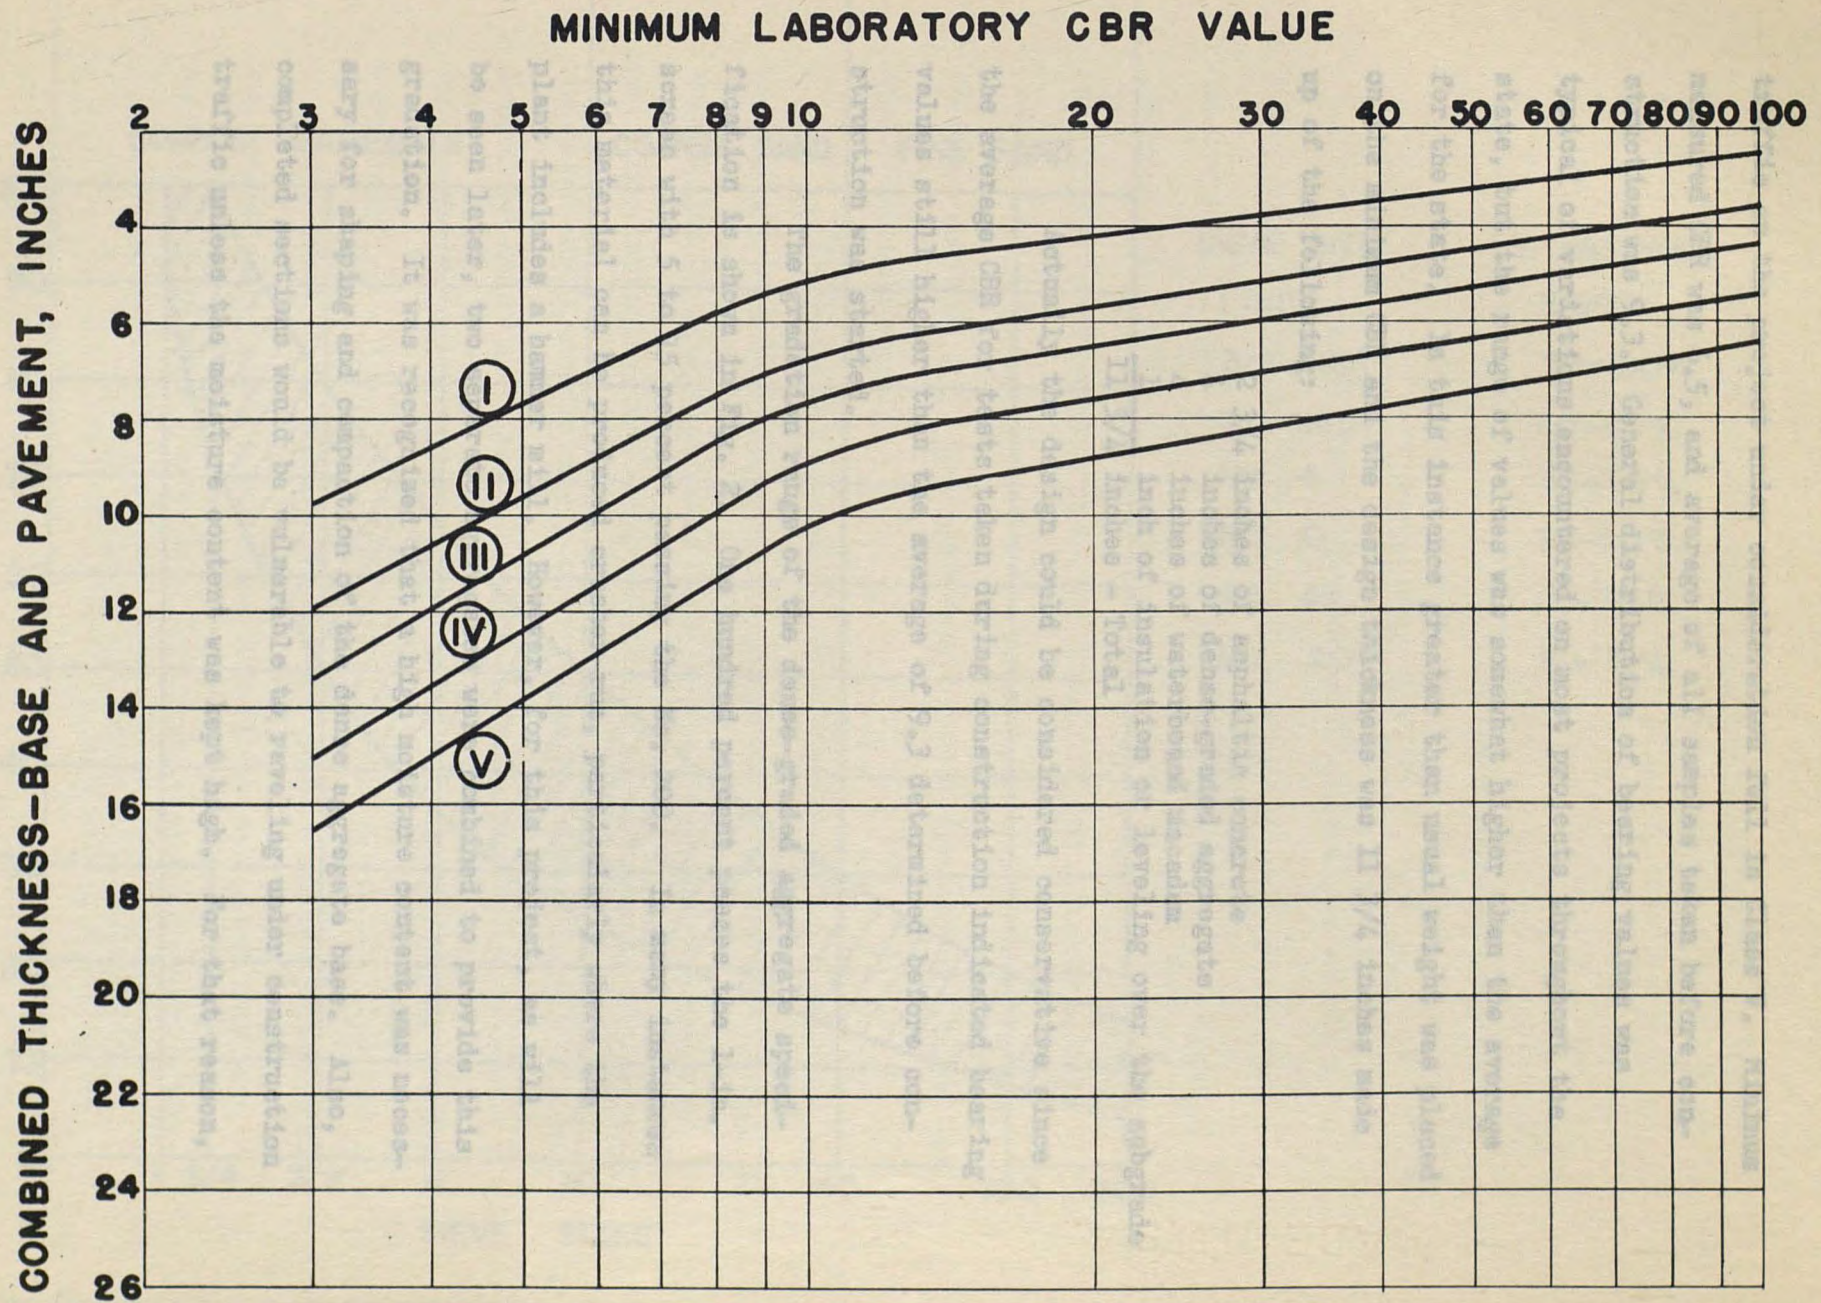
From the 1948 investigation of subgrade bearing values beneath pavements in service, the curves shown in Fig. 1 were developed. These are used for standard flexible pavement design by the Kentucky Department of Highways. The five curves represent five groupings of traffic in equivalent 5000-lb. wheel loads. Anticipated

Fig. 1. Flexible pavement design curves.

traffic on the project under consideration fell in Class V. Minimum measured CBR was 6.5, and average of all samples taken before construction was 9.3. General distribution of bearing values was typical of variations encountered on most projects throughout the state, but the range of values was somewhat higher than the average for the state. In this instance greater than usual weight was placed on the minimum CBR and the design thickness was 11 3/4 inches made up of the following:

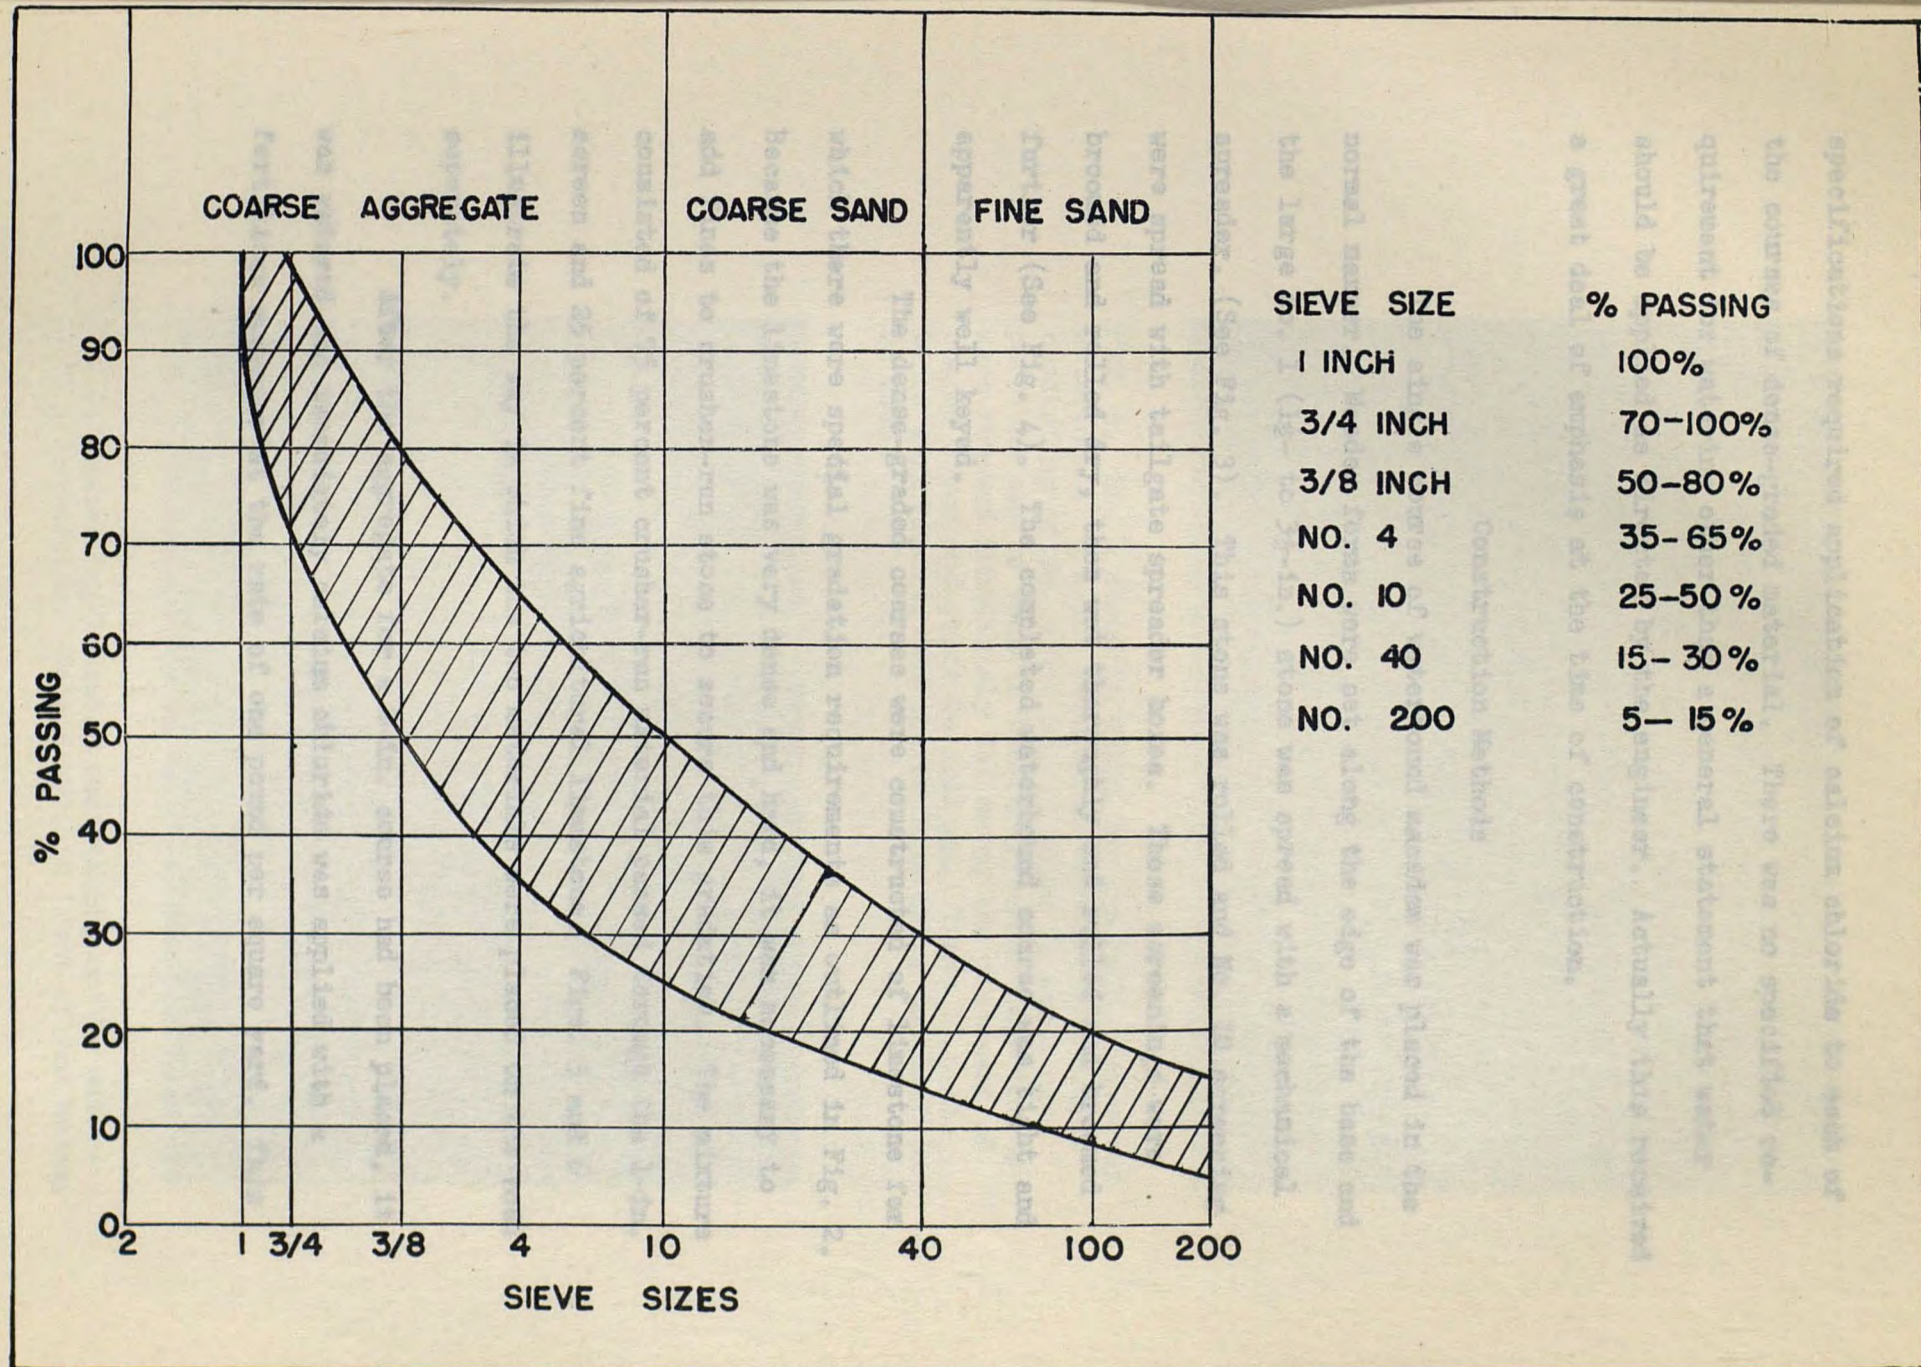
The gradation range of the dense-graded aggregate specification is shown in Fig. 2. One hundred percent passes the 1-in. screen with 5 to 15 percent passing the No. 200. In many instances this material can be produced crusher-run, particularly where the plant includes a hammer mill. However, for this project, as will be seen later, two separate aggregates were combined to provide this gradation. It was recognized that a high moisture content was necessary for shaping and compaction of the dense aggregate base. Also, completed sections would be vulnerable to raveling under construction traffic unless the moisture content was kept high. For that reason,

Fig. 2. Aggregate gradation range for dense-graded base courses.

The dense-graded courses were constructed of limestone for which there were special gradation requirements as outlined in Fig. 2. Because the limestone was very dense and hard, it was necessary to add fines to crusher-run stone to secure this gradation. The mixture consisted of 75 percent crusher-run material passed through the 1-in. screen and 25 percent fine agricultural limestone. Figs. 5 and 6 illustrate the way in which the two materials were placed on the road separately.

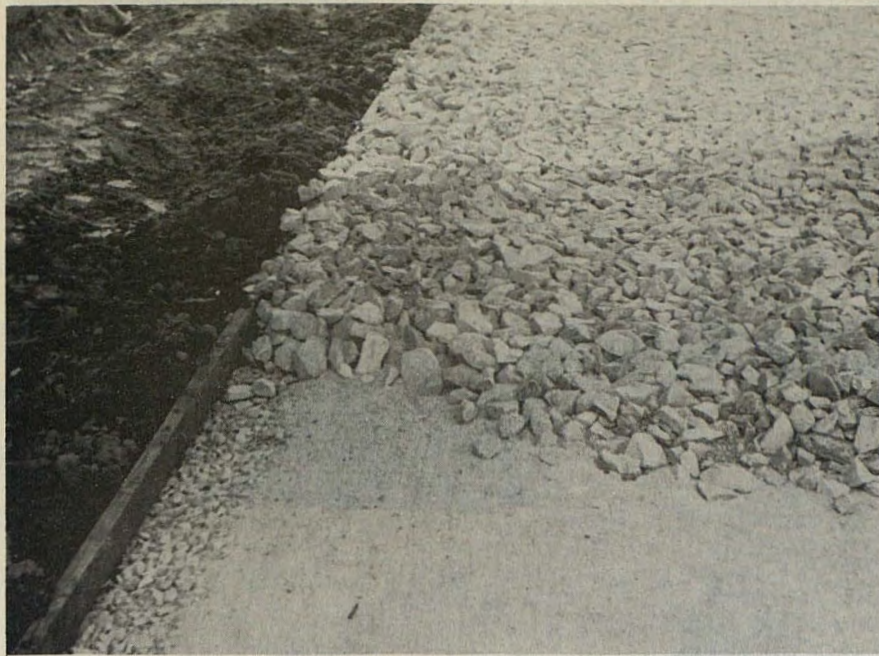
Fig. 3. No. 1 stone in place for the 4-in. course of waterbound. A 1-in. insulation and leveling course consisting of No. 5 and No. 10 stone in equal proportions can be seen in the foreground. Edge boards were removed immediately following the placement of coarse stone and prior to rolling. Three 10.5-ft. lanes were placed, the center lane being the last to go down.

The single course of waterbound macadam was placed in the normal manner. Wooden forms were set along the edge of the base and the large No. 1 ($1\frac{1}{2}$ - to $3\frac{1}{2}$ -in.) stone was spread with a mechanical spreader. (See Fig. 3). This stone was rolled and No. 10 screenings were spread with tailgate spreader boxes. These screenings were broomed and rolled dry, then wet thoroughly and rolled and broomed further (See Fig. 4). The completed waterbound course was tight and apparently well keyed.

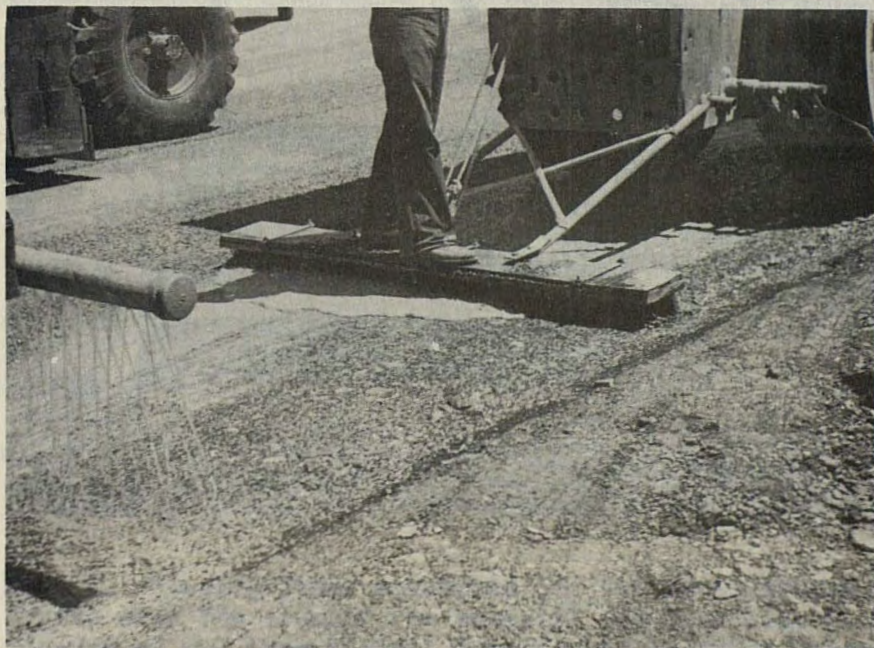
Fig. 4. Watering, brooming and rolling on the water-bound construction. Note slurry in front of the broom.

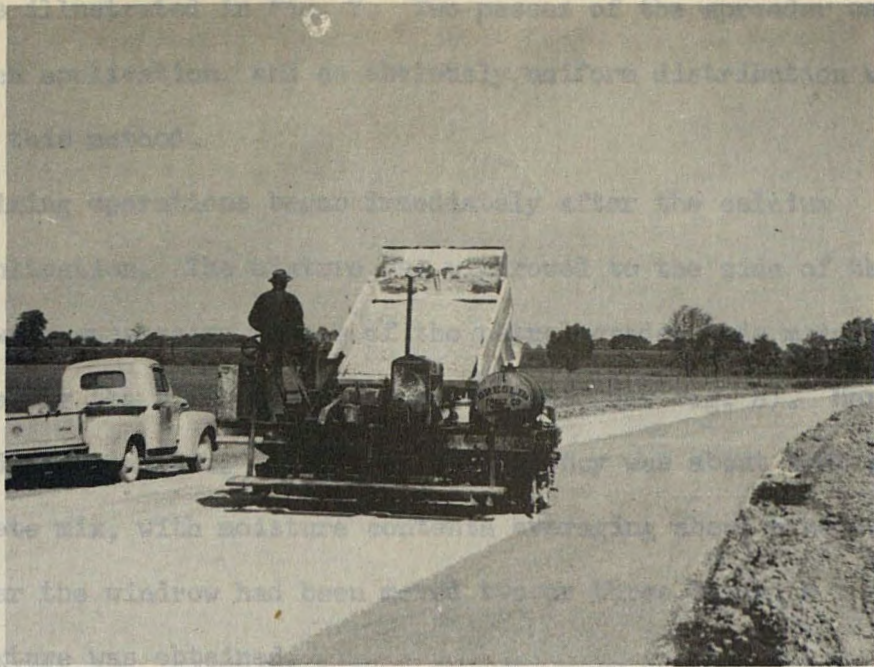
Fig. 5. Spreading the coarser of two aggregates used for the dense-graded base course construction. This stone was crusher run through a 1-in. screen with approximately three percent passing the No. 200 screen.

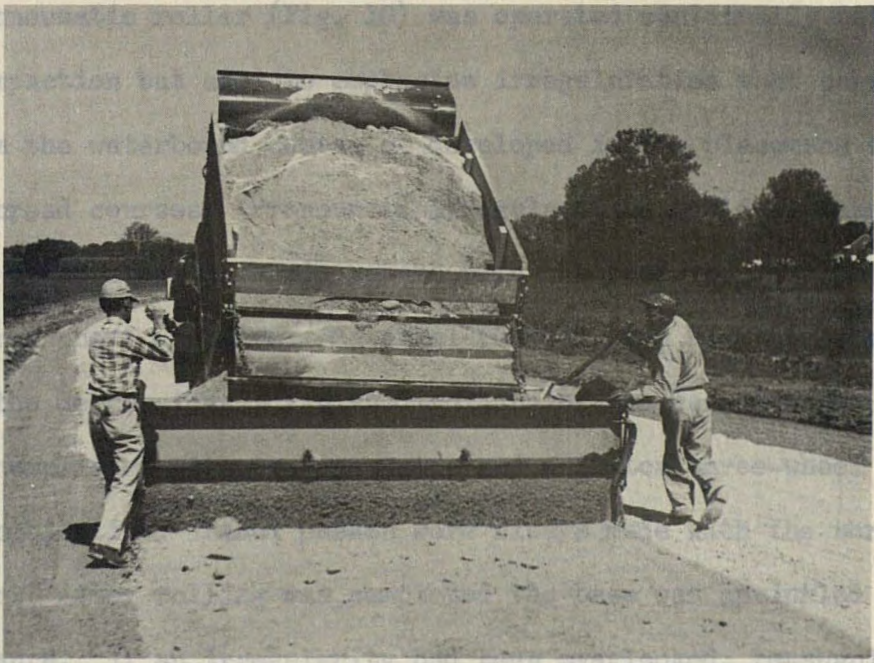
Fig. 6. Placing finer aggregate for the dense-graded course over the crusher run material shown in Fig. 5. Because of the insufficient quantity of material finer than the No. 200 mesh in the first stone placed, it was necessary to add fines which are normally sold for agricultural lime from this quarry. This fine fraction represented 25 percent of the total aggregate.

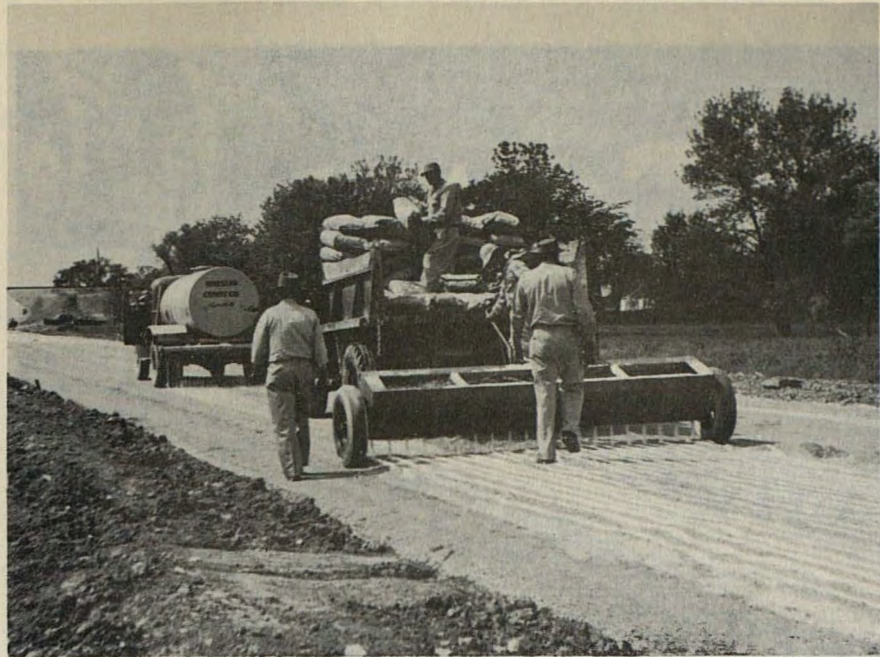
Fig. 7. Water was applied to thoroughly wet the stone prior to application of calcium chloride. This was done to assure an adequate moisture content and prevent segregation as well as facilitate manipulation during the mixing process that followed.

operation is illustrated in Fig. 7. Two passes of the spreader were made for each application, and an obviously uniform distribution was obtained by this method.

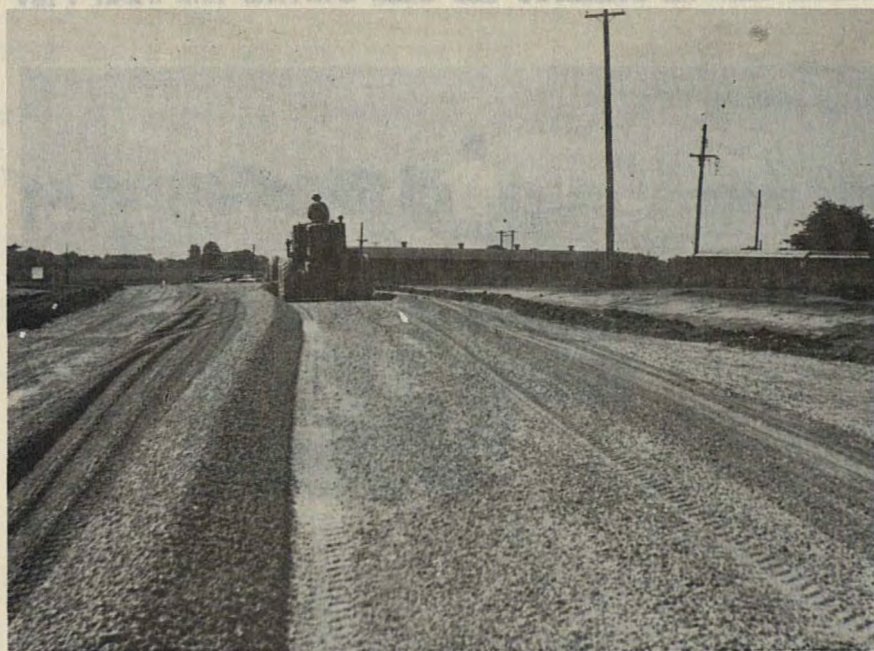
Fig. 8. Mixing the stone, calcium chloride, and water with a patrol grader. The mixture was windrowed, then portions of the windrow were rolled along the blade across the road. Thorough mixing was accomplished after several passes with the patrol graders.

Mixing operations began immediately after the calcium chloride application. The mixture was windrowed to the side of the road, then with successive passes of the patrol grader this material was rolled along the blade to the opposite lane (See Fig. 8). More water was added as needed. The final consistency was about that of a dry concrete mix, with moisture contents averaging about 8 percent. Usually after the windrow had been moved two or three times, a thorough mixture was obtained.

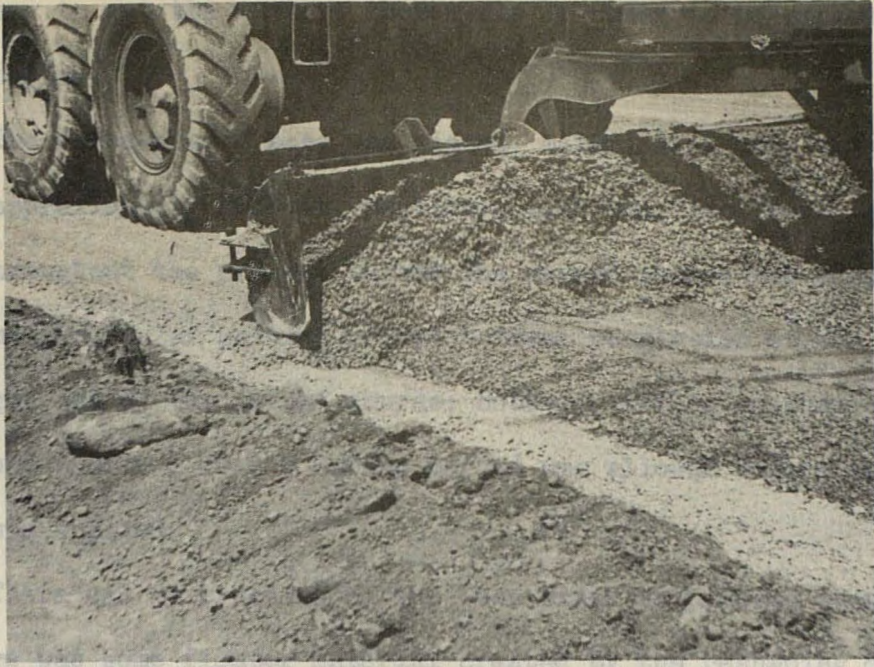
Fig. 9. Placing the edge of the dense-graded base with an edge board that was attached to the blade for the last few passes in the layingout process. This attachment could be easily removed or replaced. A very neat and uniform edge was obtained in this manner.

Material was then brought to the center of the road and laid out. Edges were kept straight by using an edger attached to the mold board of the blade as shown in Fig. 9. During the laying out process, a pneumatic roller (Fig. 10) was operated continually not only for compaction but also to emphasize irregularities that carried through from the waterbound course or developed in the placement of the blade-spread courses. Pronounced irregularities could be taken out readily by turning the blade square with the road and "square blading" for a short distance. Material removed from high spots was carried to the depressions. Finished-rolling of the dense-graded base was accomplished with the pneumatic and a 10-ton three-wheel roller in combination. Final passes were always made with the three-wheel roller. After rolling was completed the base was sprinkled and allowed to cure. If an irregularity had been overlooked, re-shaping

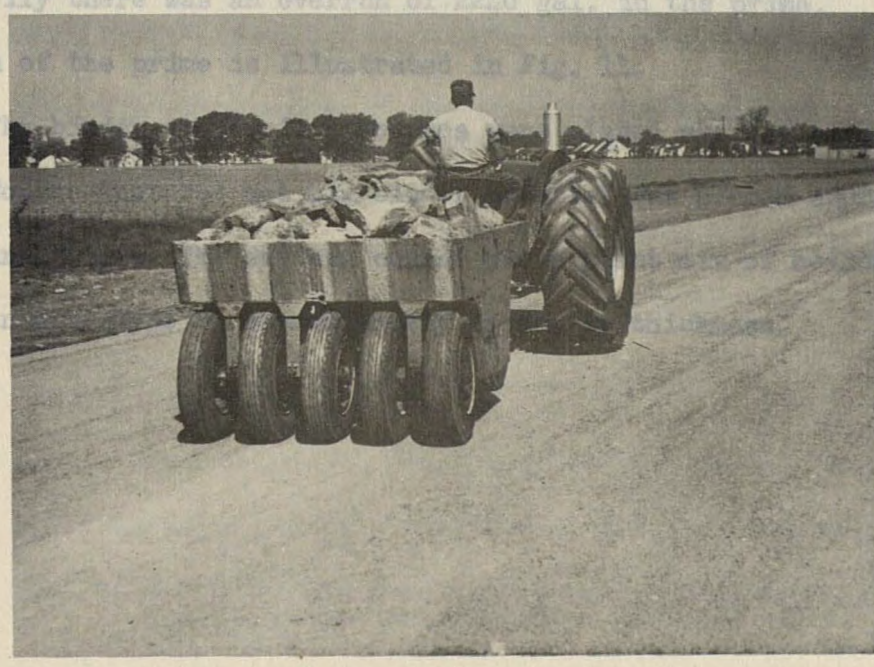
Fig. 10. Pneumatic Rolling. This operation was begun during the final shaping of the blade-spread base.

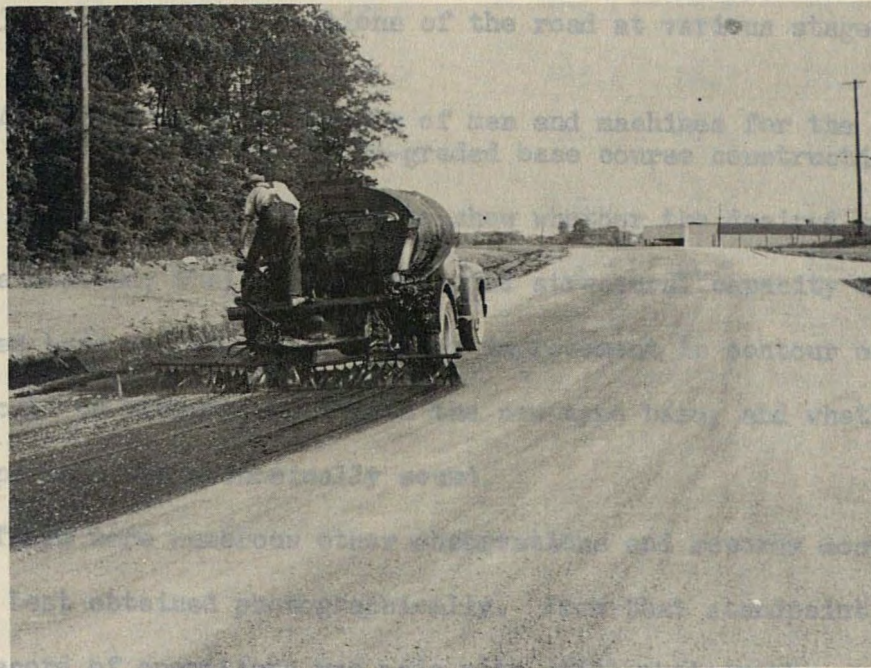
Fig. 11. Appearance of the finished dense-graded base at the time priming for the bituminous pavement was started.

There was no brooming of the base prior to priming even though there was some floater material created by the reshaping operations in a few places and by passing traffic which used the road during the waiting period. One section about 1500 ft. in length had an unusual amount of floater, and in order to tack down that material satisfactorily there was an overrun of 2240 gal. in the prime. Application of the prime is illustrated in Fig. 11.

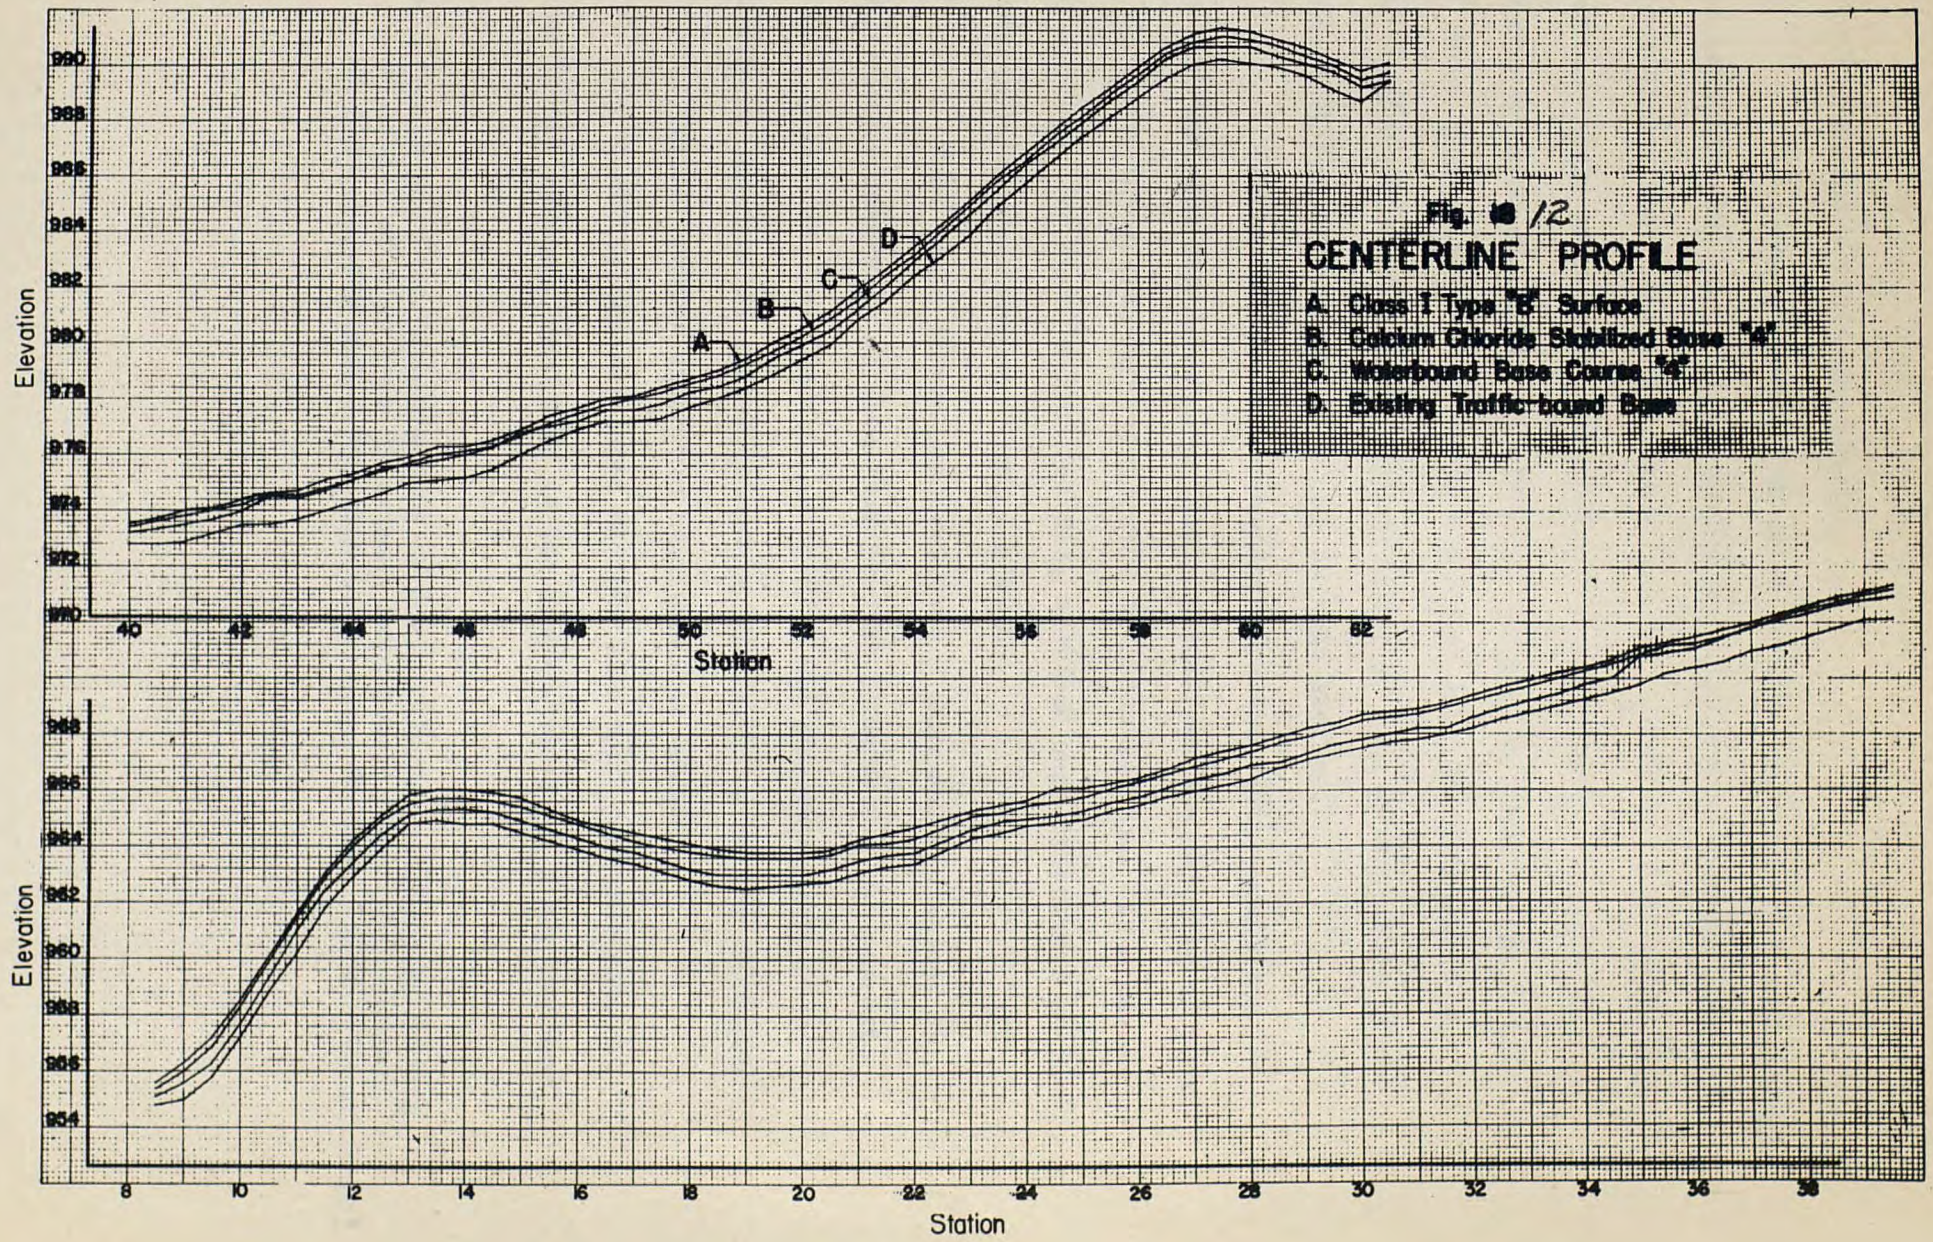
The center line profiles which were read to the nearest 0.1 ft. represented the top of the existing traffic bound prior to the beginning of pavement construction, and the elevations after completion of the waterbound course, the second dense-graded course, the bituminous binder course, and the bituminous surface course. A plot of four of these five sets of elevations is shown in Fig. 12. Those for the bituminous binder course were omitted in the interest of clarity.

Indications are that the blade-spread base did remove some pronounced irregularities of the waterbound and traffic-bound courses. However, the plots of Fig. 12 convey the impression that considerable irregularity remained after the blade-spread operations and even after

From the standpoint of actual riding qualities it is difficult to establish the significance of these slight irregularities when it is realized that they carry over a distance of 50 ft. Pavements with outstandingly poor riding qualities often have abrupt changes in elevation over distances that are hardly greater than the length of a car. Irregularities at longer intervals can give an undulating or "roller coaster" effect. The profiles of Fig. 12 show that there are no irregularities of that type in this surface.

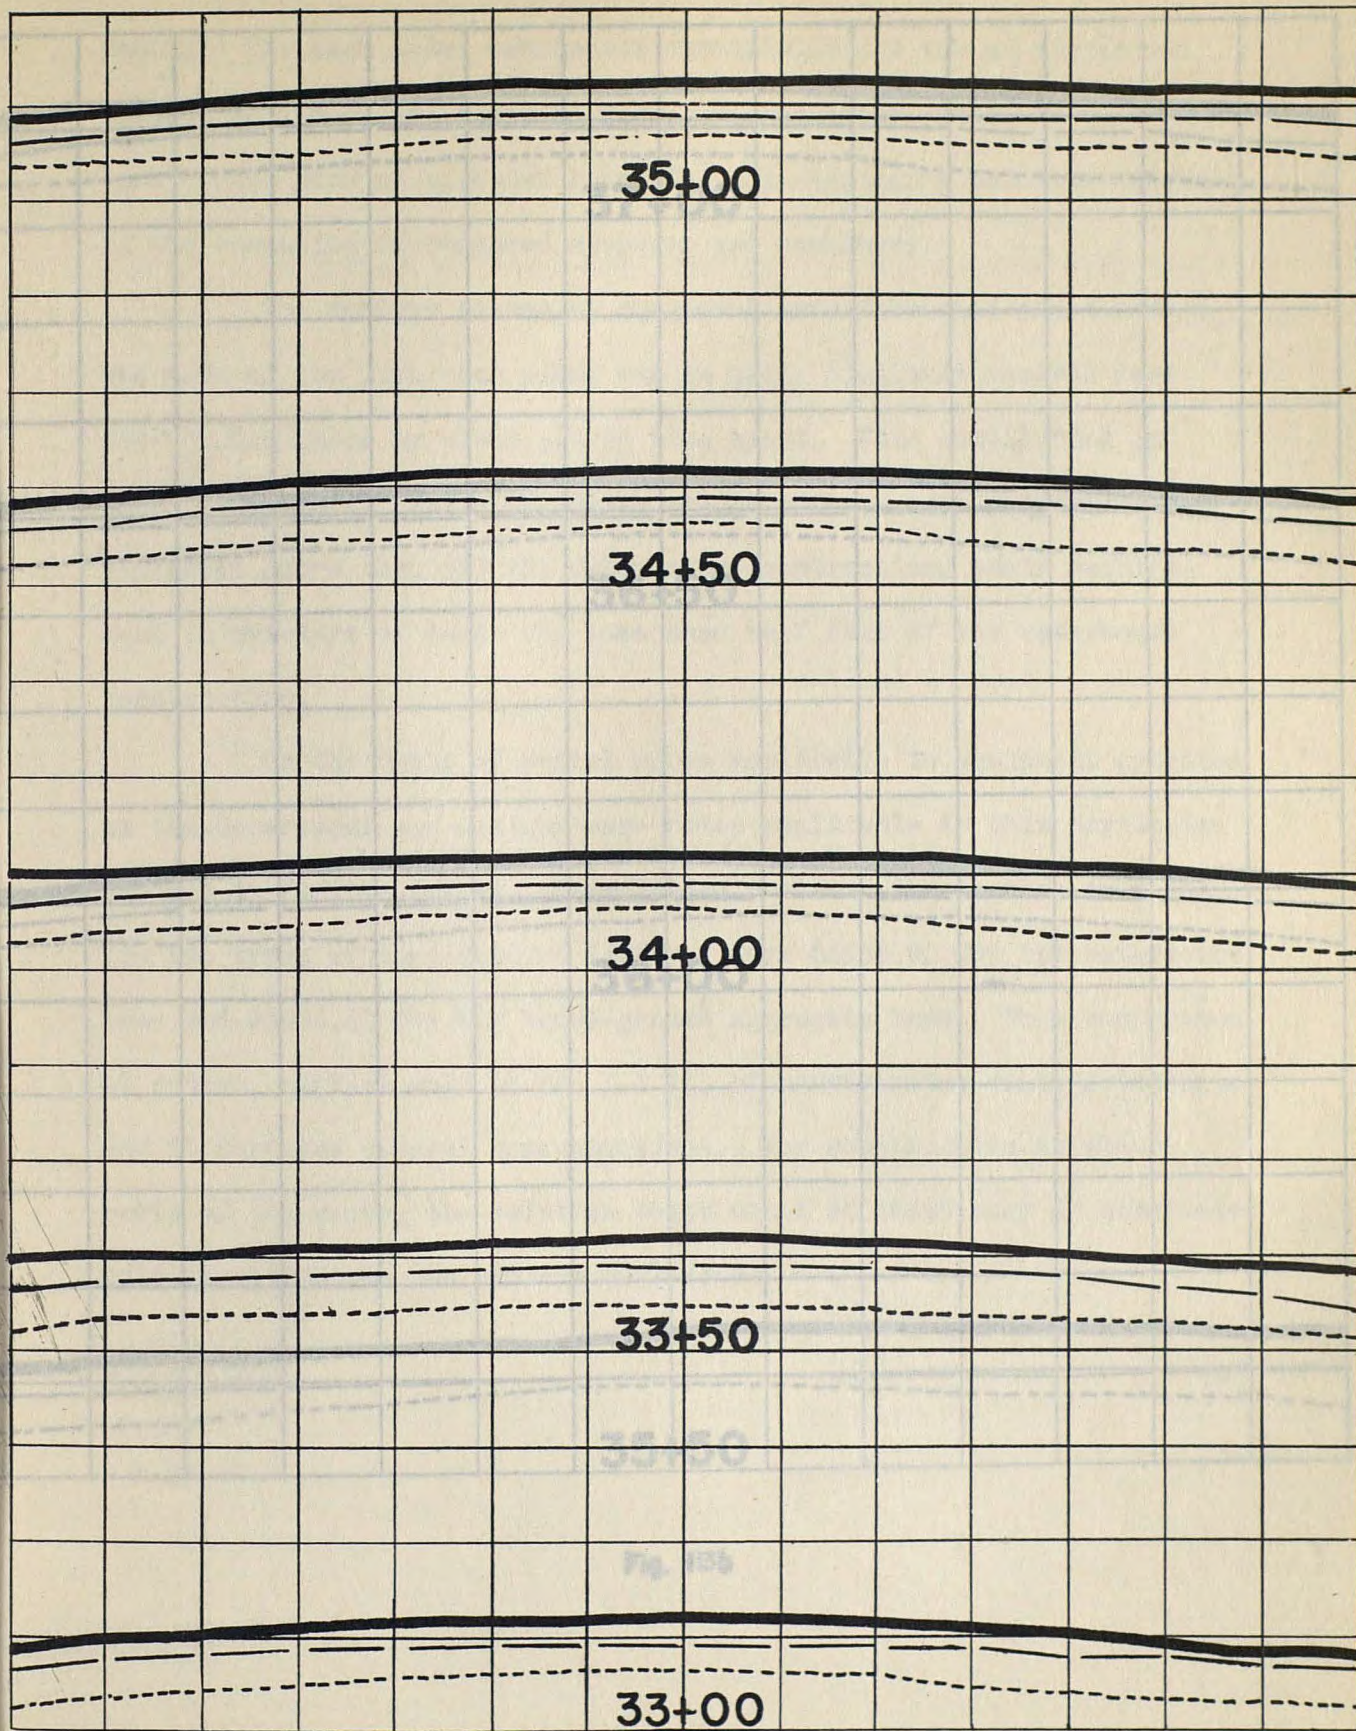
Measurements to the nearest $1/8$ inch were made on the top of the waterbound course, the top of the second dense-graded course, and the finished pavement surface. Plots of the sections are contained in Fig. 13.

Fig. 13. Cross sections taken over waterbound base course, dense-graded aggregate base course, and bituminous surface. Pavement width was 30-ft.; dense-graded base design was 4-in.; bituminous binder and surface thickness was 2 3/4-in.

Invariably the blade-spread courses had a contour which was much more uniform than the contour of the waterbound course, and almost invariably the newly formed surface more nearly approached the theoretical design section that the finished pavement was supposed to meet. In one or two instances there was very little crown in the dense-graded courses.

Generally speaking, two passes of the paver laying the bituminous courses did not improve the sections. At Stations 35+50, and 36+50, the sections of the finished pavement were decidedly poorer than the corresponding sections of the blade-spread base. It appears that settings of the paver screed were unnecessarily altered at these locations, particularly on operations in the center lane. Despite this and other influences, the few measured sections indicate that with the blade spread courses in place the paver had a better surface on which to operate than it would have had with the waterbound course alone.

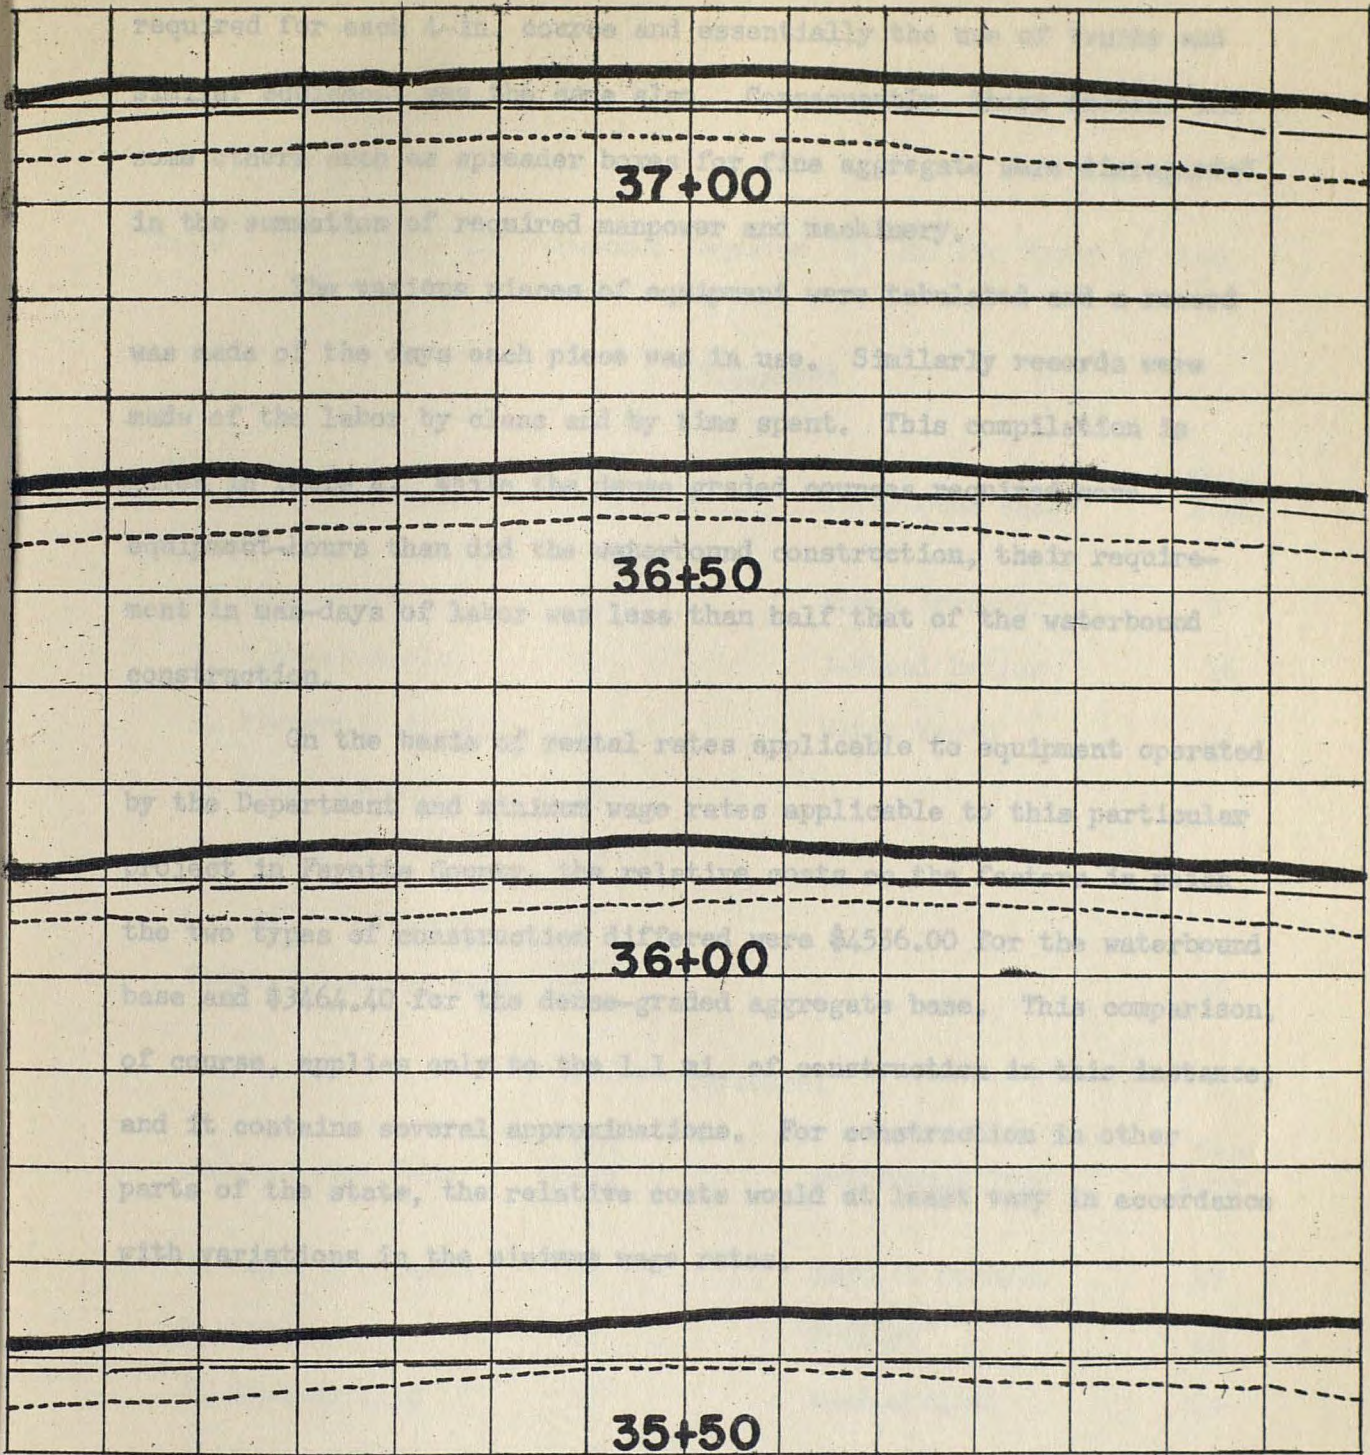
Fig. 13b

Fig. 13. Cross sections taken over waterbound base course, dense-graded aggregate base course, and bituminous surface. Pavement with the 10-ft. dense-graded base design was 4-in. bituminous binder and surface thickness was 2 1/2-in.
