REPORT NO. 1

AN INVESTIGATION OF LEAN CONCRETE MIXES AS BASE

COURSES FOR BITUMINOUS SURFACES

S. T. Collier Senior Research Engineer

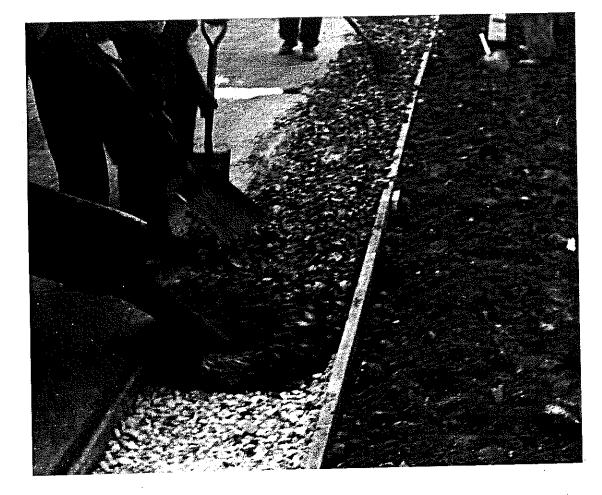
Fig. 2. Placing the lean concrete mix in the widening strip. Note the wooden forms, and the 2-inch stone insulation course beneath the pavement grade. Concrete for both the widening strips and the revisions was delivered by transit mixers from Mt. Sterling. A handdrawn vibrating screed was used to strike off the surface in the widening strips.

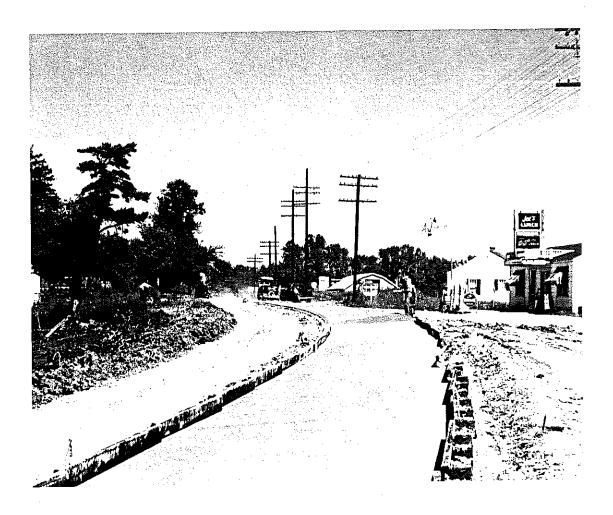
Fig. 3. Full-width revisions were placed in single lanes. This view shows one finished lane in the revision between Sta. 148/50 and Sta. 155/07. In the middle distance membrane curing compound is being placed on concrete that was finished a short time before. A vibrating screed operating lane-width across forms was used for striking off the concrete, after which the surface was finished by hand. At this particular location, and generally throughout the job on both revisions and widening strips, the hand finishing was carried much farther than necessary on a surface to be covered with a bituminous mix. per cubic yard of concrete. Field reports indicated that average mixing water was approximately 8.5 gallons per sack - an underrun of some 30 pounds.

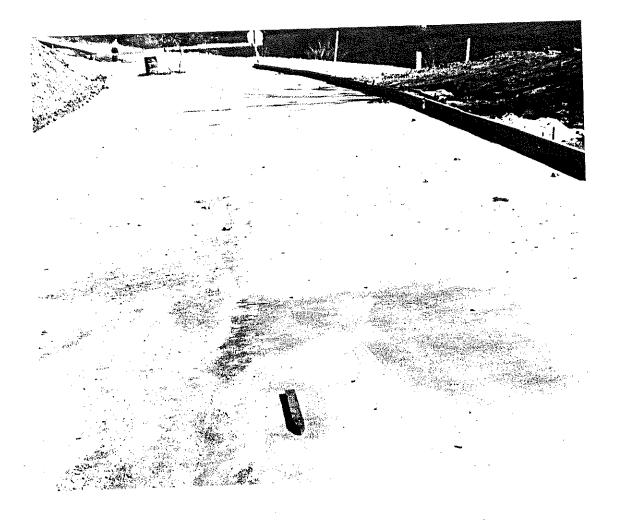
Fig. 6. Finished concrete base on the full-width revision between Sta. 113/77 and Sta. 124/11, about three weeks after placement. At that time only two cracks had developed throughout the 1000-foot section.

Only two cracks were found in the first revision, (Sta. 113+77 to Sta. 124+11.4) and they were in the two end sections that were constructed at an early date to facilitate reopening the road to traffic. The construction of the base in the intermediate portion of this revision (Sta. 115+98 to Sta. 122+50) was delayed awaiting the completion of the grade, and was not open to traffic at the time of the crack survey.
