Final Report

EVALUATION OF PLANT MIX SURFACE TREATMENTS

ROAD TEST SECTIONS

(U.S. 60, Versailles-Frankfort Road)

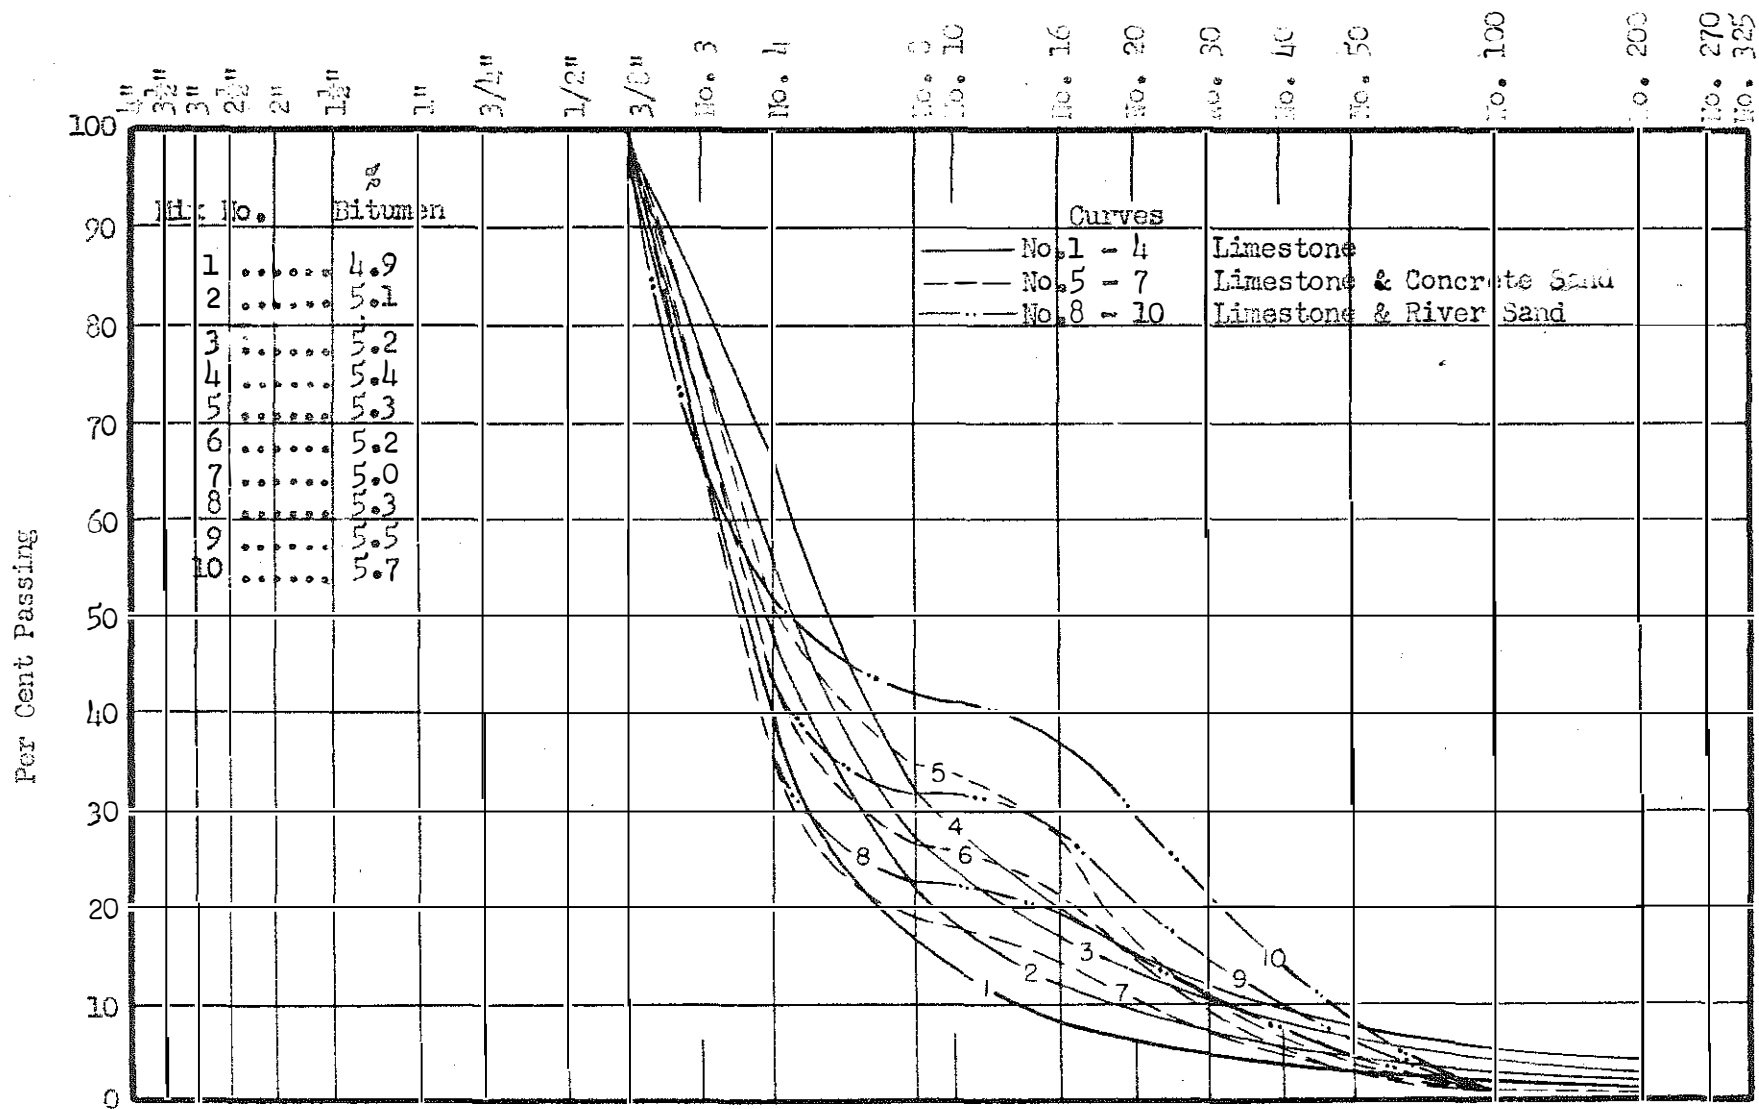
FIG. 2

There were three aggregates or aggregate combinations as follows: Limestone, Limestone and Concrete Sand, and Limestone and River Sand. The Limestone type consisted of four gradations made from mixing No. 9 and a fine stone designated as No. 11F. The Limestone and Concrete Sand type consisted of three gradations of No. 9 stone and the coarse sand. The Limestone and River Sand type consisted of three combinations of River Sand and No. 9 stone. These ten gradations are outlined in Table 1 and shown on the gradation chart in Fig. 2.

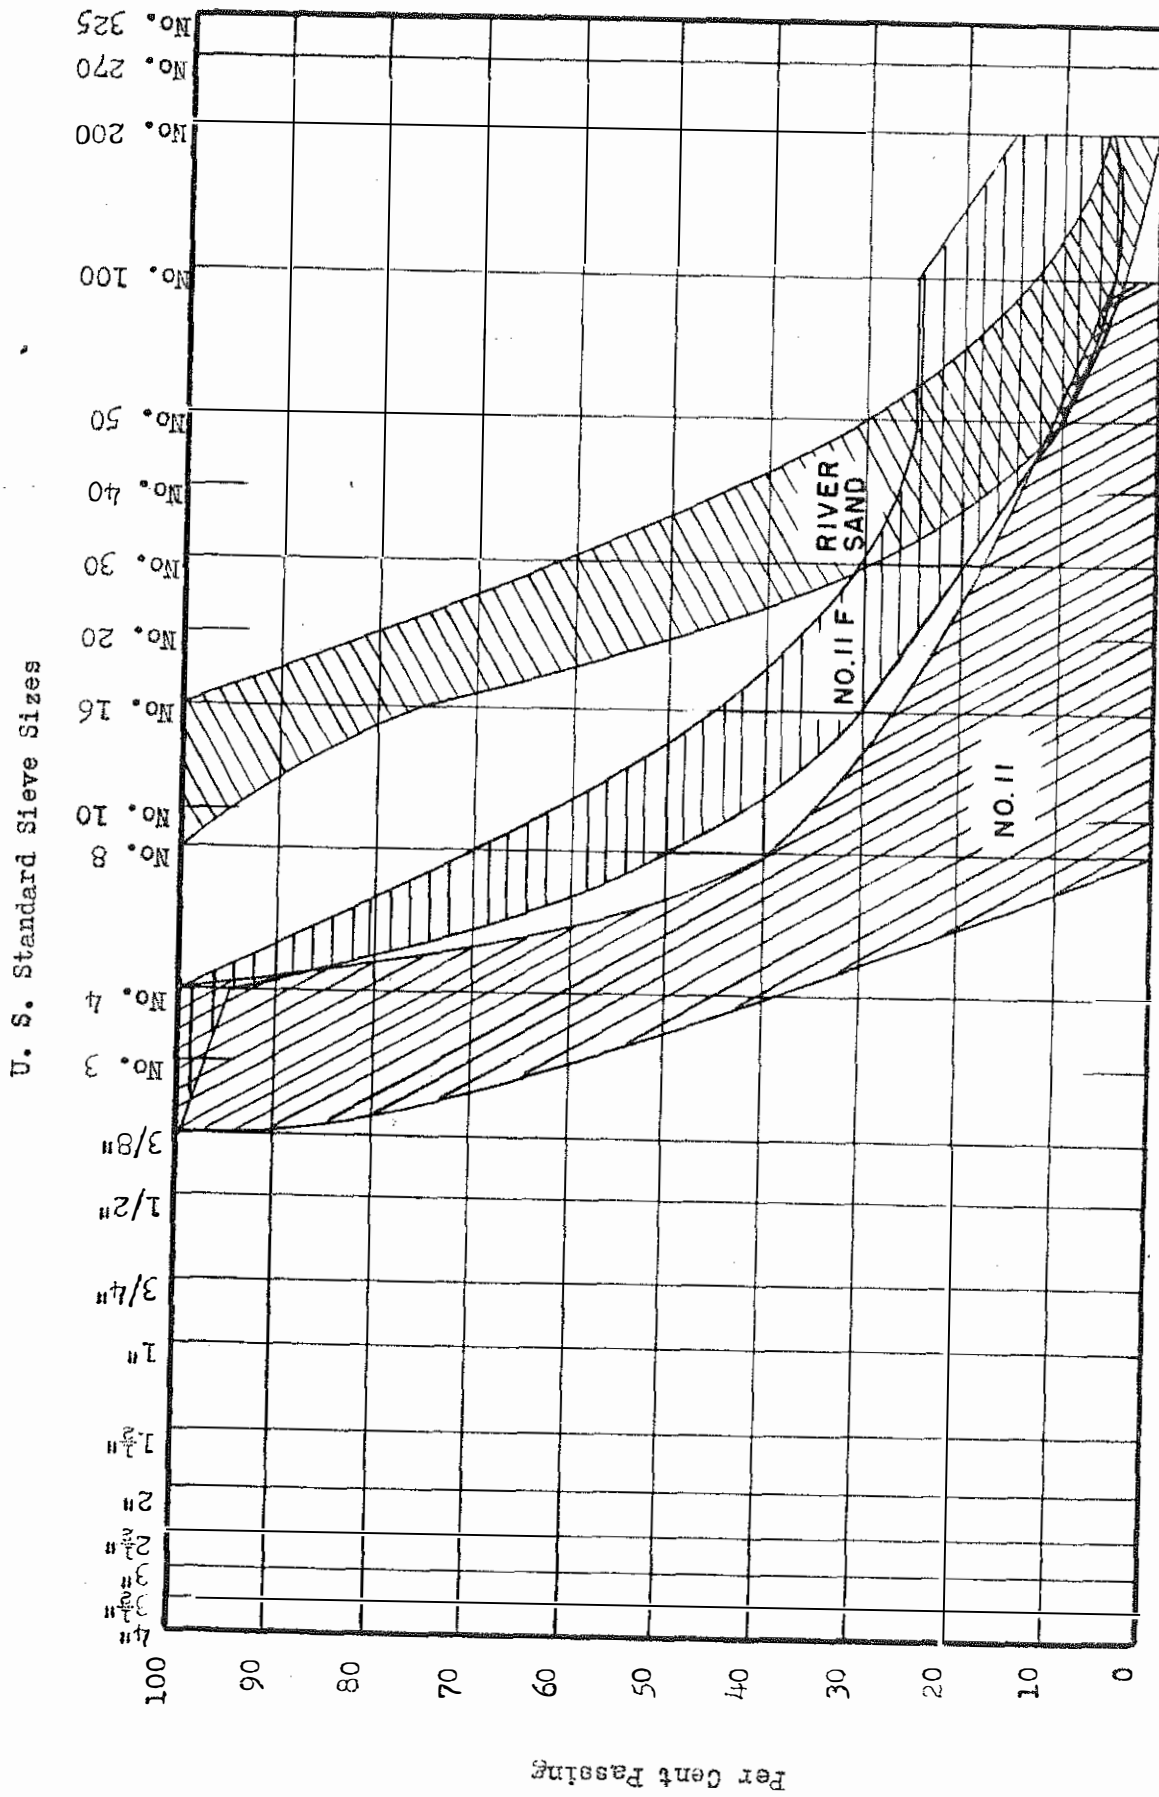
Fig. 3  
Gradation Range of Fine Aggregates

The gradation range for the 11F stone used in gradings G-1 to G-4 is in Table 1A. This was a much finer stone than the present No. 11 outlined in the same table. A plot of these gradation ranges along with one representing the Kentucky River Sand is presented in Fig. 3.

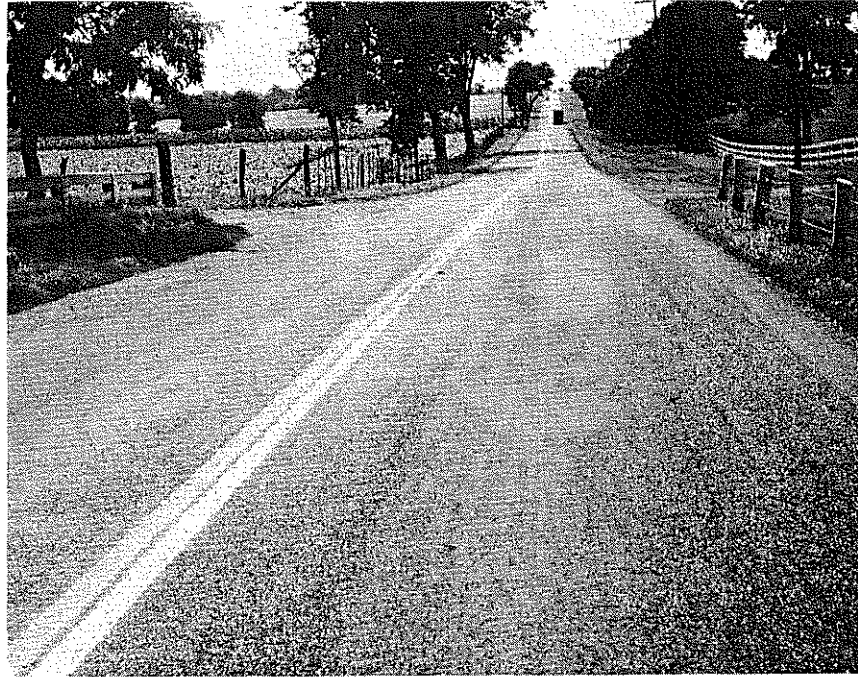
RT-12. The condition illustrated in Fig. 4 was representative of the tar (RT-12) sections in 1947. This particular location was in Section 27 which contained 50 percent No. 9 and 50 percent 11F. This aggregate combination was one of the best from the standpoint of performance throughout the project. The tar sections were subject to extreme pitting as early as 1946. There was much evidence of the tar being dry, brittle and dead

Fig. 4. Section 27, constructed in 1943, with RT-12. The aggregate for this section was 50% No. 9 and 50% 11F Limestone. This is Gradation No. 4 in Table 1 and Fig. 2. Rating in 1946 was Fair. Rating in 1947 was: Left Lane extremely poor, Right Lane poor. Note the extreme pitting of the surface. The tar had become very brittle resulting in loss of much of the aggregate. This is about an average condition for the RT-12 sections in 1947.

with consequent surface raveling and aggregate loss. This group of sections had been in service five years when they were resurfaced in 1948.

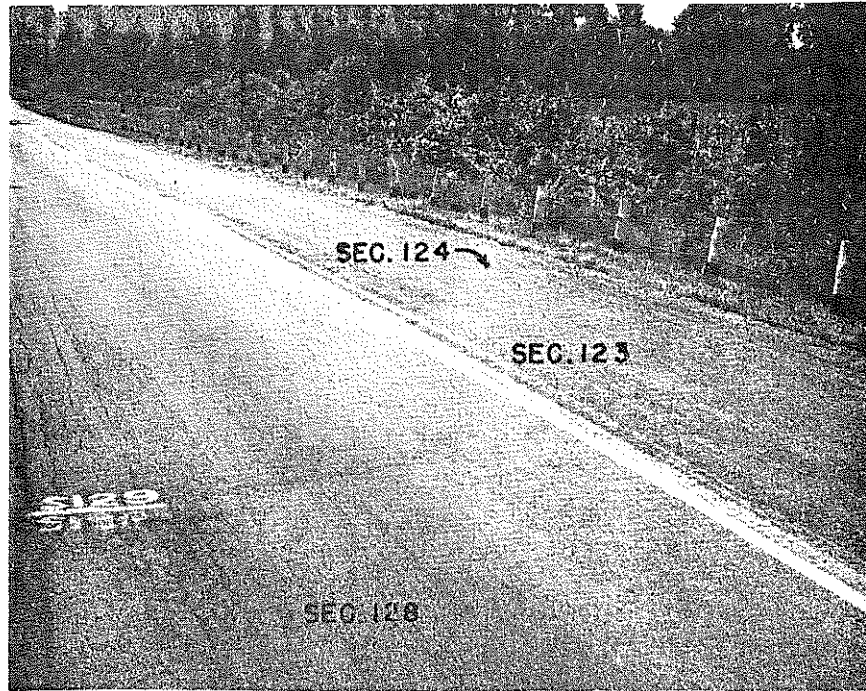
MC-5. The twenty MC-5 sections, all of which were laid in 1942, were almost six years old when covered in 1948. Fig. 5 is a photograph of the junction of four of these sections. The outstanding one of the four shown is 129 which contains 50 percent 11F. Another view of this section is Fig. 6, right lane. Many of the MC-5 sections were rated extremely poor in 1946.

Fig. 5. Junction of four sections containing MC-5, as they appeared in July, 1947, or five years after paving.

Sec.	128	123	124	129
Agg.	20% C.S.	20% R.S.	20% 11F	50% 11F
Ratings				
1946	Fair	Fair	Good	Good
1947	Fair	Poor	Poor	Good

The only photographic illustration of a mix with this grading is Fig. 5, which shows Section 128 (20 percent C.S. with MC-5). The performance rating was fair for both the 1946 and the 1947 inspections. All the records pertaining to this grading are in Table 15.

Section 123, one of the four illustrated in Fig. 5, had gradation 8 with MC-5. Performance was fair to poor.

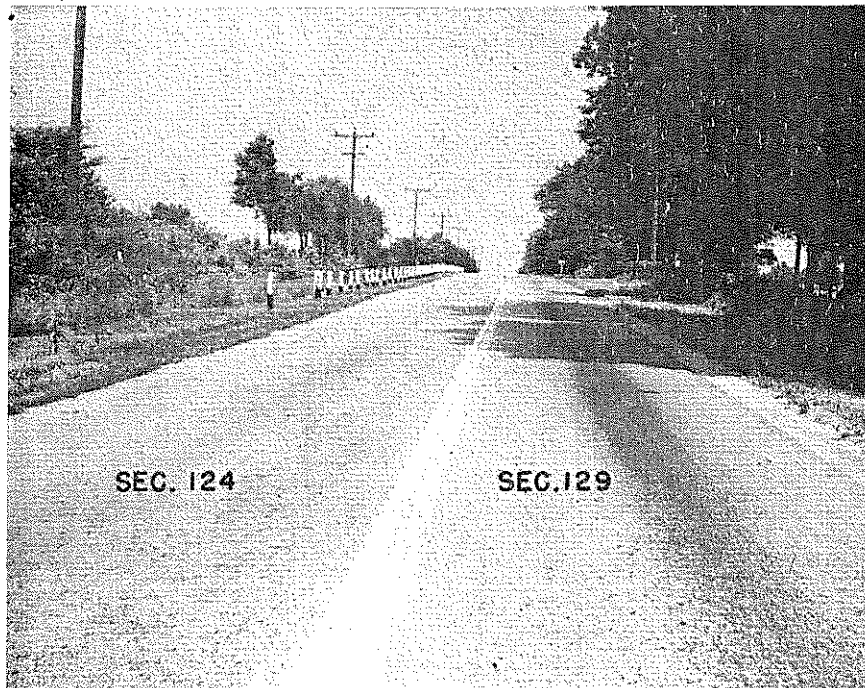
Fig. 6. View of another portion of Sections 124 and 129 referred to in Fig. 5. Section 124 is on the left and Section 129 on the right. These photographs show the difference in performance that can exist throughout the same sections in any one year and demonstrates the generalities inherent in any visual rating.

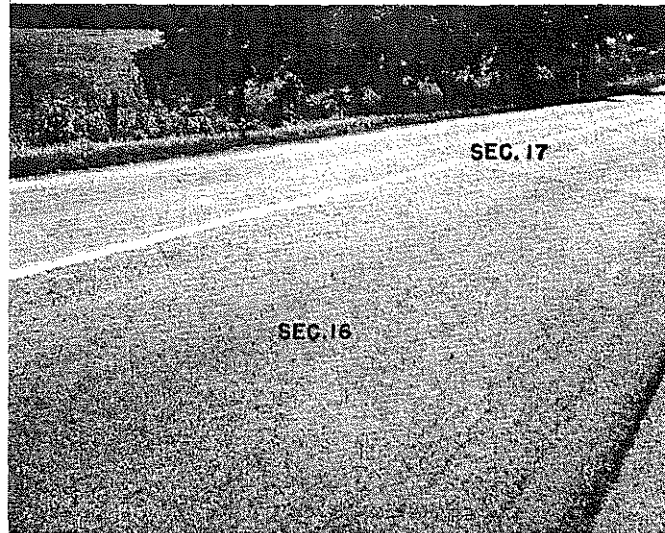
RC-5. The RC-5 sections were generally fair in 1946, but in 1947 were poor. Fig. 7 is a representative photograph of two sections of RC-5 mix. Section 17 contained 50 percent 11F while Section 16 had 40 percent Concrete Sand. The pavement in Section 17 was a denser appearing mix than that in Section 16. Both sections had spotty performance. All the RC-5 sections were resurfaced in 1948 after six years of use.

Fig. 7. Junction between Section 16 (gradation 5) and Section 17 (gradation 4), both containing RC-5. Section 16 had a pitted surface that was rougher in texture than Section 17. Gradation 4 had 4% passing the No. 200 sieve while Gradation 5 had only 0.3% of this size material.

Sec.	16	17
Agg.	40% C.S.	50% 11F
Ratings		
1946	Poor	L- Poor; R- Fair
1947	L-Poor; R- Extremely Poor	L- Poor; R- Fair

Table 13. Other illustrations of pavement with this aggregate grading and different bituminous materials are Fig. 16 (PAC-8) and Fig. 7 (RC-5).

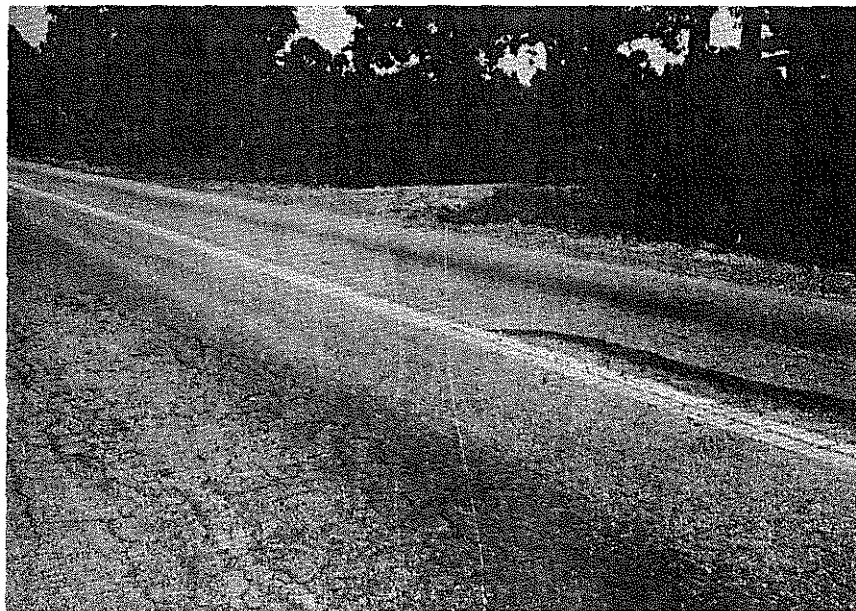
Fig. 8. Typical Base Failure. Portions of pavement that failed because of deformation of layers below the surface itself were recorded as base failures only. This photograph was taken in Section 3 containing MC-5 with gradation 3. The surface was rated poor in both 1946 and 1947, but not because of the base failures.

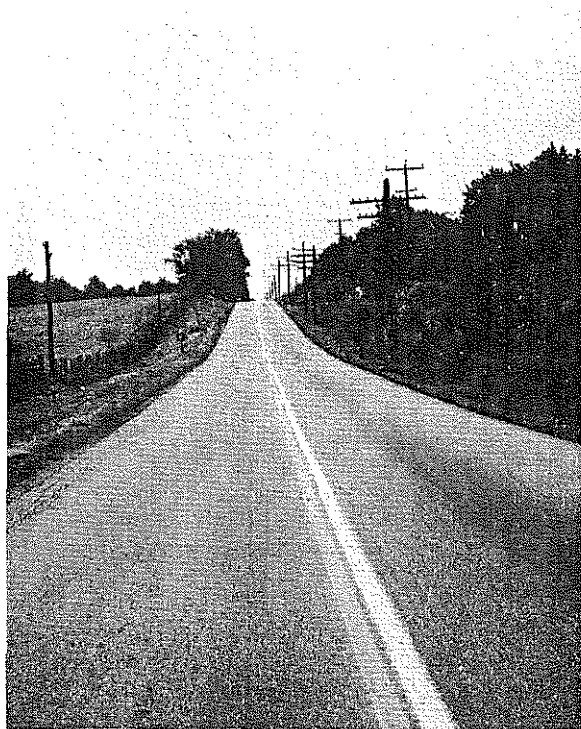
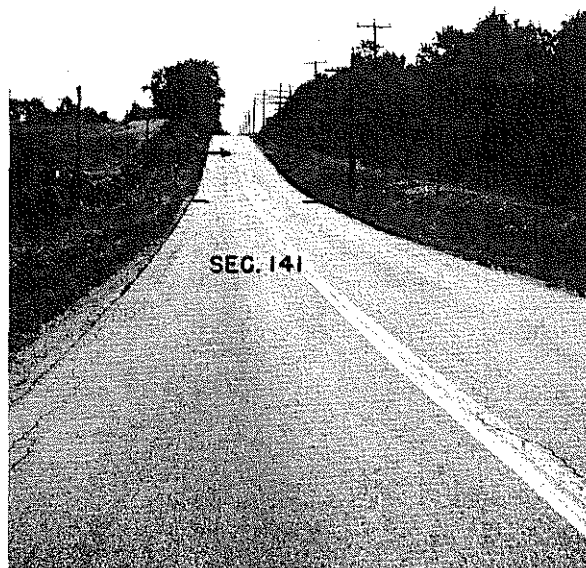
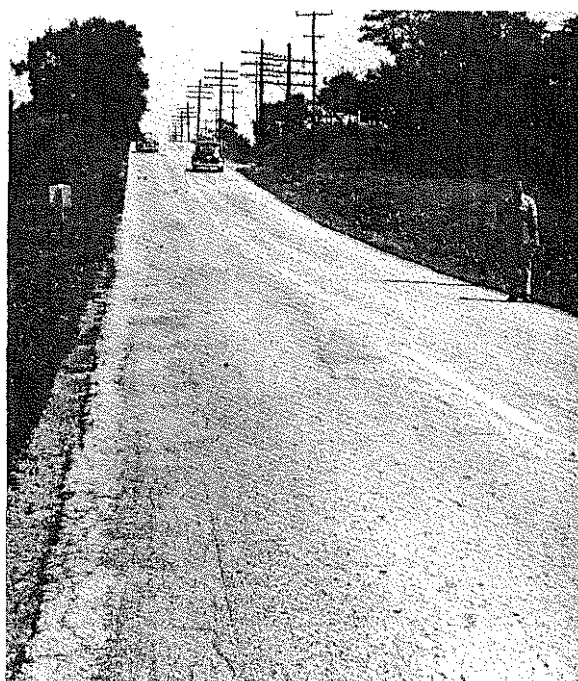
Fig. 9. Section 141 in foreground and 41 in the distance. Both sections contain 60% No. 9 stone and 40% River Sand (gradation 10). The junction between the sections is shown in the upper right photograph. The Left Lane of Section 141 contains PAC-5, and the Right Lane PAC-7. Section 41 is all PAC-7.

Sec.	41	141
Rating		
1946	L-Fair R-Good	L-Fair R-Fair to Poor
1947	L-Fair R-Good to Excellent	Fair
1948	Excellent	Excellent
1951	Fair	Poor

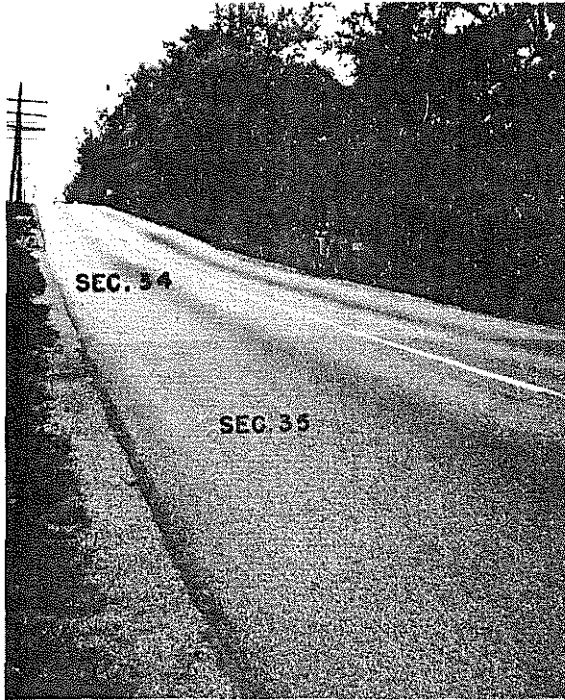
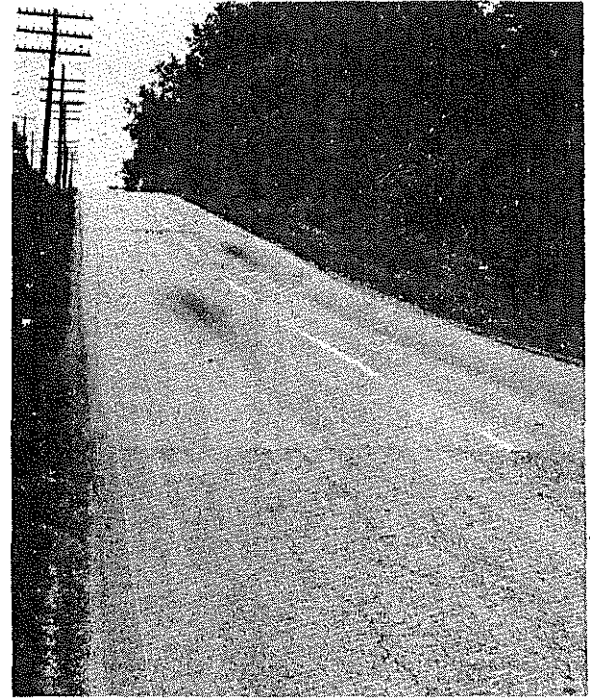
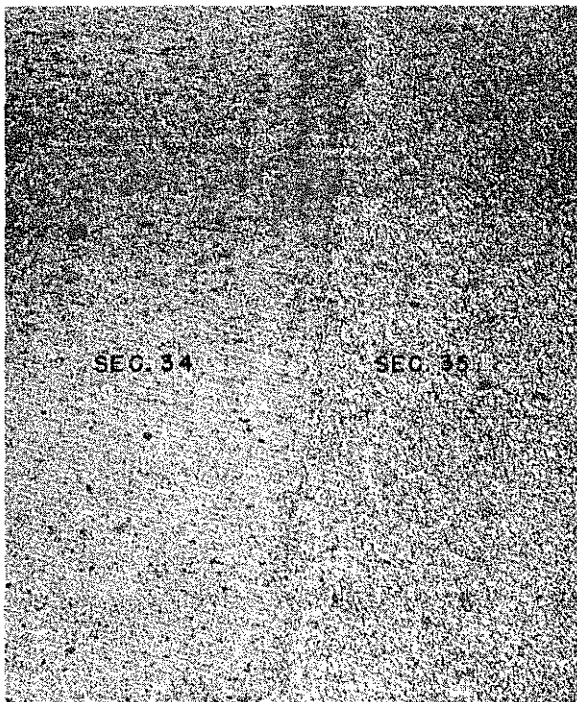
Fig. 10. Contrast in texture between sections containing 50% 11F and 40% Concrete Sand. Section 35 has gradation 5 (40% C.S.) and Section 34 has gradation 4 (50% 11F). Both sections contain PAC-5 in the mix. The oil streaks or spots in Section 34 were caused by a dip in the grade and are not bleeding of the bitumen.

Sec.	34	35
Ratings		
1946	Fair	Good
1947	Good	Fair to Good
1948	Excellent	Excellent
1951	Excellent	Good

Section 54, represented by Fig. 13 and Fig. 16, was an excellent section of this gradation in combination with PAC-8. Section 34, (Fig. 10) with PAC-5 was another outstanding section of pavement with this aggregate grading. Both of these sections were exceptionally dense but not slick.

Section 35, shown in Fig. 10, contains PAC-5 with 40 percent coarse sand. The rough texture in this section is accentuated by the dense appearing surface of Section 34. Section 35 was rated good in 1951.

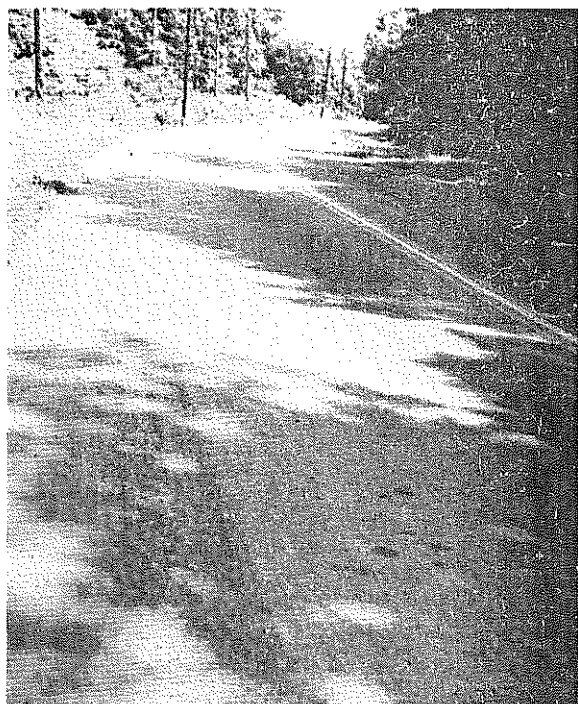
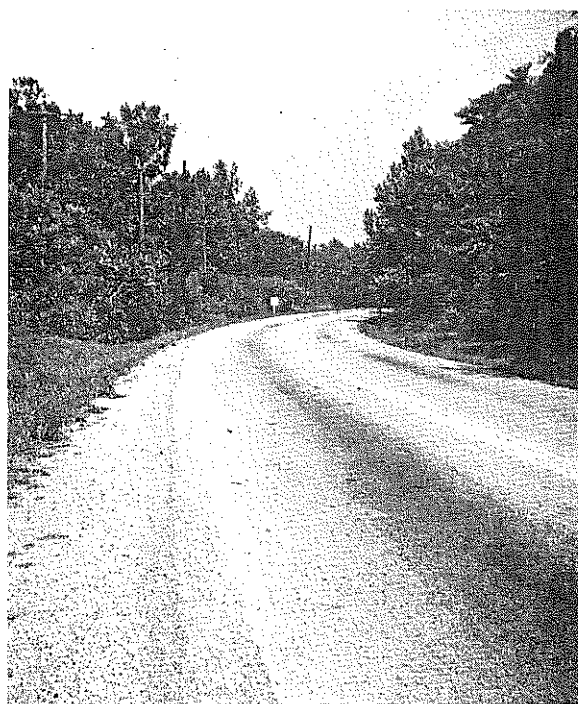
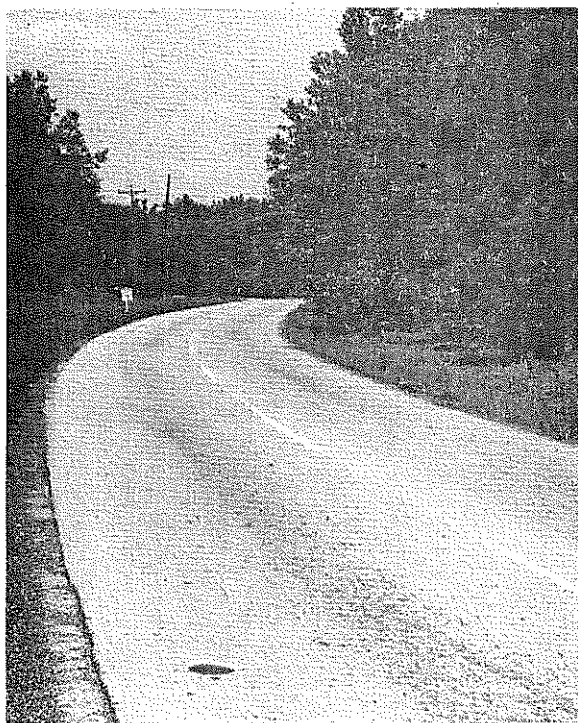
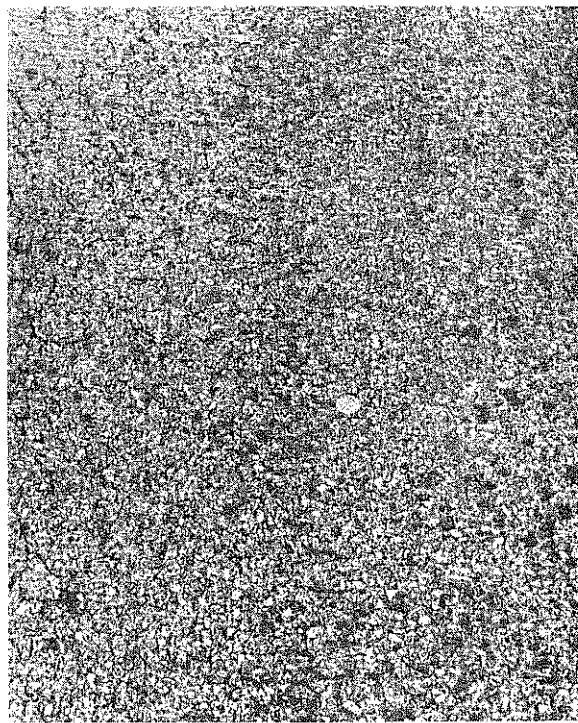
Fig. 11. Section No. 49 containing PAC-7 and aggregate gradation 2 (30% 11F). This was rated excellent in all inspections from 1946 to 1951. The lower right is a near view of this pavement.

There were some other things of interest contained in the results. For example, the amount of material passing the No. 200 sieve ran as high as five percent in some of the mixes having limestone fines, yet the pavements showed no tendency toward slipperiness. These particular surfaces were the ones having the best performance records. Also, these were the sections having the neatest appearance at least from the time of the 1946 inspection to the present. Some of these are illustrated in the report by Fig. 11, Fig. 13, and that portion of Fig. 16 designated as Section 54.

performer. Figs. 11 and 14 were taken of sections made up with this aggregate gradation. See Table 10.

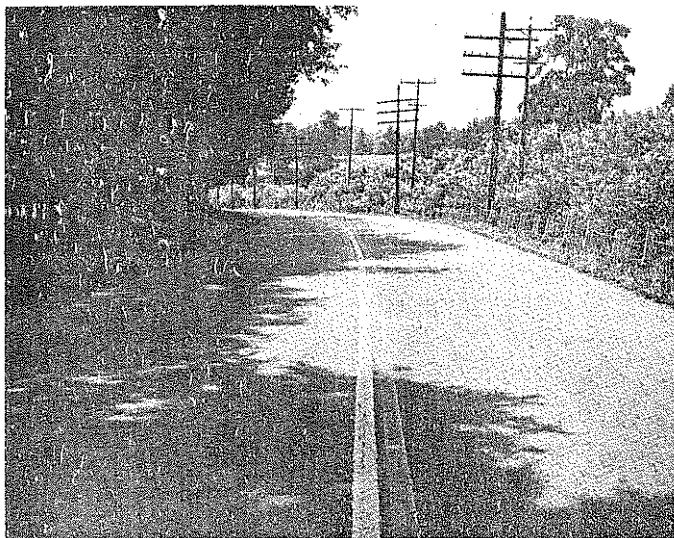
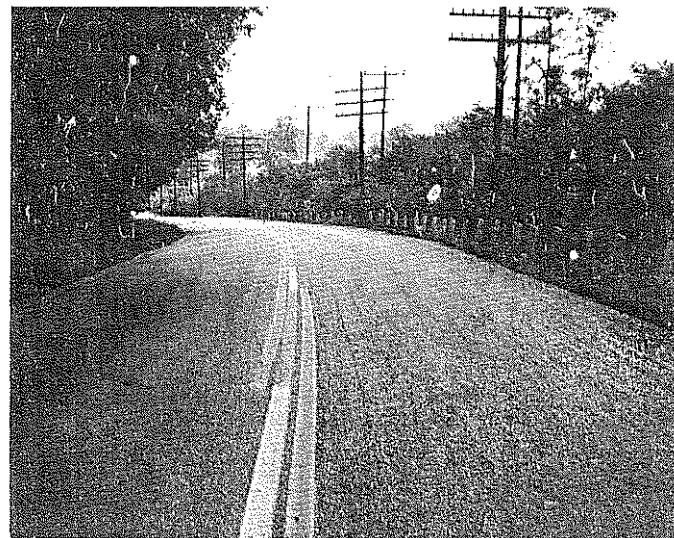
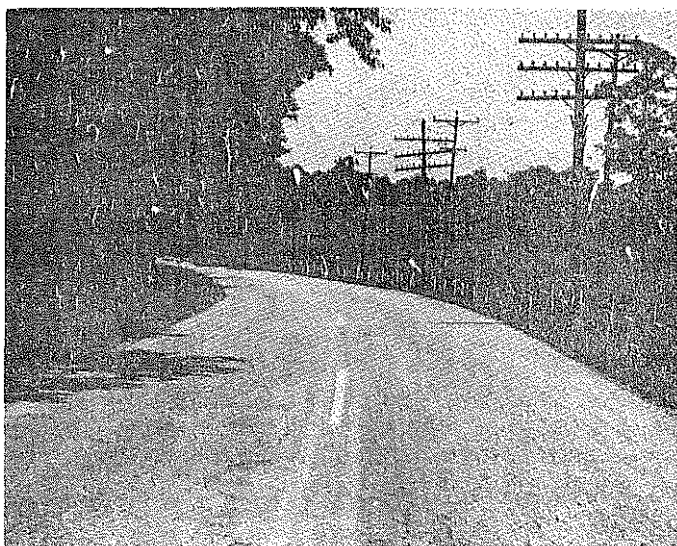
Fig. 12. Section 43 consisting of PAC-7 with 20% River Sand. Performance was rated as excellent despite the general coarseness of surface texture.

Agg. 80% No. 9 and 20% R.S.

1951 Fair

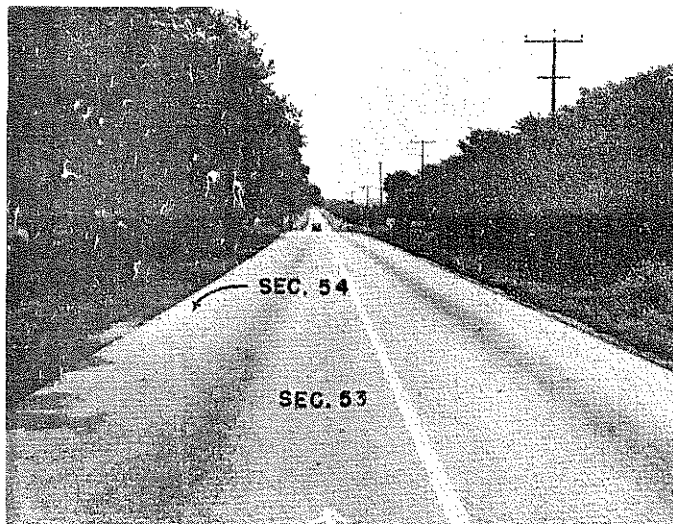
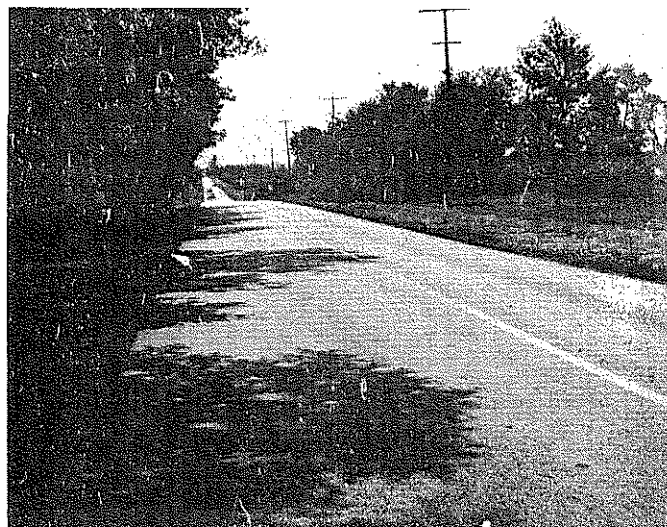
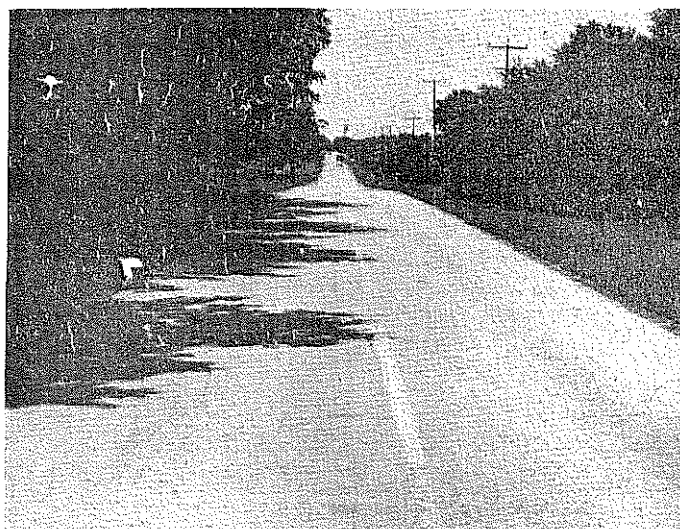
Fig. 13 shows two sections of pavement with PAC-8 and 40 percent and 50 percent 11F. These pavements are very dense and the performance has been good to excellent. In Fig. 14 two sections with the same gradation of aggregate are shown. Section 50 contains PAC-7 and Section 51 contains PAC-8, both with aggregate gradation 2 having 30 percent 11F. These photographs indicate that the PAC-8 had more tendency to bleed than did the PAC-7. This bleeding was not excessive and did not produce a slick surface at this location.

Fig. 13. Two sections of PAC-8 are shown in these photographs; Section 53 and Section 54. The junction is located on the 1947 photograph.

Sec.	53	54
Bit.	PAC-8	PAC-8
Agg.	60% No. 9 40% 11F	50% No. 9 50% 11F
Rating		
1946	L-Excellent R-Fair	Good
1947	L-Excellent R-Good	Excellent
1948	Excellent	Excellent
1951	Good	Excellent

Section 53, illustrated in Fig. 13, contained 40 percent 11F. The performance of this section was obviously outstanding. Data in Table 11 confirm the fact that this grading also had a fairly good record with cut-backs and the tar.

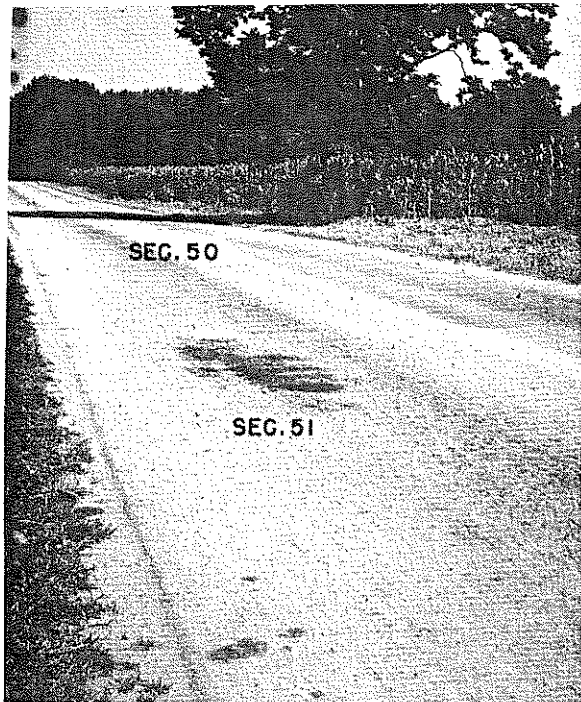
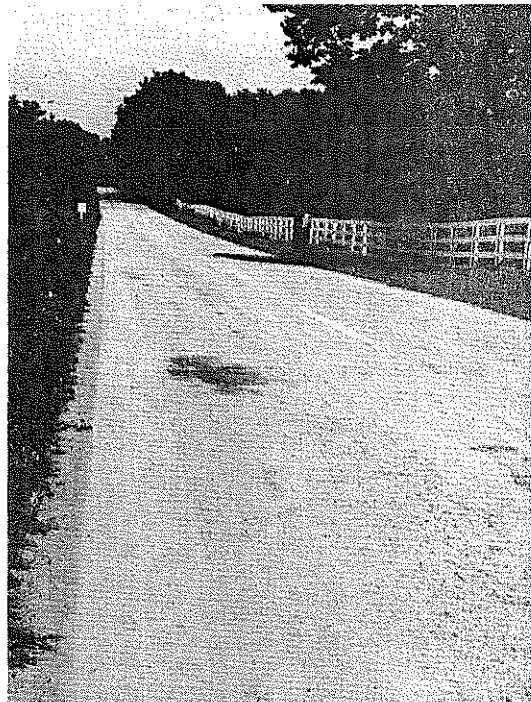
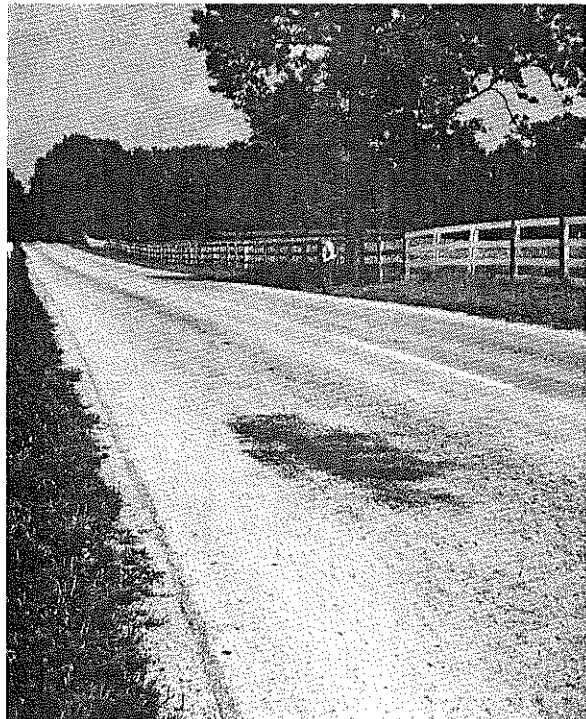
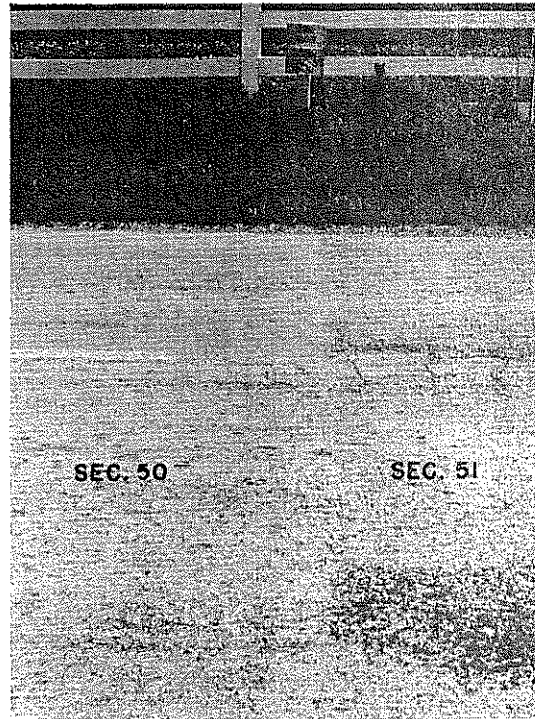
Fig. 14. Junction between Section 50(PAC-7, G-2) and Section 51(PAC-8, G-2), viewed from a distance and close up. The fat spot is just inside the PAC-8 section. Performance ratings are given in Table 9.

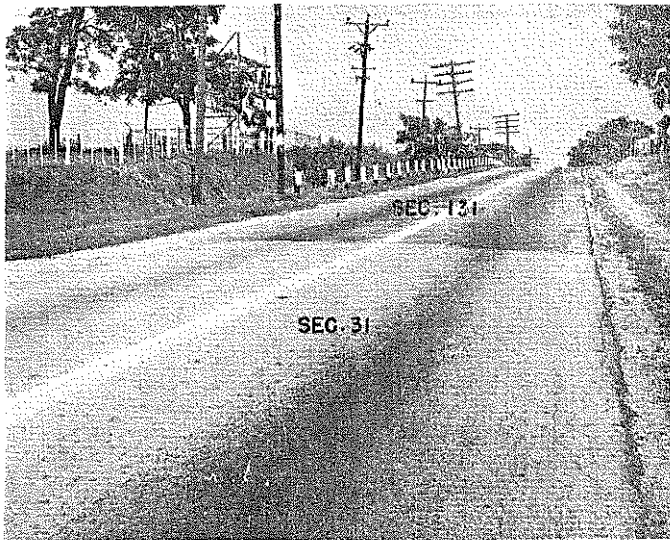
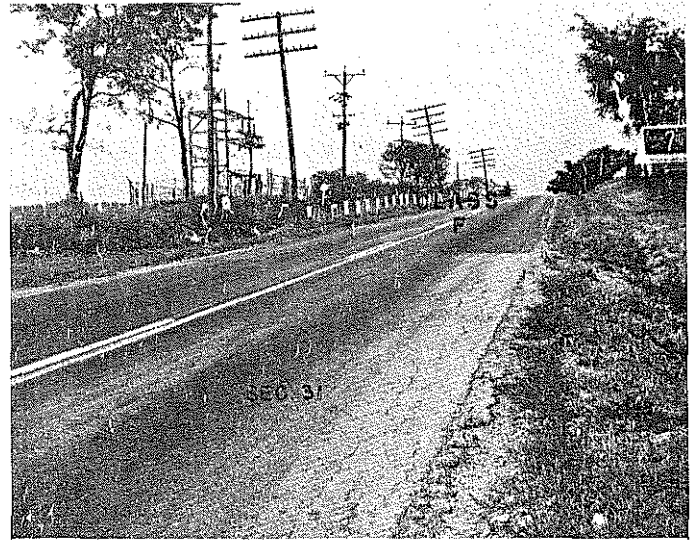
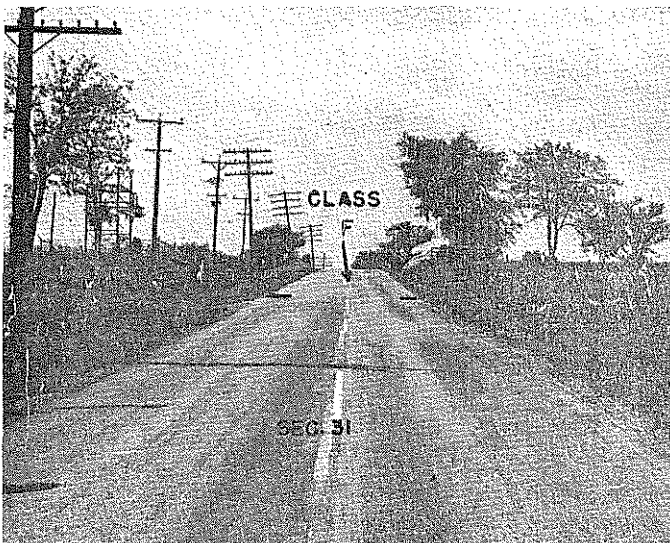
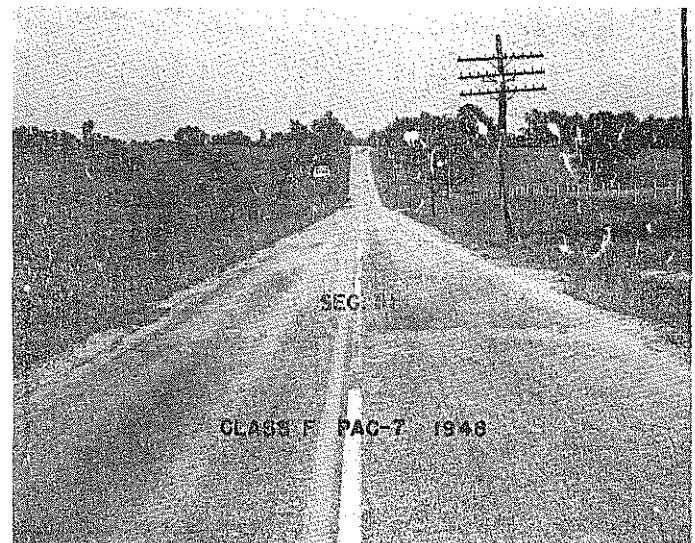
One of the photographs in Fig. 15 shows adjacent sections containing gradation No. 1. This was a fairly coarse mix with a resultant rough textured surface. The performance of mixes with this aggregate grading was not outstanding with any of the bituminous materials throughout the project, as evidenced by Table 9.

Fig. 15. Junction between Section 31 (in the foreground) containing PAC-5 and Section 131 containing RT-12, in the distance on the photograph taken in 1947. Both mixes contained gradation 1 (80% No. 9 and 20% 11F Limestone). In 1948 prior to the inspection and the taking of photographs that year, the tar was covered with a Class F mix containing PAC-7. This mix is shown in the distance of the corresponding 1948 and 1951 views, and in the foreground of the additional view taken in 1951 looking the opposite direction (lower right). Note the rough texture of the Class F. Ratings of the two sections are given in Table 9.

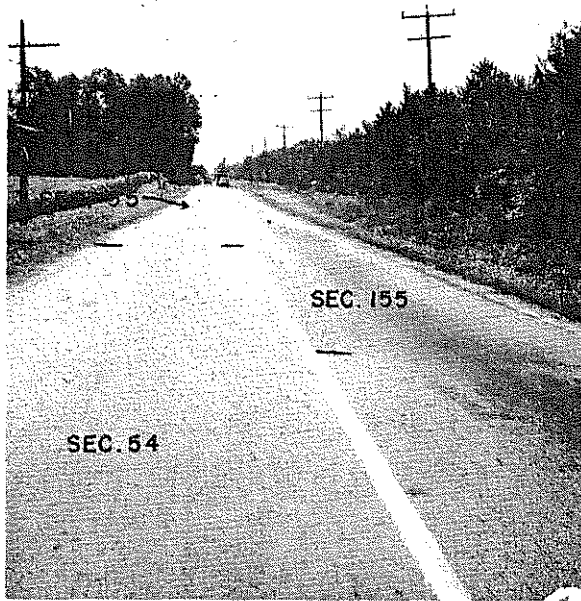
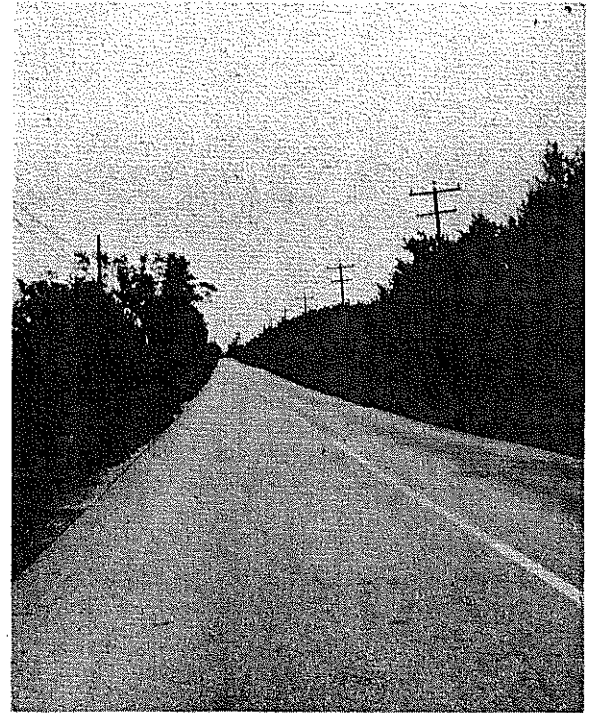
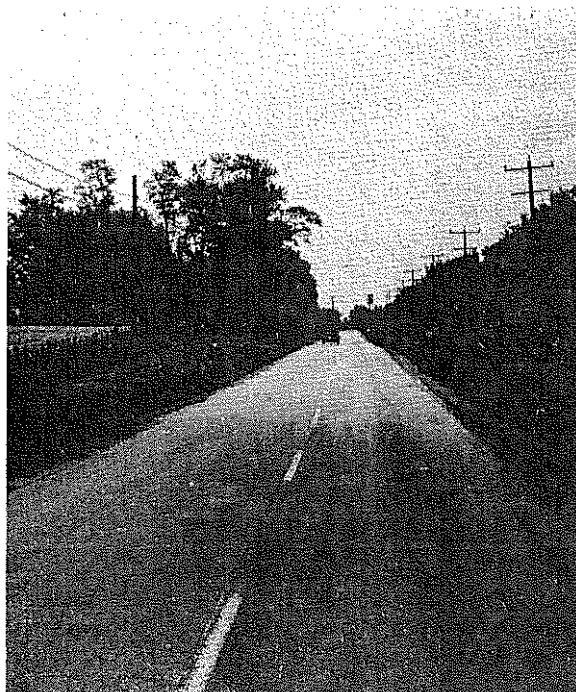
Fig. 16. Three sections with PAC-8 and contrasting aggregate gradations. Section locations are noted on the 1947 photograph.

Sec.	54	55	155
Agg.	50% 11F	40% C.S.	20% R.S.
Rating			
1946	Good	Good	Fair
1947	Excellent	Excellent	Good
1948	Excellent	Excellent	Excel.
1951	Excellent	Good	Good
