REPORT NO. 3

A CONCRETE PAVEMENT WITHOUT  
TRANSVERSE JOINTS

W. B. Drake  
Research Engineer

February, 1951

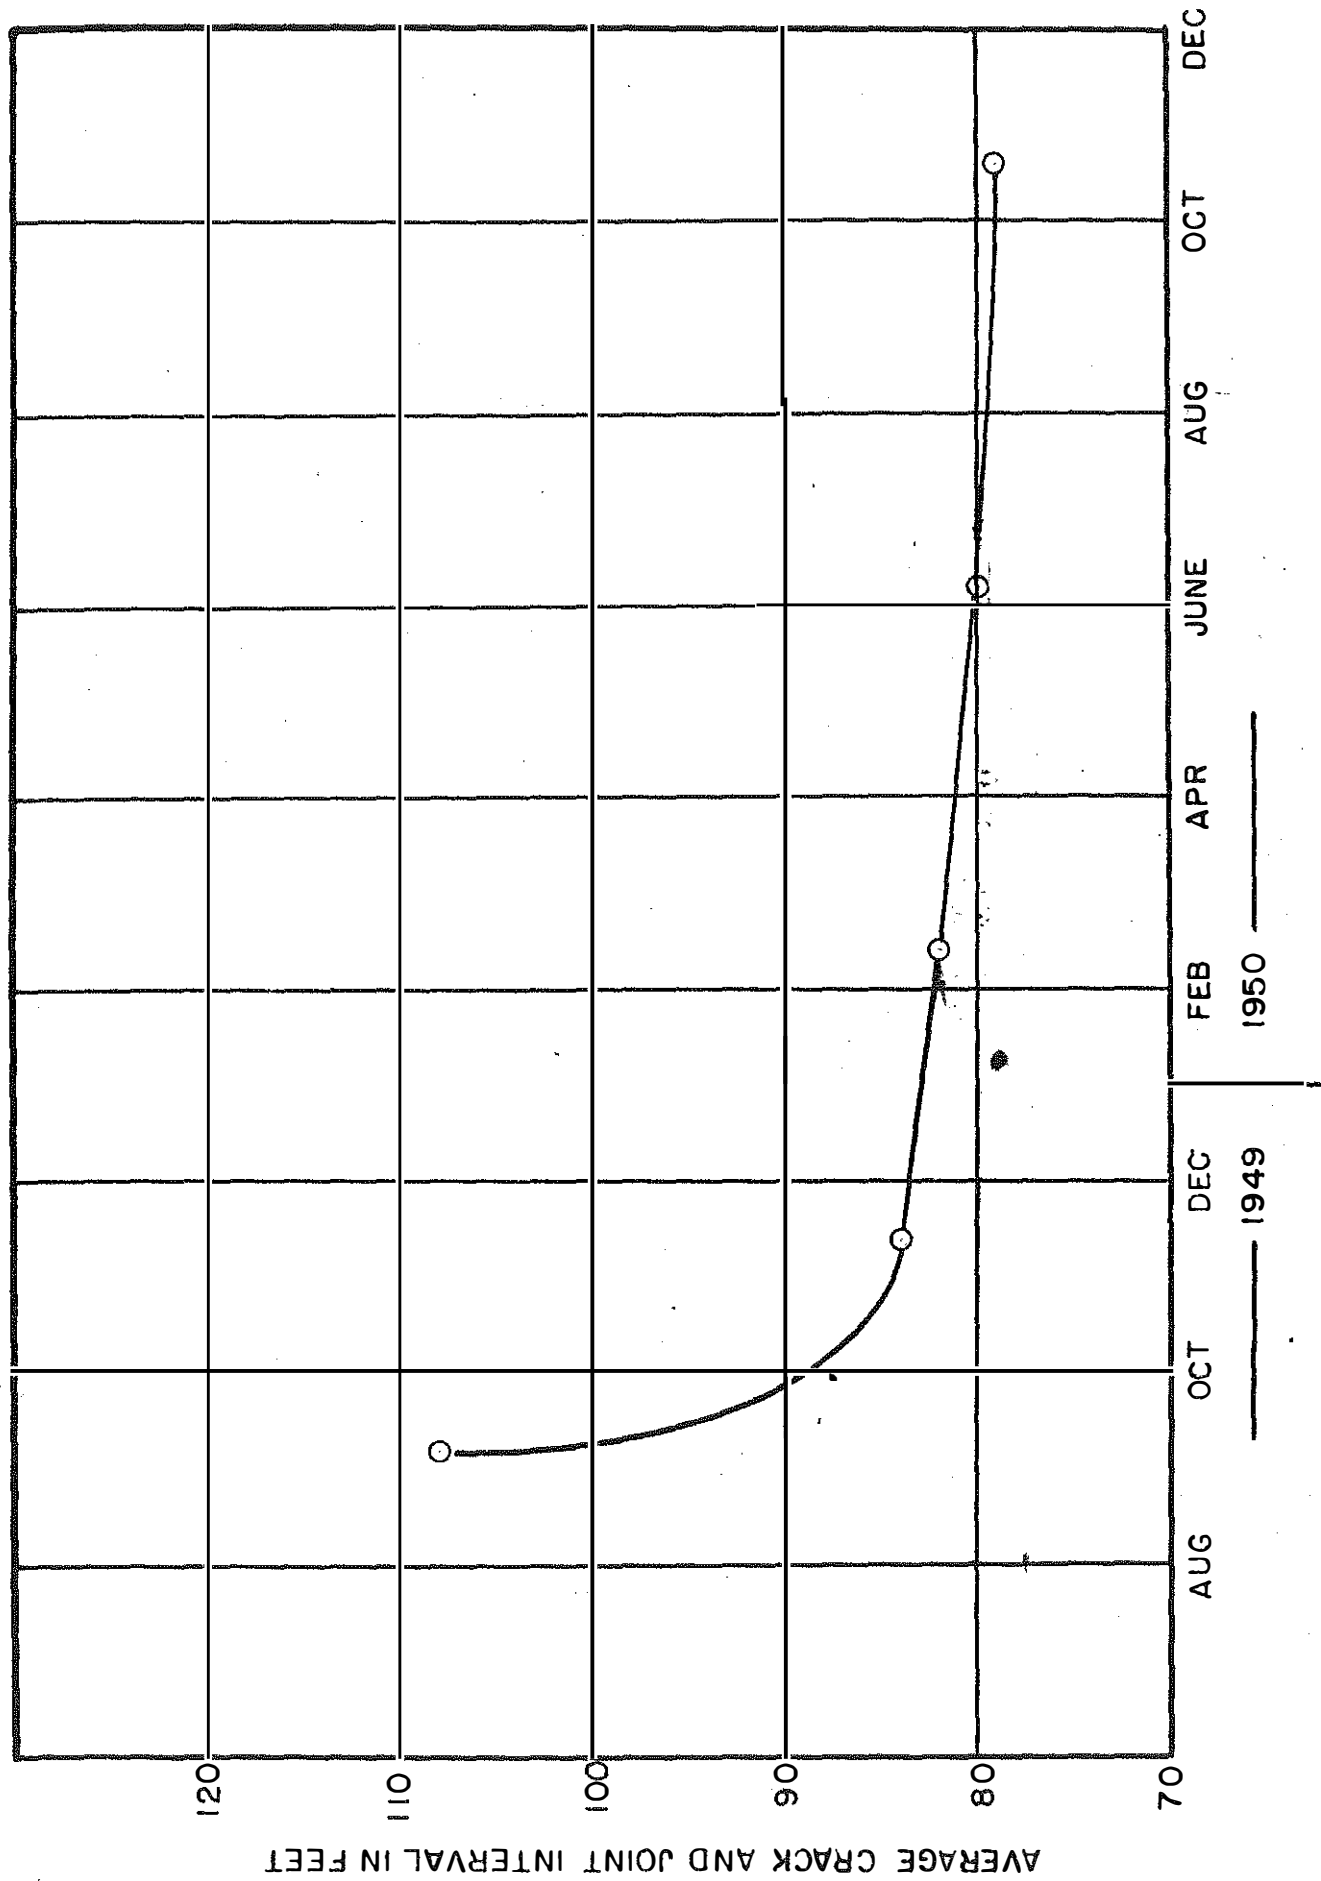
During 1950 three crack surveys were taken with the crack interval dropping from 84 to 79 feet. The graph following this page is a plot of the average crack and joint interval for the time this pavement has been observed. The curve appears to be

flattening out.

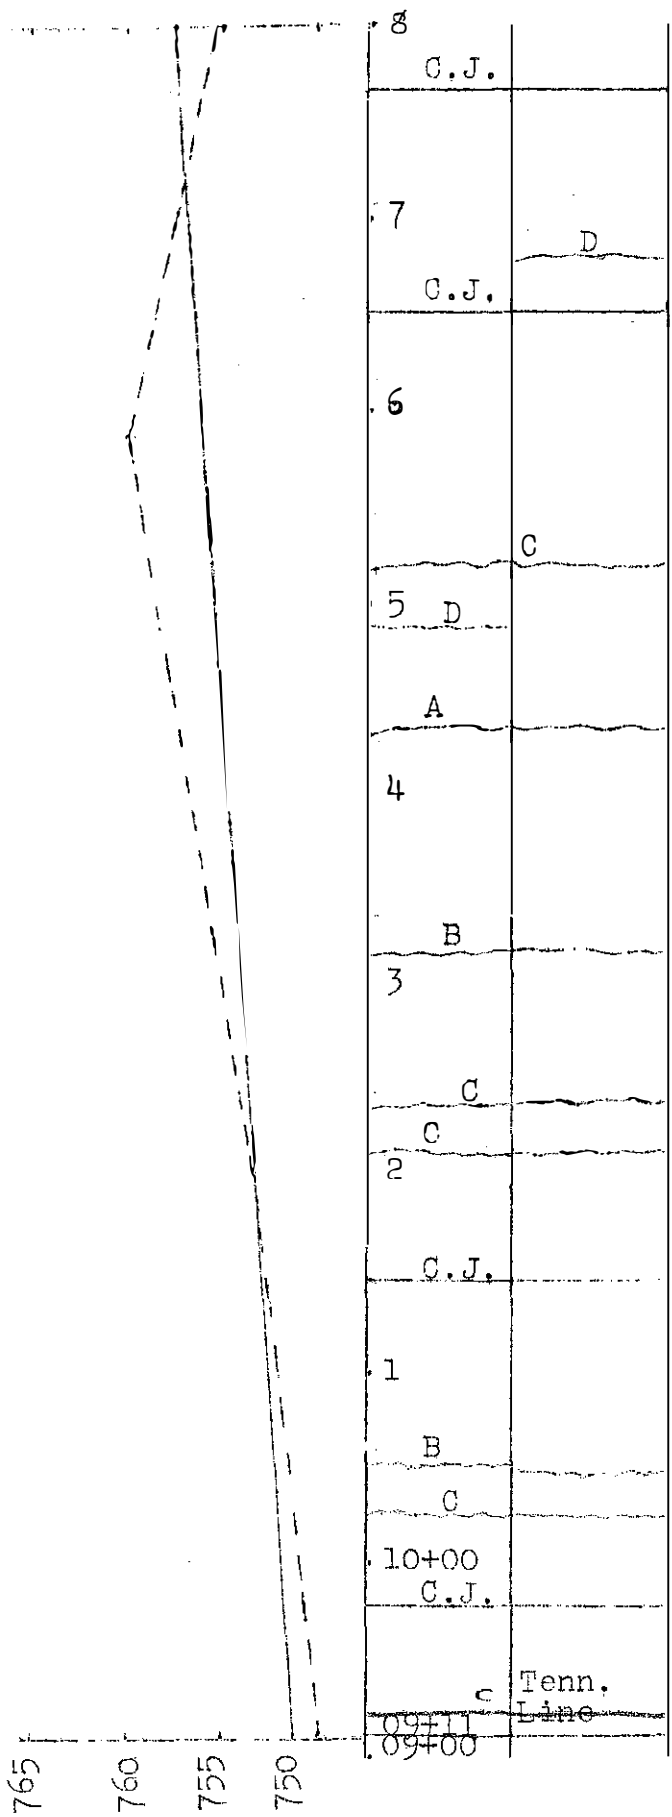
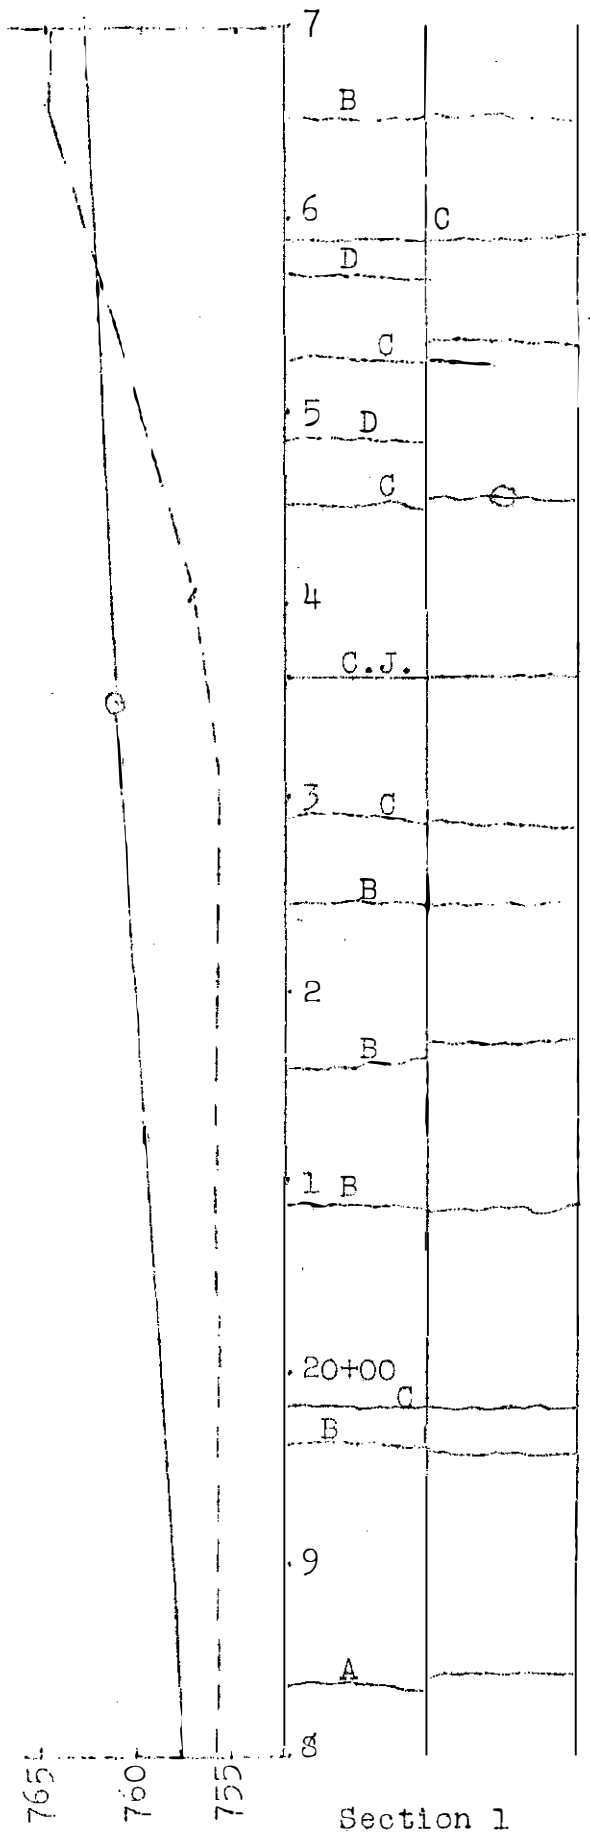
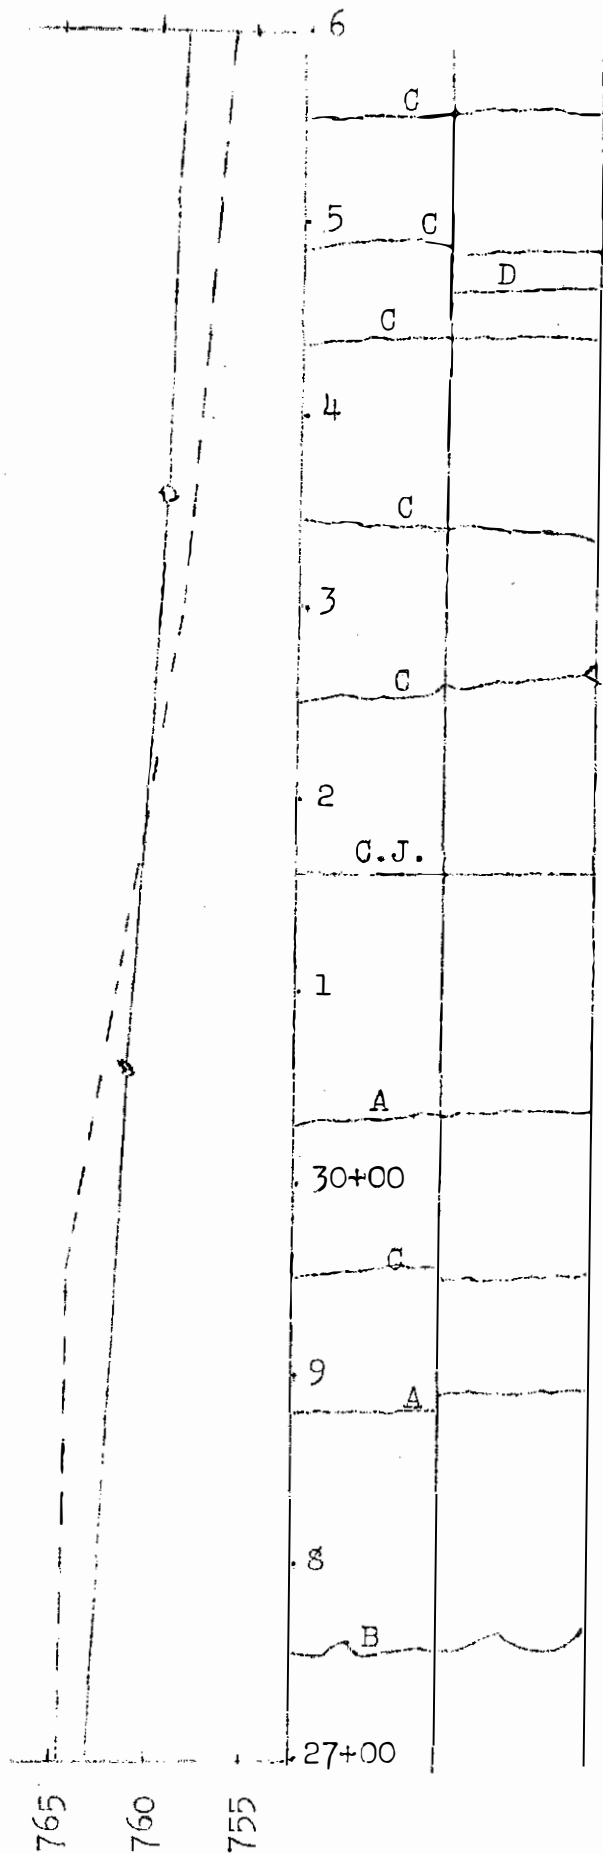
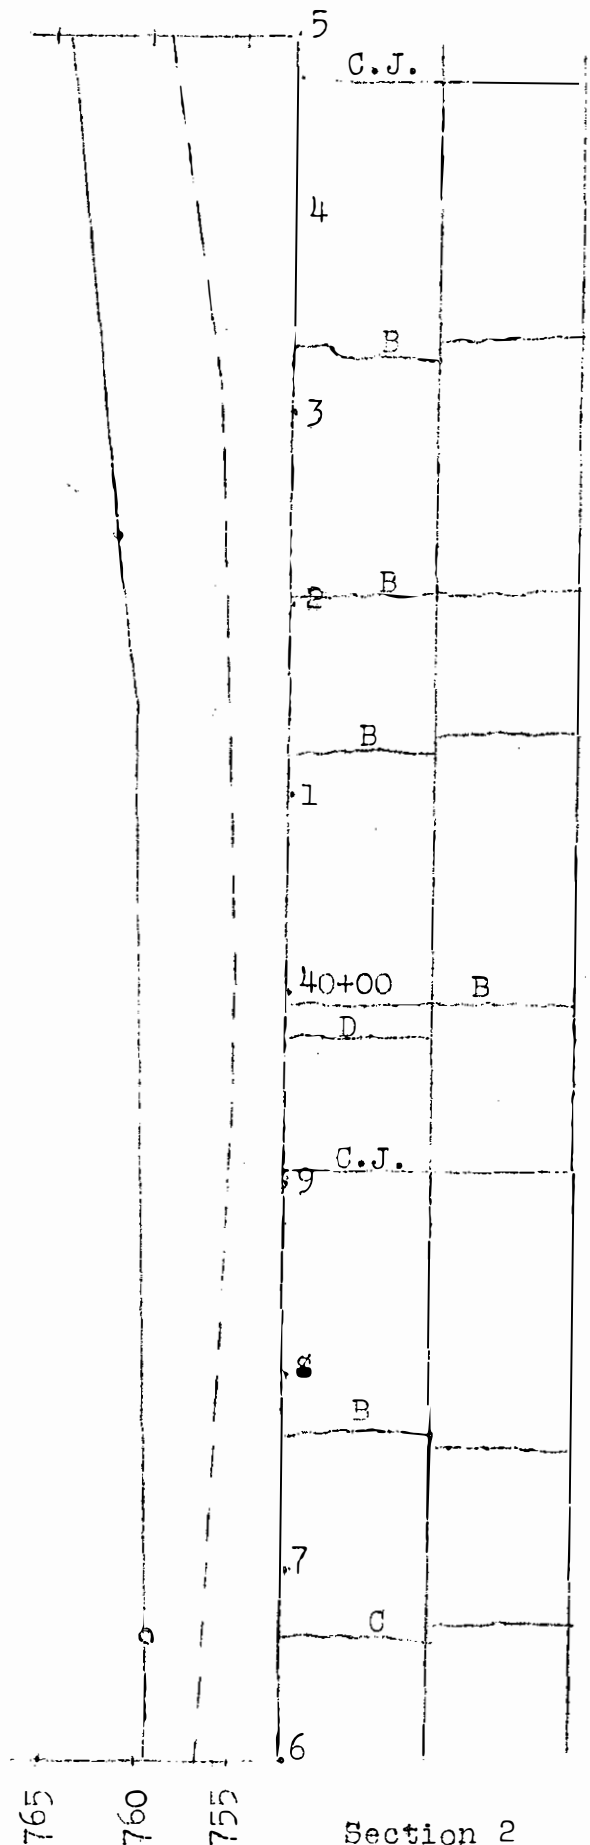
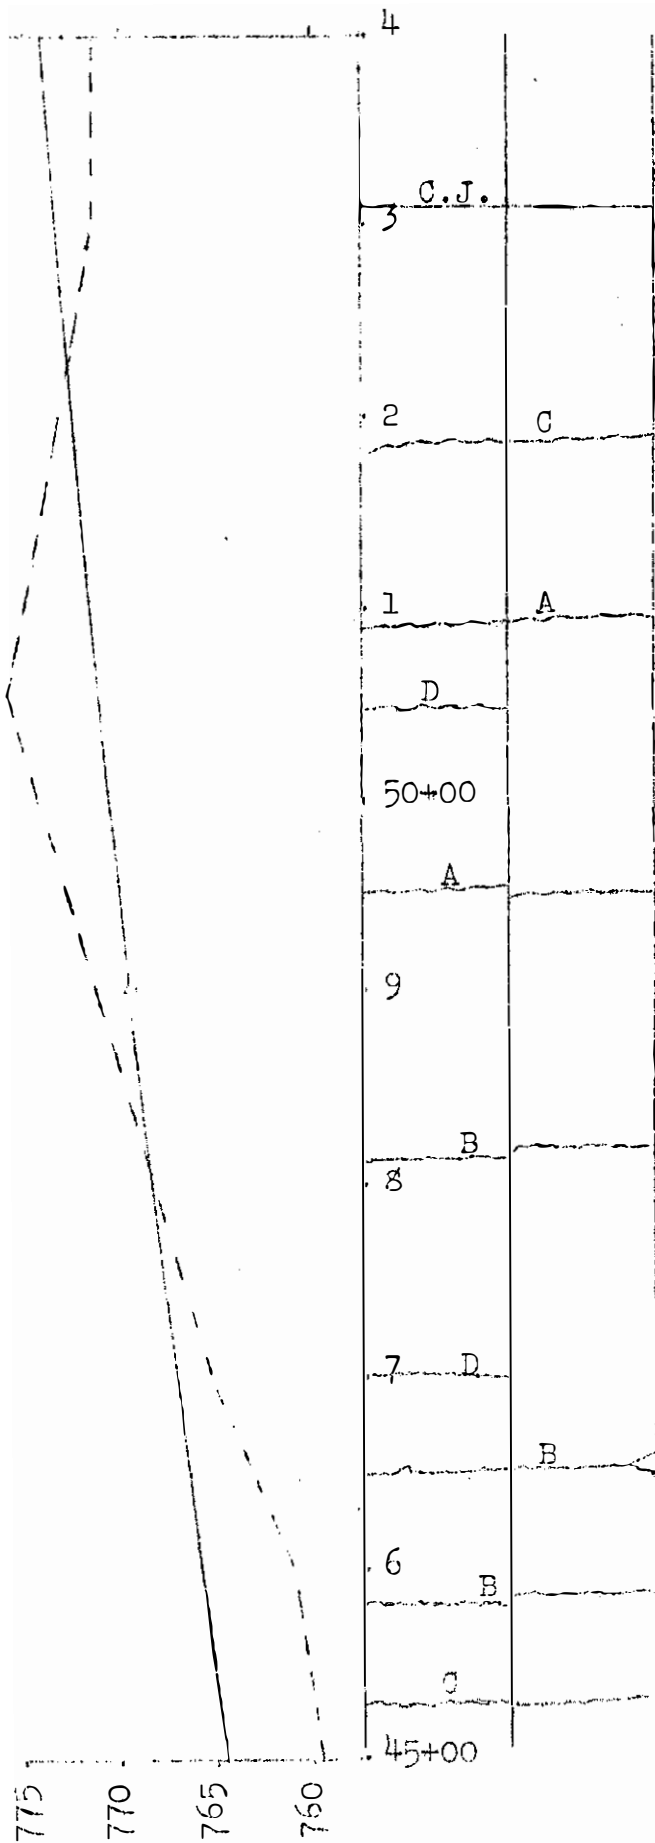
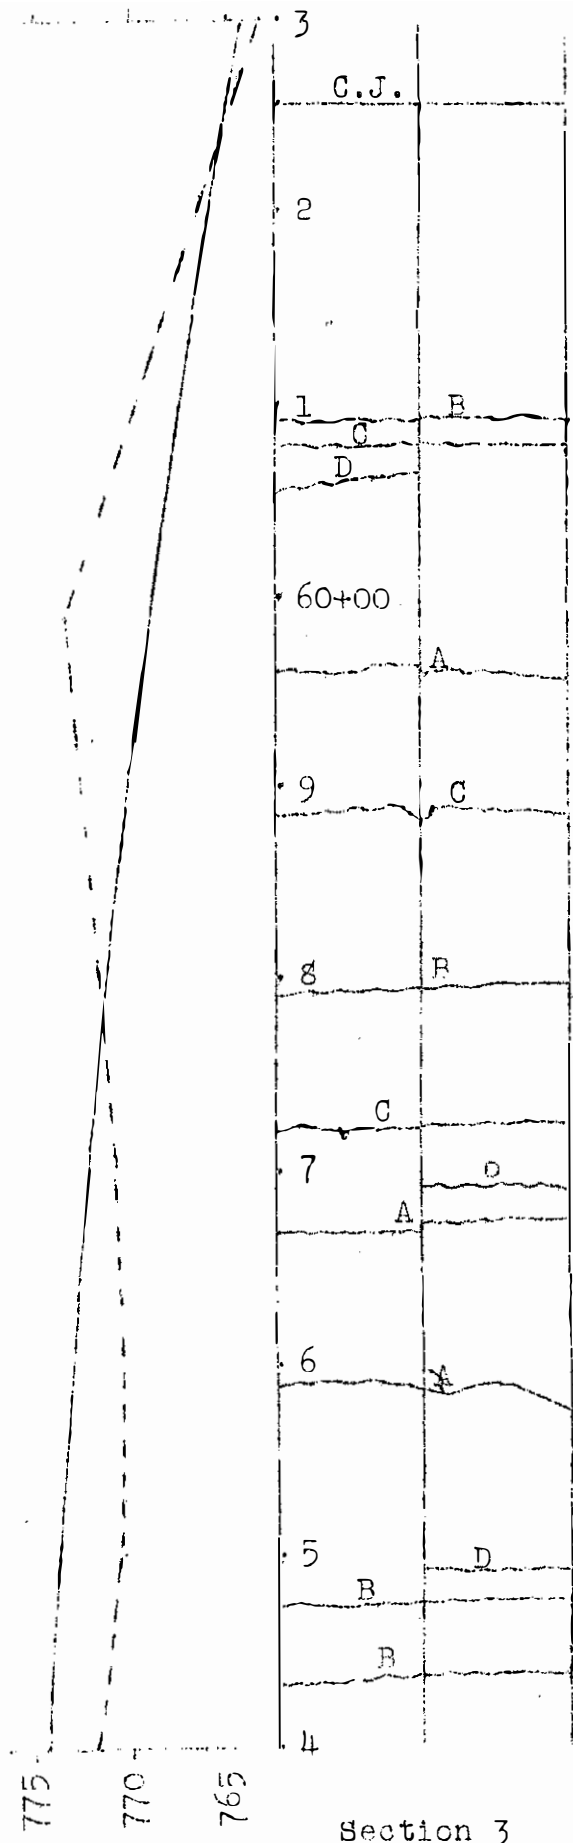
### STRIP MAP OF PROJECT

The strip map in Appendix 1 contains the progress of the cracking since November, 1949. The cracks that developed between each survey are designated by a particular color. The grade line and the former ground line are plotted opposite each section. The tables presented are only summaries of the data shown in the strip map.

Cracks marked in black occurred before November 18, 1949 (third survey). The cracks shown in blue occurred between November 18, 1949 and February 16, 1950 (fourth survey). The cracks shown in green were noted in the fifth survey on June 5, 1950. The cracks marked in yellow appeared on the October 19, 1950 survey (sixth survey). The class of crack is noted by the letter A, B, C or D. Construction joints are marked C.J. The grade line of the road is shown with each section. The ground line is shown dashed.
