Highway Materials Research Laboratory  
132 Graham Avenue, Lexington 29, Ky.  
December 27, 1950

A SURVEY OF ACIDITY IN DRAINAGE WATERS AND THE CONDITION  
OF HIGHWAY DRAINAGE INSTALLATIONS

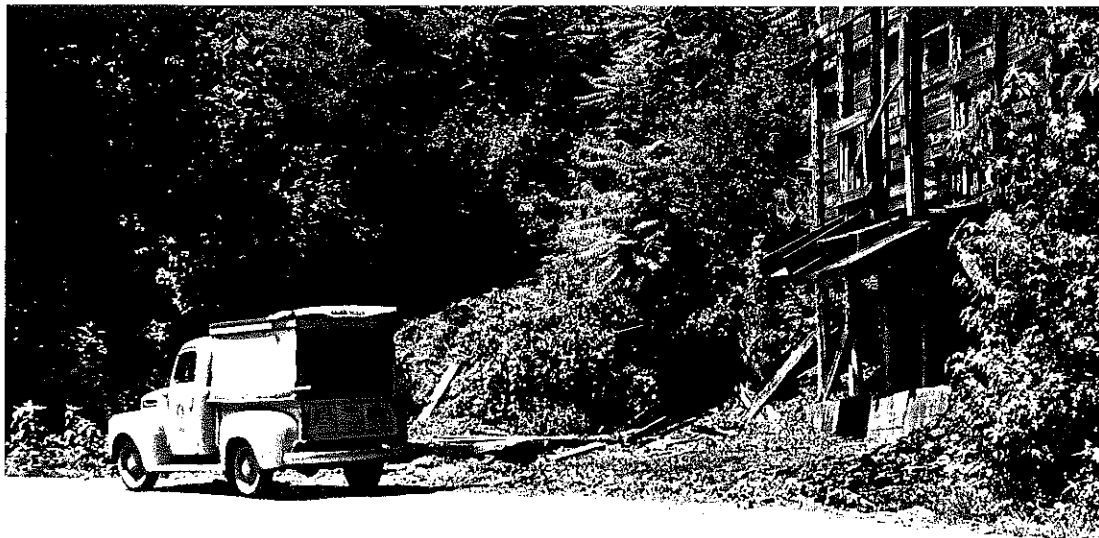
Fig. 2. Mobile Laboratory equipped for on-the-spot analyses, shown at a typical location of high acidity. Abandoned mines such as this one are prevalent along roads in many parts of eastern Kentucky.

With this and accessory equipment, a mobile laboratory was improvised in a 1/2-ton pick-up truck shown at an actual acid location in Fig. 2. By this means it was possible to perform on-the-spot tests in fifteen to twenty minutes.

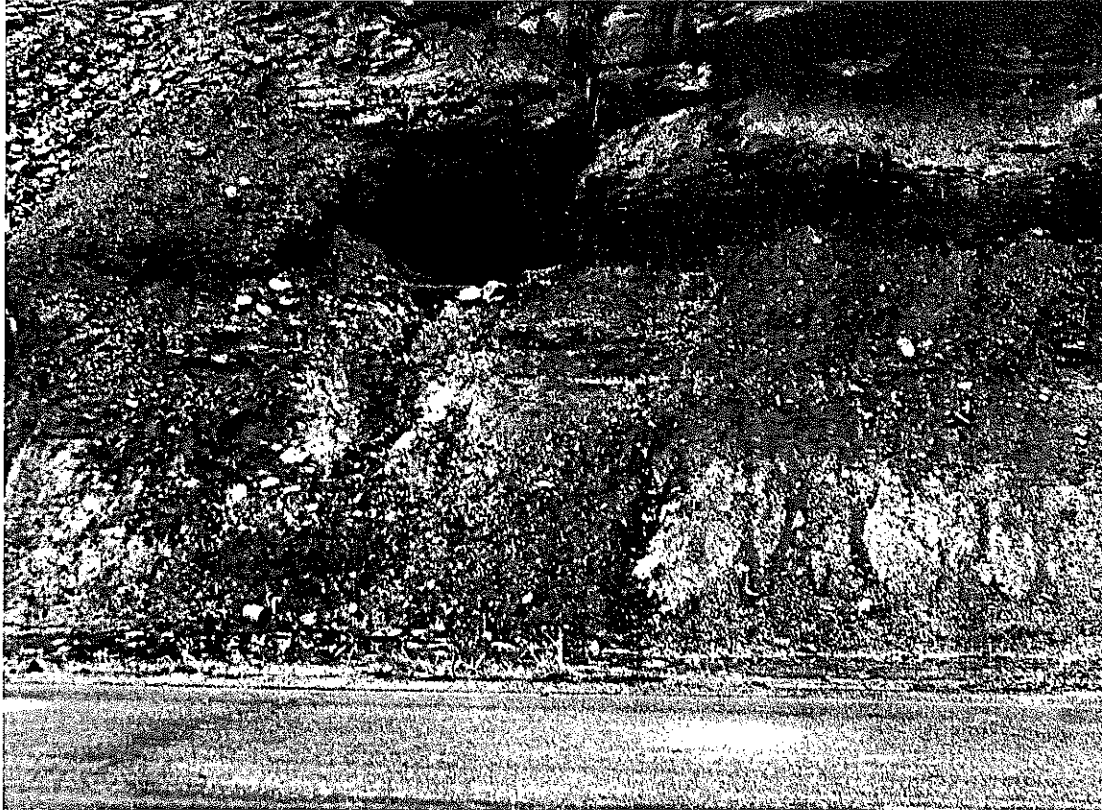
Fig. 4. Drift mine opening in the face of a cut, located on Ky. 180 between Cannonsburg and the Junction with US 23. Boyd County, water sample no. 34. Specific resistance - 346 ohms at 25°C., measured pH -3, titrable acidity - 0.026 eq./ liter, positive qualitative tests for -  $\text{Ca}^{++}$ ,  $\text{SO}_4^-$ ,  $\text{Fe}^{++}$ .

A common situation is illustrated by Fig. 4, which shows a drift mine from which highly acid water flows and, although this usually amounts to seepage, it is fairly regular. Water from this mine flowed along the side-ditch, merged with a larger non-acid stream, and then proceeded through a cross-drain. From the point of merger the concentration became progressively lower, and the nearest culvert received only mildly acid water. No other culvert in the vicinity was affected. Where a cross-drain is immediately adjacent to the source, the effect is, of course, quite different. Mines of this type are numerous in the eastern field, and the associated drainage is always acid. In the western field, drift mining is relatively unimportant.

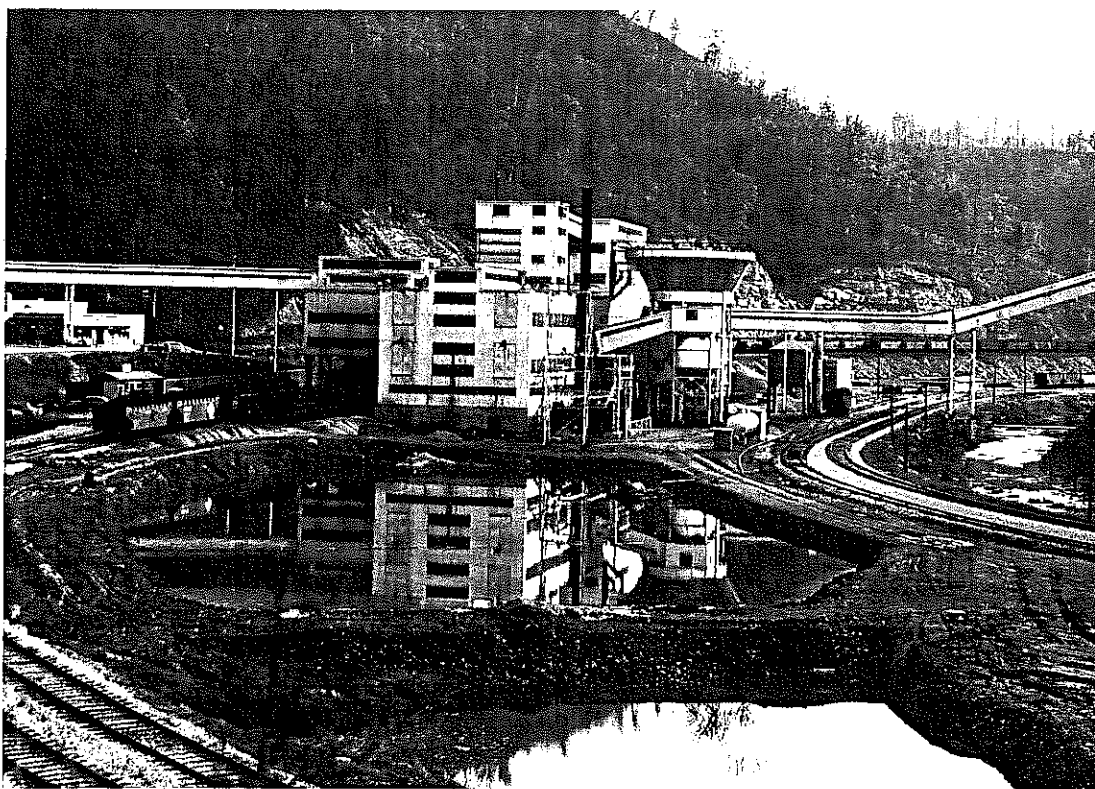
Fig. 5 Tipple and settling basins, Inland Steel Mine, at Wheelwright on Ky. 122. This is one of the largest coal processing plants in the State. The stream at the right is the left fork of Beaver Creek which receives the over-flow from the settling basins in the foreground.

In contrast to the primitive mine shown in Fig. 4, the very elaborate mining operation pictured in Fig. 5 produces large quantities of coal. In this case the coal is washed free of mine dust, and by means of the settling basins in the foreground a feeble attempt is made to recover dusts and solids

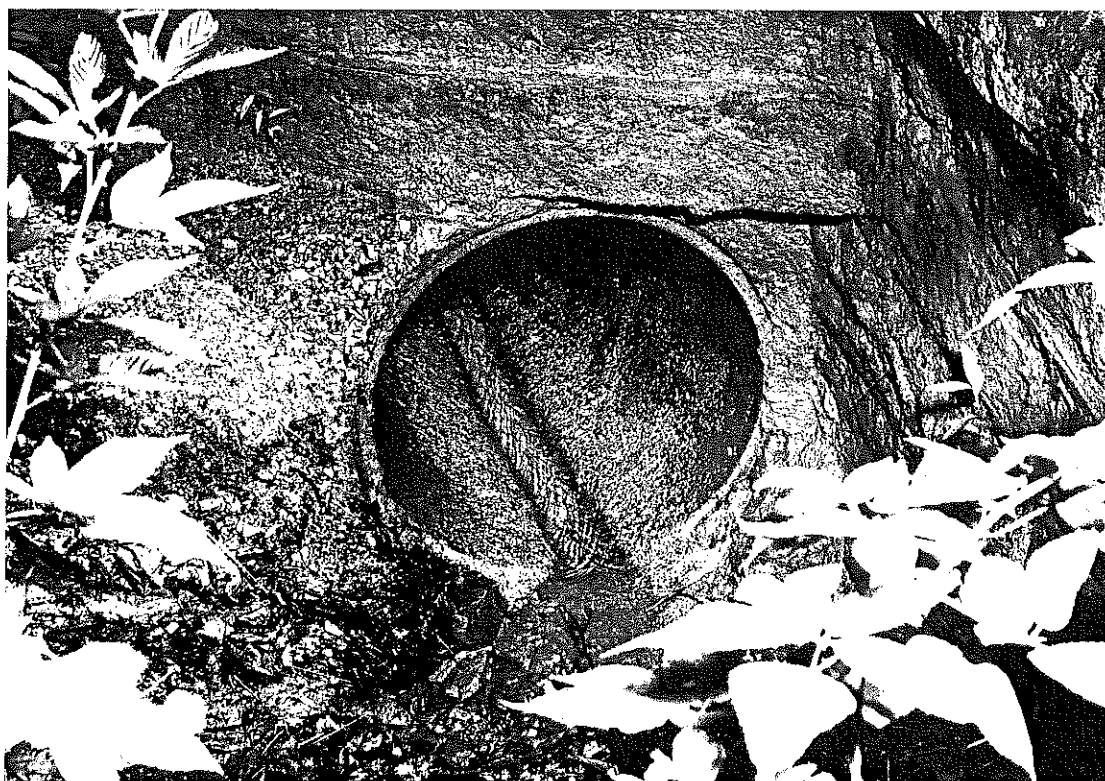
Fig. 6. An etched concrete cross-drain with sandstone masonry headwalls located on Ky. 74 in Bell County, 7 miles from Middlesboro. The source of water here was an abandoned mine and slack-pile. The water was continuous flow as evidenced by the corroded channel. It was not possible to determine how long the acidity had existed or what variations have occurred in the degree of acidity. The pipe, according to records available, has been in service since 1927.

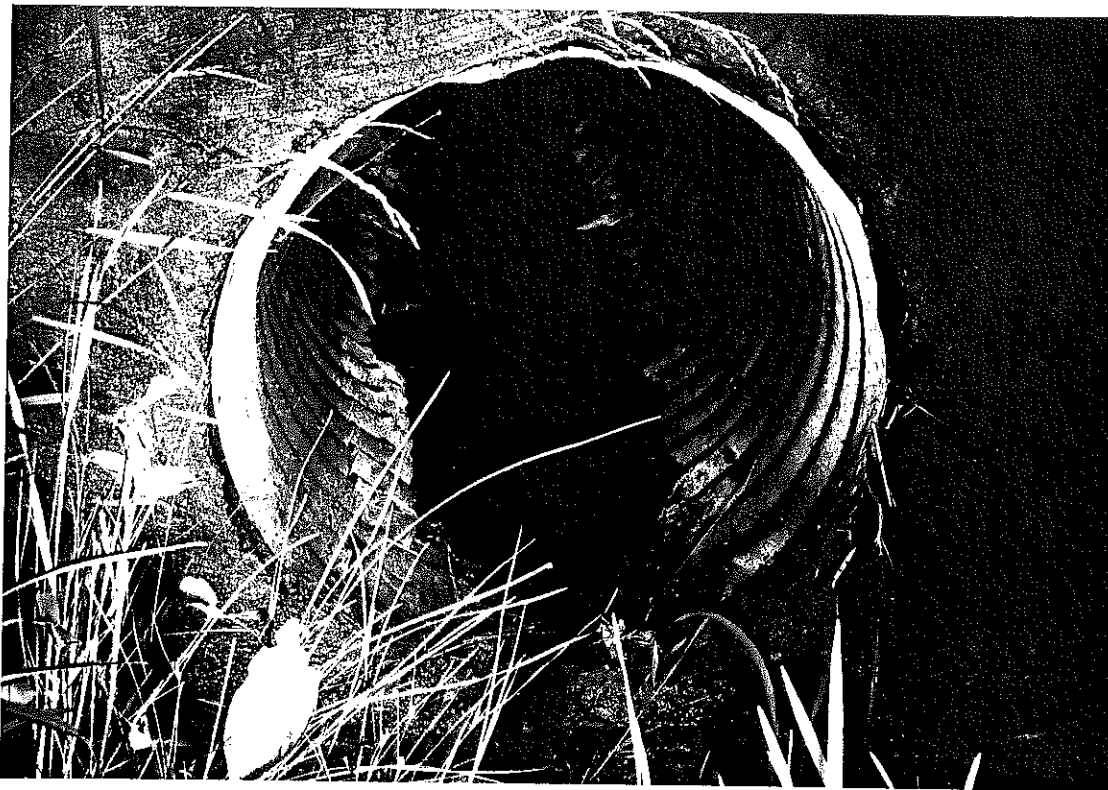
Fig. 7. Corrugated metal cross drain on US 60 at Bluestone. This culvert, for which the records indicate service-life of twenty-nine years, was replaced in the process of reconstructing the road shortly after this photograph was taken in June, 1950. The invert has been eaten away and water is standing in the channel. This static water (sample No. 16) showed a specific resistance of 930 ohms and positive qualitative tests for sulfates, chlorides, and calcium. It is not known definitely what the source of contamination has been or how long the corrosive agents have been active. There is a building-stone quarry above the road which has been operated intermittently over the past several years. Also, the location is on the very edge of the eastern coal field.

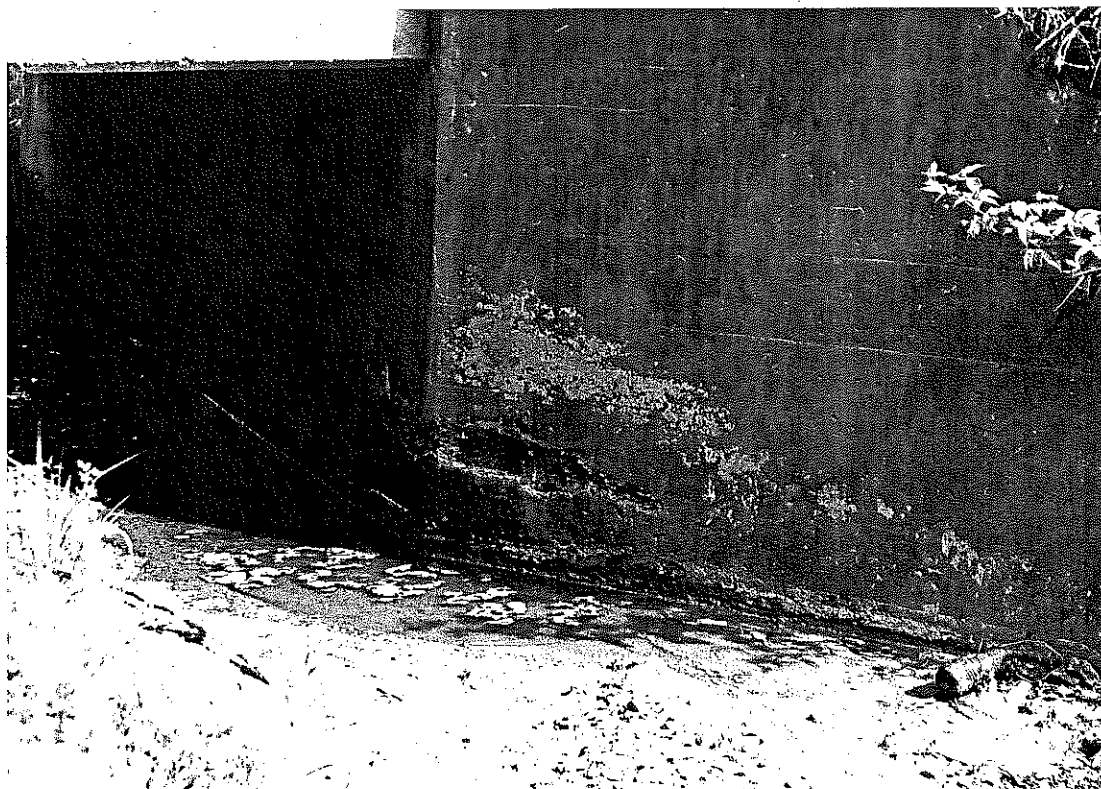
Fig. 8. Etched wing-wall on US 60 in Union County, 14.8 miles from Crittenden County line. At the time of sampling only residual water was found. Water sample No. CY-13 gave a specific resistance of 357 ohms. Positive qualitative tests were obtained for chlorides only. There are several producing oil wells in this area and, although the source of contamination can not be attributed directly to them, the presence of chlorides and the absence of iron and sulfates seems to indicate that the contaminating source is something other than coal mines. It is not unusual in the drilling of oil wells to pump highly concentrated salt water from the wells.

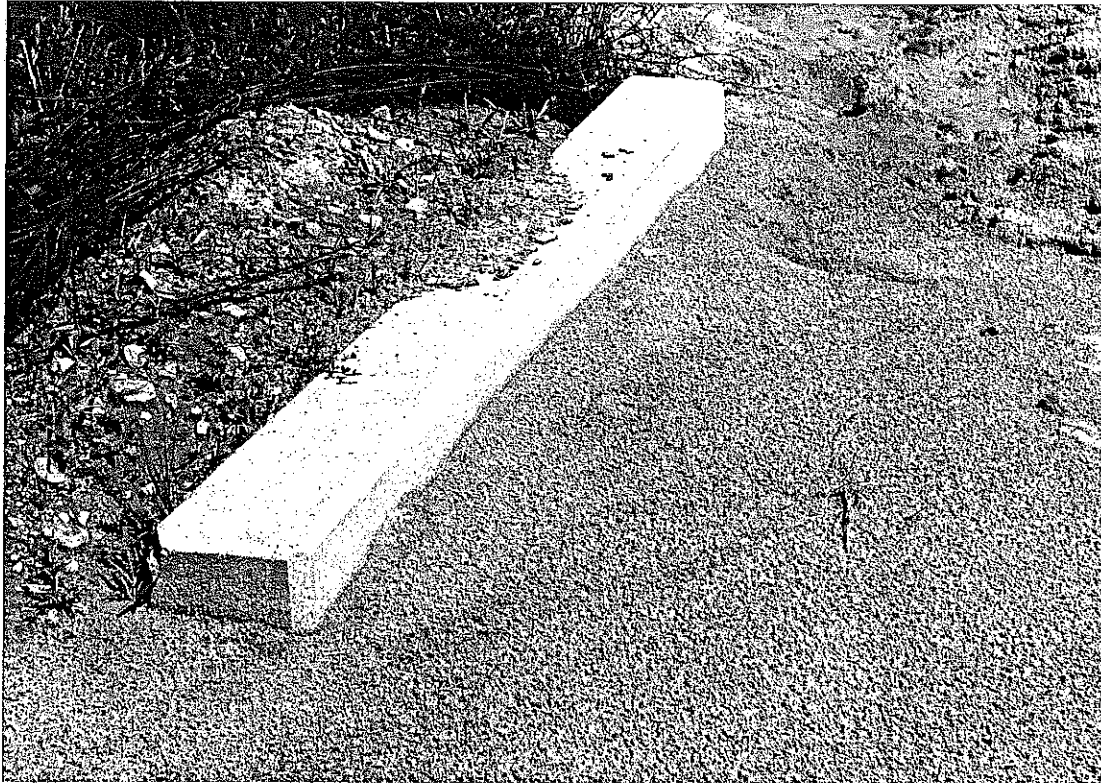
Fig. 9 Entrance to a cross drain completely obstructed by silting. This location on Ky. 174 between Madisonville and Webster County Line, accentuates the importance seeding and mulching for erosion control as soon after construction as possible.

A large number of the silted cross drains observed to date were on newly constructed highways, yet these represented only a small portion of the total. Grading a project one year and surfacing it the next introduces an erosion and culvert-silting situation which is difficult to overcome, particularly when quantities for shouldering are omitted from the original grading contract. Effective cleaning of all cross drains and entrance pipe carried out along with the erosion control measures should be satisfactory, provided erosion control is part of the contract.

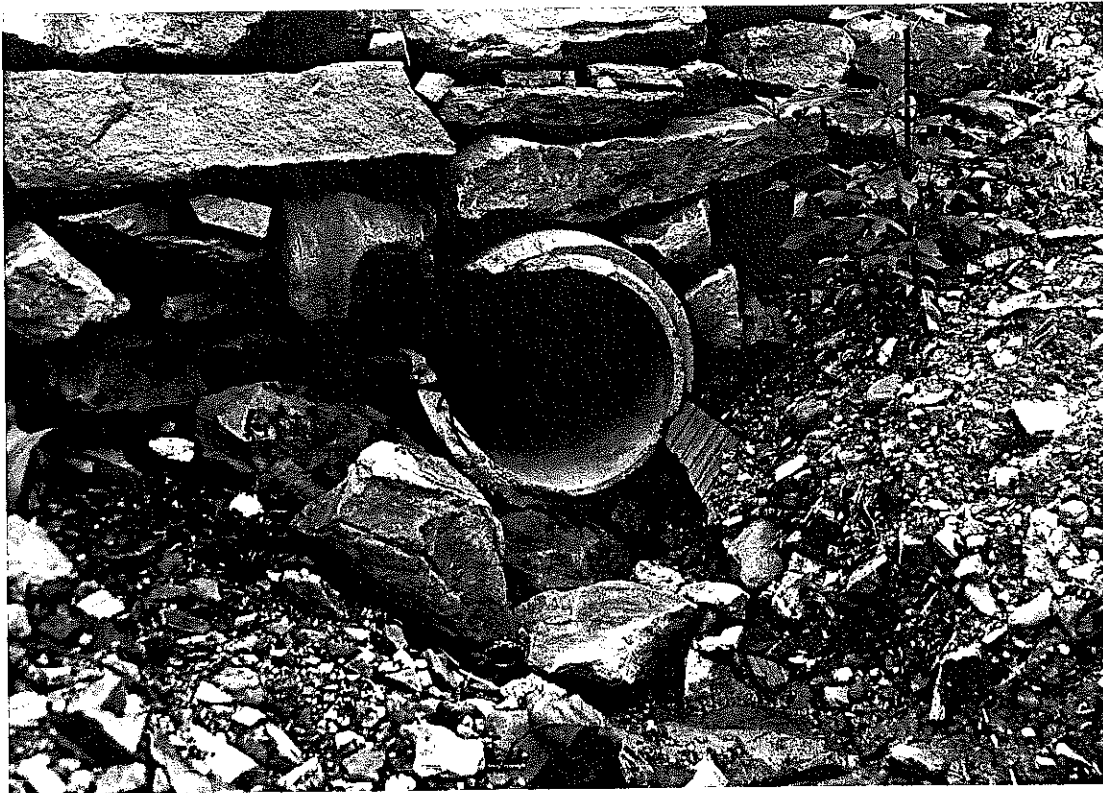
Fig. 10. Undermined culvert on Ky. 15 in Perry County, where water sample No. 1 was taken. The pipe has been pulled apart at joints near the upstream side of the fill, and water passes beneath the pipe to the downstream side during period of flow.

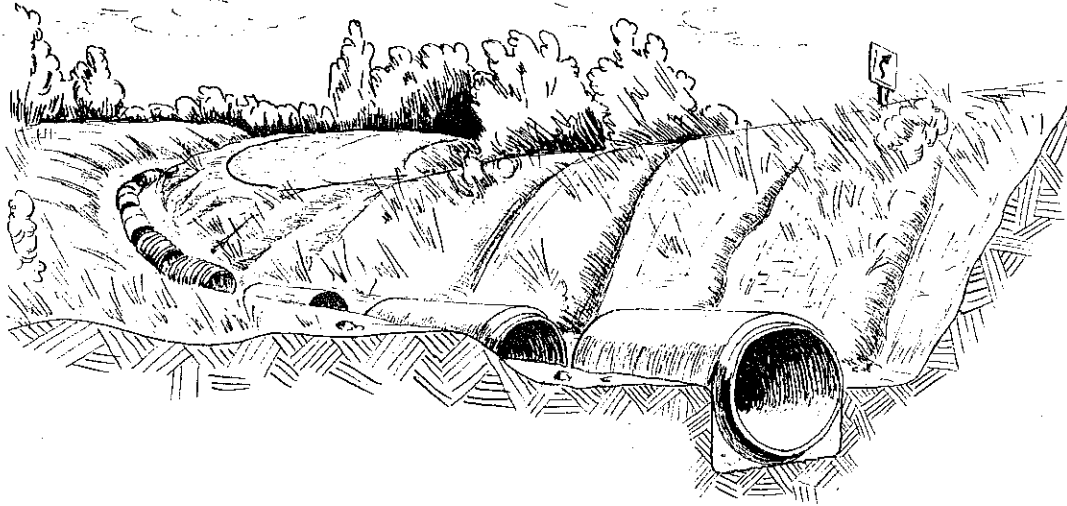
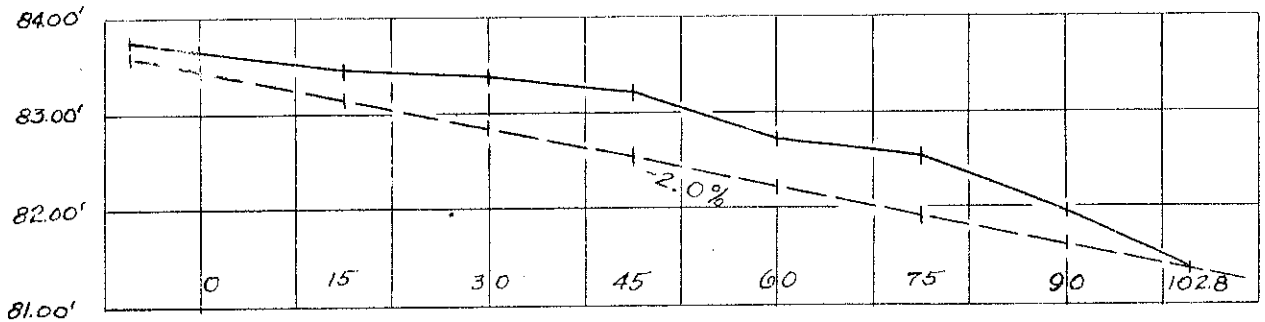
Fig. 11

1. reinforced concrete pipe
2. reinforced conc. pipe coated
3. c.m. asb. bond. coated & paved
4. c.m.(plain galv.) coated & paved, Ky. spec.
5. c.m. paved & half coated
6. c.m. double full coated only
7. c.m. plain galvanized
8. vitrified clay.

**PROFILE** ☉ AND CHANNEL

**PLOT PLAN**  
**CULVERT TEST**  
**INSTALLATION**

In order to establish more tangible evidence of the relative compatibilities of culvert materials under so-called adverse conditions of acidity, a series of test installations have been proposed adjacent to U. S. 41 at the south city limits of Mortons Gap in Hopkins County. The site selected is at the north end of the L. & N. overpass and on the west side of the pavement. The ditch in which the pipes are to be placed cuts through slack and mine refuse and is fed by seepage from springs or abandoned mine tunnels on the hillside overlooking the site. The basis for selecting this water

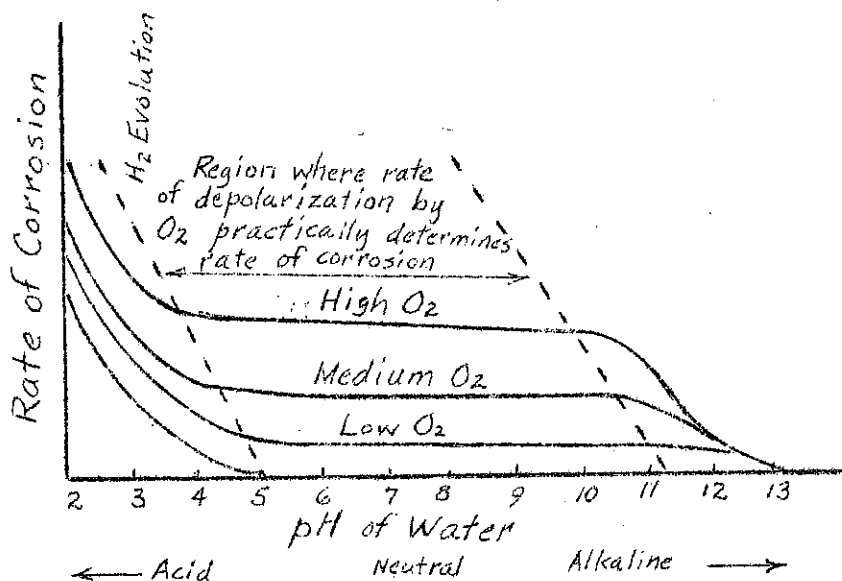
Fig. The influence of pH and oxygen concentration on the rate of corrosion of iron. From McKay and Worthington.

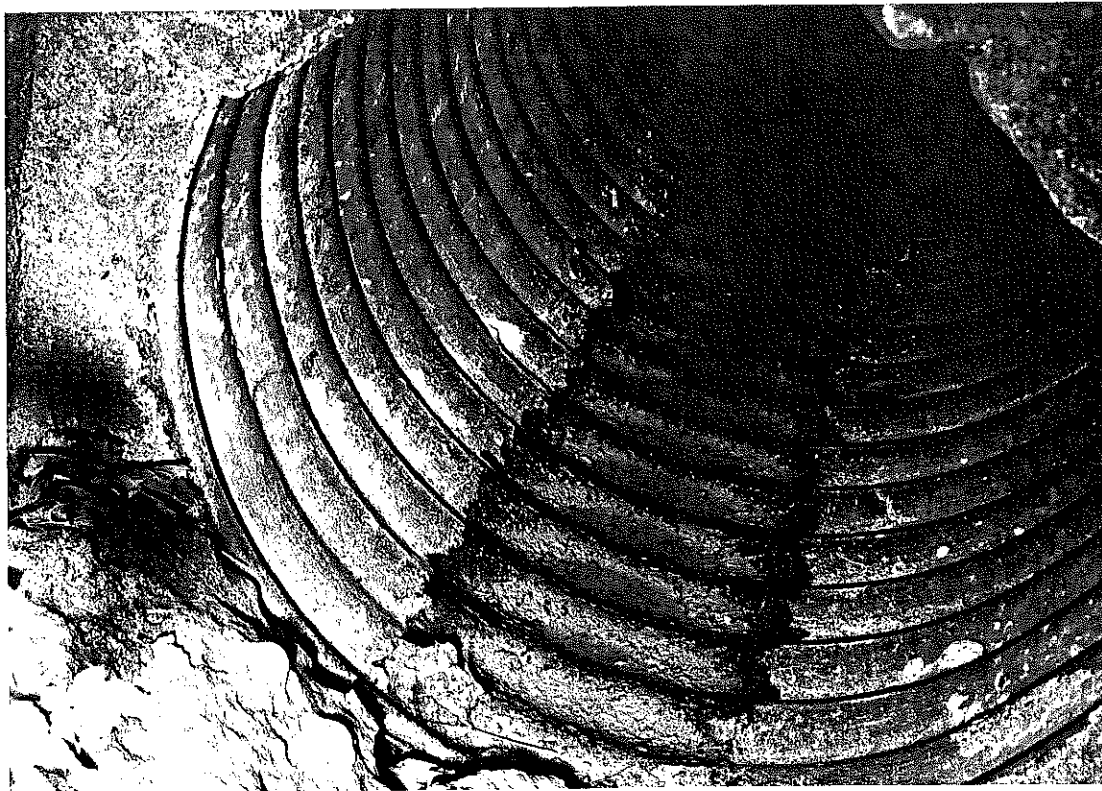
Fig. 13. Plain corrugated metal cross-drain located on Ky. 36 in Bath County. According to the best records available the date of installation was 1926. It is located in a limestone region and apparently accomodates only surface run-off. A sample of residual water taken below the exit showed a specific resistance of 1880 ohms at 25 degrees Centigrade. Although this is a comparatively low value, it cannot be attributed to acidity or the severely corrosive salts.

The water filling the corrugations demonstrates the oxygen and concentration-cell corrosion. Obviously, there has never been appreciable concentration of acid here. The type of rusting or corrosion shown here is very slow in comparison with severely acid exposure.

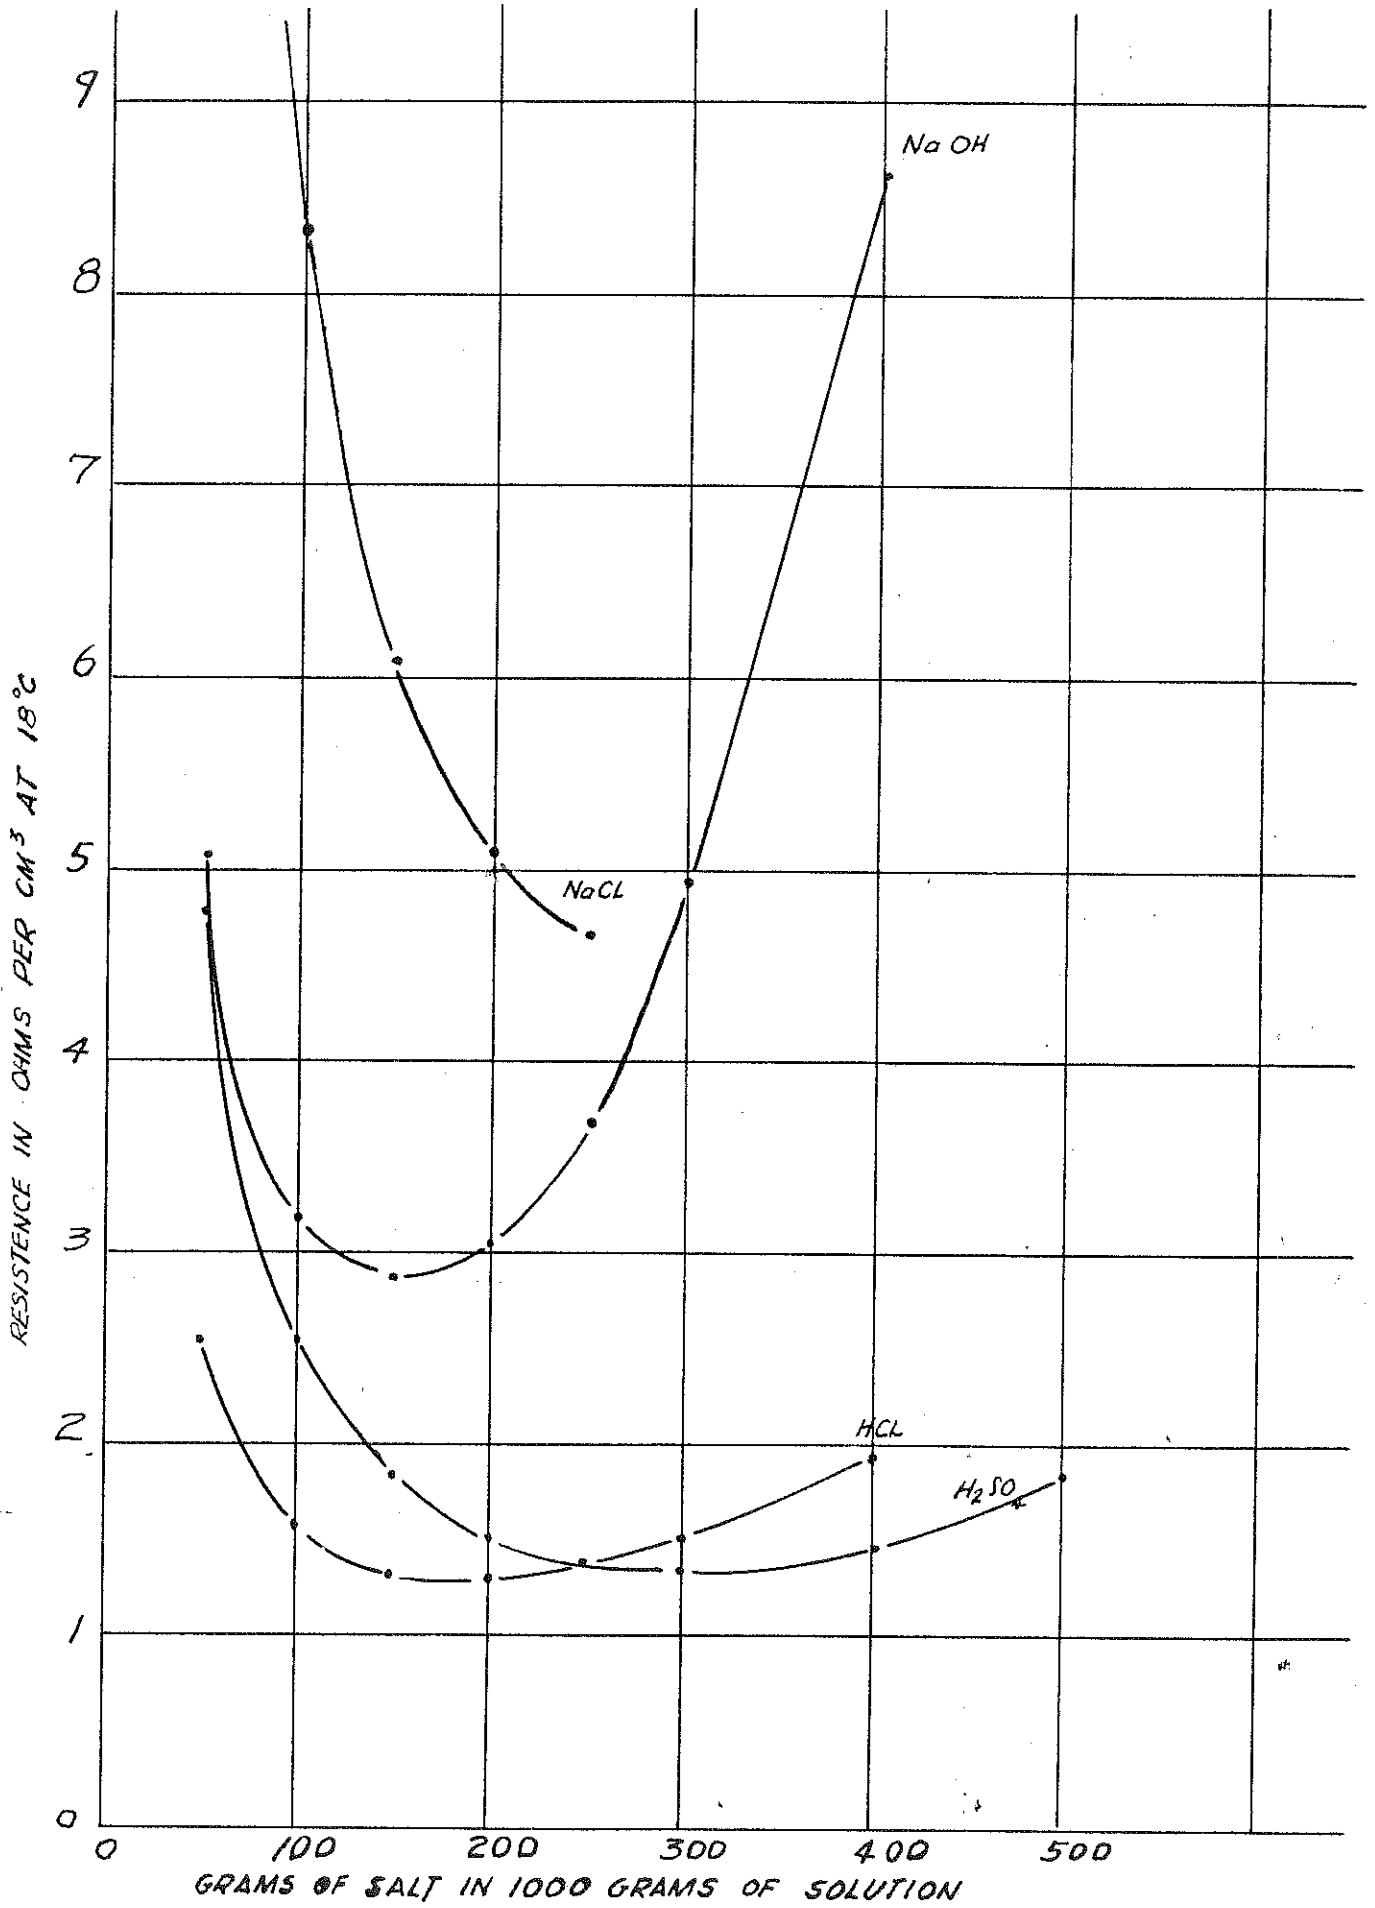
Fig. 15 Showing Specific Resistance Curves

Specific resistance is related to concentrations in a manner described by typical curves as shown in Figure 15 for several strong electrolytes. These relations do not in themselves indicate the number of ions introduced per unit weight of the solutes because concentrations are expressed in grams of salt per 1000 grams of solution. The curves represent extremely high concentrations - many times higher than could ever be ex-

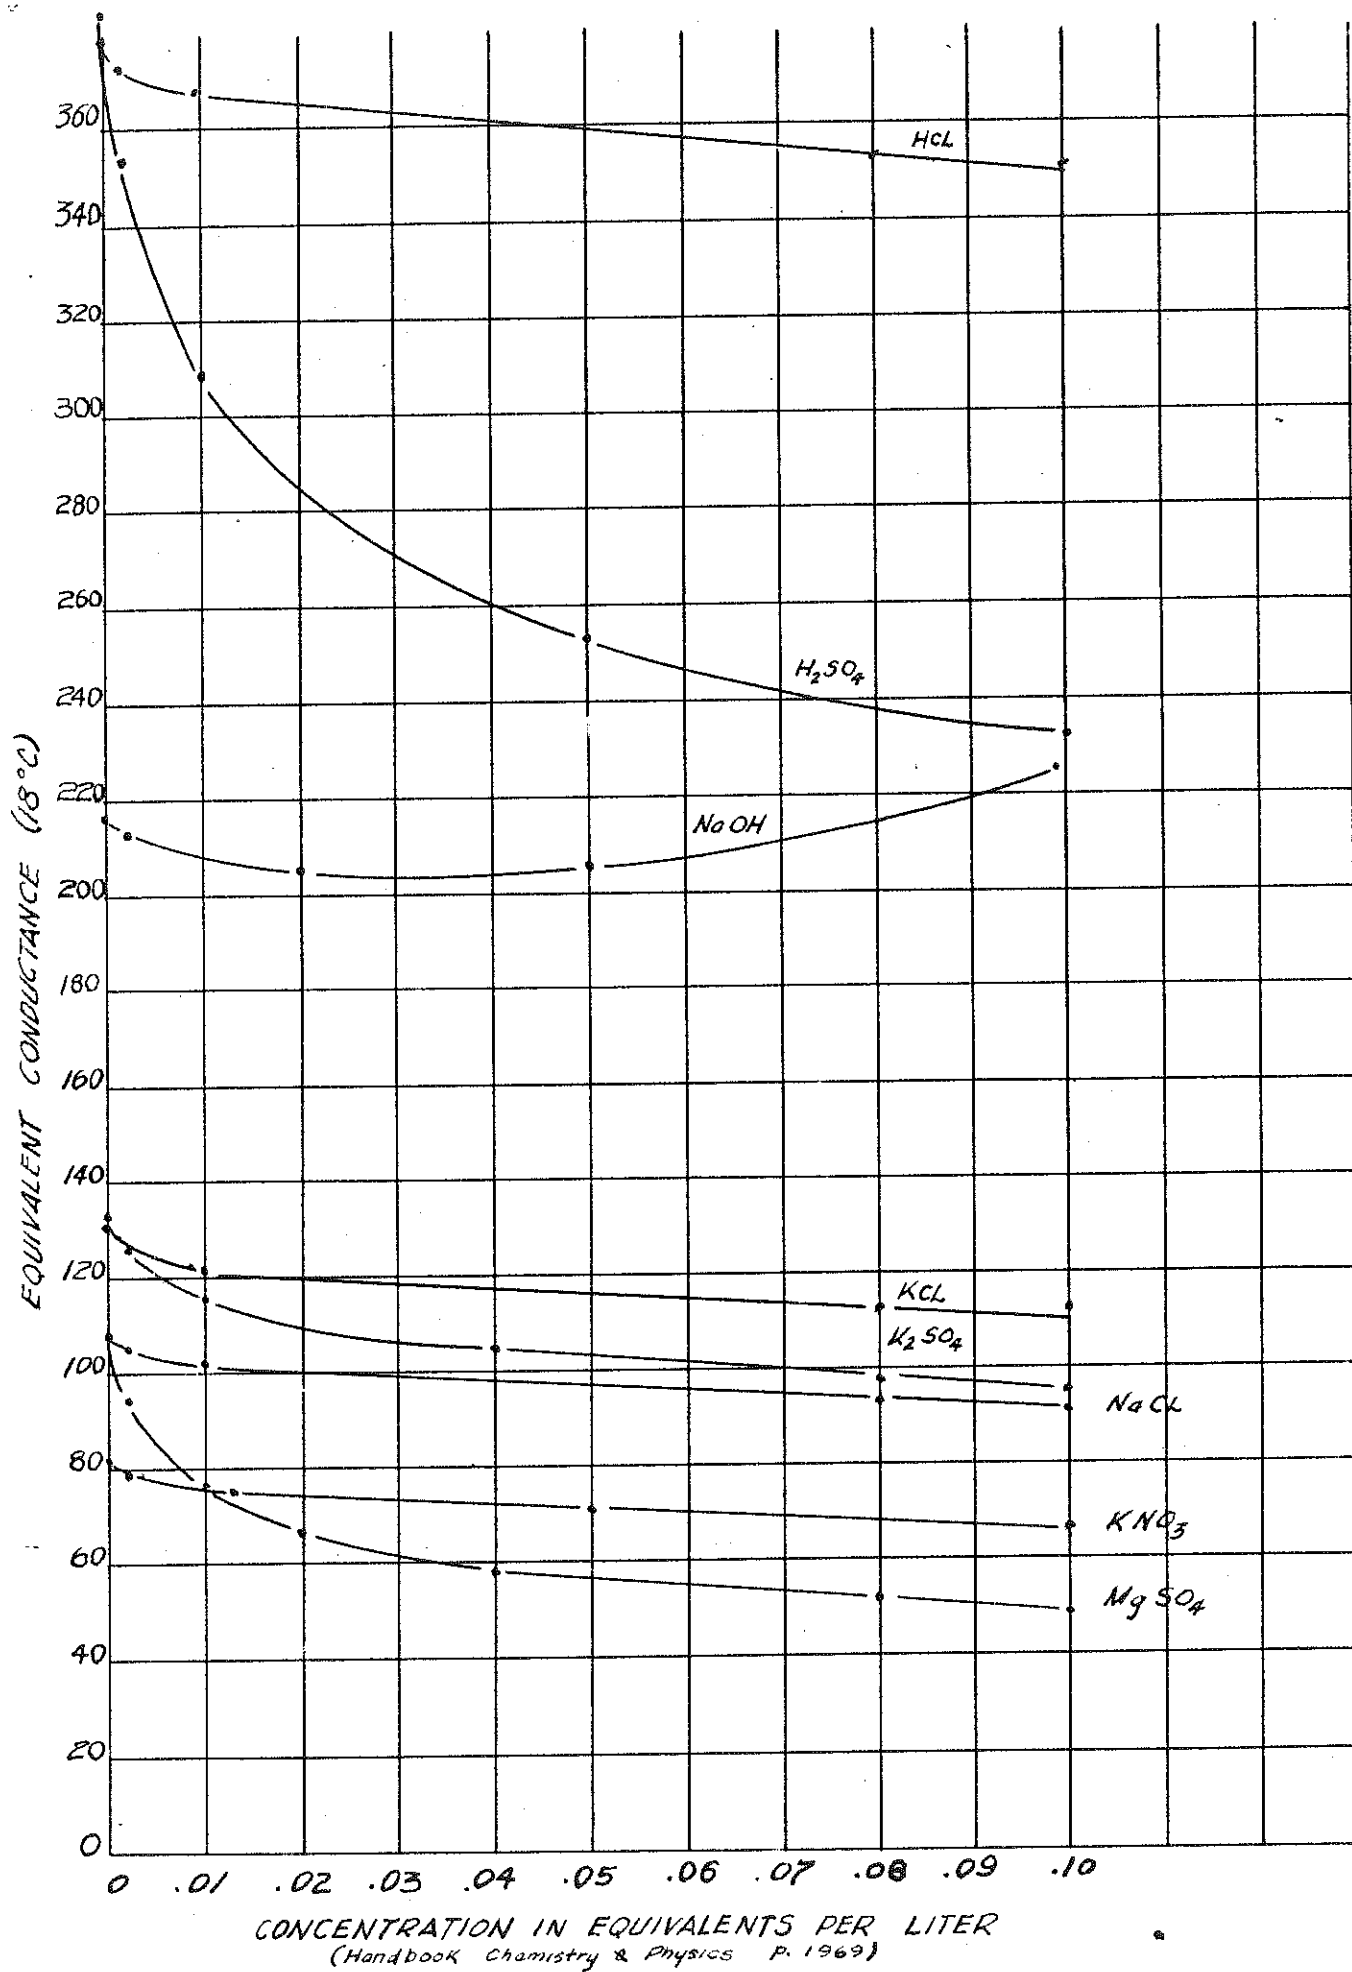
Fig. 16 Showing Equivalent Conductance Curves

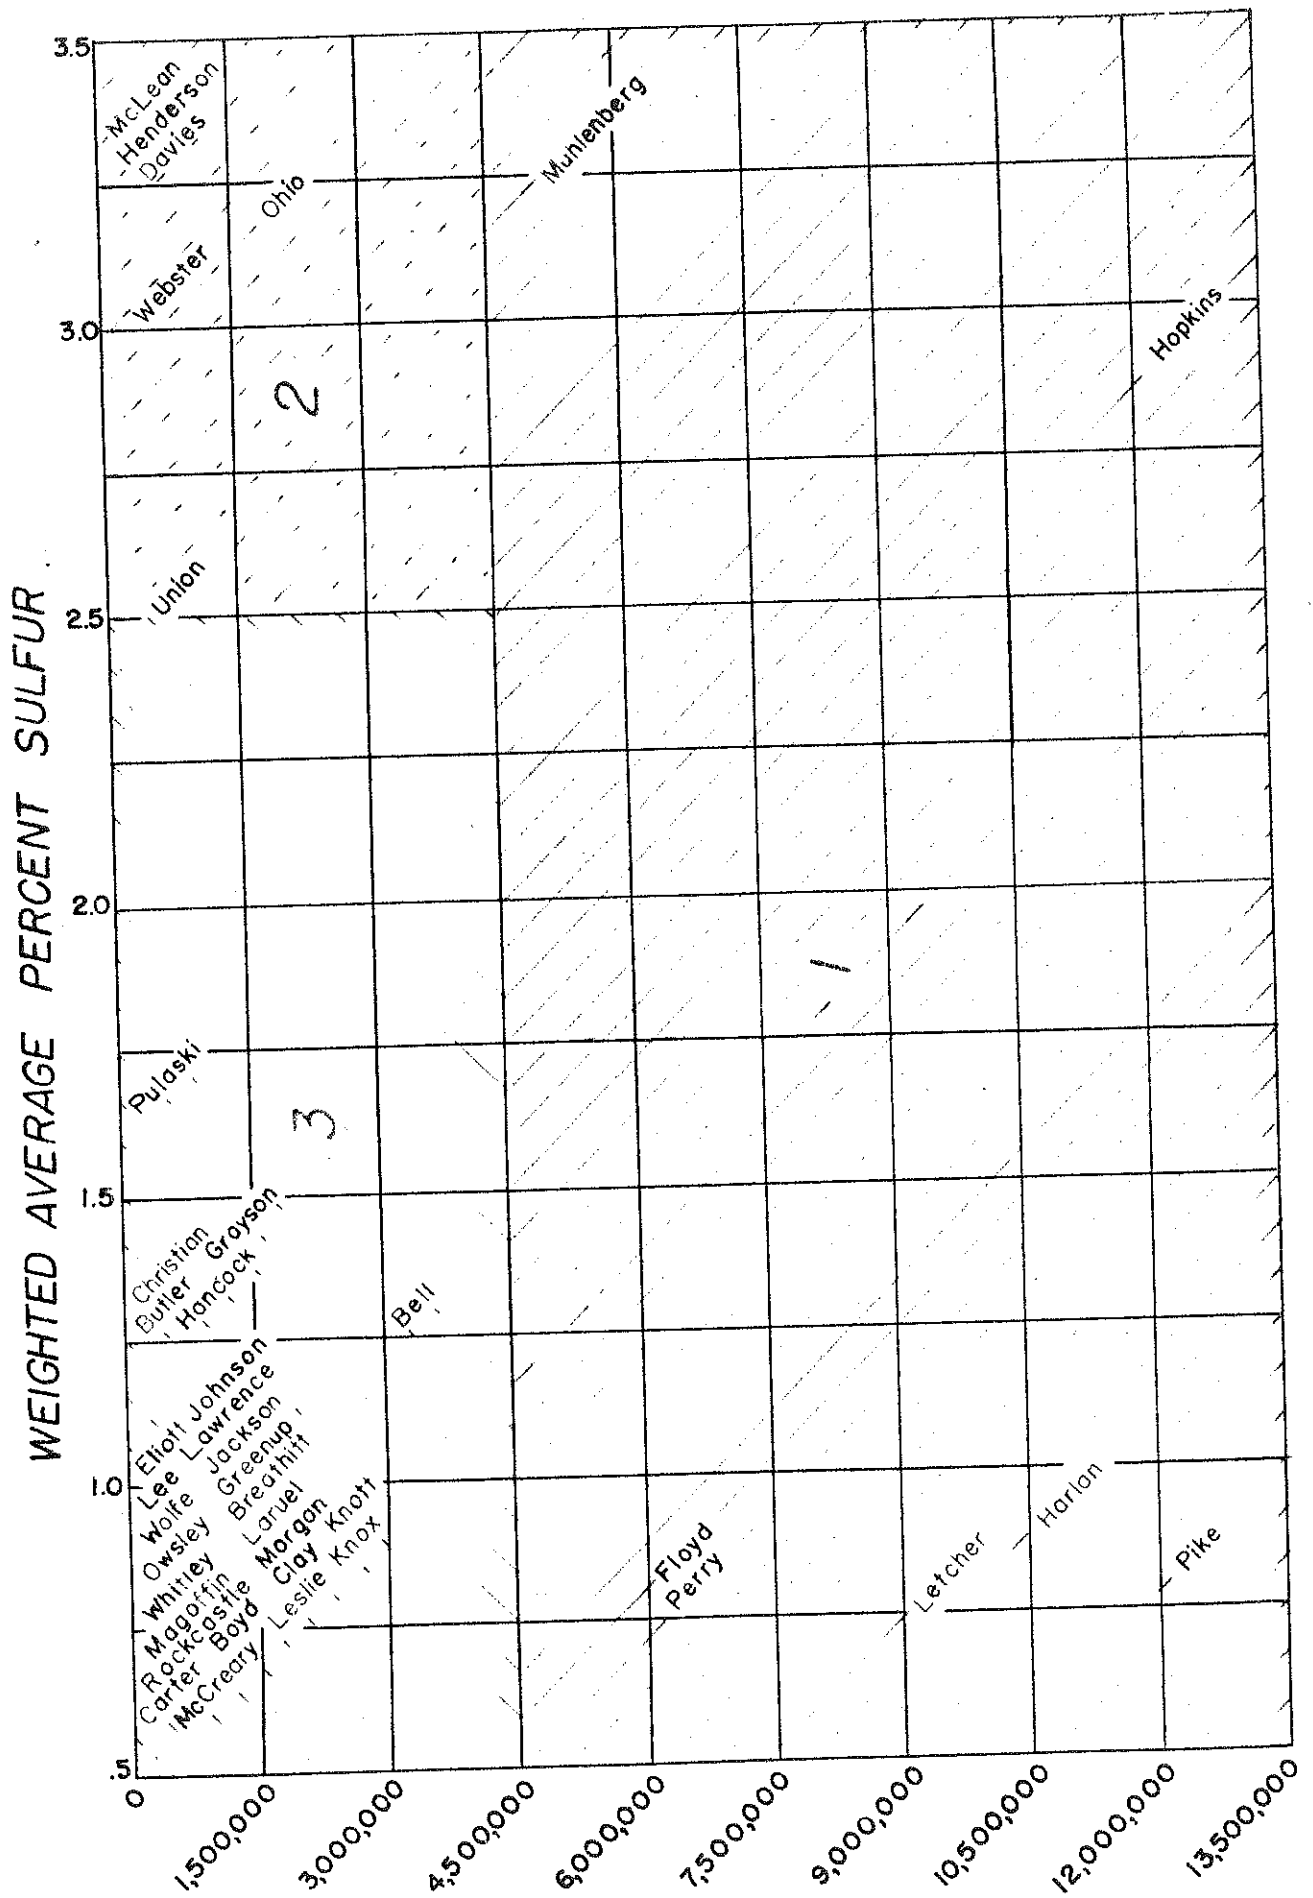
Fig. 17 Showing Grouping of Counties by Production and Sulfur Content

An attempt is made here to integrate these data by counting every coal seam that was mined in each county and the number of mines working each seam. The percent sulfur was multiplied by the number of mines for every seam and an average was taken for all seams mined. On a plot of average percent sulfur versus annual production, the various counties tend to group into three categories is shown in Fig. 17. From this analogy, three categories seem to describe a natural basis for classification. By further projection the classification may be defined in more definite terms, as follows:
