A LABORATORY INVESTIGATION OF MINERALOGICAL,
CHEMICAL AND PHYSICAL PROPERTIES OF LIMESTONE AGGREGATES

J. L. Young, Jr., Research Geologist
J. H. Havens, Research Chemist
and
L. E. Gregg, Associate Director of Research

Prepared for Presentation at
The 28th Annual Meeting of
The Highway Research Board
Washington, D. C.

Highway Materials Research Laboratory
Lexington, Kentucky

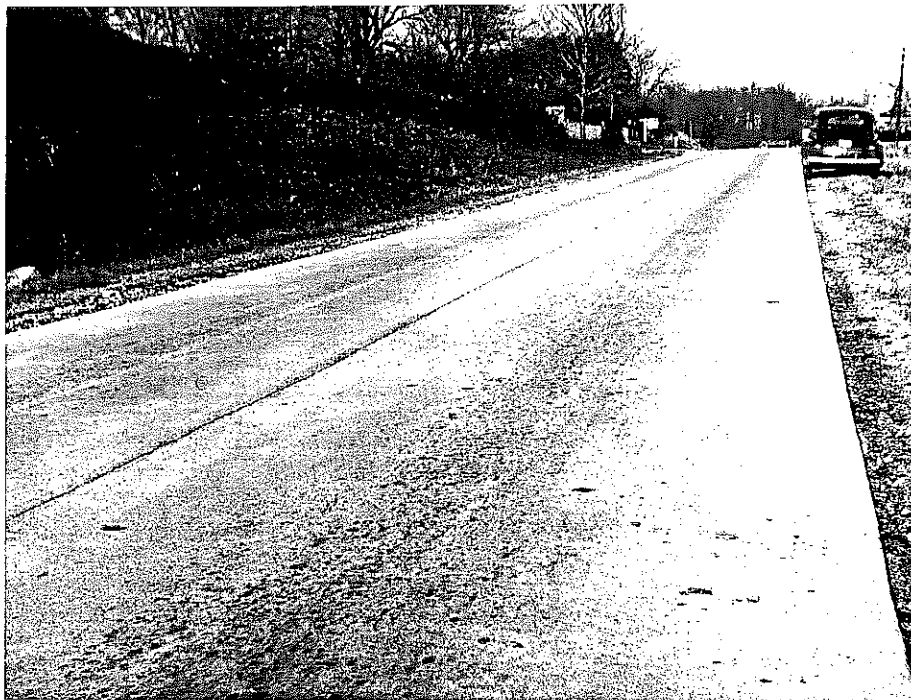
In order to isolate limestone aggregate showing distinct ranges in performance, four quarries were initially chosen and generally rated as to their influence on concrete pavements. This rating was made from performance surveys of pavements in service. *Slide No. 1 illustrates a heavily traveled pavement, (U.S. 25) made with aggregate from Quarry No. 2, which was rated as good. This pavement has 21 years of service.

Slide No. 1. U.S. 25 - Berea-(Roundstone)

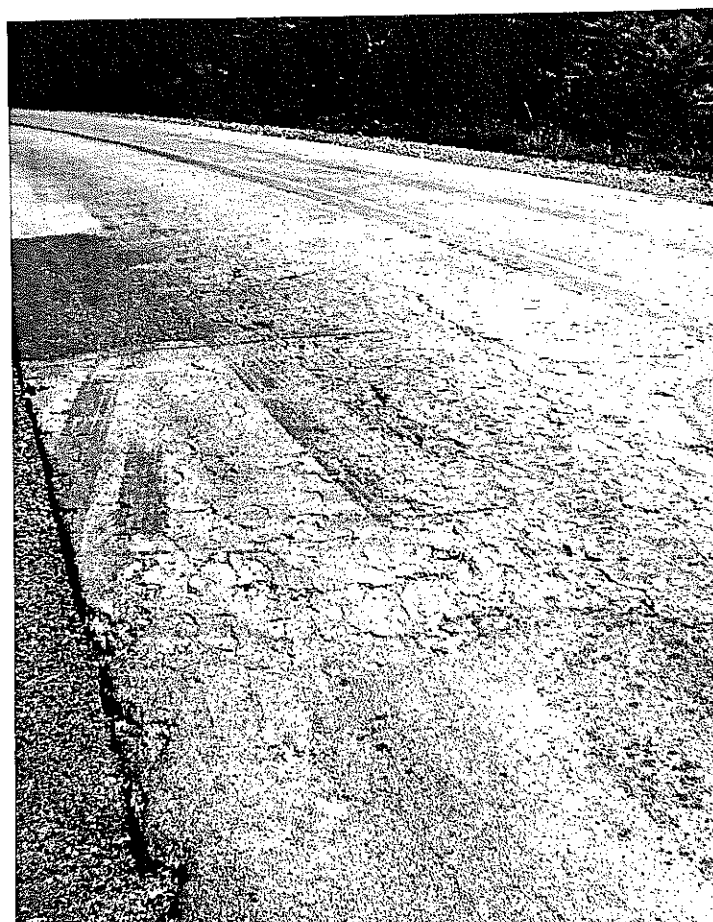
Slide No. 2 shows a failing pavement on U.S. 60, which is less heavily traveled than U.S. 25 and which has 24 years of service. This concrete was made with aggregate from Quarry No. 3, which is rated as poor. Of the two remaining sources, Quarry No. 1 was rated fair on the basis of extensive service records and Quarry No. 4 as excellent on the basis of more restricted use and pavements of more recent origin. The sources

Slide No. 2. U.S. 60 - Made from Quarry No. 3

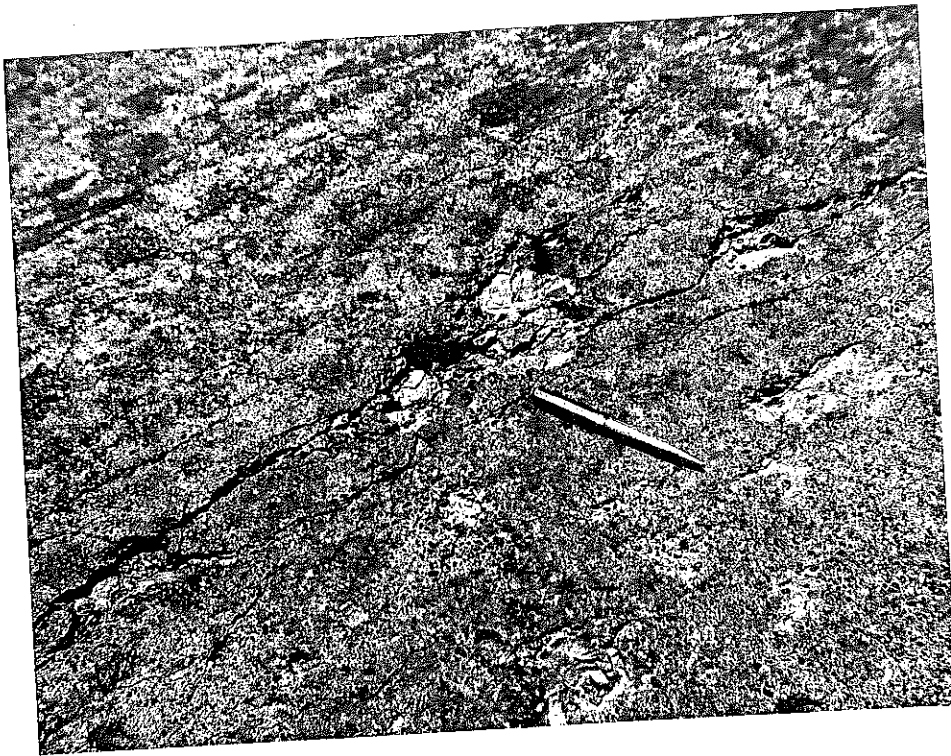
Slide No. 3. U.S. 60 - Made from Quarry No. 3

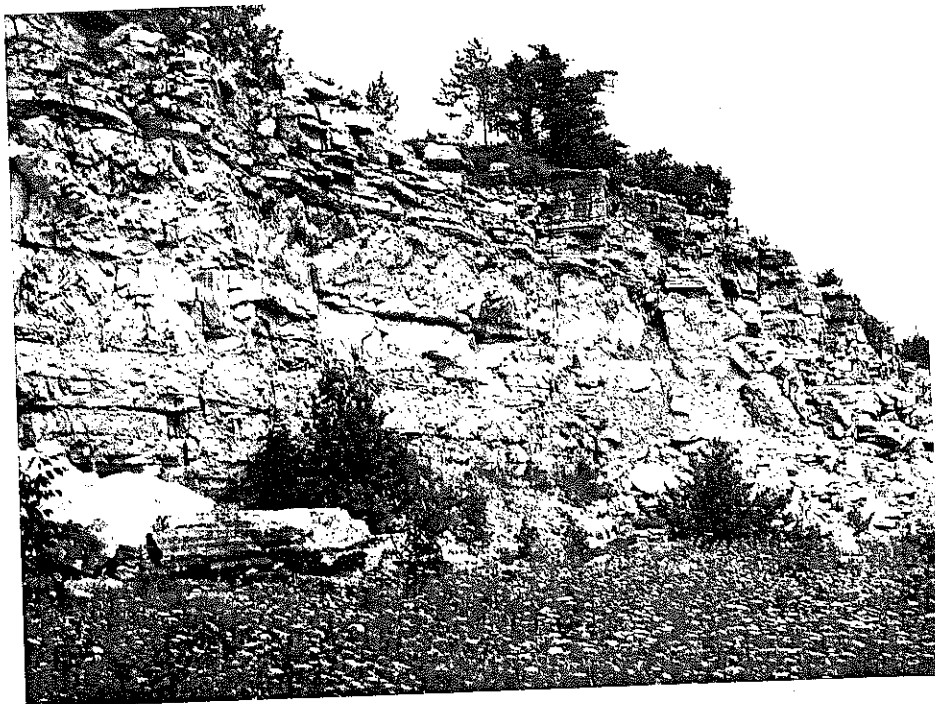
Examination of Quarry No. 3 (Slide No. 4) showed this ledge to be a pure cream colored, fine-grained limestone, which had the appearance of being quite sound. However, blocks of this material on the quarry floor had disintegrated almost completely in comparison to other materials (Slide No. 5).

Slide No. 4. Quarry No. 3
(Ledge shown by arrow)

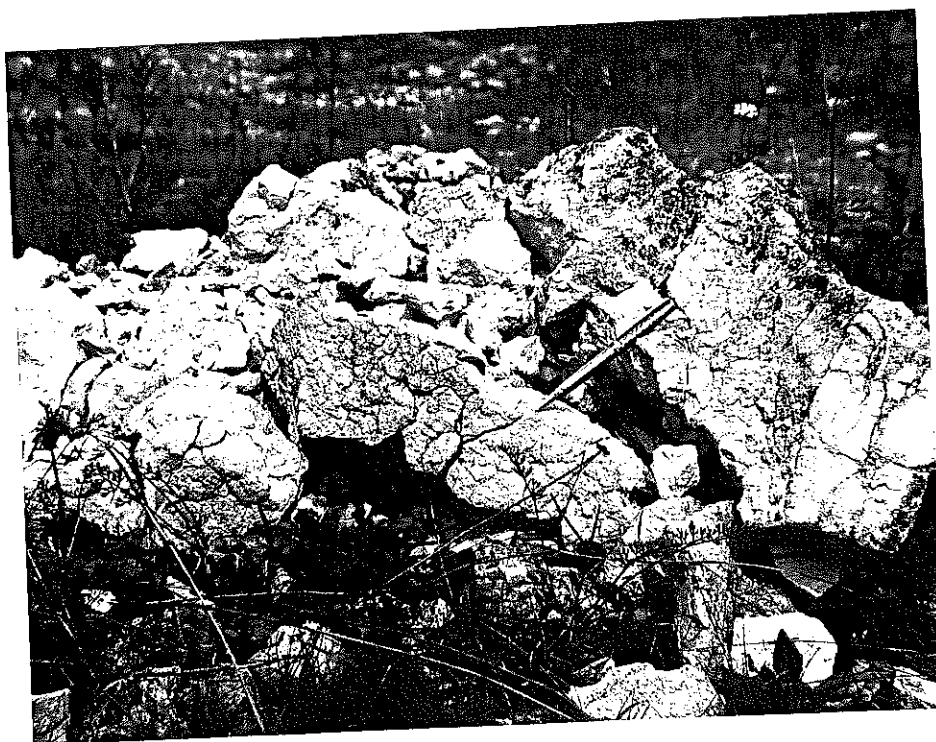
Slide No. 5. Weathered Block in Quarry No. 3

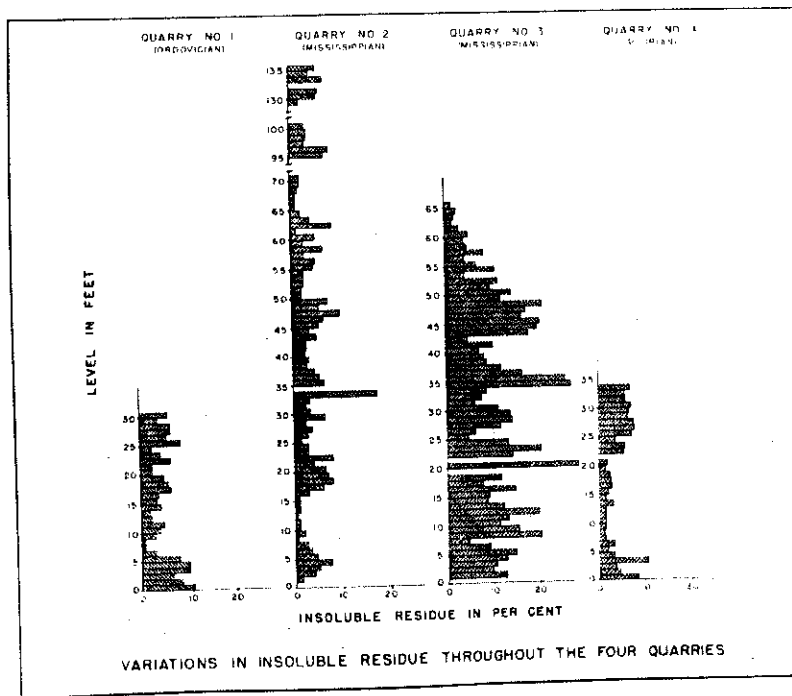
Slide No. 6. Variations in Insoluble Residue Throughout the Four Quarries.

In Slide No. 6, the variations in amount of insoluble residue on a foot-by-foot basis is indicated for the four quarries tested. Not only does this show that a range in this property occurs in the four quarries, but the quarry averages of Insoluble Residue in percent per unit weight of material could not be correlated directly with the general ratings given the quarry on the basis of pavement performance rating. These averages are: Quarry No. 4, Insoluble Residue 4.166%, Rating - excellent; Quarry No. 2, Insoluble Residue 3.880%, Rating - good; Quarry No. 1, Insoluble Residue 5.145%, Rating - fair; Quarry No. 3, Insoluble Residue 11.900%, Rating - poor.

First, the residues were examined under the microscope. It is necessary for brevity to describe these in generalities. (Slide No. 6)

Quarry No. 1 was highly organic in nature as revealed by insoluble residues. This could be expected from the richly fossiliferous character of the rock. Silica in the form of chert was the most predominate element, often replacing entire fossils. Crystalline Quartz, Galena, Pyrite and Mica formed minor elements in the residues. Clay was prominent in every fraction.

Quarry No. 2 was quite pure, averaging better than 95% carbonates. Silica in the form of sand grains and crystalline quartz was predominant. The minor mineral suites of Pyrite, Mica and Gypsum were present, but in correspondingly smaller amounts. Occassionally small bits of coal could be found. Clay was again present, but not prominent.

Quarry No. 3 was the most impure in composition, with only about 85% carbonates. A peculiar aspect of this quarry was the abundance of large rounded and frosted sand grains. Bearing in mind that Quarries No. 2 and No. 3 are identical in age it is apparent that an abrupt change has occurred in the type of limestone formed. The average amount of residue increased approximately 5 times. In contrast, the minor mineral suites

Quarry No. 4 was dolomitic limestone with better than 94% carbonates, of which about 18% was $MgCO_3$. The minor mineral suites were dominated by Pyrite, with Quartz and Clay about equally predominant.

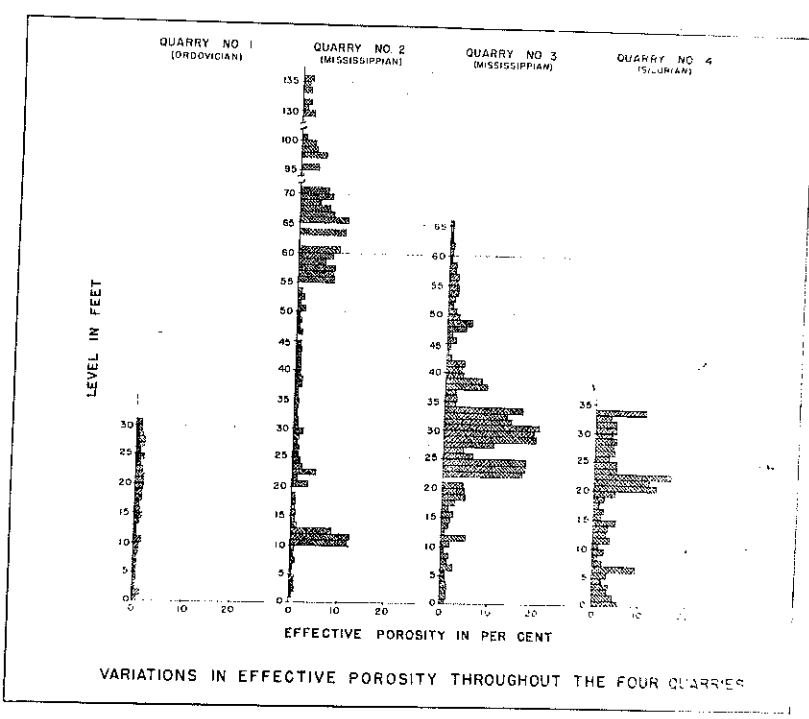
In Slide No. 7, the variations in amount of "effective"

Slide No. 7. Variations in Effective Porosity Throughout the Four Quarries

porosity is shown. This again is on a foot-by-foot basis and is intended to show the lack of uniformity within any quarry tested.

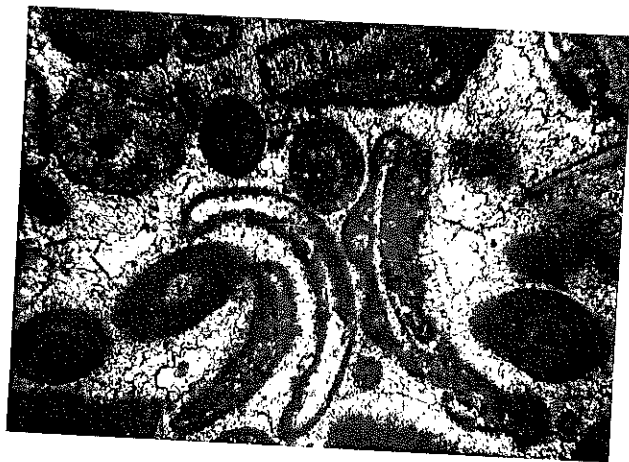
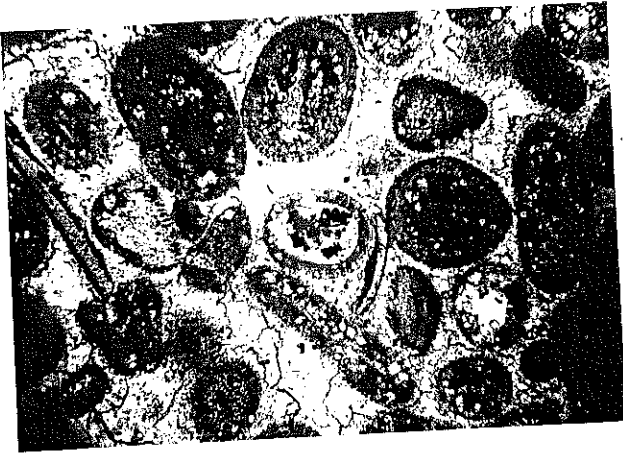
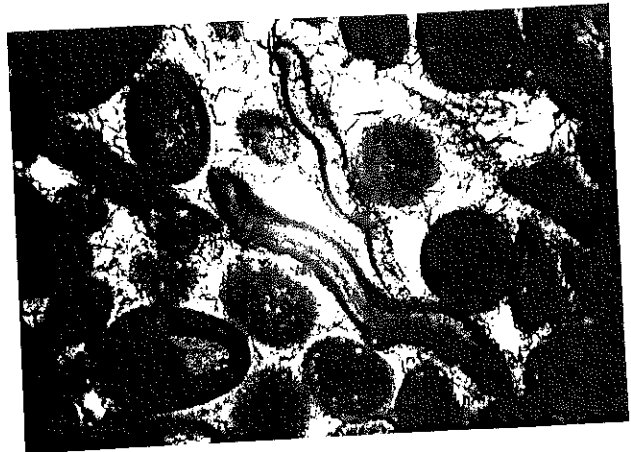
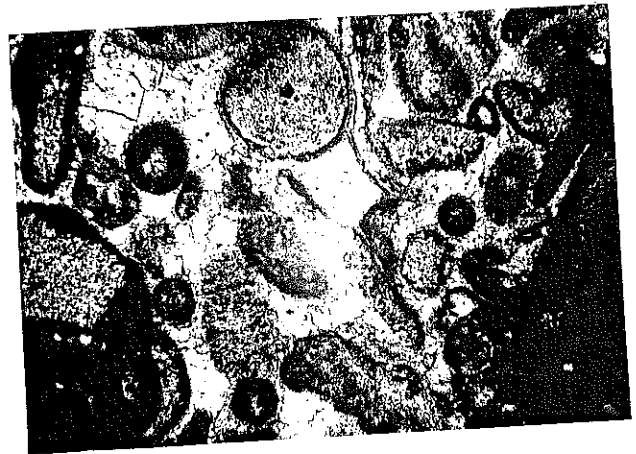
Structural variations within a quarry are often extreme. In the following series of slides, a ten foot vertical distance is covered foot-by-foot. These represent thin-sections made from material in Quarry No. 2. In every case the section was made in a vertical plane. The variations within a quarry as shown here is typical for all of the properties thus far investigated.

Slide No. 8
61 ft. Level, Quarry No. 2

Slide No. 9
62 ft. Level, Quarry No. 2

Slide No. 10
63 ft. Level, Quarry No. 2

Slide No. 11
64 ft. Level, Quarry No. 2

Slide No. 12
65 ft. Level, Quarry No. 2

Slide No. 13
66 ft. Level, Quarry No. 2

Slide No. 14
67 ft. Level, Quarry No. 2

Slide No. 15
68 ft. Level, Quarry No. 2

Slide No. 16
70 ft. Level, Quarry No. 2

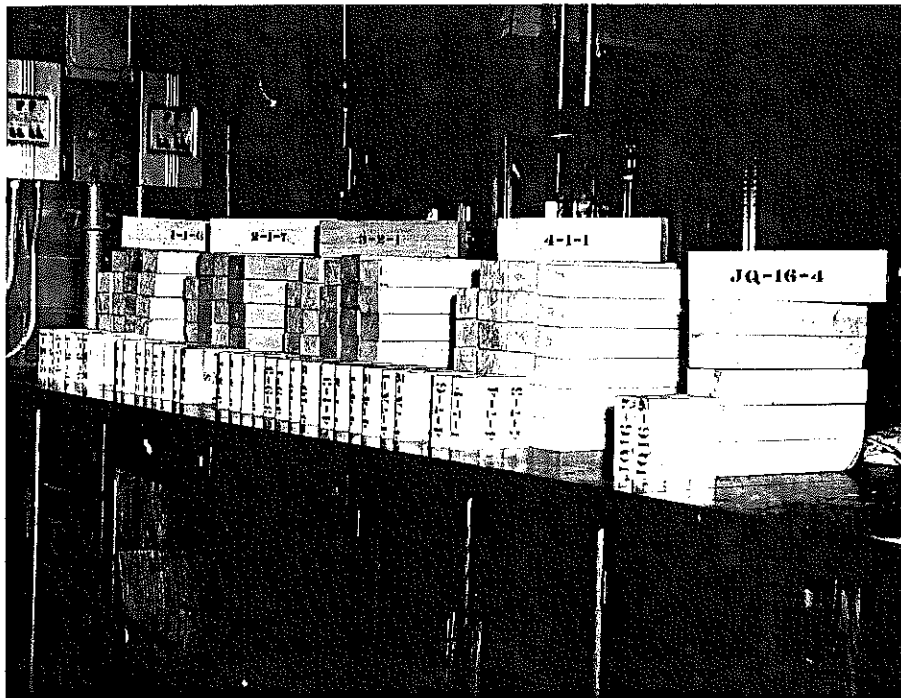
From these test specimens, beams of limestone were sawed and cores were drilled.

Half of each set were broken, the beams by flexural (third point) break and the cores by compressive break. The remainder were saturated by vacuum and entered in freeze and thaw. Concrete beams were made of the same material using the

Slide No. 17. Beams and Cores of Limestone

Concrete and limestone beams were measured every seven cycles for length and sonic modulus of elasticity. At the present, durability tests are still in progress so that this phase cannot be reported.

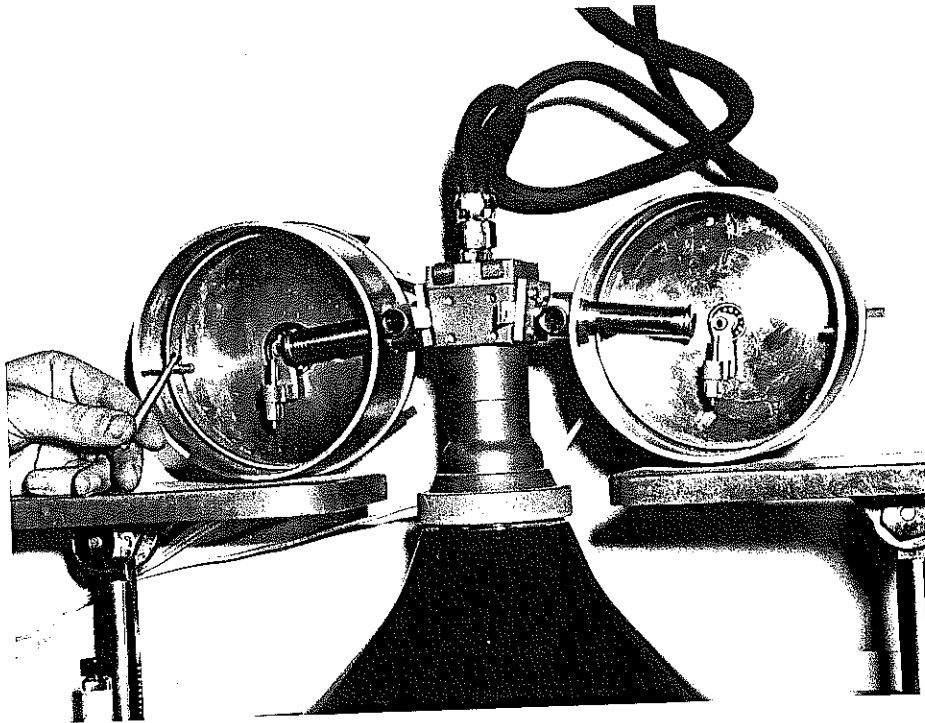
The clay present was analyzed next by quarry zones and next by individual level for the 17 individual levels. X-ray diffraction was employed using the powder method, an adaptation of the Bragg method of X-ray analysis. Clay samples were obtained from a modified insoluble residue process. The colloidal fraction from this process was separated, dried and ground to pass a No. 325 sieve. It was then mounted in a wedge shaped sample holder (shown being held in Slide No. 18), the specimen and holder were then mounted in the Cylindrical Powder Camera. Film was clamped around the inner periphery, the camera sealed, and the specimen was then bombarded with X-rays. The minerals diffracted the X-rays characteristically, and a pattern was obtained on film (Slide No. 19) by which the specimen was identified mineralogically.

Slide No. 18. X-ray Powder Cameras

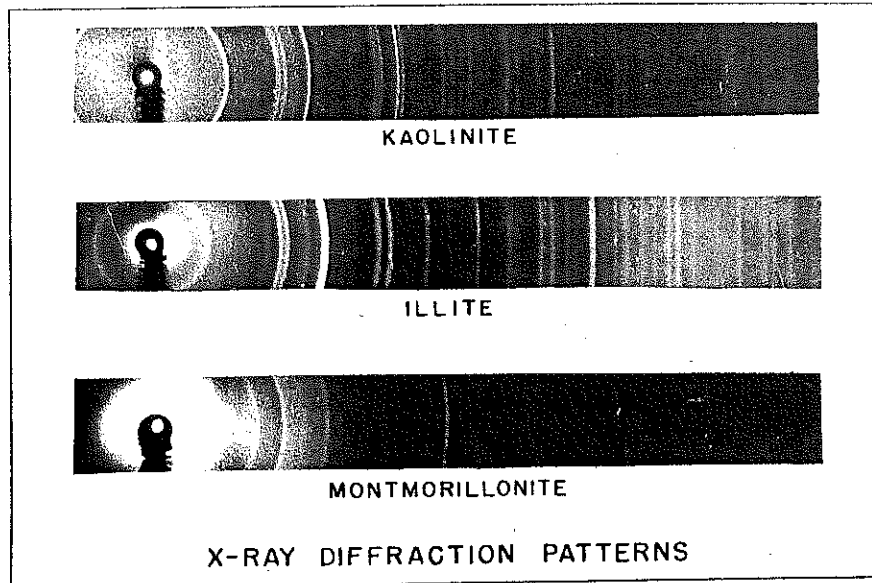
Slide No. 19. X-ray Diffraction Patterns

In Quarry No. 1, the clay was composed principally of Illite, with one occurrence of pure Kaolinite.

In Quarry No. 2, the clay was composed principally of Illite. However in two instances, there were contrasts. One was a pure Montmorillonite and the other an Illite, Montmorillonite combination.

In Quarry No. 3, the clay was exclusively Illite throughout.

In Quarry No. 4, the clay was dominantly Illite and Kaolinite.
