Research Report
KTC 93-16

PERFORMANCE OF EXPERIMENTAL
HIGHWAY BASE AND SUBBASE LAYERS
CONTAINING BY-PRODUCT MATERIALS
FROM A COAL-FIRED POWER PLANT:
KY ROUTE 3074, BLEICH ROAD

Kentucky Transportation Center
College of Engineering
University of Kentucky

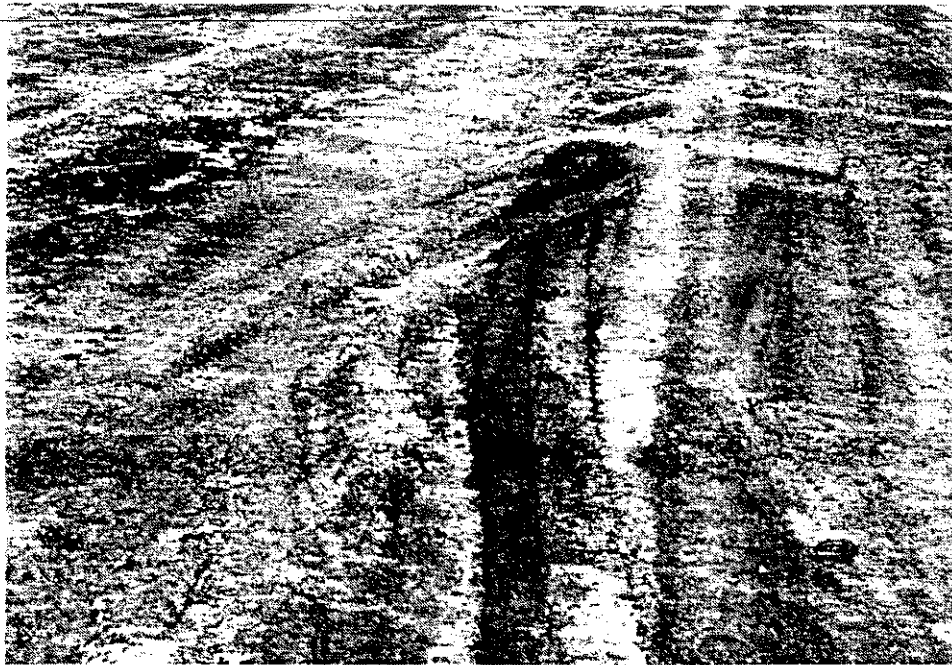
Figure 3. *A view of the westbound lane of the experimental AFBC concrete base layer near STA 51+50 shortly after construction.*

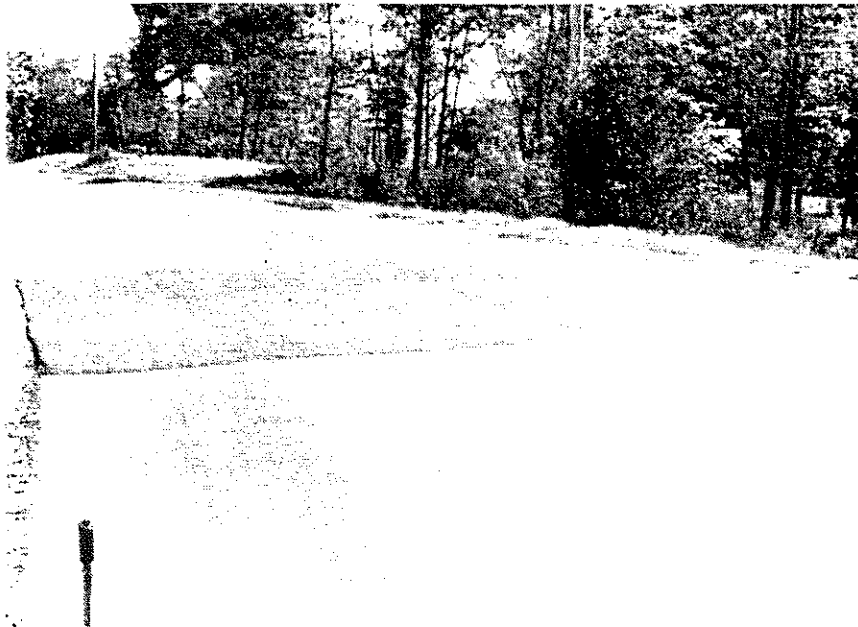
Figure 6. *The pavement near STA 50+00 had been milled and a full-width bituminous patch had been placed.*

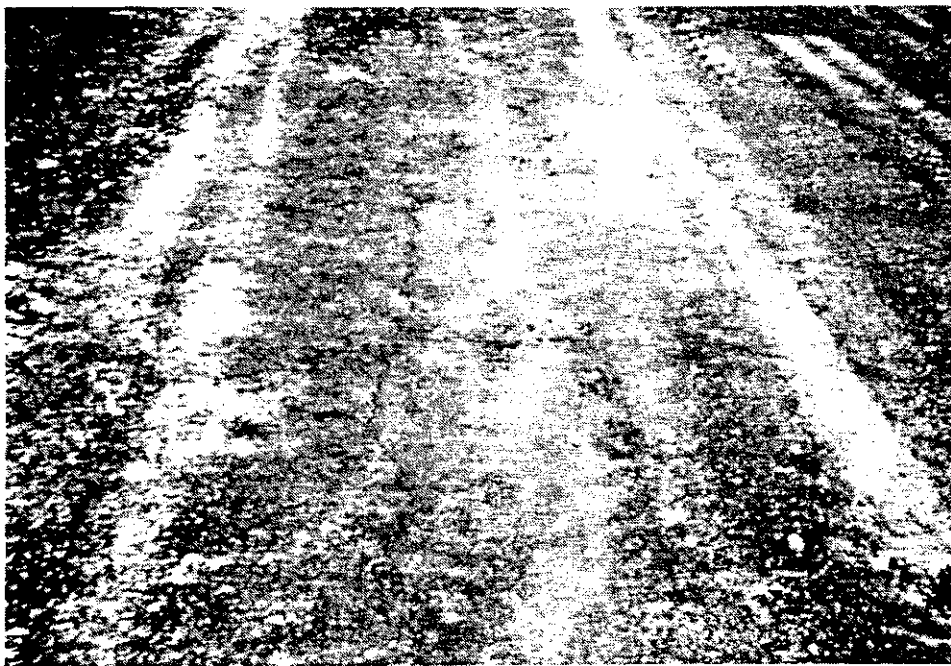
Figure 8. *Longitudinal centerline cracking of the AFBC concrete base near STA 45+50 approximately two weeks after final compaction.*

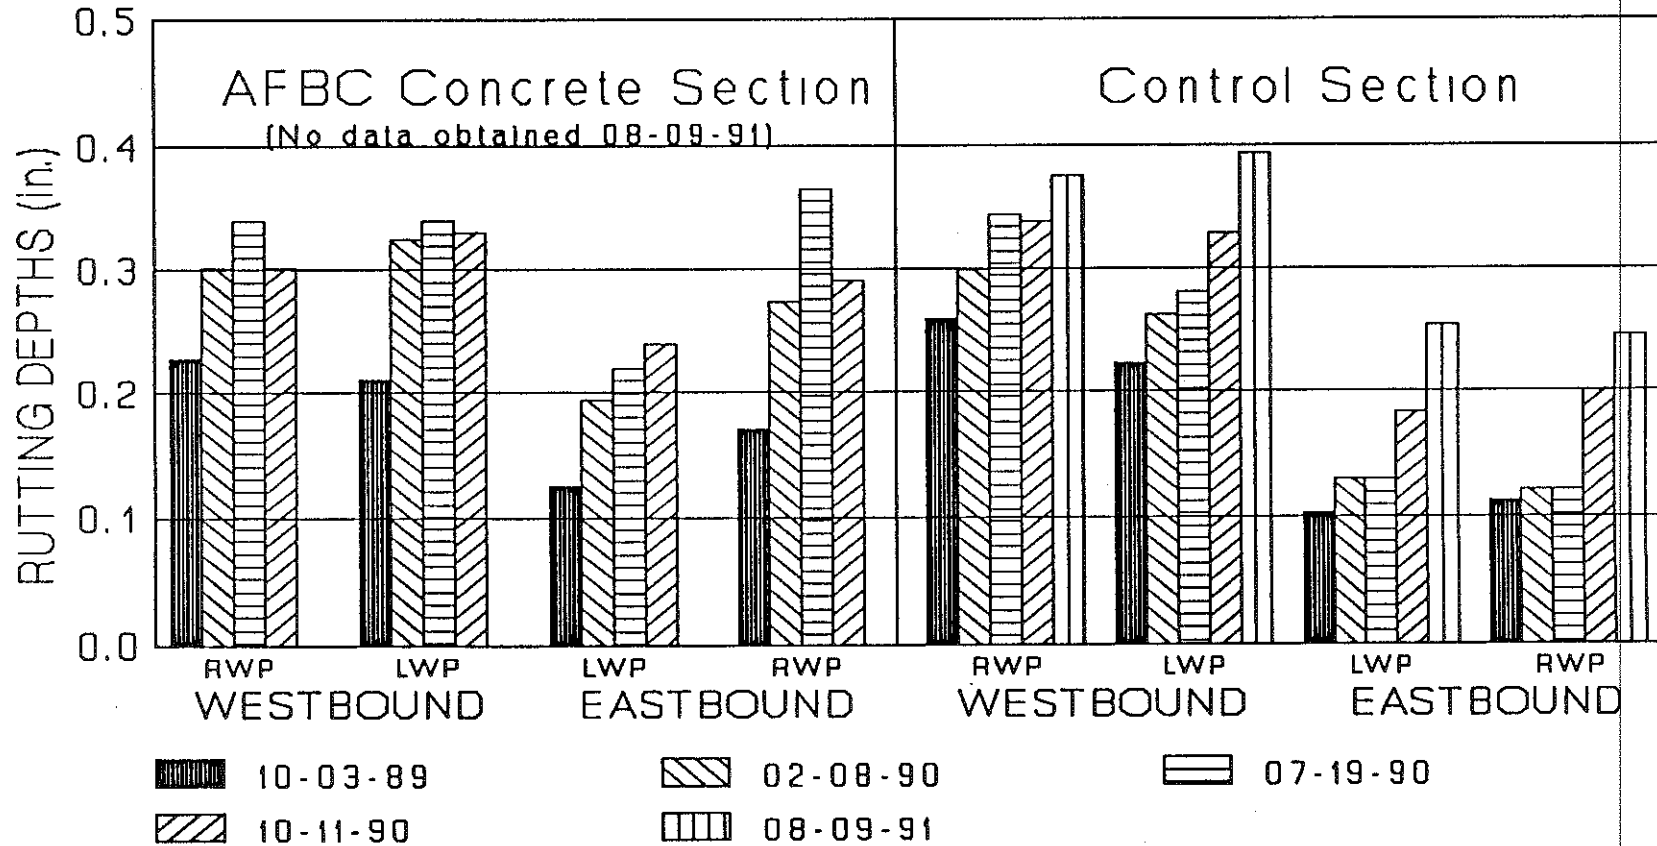
Average Rut Depths for entire Section

Figure 10. Rutting characteristics of the experimental AFBC concrete base section and the control section as a function of time.

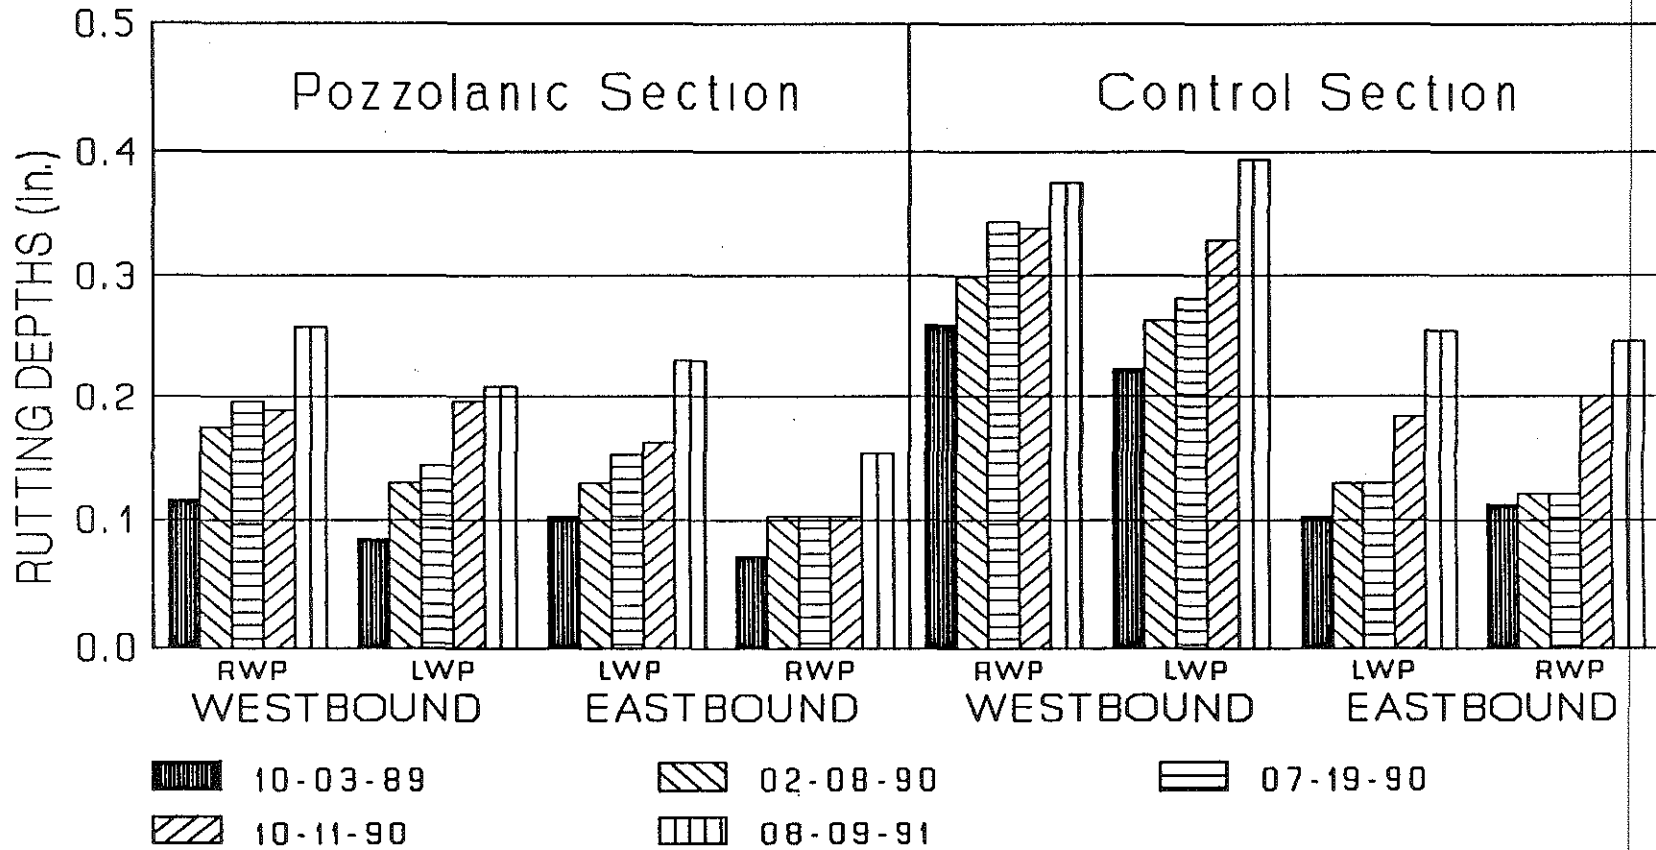
Average Rut Depths for entire Section

Figure 11. Rutting characteristics of the experimental pozzolanic base section and the control section as a function of time.

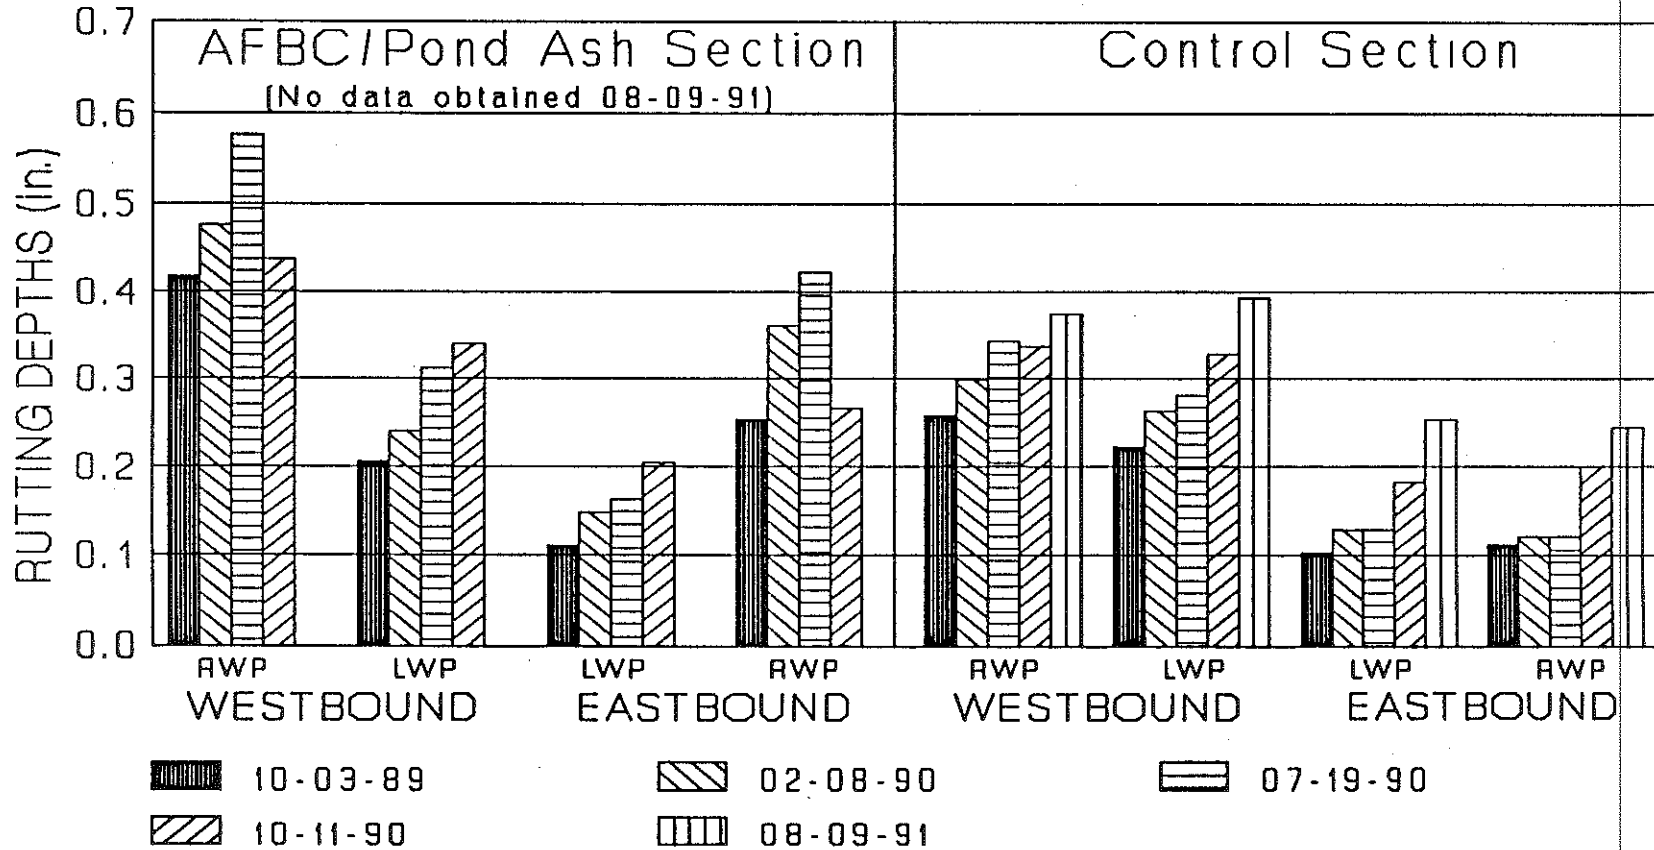
Average Rut Depths for entire Section

Figure 12. Rutting characteristics of the experimental AFBC stabilized pond ash subbase section and the control section as a function of time.

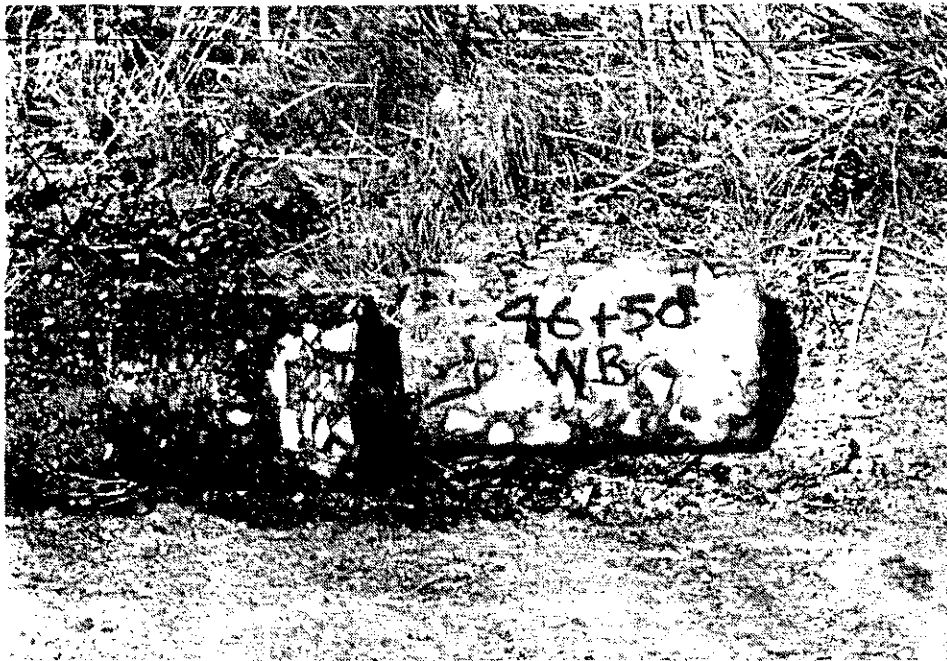
Figure 13. *A field core obtained in the AFBC concrete section during the 1990 investigation exhibited shrinkage of the paste from the coarse aggregate.*

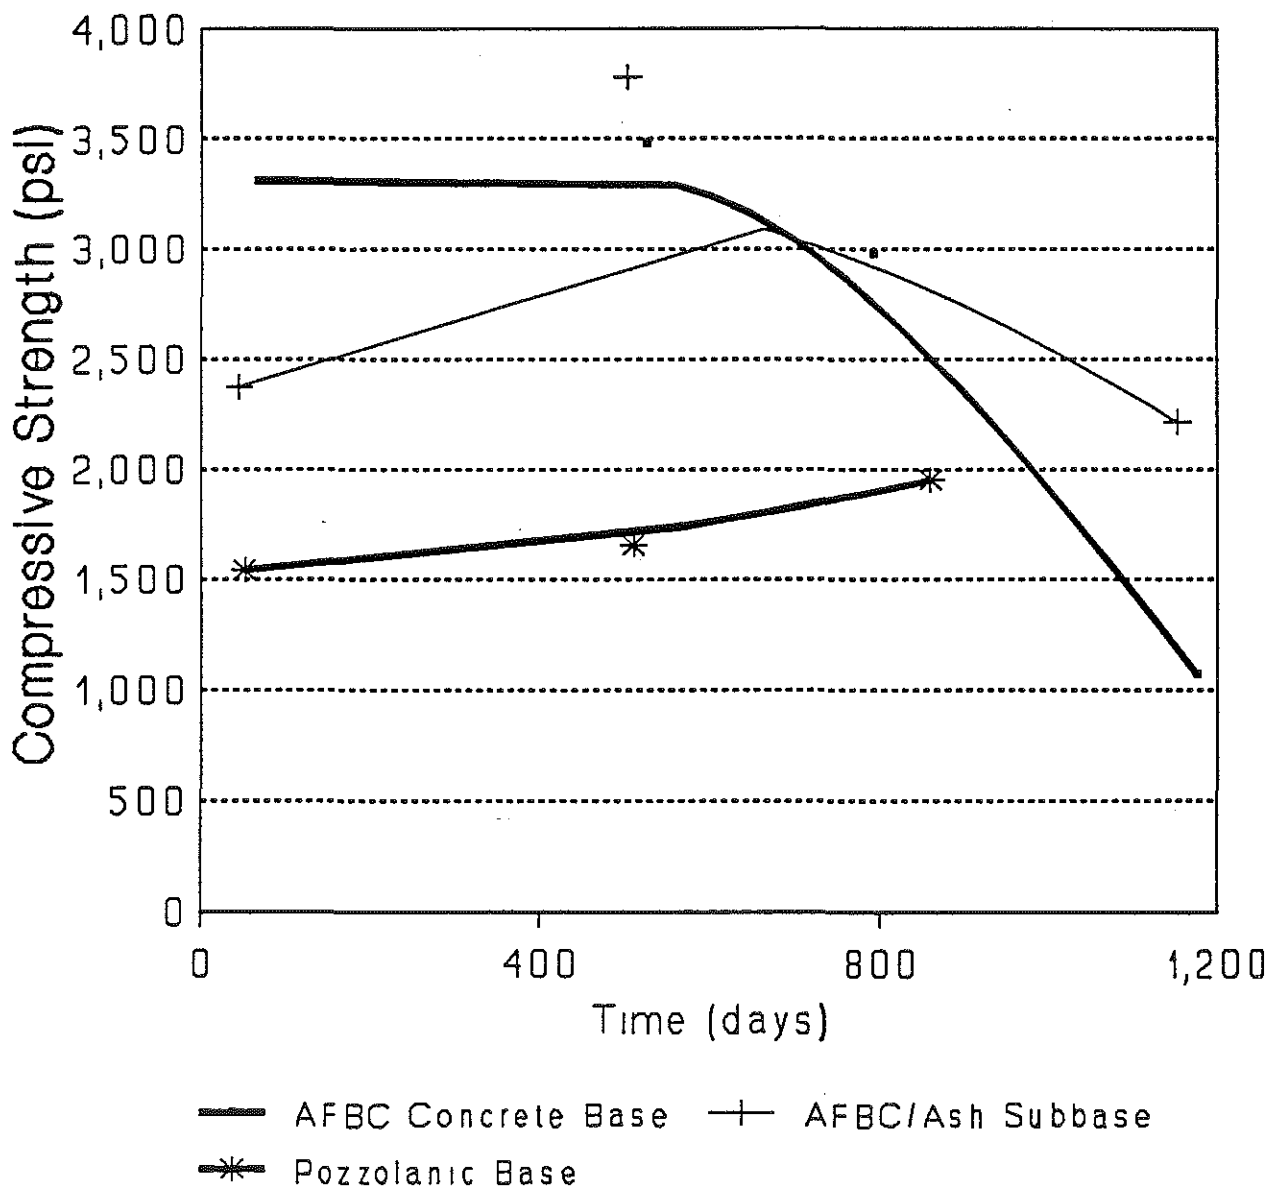
apparent increases and decreases in the average compressive strength of specimens obtained from the AFBC stabilized pond ash subbase. The average compressive strength of core specimens obtained from the pozzolanic base section however, appears to be increasing slightly with the passage of time. Appendix C contains data obtained from the coring and testing activities.

Figure 16. Average compressive strength of field core specimens as a function of time.

From the results of coring activities, visual inspections of the cored specimens and physical tests performed on the cores, it was concluded that the experimental AFBC concrete base material underwent significant changes as it aged. The expansive nature of the AFBC residue caused complete destruction of the structural integrity of the materials. The apparent shrinkage of the paste material from the coarse aggregate was thought to be a function of this phenomenon. The AFBC concrete base layer appeared to be weakest in those areas where water was trapped in the section, particularly in the westbound lane near Station 51+00. Figure 15 is a photograph of a core taken in the westbound lane at Station 51+50 during the 1990 investigation and illustrates the deterioration that the experimental base layer underwent after construction. The lower portion of the core is quite deteriorated and delamination occurred between the first and second lifts. There is visible evidence that the experimental layer underwent extreme stress during placement of the stress absorbing membrane interlayer (SAMI). The asphalt emulsion permeated through cracks in the AFBC concrete base layer that were caused by the asphalt spreader. The deterioration of the experimental materials is further demonstrated by the decrease in the compressive strength of the materials obtained by testing field core specimens. Figure 16 graphically depicts the average compressive strength of field core specimens obtained from the experimental sections as a function of time. The general deterioration of the experimental AFBC concrete base mixture with time is quite evident although the data were limited. Figure 16 also depicts

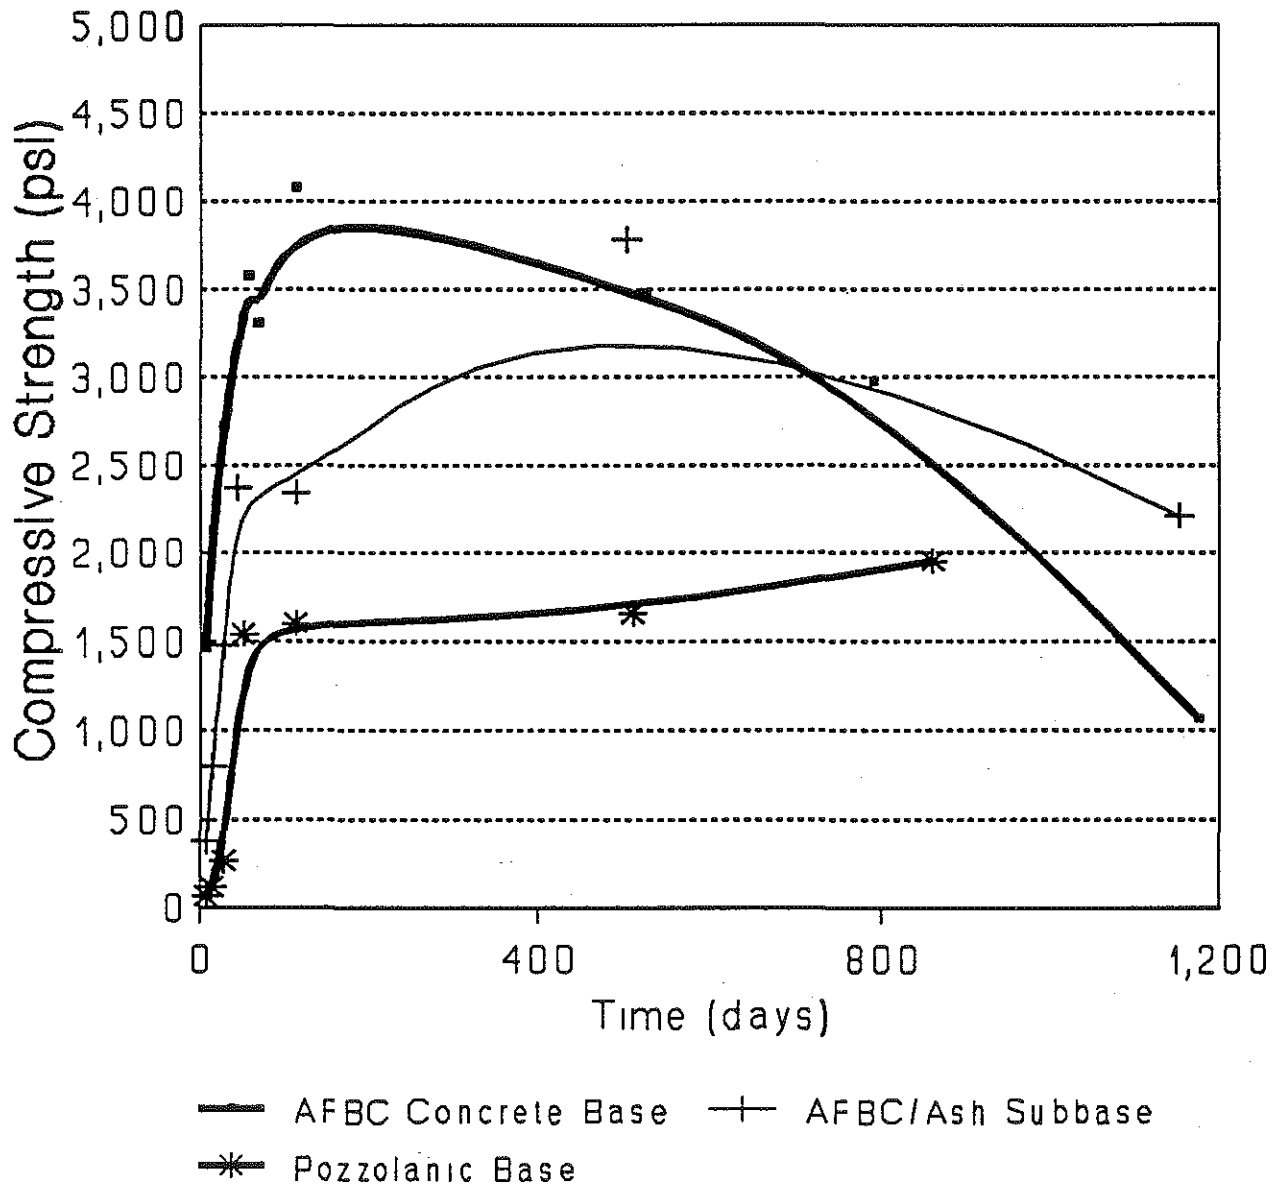
Combining the compressive strengths of the field specimens and the compressive strengths of specimens compacted in the field during construction of the experimental sections provides a complete history of the compressive strength development and subsequent deterioration of the of the mixtures containing residue from the AFBC process. Figure 17 illustrates the initial strength gain of the mixtures containing the

AFBC residue and following decrease in compressive strength. The deterioration of the AFBC concrete layer is most evident whereas the AFBC stabilized pond ash mixture still displays adequate strengths. Figure 17 also depicts the constancy of the pozzolanic base mixture that contains approximately 11 percent ponded fly ash.

Figure 17. Average compressive strength of field compacted specimens and field core specimens as a function of time.
