Research Report
KTC-94-13

EVALUATING THE DESIGN
AND EFFECTIVENESS
OF SUBSURFACE DRAINAGE LAYERS

June 1994

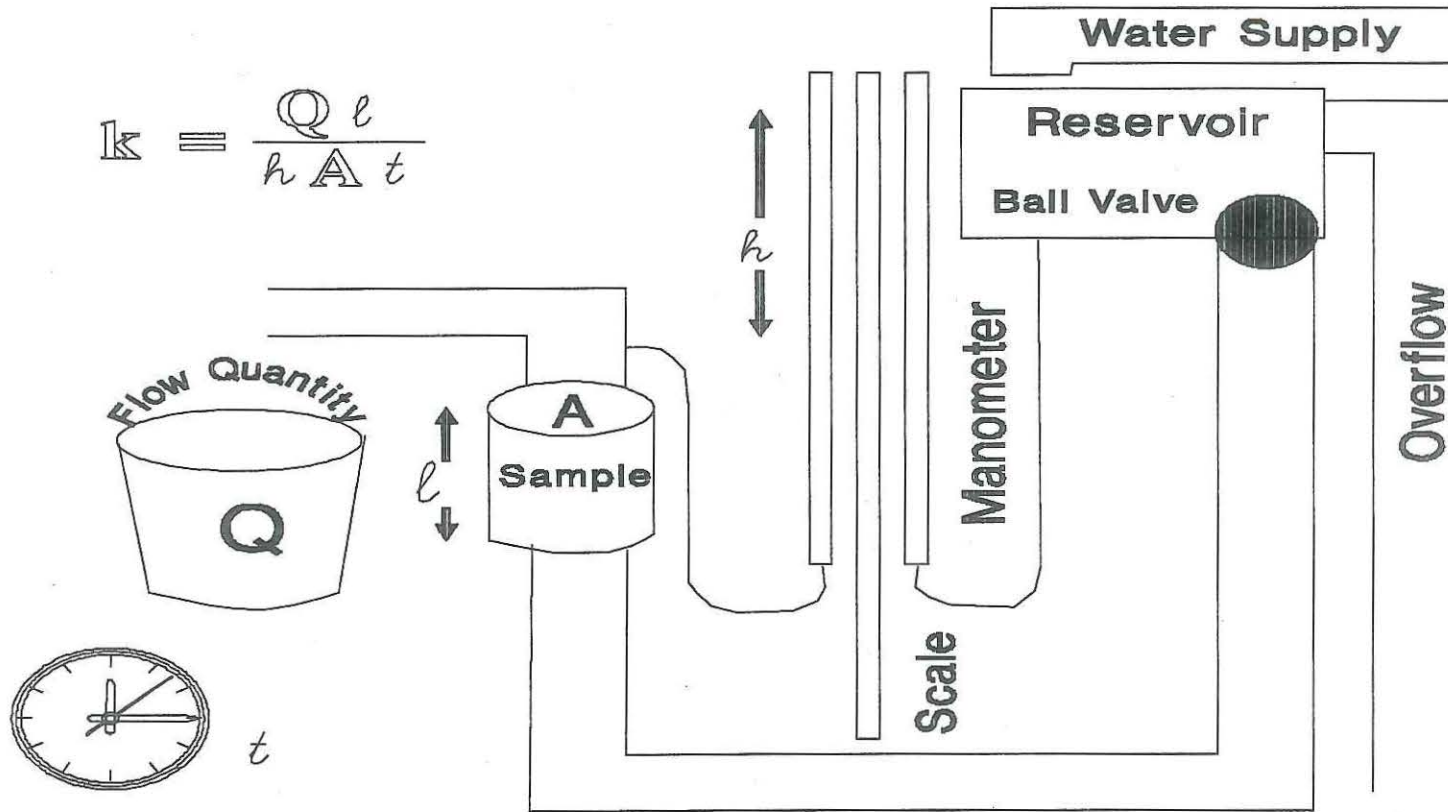
Figure 1. Schematic of Laboratory Permeability Apparatus.

The flow test apparatus consisted of a shallow (10 inches) reservoir having a large cross section (12.5 square feet), a 4-inch supply line to the specimen, a movable specimen holder, and a manometer. The reservoir permits the establishment of a constant depth of water in the tank by having an adjustable, high volume supply (water main) to the reservoir, an overflow, and an on/off valve for the 4-inch specimen supply line. Once a specimen was in place and flow through the system began, input to the reservoir was adjusted so supply to the tank was balanced to the flow through the specimen and overflow combined.

Head was monitored by attaching one side of a manometer to the reservoir and the other side to the overflow or tail water side of the specimen. Due to changes in the specimen during testing, the flow rate and thus the head sometimes changed. The large tank cross section and overflow minimized the rate of head change and the manometer permitted precise and constant monitoring of the head. The adjustable specimen holder allowed adjustments to the head when specimens of various lengths were tested.

Flow through the specimen was monitored by directing the tail water or flow from the specimen into a calibrated container and the collection was timed with an electronic timer. A schematic of the flow test apparatus is shown in Figure 1.

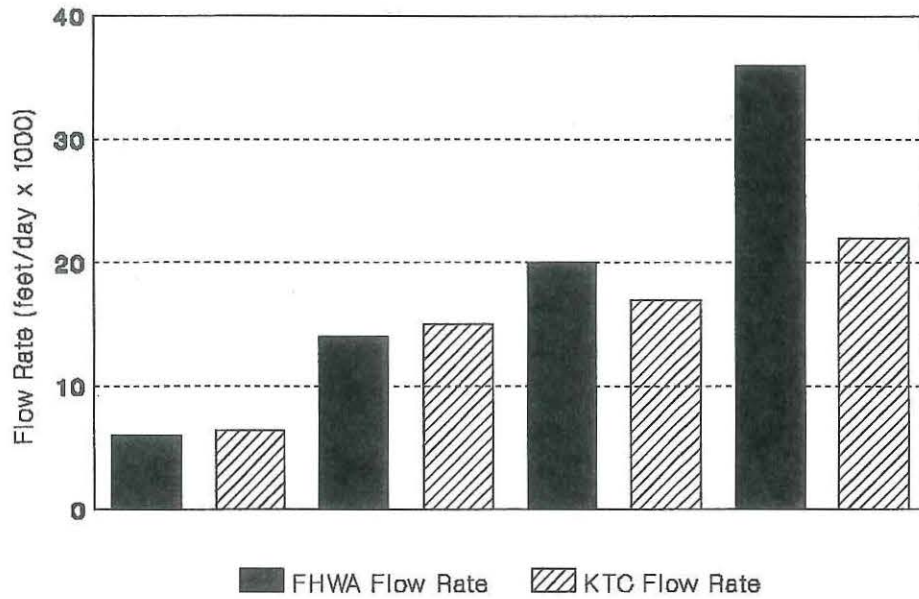
KTC VS FHWA

Figure 2. Comparison of KTC and FHWA Flow Rates for Open Graded Materials.

Results of the calibration flow tests indicated that the apparatus yielded values similar to FHWA's tests for gradations at flow rates of 6,000 and 14,000 ft/day. At higher flow rates, KTC values were less than FHWA values. This could be due to turbulent flow. Since KTC tests were conducted on relatively large specimens and with head conditions expected in the field, researchers have confidence that KTC laboratory flow rate test results are representative of field conditions. Results of calibration tests versus FHWA predictions are graphed and shown in Figure 2.

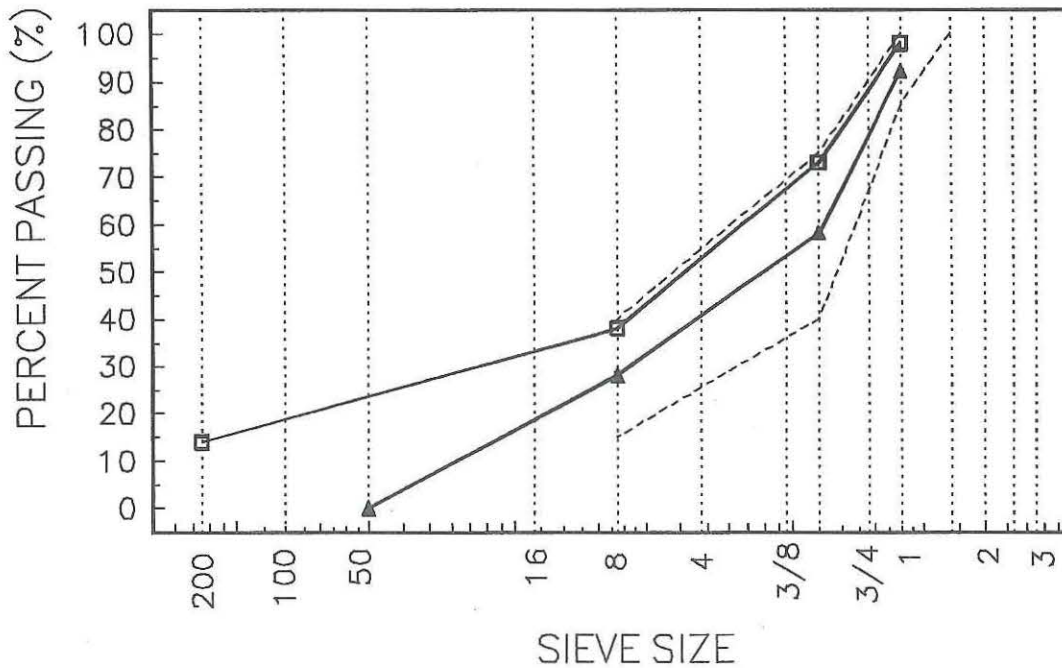
Figure 3. Laboratory Samples Were Recombined at the Center and Fine Limit of Each Gradation Specification.

for testing were 57's, 610's, 67's, 68's, 710's, 78's, and 8's. Gradations were recombined to the center and fine side of the specification band. An example of the manner in which the specimens were recombined is shown in Figure 3. Compaction of specimens was the same as in the calibration specimens and a Number 10 screen was placed at both ends of the specimens.

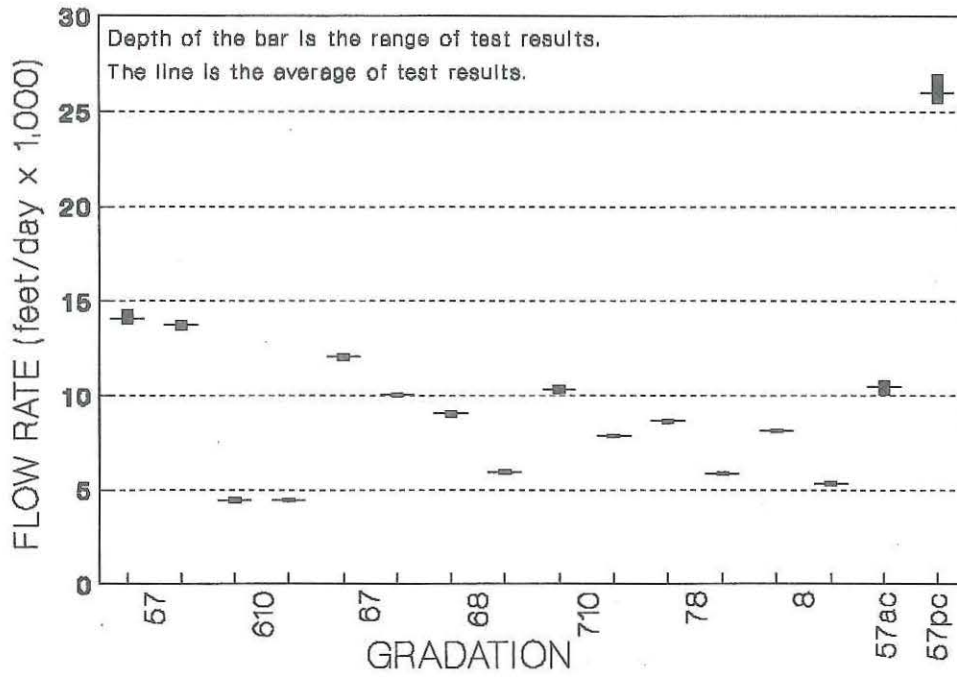
Figure 4. Flow Rate of Laboratory Recombined Samples.

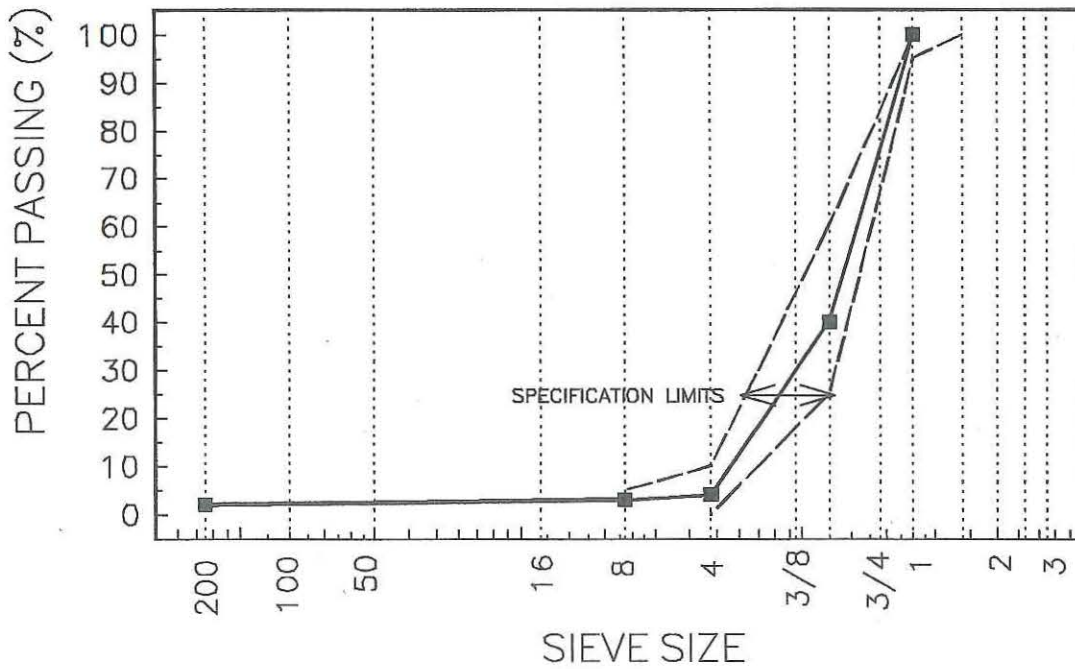
Figure 5. Distribution of Supplier Stockpiled Gradation 57.

specification requirements and stockpile gradation test results are shown in Figures 5 through 11.

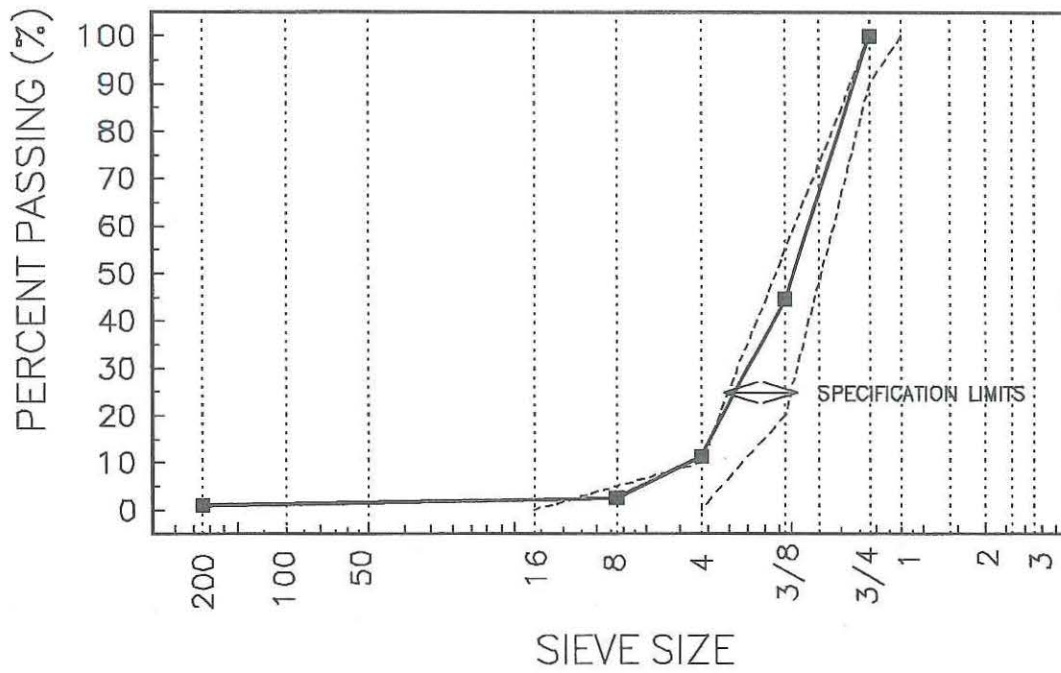
Figure 6. Distribution of Supplier Stockpiled Gradation 67.

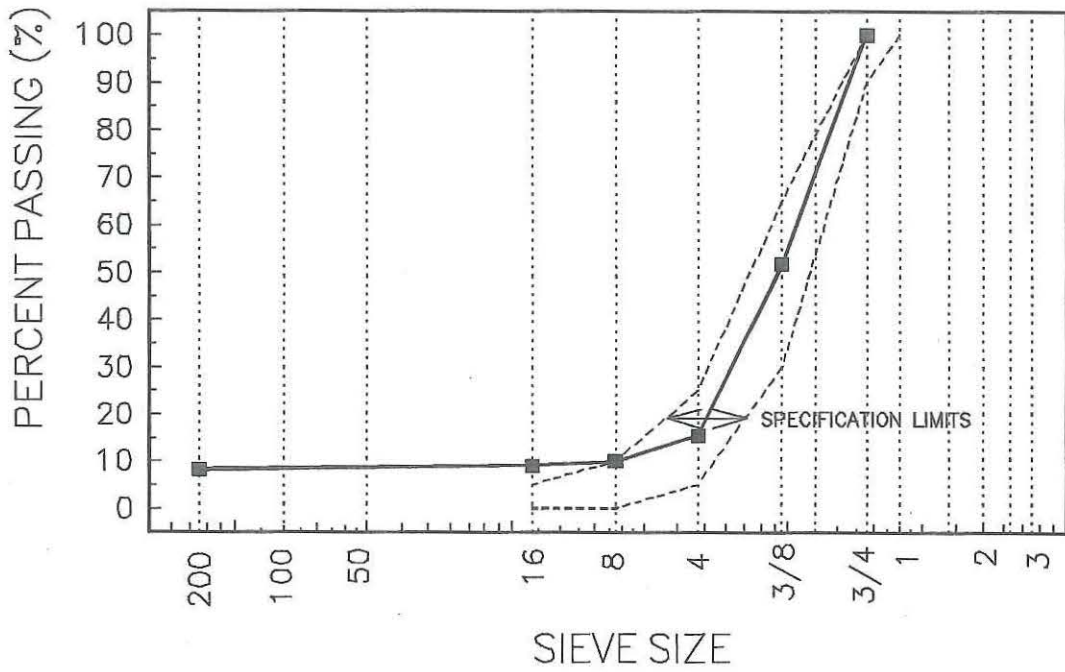
Figure 8. Distribution of Supplier Stockpiled Gradation 68.

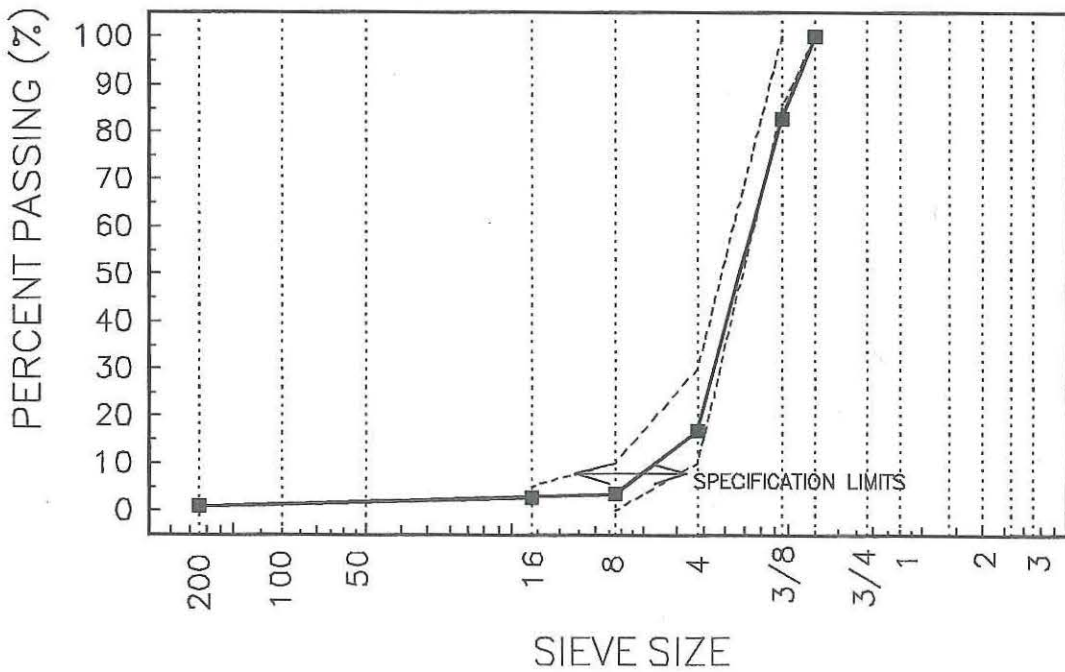
Figure 9. Distribution of Supplier Stockpiled Gradation 8.

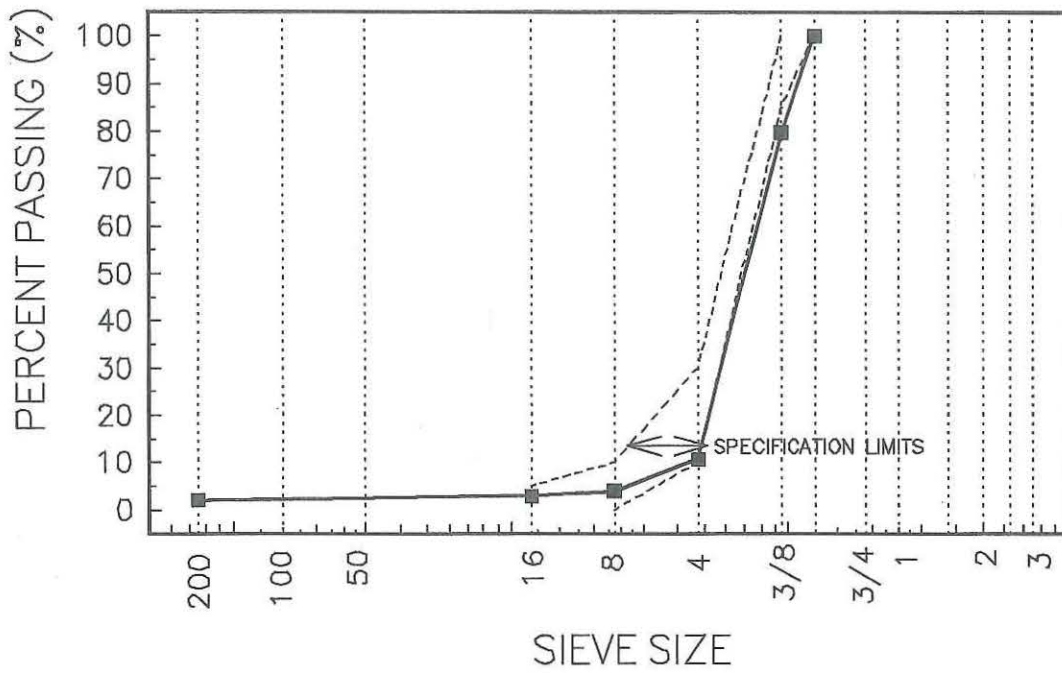
Figure 10. Distribution of Supplier Stockpiled Gradation 8 (second source).

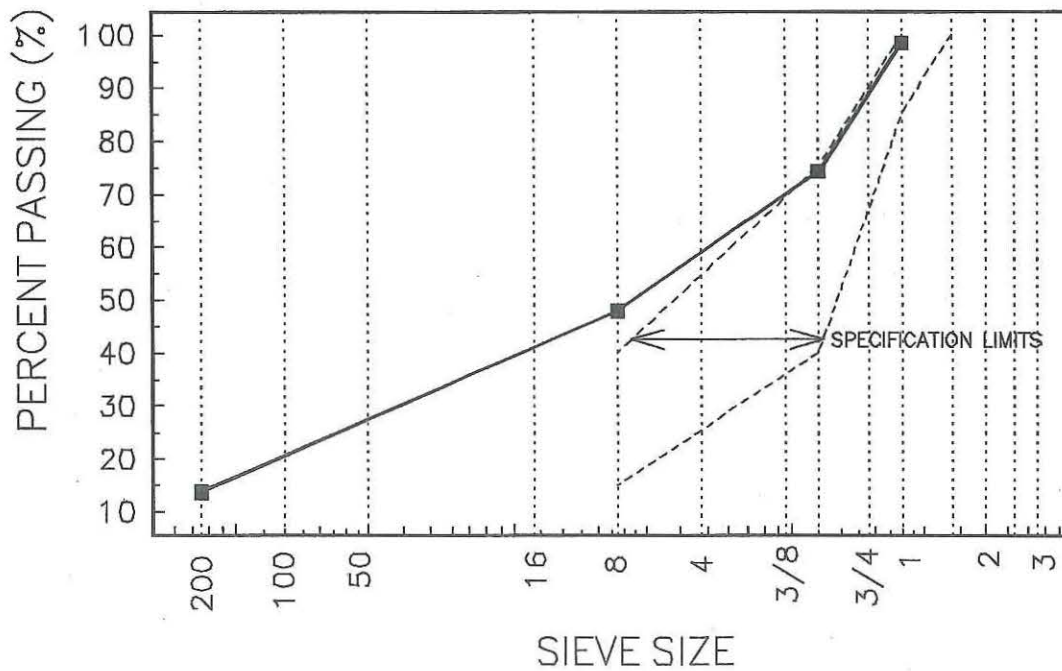
Figure 11. Distribution of Supplier Stockpiled Gradation 610.

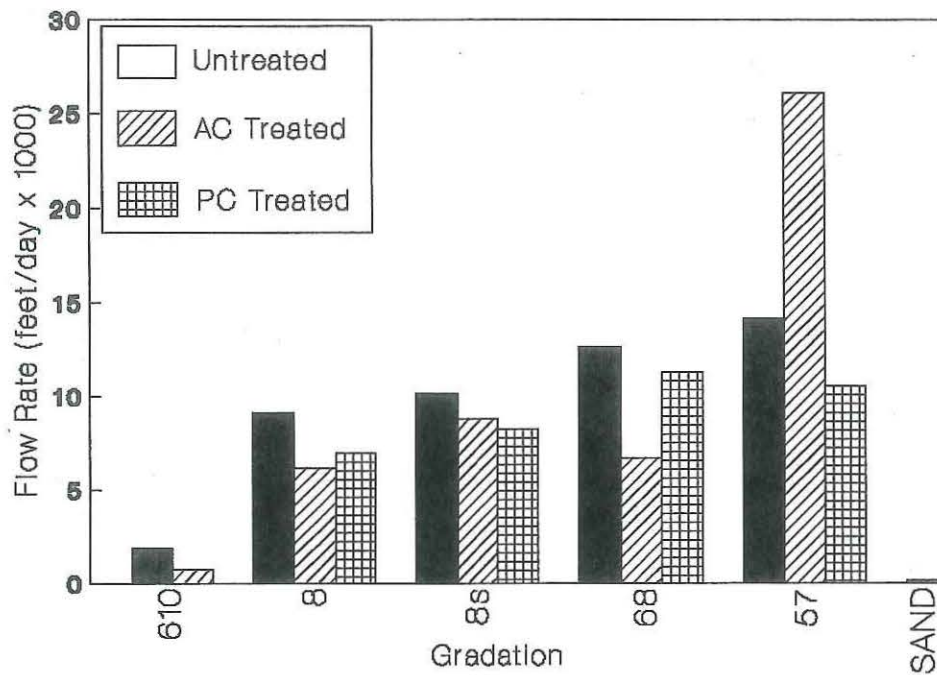
Figure 12. Flow Rate of Supplier Gradations. Samples Are Untreated, Asphalt Treated, and Portland Cement Treated.

Flow rates of these specimens are, in some cases, different from the flow rates of laboratory prepared gradation specimens. All gradations except Number 57 indicated the highest flow rate in the untreated condition with some reduction of flow rate for asphalt or portland cement treatment. In most cases, the reduction in flow rate was 2,000 to 3,000 ft/day. Number 57 gradation, when treated with portland cement, indicated an increase in flow rate. The significant increase in flow rate appears to be related to the decreased unit weight of the portland cement treated specimens (about 97 lbs/ft³). Initial analyses of all density versus flow rate data tends to indicate a moderate correlation, i.e., an increased flow rate typically occurs at lower specimen densities as shown in Table B. It was not possible to prepare an asphalt treated Number 610 gradation specimen. The large amount of fine material in the Number 610 absorbed the asphalt and did not permit coating of the larger particles.

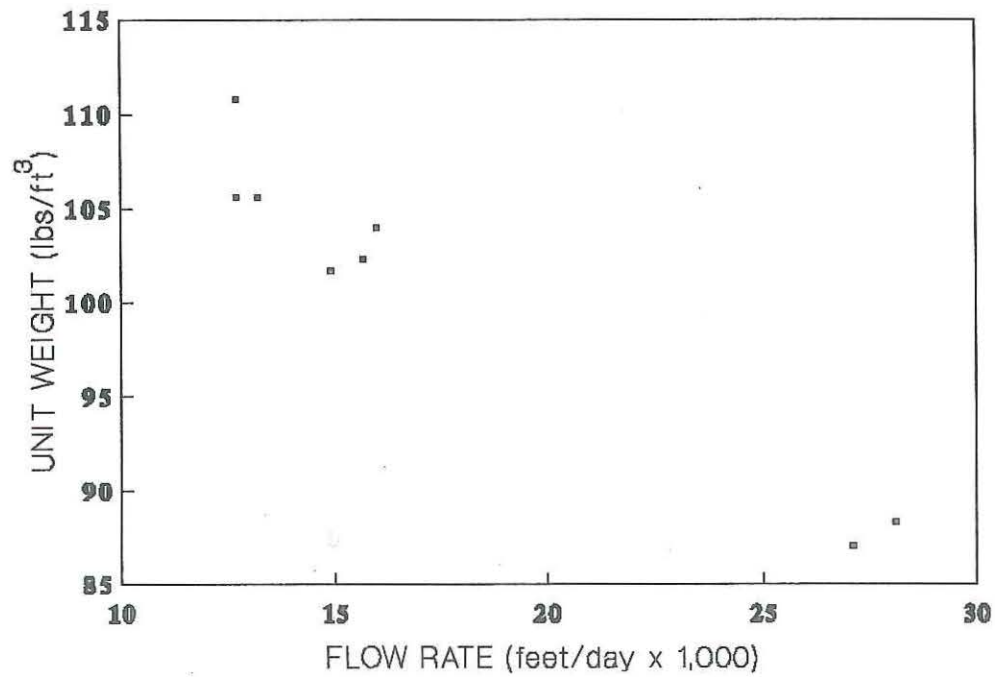
Figure 13. Flow Rate Versus Unit Weight of Field Compacted Samples. Material Is Asphalt Treated Gradation 57.

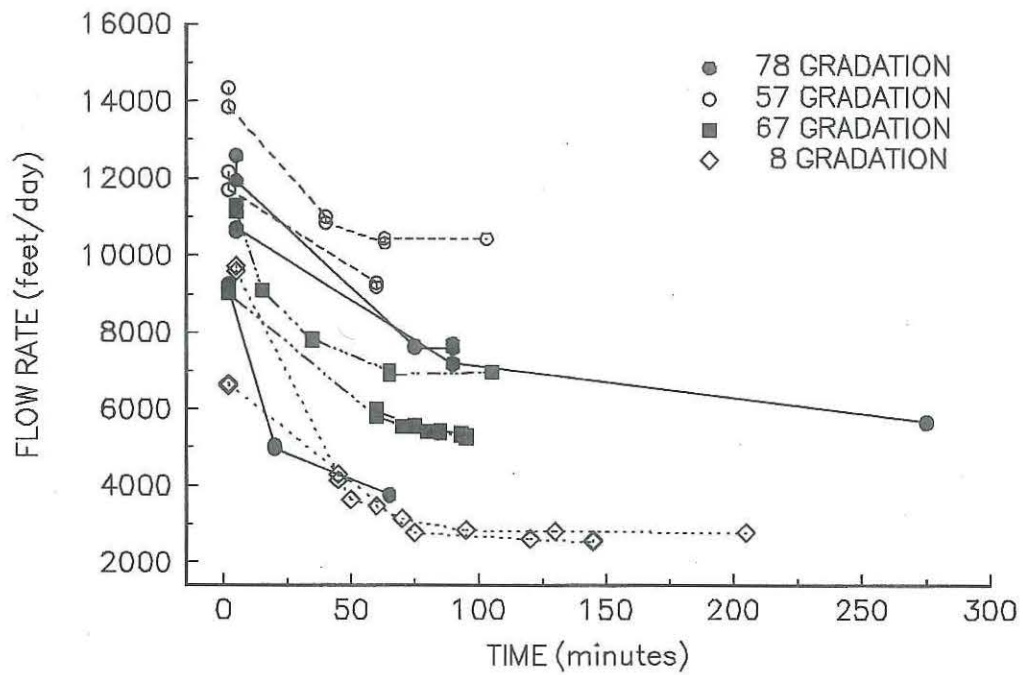
Figure 14. Flow Rate Versus Time for Asphalt Treated Samples.

During the testing of field specimens, it became obvious that the flow rate of the asphalt treated specimens tended to decrease as the specimen was subjected to longer periods of flow. After flow tests had been conducted, specimens were broken and examined. Stripping had occurred and clogging of voids was the probable cause of decreased flow rate.

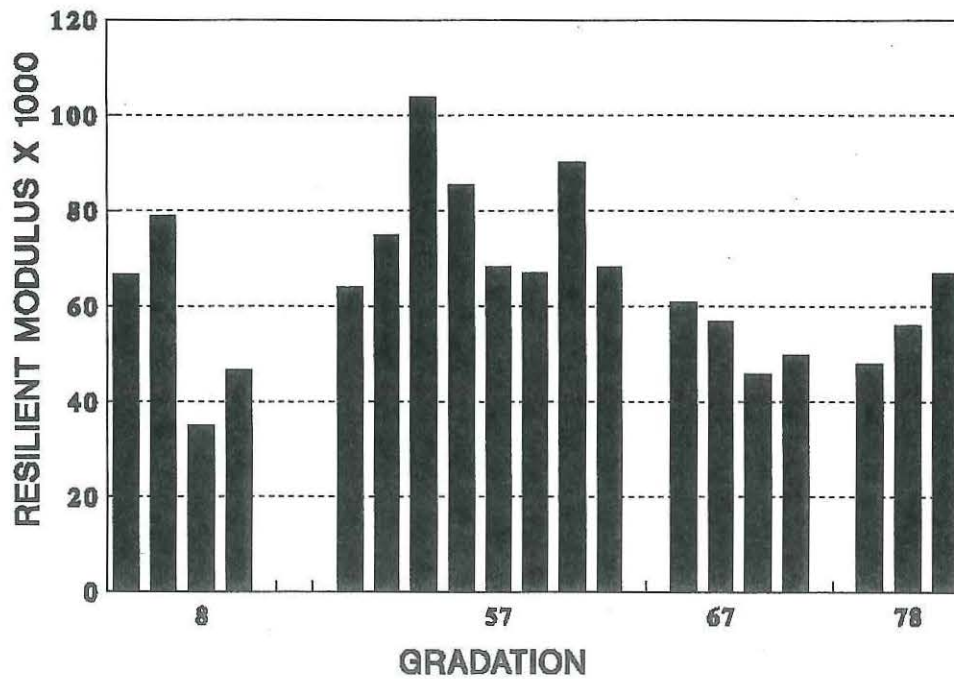
Figure 15. Resilient Modulus of Asphalt Treated Gradations.

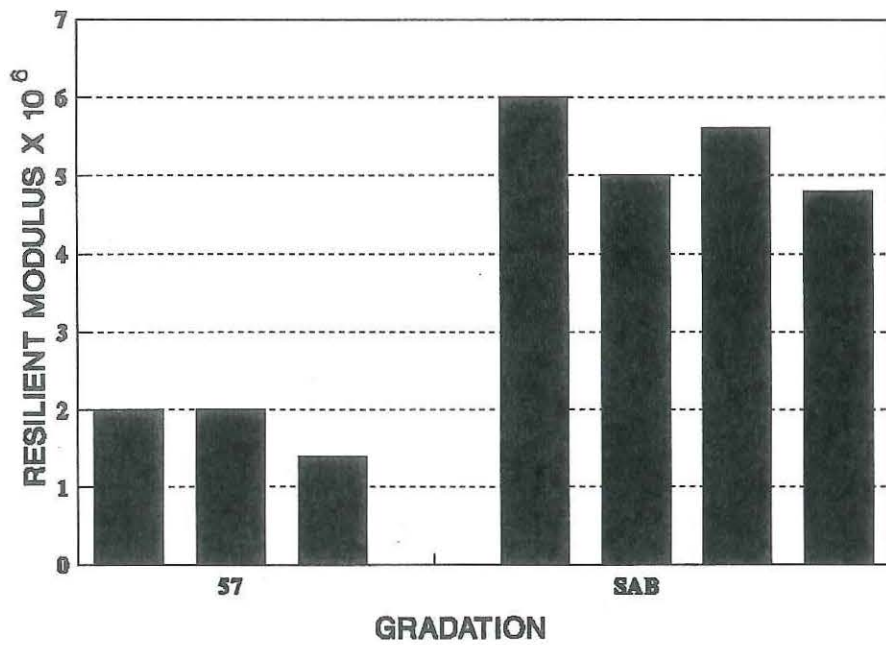
Figure 16. Resilient Modulus of Portland Cement Stabilized Materials.

Specimens of the Number 57 gradation with portland cement stabilization, conforming to Kentucky Specifications, were prepared. Two specimens were cured in the mold with plastic covers and the other two were cured in the mold with damp burlap covers. One of the plastic covered specimens was damaged but the other one had a modulus of 2,000,000 psi. The wet cured specimens had moduli of 2,000,000 and 1,400,000 psi. Moduli of portland cement stabilized specimens are graphed in Figure 16.

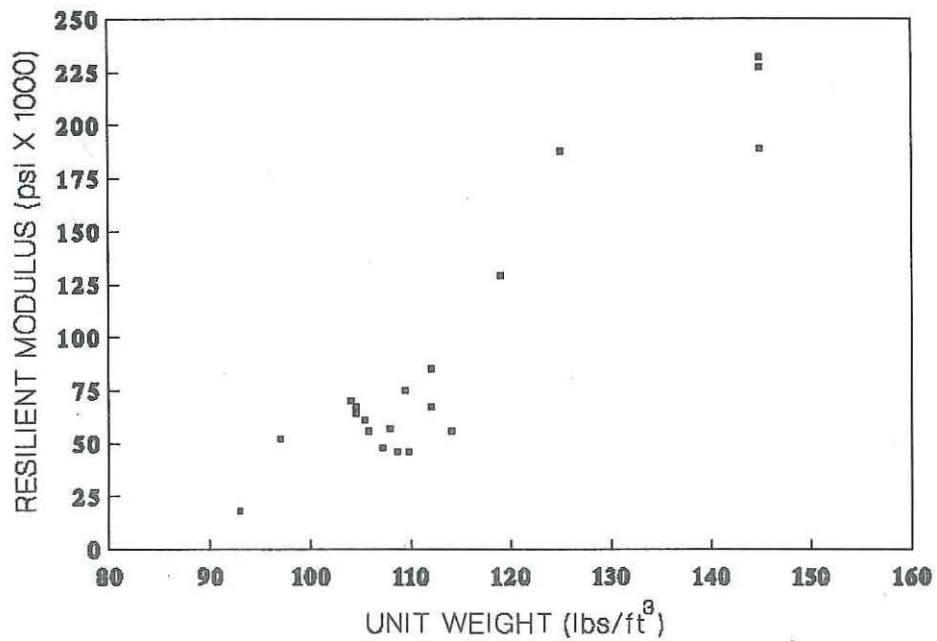
Figure 17. Resilient Modulus Versus Unit Weight of Asphalt Stabilized Materials.

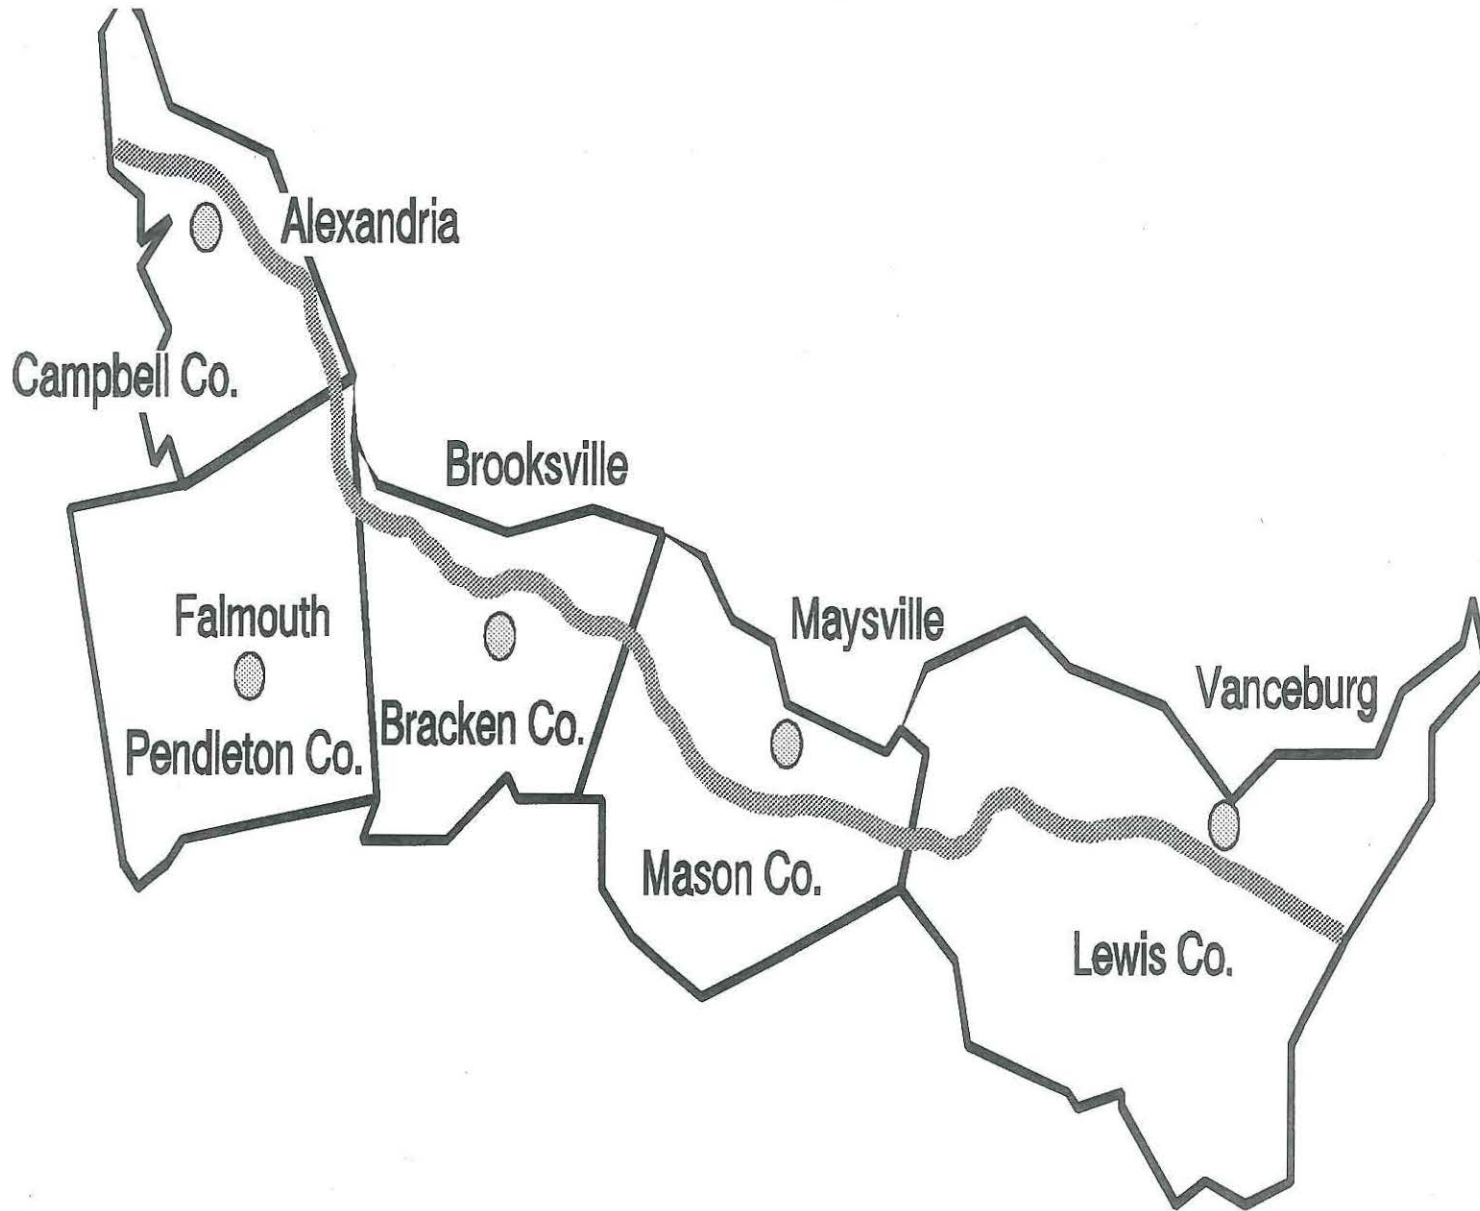
Figure 22

Figure 22. AA Highway in Northern Kentucky Where Pavement Included Treated Blankets, Untreated Blankets and Undrained Sections.

All components of the pavement structure varied depending upon design. Subgrade conditions were either untreated, lime treated or cement treated. The base was either DGA, SAB, or deleted. Pavement thickness and mix varied. A filter fabric was used in one section and the drainage blanket was daylighted in another. The various design sections are included in Appendix B.

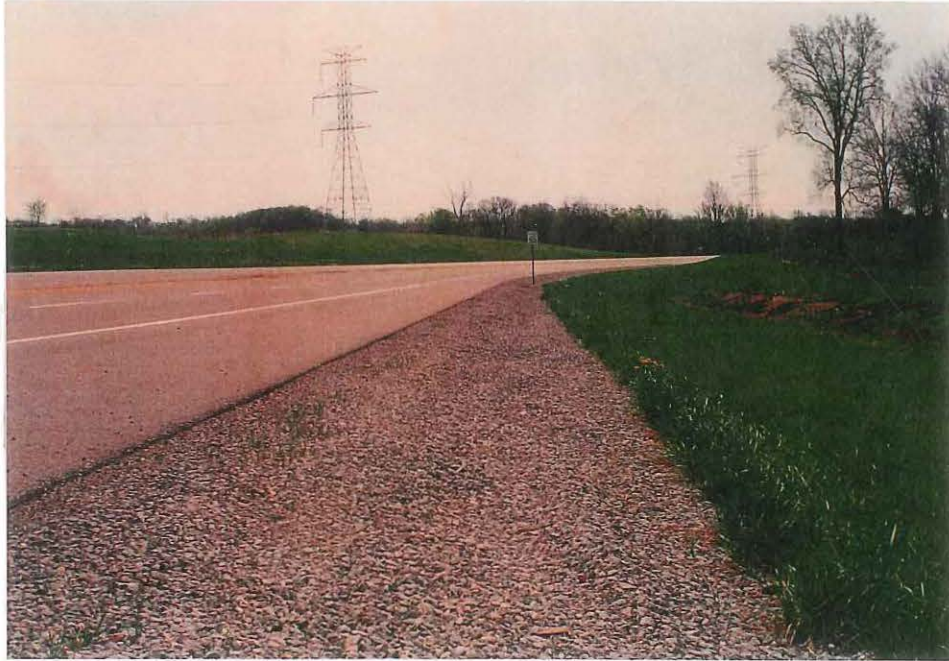
Figure 23. Daylighted, Untreated Drainage Blanket at AA Highway. Little Vegetation after Seven Years.

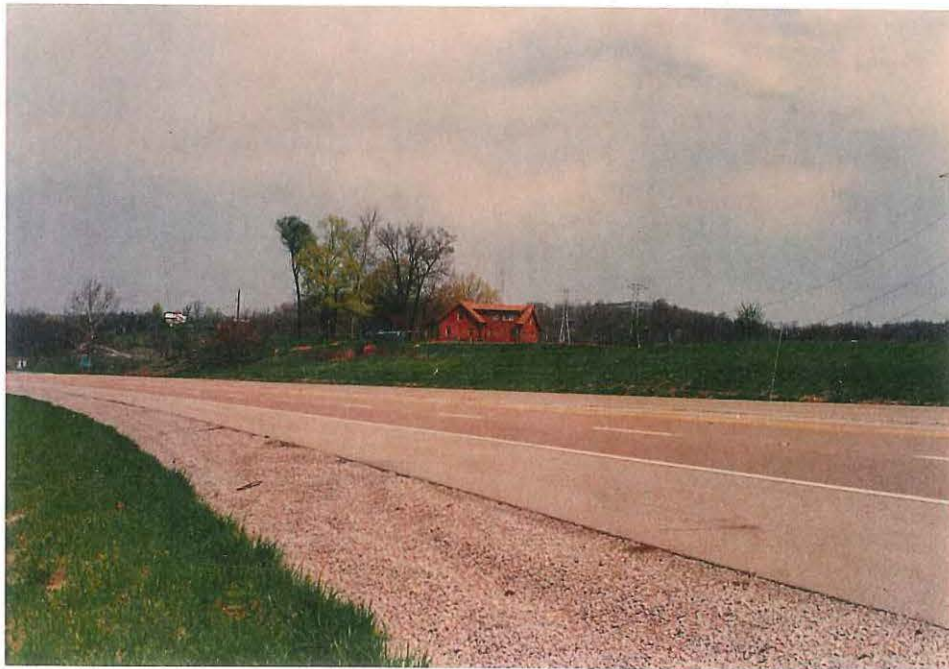
Figure 24. Daylighted, Untreated Drainage Blanket at AA Highway. Little Vegetation after Seven Years.

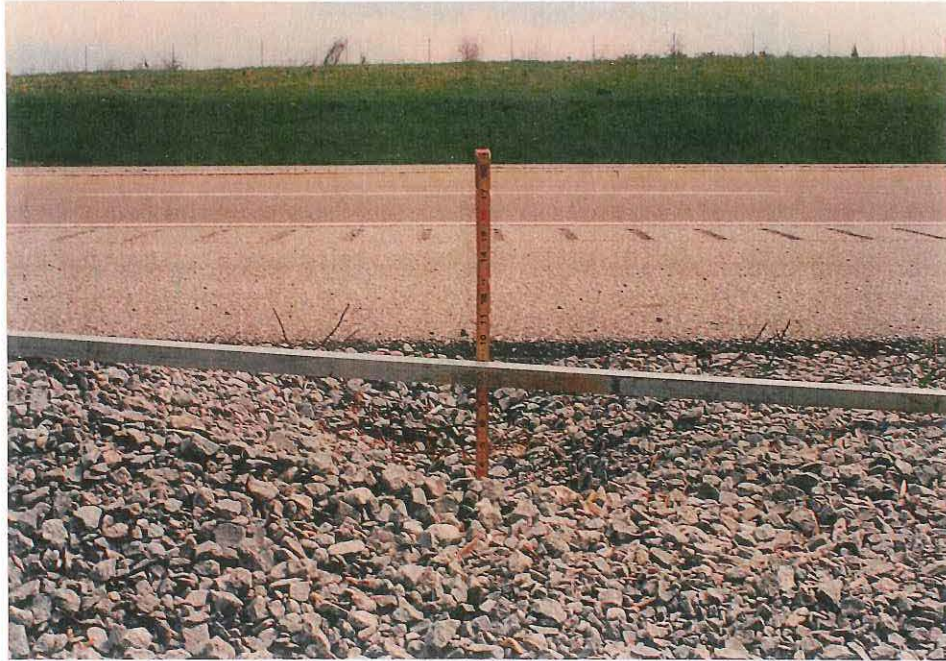
Figure 25. Untreated, Daylighted Drainage Blanket Displaced on Shoulders.

Two problems observed during construction were maintaining the profile of the drainage blanket due to rutting or displacement and compaction of the first base course of the bituminous pavement. Blanket profile was maintained by shaping and rolling in front of the paving operation. The first course of the bituminous base tended to spread under compaction by nearly one foot on each side of the mat. While some spreading is to be expected, this appeared excessive and due in part to movement of the untreated drainage blanket.

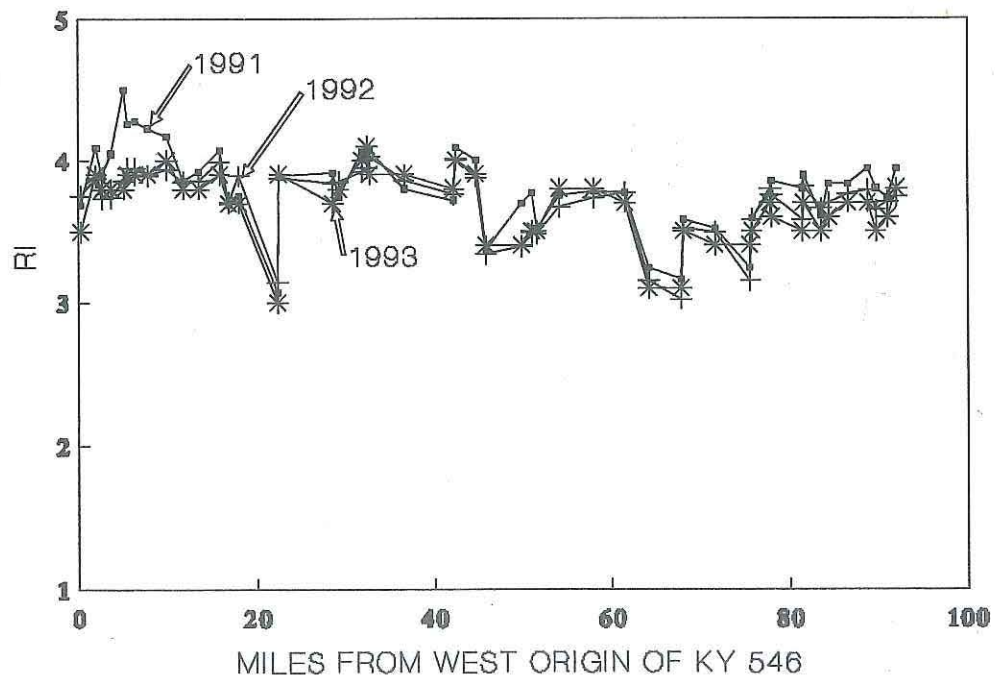
Figure 26. RI values for East Bound AA Highway.

Monitoring of pavements having drainage blankets as used on the AA highway has consisted primarily of pavement deflection testing, pavement distress surveys, rideability indices (RI), visual surveys of drainage during and after precipitation, and outlet condition surveys.

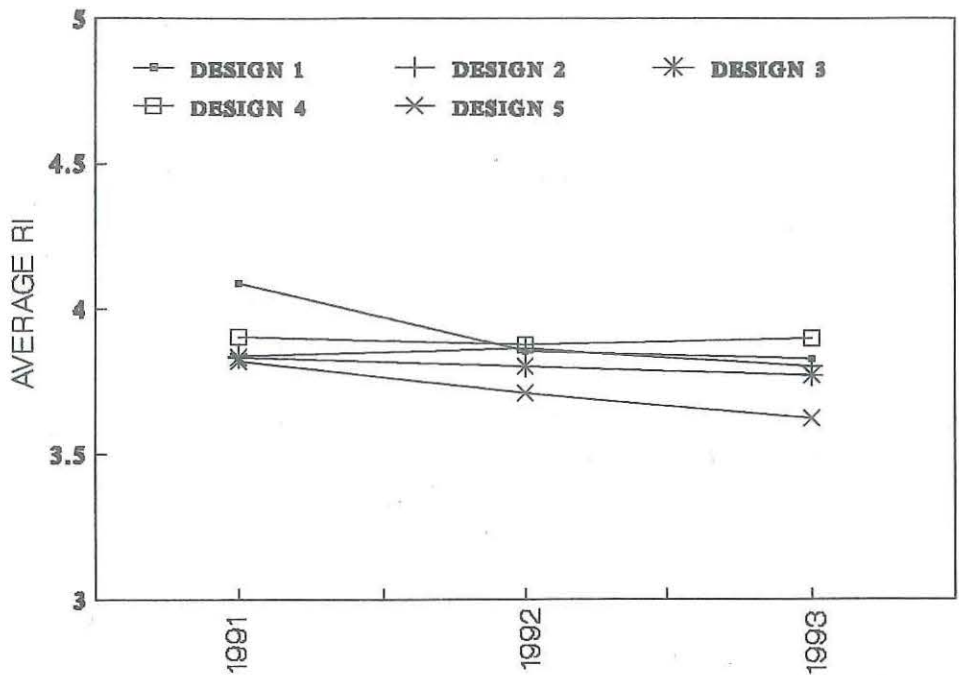
Figure 27. Eastbound AA Highway RI Values Averaged by Design Section.

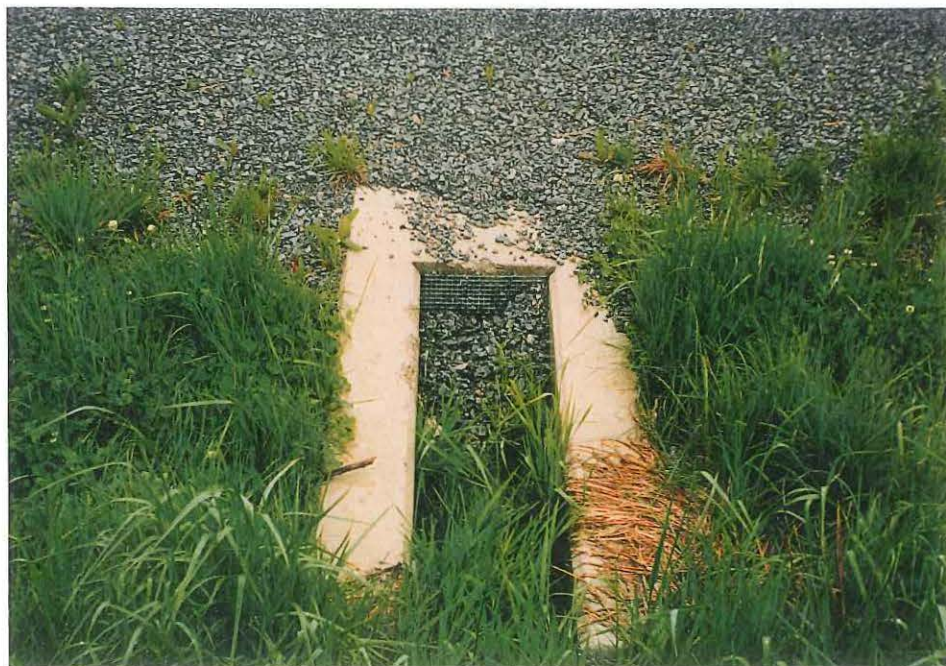
Figure 30. Drainage System Outlet Plugged with Debris and Vegetation.

A visual survey of the site during a heavy rainfall in 1994 revealed that of 39 outlets inspected 21 had some obstruction to free discharge. Fifteen outlets had severe obstruction, three had some debris in the headwall and three were clear but had no discharge. The severe obstruction was usually due to ponding as a result of the outlet being nearly at the same level as the ditch. Blocking of the ditch causes, in some cases, the outlet to be submerged. The problems at the three outlets having less severe obstructions were headwalls filled with shoulder material that, when removed, allowed free drainage. The three outlets with no discharge are suspected of having construction damage. Figures 30 through 32 show some of these conditions.

Collector system outlets are typically not maintained properly and are often poorly designed. Excluding the AA Highway, most outlets were not draining properly due to either siltation in the headwall, vegetation in the headwall, damage to the outlet pipe, or ponding. Ponding is sometimes due to blockage in the ditch but design at two of the sites allowed outlet headwalls to be placed level with the original ditchline elevation. Headwalls were observed with water ponded above the outlet pipe elevation. All headwalls should be at least 6 inches higher than the ditchline elevation.

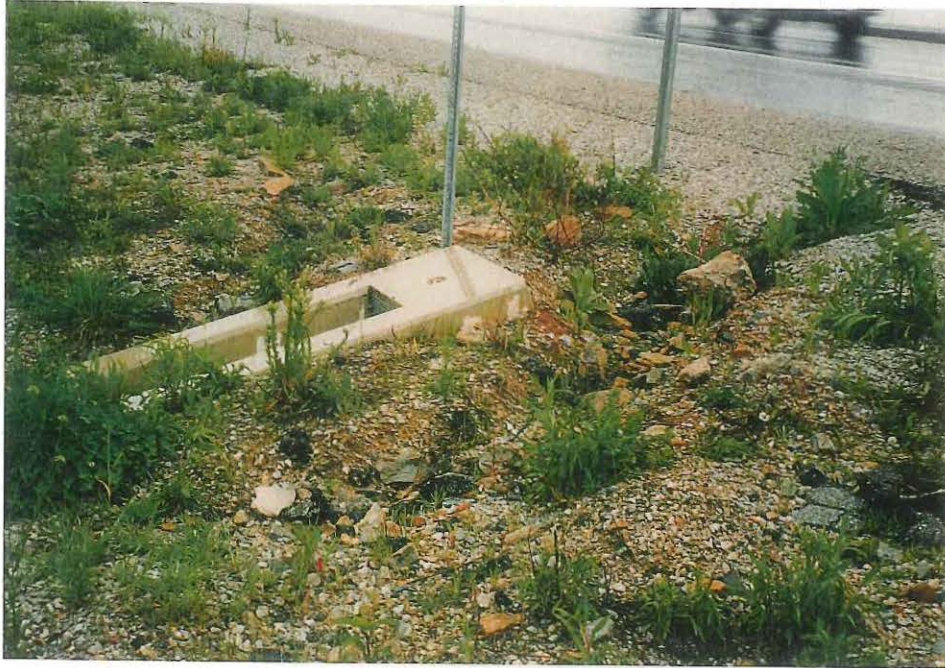
Figure 31. Drainage System Outlet Pipe Severed above the Headwall.

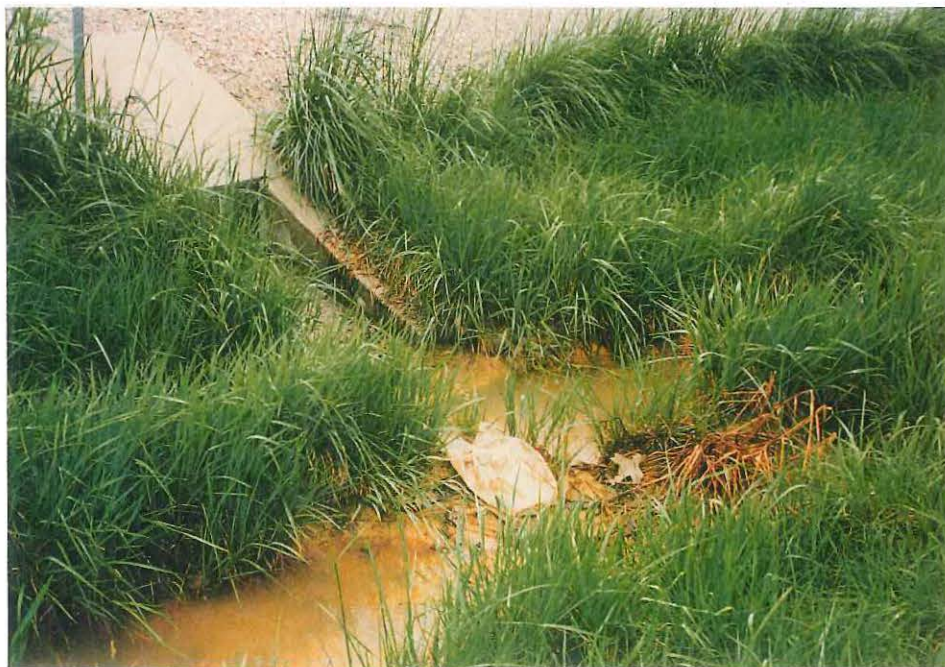
Figure 32. Drainage System Outlet Located Lower than the Ditch Line.
