Theses and Dissertations--Mining Engineering

Optimal Roof Coverage and Identification of Potential Roof Problems in Underground Coal Mines Using LED Lighting

James A. Samples

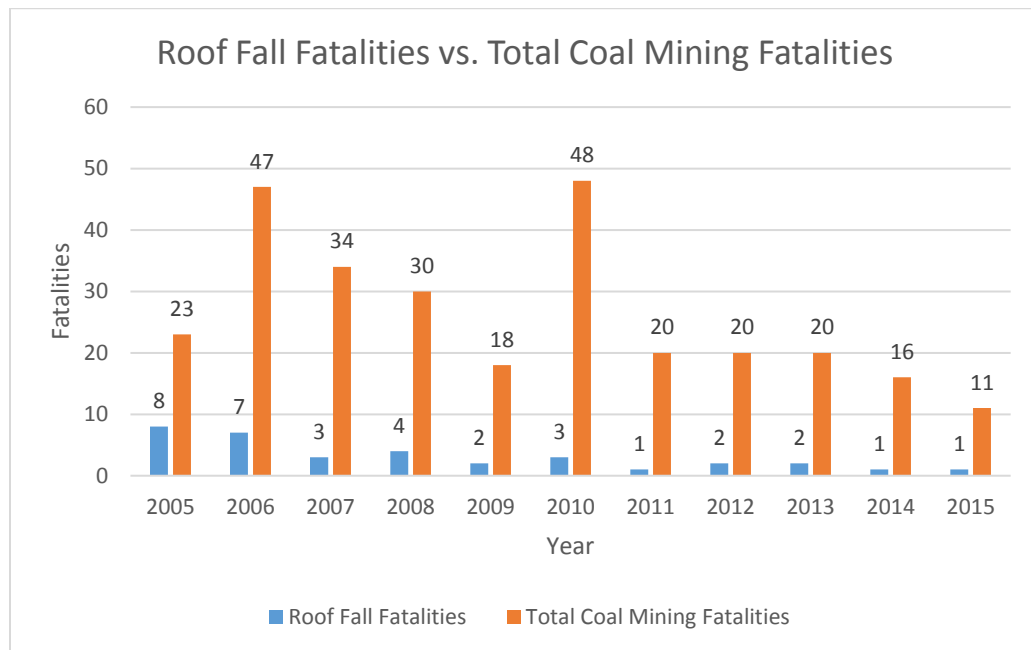
Figure 1.1: Roof Fall Fatalities Compared with Total Fatalities in US Coal Mines (MSHA [A], 2016)

Since the beginning of underground coal mining, the threat of accidental roof falls has posed a grave danger to miners in all parts of the mine. Roof falls hazards are especially high for miners working near active mining areas and more specifically for those miners working near roof bolting machines. Miners working around roof bolting machines are more often exposed to unsupported roof conditions compared to other mine equipment requiring an operator. Fatalities due to roof falls in the United States has decreased drastically with the introduction of roof bolts in the 20th century, and thus fatalities associated with underground coal mining have also reduced. Figure 1.1 shows the number of roof fall fatalities compared with the total number of coal mining fatalities, surface and underground, in the United States for the past eleven years (MSHA [A], 2016).

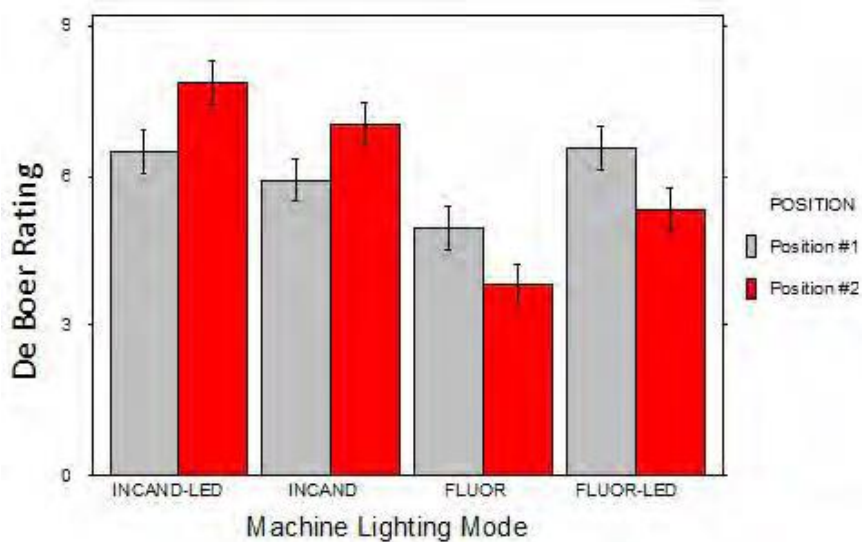
Figure 2.12: Glare Ratings by Lighting Mode and Position (Reyes, Gallagher, and Sammarco, 2009)

Overall results from these experiments show that age has a significant impact on visual performance (Reyes, Gallagher, and Sammarco, 2009). However, lighting conditions also play a significant factor. LED combinations with other light sources provided the best results compared to the other sources tested. The LED and fluorescent lighting mode provided the best results during the peripheral vision detection study due to the increased amount of short wavelength light provided and increased illuminance. The LED and incandescent mode provided the quickest reaction times for the trip fall study, but the differences were not statistically significant when compared to the LED and fluorescent mode. Thus it was determined that the increased illumination likely provided the superior detection time, as well as an increase in short wavelength light. The final conclusion of the paper states that “the use of LED lights, as an auxiliary source of area lighting, would improve the visual performance of miners working around the perimeter of a machine” (Reyes, Gallagher, and Sammarco, 2009).

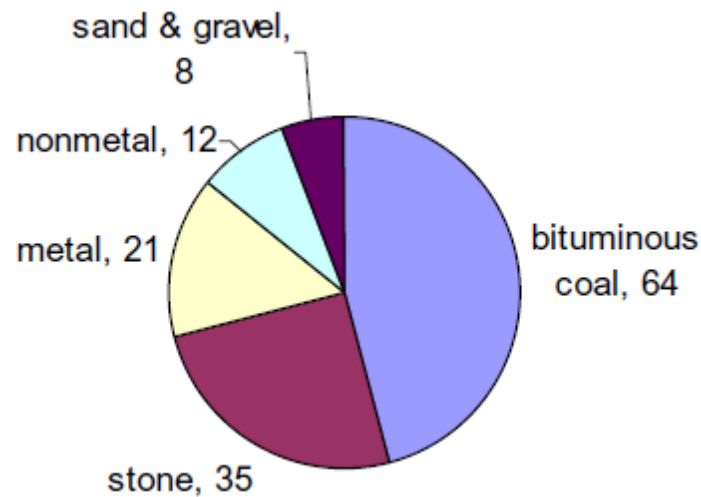
Figure 2.17: Lighting Accidents by Mining Classification (Yenchek and Sammarco, 2010)

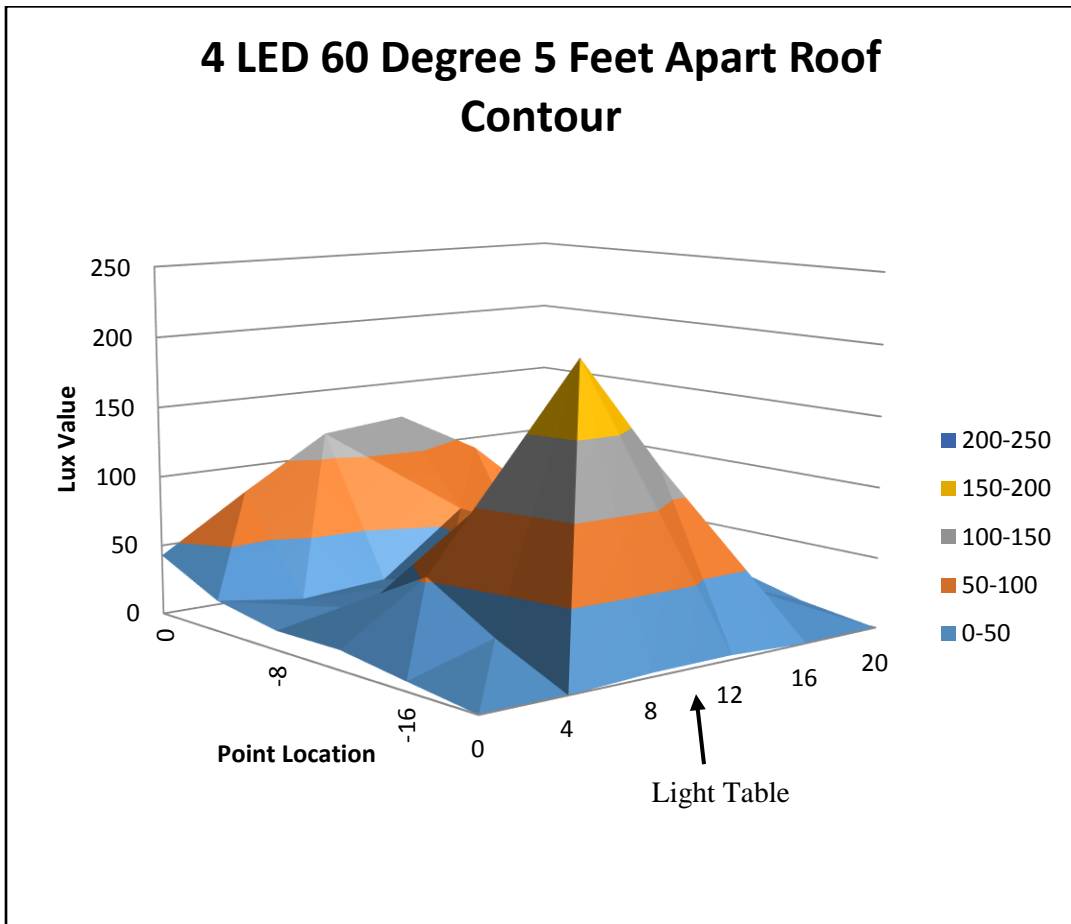
Figure 3.10: 4 LED 60 Degree 5 Feet Apart Photographic Result and Roof Light Contour

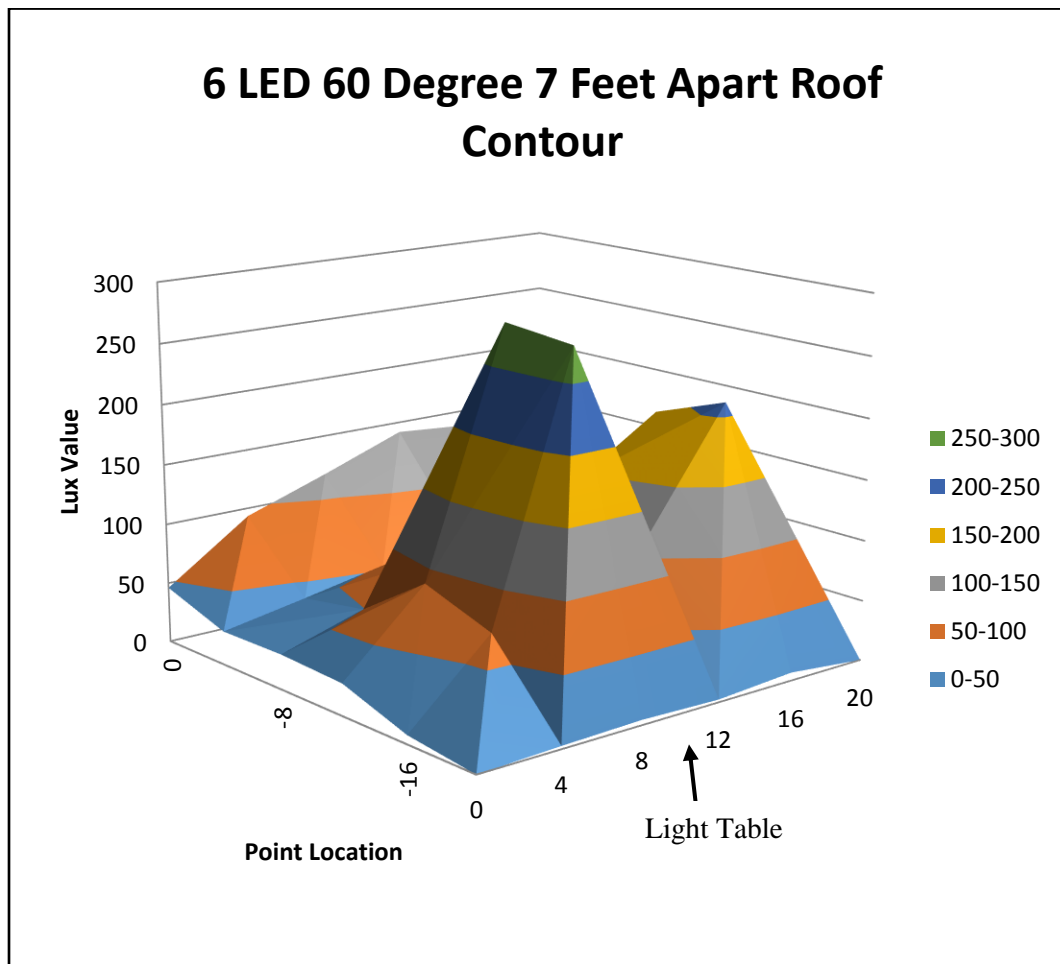
Figure 3.17: 6 LED 60 Degree 7 Feet Apart Photographic Result and Roof Light Contour

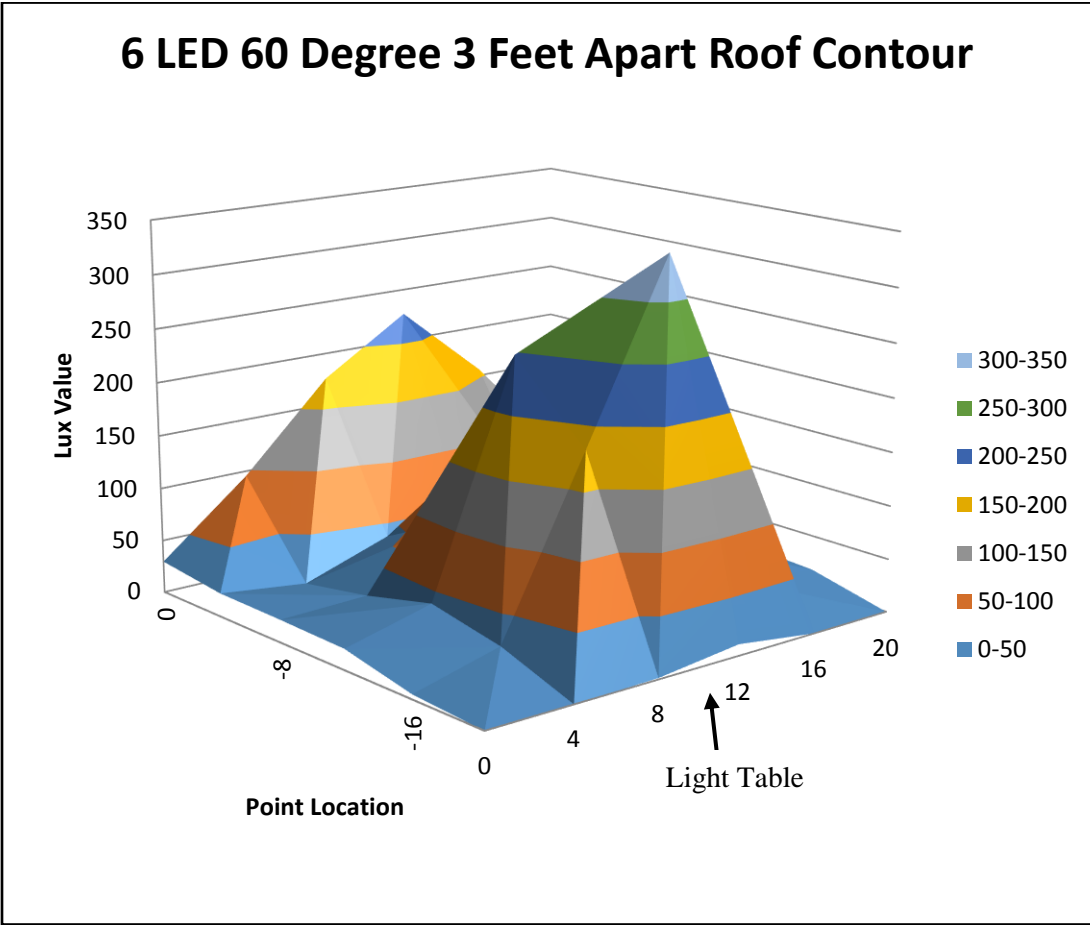
Figure 3.19: 6 LED 60 Degree 3 Feet Apart Photographic Result and Roof Light Contour

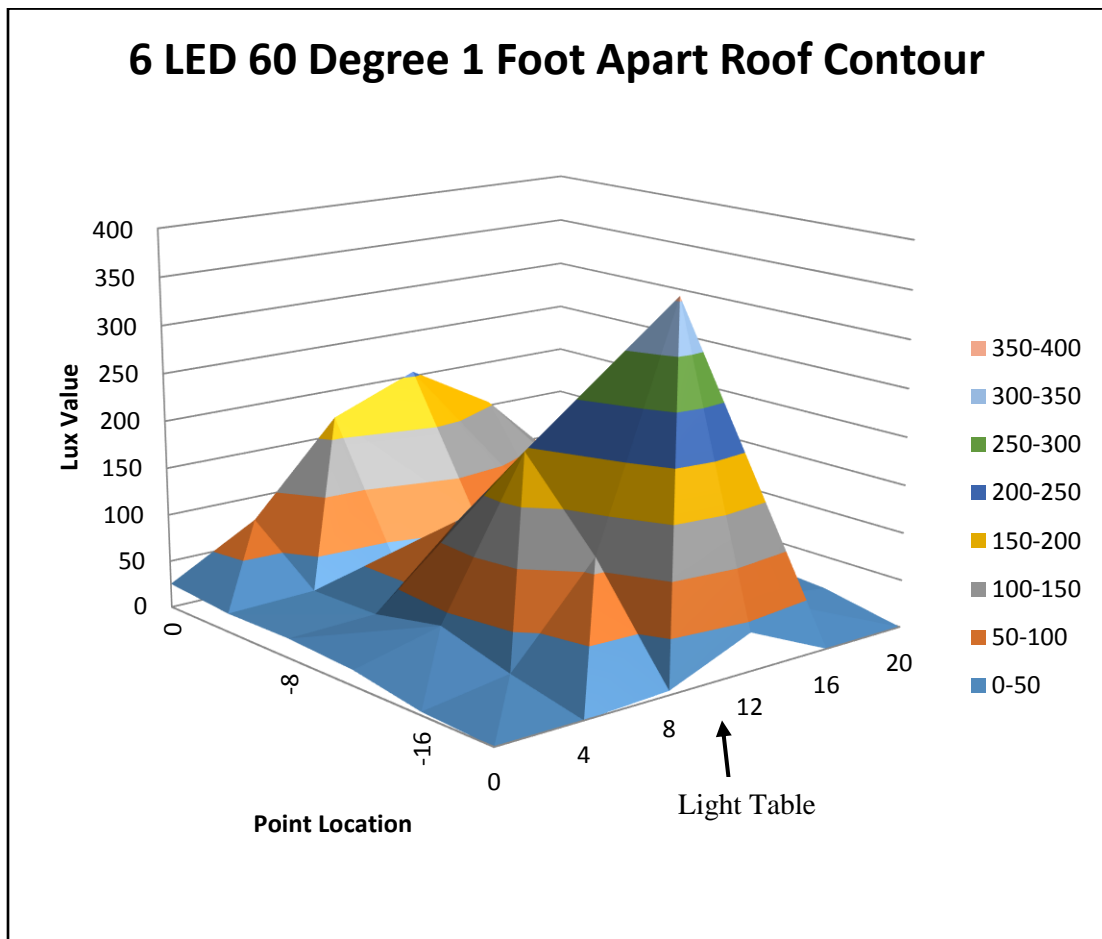
Figure 3.20: 6 LED 60 Degree 1 Foot Apart Photographic Result and Roof Light Contour

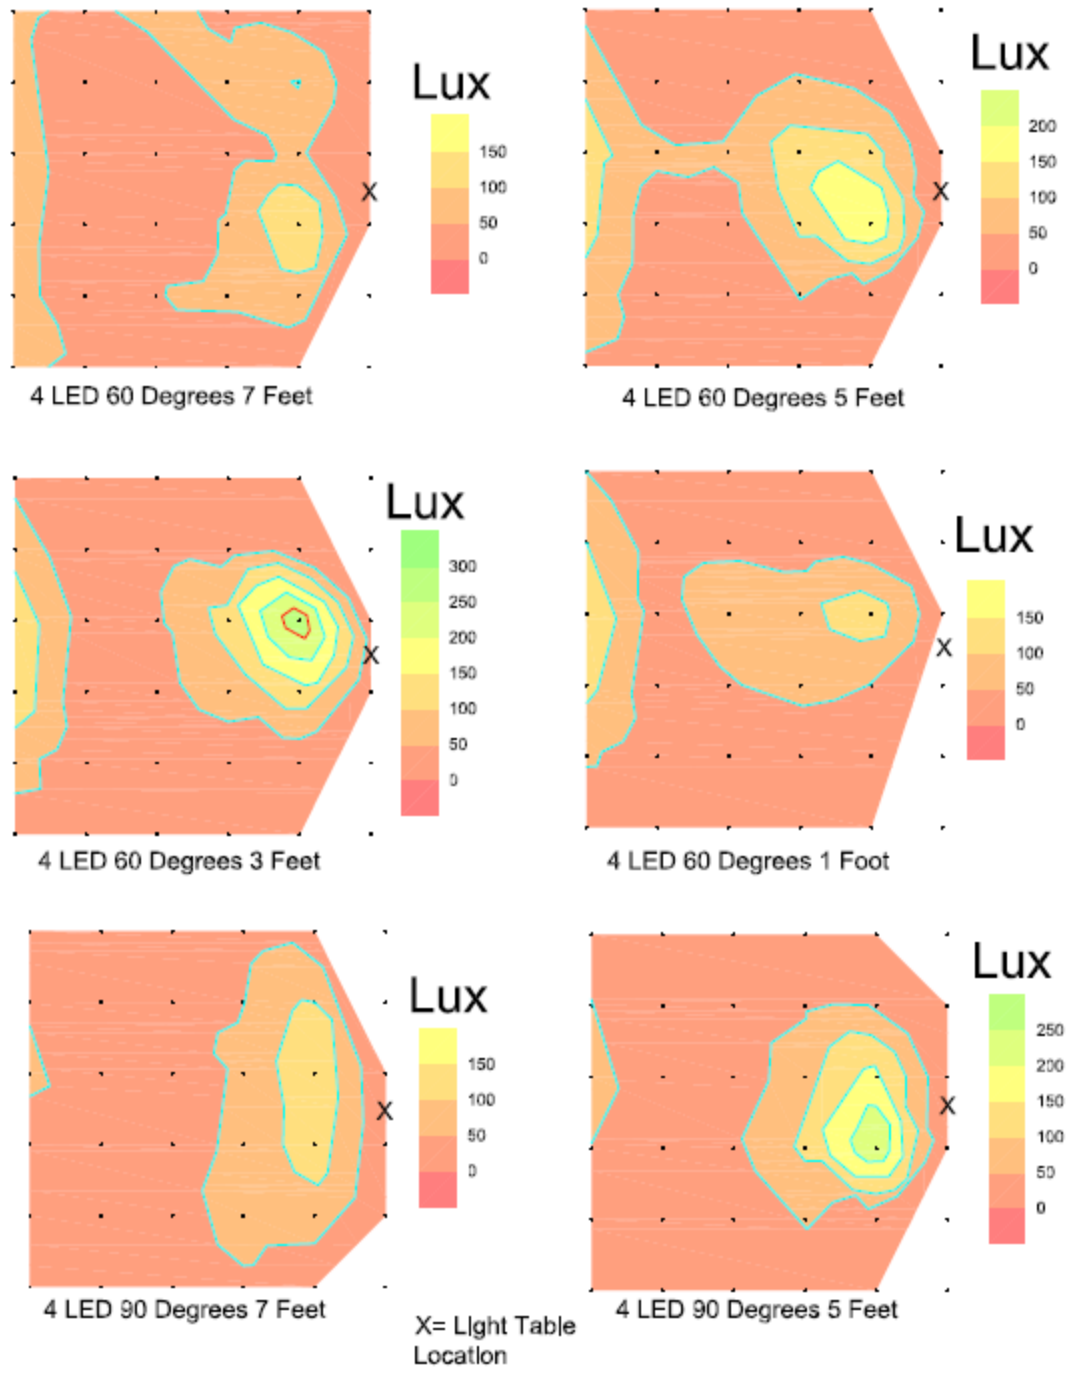
Figure 3.47: Two Dimensional Lux Contours (1)

The impact of different light angles can be observed when comparing the results obtained within each contour chart. For example, the four LED experiments show that as the light angle increased, the amount of light that reached the roof above the face was less. However, the light that reached the roof above the roof bolter was higher with the ninety degree LED lights than with the sixty degree lights. The six LED configurations follow a similar pattern, except for the five feet separation trial where the sixty degree light provided a higher lux value above the roof bolter. The difference of lux values to the

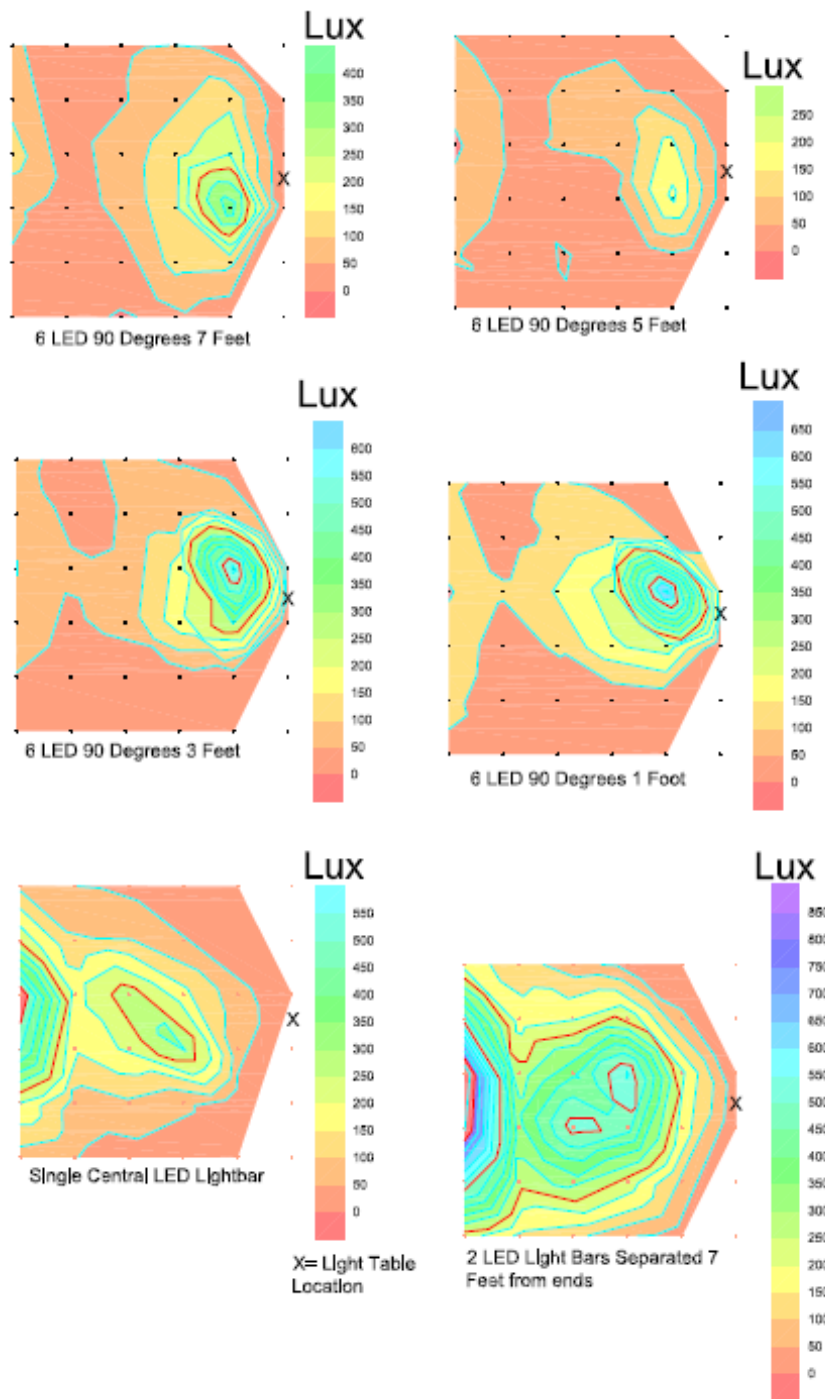
Figure 3.49: Two Dimensional Lux Contours (3)

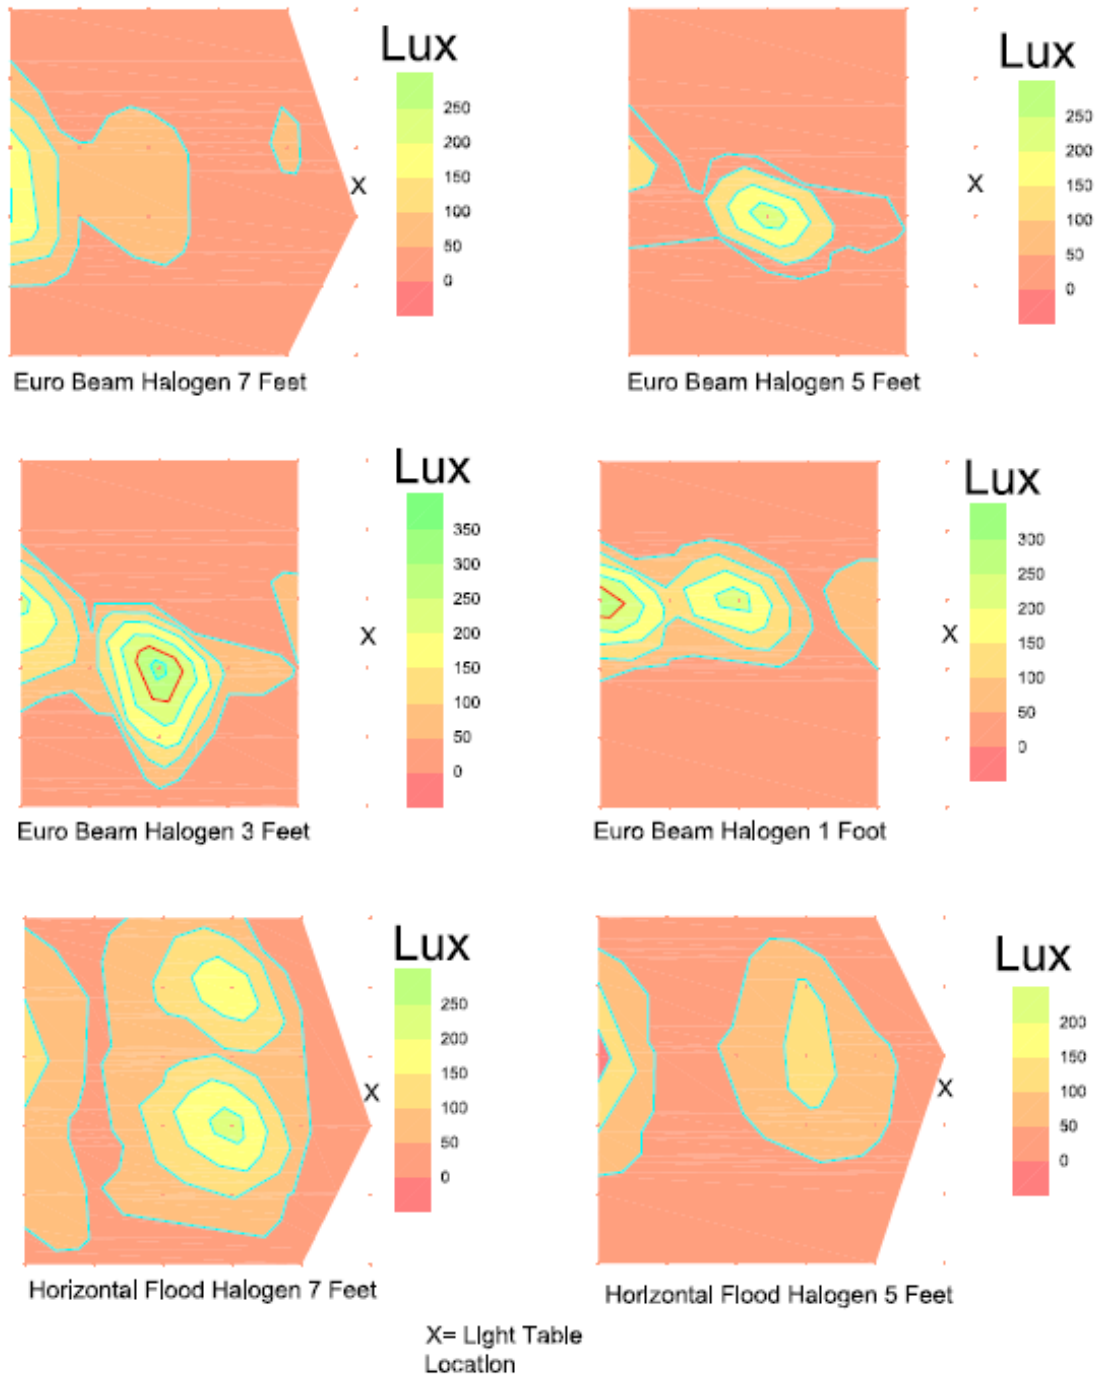
Figure 3.50: Two Dimensional Lux Contours (4)

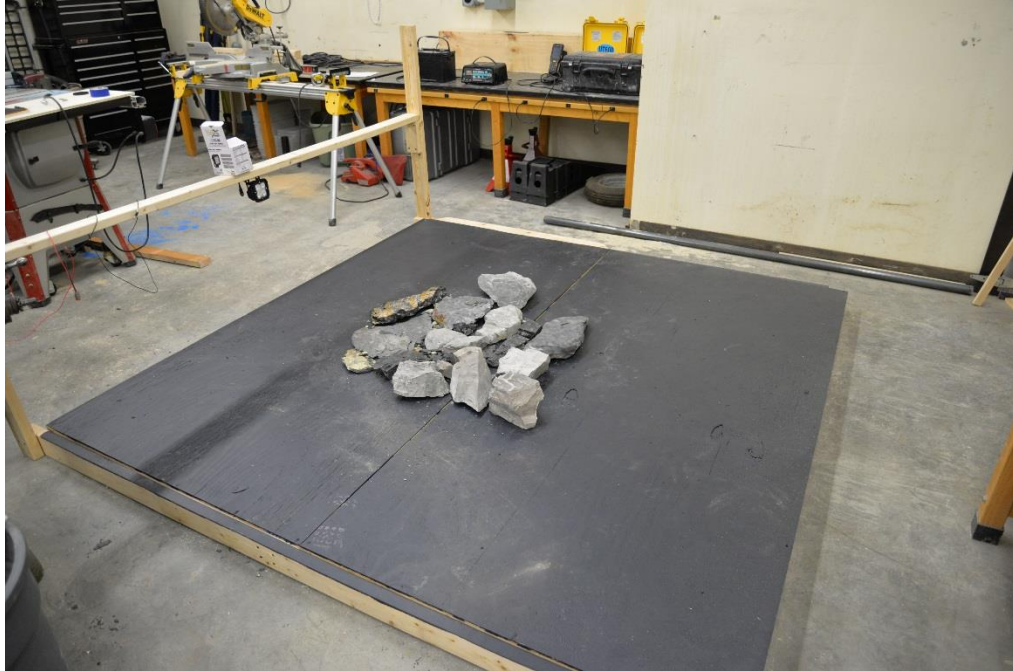
Figure 4.1: Discontinuity Identification Experimental Setup

Experimentation for the discontinuity lighting portion of the research took place in the basement of the Mining and Minerals Resources Building at the University of Kentucky. Multiple samples of coal and shale were obtained from the Red Hawk Number 1 mine in Printer, Kentucky. Limestone samples were also obtained from the UKERT laboratory in Georgetown, Kentucky. The rock samples were set up on the center of a wooden eight foot by eight foot board to simulate differing roof conditions and geologic discontinuities found in underground coal mines. These include coal roof, slickensides, cracked and fractured roof rock, and micro-fractures.

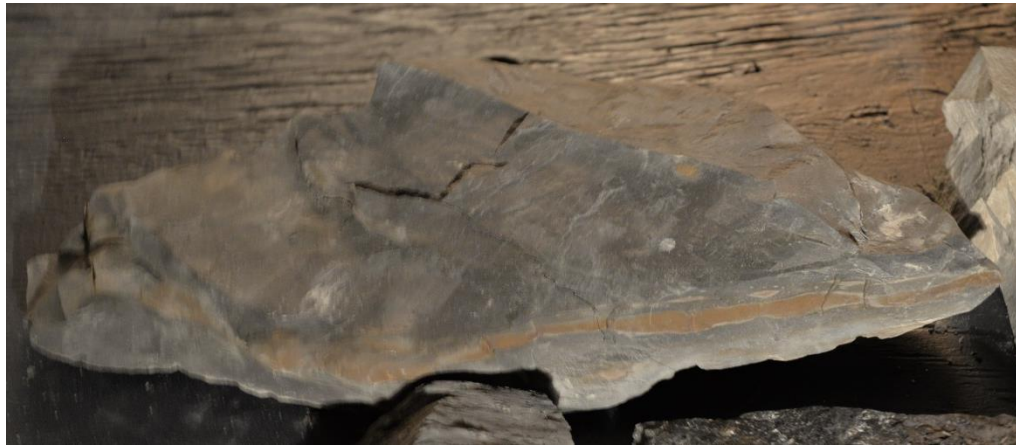
Figure 4.10: Shale Microfracture Using Halogen Euro Beam Pattern

Visual results between both halogen lights were nearly identical. The simulated discontinuities were identified, but not easily. Due to the reduced brightness, the shine of coal and shadows were not as pronounced as other light forms. The horizontal flood performed slightly better than the euro pattern due to its increased horizontal range providing more light. Photographs from this setup can be seen in Figure 4.10 through Figure 4.13.

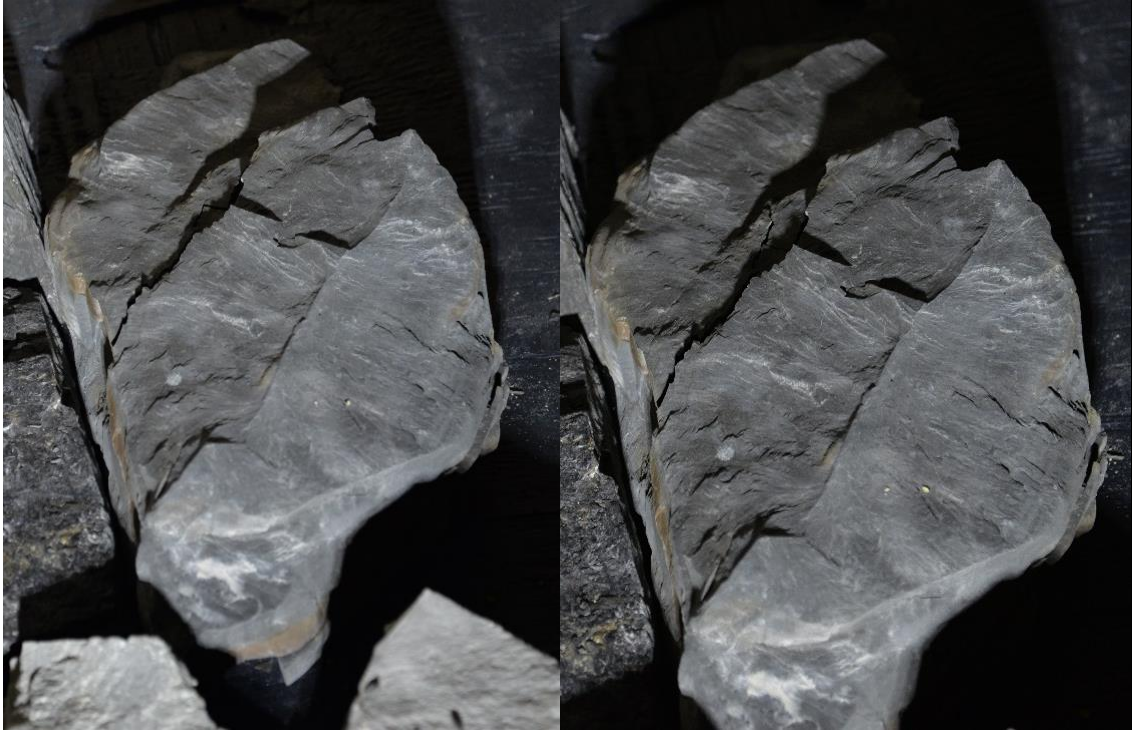
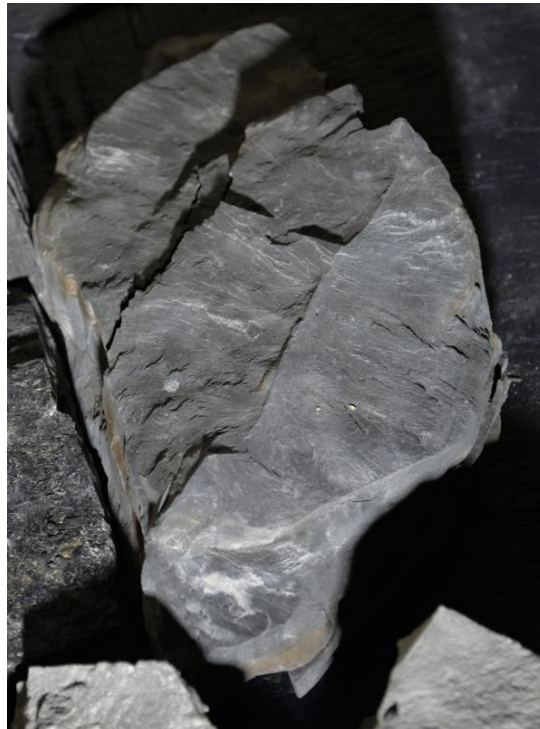
Figure 4.20: Fractured Shale Using LED Lights

Visual results of all LED lights were similar. Every simulated discontinuity was easily identified, as was the same during the first setup. As the LED lights got brighter, the indicating factors of shine and shadow were easier to identify. During this setup there was an issue with identifying the fractured shale from the light position. The only indication of a potential issue with this shale sample that could be seen from the light location was a small, jagged edge protruding from the top of the sample. The LED lights all performed adequately when identifying this edge, but the brighter lights performed marginally better. Photographs from this setup can be seen in Figure 4.20 and Figure 4.21.

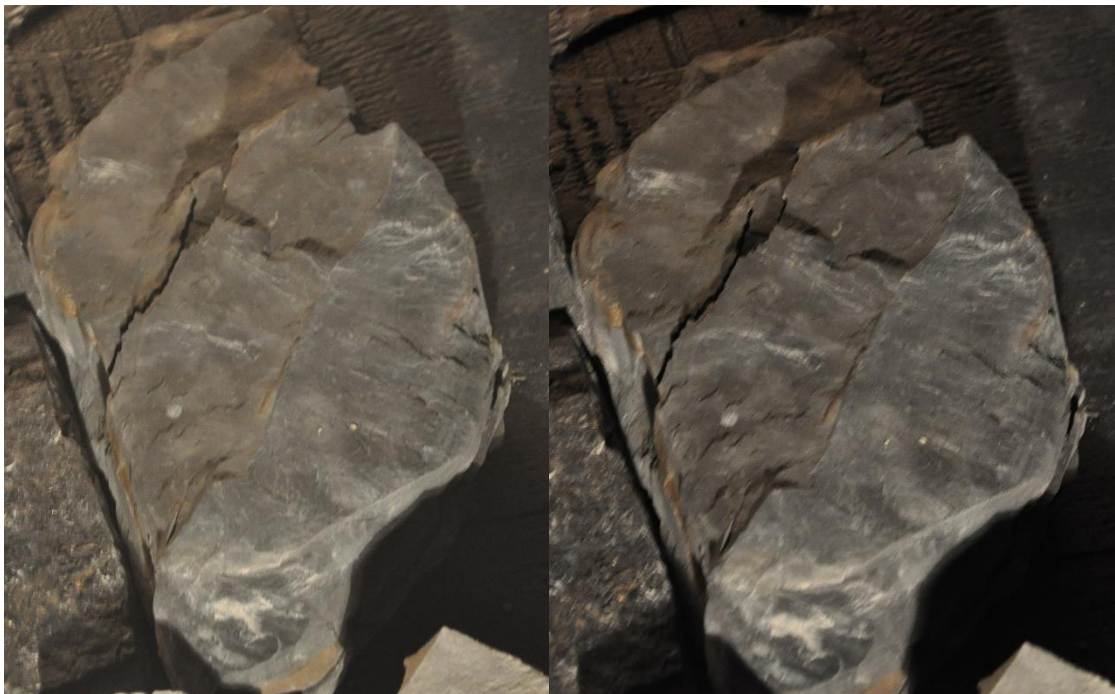
Figure 4.23: Fractured Shale Using Halogen Lights

Visual results between both halogen lights were nearly identical. The simulated discontinuities were identified, but not easily. Due to the reduced brightness, the shine of coal and shadows were not as pronounced as other light forms. The jagged edges of the fractured shale sample were surprisingly easy to locate with both halogen lights. Since less shadow was present for the edge to blend against, the lower amount of light made the edge easier to identify. Photographs from this setup can be seen in Figure 4.23 and Figure 4.24.

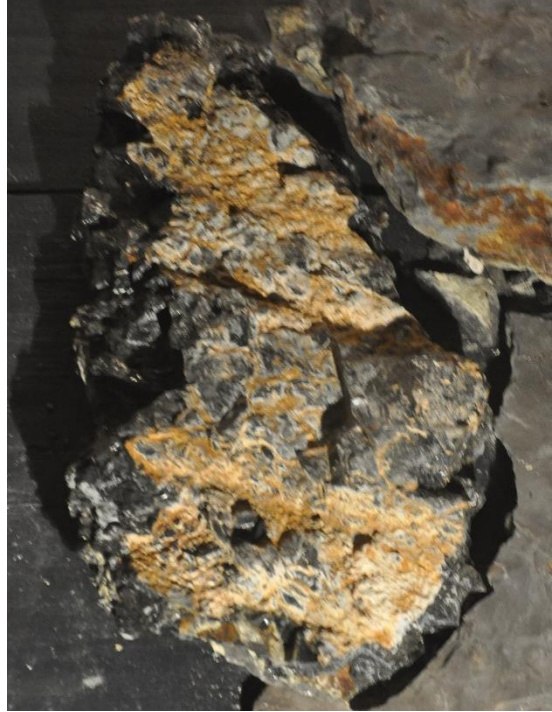
Figure 4.24: Coal Roof Using Halogen Euro Beam Pattern

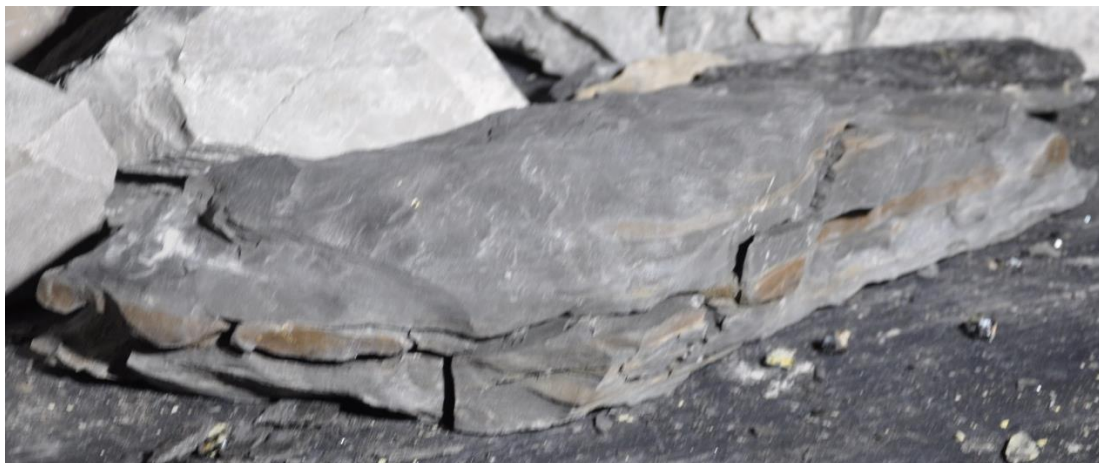
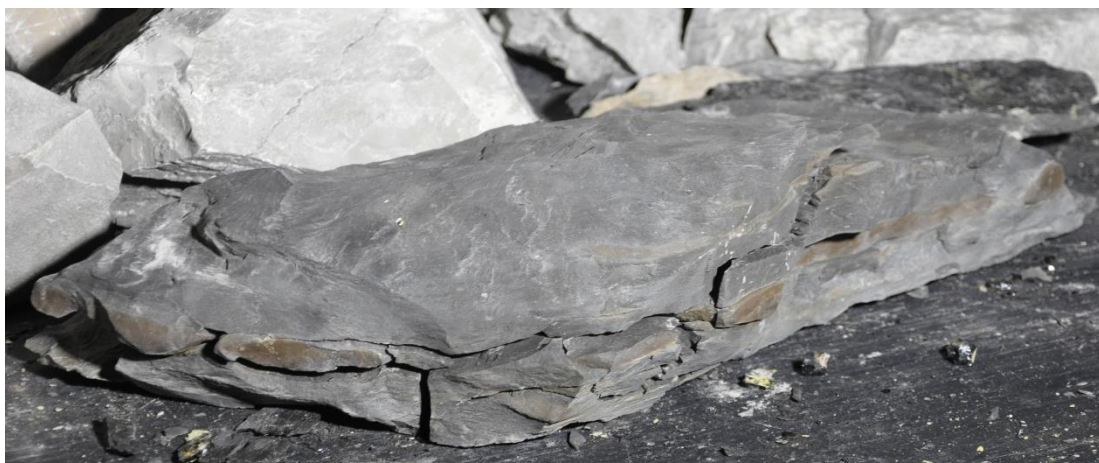
Figure 4.29: Fractured Shale Using LED Lights

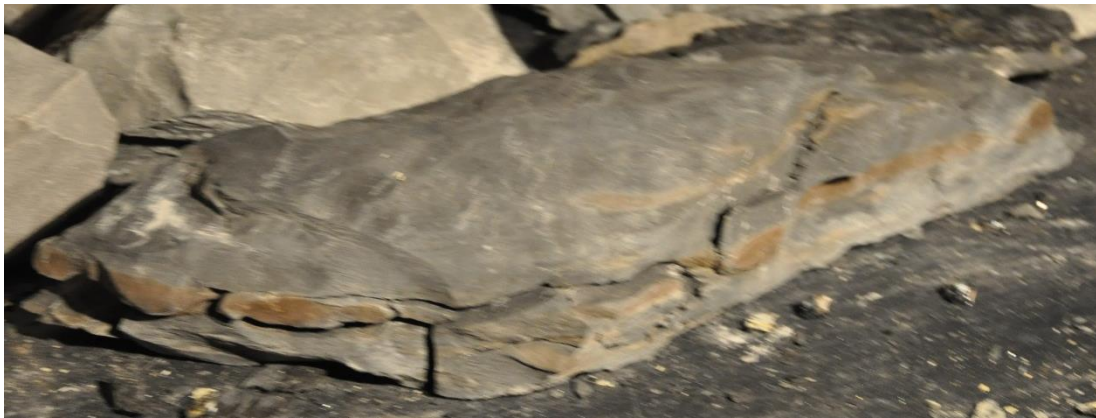
Figure 4.32: Fractured Shale Using Halogen Euro Beam Pattern

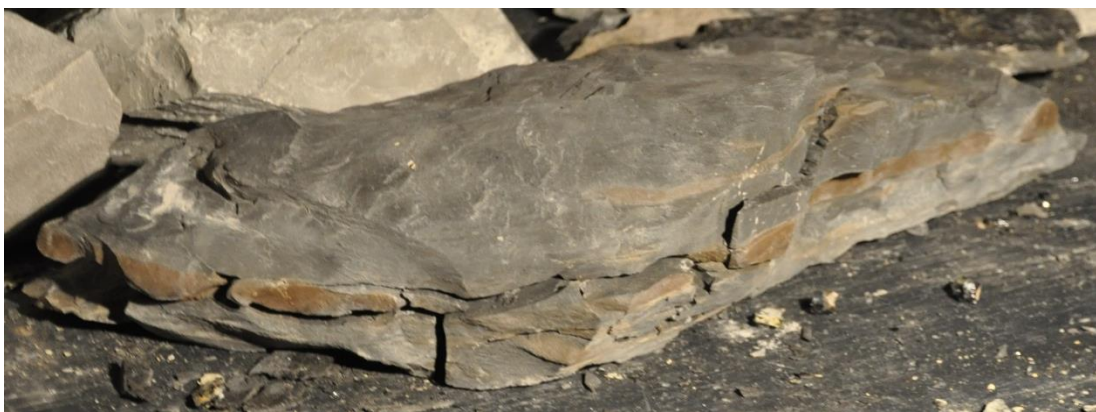
Figure 4.33: Fractured Shale Using Halogen Horizontal Flood Beam Pattern

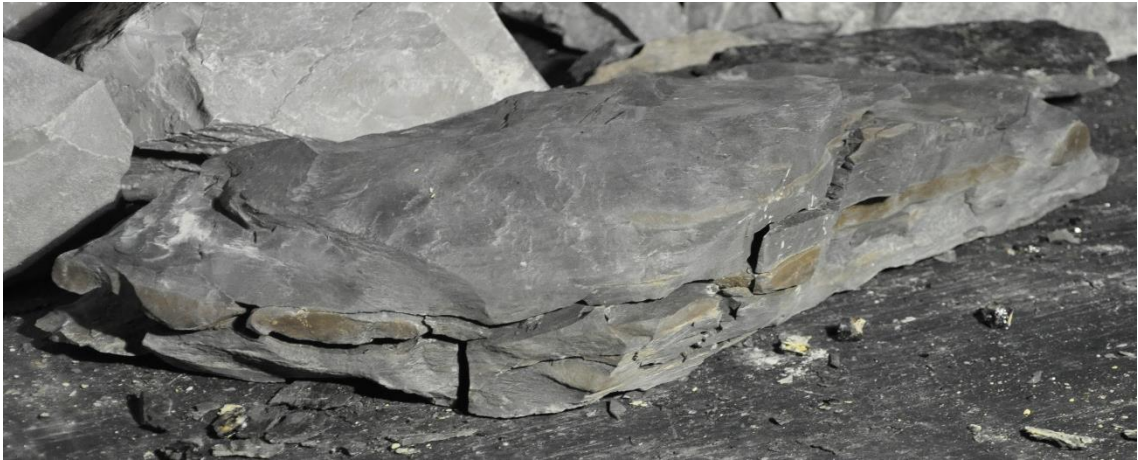
Figure 4.36: Fractured Shale Using HID Euro Beam Pattern

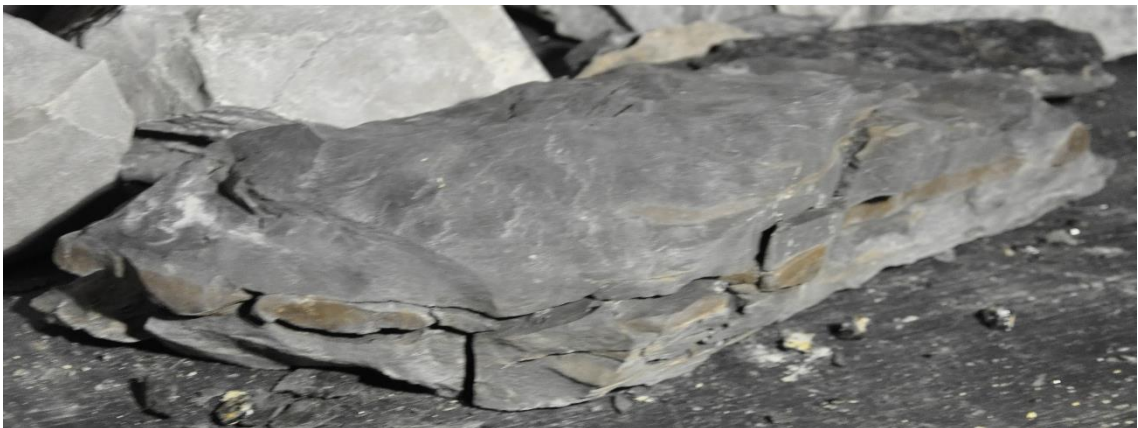
Figure 4.37: Fractured Shale Using HID Horizontal Flood Beam Pattern

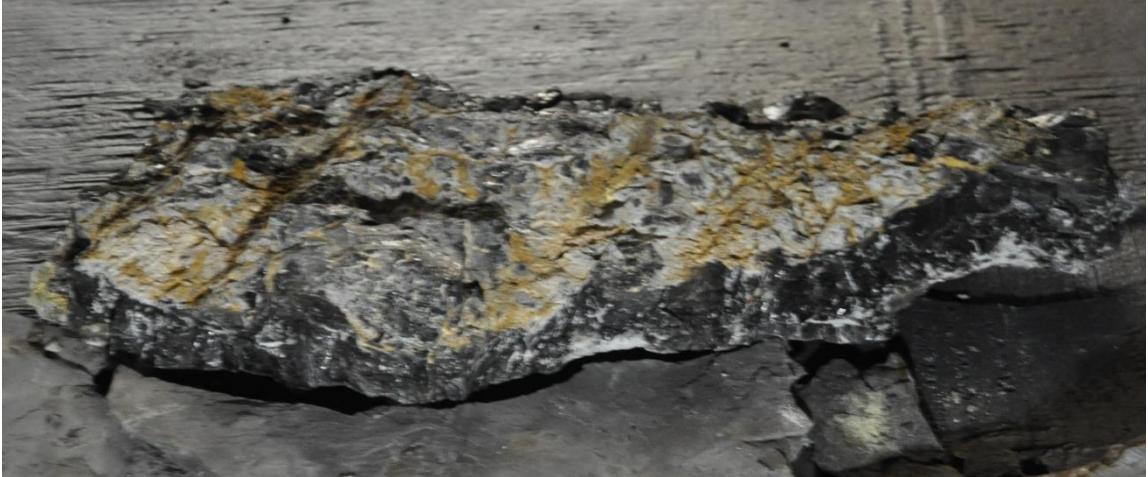
Figure 4.38: Coal Roof Using HID Euro Beam Pattern
