## Pavement Condition Index and Cost of Ownership Analysis on Preventative Maintenance Projects in Kentucky

Dominic J. Michels

University of Kentucky, dmichels57@hotmail.com

THESIS

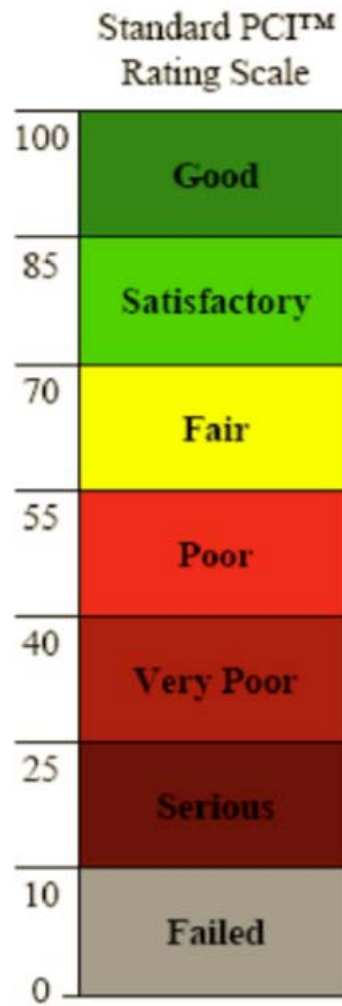
Figure 4.5: ASTM D6433 Rating Scale (ASTM 2007)

Once a PCI is calculated for each sample unit in the section, an area weighted average is calculated in order to determine the final PCI of the pavement. Figure 4.5 provides a rating scale based on the PCI value.

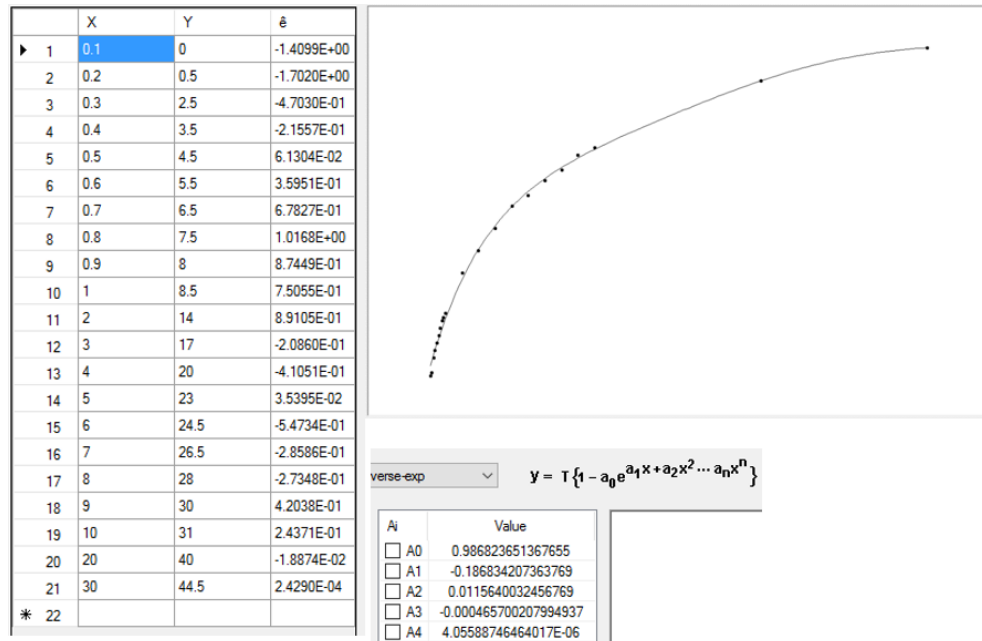
Figure 5.1: CADRE Regression Output

The first step was to determine the equations for the deduct value curves, as well as the corrected deduct value curves. As described in the ASTM D6433 document, the process of developing the curves was empirically based without any strict mathematical equations defining them. Therefore, the curves were manually replotted by estimating the coordinate values along them. The CADRE Regression software was used to input the data points and apply a line of best fit to each curve. An equation for the line would then be displayed within the software. Some sample screenshots from CADRE are shown below.

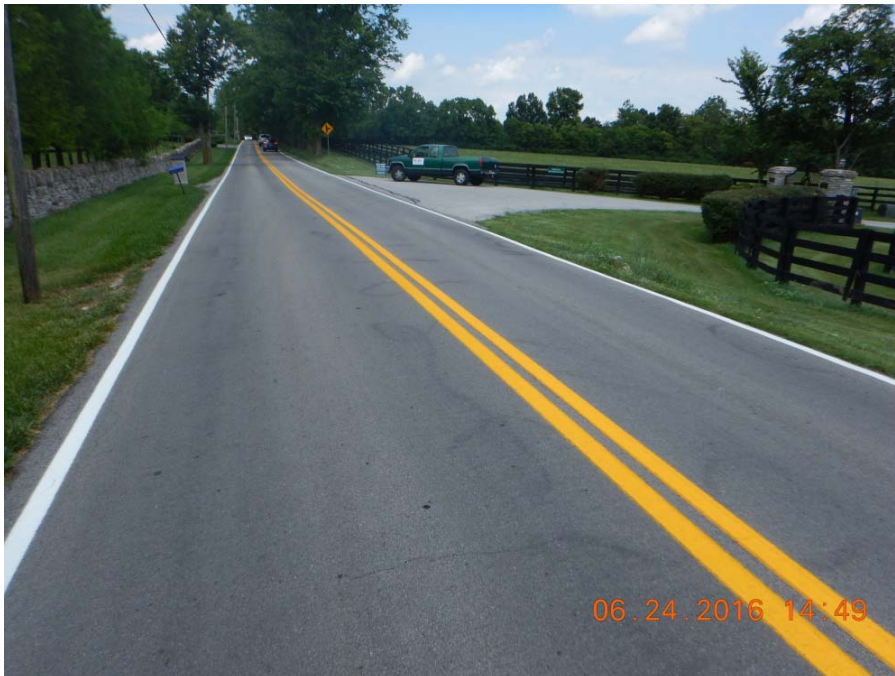
Figure 7.1: Fayette County, Bleeding Distress

Microsurfacing was found to be more susceptible to liquid asphalt bleeding than Thinlay. The bleeding would primarily originate from the presence of crack sealing material underneath the surface. While this distress did not contribute much numerically to the PCI difference, its commonality with Microsurfacing is worth noting. Some examples of this distress are shown below.

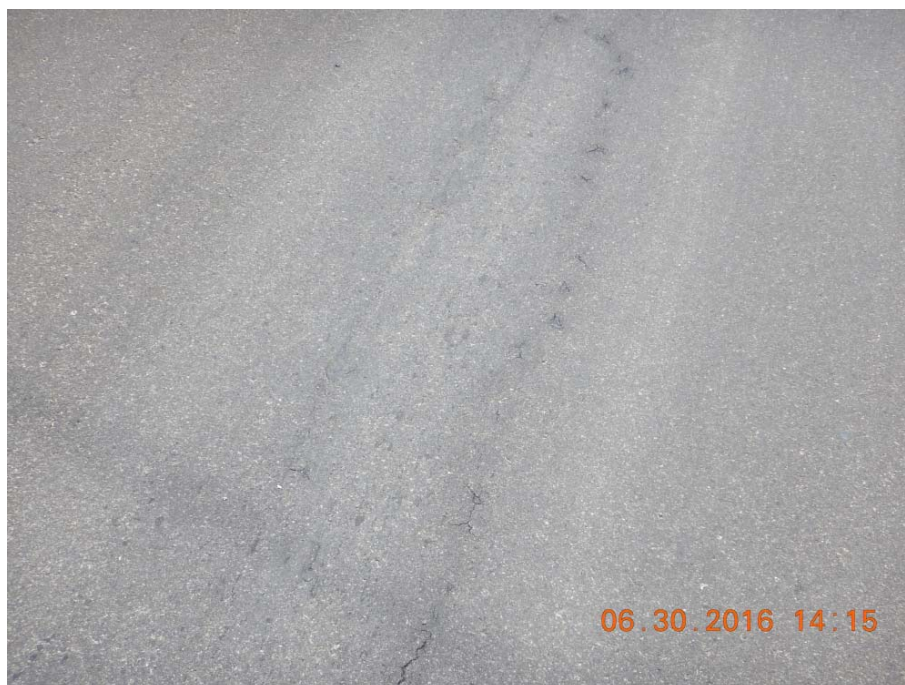
Figure 7.2: Morgan County, Bleeding Distress, Brand New Surface

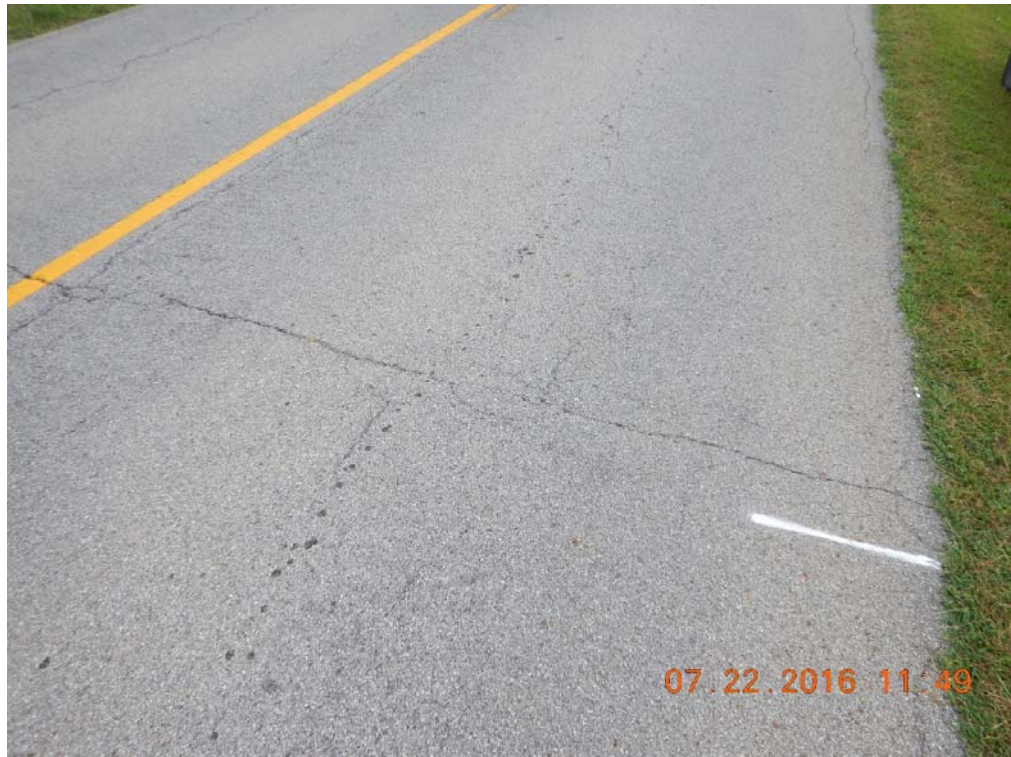
Figure 7.3: Green County, Longitudinal/Transverse Cracking, Thinlay

Edge Cracking as well as Longitudinal/Transverse Cracking were found to be the most common distresses between both products. Edge Cracking can be caused by either repeated traffic loading or a weakened base/subgrade under the edge of the pavement surface. Longitudinal and Transverse Cracking can be caused by traffic loading or

environmental conditions, such as oxidation and hardening of the surface combined with multiple freeze-thaw cycles. In the case of surface treatments, it is very characteristic for cracks in the old surface to reflect through to the new surface. It is apparent that Microsurfacing is more susceptible to this reflection cracking due to its thinness. Therefore, Microsurfacing is more susceptible to Longitudinal and Transverse Cracking at an earlier age, which could partly explain the PCI disparity between the two products. It was found that Edge Cracking is at more of an even level between Microsurfacing and Thinlay, most likely due to the factors affecting that distress outside of the surface treatment properties. Some examples of these distresses are shown below.

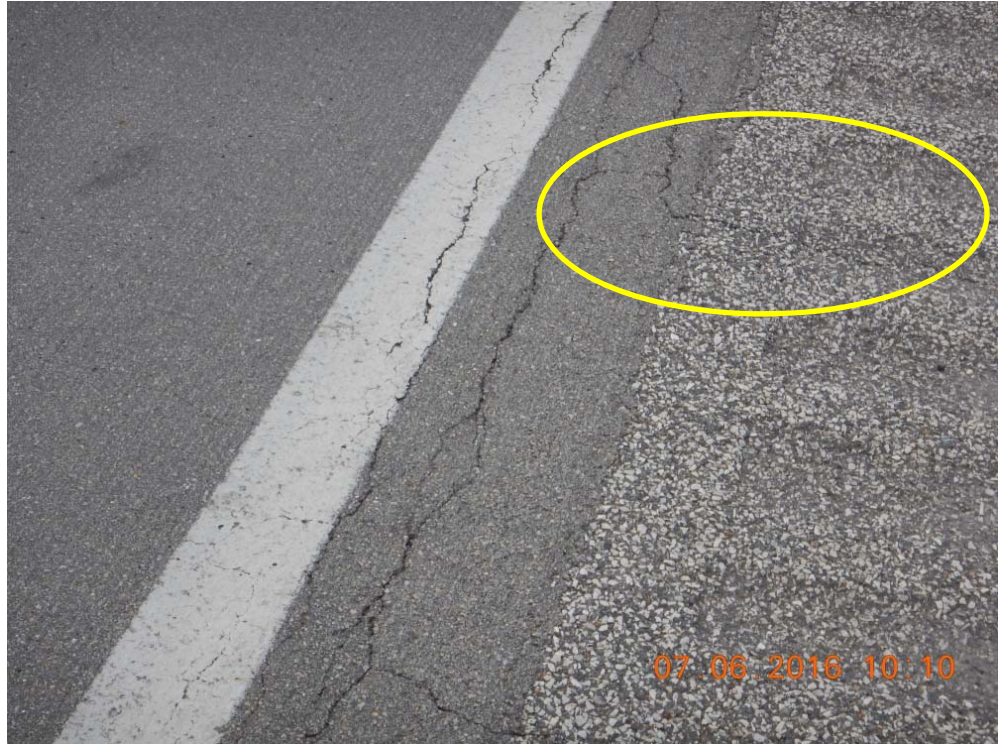
Figure 7.4: Greenup County, Reflective Crack/Edge Cracking, Microsurfacing

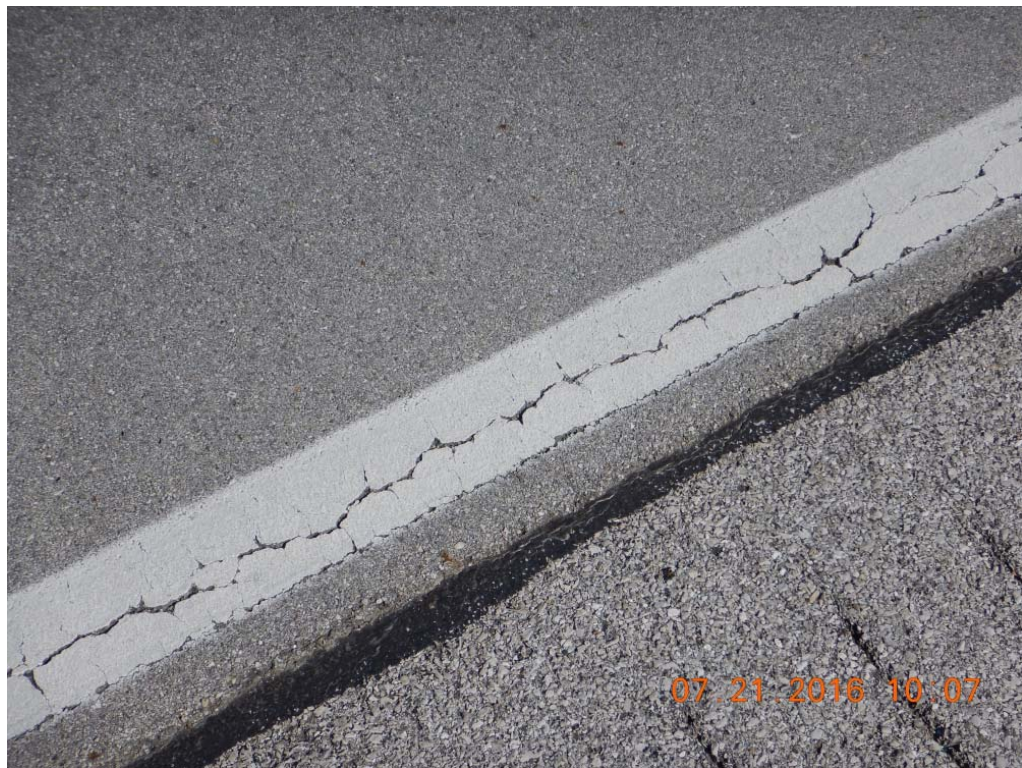
Figure 7.5: Pulaski County, Edge Cracking, Thinlay

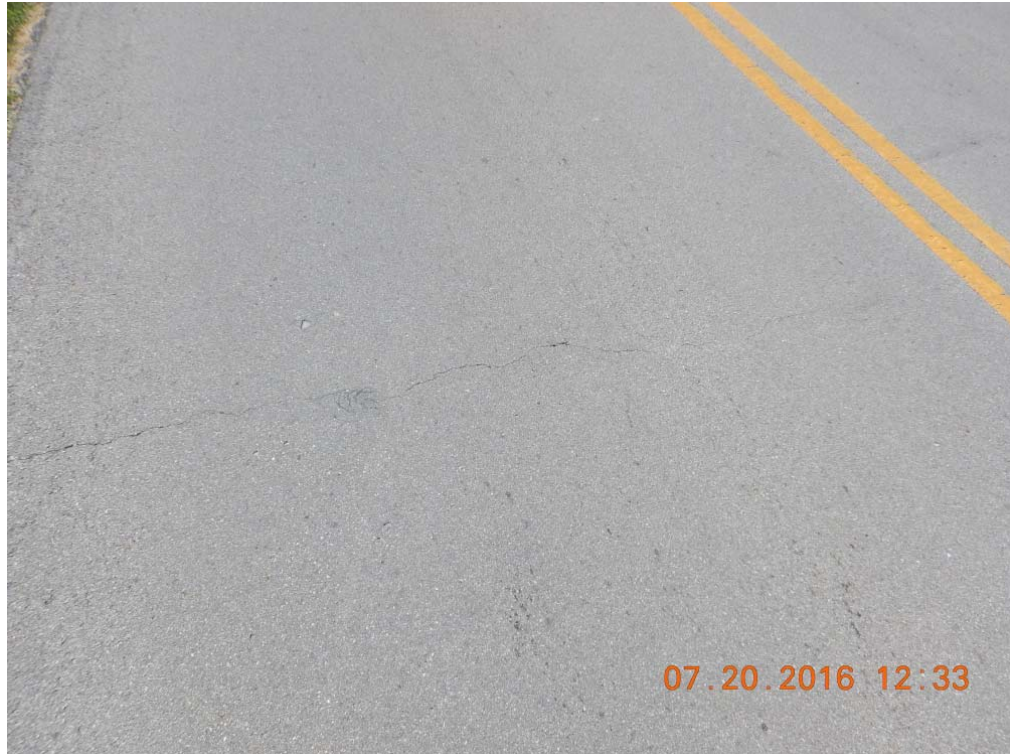
Figure 7.6: Laurel County, Transverse Cracking, Microsurfacing

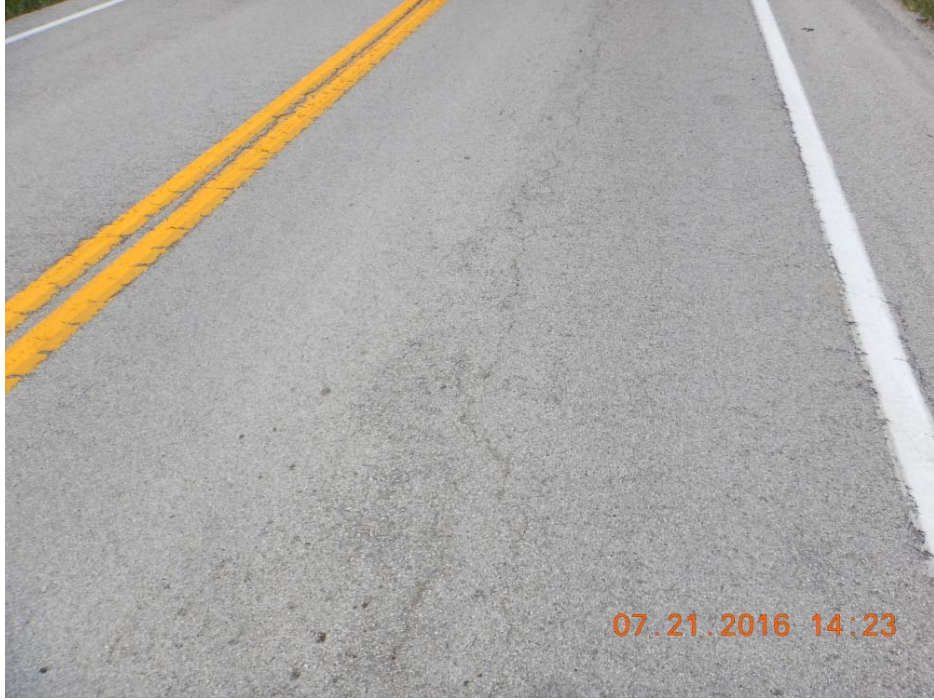
Figure 7.7: Wayne County, Alligator Cracking, Thinlay

Alligator Cracking was a common distress encountered during the pavement evaluations. This distress is caused by repeated traffic loading that eventually causes the pavement to crack and break apart in a pattern similar to chicken wire or alligator skin. It is a symptom that there is structural damage occurring in the pavement, and that the cracks are forming from the bottom to the top. Alligator Cracking appeared to be more common amongst Microsurfacing sites than Thinlay. There are a number of factors that may have contributed to this observation, including the thin layer thickness of Microsurfacing, or the possibility that the pre-existing pavement already had structural damage. If Microsurfacing or a Thinlay is applied to a surface with such structural damage, sub-par performance is expected of either product. Within the ASTM deduct value curves, alligator cracking is a very sensitive parameter, and can significantly reduce the PCI with a relatively small density. Therefore, the presence of more alligator cracking in Microsurfacing significantly contributed to its low PCI values. Some visual examples of this distress are shown below. These images, as well as the vast majority of recorded alligator distress, represent low severity, before the cracking patterns into alligator skin.

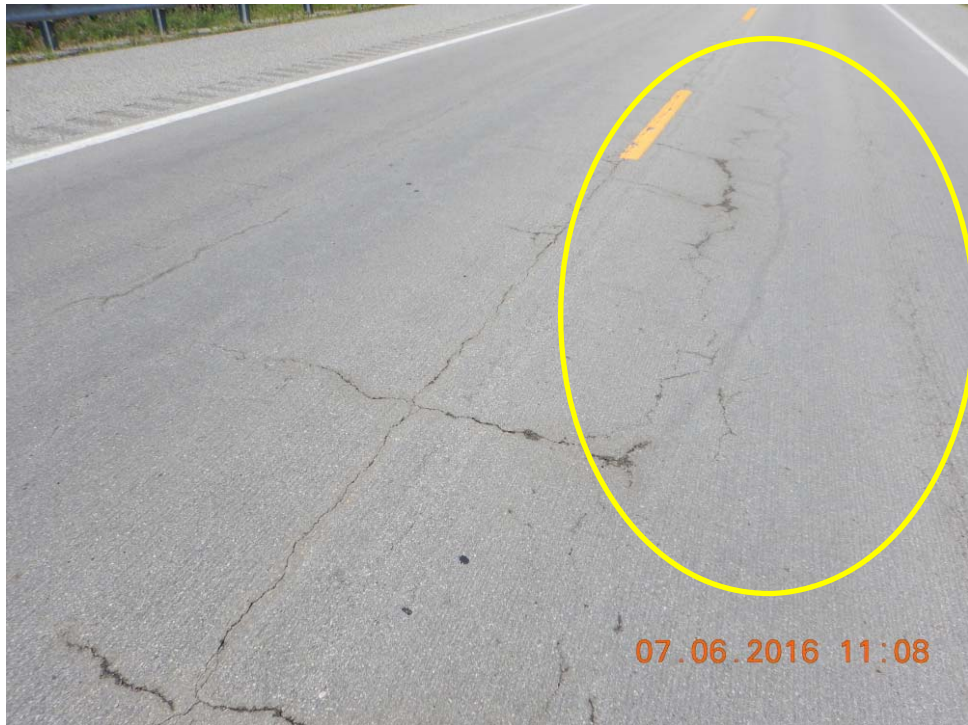
Figure 7.8: Greenup County, Alligator Cracking, Microsurfacing

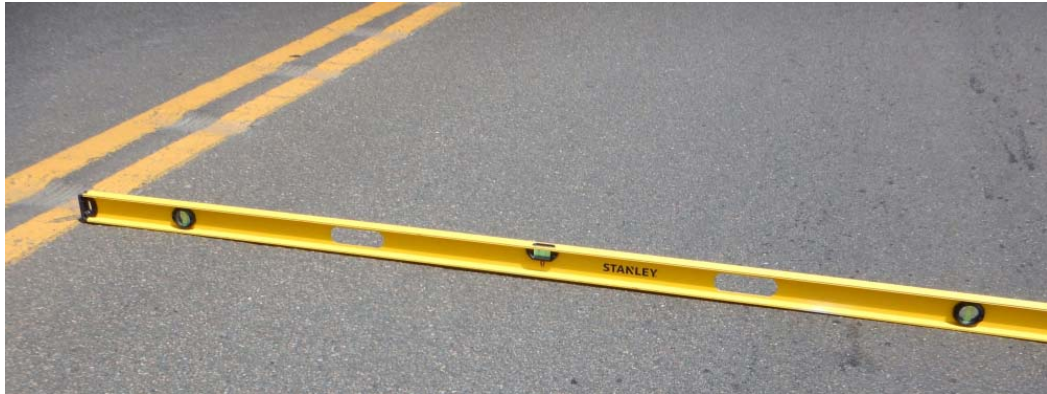
Figure 7.9: Harlan County, Rutting, Microsurfacing

The distress within the ASTM method that most significantly contributed to PCI loss was rutting, which is longitudinal deformation caused by wheel loading. It was found that Microsurfacing recorded significantly more cases of rutting than Thinlay. All rutting recorded was found to be low severity, which means that the maximum depth was between ¼” and ½”. It could be that Microsurfacing is too thin to properly correct for even minor rutting, or that physical wearing in the wheel path is creating the rut. Some examples are shown below.

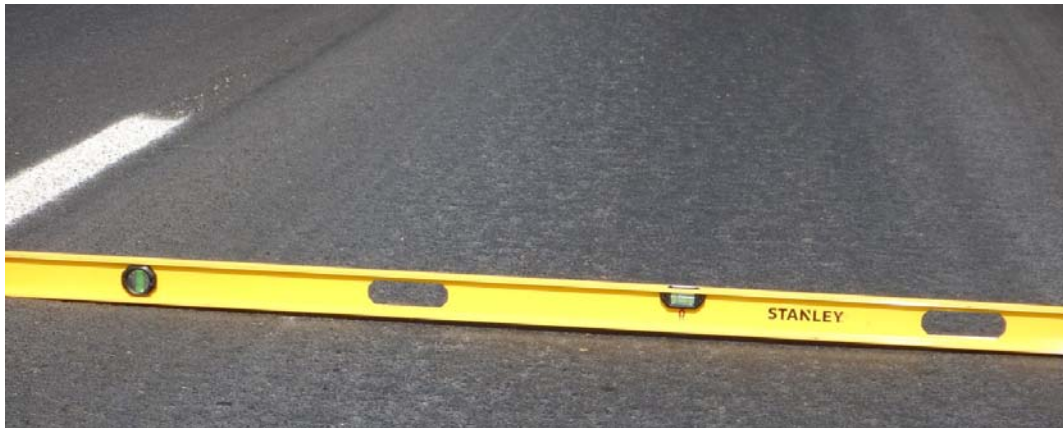
Figure 7.10: Warren County, Rutting, Microsurfacing

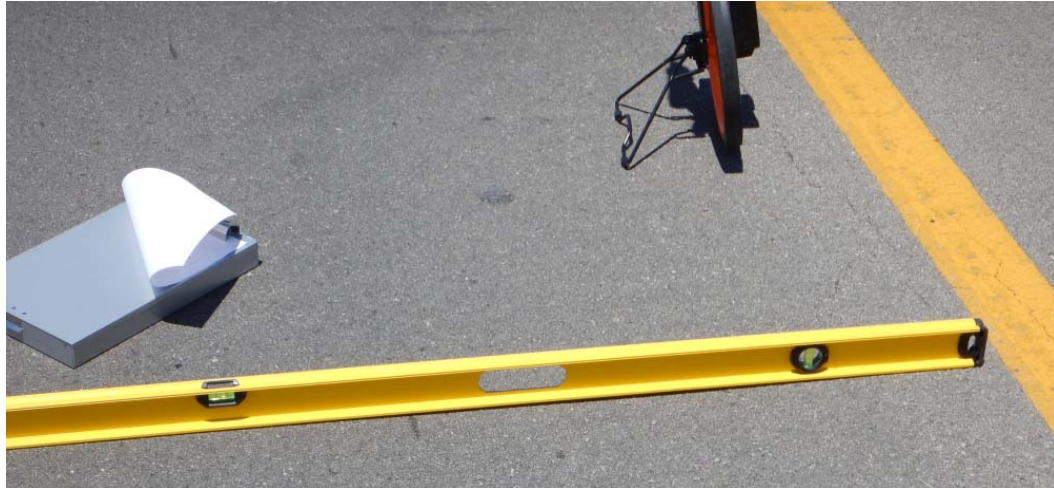
Figure 7.11: Nelson County, Rutting, Microsurfacing

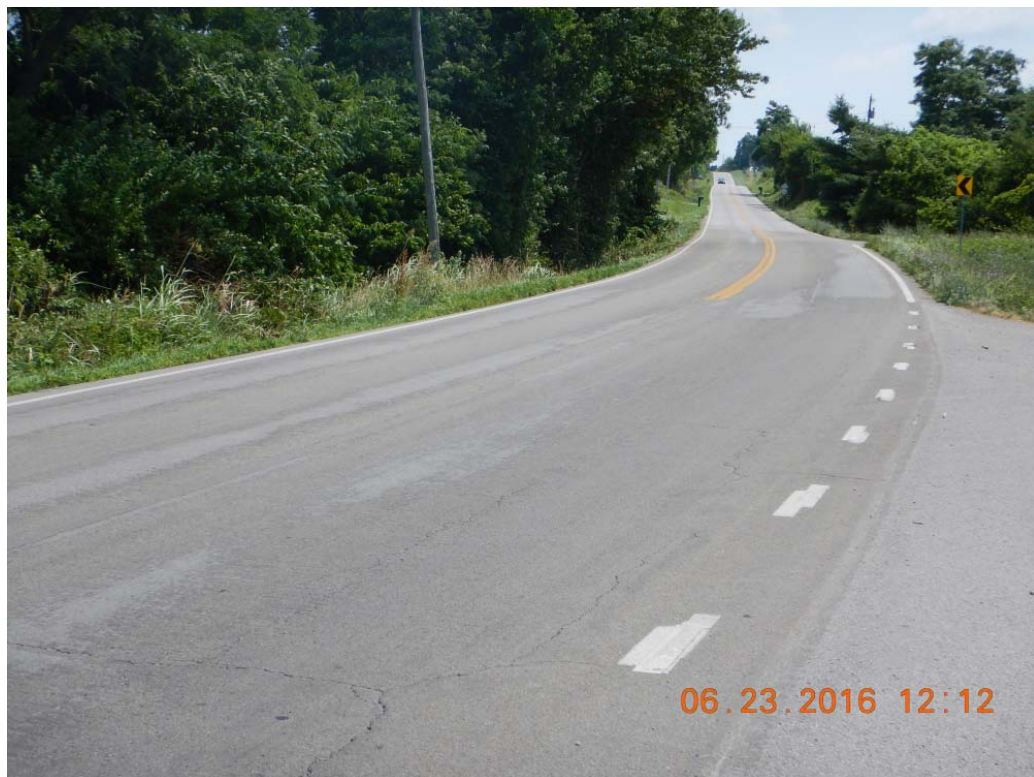
Figure 7.12: Boyle County, Surface Wearing, Microsurfacing

In certain Microsurfacing sites, it was found that the material was visibly wearing away and the underlying pavement layer was visible. While this severe wearing was not common to every site, it is worth noting as a distress unique to Microsurfacing, and was never seen on a Thinlay product. The notable occurrences were at the Fayette County and Boyle County Sites, as shown below.

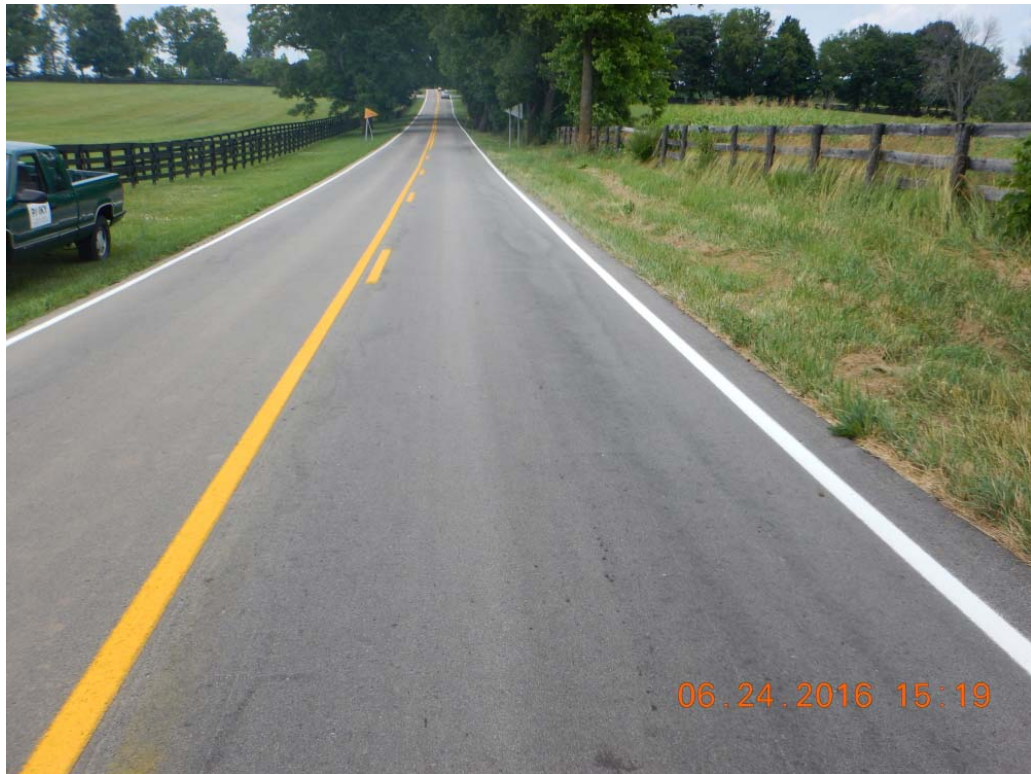
Figure 7.13: Fayette County, Surface Wearing, Microsurfacing

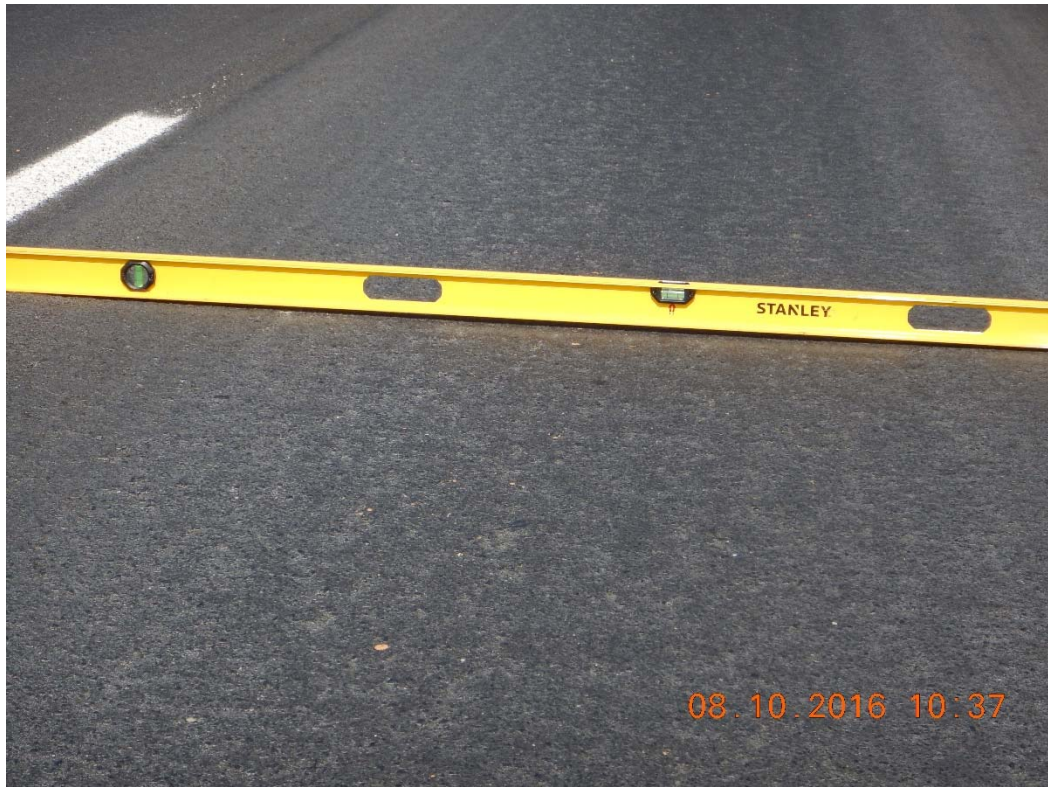
Figure 7.14: Warren-Allen County, Rutting, Fresh Microsurfacing

Very shortly after Microsurfacing was applied to the Warren and Allen County precondition sites, the opportunity was taken to observe how Microsurfacing was

performing early in its life. Since Warren County exhibited rutting and Allen County exhibited rutting/alligator cracking before treatment, the observations yielded results about how distresses reflect through Microsurfacing. Both the Warren and Allen County sites showed that the rutting had immediately reflected through after construction, providing concrete evidence that Microsurfacing struggles to fill ruts when applied. The alligator cracking encountered at Allen County in the pre-condition state had not reflected through that early in the treatment's life. Some images of rutting taken from these sites are shown below. Moving forward with the pavement evaluations in the future, it will be important to observe how these sites perform, knowing that they contained significant distress beforehand.

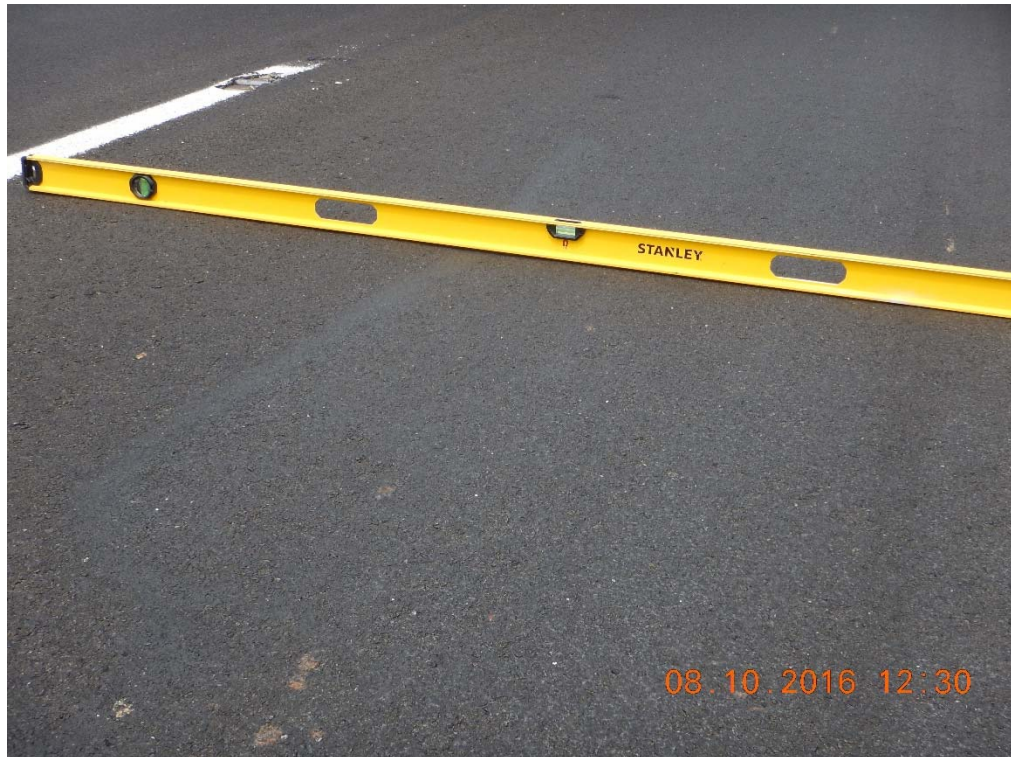
Figure 7.15: Warren-Allen County, Rutting, Fresh Microsurfacing

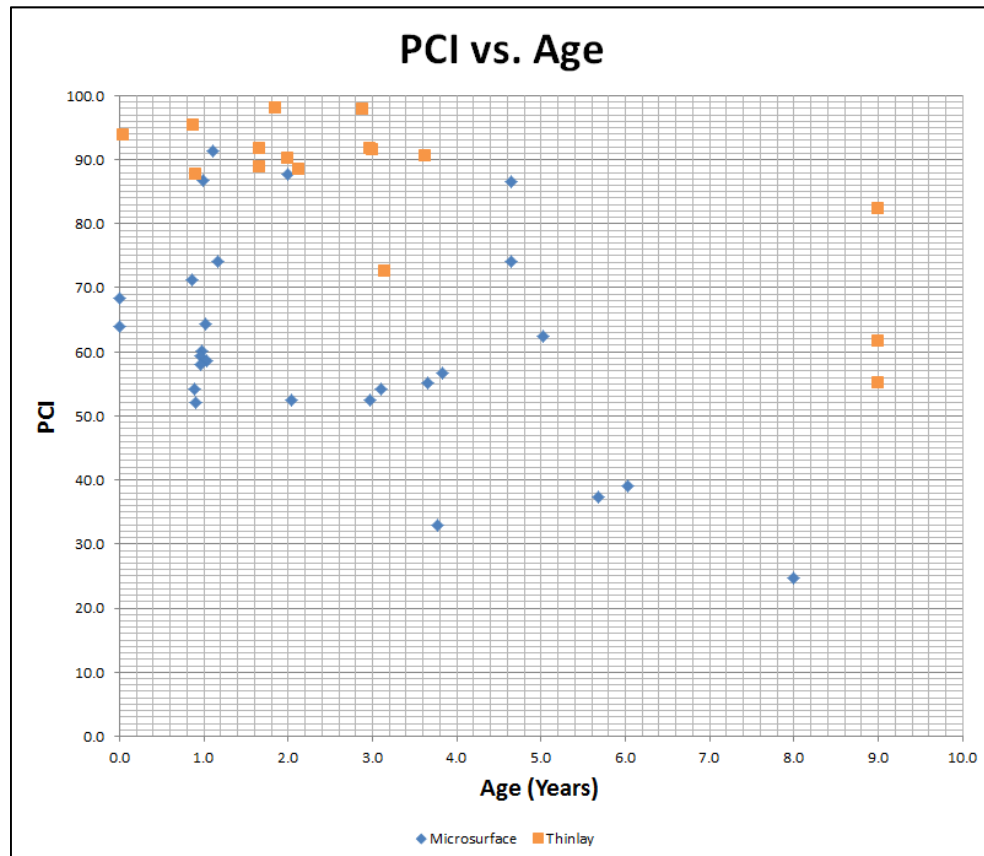
Figure 9.1: PCI vs. Age without Trendlines

After compiling the raw PCI data from each site, it was decided that graphing PCI vs. surface Age would most likely be the most effective method to graphically represent the data. The statistical model found in Chapter 8 confirms this suspicion. Figure 9.1 below simply shows each data point, before applying a trendline.

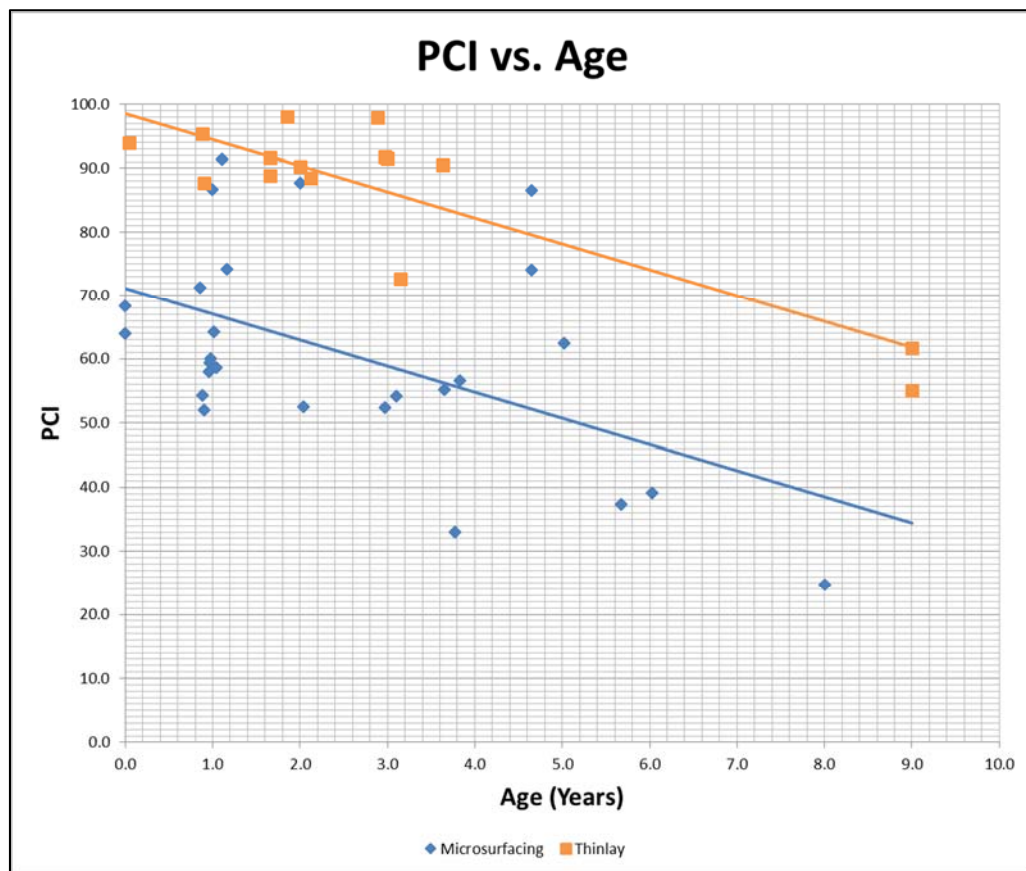
Figure 11.1: PCI vs. Age with Prediction Model

With the ever increasing use of Preventative Maintenance in Kentucky, it is significantly important to further study this issue to understand the value to the taxpayers of Kentucky. ASTM D6433 was selected as the method of evaluation due to its unbiased and statistical approach. After a period of approximately two months, PCI data for all the projects was obtained and compiled into a spreadsheet database. From the first glances at the completed data, it became apparent that Thinlay was outperforming the Microsurfacing sites from an engineering point of view. The data was graphed and trendlines were applied based off of the multiple linear regression model in Chapter 8. After deciding to use PCI vs. Age as the primary graphing method, Figure 11.1 was used as the basis for the age/cost analysis:
