# Utilization of Light Detection and Ranging for Quality Control and Quality Assurance of Pavement Grades

Kentucky Transportation Center Research Report – KTC-18-01/SPR15-496-1F

**Research Report**  
KTC-18-01/SPR15-496-1F

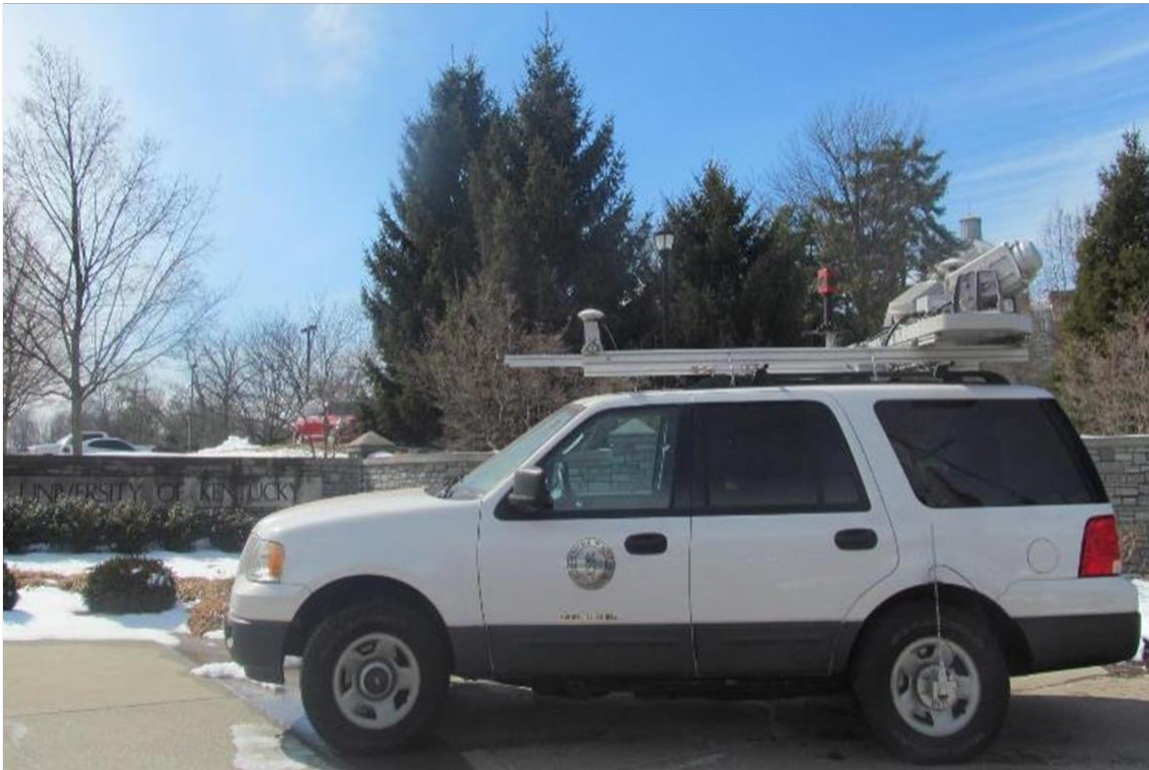
This study utilized a survey grade Lynx V200 mobile mapping system manufactured by Teledyne Optech. The Lynx V200 can collect 200,000 survey grade LiDAR data points-per-second using two spinning lasers (Figure 1). Each LiDAR data point has four attributes: x, y, z, and intensity value. The x, y, and z values define the collected data point's geospatial position (i.e., longitude, latitude, and elevation). The intensity value is a numeric value assigned to a LiDAR data point that signifies the scanned object's ability to absorb and/or reflect the laser energy.

**Figure 1** Lynx V200 mobile mapping system from Teledyne Optech

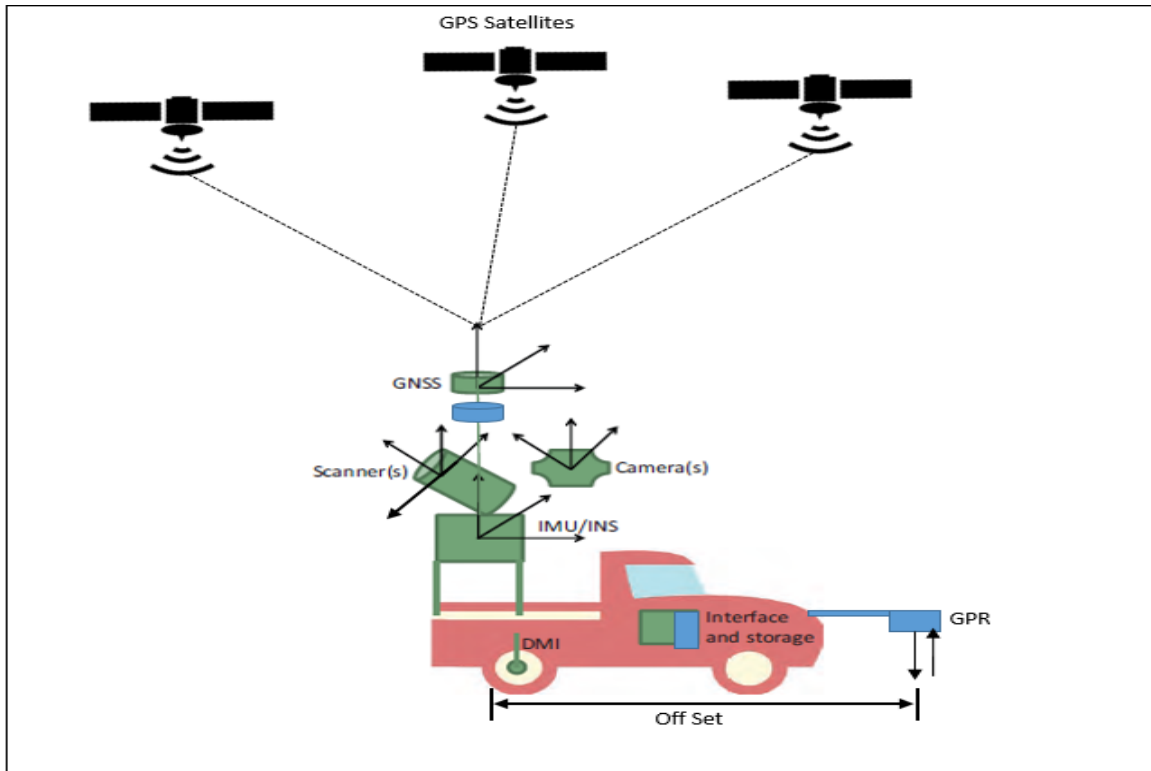
The Lynx V200, as well as most mobile LiDAR units on the market today, consists of two infrared laser scanners, an inertial measurement unit (IMU), a distance measurement device (DMI), a Global Positioning System (GPS), and a data collection unit (Figure 2). Figure 2 also depicts cameras, which are optional on most mobile LiDAR systems. They can be used to colorize a point cloud with RGB values.

**Figure 2** Mobile LiDAR diagram

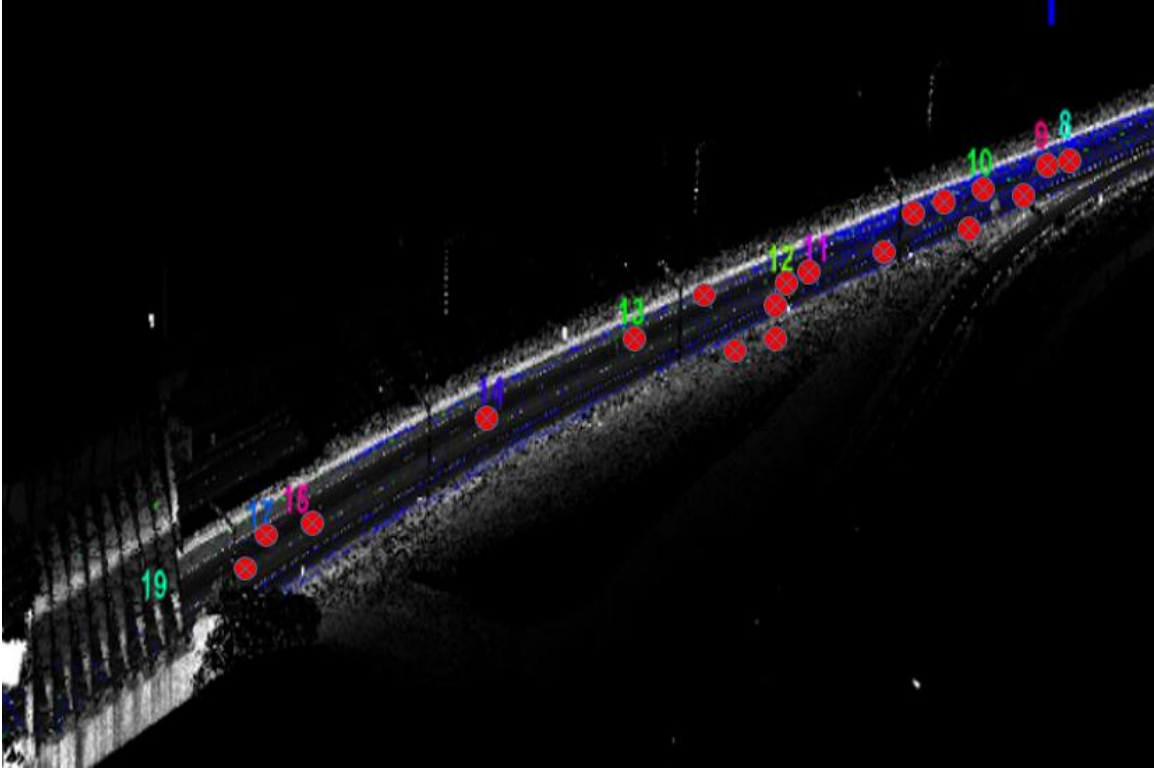
Therefore, mobile LiDAR data were collected and analyzed for this area to better understand surface-water drainage patterns. For visualization purposes, the approximate locations of the 19 accidents recorded by attending police officers shortly after each occurrence are overlaid on the LiDAR point cloud (Figure 3).

**Figure 3** Accident locations overlaid on the mobile LiDAR point cloud

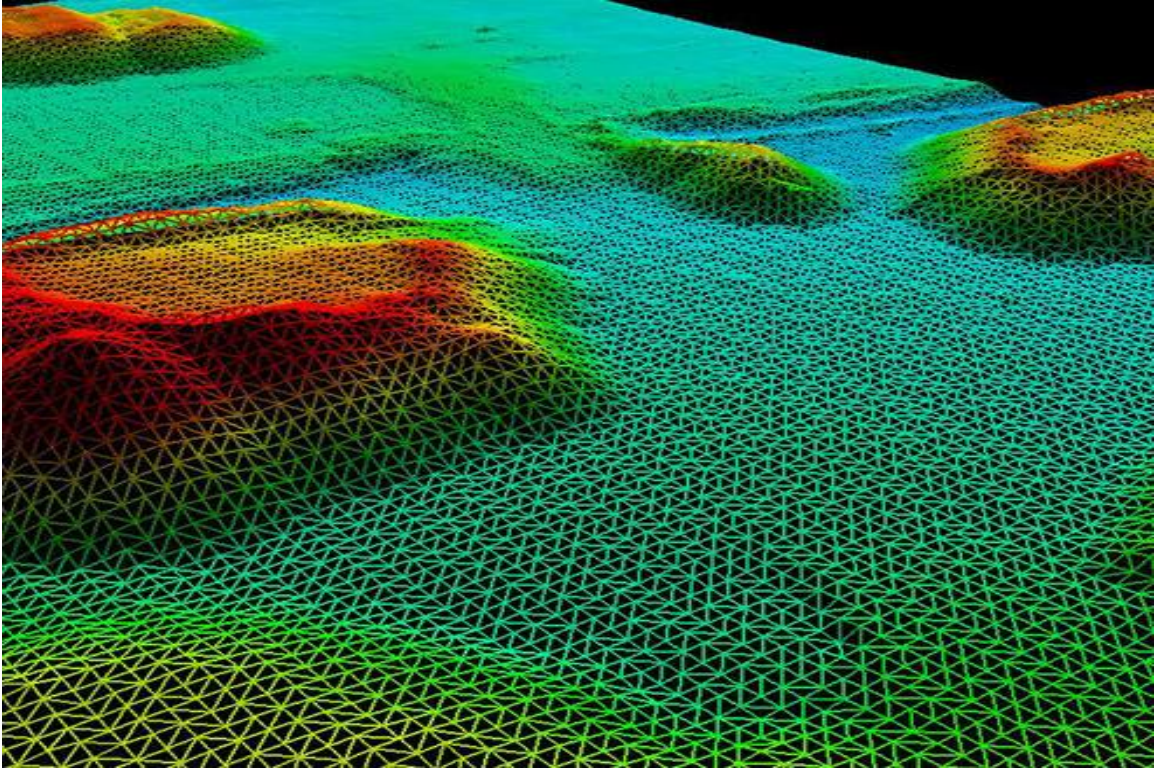
To identify inadequate pavement surface drainage areas on this 1,000-foot stretch of roadway, the LiDAR point cloud was first converted into a digital terrain model (DTM). As standard practice, a DTM is created by triangulating survey points into a surface model. Figure 4 is an example of a triangulated point cloud converted into a surface model. This DTM, as well as others mentioned throughout this report, was created using TopoDOT from Certainty 3D. TopoDOT is a program that converts raw LiDAR point clouds in LAS format into DTMs. After generating the DTM, simulated surface-water flow paths were mapped using Bentley’s MicroStation “downstream trace and/or trickle command.”

**Figure 4** Triangulated LiDAR data representing a surface DTM

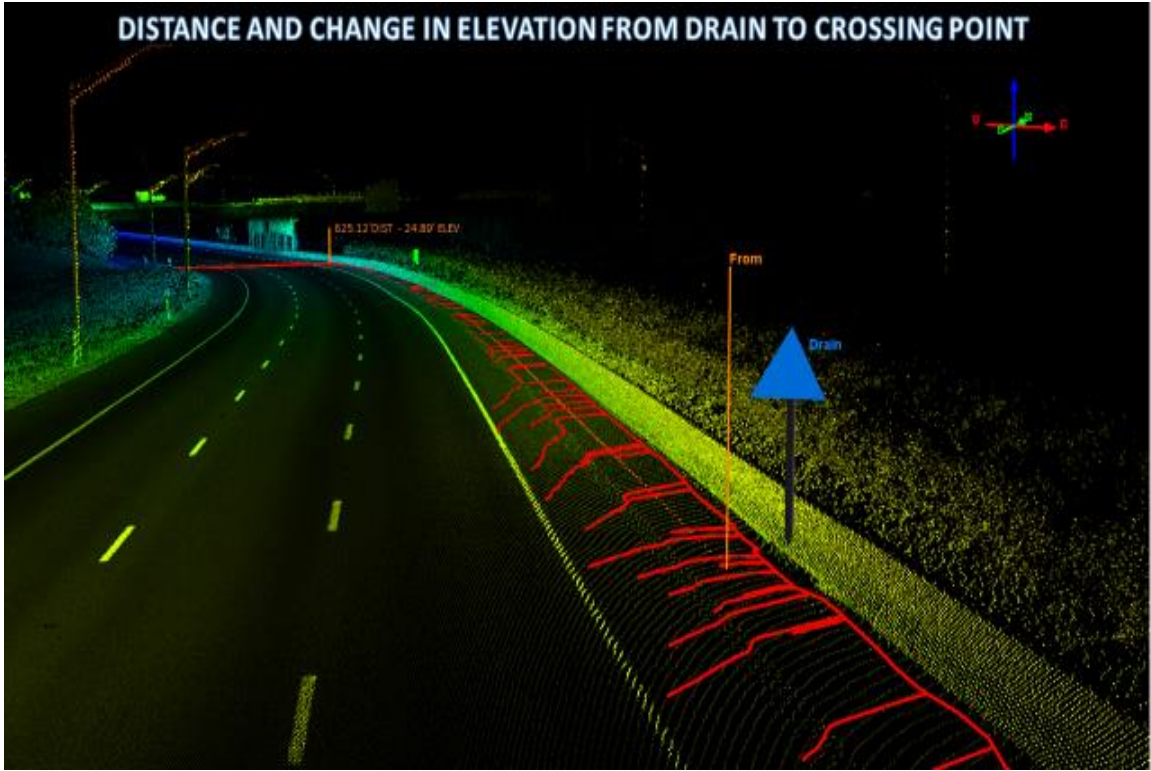
In Figure 5 the surface water can be seen channeling downstream against the inside barrier wall to a point of concern. At approximately 625 feet downgrade against the barrier wall, the water appears to drain back onto the roadway surface (Figure 6). This indicates a low spot and/or sag in the crown-line of the pavement on the high-side of the super-elevated section.

**Figure 5** Water flow analysis depicting water flow paths

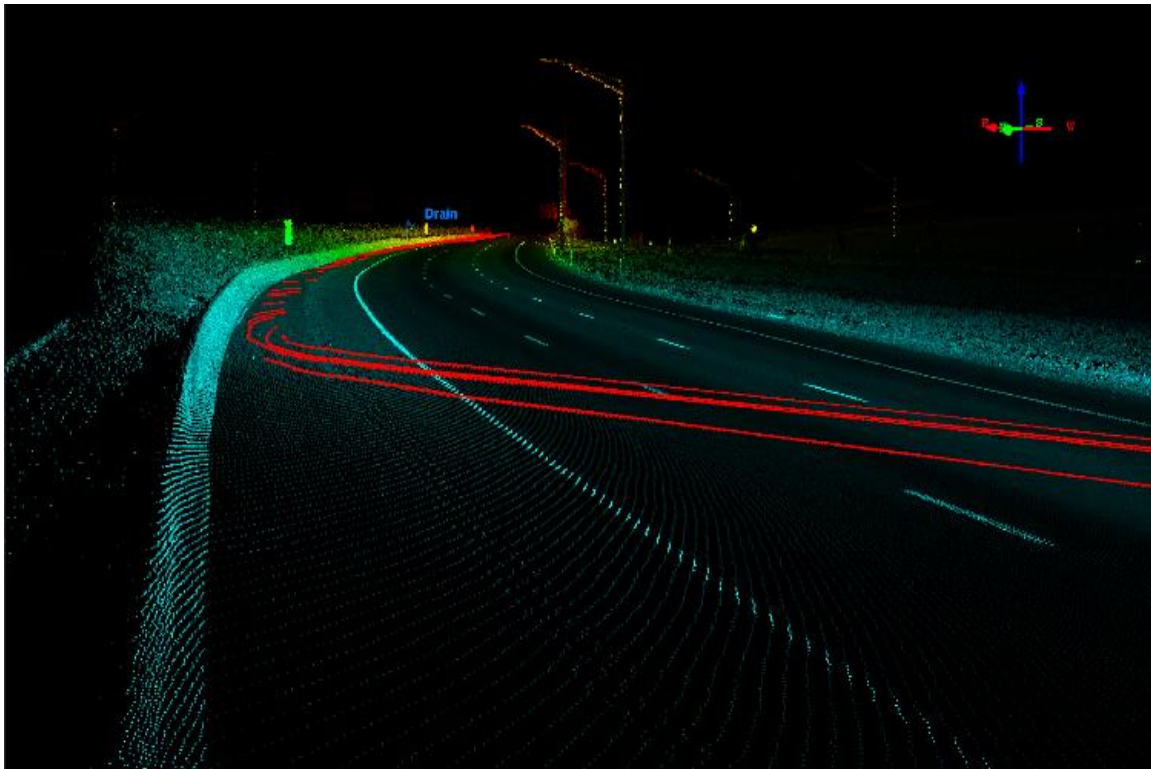
**Figure 6** Water flows along barrier wall and returns to roadway surface

Once the problematic surface-water flow paths were better understood, Cabinet officials deployed a pavement grinding machine to the project location. They used the grinding machine to lower the elevation of the pavement surface adjacent to the sagged location. This let the surface-water flow remain within the gutter line next to the barrier wall away from the driving lane. Since the pavement elevation was lowered, no wet-weather accidents have been recorded at this location.

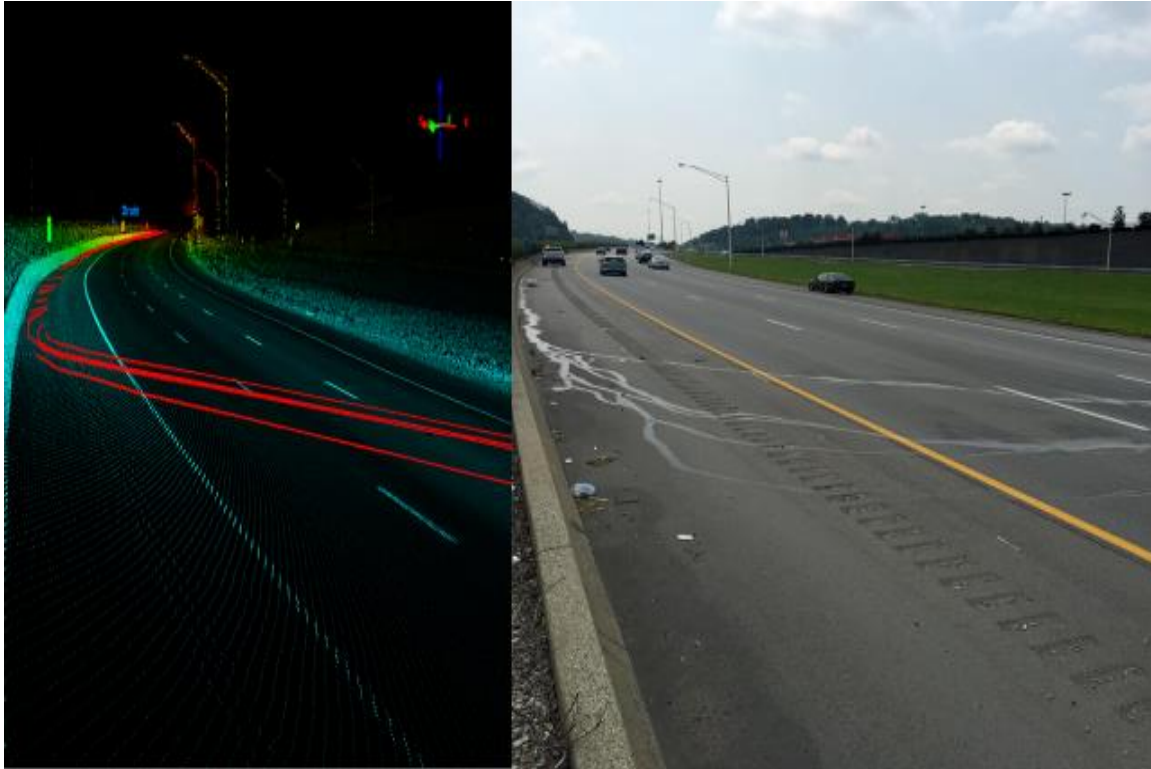
To confirm the simulated LiDAR results, a 25-gallon water tank was emptied on the shoulder of the roadway to recreate the surface-water flow paths. Figure 7 compares the actual surface water flow paths to the simulated water flow paths derived from the LiDAR dataset. The simulated results mirrored the field observations.

**Figure 7** Simulated flow analysis compared to field flow analysis

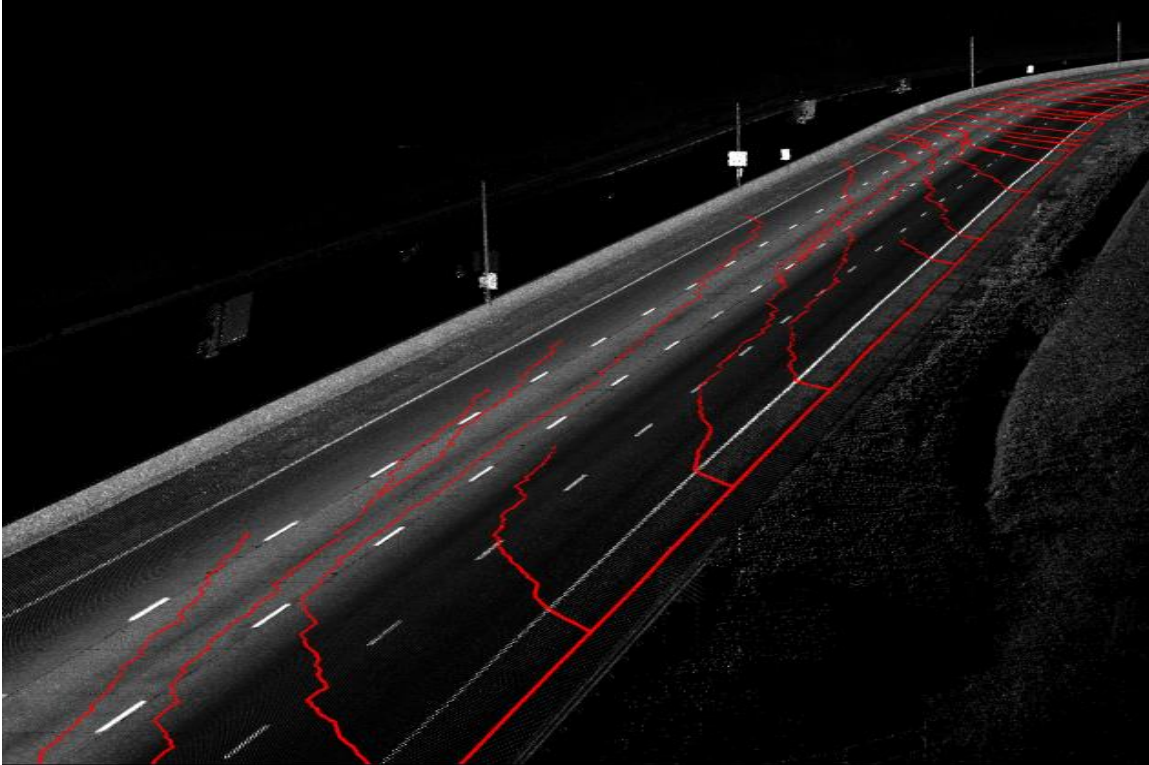
A 1,500-foot long section of roadway on I-75 in Boone County had also seen an increase in wet-weather related crashes. Similar to the I-471 section discussed above, GPS points from accident locations were plotted against the mobile LiDAR data set. After analyzing the LiDAR dataset utilizing the trickle command, it appeared that the surface runoff water drains back onto the left driving lane from the inside shoulder and runs downgrade within the travel lane for approximately 250 feet (Figure 8).

**Figure 8** Water flow paths on I-75, Kenton County, Kentucky

Given the speed limit on this section of roadway is 70 mph, it is presumed the surface runoff on the roadway will cause vehicles to hydroplane in this area—thus resulting in potential accidents. As Table 1 shows, the average reduction of freeway speeds during precipitation events varies from 3% to 16% (6). Therefore, using the maximum average speed reduction in rain events of 16%, and assuming a travel speed of 70 mph, a vehicle normally traveling the posted speed limit would reduce its speed to 58.8 mph (93.34 km/hr.) during rainfall. Figure 9 indicates that a vehicle traveling 58.8 mph could possibly hydroplane with as little as 2 mm (5/64 inch) of water on the roadway surface (6).

To reduce the number of wet-weather accidents on this stretch of roadway caused by surface-water runoff, transportation officials corrected the grade issues using a grinding machine. Since the grade was corrected, no apparent wet-weather accidents have occurred at this location, and the surface water appears to drain normally across the super-elevated section.

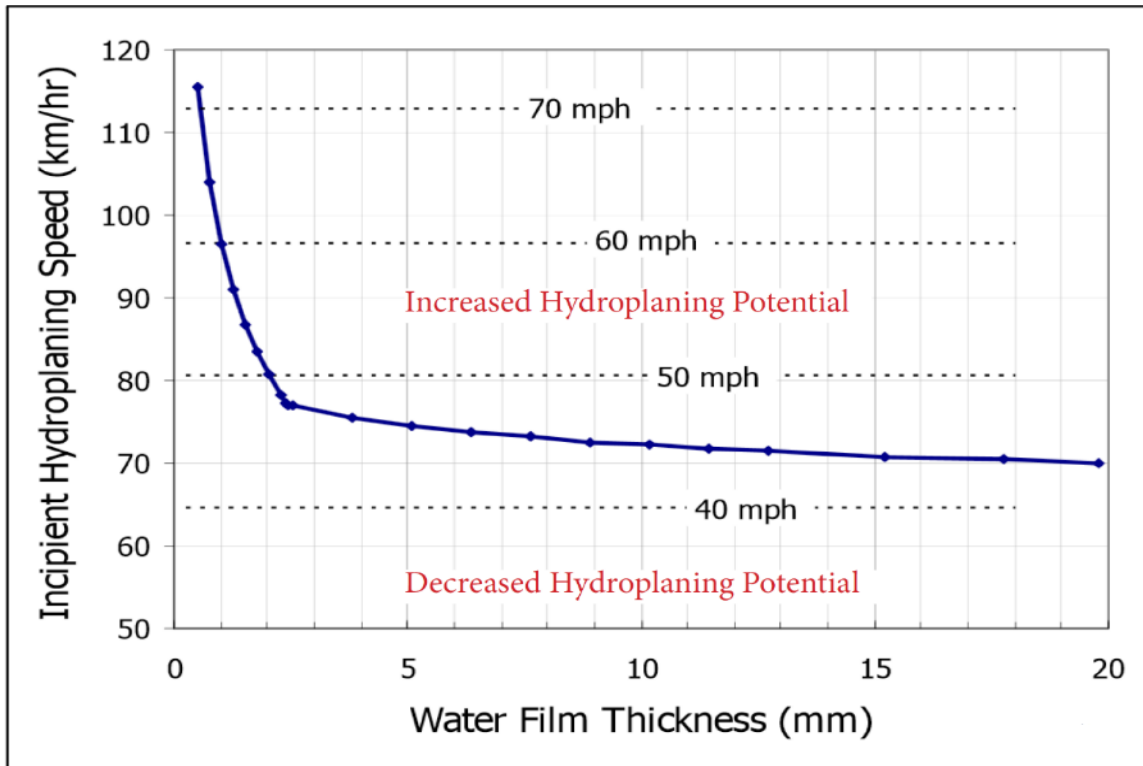
**Figure 9** Incipient hydroplaning speed versus water film thickness

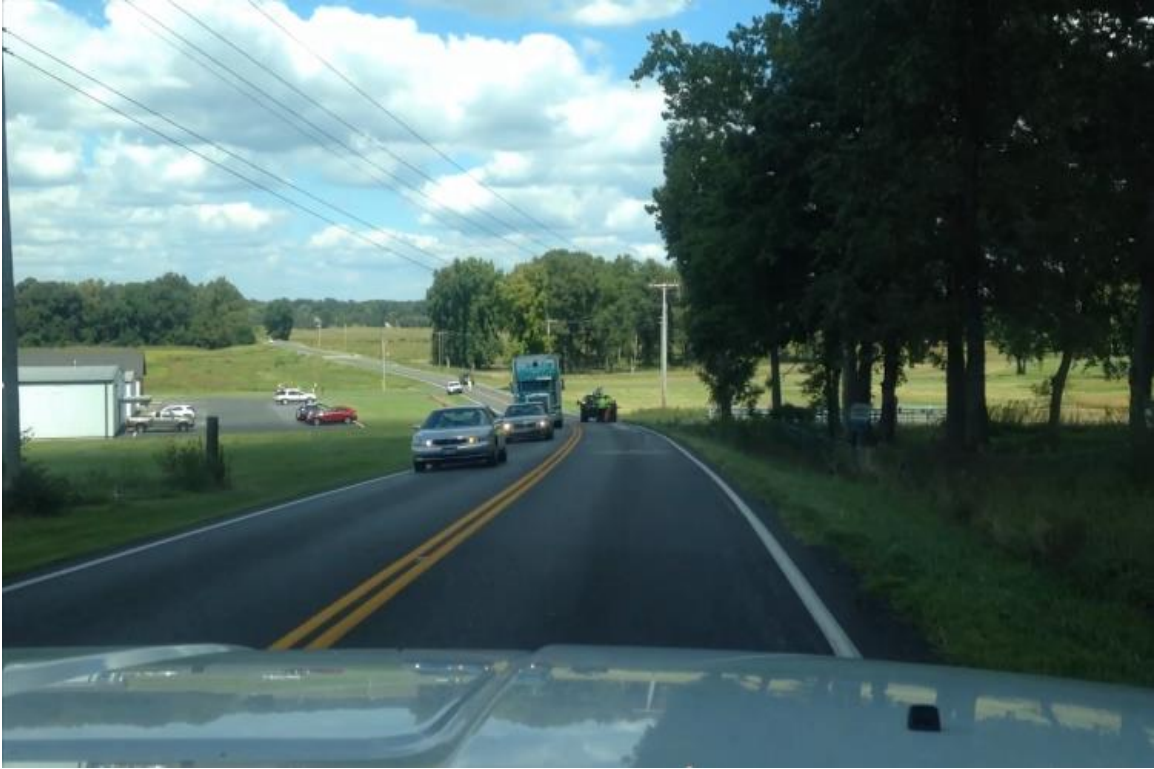
US-641 in Calloway County, Kentucky is another location that exhibited a high number of crashes during rainfall events (7). This location is a two-lane road that does not have the same shoulder configuration as the roads described above (Figure 10).

**Figure 10** US-641 Calloway County project site

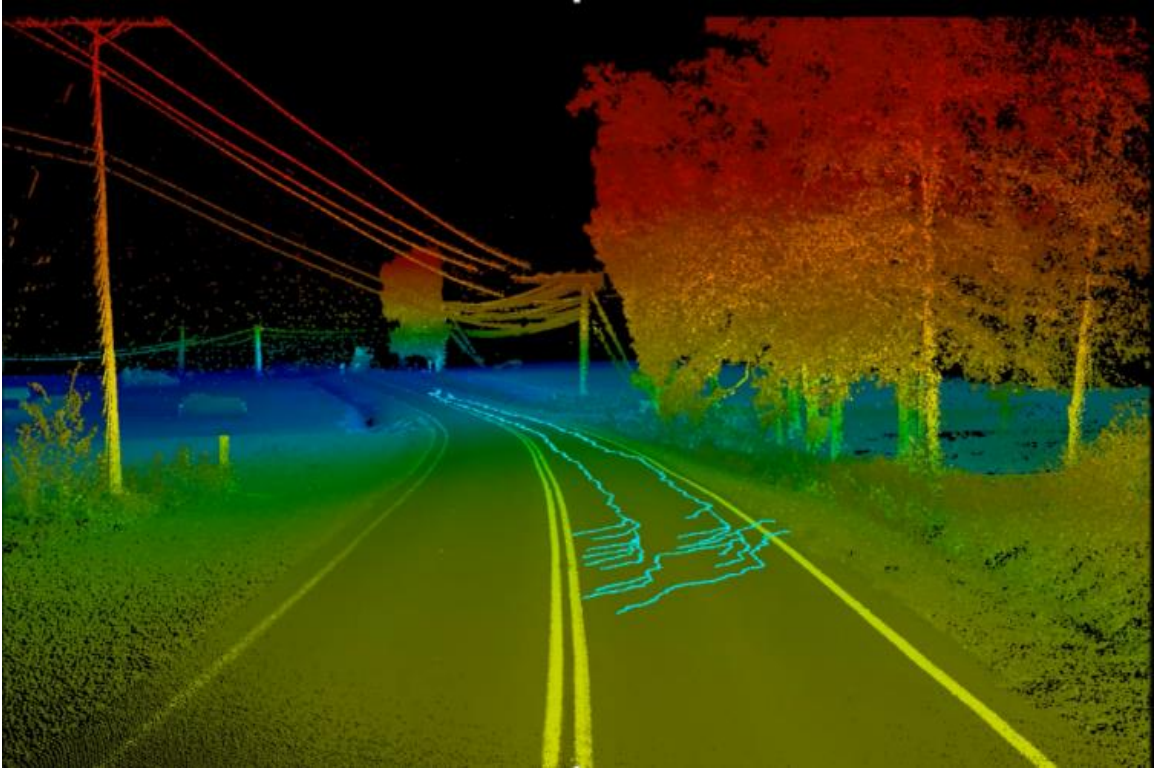
For this segment, the water trickle tool was used to evaluate drainage patterns (Figure 11). Simulated results indicated that water channels within wheel-paths of the pavement—indicative of pavement rutting. Given that cars may travel this stretch of roadway at speeds over 45 mph during wet-weather events, it is possible that the accumulated water within the wheel paths, combined with increased driving speeds, may have contributed to the crashes at this location. To ameliorate crash risk, transportation officials repaired this section of roadway once the water channeling within the wheel paths was understood (7).

**Figure 11** US 641 simulated flow paths

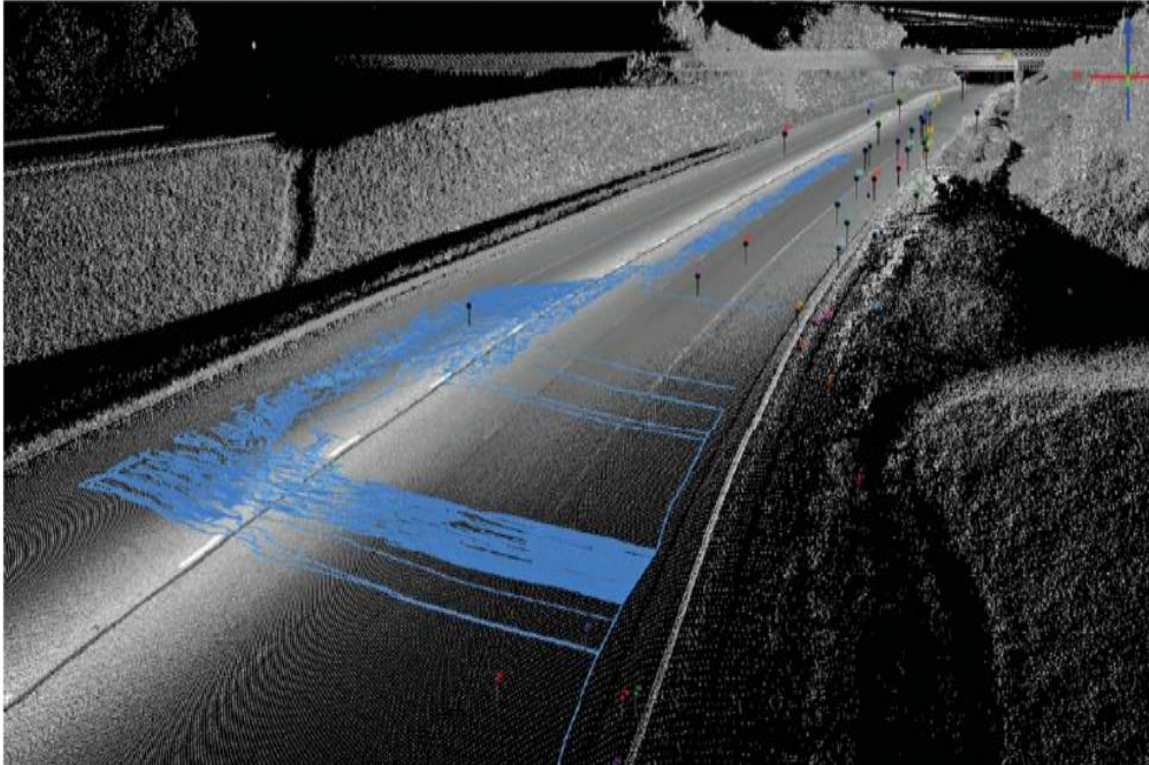
I-75 in Grant County Kentucky experienced 37 wet-weather crashes, all along a short section of roadway. These accidents were recorded by Kentucky State Police in the spring of 2016. The approximate accident locations are denoted by the colored pins overlaid on the mobile LiDAR dataset (Figure 12).

**Figure 12** I-75 accident locations with simulated flow paths

Transportation officials made several attempts to monitor this location during heavy rainfall. However, no discernable pavement grade deficiencies that would have resulted in improper water drainage were recognized during these site visits. Modeling surface water flow paths using the trickle command revealed that a problematic grade issue produced improper water drainage (Figure 12). The grade issue was under repair at the time this report was written.

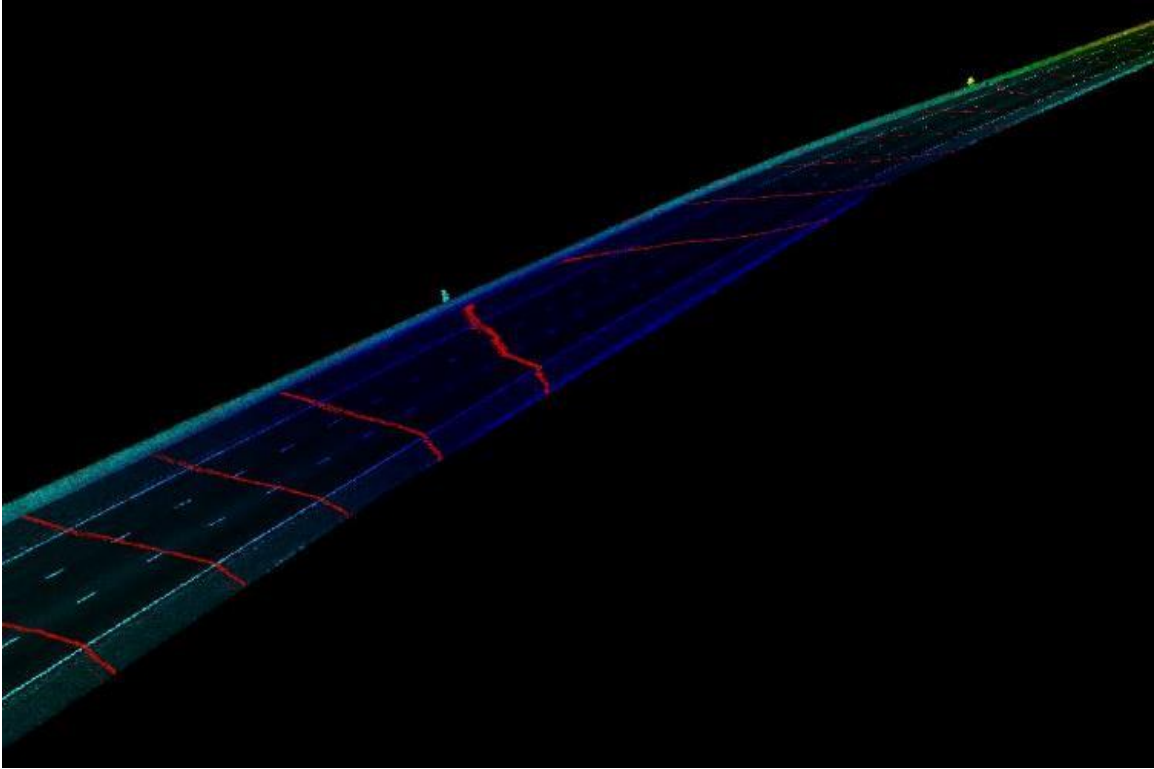
Instead of processing the LiDAR data using the water trickle feature, a different water flow analysis method was used. The surface-water flow was analyzed using Applied Imagery’s “Quick Terrain Modeler” contour feature (Figure 13). As shown in Figure 13, contour lines depict where the surface water flows, but the pavement grade transition between the vertical and horizontal curve appears flat, as denoted by the jagged contour line. If water is draining downgrade, this jagged contour line indicates it will slow and pool in this area.

**Figure 13** Contour lines derived using "Quick Terrain Modeler"

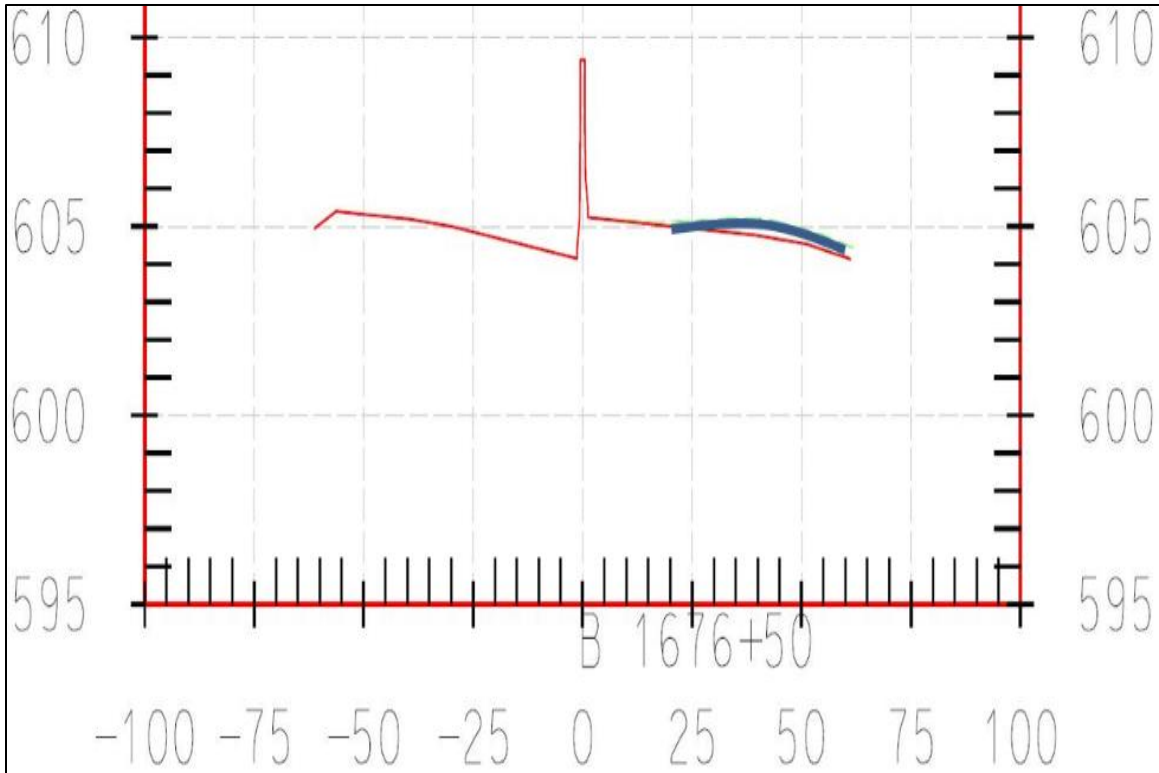
To understand how the flattened section compares to the intended design grade, Figure 14 compares the design cross section in red to the approximate as-built grade (imaged in blue). It appears that the as-built grade was above the design grade, thus trapping water. Once the contractor was notified of the improper grade issue, they milled the surface to obtain the correct cross slope.

**Figure 14** As-built surface (blue) compared to design surface (red)—x-y axis dimensions in feet

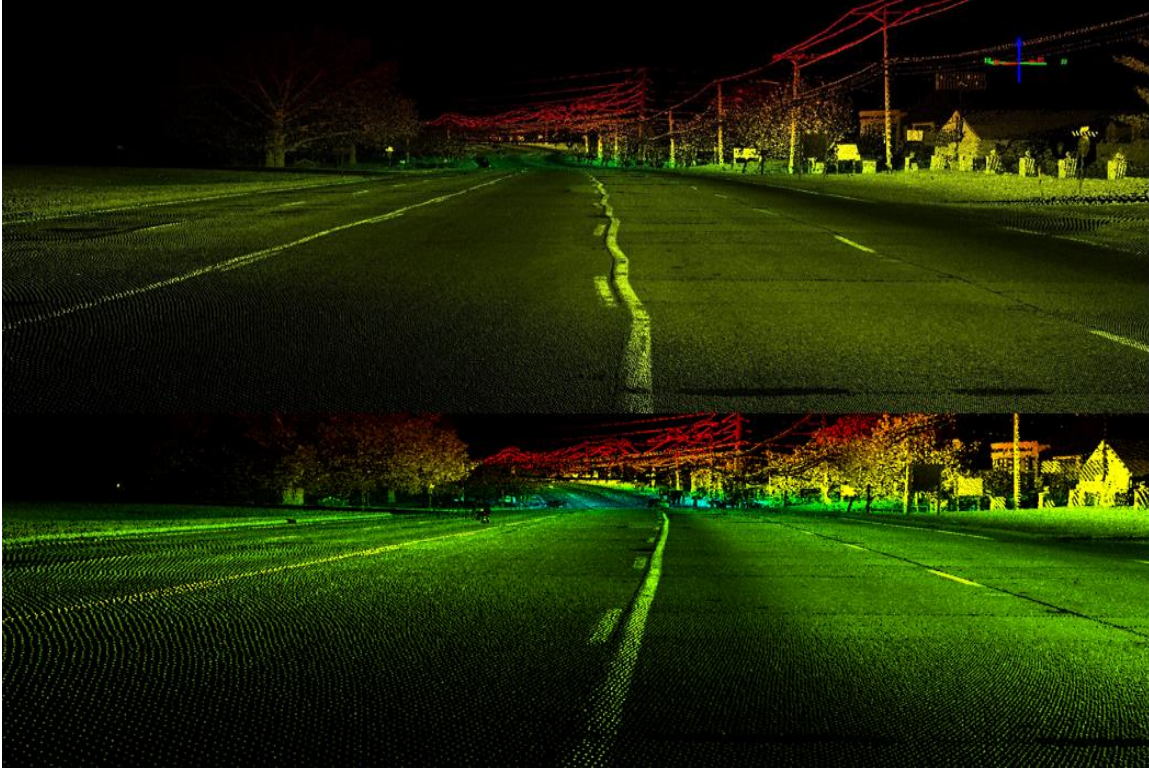
As reported in the March 17, 2015 Washington Post, a G4 solar storm occurred on March 16, 2015 that disrupted radio communications of many of the world’s GPS satellites. Unfortunately, one of the LiDAR scans needed for this study was conducted unknowingly during this solar event. Figure 16 displays the solar storm’s impact on collected LiDAR data. Compare the centerline striping of the data collected during the solar storm (top photo) to the recollected data (bottom photo). It is apparent that data collected during the solar storm is not properly aligned. Despite numerous attempts to realign the LiDAR dataset using differential correction, the dataset could not be geospatially corrected. Therefore, the data had to be recollected.

**Figure 16** Effect of G4 solar storm on mobile Lidar data

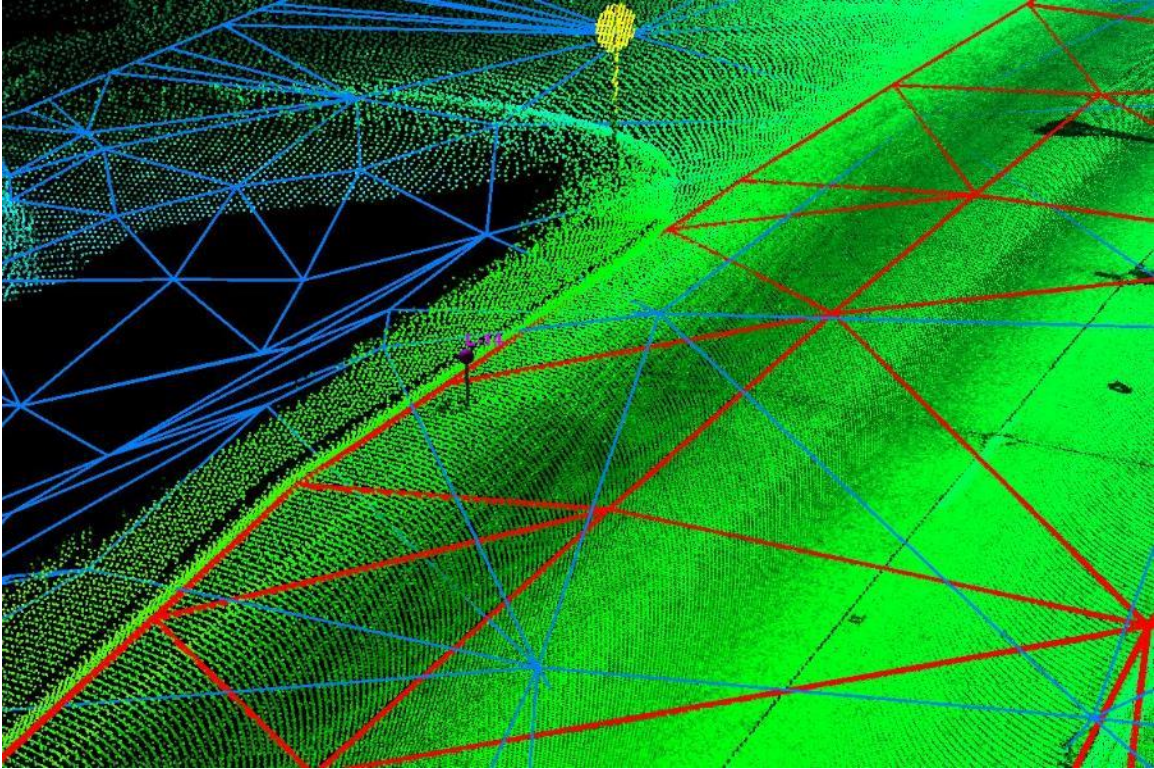
During this study it became apparent that there may be some confusion within the industry that all LiDAR data is the same. Figure 17 contains DTMs created from two datasets collected with different LiDAR technologies. One collected using planning grade Lidar (denoted in blue) and one with survey grade LiDAR (denoted in red). As seen in Figure 17, the triangulation of the DTMs does not overlap for the paved surface. Therefore, caution should be exercised when using LiDAR data to not overstate the accuracy to avoid a situation where that expectation does not align with the data that were actually collected.

**Figure 17** Comparison of survey grade and planning grade DTMs
