# Ground Motions Induced by the March 11, 2018, Implosion of the Capital Plaza Tower, Frankfort, Kentucky

N. Seth Carpenter, Michael J. Lynch, Brandon C. Nuttall, Zhenming Wang,  
and Andrew S. Holcomb

Kentucky Geological Survey  
University of Kentucky, Lexington

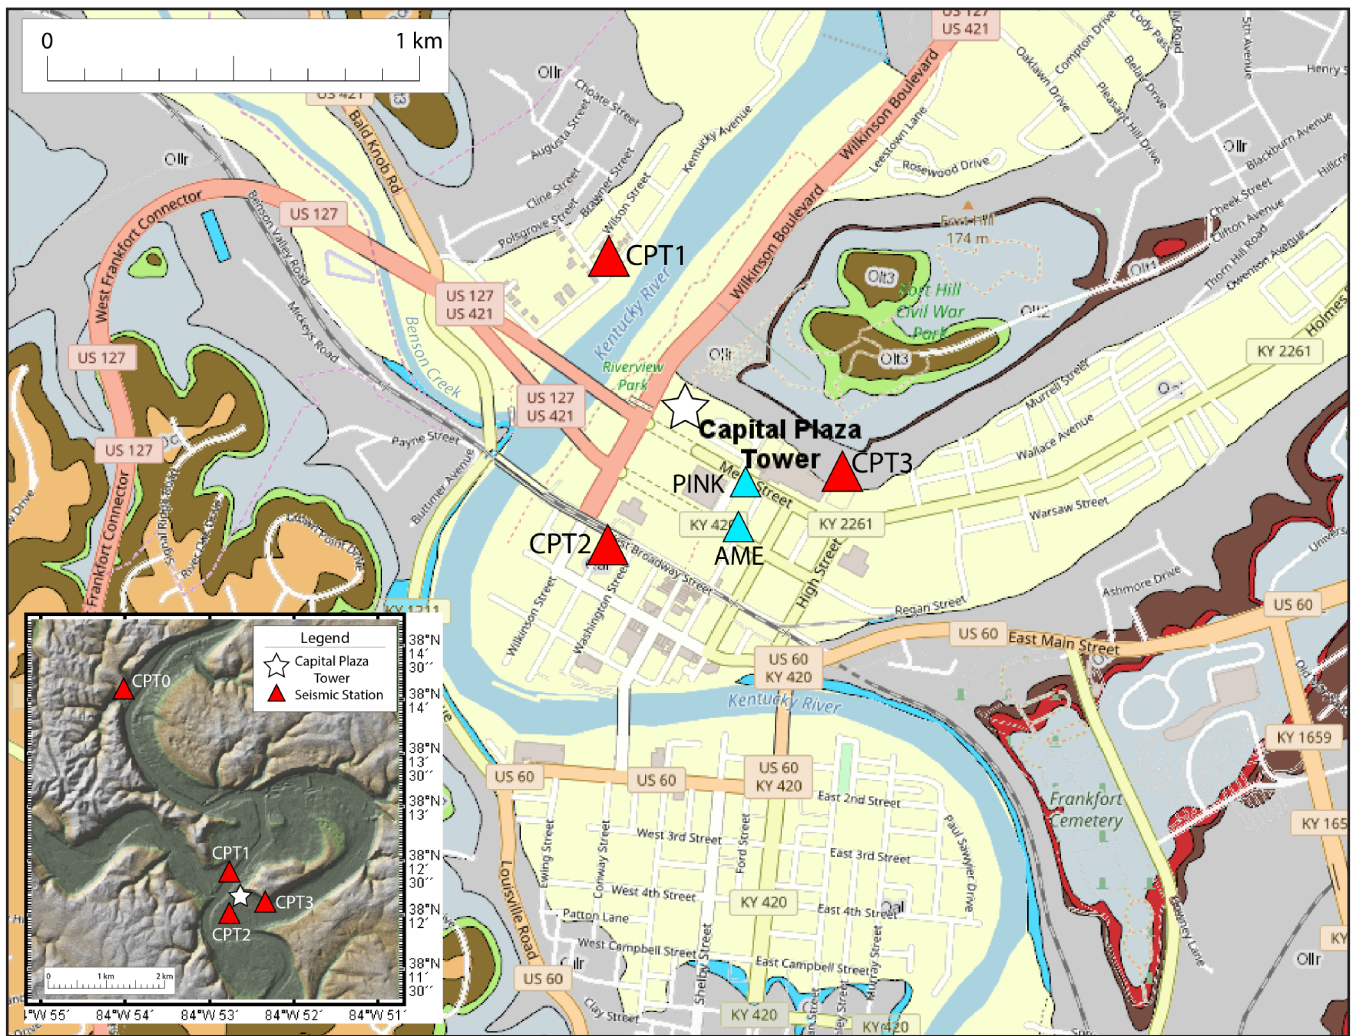
Figure 1. General geology of Frankfort, Ky. Red triangles show locations where ground-motion recordings from the implosion of the Capital Plaza Tower (white star) were collected by KGS instruments. Stations deployed by the Energy and Environment Cabinet's Explosives and Blasting Branch are shown as blue triangles. Inset shows the locations of all four KGS stations.

the KGS's monitoring sites (Fig. 1), range from 0 m at soil-bedrock outcrop contacts to 22 m at a boring next to the Kentucky Transportation Cabinet building, approximately 130 m southeast of the Capital Plaza Tower (S&ME, 2012; William M. Andrews Jr., Kentucky Geological Survey, personal communication, March 21, 2018). Seismic stations CPT1 and CPT2 are located on top of Kentucky River Valley sediments, and both are in the same valley as the current, active channel of the Kentucky River. But because the stations are different distances from bedrock outcrops and other river channels—Benson Creek at CPT1 and an abandoned Kentucky River channel at CPT2 (Andrews, 2006)—they overlie sediments of potentially different thickness and type. Seismic station CPT3 is located directly on bedrock from the lower part of the Lexington Limestone.

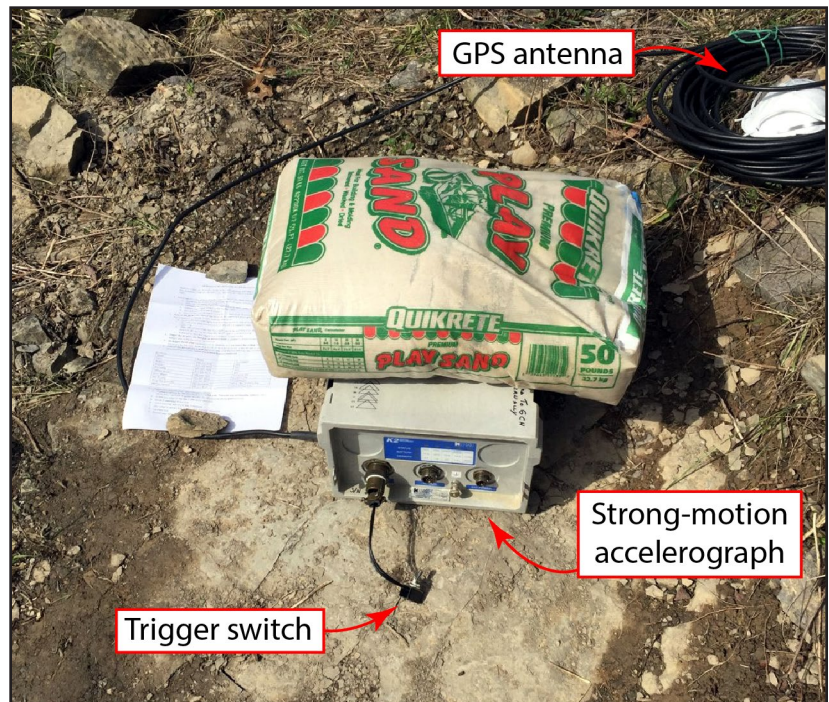
Figure 2. Instrumentation at station CPT3. Photo by Zhenming Wang.

Table 1 gives the instrument locations, which were at horizontal distances of 404 to 432 m from the center of the Capital Plaza Tower, prior to its demolition, and at variable azimuths. All sites were instrumented with strong-motion accelerographs, each of which was oriented to record motions in the vertical, horizontal radial (away from and toward the tower), and horizontal transverse (perpendicular to radial) directions. Bags with 50 to 100 lb of sand were placed on top of the strong-motion accelerographs to enhance the sensors' coupling with the ground, and to prevent differential motion between the accelerograph and the ground in the event of strong shaking (Fig. 2).

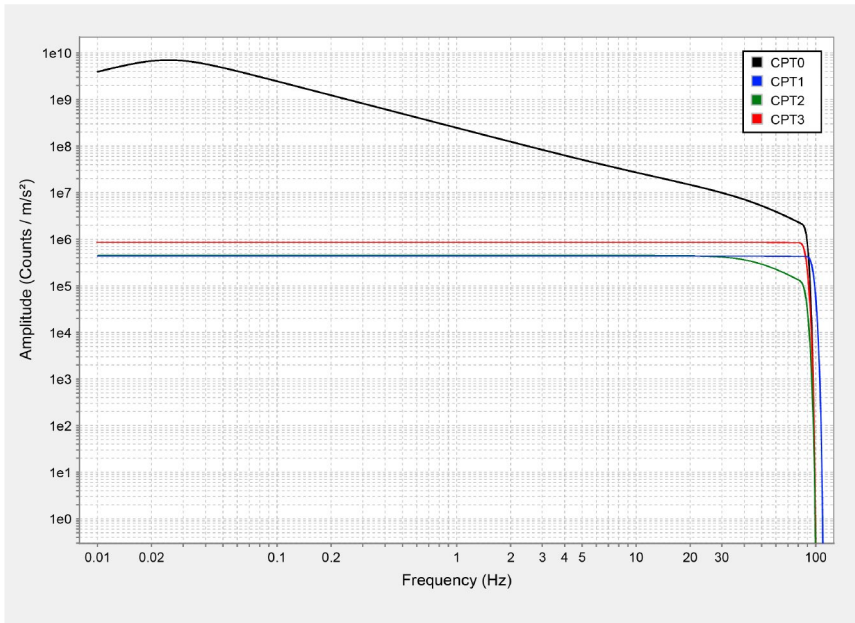
Figure 3. Amplitude responses from input ground acceleration for the instruments used at each site. Differences between the responses of each orthogonal component for a particular instrument are indistinguishable on this plot, and only the vertical-component frequency responses are shown.

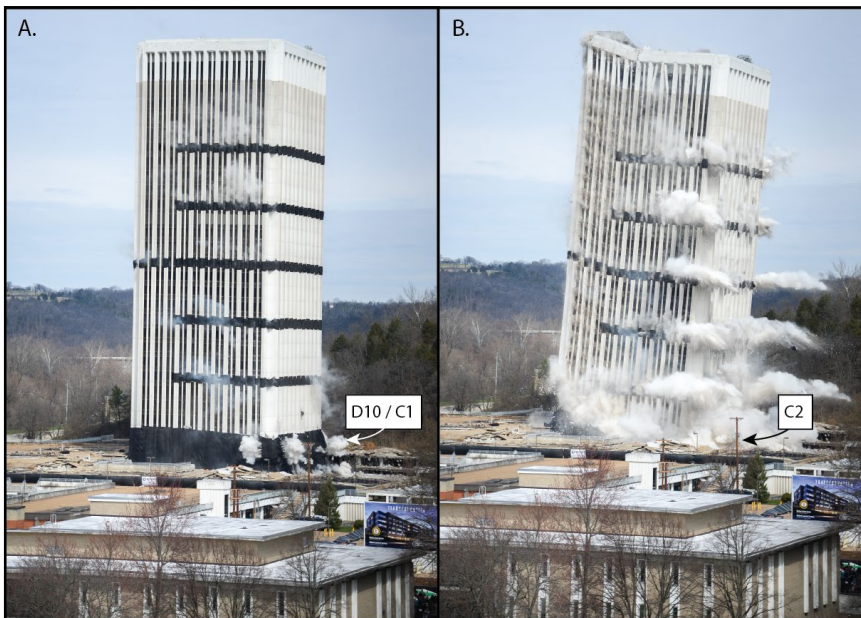
Figure 4. A. Final detonation (D10) and the nearly simultaneous initiation of the collapse of the Capital Plaza Tower (C1). B. The tower above the ground floor impacts the ground (C2) to induce the strongest shaking recorded. Photos courtesy Hannah Brown, © 2018 *The State Journal*; reproduced with permission.

The Capital Tower Plaza was demolished through a sequence of at least 10 explosive detonations, noted as D1 to D10. Figure 4 shows the final detonation (D10) and subsequent collapse of the tower. Downward displacement began with D10, which removed support from the southeast side of the foundation or ground floor. Energy from the initiation of the collapse generated seismic waves that were observed at all recording stations. As the

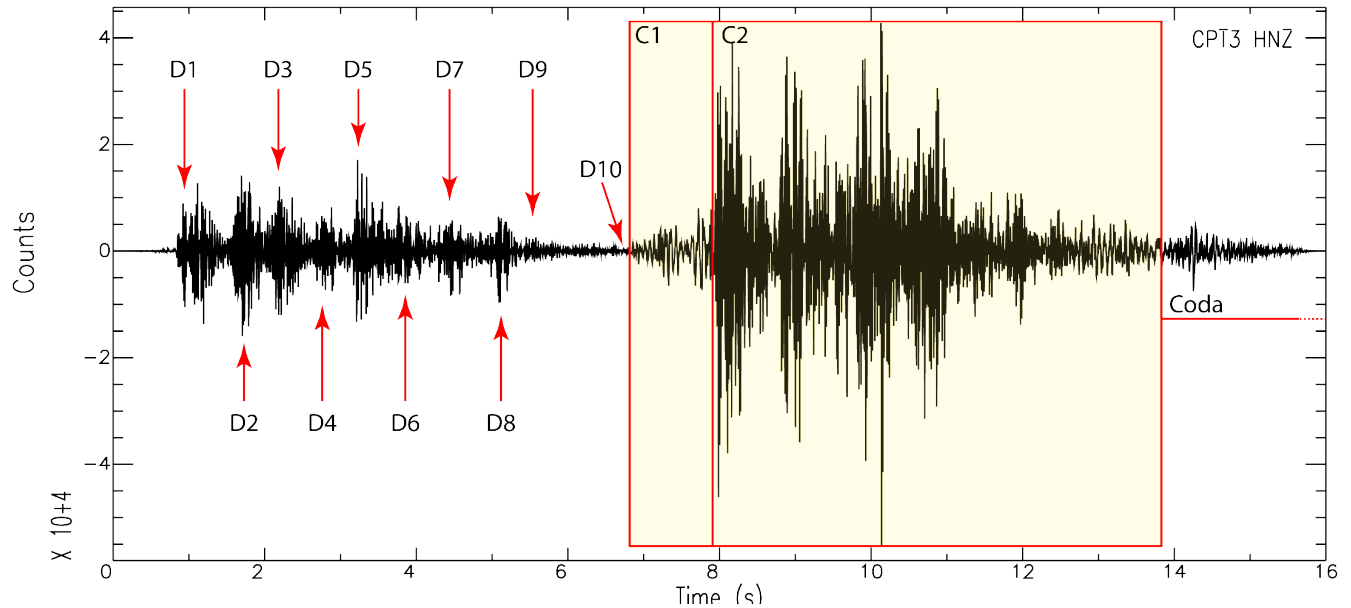
Figure 5. Ground-motion time history recorded at CPT3. The ground motions from the blast detonations in or under the Capital Plaza Tower are labeled sequentially (D1–D10), and the seismic wave arrivals from the collapse of the tower are highlighted in yellow. The collapse began (C1) with the final detonation (D10) and the nearly simultaneous collapse of the southeastern side of the tower’s foundation or ground floor; collapse event C2 includes the prolonged impact of the collapse of the remainder of the tower. The coda—the series of scattered waves arriving after the primary arrivals—is composed of reflected seismic waves and is not related to direct seismic arrivals.

All three strong-motion accelerographs recorded the entire demolition process, from the first detonation through the entirety of the collapse of the tower. The recordings also captured reflected or trapped waves within the Kentucky River Valley sediments. Figure 5 shows the ground-motion time series recorded at CPT3, annotated with the major events of the demolition.

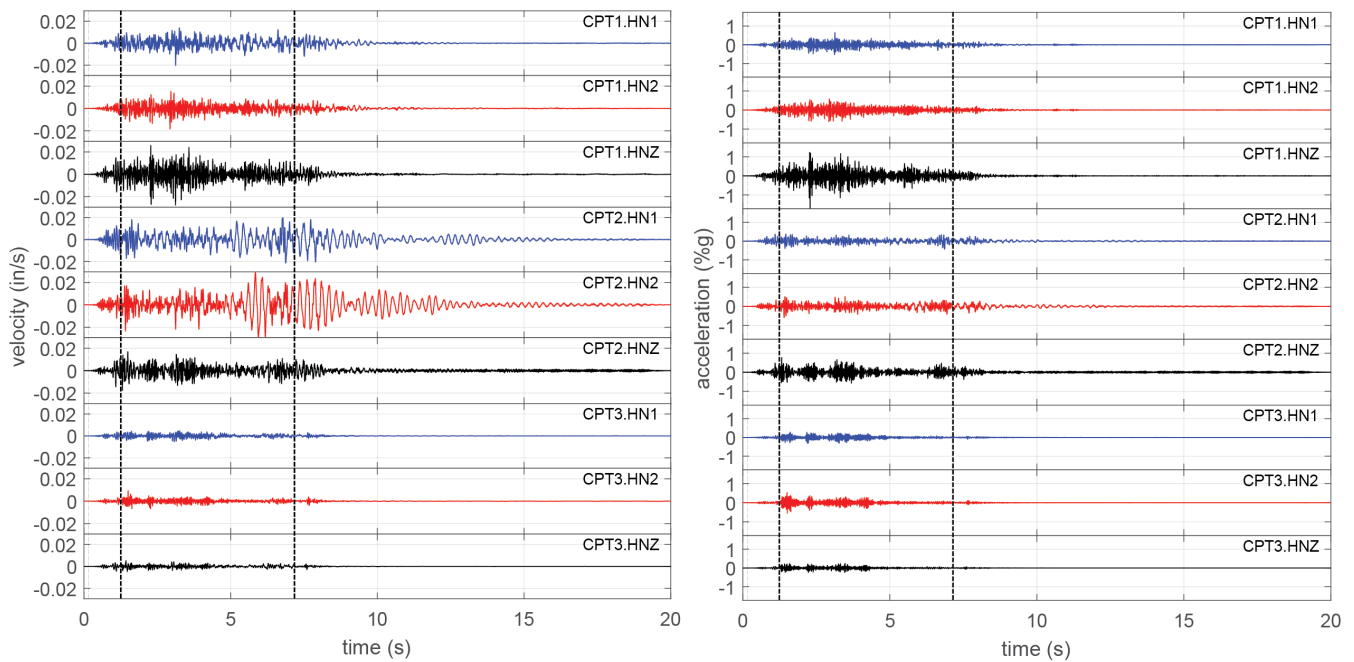
Figure 6. Ground-velocity (left) and acceleration (right) time histories of the Capital Plaza Tower collapse (preceding detonations not included). The same vertical scale is used for each trace. Traces are labeled by station name and component (HN1 = radial, HN2 = transverse, HN3 = vertical). The vertical dashed lines delineate the C1 and C2 time periods shown in Figure 5.

Time histories of the ground motions induced by the tower collapse recorded by each strong-motion accelerograph are shown in Figure 6 and the peak ground-motion levels are given in Table 2. The peak velocities (in inches per second to be consistent with the Explosives and Blasting Branch's recordings and regulations) and accelerations recorded at the soil sites exceeded those recorded by the corresponding components at the rock site: 0.027 in./s and 0.029 in./s were observed at soil sites CPT1 and CPT2, respectively, and 0.009 in./s was observed at rock site CPT3.

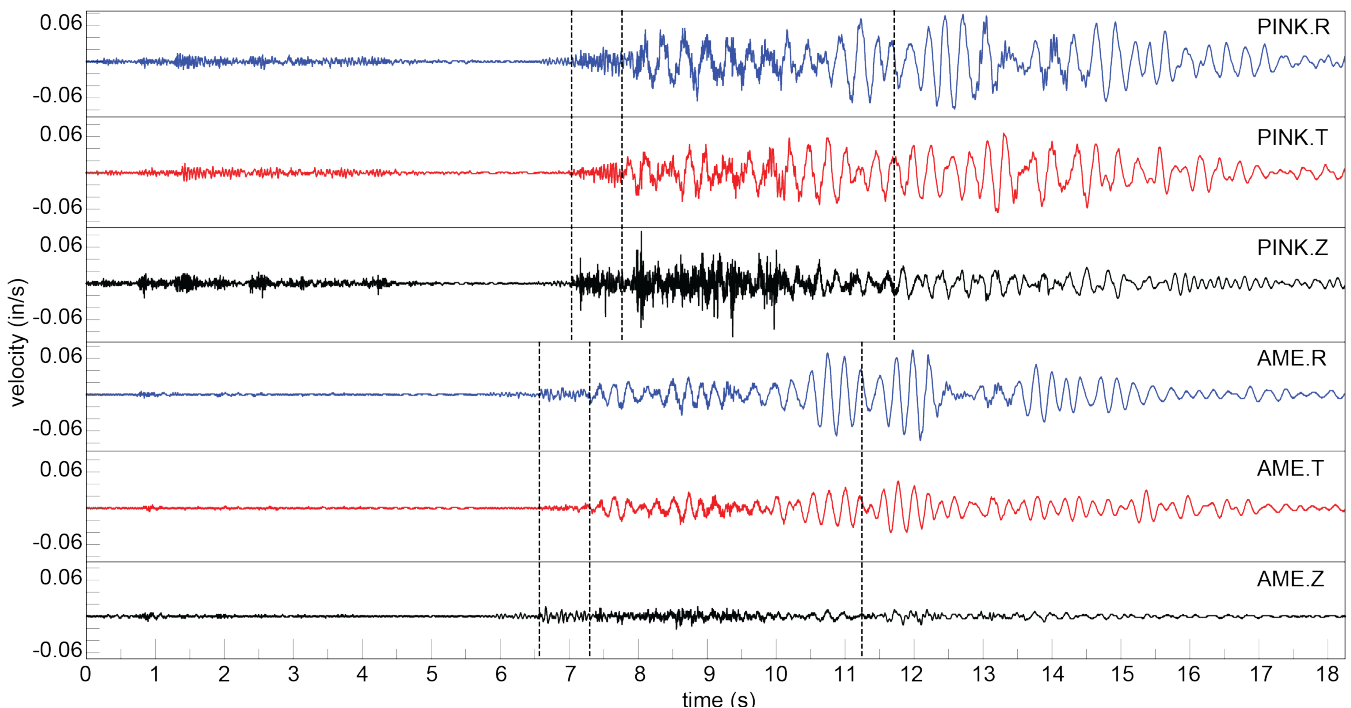
Figure 7. Ground-velocity recordings by seismographs deployed by the Explosives and Blasting Branch (Fig. 1). The same vertical scale is used for each trace. The vertical dashed lines approximately delineate the C1 and C2 time periods shown in Figure 5.

Recordings from Explosives and Blasting Branch stations PINK and AME are shown in Figure 7. Ground motions from the explosives are apparently captured in these recordings (absolute timing is unavailable), as well as ground motions from the tower collapse. Because the Explosives and Blasting Branch sites, which are also on Kentucky River Valley sediment, were significantly closer to the tower, the peak velocities they recorded were expected to be higher than those from the KGS stations, and this was in fact the case: 0.078 in./s and 0.075 in./s were recorded on the radial components at the PINK station (203 m from the tower) and AME station (293 m from the tower), respectively.

from the Explosives and Blasting Branch stations, the predominant frequencies at each site were estimated from the transverse-component seismograms shown in Figure 7: 3.7 Hz at the PINK site and 4.8 Hz at AME.

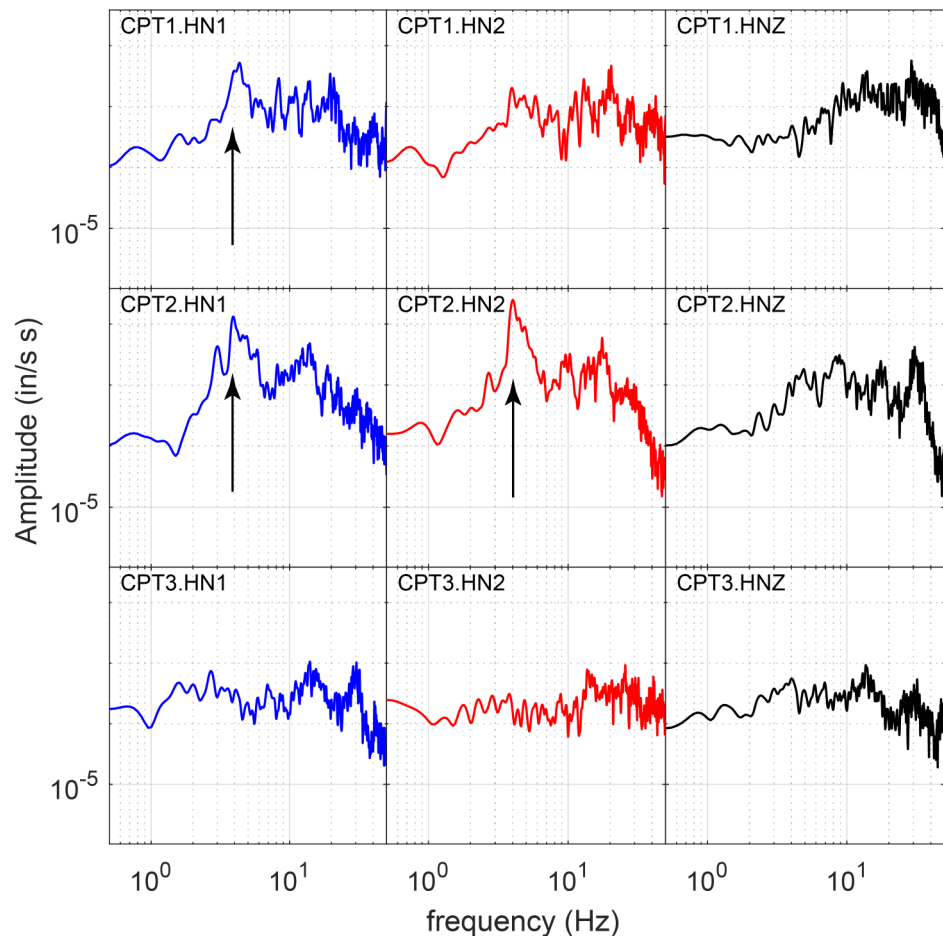
Figure 8. Amplitude spectra of the velocity time histories from Figure 6. The predominant peaks, indicated by arrows on the velocity spectra, at soil sites CPT1 and CPT2 are evidence of seismic-wave resonance in the underlying soils. Spectral plots are labeled by station name and component (HN1 = radial, HN2 = transverse, HNZ = vertical).

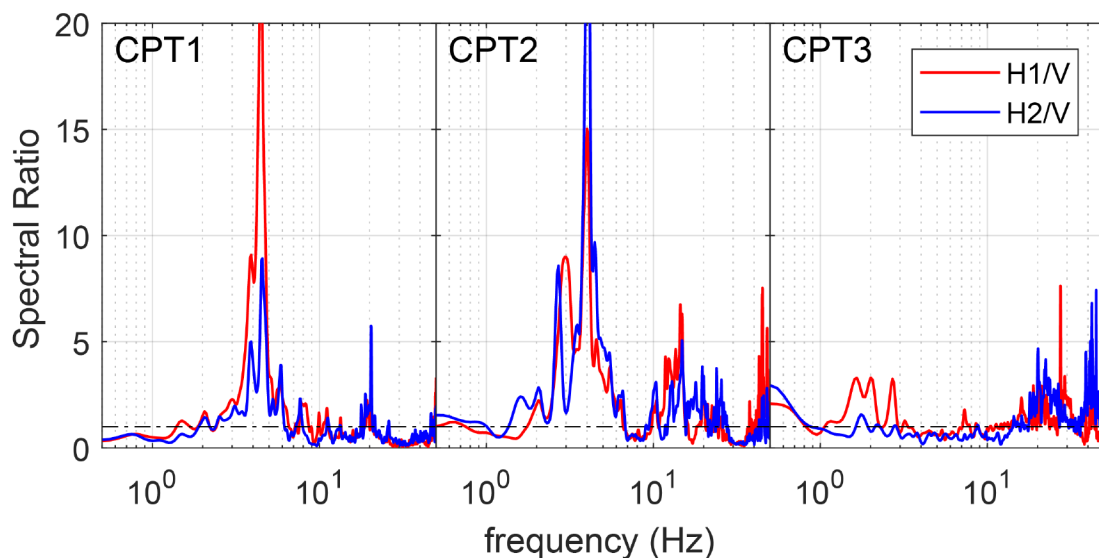
Figure 9. Ratios of each horizontal component's amplitude spectrum to that of the vertical component (HV) for each KGS site. The dash-dotted horizontal line corresponds to a ratio of 1.0. HV ratios have been used to quantify site response (i.e., site effect) in other settings.

Figure 9 shows the resonant peaks more clearly through spectral ratios. For each site, each horizontal component's amplitude spectra was divided by that of the vertical component. In this way, differences in wave propagation paths between the sites instrumented with strong-motion accelerographs and some of the complexities of the physics of the tower collapse are effectively removed, and the results are approximations of the empirical site responses, or measurements of site effect at these locations. These plots reveal resonance peaks of 4.5 and 4.0 Hz at soil sites CPT1 and CPT2, respectively. Also, the spectral ratios for CPT3 indicate that there was only minor amplification at this rock site, which is expected for sites lacking underlying soil layers. Although digital data were not available

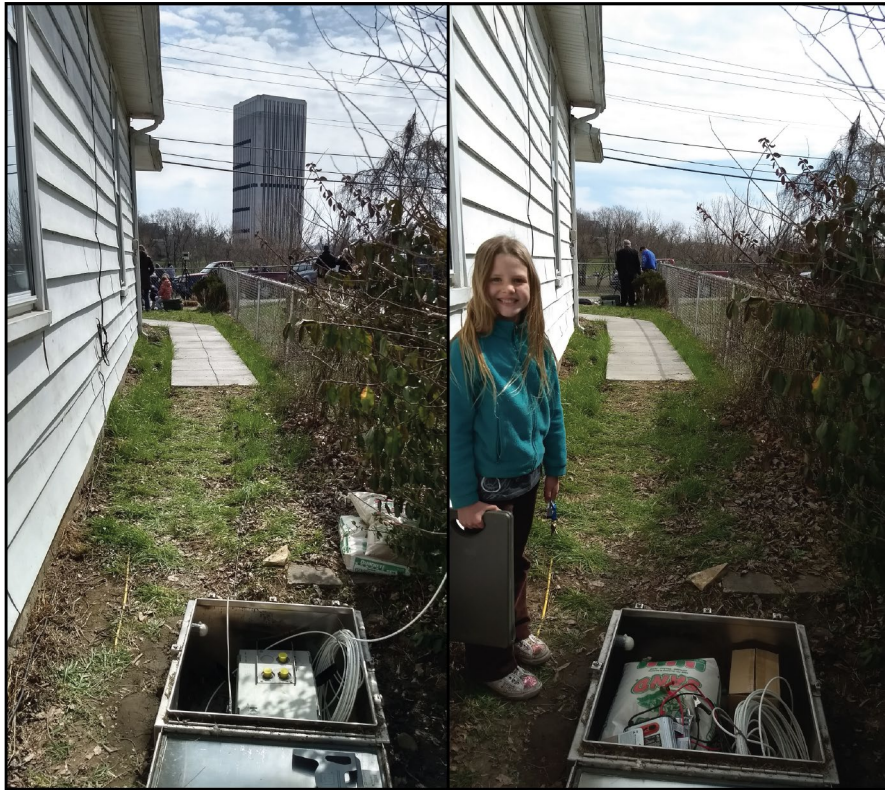
Figure 10. (Left) Capital Plaza Tower from the location of station CPT1 shortly before the implosion. (Right) The same view, shortly after the building's demolition, with a student observer next to the instrument. Photos by Seth Carpenter.
