Object Detection for Agricultural and Construction Environments Using an Ultrasonic Sensor

J. S. Dvorak, M. L. Stone, K. P. Self

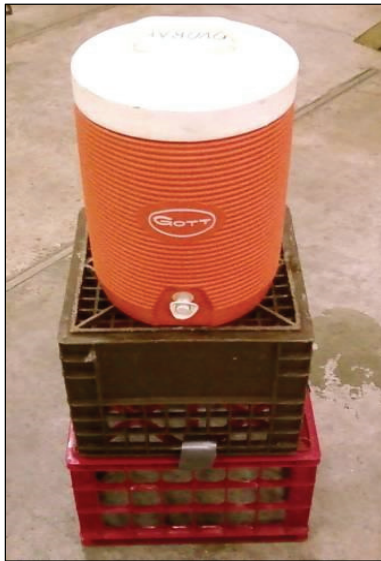
The water jug (model 1692, Gott Mfg. Co., Winfield, Kans.) had a diameter of 25 cm and was 40 cm tall (fig. 1). Its 7.5 L capacity was filled with room temperature water. Although water jugs are not often encountered in open agricultural fields, they can be found in areas where humans are working near machinery, such as around barns or in construction sites. The water jug is also similar to many other containers (toolboxes, buckets, crates) that are often found in similar environments in that it is a small, rigid, compact, manufactured object. The water jug was supported on plastic crates so that the center of the jug was located at the same height as the ultrasonic sensor during testing.

Figure 1. Water jug target object.

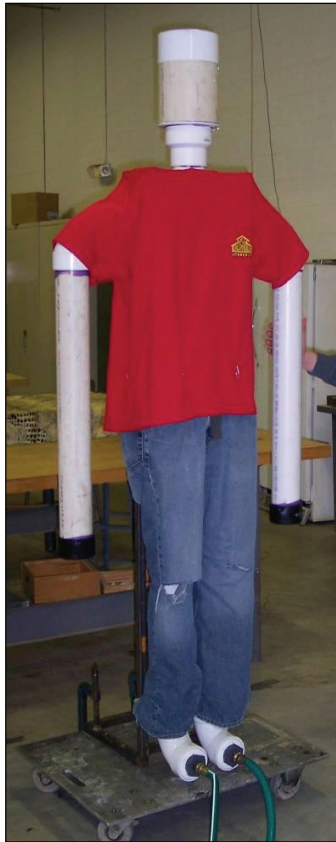
The human model used for testing was a more complicated object. A model for a human was used rather than actual human test subjects to reduce concerns about human safety and privacy, to provide a consistent target object over time, and to ensure compliance with regulatory requirements. A picture of the human model as it was tested is shown in figure 4. Figure 6 is a computer drawing of the structure of the model, since clothing obscures much of the structure in figure 4. The human model consisted of a human form made of polyvinyl chloride (PVC) and a metal stand to support the model. The stand was attached to a wheeled metal cart to allow the model to be moved easily.

The torso was made of PVC sheets, and the rest of the body was made with PVC tubing. Silicone caulk was used to seal the corners of the torso. The arms, legs, and neck were PVC tubing with an outside diameter of 89 mm and an inside diameter of 78 mm (nominally 3 in., schedule 40 PVC tubing). The joints for the shoulders and feet were 90° PVC elbows. Flanges connected all the tubing to the torso, and the arms and feet were capped at the ends. The head was constructed of PVC tubing with an outside diameter of 170 mm and an inside diameter of 154 mm (nominally 6 in., schedule 40 PVC tubing). Two reducers were required to connect the head to the torso. The short piece of tubing connecting the reducers to the torso had an outside diameter of 118.4 mm and an inside diameter of 102 mm (nominally 4 in., schedule 40 PVC tubing). The top of the head was machined so that a drain waste vent (DWV) cap with an outside diameter of 170 mm and an inside diameter of 160 mm slipped freely over the top of the head.

The human model was filled with water during testing. Although the water was not expected to have an impact on the ultrasonic sensor, this model was also used for testing other sensors that relied more heavily on the water content for detection. Fittings were attached to the caps on the feet so that warm water could be pumped through internal piping within the model to maintain its temperature close to body temperature. This temperature control was not expected to play a significant role in the ability of the ultrasonic sensor to detect the human model; however, as the human model was also used to test other sensors, this capability was built into the model. Finally, the human model was clothed in a t-shirt and jeans by cutting the backs of the clothes and fastening the clothes around the human model with safety pins. During testing, the human model was oriented so that it was facing the sensor. This provided the largest surface area to the sensor and represented the best expected detection scenario.

Figure 4. Human model target object.

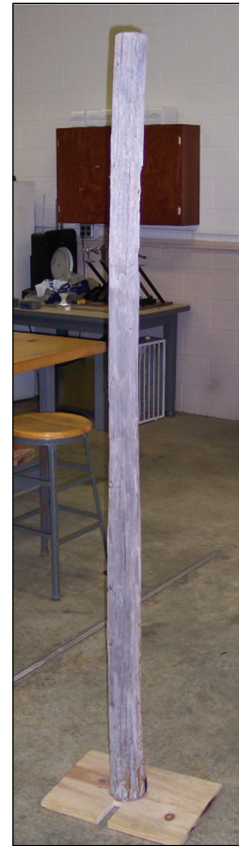
The wooden fence post (fig. 5) was a round wooden post sold for use in constructing agricultural fences. It was 7.6 cm in diameter and 170 cm tall. Like the metal fence post, the wooden fence post was selected because it was similar to the wooden posts that are commonly used in outdoor environments for fence construction and to support other objects. The sensor tests included two types of fence posts (wooden and metal) because both types are commonly used, they were made of different materials with different properties, and they represented two different target geometries.

Figure 5. Wooden fence post target object.
