Kentucky Geological Survey

2008

Foundation Problems and Pyrite Oxidation in the Chattanooga Shale, Estill County, Kentucky

Warren H. Anderson

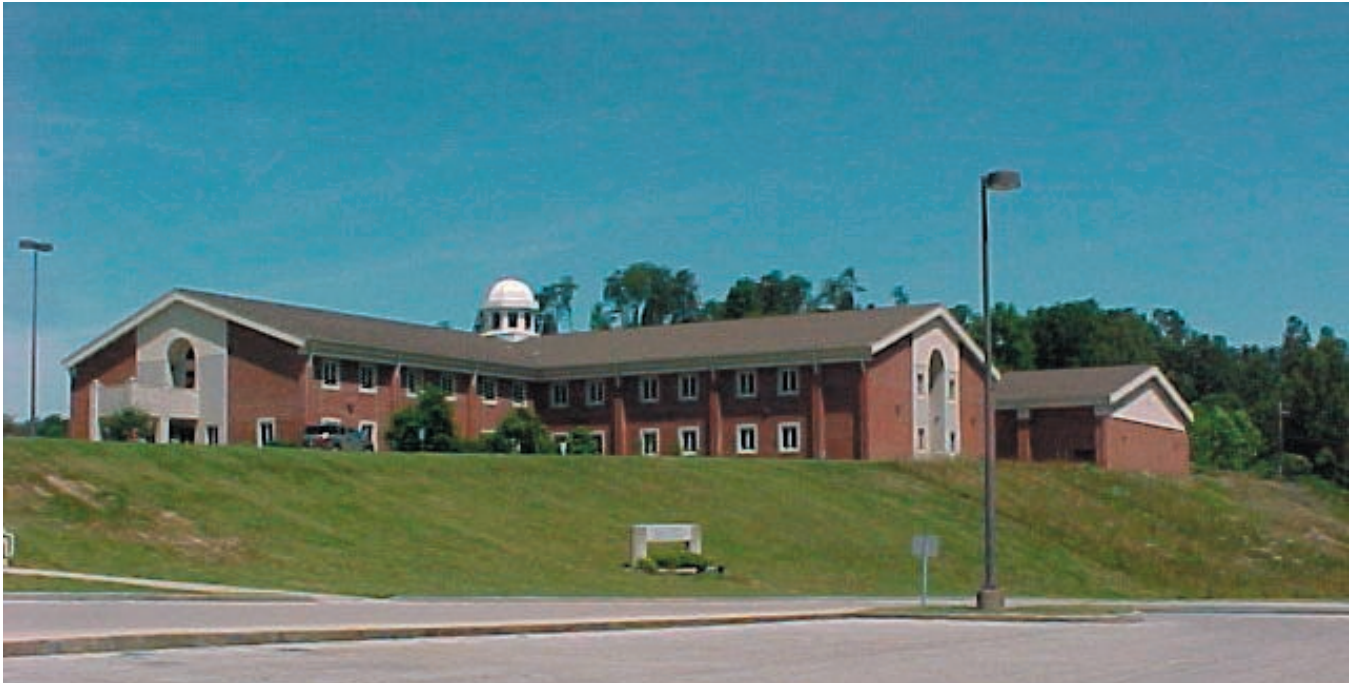
Figure 3. Estill County Middle School (looking northwest).

The middle school (Figs. 3-4) was built in 1996 and has had extensive foundation problems and numerous stages of remediation to correct the problems. The Carhartt factory was built in 1994 and has had severe foundation problems since it was constructed; remediation possibilities are currently being evaluated. The hospital was built in 1959, and although the entire history of previous repairs is not known, it is known to have had minor repairs to correct foundation-related problems at the time this report was completed. Ky. 499 was constructed in 2000 and has had swelling problems since the initial construction. Extensive milling and repair work were required. All of these problems appear to be related to their foundations being developed in the Devonian Chattanooga Shale, with the exception of Ky. 499, whose foundation is in the Crab Orchard Formation, a unit that underlies the Chattanooga Shale.

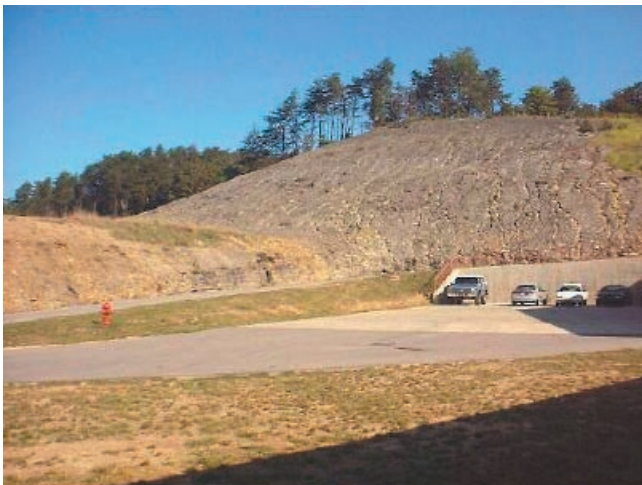
Figure 5. Chattanooga Shale outcrop behind the middle school (toward the north). Note retaining wall.

An outcrop behind the school exhibits sulfates, pyrite nodules, and pyrite lenses (Figs. 5–10). The sulfate formation is visible in the core, as described in Table 1 (samples 1 to 4), in the subcrop foundation of the school (Figs. 15–17), and in the outcrop behind the school (Figs. 7–8). Massive pyrite oxidation occurring in the shale leaches minerals, including sulfates, sulfur, and iron, into Masters Creek, resulting in low pH, high sulfate, and significant iron-staining in the creek. The outcrop behind the school is red-stained with iron oxide precipitates.

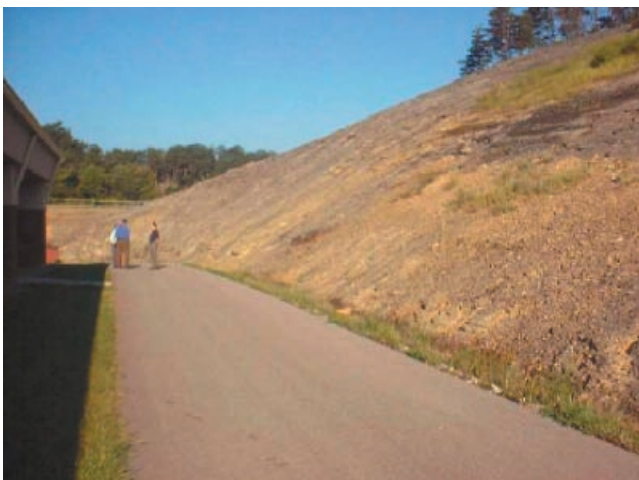
Figure 6. Outcrop and road behind Estill County Middle School.

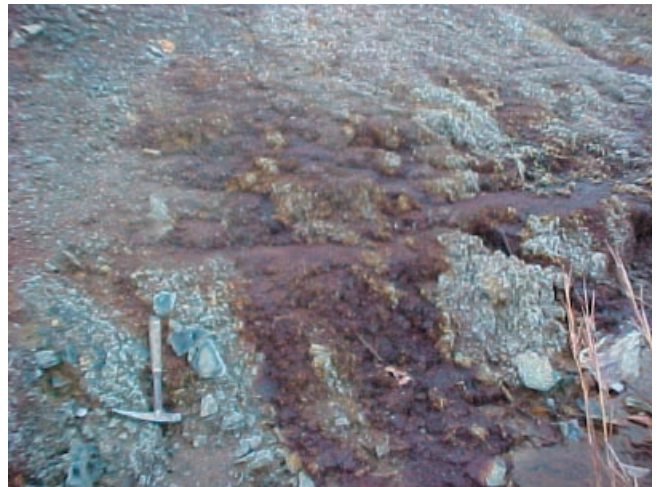
Figure 7. Pyrite oxidation, iron oxide, and sulfate staining and precipitate in the Chattanooga Shale at the middle school.

The pyrite zones (Figs. 7–10) within the Cleveland or Huron Member of the Chattanooga Shale appear to be a common factor in the foundation problems in Estill County. Additional pyrite zones in the Chattanooga Shale could cause similar problems. The stratigraphic location of each building and roadway in this study founded on the Chattanooga Shale is shown in Figure 12. Pyrite zones in other shale units such as the Crab Orchard Formation may also cause foundation problems, but were not examined in this study.

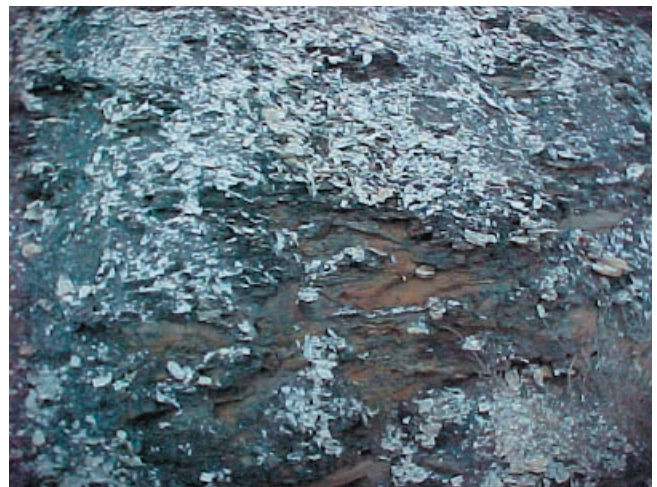
Figure 8. Secondary sulfate coating on Chattanooga Shale outcrop at the middle school.

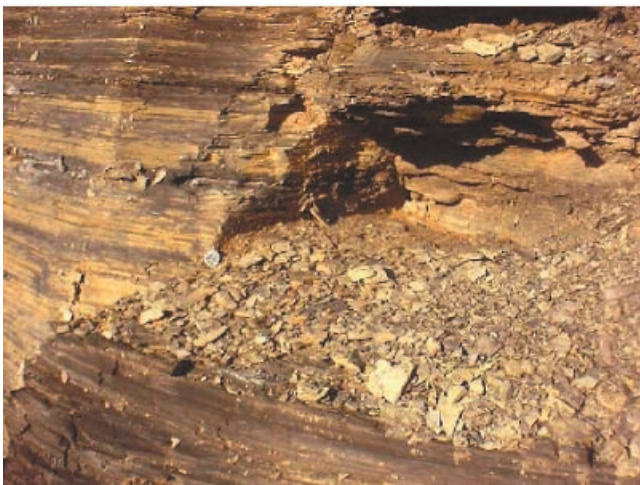
Figure 10. Intersection of pyrite zone with cleat zone in Chattanooga Shale at the middle school. Note extreme weathering of the shale.

this weathered shale lie in the outcrop drainage behind the middle school (Fig. 10), where it is evident that it has a semiplastic property with little or no shear strength.

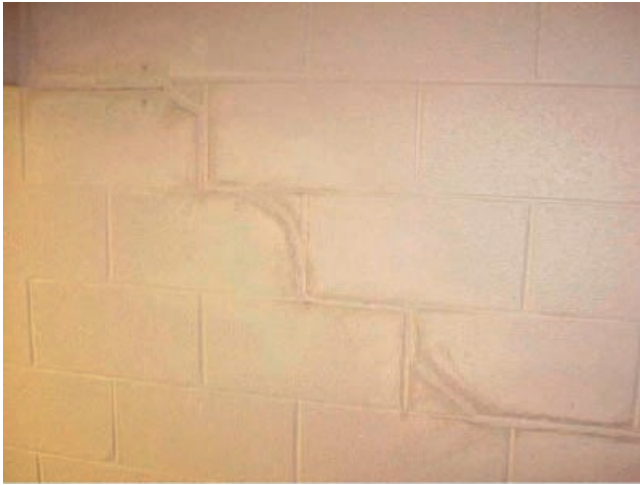
of the severity of cracking. The middle school has had gaps in the tile floors, cracks in the ceramic floor, and 1-in. offsets in brick and concrete-block walls (Fig. 13). The gymnasium floor has also heaved considerably, and the raised relief of the gym floor was impeding the opening and closing of the bleacher seats in 2000 (Fig. 13). The gym floor (Fig. 14) was excavated in 2005; all flooring and foundation material was removed, and the subcrop bedrock foundation was sealed with an asphaltic fiber resin to prevent further oxidation and heaving. Subsequent remediation in 2006 in other parts of the school (Figs. 15–18) removed additional concrete floors and utility lines and replaced them with concrete columns, steel beams, and joists to create a subfloor above the shale. The damage apparently has not penetrated to the second floor; only minor damage was noted there.

Figure 13. Repaired masonry block cracks.

Estill County Middle School. As early as the opening of the middle school, problems were noted with the floors, walls, and doors. Several cosmetic repairs have been made to masonry cracks in the walls, concrete floors, and along door frames, including cracks around the frame of the only elevator in the building. Many sections of exterior concrete walkways have been replaced because

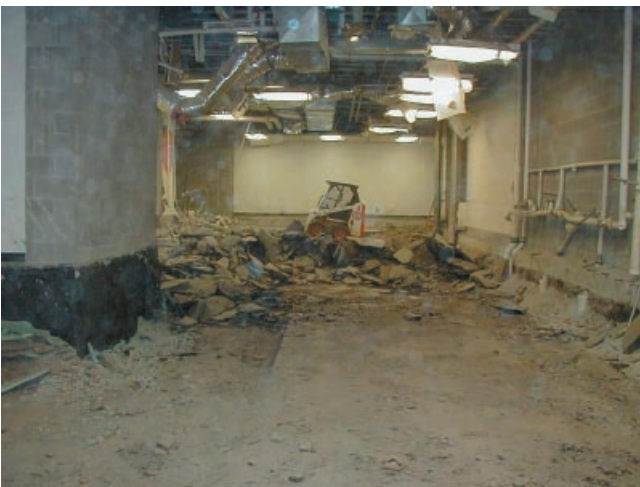
Figure 14. Repair of heaving floors in middle school gymnasium. The original foundation and fill had to be removed and sealed with a resin to prevent further oxidation and heaving of the shale. Photograph by John F. Stickney, Kentucky Rural Water Association.

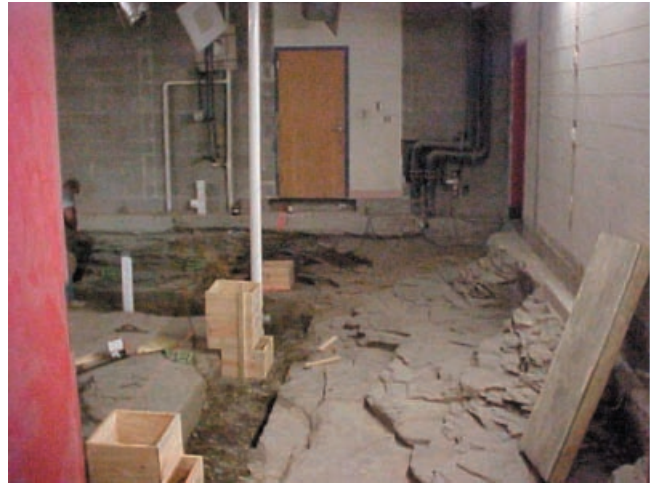
Figure 15. New trench constructed in shale subcrop beneath the middle school. The sulfate mineral copiapite has formed in cleats. Note that load-bearing walls on the right side of the photograph and in the background do not show any signs of failure.

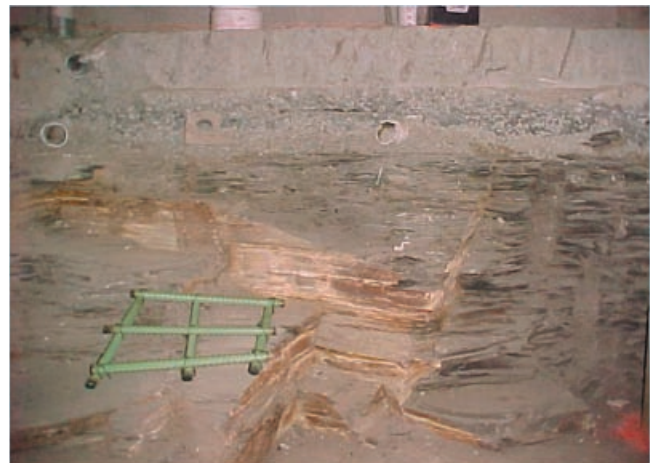
Figure 16. Multidirectional cleat fractures coated with secondary sulfate precipitates such as jarosite, copiapite, and melanterite in the Chattanooga Shale beneath flooring at the middle school. The sewer drain tile was broken by heaving floor slabs, and subsequently was removed. Rebar is being inserted into reinforced concrete columns.

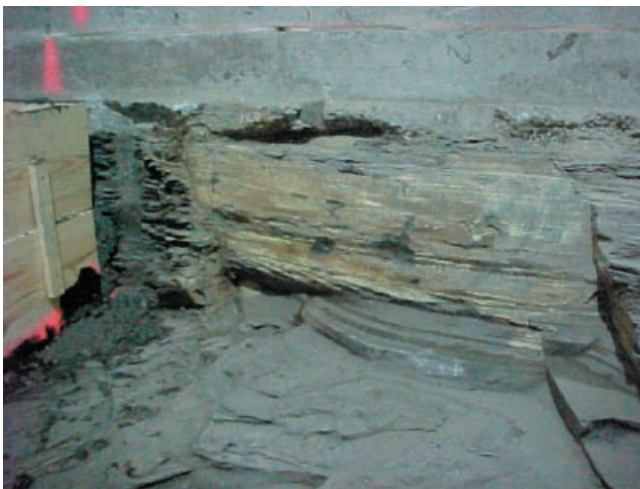
Figure 18. Cleats with sulfate precipitation in shale subcrop beneath the middle school, along with forms for construction of new concrete columns.

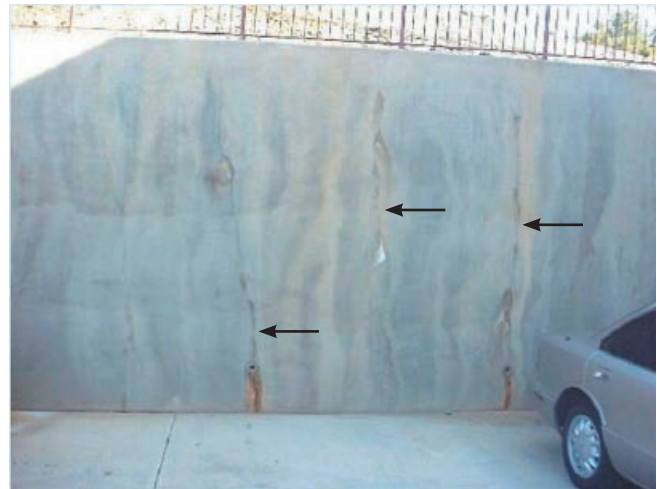
A 10-in. poured-concrete retaining wall in the parking lot shows signs of bulging, confirmed by tension fractures along its face (Fig. 19). Mineral precipitates in the tension cracks and drainholes along the wall (Fig. 20) confirm the presence of sulfate minerals.

Figure 19. Tension fractures (arrows) along exterior retaining wall and iron-stained drainholes.

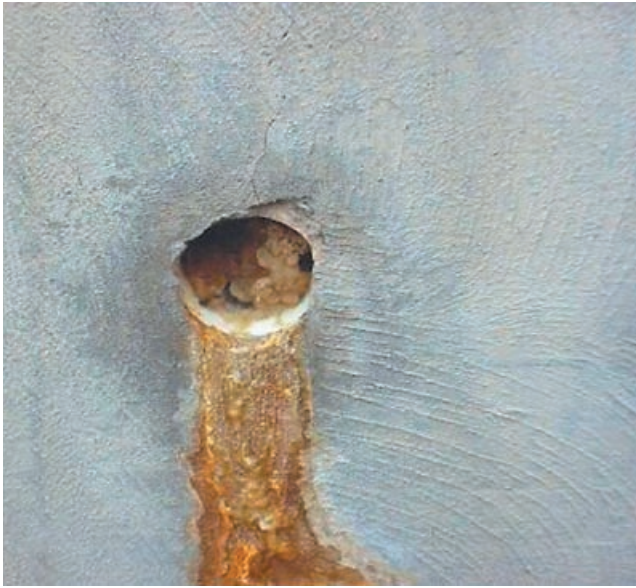
Figure 20. Drain-pipe precipitates (sulfates).

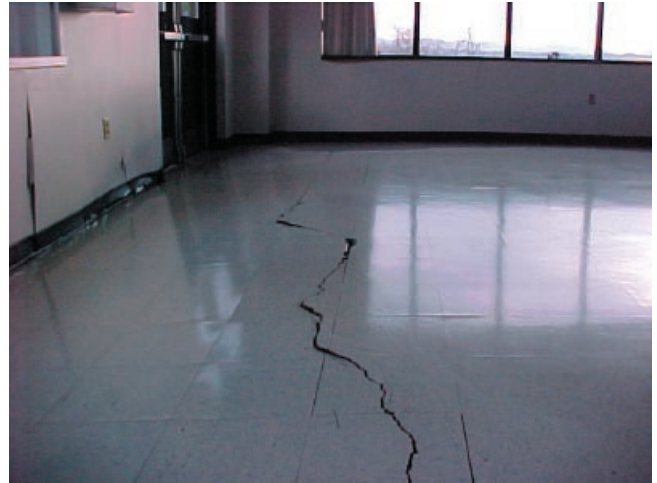
Member of the Chattanooga Shale. Floor heaving was considerable: 4 in. adjacent to the load-bearing walls. There were also cracks near doorways, ceilings, and in floors (Figs. 21-22). Doorways have been cut to allow functionality (Fig. 23). In the truck-loading area, steel inclines had to be installed so that forklifts could be driven over heaved flooring (Fig. 24). Although no major remediation was conducted in 2006, options for repair are being evaluated.

Figure 21. Substantial floor cracks in Carhartt break room.

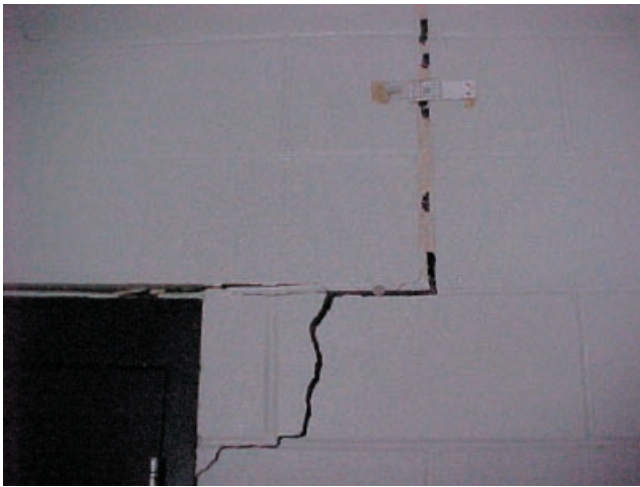
Figure 22. Large cracks (1 in.) in concrete block adjacent to doorway at Carhartt factory.

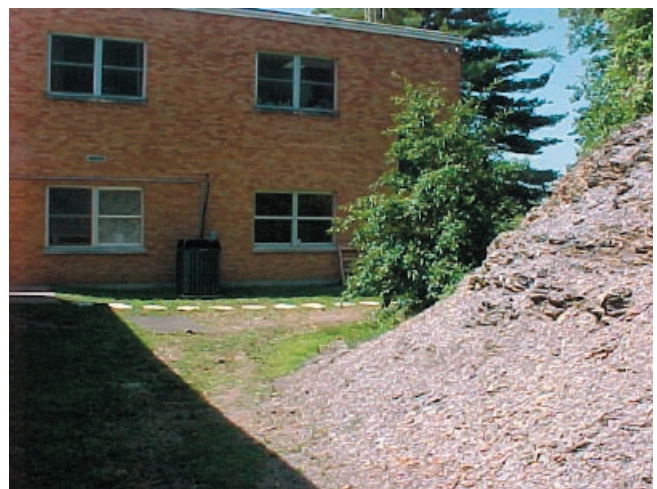
Figure 25. Exterior of the Marcum and Wallace Hospital office wing and outcrop of the Cleveland Member of the Chattanooga Shale. Note the absence of cracks or offsets in exterior brickwork near windows, even though behind these windows, interior floor heaving was extensive.

The primary foundation problems were repaired by reinstalling water lines and radiators, replacing drywall and ceiling tile, and patching cracked concrete-block walls. But unless the drainage system is modified, heaving problems in floor slabs could continue. Damage appears to be restricted to nonload-bearing walls, since damage to exterior load-bearing walls was not observed (Figs. 25–28).

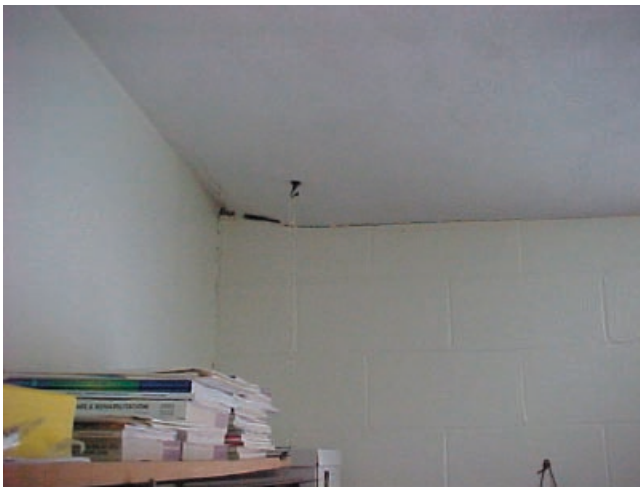
Figure 27. Displacement of ceiling wallboard at hospital along nonload-bearing walls caused by floor heaving.

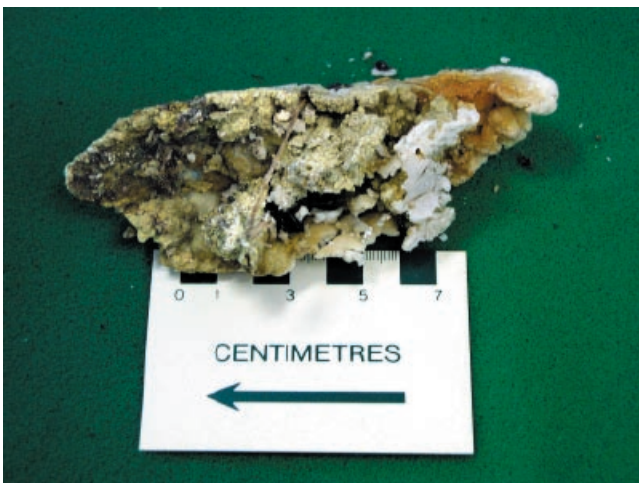
Figure 30. Secondary sulfates copiapite and melanterite derived from retaining-wall drain tiles at rear of middle school.

Sulfate Analysis. The sulfate minerals jarosite, melanterite, copiapite, gypsum, alunite, kalinite, pickeringite, and eponite – oxidation products of pyrite – were detected visually and by X-ray diffraction (Figs. 30–31). Other minerals may also occur. Tuttle and others (2003) determined that melanterite, halio-trichite, and szomolnokite occurred in the Middle Huron at a sample site 7 mi north and east near Clay City in Powell County. The abundance of trace elements and pyrite in the shale produces many elements for the formation of various secondary sulfates. These sulfates are humidity- or water-sensitive and can change chemistry hourly. Each rainfall will remove or alter existing sulfates, promoting new crystal growth.

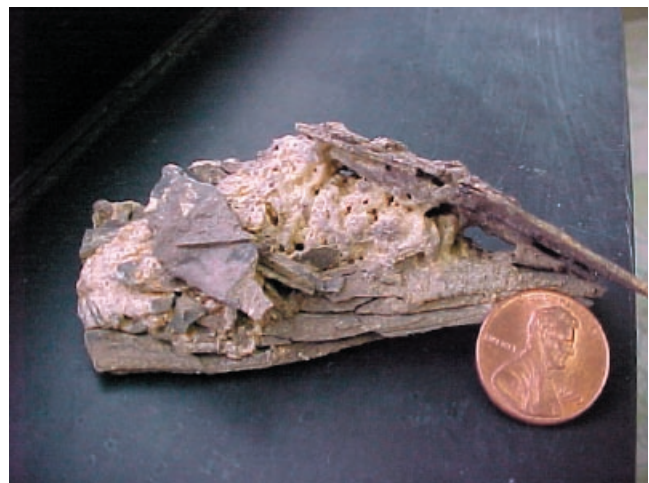
Figure 31. Evidence of heaving by growth of secondary sulfate copiapite in the Chattanooga Shale.
