Using LiDAR to Map Landslides in Kenton and Campbell Counties, Kentucky

Matthew M. Crawford

Kentucky Geological Survey
James C. Cobb, State Geologist and Director
University of Kentucky, Lexington

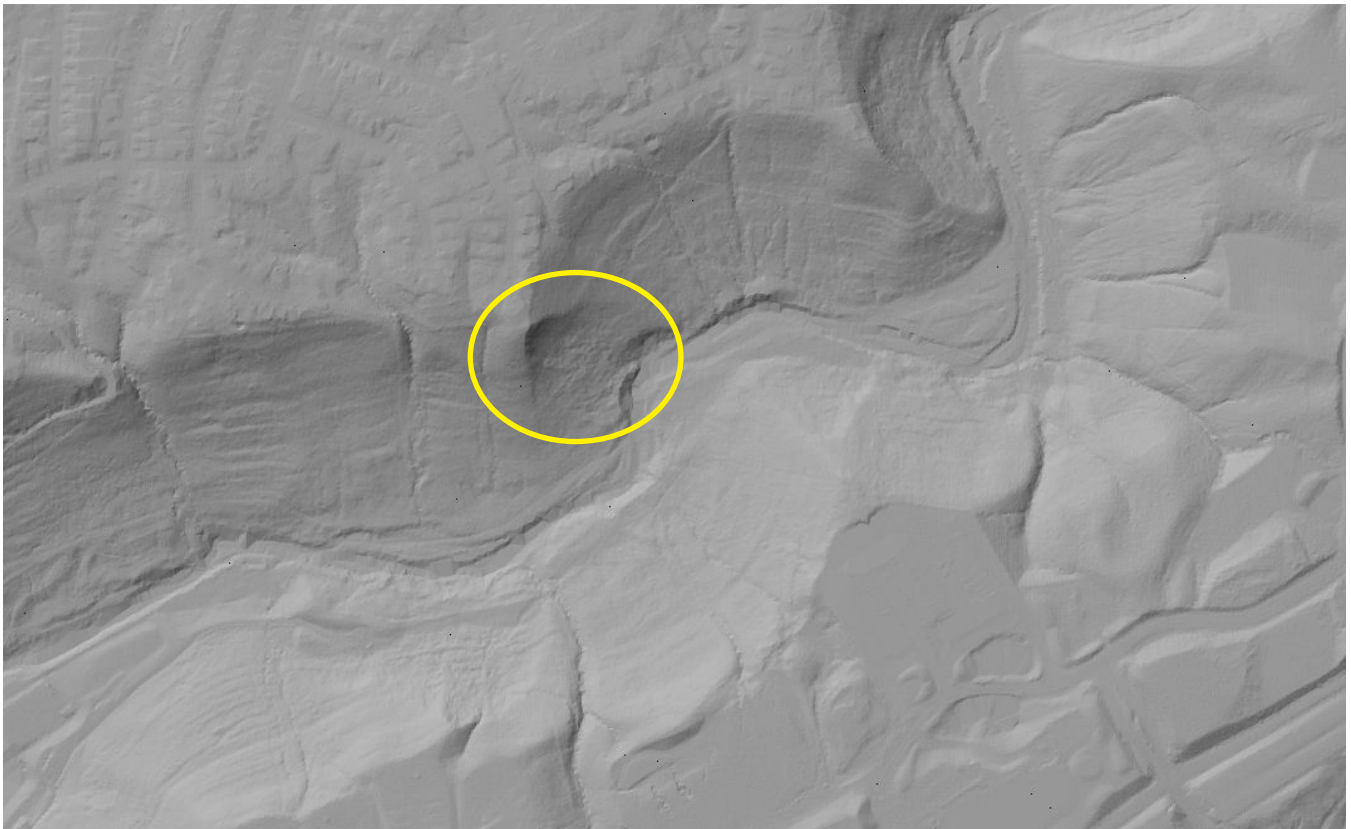
On the cover: Example of a LiDAR hillshade digital elevation model in Kenton County, Ky. A landslide is circled in yellow, identified by the methods described in this report.

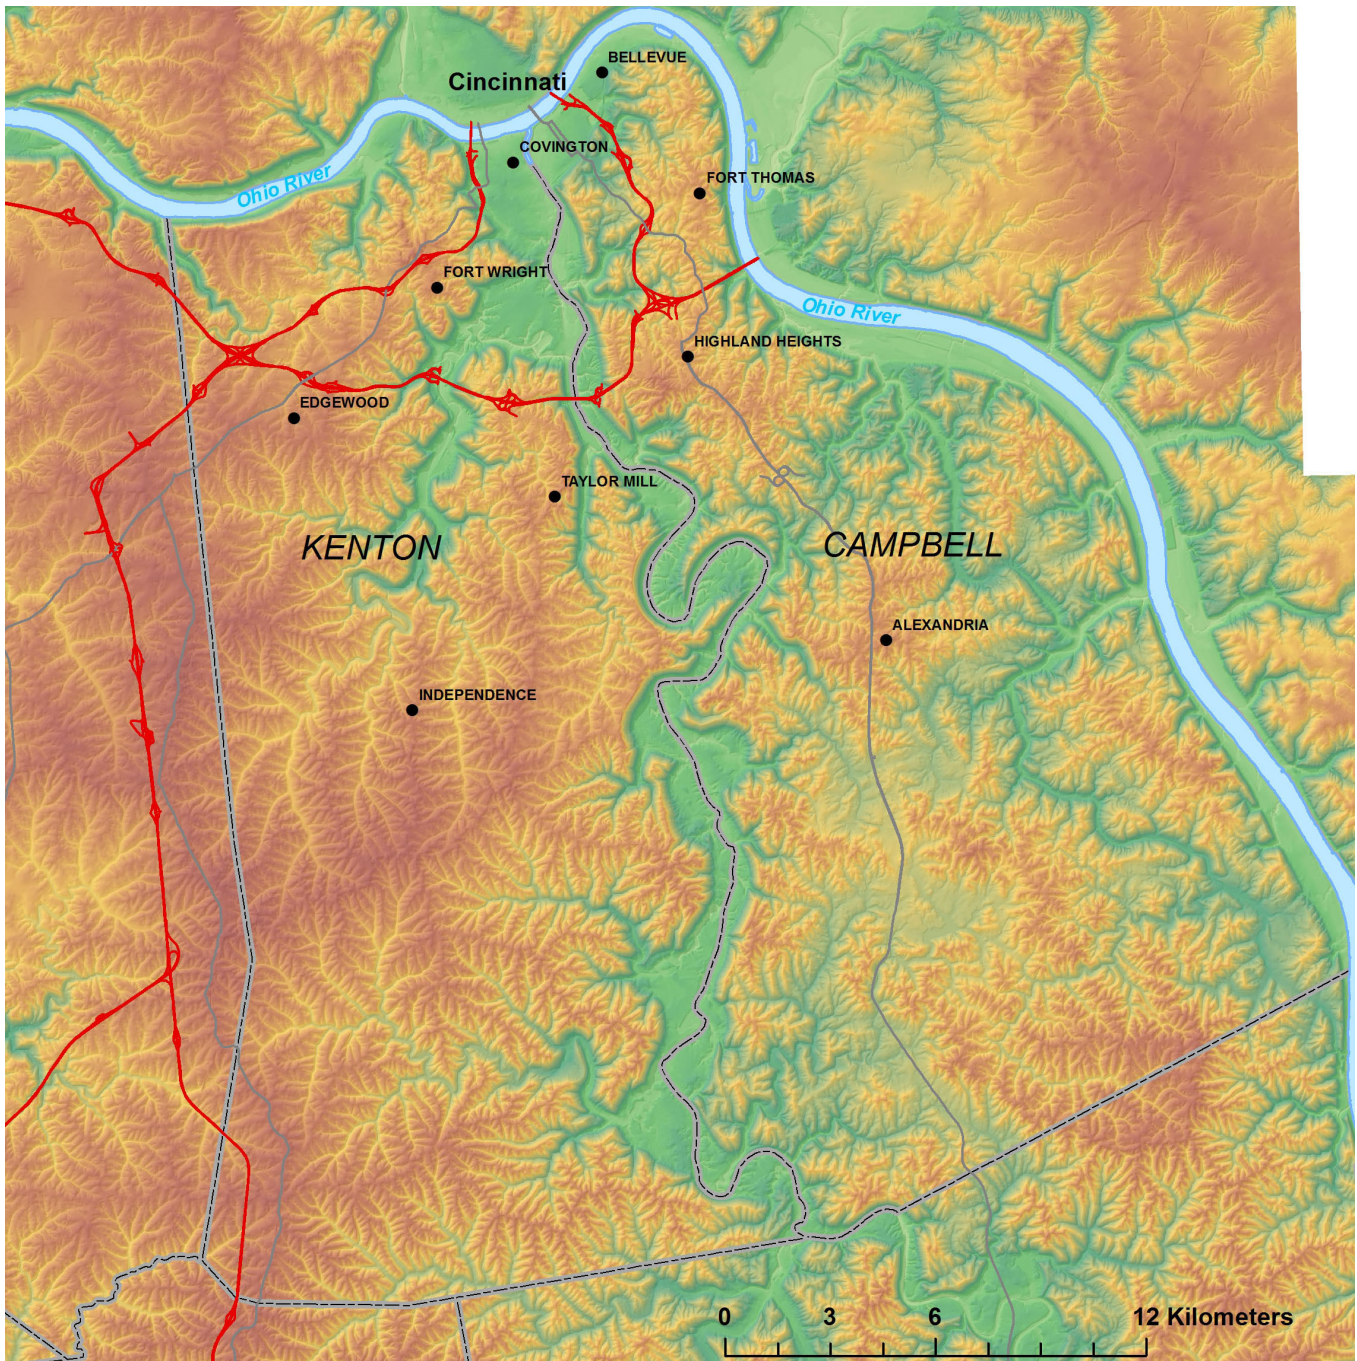
Figure 1. Location of Kenton and Campbell Counties. Elevation contours are draped over the hillshade. Green represents lower elevations and warm colors represent higher elevations. Interstate highways are shown as red lines and major state roads are light gray.

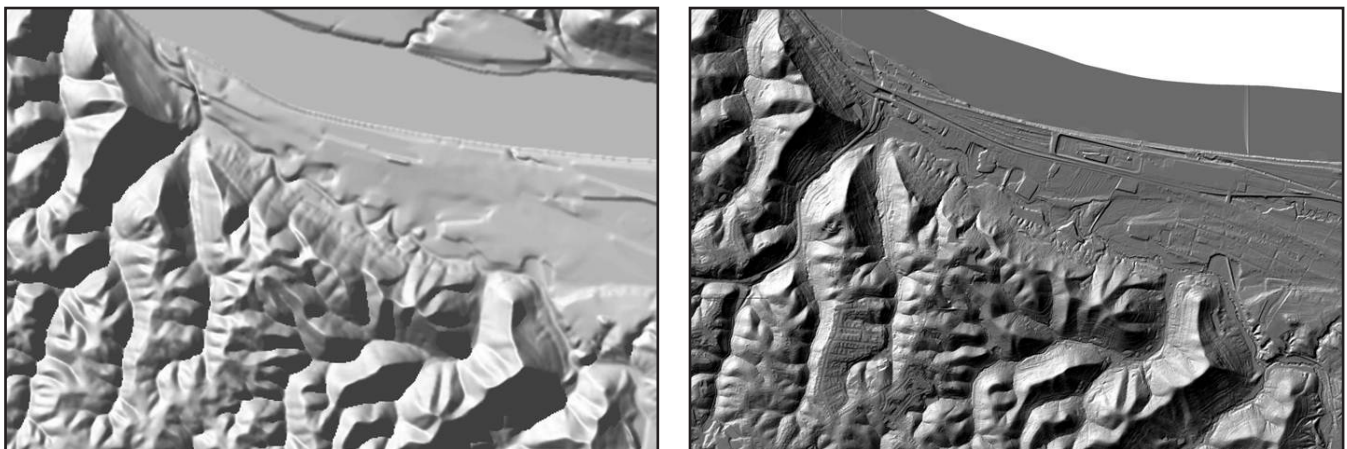
Figure 2. Comparison of elevation models: a 10-m digital elevation model hillshade (left) and LiDAR hillshade (right).

a tree branch, a building, or a car. This classification results in bare-earth, hillshade surface models (Fig. 2) as well as other geomorphic derivatives of LiDAR data, including elevation, topographic contours, slope, curvature, roughness, and moisture index. A successful project finds the right combination of these data sets in a multilayered geographic information system and makes an interpretation resulting in useful information.

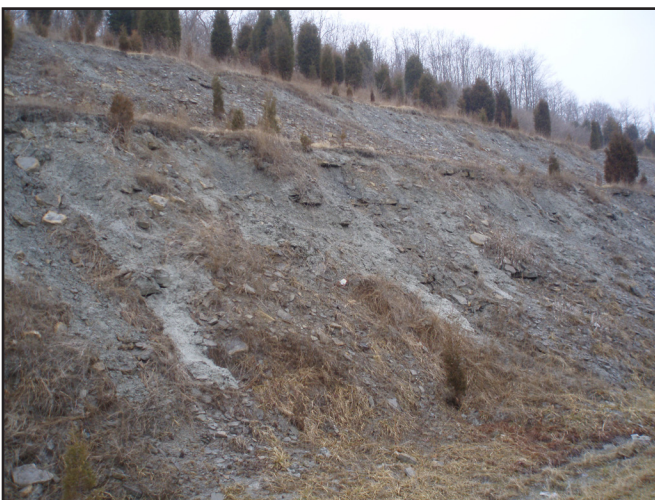
Figure 3. Outcrop of the Kope Formation. Thin to thick, stony, clay-rich colluvial soil covers the slopes. When saturated, the soil can erode rapidly, potentially developing landslides.

in the area. The Kope consists of approximately 75 percent shale and is 200 to 250 ft thick, primarily cropping out along river valleys and the lower parts of hills. The Kope shale weathers easily, slumping and producing colluvial soils of variable thickness (Fig. 3). Composition of the colluvium ranges from clayey (predominantly illite) to silty to coarse-grained with abundant limestone slabs. Thickness of colluvial soils varies, but they are typically thicker at the toe of a slope. Landslides occur on steep slopes in the colluvium or along the colluvial-bedrock contact. When clay-rich colluvium is mixed with large amounts of water, the soil's pore-water pressure increases, adding to the overall load on the slope. When the pore-water pressure increases, the effective stress decreases, causing a decrease in strength, which can cause landslides (Fig. 4). Other surficial deposits in the area are prone to landslides as well. Pleistocene glaciation in the region produced clayey lake deposits, outwash, glacial drift, and other fluvial deposits that fail and can damage roads or other infrastructure. Artificial fill, particularly above and below roadways, is also susceptible to landslides.

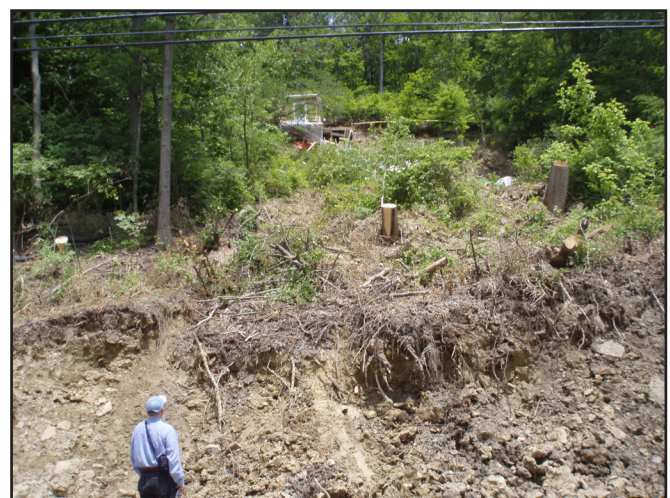
Figure 4. Landslide along Ky. 3187. Thick colluvium is shown at the bottom of the photo and a threatened home toward the top.

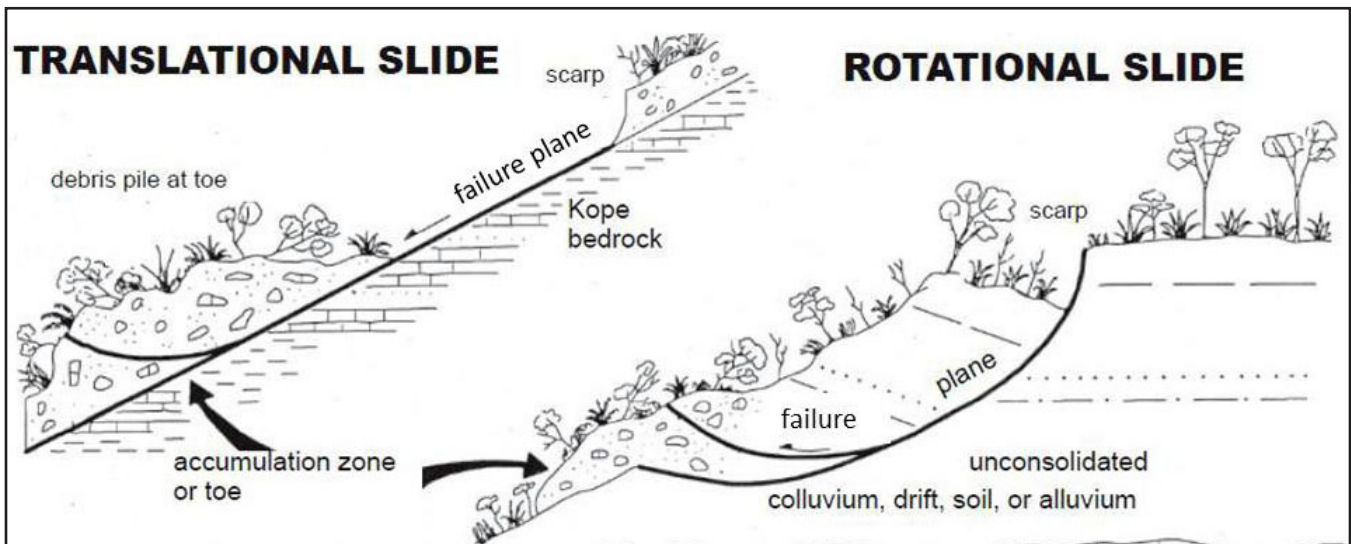
Figure 5. Illustrations of translational and rotational landslides in the study area. From Potter (2007).

The most common types of landslides are small, thin translational slides and thick rotational slides on steeper slopes (Fig. 5). Less frequent block slides occur in unconsolidated glacial deposits. In a translational slide, thin layers of colluvium move downslope along the underlying bedrock contact. Rotational slides occur in thicker colluvial slopes,

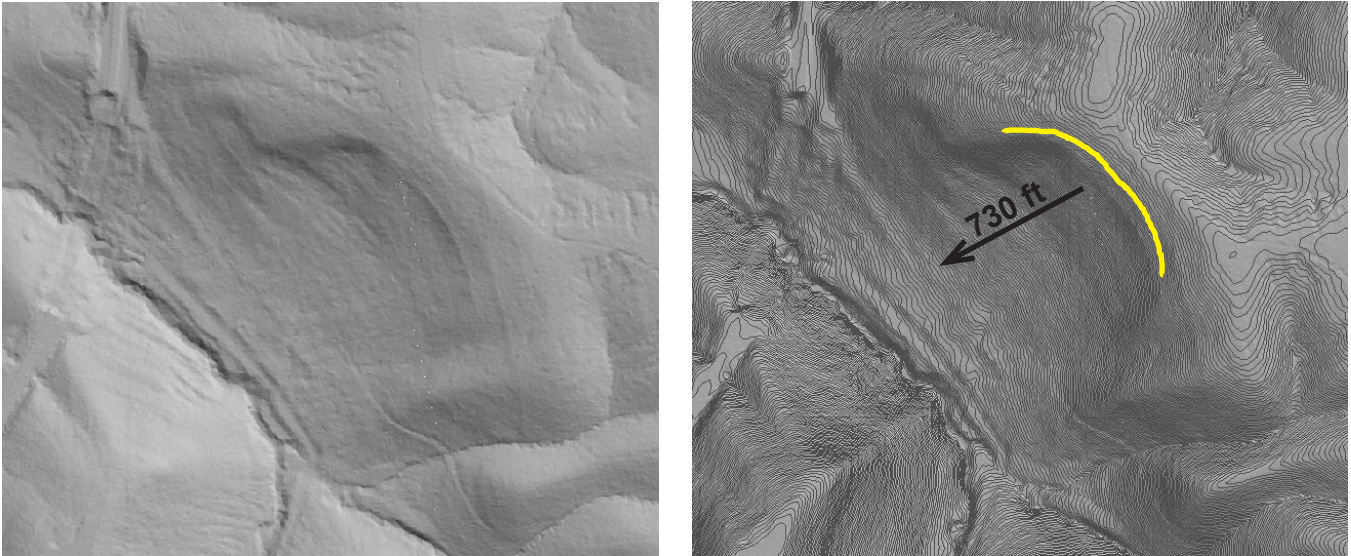
Figure 6. LiDAR hillshade DEM without contours (left) and with contours (right). The 2-ft contours accentuate the slope morphology: scarp (in yellow), concavity, landslide flanks, and hummocky terrain.

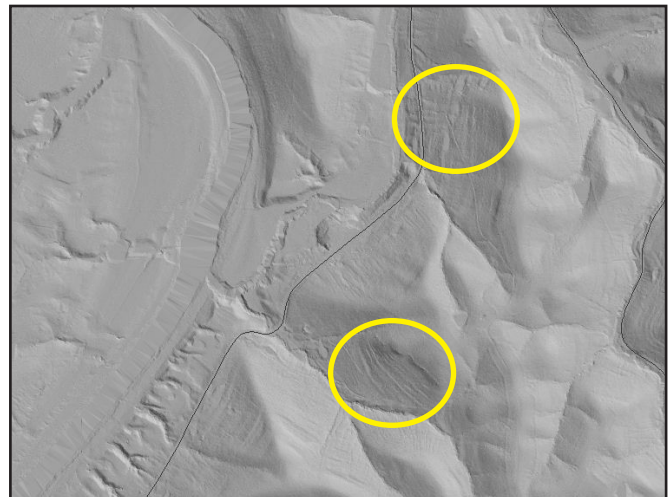
Figure 7. LiDAR hillshade exhibiting hummocky slopes and roughness. Although these slopes may be creeping, the roughness is probably an artifact of forested slopes, aspect, and geology.

Distinguishing between hummocky landslides and a general “roughness” in the LiDAR hillshade (Fig. 7) was a challenge. (“Roughness” refers to the hillshade quality and local landscape variability. The roughness may represent actual landscape ruggedness and discrete features, or a “false topography” because of sun angle, azimuth, resolution, and bare-earth derivation of actual landscape.) The data-processing algorithms that produce bare-earth models can also create false ground-surface roughness (McKenna and others, 2008). Roughness appears to be more prominent on forested slopes, particularly slopes with many cedar trees. Southwest-facing slopes also exhibited more roughness than other slopes of similar land use. This would most likely change if hillshade DEM’s were created with different azimuths. Mapping landslides in the more urban areas of Kenton and Campbell Counties was also a challenge. Densely populated neighborhoods with altered

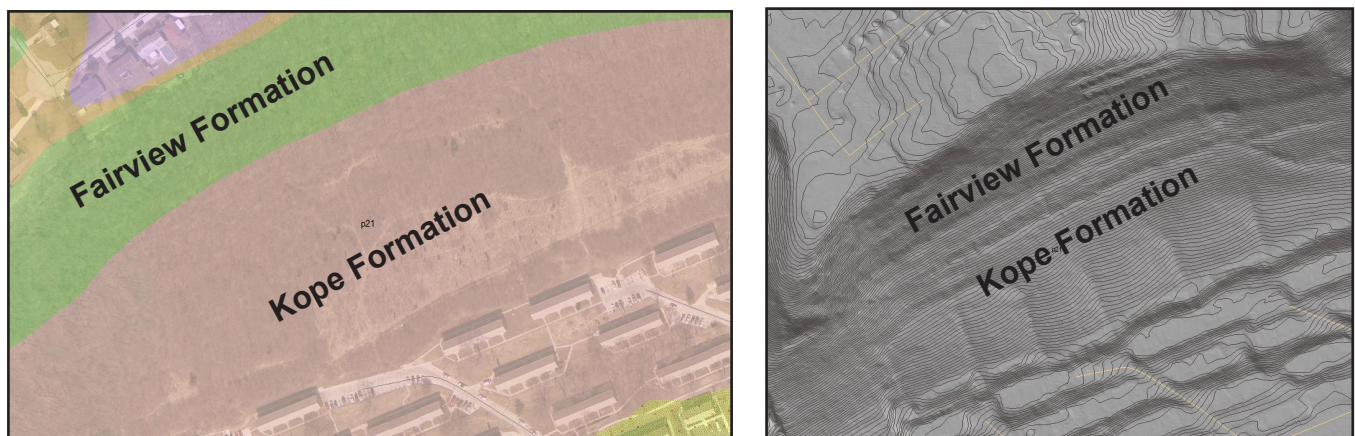
Figure 8. Geology (left) compared to the LiDAR hillshade image (right). The break between the more limestone-rich Fairview Formation and the shale-rich Kope Formation is evident in the LiDAR image.

tionable geomorphology were actually the contact between the Fairview Formation and the underlying Kope Formation. The Fairview is interbedded limestone and shale with about 40 percent limestone near the base increasing to about 65 percent near the top. The Kope is interbedded shale and limestone, shale comprising about 80 percent of the formation. The transition of a more resistant limestone to weaker shale shows up very well in the LiDAR hillshade (Fig. 8). The breaks in slope in the Fairview are probably limestone beds that extend in a more continuous fashion along the slope than a landslide scarp would.

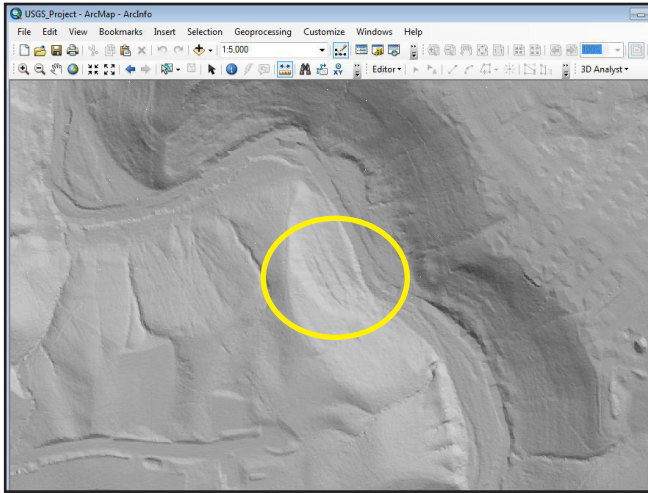
Figure 9. Image of a potential landslide (circled), viewed in ArcMap. Azimuth and sun angle were 45° when hillshades were created.

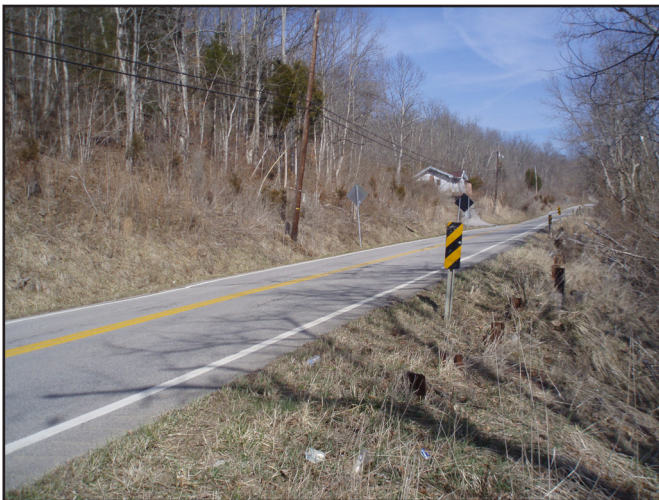
Figure 11. An old I-beam pier retaining wall in the grass suggests previous slope failure, and a leaning telephone pole suggests the slope is actively creeping.

Many of the confirmed landslides could be seen from the road, and road damage was usually associated with them (Figs. 11–13). Recent scarps were also present in many slides, and deposition was active toward the toe of the slide (Fig. 14). Determining that potential landslides were likely was a subjective process. For example, a potential landslide might have been identified on a slope, and slumping in the road below it provided field verification, but it was not clear whether there was ac-

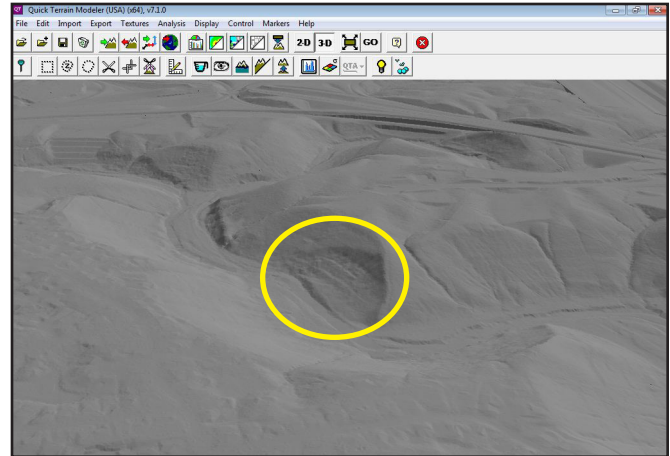
Figure 10. Three-dimensional view of the same landslide shown in Figure 9 in Quick Terrain Modeler. Changing the sun angle and azimuth can make the scarp and flanks stand out. The image was rotated in 3D and the azimuth was changed to 225° . This landslide was termed confident after it was viewed with Quick Terrain Modeler.

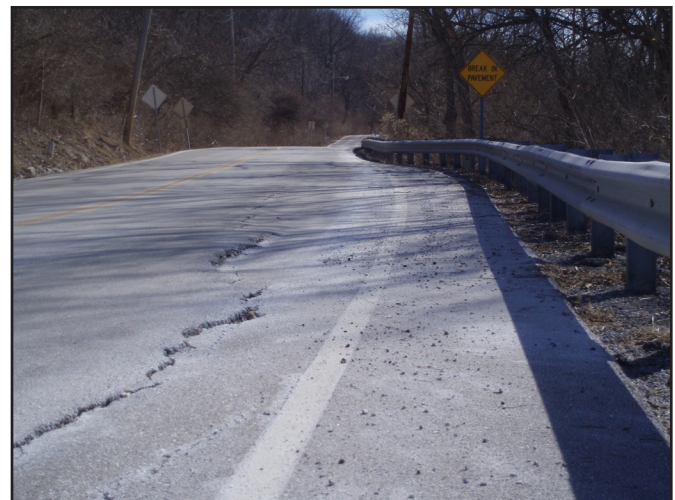
Figure 12. Evidence of landslide activity: The road is benched into the middle of the slope and the landslide stretches above and below the road. There is significant offset in the pavement.

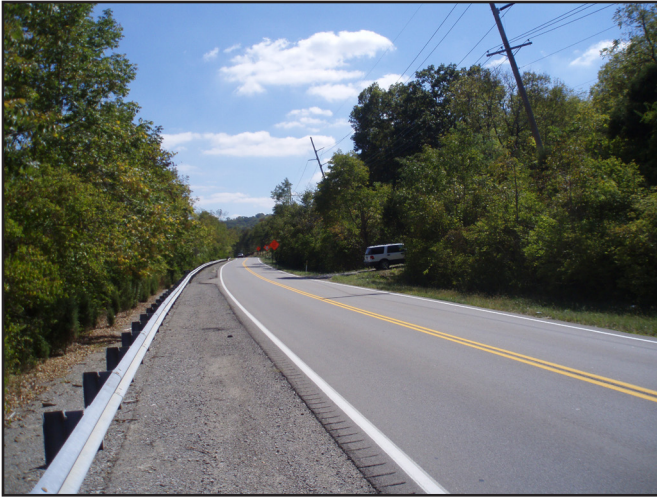
Figure 13. Recently repaired I-beam piers and leaning telephone poles along Ky. 8 are evidence of landslide activity. Ky. 8 is in constant need of repair because of landslide damage.

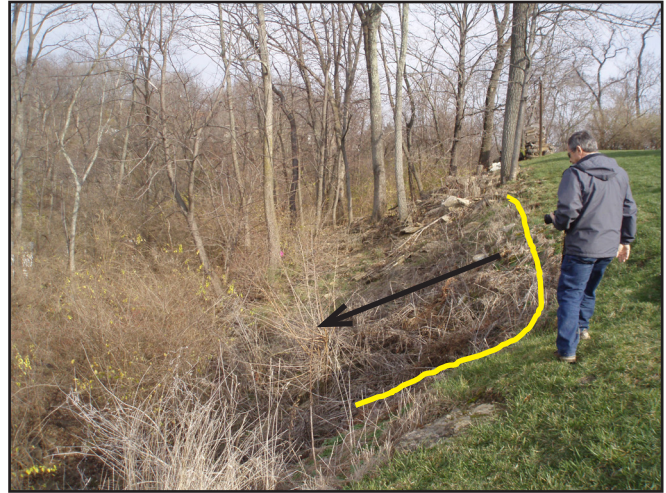
Figure 14. A scarp (outlined in yellow) from a recent landslide. Identification of offsets like this using LiDAR can flag these areas as highly susceptible to future failure.

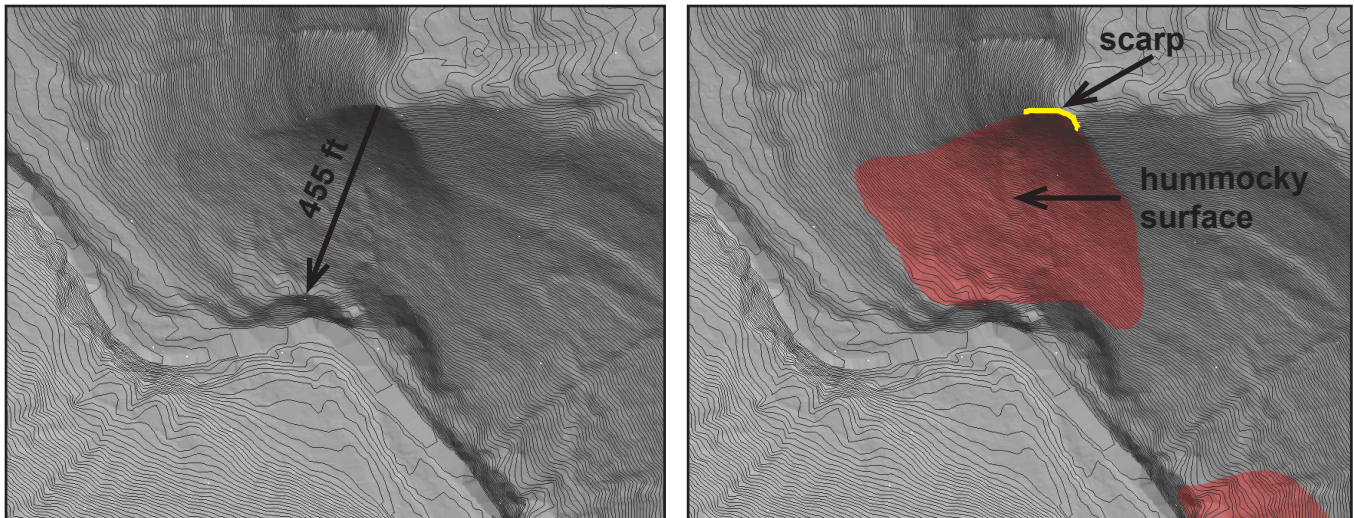
Figure 15. Example of a landslide identified on the LiDAR image (left) and the digitized polygon (right). Note the scarp (dashed yellow line) at the steep top part of the slide, boundary flanks, and hummocky surface. The contour interval is 2 ft. The steep scarp along the cutbank of a stream eroding the toe of the slope probably contributed to the landslide. This slide initially was attributed as confident.

Two hundred thirty-four potential landslides were detected in Kenton and Campbell Counties, and their extents were digitized. Twenty landslides (approximately 9 percent) were initially attributed as confident (Fig. 15). The other slides were attributed as questionable or moderately confident (Figs. 16–17). The LiDAR hillshade geomorphology, ge-

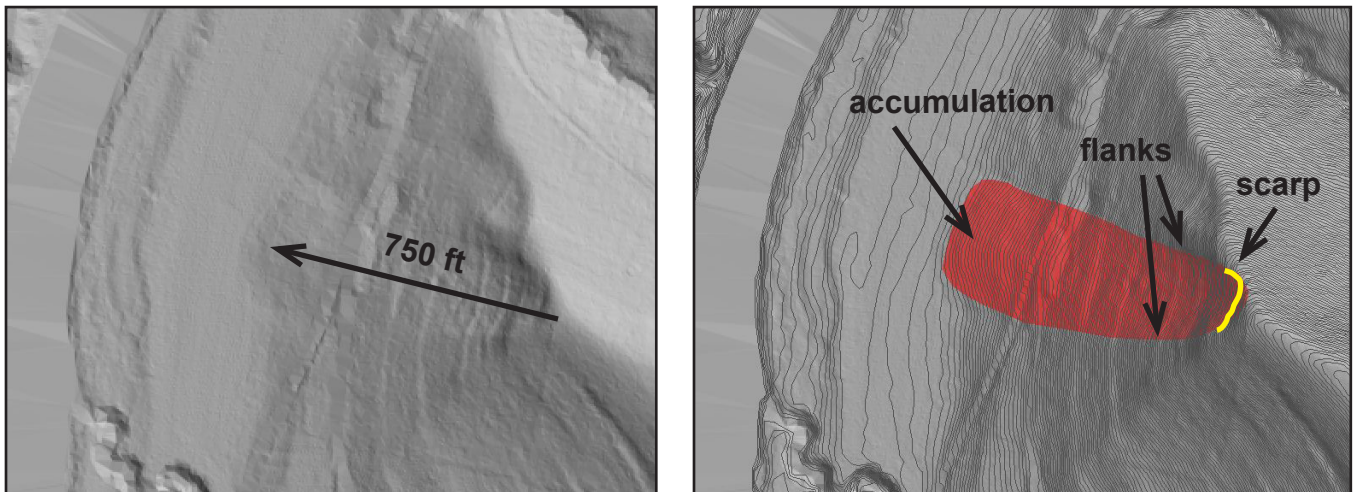
Figure 16. Example of a landslide identified on the LiDAR image (left) and the digitized polygon (right). Note the steep scarp, boundary flanks, hummocky surface, and accumulation at the toe. The contour interval is 2 ft. This slide was attributed as moderately confident.

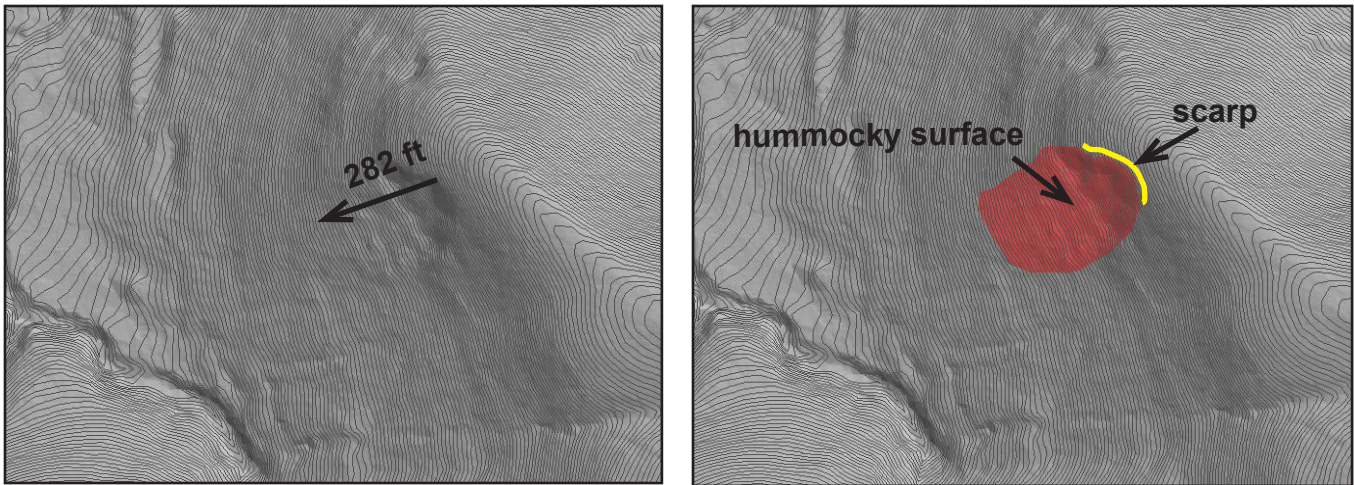
Figure 17. Example of a landslide identified on the LiDAR image (left) and the digitized polygon (right). Note the steep scarp, boundary flanks, and hummocky surface. The contour interval is 2 ft. This is a good example of a slide not associated with a road and occurring on a natural slope. The slide was attributed as questionable.

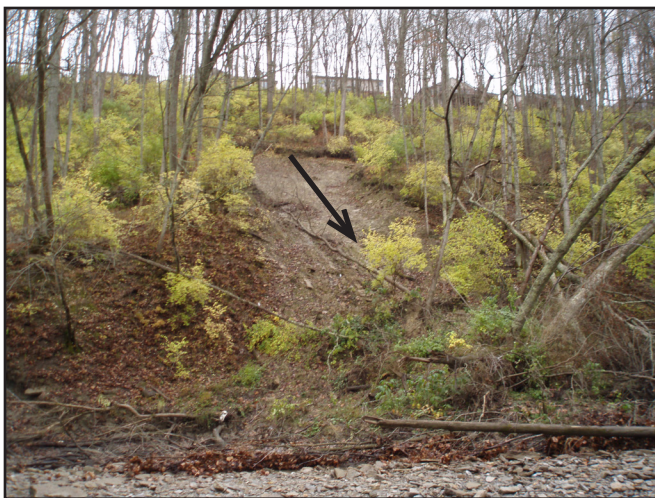
Figure 18. A small translational slide in November 2011 is indicated by debris and leaning trees at the toe and the neighborhood above the scarp. The greater slope area was predicted using LiDAR beforehand.

ing slides that may not yet have been a problem. A heavy rain or other trigger could cause these existing landslides to move again, potentially quickly and unexpectedly (Figs. 18–19).

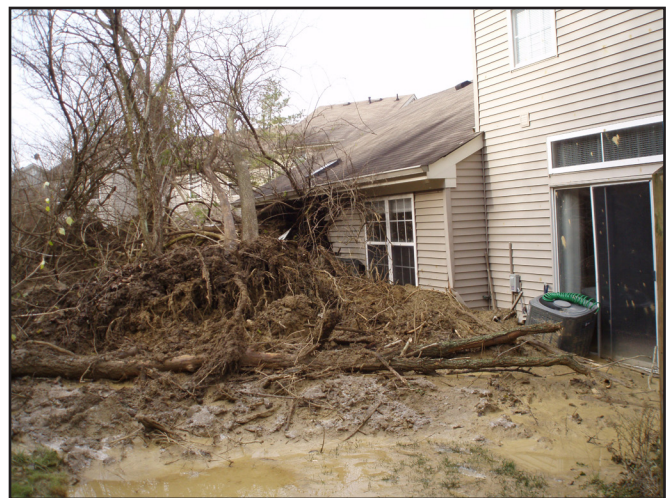
Figure 19. A large translational slide in December 2011 brought debris downslope into two condominiums. The greater slope area was predicted by LiDAR beforehand.
