Kentucky Geological Survey
University of Kentucky, Lexington

Geologic, Geotechnical, and
Geophysical Investigation of a Shallow
Landslide, Eastern Kentucky

Matthew M. Crawford, Junfeng Zhu, and Steven E. Webb

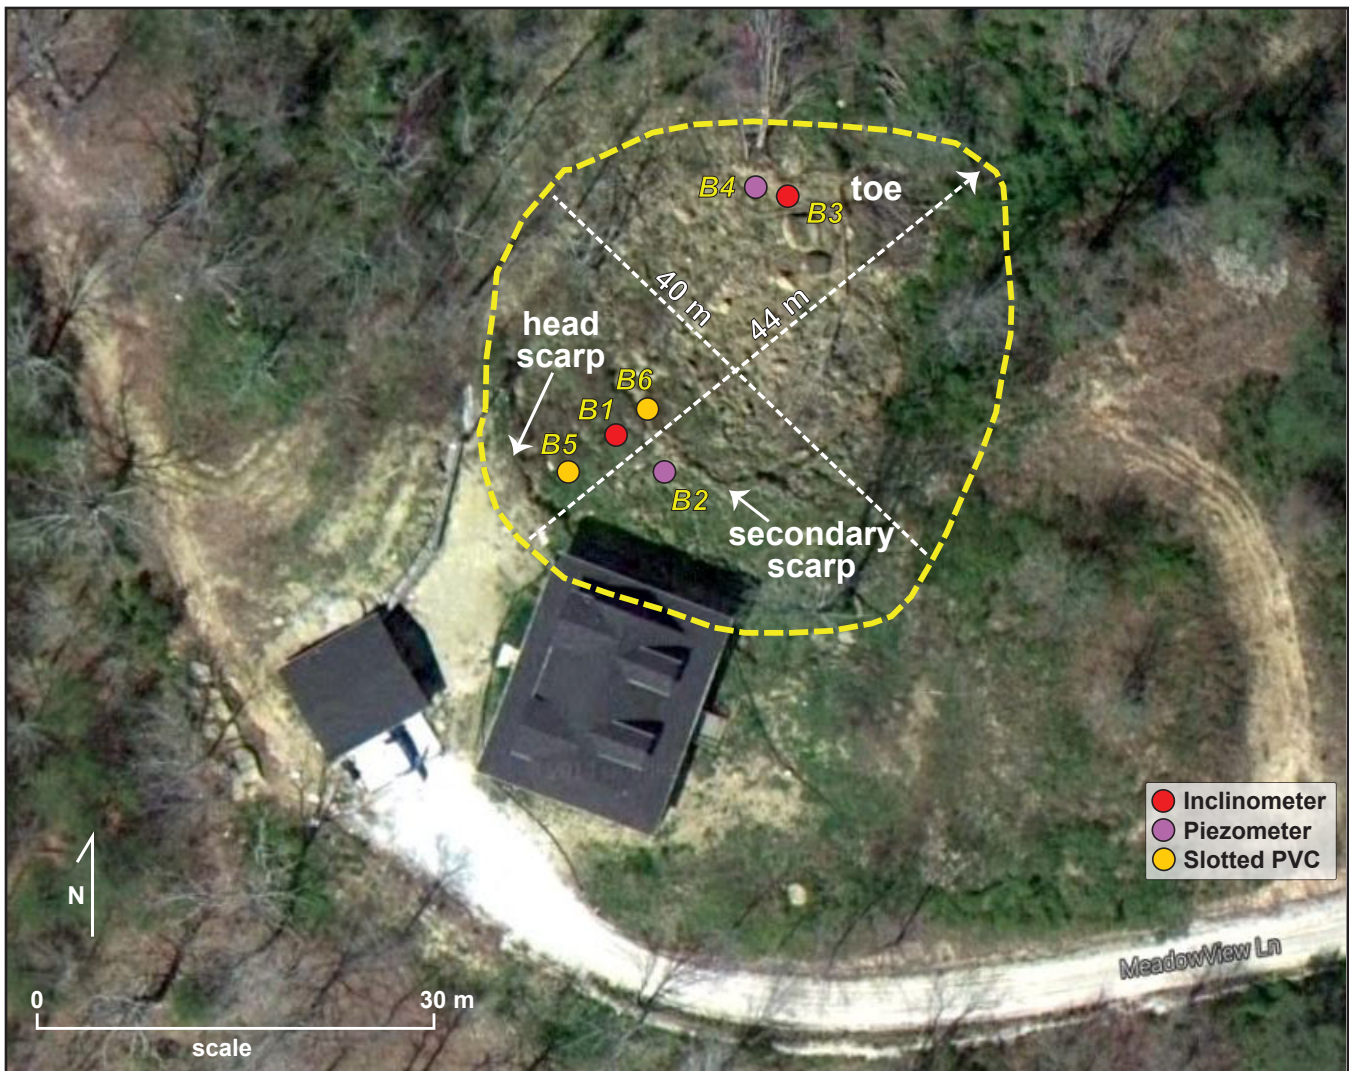
Figure 3. Aerial image of the Meadowview landslide. The main landslide area is within the dashed outline. Axes show dimensions of the slide. Borehole locations and instrumentation types also shown.

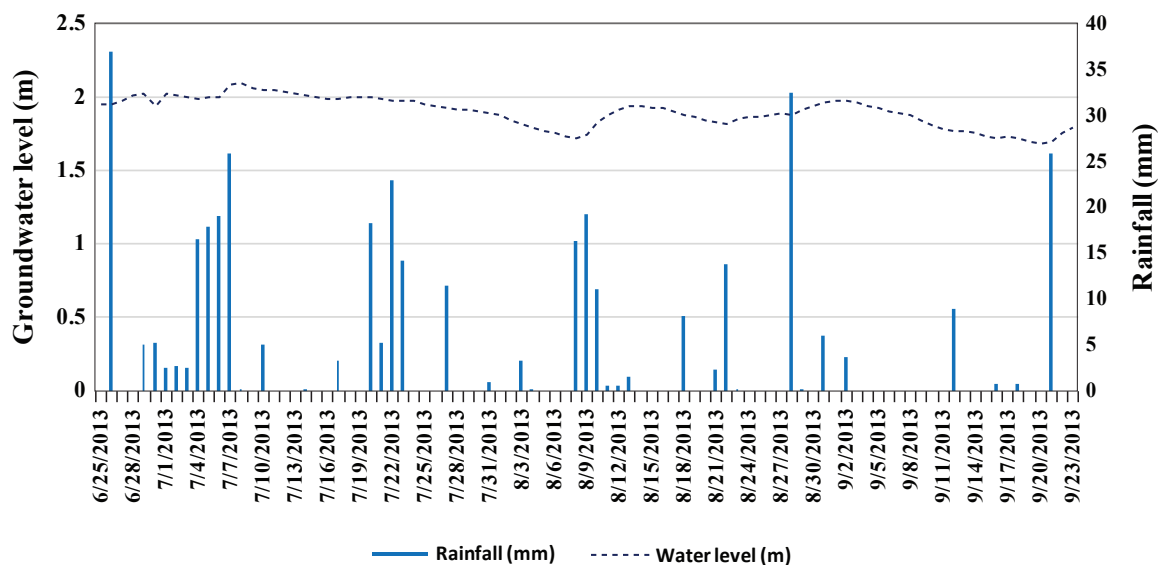
Figure 5. Maximum daily groundwater levels measured from the pressure recorder in borehole B1 compared with daily rainfall from June 25 through September 23, 2013. Groundwater level increased after rainfall events.

We correlated groundwater fluctuations (measured in the piezometers) with rainfall. The largest pulses of rainfall caused an increase in groundwater level in the piezometers. A graph from late June to mid-September 2013 correlates increases in groundwater level above the bottom of the borehole with rainfall pulses (Fig. 5). In B2, groundwater level change above the sensor, after rainfall pulses, varied from 80 mm in spring of 2013 to 122 mm in spring of 2014. The timeframe for the groundwater increase ranged from 1 to 3 days following a rainfall pulse. The clayey colluvial fill stores a lot of water, which is perched on the low-permeability clay layers, controlling a smaller groundwater level response to rainfall.

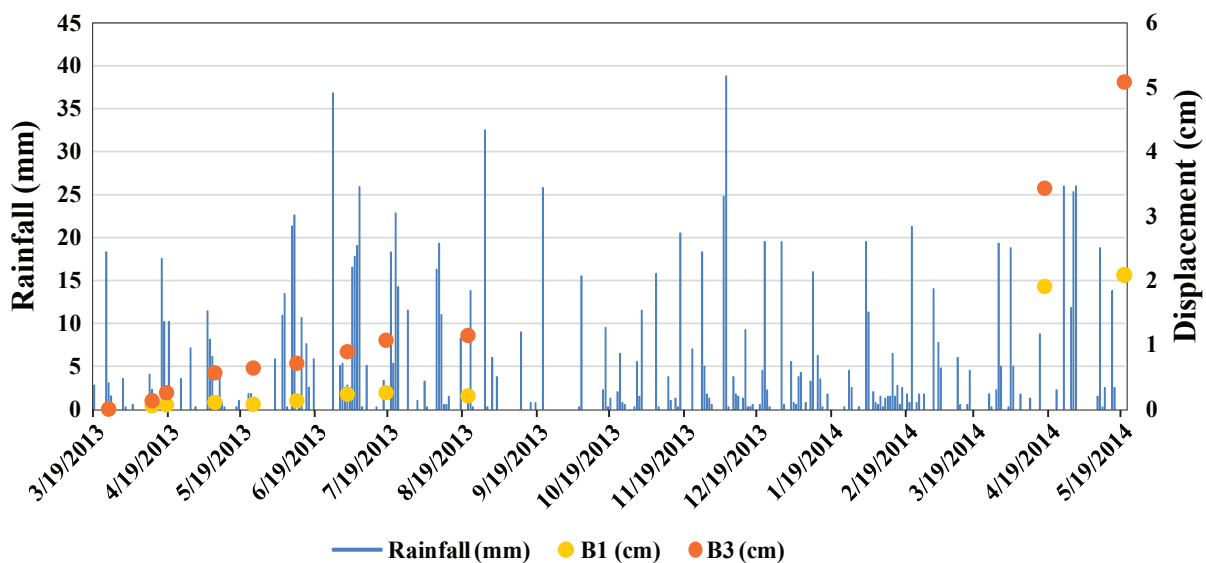
Figure 6. Inclinometer displacement versus time in boreholes B1 and B3, plotted with rainfall. From June 11 to July 2, 2013, a high frequency of rainfall occurred, resulting in highest average velocity displacement during the study. Rainfall from June 11 to July 2, 2013, totaled 78.7 mm and included the second highest daily rainfall amount of 36.8 mm on June 26.

Readings were taken once a week for the first 2 mo and once a month after that. Cumulative horizontal displacement in B1 in the head of the landslide through May 20, 2014, was approximately 2 cm. Cumulative displacement in B3 near the toe of the landslide through May 20, 2014, was approximately 5 cm. The greatest average velocity in B1 (0.05 mm/d) occurred from June 11 to July 2, 2013. This interval corresponded with 78.7 mm of rainfall and had the second highest daily total during monitoring, 36.8 mm on June 26. The two greatest average velocity increases in B3 were 0.16 mm/d from April 19 to May 8, 2013, and 0.5 mm/d from April 19 to May 20, 2014. These intervals corresponded with 46.9 and 130.7 mm of rainfall, respectively. Although the inclinometer measured little movement, landslide movement and rainfall events were correlated (Fig. 6).

Generally, the increase in movement in B3 in spring 2013 and spring 2014 correlated with the obvious pulses of rainfall. During the summer months, pulses of rain triggered most of the movement in B1. Movement increased significantly in April and May 2014, backed up by more rainfall in these months (166.5 mm) than in 2013 (92.2 mm). So that seasonal patterns in movement can be observed, monitoring should extend beyond the 14 months of data presented here. Cumulative and in-

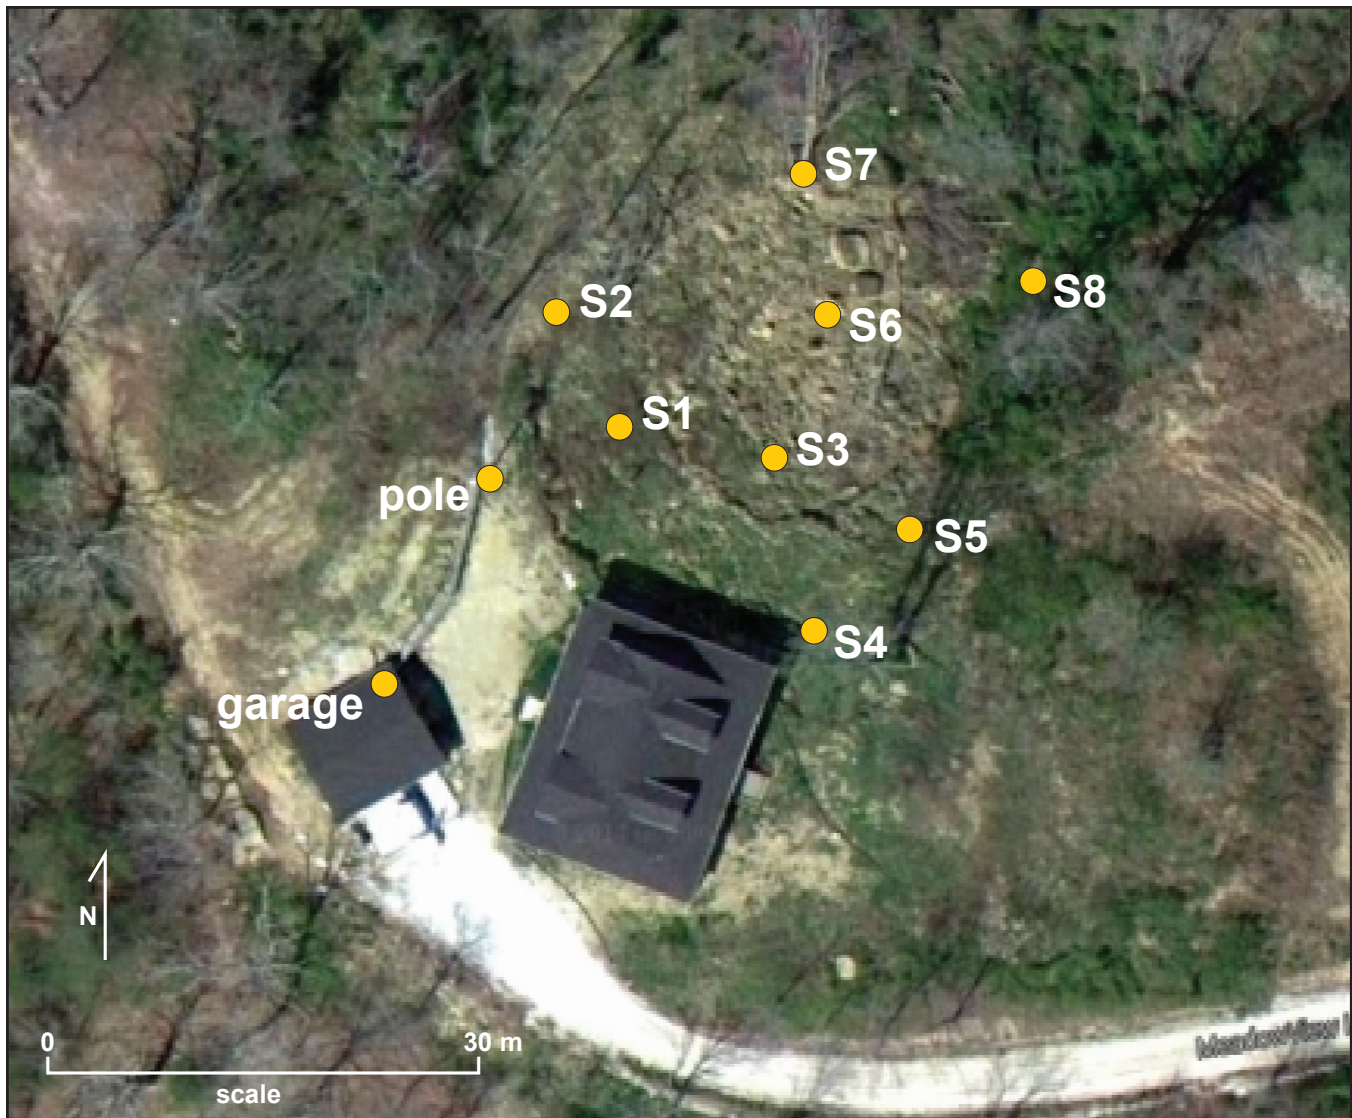
Figure 7. Locations of total station monuments.

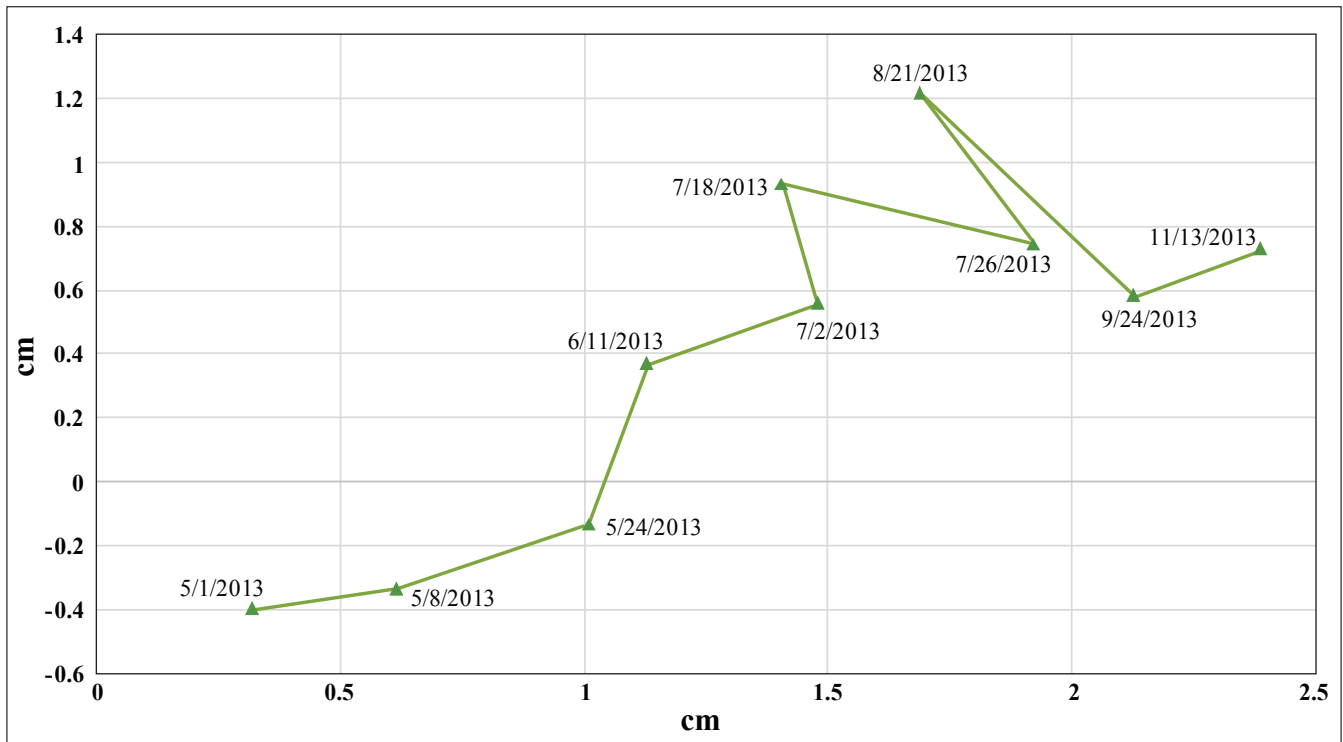
Figure 9. Movement of total station monument S3 over time. The general direction of movement is to the northeast.

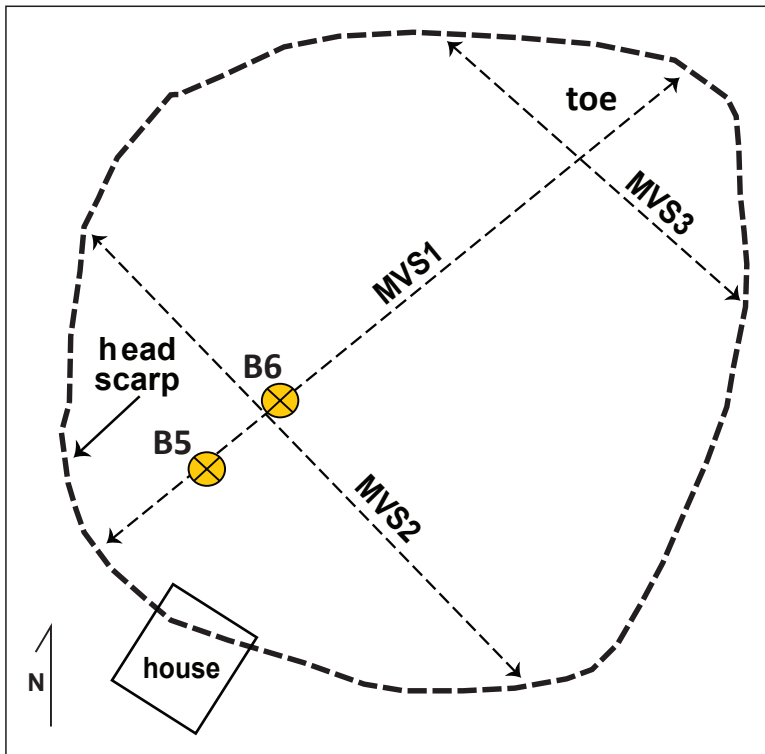
Figure 10. Electrical-resistivity array locations in the Meadowview landslide.

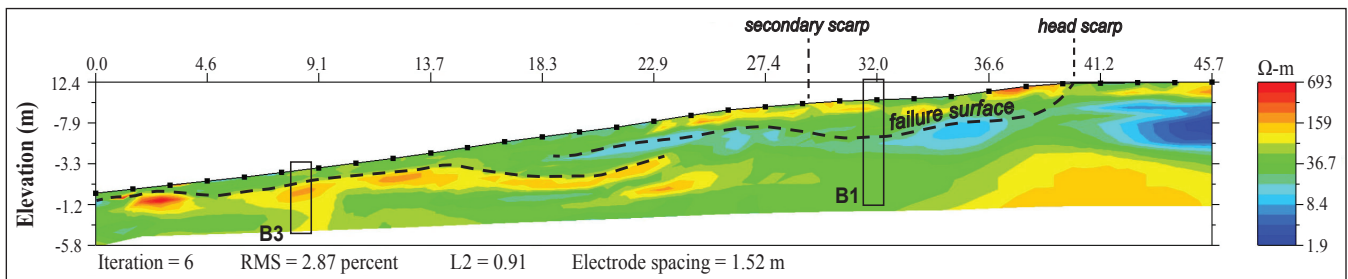
Figure 11. Inverted electrical-resistivity array MVS1. Dashed lines represent multiple failure surfaces. Locations of boreholes, the head scarp, and secondary scarp are shown.

Toward the toe (Fig. 11), the distinct resistivity zones became more complex. Extracted resistivity and depth data (x, y, and z) from the raw inverted-resistivity profiles at the location of borehole B3 showed a high-resistivity peak of 79 Ω -m just below the surface. At B3, the colluvial fill was only 0.6 m deep, supporting the shallow flow type of slope movement at the toe. The failure surface was difficult to identify in the inverted-resistivity section's correlation to the borehole data. The inclinometer data from borehole B3 indicated that the failure surface was 1.2 to 1.5 m below the surface. The underlying high-resistivity layer (curved yellow layers and orange layer that start midslope) was approximately 90 to 130 Ω -m and correlates to the lean clay-clay shale contact where a stiff, structured lean clay transitions to a very soft, weathered clay shale. A distinct low-resistivity peak of approximately 50 Ω -m occurred about 4.3 m below the surface, which correlates with the clayey shale-shale contact and a decreasing moisture content, as described in the borehole. A high-resolution, lenticular zone was present at the end of the MVS1 array. This zone was approximately 2 m in length and had significantly higher resistivity values than the continuous high-resistivity zone that started midslope and curved toward the toe. This feature could be a large sandstone boulder that was dislodged during excavation of the house foundation.

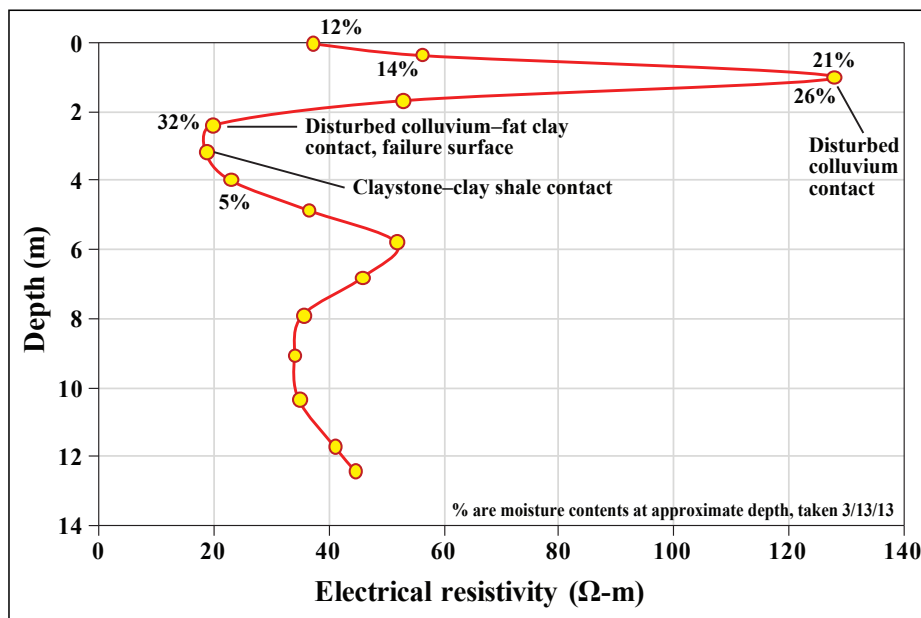
Figure 12. Vertical electrical-resistivity profile at borehole B1. Depth starts at the first point, toward the top of the curve, which is at the surface.

To get a closer look at the resistivity data, we extracted resistivity and depth (x, y, and z) from the raw inverted resistivity data at the location of borehole B1. These data are shown in a resistivity profile through the high- and low-resistivity layers near the head scarp (Fig. 12). The sharp peak of a resistivity increase at a depth of 1 m to about 128 Ω -m correlates to the lithologic change in the disturbed colluvial fill. This material grades from

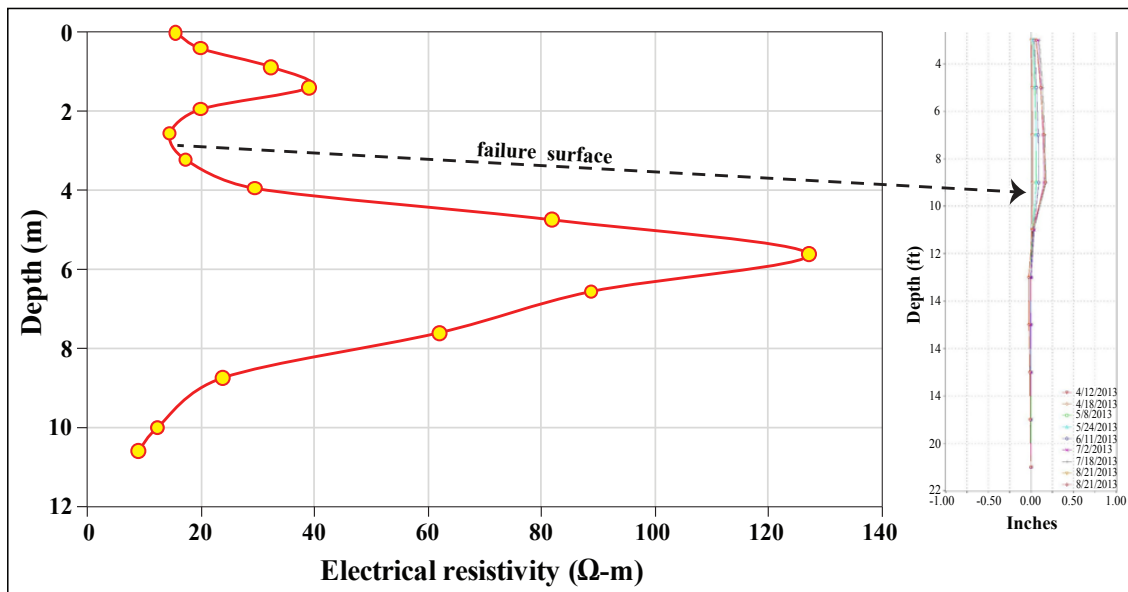
Figure 13. Vertical-resistivity profile taken midslope from section MVS1. The low-resistivity peak correlates with the failure surface depth measured with the inclinometer. Depth starts at the first point, toward the top of the curve, which is at the surface. Values on the inclinometer reading are depth in feet.

Midslope, approximately 17.3 m downslope from the head scarp, resistivity ranged between 14 and 19 Ω -m in the low-resistivity zone that is the interpreted failure surface. Below the failure surface, resistivity increased toward two distinct high-resistivity zones. One is a continuous arcuate zone that continues downslope; the other deeper zone is lenticular shaped. These may be the deeper, drier(?) clay-shale layers (less conductive). These high-resistivity zones ranged between approximately 80 and 160 Ω -m. No borehole was drilled midslope, but the interpreted failure surface (low-resistivity peak) from the resistivity profile from MVS1 (Fig. 13) correlates with the failure surface determined from the inclinometer data.

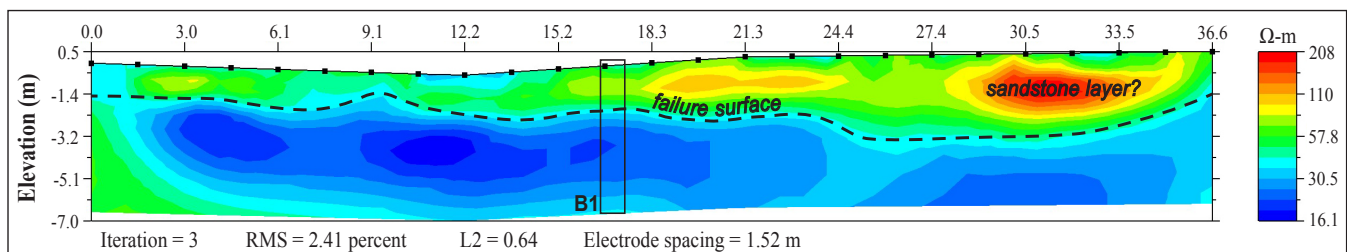
Figure 14. Inverted-resistivity profile MVS2 in a transverse direction, below the head scarp of the landslide.

MVS2, 7/26/2013: Perpendicular to the downslope direction, upper slope – Electrical-resistivity array MVS2 spanned 36.6 m perpendicular to the downslope direction along the upper part of the slide. This array crosses borehole B1 (Fig. 14). There was a clear contrast between a higher-resistivity zone and an underlying low-resistivity zone. We interpreted this boundary to be the failure surface, which corresponds with the colluvial fill and fat clay

bedrock contact, and the landslide depth indicated in the inclinometer data from borehole B1. Two lenticular-shaped high-resistivity zones (possibly connected) occupied the right side of the inverted section above the failure surface. The right side of the section (toward the end) runs northwest, leading toward the head scarp. A moderately thick (approximately 1 to 1.5 m) sandstone layer crops out behind the head scarp, and MVS2 may be intersecting this high-resistivity layer.

Resistivity at this location and along the identified failure surface ranged between approximately 20 and 30 Ω -m. Similarly to MVS1, a high-resistivity peak from x, y, z data extracted at the B1 location correlates to the contact between colluvial fill types, sandy lean clay, and sandy fat clay. The highest moisture content along the B1 transect was measured at a low-resistivity peak, supporting the location of the failure surface.

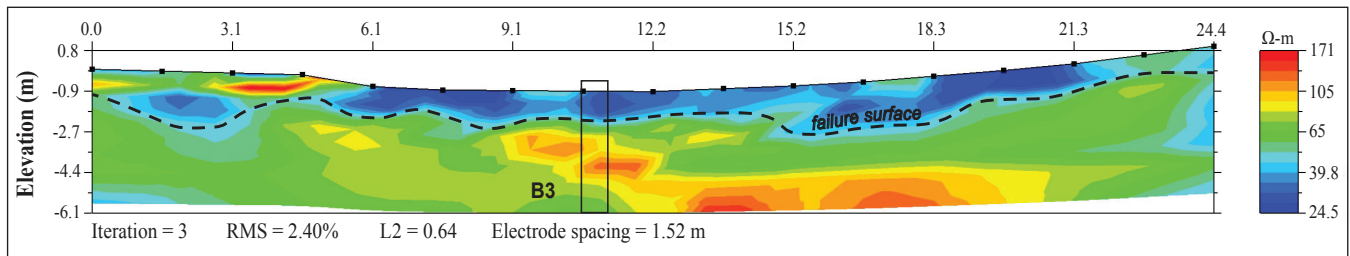
Figure 15. Inverted-resistivity profile MVS3 perpendicular to the downslope direction, along the toe of the landslide.

MVS3, 7/26/2013: Perpendicular to the downslope direction, toe slope – Electrical-resistivity array MVS3 spans 24.4 m in a transverse direction across the toe of the slide. The inverted section shows a complex pattern of resistivity zones (Fig. 15). An undulating low-resistivity zone was present near the surface. This zone ranged from approximately 24 to 50 Ω -m. This low-resistivity zone transitioned to a high-resistivity zone with lenticular regions. The undulating boundary between the low- and high-resistivity zones for MVS3 was shallow, about 0.6 m deep, and correlates to the contact between sandy lean clay with gravel fill and stiff, residual, lean clay. The inclinometer measurements from borehole B3 indicate the failure surface is below the colluvial fill-lean clay contact; therefore, the failure zone at the toe may also include the lean clay unit.

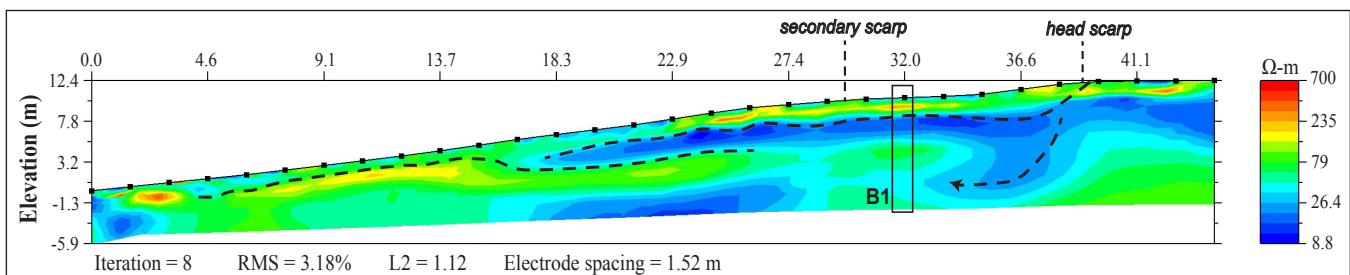
Figure 16. Inverted-electrical-resistivity array MVS1-2, measured in November 2013. Dashed lines represent multiple failure surfaces. Locations of borehole B1, the head scarp, and secondary scarp are shown.

On November 13, 2013, arrays with the same starting and ending points used for the July arrays were laid out and the electrical resistivity was measured. In general, the resistivity contrasts, interpreted features, and correlations to stratigraphic boundaries were similar to what was measured in July (Figs. 16–18). One change in MVS1 was the presence of a low-resistivity zone (8–26 Ω -m) that extended down vertically below the inferred failure surface, just in front of the head scarp (Fig. 16). This zone accentuated the rotational movement in the head. More water may have infiltrated this area, causing the low-resistivity zone. For MVS3 (November measurement), the measurements from the high-resistivity zones (24–50 Ω -m) were larger and spaced differently than the measurements from the July inverted section. Approximately 104 mm less rainfall was measured in the month preceding the November resistivity measurements. This could account for the increased area of higher resistivity in MVS3.

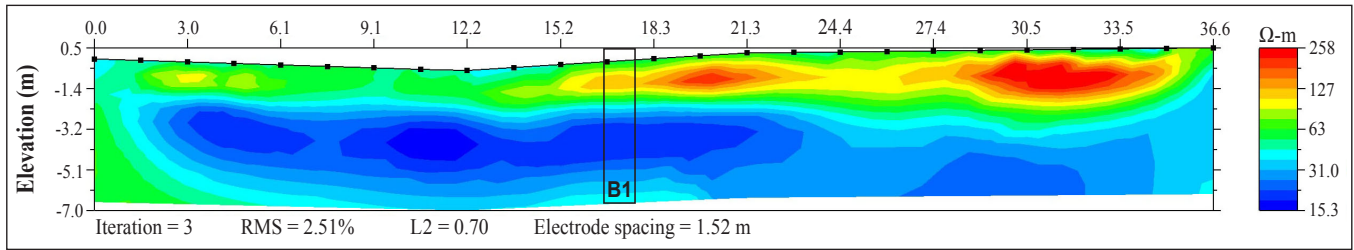
Figure 17. Inverted-electrical-resistivity array MVS2-2, measured in November 2013. Dashed lines represent the failure surface near the head scarp. Location of borehole B1 is shown.

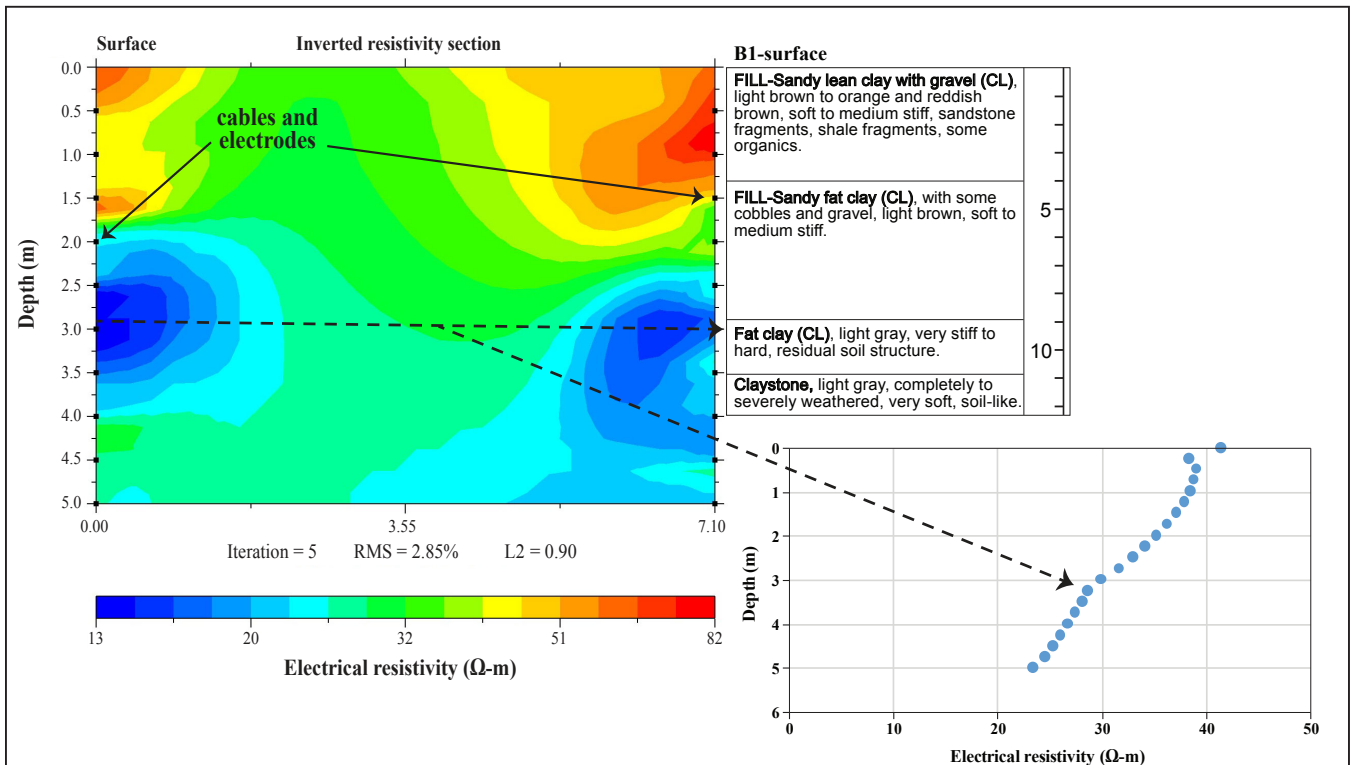
Figure 19. Borehole resistivity results from June 14, 2013. The middle of the inverted section shows a contrast in resistivity that correlates to the colluvial fill-fat clay stratigraphic boundary.

boreholes. Figure 19 shows, in the center of the inverted section, a change in resistivity that correlates with a change in material type in borehole B1 (black dashed line). B1 is between the slotted PVC holes (B5 and B6), which are 7.1 m apart. There was no significant difference between the June 14 and November 11 measurements and resulting inverted profiles. Figure 13 shows the resistivity data at depth taken from the middle of the borehole profile. There is a slight decrease in resistivity that correlates to the failure surface depth.

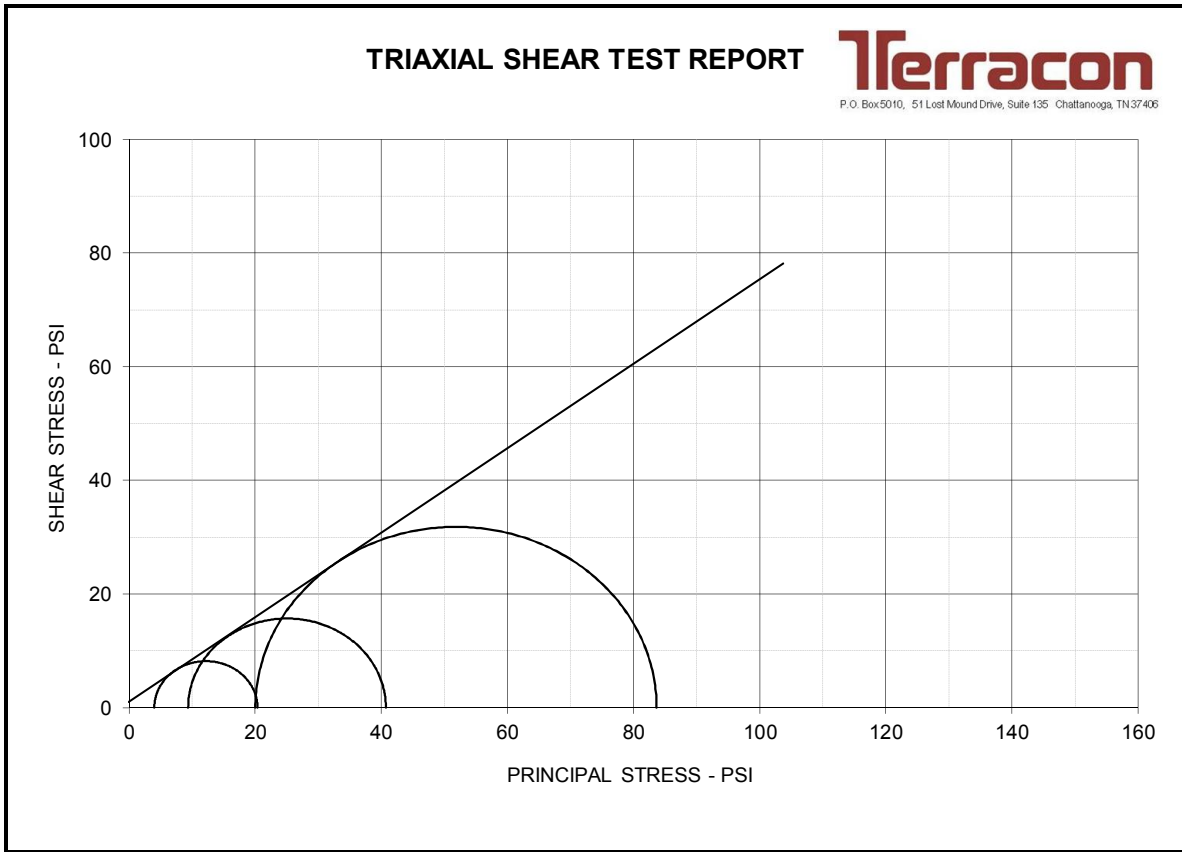
EFFECTIVE STRESS PARAMETERS	$\phi' = 36.6 \text{ deg}$	$c' = 1.0 \text{ psi}$
------------------------------------	----------------------------	------------------------

TEST DESCRIPTION	PROJECT INFORMATION
TYPE OF TEST & NO: CU with pore pressure SAMPLE TYPE: Shelby Tube DESCRIPTION: Olive Gray Clay with Weathered Shale SAMPLE LOCATION: B2 S-1 4.5-6.5 ft ASSUMED SPECIFIC GRAVITY: 2.7 LL: X PL: X PI: X Percent -200: X REMARKS: Multistage Triaxial	PROJECT: Meadowview Lane LOCATION: Rush, Kentucky PROJECT NO: N2135021 CLIENT: Kentucky Geologic Survey DATE: 4/18/13
	TERRACON
