Characteristics of Cover-Collapse Sinkholes in Kentucky

Kentucky Geological Survey
University of Kentucky, Lexington

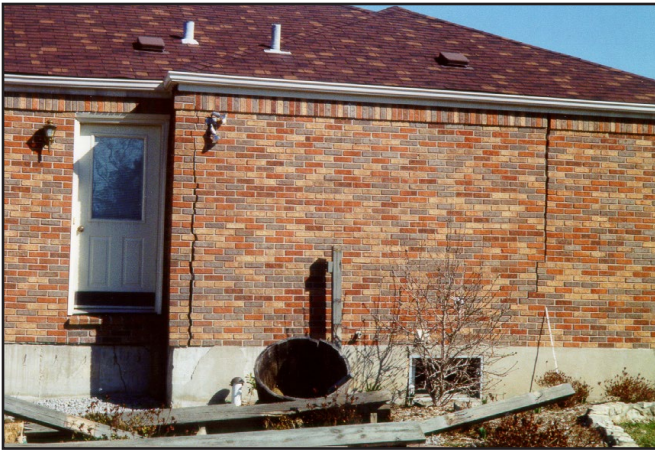
Figure 2. A cover-collapse sinkhole caused more than \$40,000 in damage to a home near Louisville in April 2001.

Cover-collapse damage is distributed widely across Kentucky and frequently damages buildings, roads, utility lines, and farm equipment (Fig. 2). It has killed livestock, including some Thoroughbred horses, and has injured people. Of the nearly 4 million people in Kentucky, 2.9 million, or 67 percent of the population, lived on karst in 2010 (Cecil, 2015).

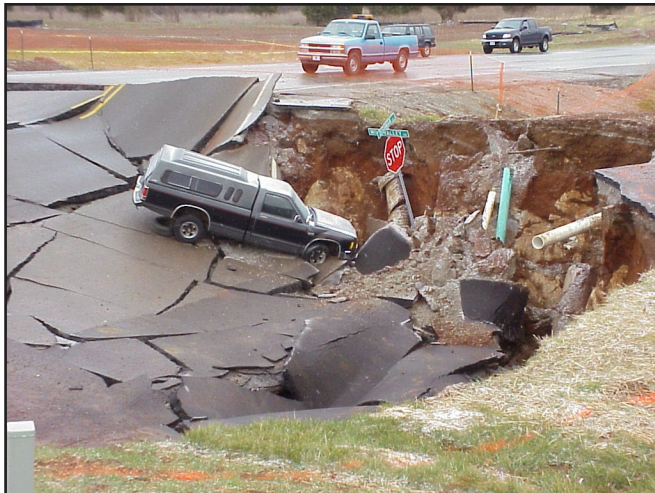
Figure 3. By chance, the collapse at Dishman Lane in Bowling Green did not cause any fatalities.

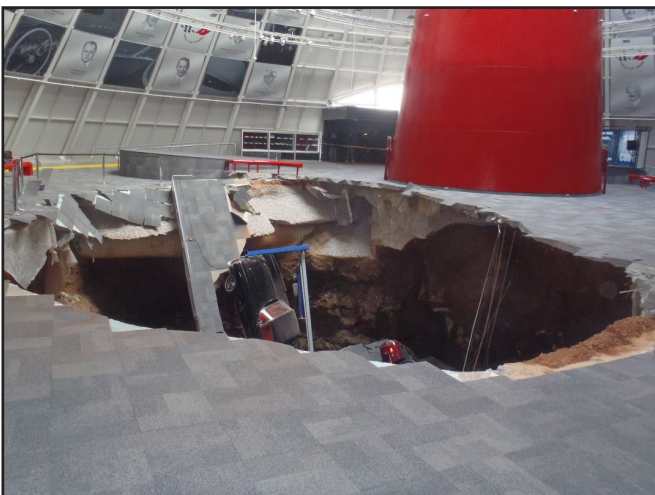
Figure 4. Cover collapse under the Skydome at the Corvette Museum, Bowling Green, Feb. 24, 2014.

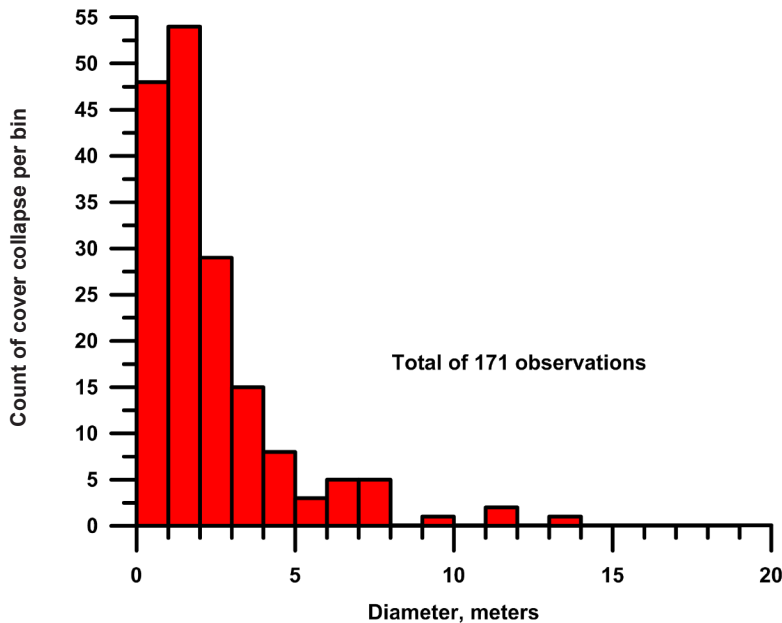
Figure 5. Size distribution of the diameter parameter calculated from measurements of the long and short axis lengths.

however. The arithmetic mean of the 219 records is 1.96, and the geometric mean is 2.11. The mean of circularity for 222 data sets is 0.84. The distribution of the parameters for all of the sites in the database is asymmetric in a manner similar to a log-normal distribution (Fig. 5).

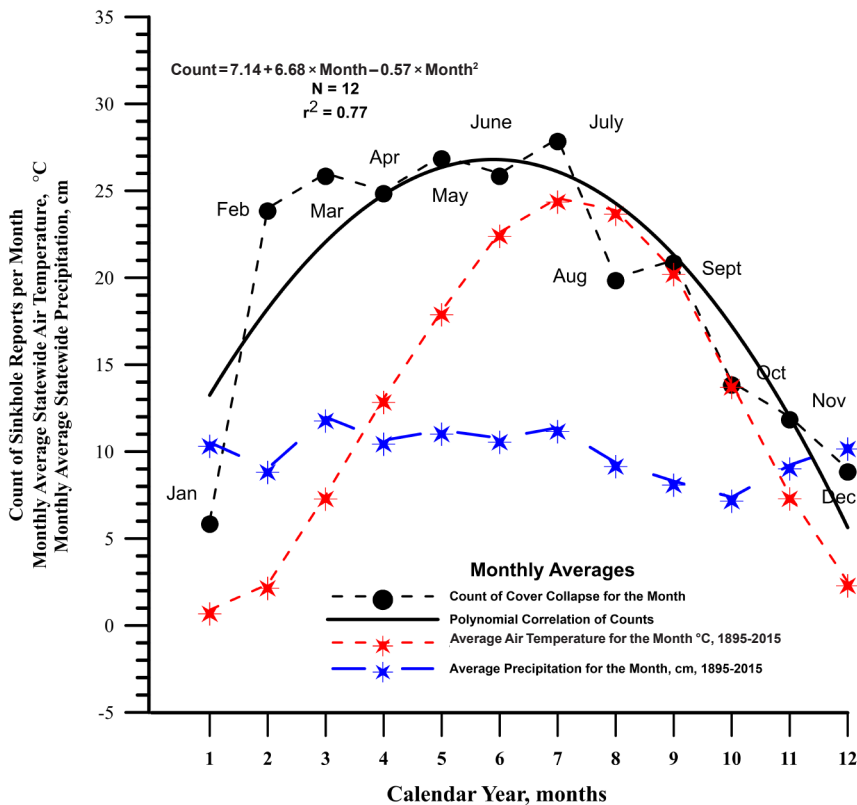
Figure 6. The statewide average temperature and precipitation and the counts of cover collapses for each month.

sity of Kentucky College of Agriculture (www.gwv.ca.uky.edu/ky/data.php#KY_Monthly_Data; last accessed August 2016) for the same month, irrespective of year. The data were plotted, and goodness-of-fit was $r^2=0.56$ (significant at $\alpha=0.05$). The comparatively weak correlation is likely caused by the precipitation data being too generalized. A polynomial regression drawn through all 12 monthly counts versus precipitation improved the prediction of the counts compared to linear regression ($r^2=0.77$, significant at $\alpha=0.05$) (Fig. 6).

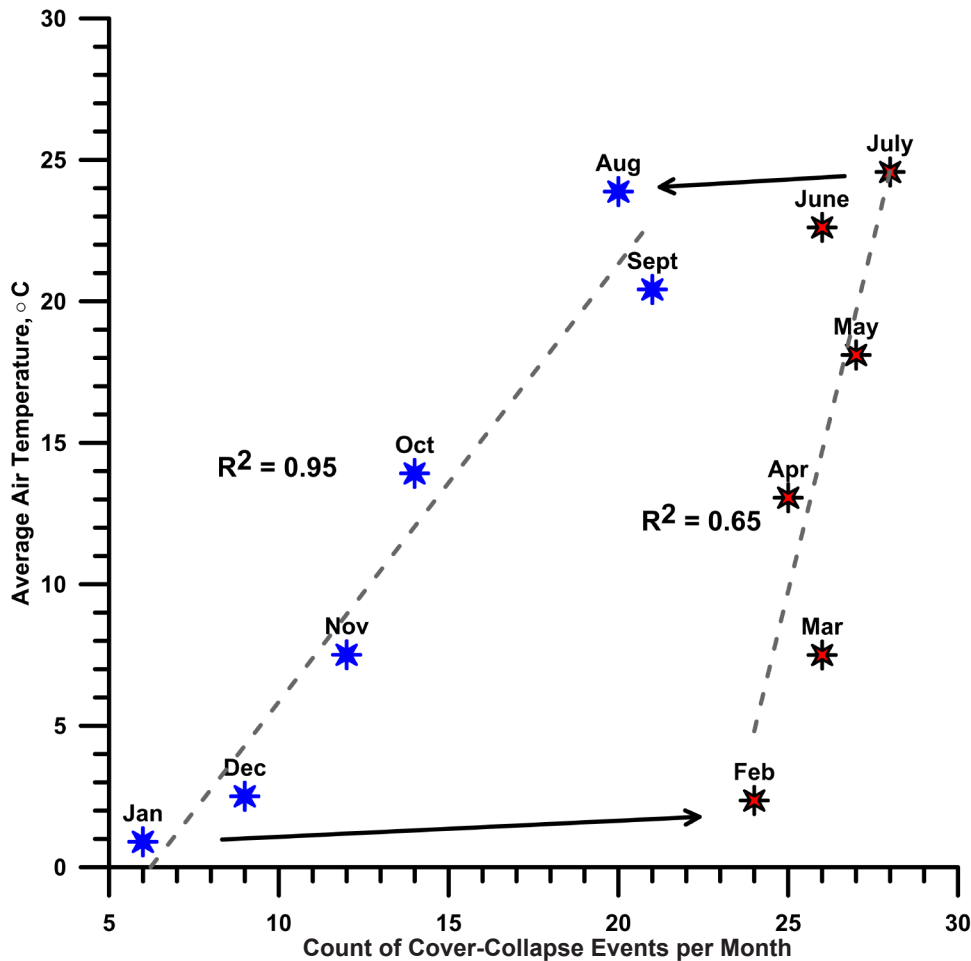
Figure 7. Count of cover-collapse events per month versus average air temperature.

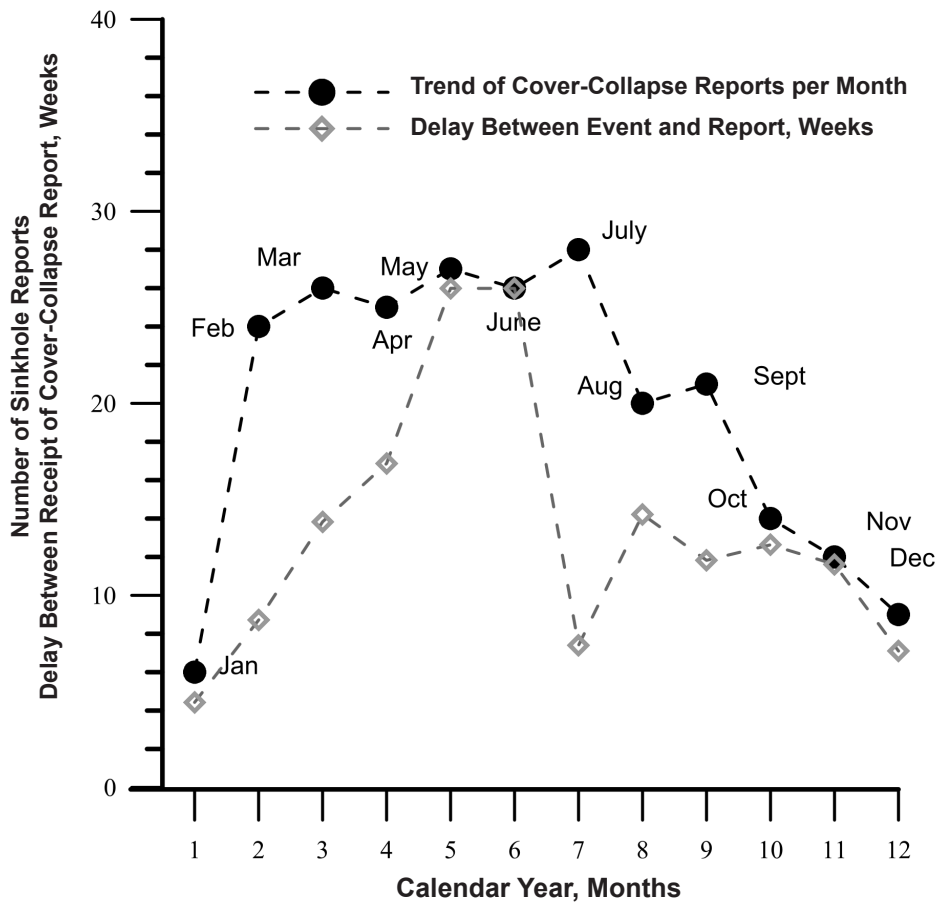
Figure 8. Comparison of the delay in weeks between a collapse and the receipt of a report at the Kentucky Geological Survey.

and early summer (gray dashed line), except for July. The July data are skewed by a cluster of cover collapses, which had an estimated similar date of occurrence and a uniform report date and a smaller than typical average delay. Otherwise, the winter months have some of the shortest delay times between occurrence of an event and its report, suggesting that winter collapses were found soon after they developed.
