Geologic Hazards in Kentucky

Daniel I. Carey, Terry D. Hounshell, and John D. Kiefer

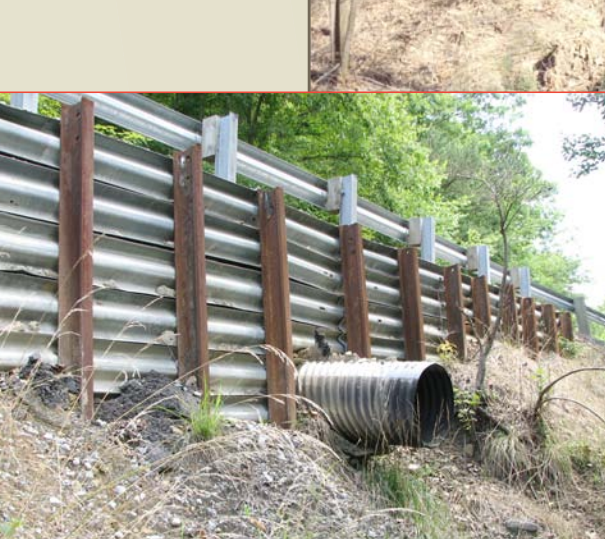
Additional support and drainage management are often required to prevent pavement failure of roads built on slopes underlain by shale (as above in Martin County). Photo by Dan Carey, Kentucky Geological Survey.

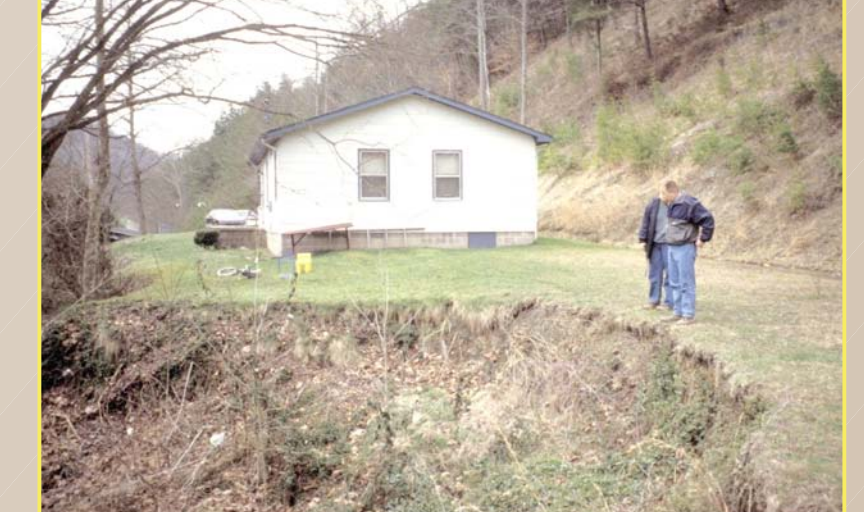
This landslide in Johnson County was caused by a septic drain field. Photo by Paul Howell, U.S. Department of Agriculture, Natural Resources Conservation Service.

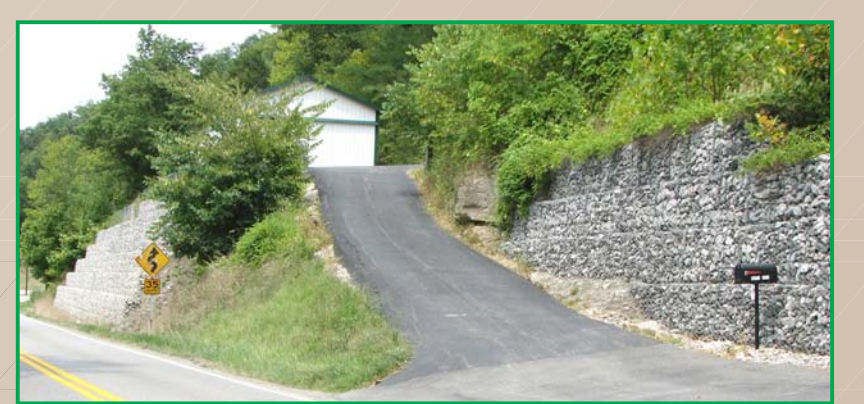
Additional support for foundation stability is often required for construction on slopes (Johnson County). Photo by Dan Carey, Kentucky Geological Survey.

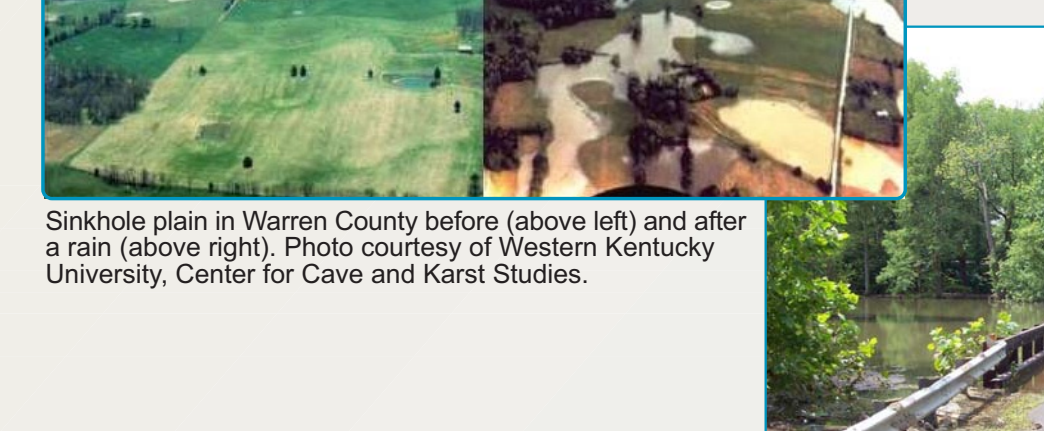
Sinkhole plain in Warren County before (above left) and after a rain (above right). Photo courtesy of Western Kentucky University, Center for Cave and Karst Studies.

Sinkhole flooding in the Inner Bluegrass (Fayette County). Photo by Jim Betmann, Lexington-Fayette Urban County Government.
