The VAD Journal: The journal of mechanical assisted circulation and heart failure

Outcomes of external repair of HeartMate II™ LVAD percutaneous leads

The VAD Journal, 2. doi:
<http://dx.doi.org/10.13023/VAD.2016.14>

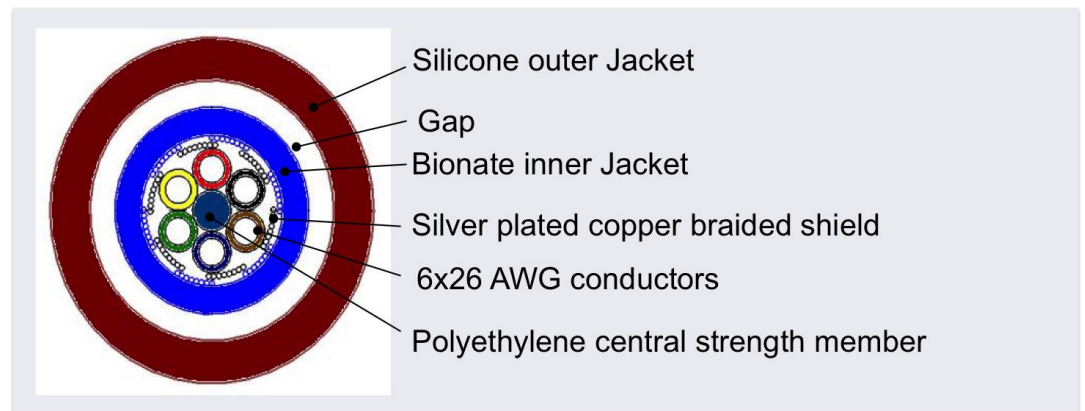
Figure 1: Schematic of HeartMate II percutaneous lead

The HeartMate II percutaneous lead consists of three pairs of redundant wires that are electrically shielded and protected by two water-resistant jackets (Figure 1). The internal wiring schematic is shown in Figure 2. Damage to the external lead by repeated flexion can be manifested by retraction of the silver-coated copper

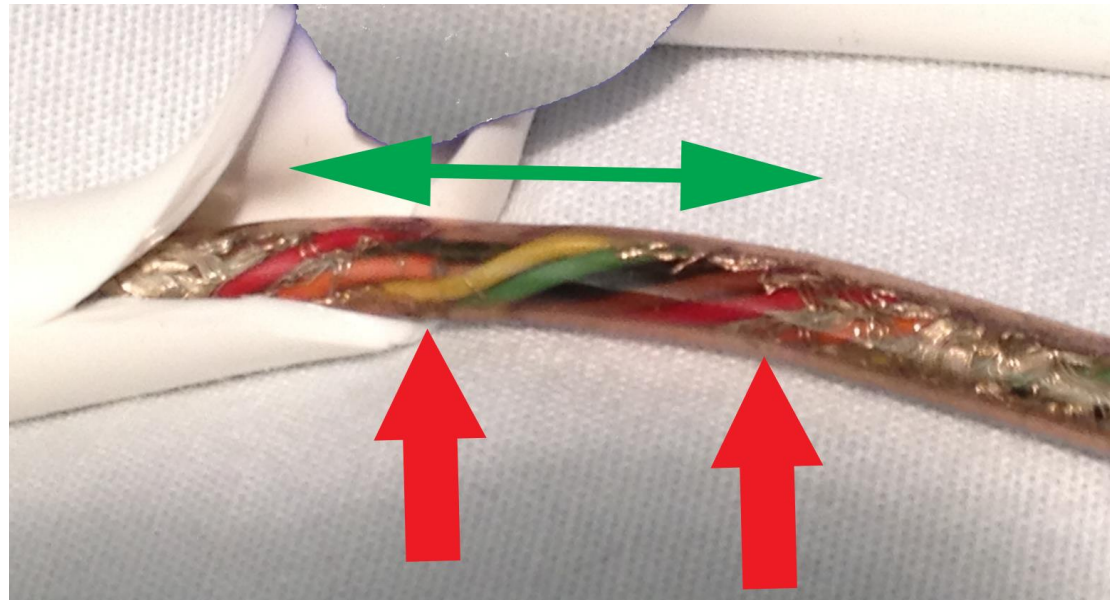
braided shield and fracture of an individual wire (Figure 3). Damage to the braided shield without internal wire fracture, can lead to a phenomenon known as short-to-shield, which can result in pump dysfunction when connected to a grounded power source⁵. There is also the possibility of a short between two different motor leads by the shield wires which cause pump stoppage even if a non-grounded shield cable is used.

Figure 3: Damage to the external lead by repeated flexion can be manifested by retraction of the silver-coated copper braided shield and fracture of an individual wire (orange).

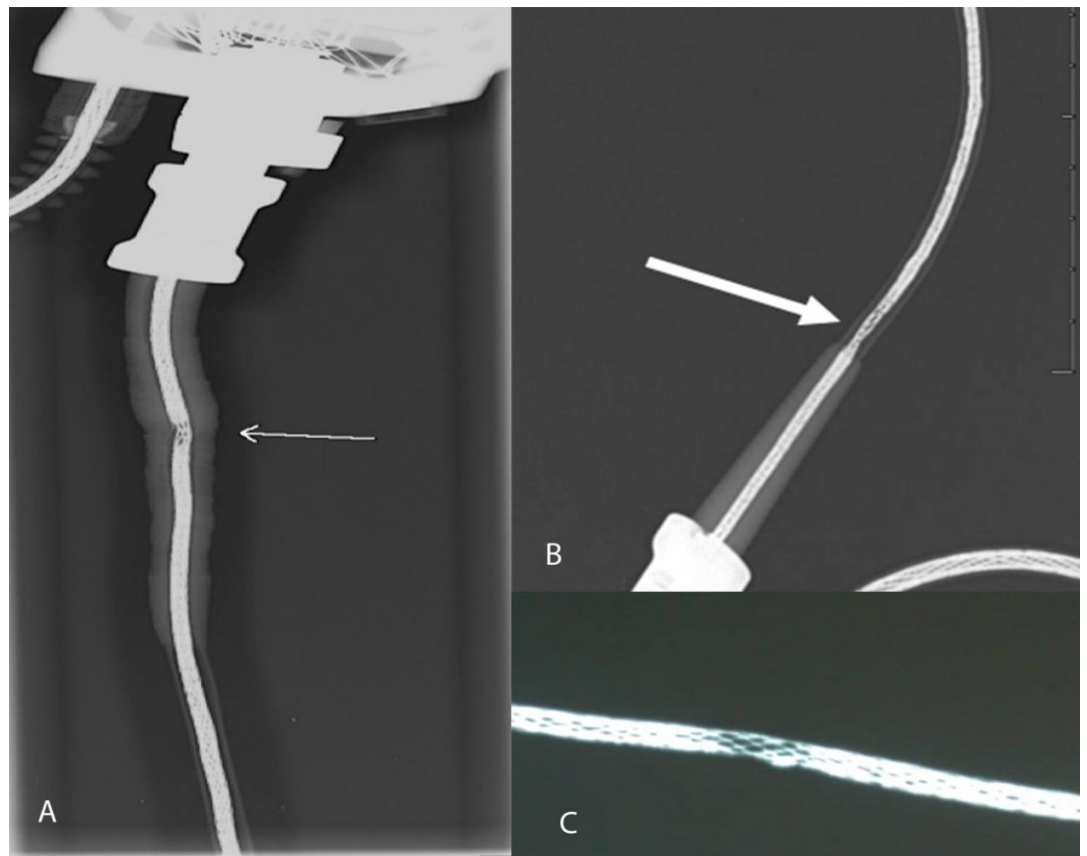
Figure 4: Radiographs of lead damage

A retrospective review was undertaken of all percutaneous lead repairs performed by the St Jude Medical Technical Services Team. The HeartMate II log file for each patient was reviewed for alarms, unexplained pump stoppages, pump speed and/or power fluctuations. Each patient initially underwent a controller exchange and close examination of visible connectors to ensure adequate contact. A radiograph of the externalized portion of the percutaneous lead was obtained, and examined for evidence of broken wires or abnormal shielding. If external damage was identified (Figure 4), preparation for repair by St. Jude Medical personnel was undertaken.

A cohort of patients experienced ongoing pump dysfunction after lead repair, necessitating LVAD exchange. This could be due to concomitant intracorporeal lead fracture, or other electrical damage not grossly visible on examination of the driveline. Therefore, we recommend comprehensive and careful radiographic evaluation to ensure that the intracorporeal portion of the percutaneous lead is intact, and that areas not easily visible on radiographs are directly examined prior to proceeding with external percutaneous lead repair.

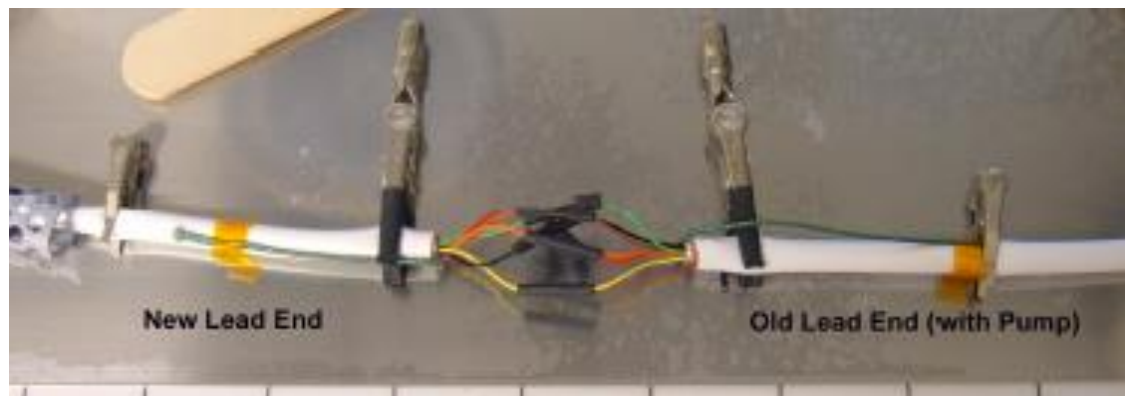
Figure 5: Repair of external percutaneous lead

A procedure for external percutaneous lead replacement was developed and approved for implementation by the U.S. Food and Drug Administration. The repair technique involves removing the silastic covering from the driveline, separating each pair of wires, and splicing a new lead to the damaged set of wires (Figure 5). The pump continues to function on the intact wires of the original lead. The new lead is then tested, and control transferred to the new controller. The second set of wires is then transferred to the new lead, and the repaired section is re-insulated and encapsulated in a water-resistant enclosure (Figure 6). Of note, the external percutaneous lead repair requires approximately 15cm from the skin exit site, and must not include any velour-covered areas.
