Lessons Learned from Six Different Structural Health Monitoring Systems on Highway Bridges

Lessons learned from six different structural health monitoring systems on highway bridges

Journal of Low Frequency Noise,
Vibration and Active Control
0(0) 1–15
© The Author(s) 2018
DOI: 10.1177/1461348418815406
journals.sagepub.com/home/lfn

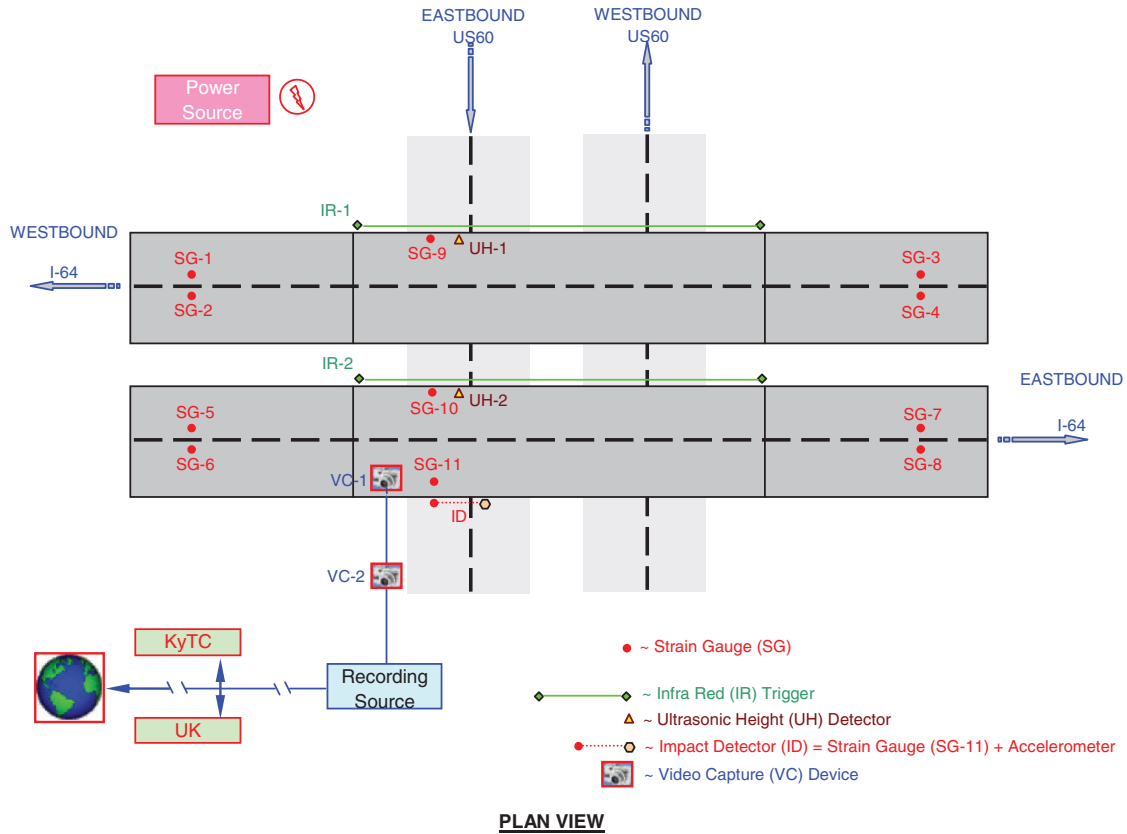
Figure 3. Sensor layout on I-64 parallel bridges.

Since the bridges are similar in terms of dimensions and expected loading, the effects from the potential impact on the eastbound bridge (i.e., the subject) can therefore be compared to the westbound bridge (i.e., the base). Figure 3 indicates the locations on the bridges of various devices employed in this project. Included among the devices are strain gauges (SG), temperature gauges, infrared sensors, ultrasonic height (UH) detectors, accelerometers, and video cameras (VCs). Strain gauges are installed at 11 locations (indicated as SG-1 to SG-11).

Five strain gauges are in the westbound I-64 bridge, and the remaining ones are in the eastbound bridge. SG-1, SG-2, SG-3, and SG-4 on the westbound bridge and SG-5, SG-6, SG-7, and SG-8 are placed on the vertical face of the bottom flange of the two interior girders of the six plate girders. Each pair of gages (SG-1/SG-2, SG-3/SG-4, SG-5/SG-6, and SG-7/SG-8) is placed on the two girders facing each other. SG-1 to SG-8 study the strain effects under ambient conditions and compare the differences between the two ends of each bridge. The strain effects due to potential impacts are studied through SG-9 to SG-11. SG-9 and SG-10 are on the vertical face of the bottom flange on the inside of the first exterior girder facing traffic within the center span of westbound and eastbound bridges, respectively. SG-11 is on the vertical face of the bottom flange on the inside of other exterior girder on the eastbound bridge. The mounting tabs for the strain gauges were adhesively bonded to the steel beams. The wires were standard sheathed wires provided by the sensor manufacturer. These were bundled and run through a polyvinyl chloride (PVC) conduit leading to the data acquisition system.

The infrared sensors (IR-1 and IR-2) detect trucks that would impact Girder 1 on the eastbound I-64 bridge. Each sensor unit consists of an emitter and receiver mounted on a cross frame erected between the first two girders facing oncoming traffic within the center span of each bridge. When the infrared mechanism is interrupted—presumably due to a truck—the sensor simultaneously triggers its adjacent UH detector and VC to measure the truck height and capture images of the truck, respectively. A UH detector functions by sending a pulse-wave of specific frequency. When the pulse-wave encounters a solid surface (e.g., hood of a truck), the wave will reflect and return to the source. A single triaxial accelerometer is also employed on this project, with one axis oriented along

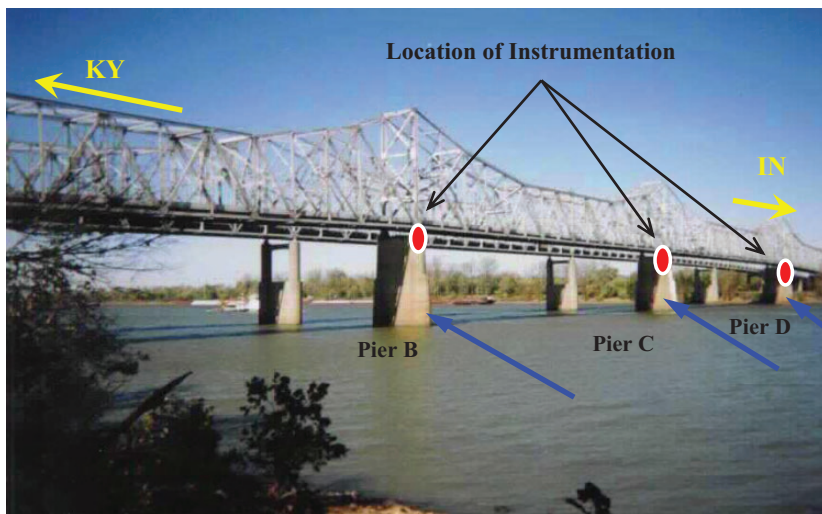
Figure 4. Instrumentation locations on NB US 41 bridge over the Ohio River.

Typical data collected include acceleration, displacement, and visual (video and still) records. A plot of the time history for the accelerations and displacements immediately prior to (≈ 2 to 5 s) and following impacts (≈ 15 to 30 s), as well as maximum hourly acceleration and displacement data, is accessible through the project website. Video and photographic records are stored for 10 min prior to an event and 10 min following an event. Due to the need to store a large amount of data, including video files, separate data acquisition systems were set up on each pier. The three systems operated independently when detecting impacts on any of the three piers. Each had its own cellular data connection for information transmission. The power required to operate the equipment was obtained via a large array of solar panels set up on the steel trusses. Various acceleration and displacement limits or thresholds were set to identify severe and/or critical impacts. The threshold limits in the longitudinal, transverse, and vertical directions relative to the axis of the bridge were selected based on a previous study of multi-barge flotilla impact forces on bridges.¹² An impact causing an acceleration over $0.2g$ was considered as severe, only an acceleration exceeding $0.05g$ was required to activate the system data storage prior to and immediately following an impact. A severe impact is defined as the limit or threshold of impact that would cause possible damage to the piers in question. A critical impact is defined as the limit or threshold of impact that damages the pier, an impact whose magnitude would also require closing the bridge for further inspection. Critical and severe impacts are defined for each structure based on limits for displacement at expansion joints and/or acceleration and/or strain measurements.

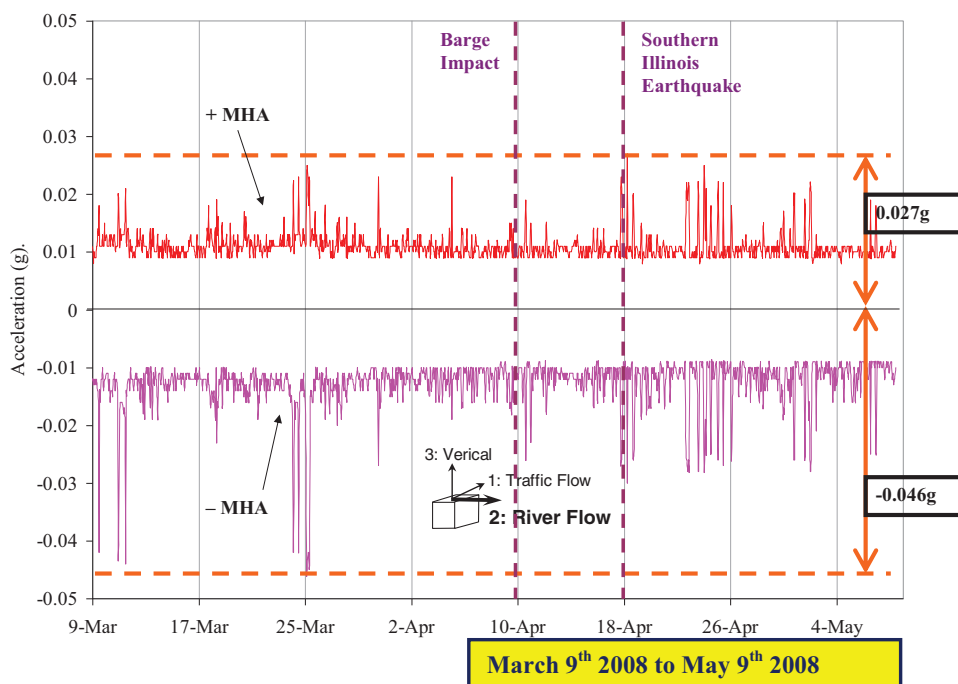
Figure 5. Maximum hourly acceleration at Pier D in direction 2 (River Flow) MHA: Maximum Hourly Acceleration.

The SHM system was installed by a private company following a bidding process and then transferred over to KTC research team following a three-year maintenance period. Following the transfer, communication with the data acquisition system via remote access through the cell modem was found to be sporadic. This was identified as being due to differences in communication protocols following a change in the cellular data service provider. Due to the available funding limits, following the three-year implementation period, upgrades to the system were not feasible. In addition, the system's effectiveness in detecting barge impacts was thrown into doubt following a barge impact that occurred on 10 April 2008. The magnitude of the accelerations produced by the barge impact on 10 April 2008, reported by the US Army Corp of Engineers, and the Southern Illinois Earthquake on 18 April 2008, was less than 0.05g in all three directions. Consequently, since the trigger for data capture and storage is 0.05g, only the maximum hourly acceleration is saved. Had either one of the events triggered the threshold acceleration in any direction; the event history would have been saved in place of the hourly maximum acceleration. As seen in Figure 5, the maximum hourly accelerations were less than the trigger acceleration of 0.05g.

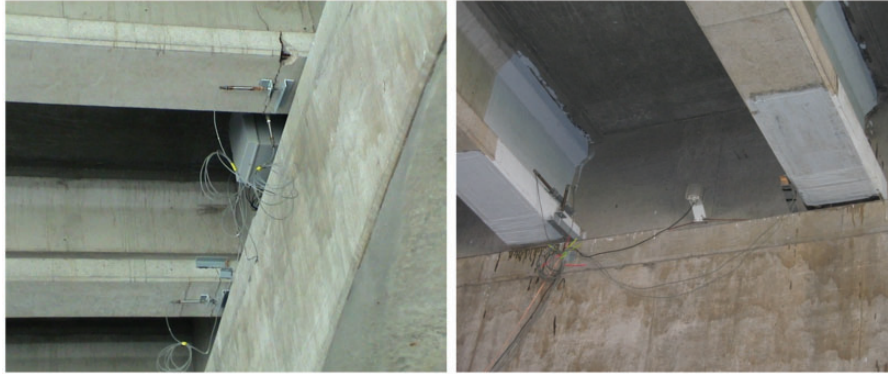
Figure 6. Instrumentation on Beams 6 and 7 before and after strengthening with CFRP sheets/fabric.

To investigate the liveliness of the cracks, two girders (Girders designated as Beams 6 and 7) were instrumented with LVDTs in the horizontal and vertical directions to measure their respective movements. Figure 6 shows the LVDTs mounted over the cracks before and after they were strengthened with CFRP. Instrumentation was installed on 16 February 2004 and the maximum daily movement and temperature measured until 27 June 2005. Data collected over this period were used to design the retrofit measures, and once the repair was complete the LVDTs were reattached at the same locations to assess the retrofit's effectiveness. Prior to the retrofit, the SHM indicated that the cracks, though active, were within acceptable limits. This permitted the use of CFRP fabric to strengthen the girders, avoiding the more expensive alternatives of extending the pier cap support or construction of new piers. Monitoring following the retrofit confirmed that a significant reduction in horizontal movement attributable to the retrofit (Figure 7), while in the vertical direction, the retrofit prevented the further increase of vertical movement. It should be noted that the crack measurement following the retrofit, starting on 3 September 2006, was initiated at the final measurement recorded prior to the retrofit (27 June 2005).

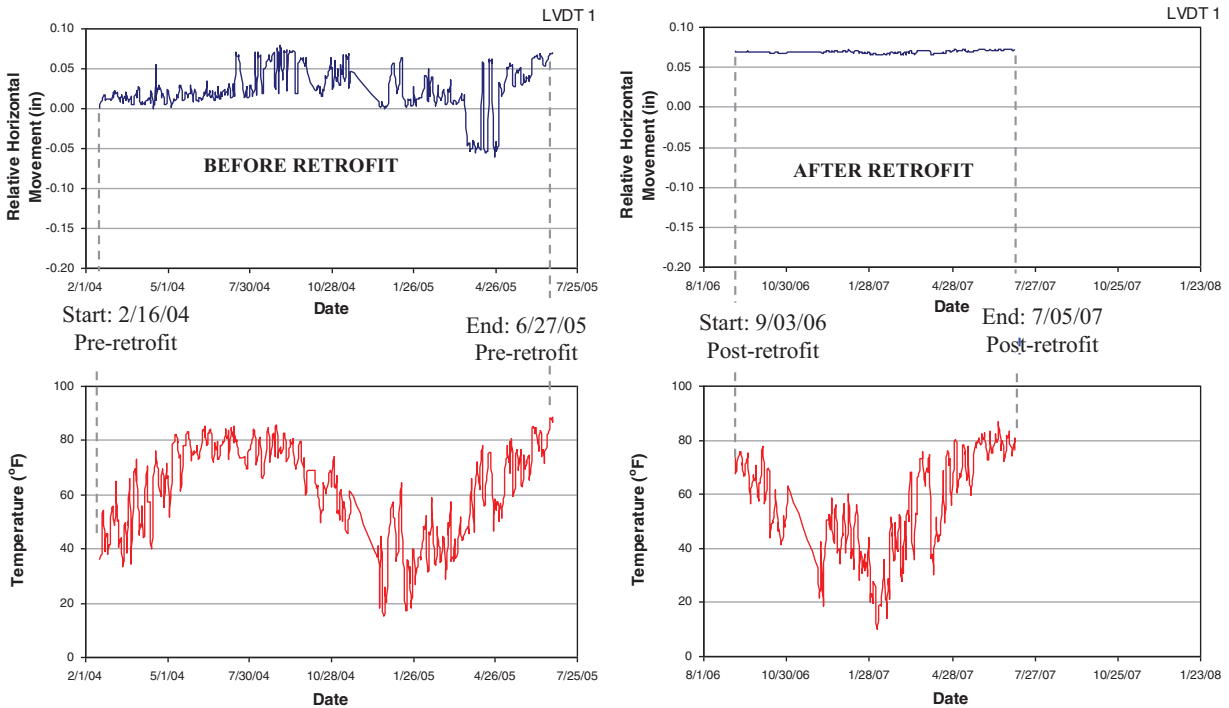
Figure 7. Relative horizontal movement measured at Beam 6. LVDT: linear variable displacement transducer.

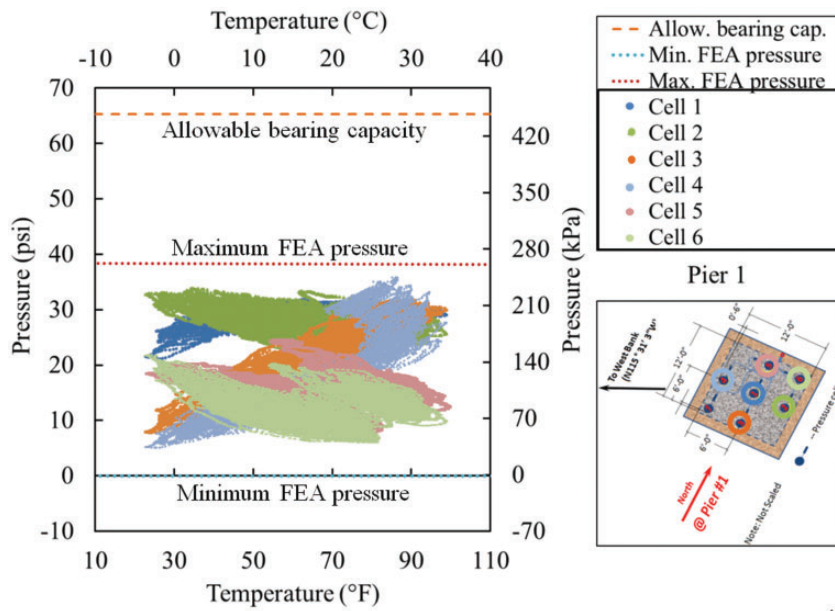
Figure 9. Pier 1 foundation bearing pressures versus temperature. Note that Cell 7 is defective. FEA: finite element analysis.

Finite element (FE) modeling and analysis of temperature loadings on the bridge were used to estimate the bridge pier motion and foundation pressures using methodologies provided in AASHTO design provisions. Estimates were compared to physical measurements obtained at the bridge site. This established a foundation to assess the merit of current AASHTO provisions related to temperature-induced response for the study site. Data records for Pier 1 (Figure 9) indicated that the pier footings were designed to limit pressures to approximately one-half of the allowable bearing capacity for the bridge site (450 kPa or 65 psi). Comparing the FEA-derived pressures generated by introducing extreme temperature values specified in the AASHTO provisions and field data indicates that the AASHTO design provisions produce conservative estimates of foundation design pressures.

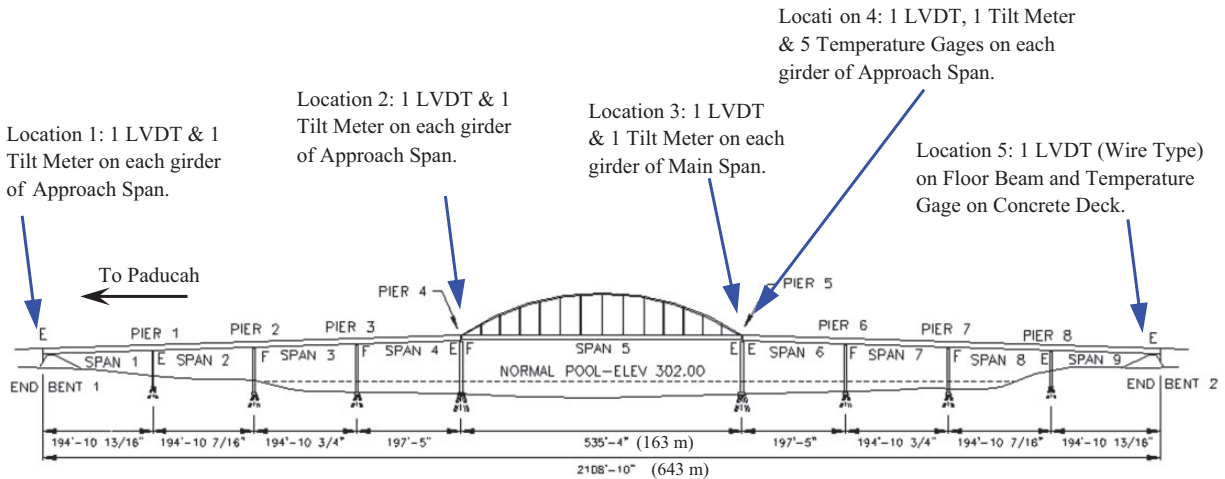
Figure 10. Instrumentation locations of Eastbound I-24 Bridge. LVDT: linear variable displacement transducer.

The parallel Tennessee River Bridges on I-24 in western Kentucky are steel plate-girder bridges. Each bridge consists of nine spans symmetrically located on either side of the tied-arch main span and has a total length of 643 m (2109 ft 10 in). The main spans of each bridge are a single span steel-girder tied-arch with a span length of 163 m (534 ft 4 in). Five locations that were free to move were instrumented along the length of the eastbound bridge (Figure 10). Two of these locations (Locations 1 and 5) were the abutment ends of the two approach spans. Locations 2 and 4 were the other ends of the approach spans, where they meet the main span, over Piers 4 and 5. The final place instruments were installed (Location 3) was the free end of the main span over Pier 5. The SHM setup on the eastbound I-24 Bridge was designed to collect data on temperature and displacement. Parameters measured by the instruments include the expansion and contraction as well as the inclinations of instrumented bridge ends. The temperature of the bridge girders is also monitored. The instrumentation included LVDTs to measure longitudinal displacements of the girders in the approach and main spans. A total of nine LVDTs were installed. Eleven temperature sensors recorded the temperature of the steel girders and concrete deck. Eight tilt meters recorded the inclination of the steel girders in the two approach spans as well as the main span. The layout of the locations and the type of instrumentation used at each location are provided in Figure 10. Data loggers were installed at each abutment and the two piers to gather data on displacement, tilt, and temperature. Additional instrumentation was set up for remote monitoring and periodic data backup. The instrumentation readings at each location are transmitted wirelessly to a transmitter at one location, from where the data are periodically uploaded to the KTC servers using a phone modem via a cellular data connection.

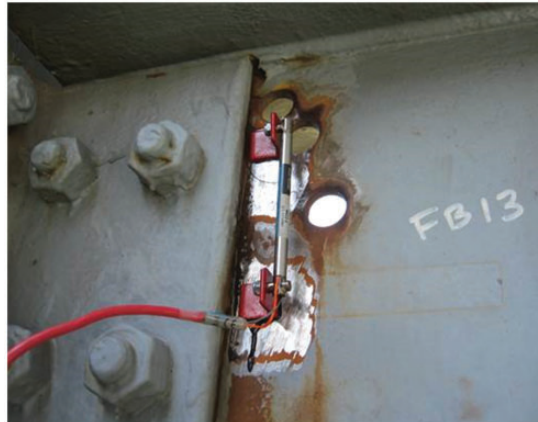
Figure 12. Crack gauge setup.

A routine KYTC inspection of the I-275 Bridge over the Ohio River revealed cracks in similar locations on the webs of several floor beams in the main span. The 1235 m (4051 ft) bridge is a continuous steel arch-shaped truss, with a main span of 229 m (750 ft). The cracks were near the top of the web, at the end of the floor beam. Holes were drilled at the crack tips with the expectation of arresting crack growth. Prior to repair work, it was deemed necessary to evaluate if the cracks were widening over time. A vibrating wire micro crack meter was placed across a selected crack and the movement measured in real time (Figure 12). The data acquisition system

transmits the crack data to a server by cell modem every 10 min. Crack opening thresholds were established; once threshold values were exceeded, stakeholders received an immediate email notification.

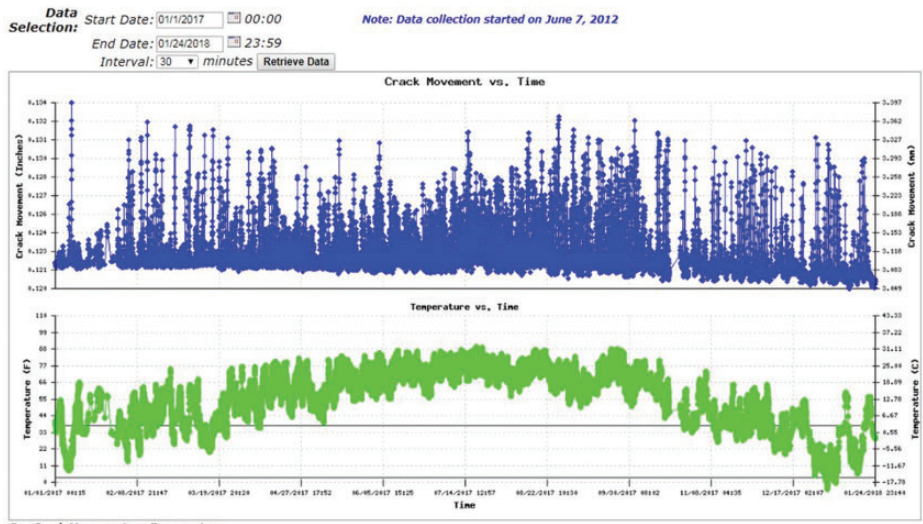
Remote crack monitoring of Carroll Cropper I-275 Bridge in Boone County, KY

Figure 13. Crack gauge setup.

The simple SHM, set up in 2012, has been continuously operational and verified that the crack growth has been arrested. With cracks not progressively growing, additional costly repairs were deemed unnecessary. The crack displacement and temperature data can be retrieved for a given period via the KTC Remote Bridge Monitoring website. Figure 13 shows data for 2017, with a displacements data interval of 30 min. The maximum and minimum crack openings, as well as temperatures and the corresponding dates, are also tabulated by the website for the chosen duration.
