PCB source tracing in storm drains in the Lower Duwamish Waterway

PCBs Source Tracing In Storm Drains Lower Duwamish Waterway

Seattle Public Utilities
April 30, 2014

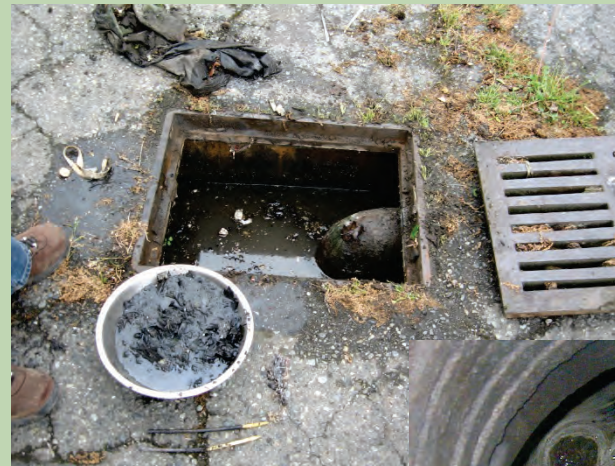
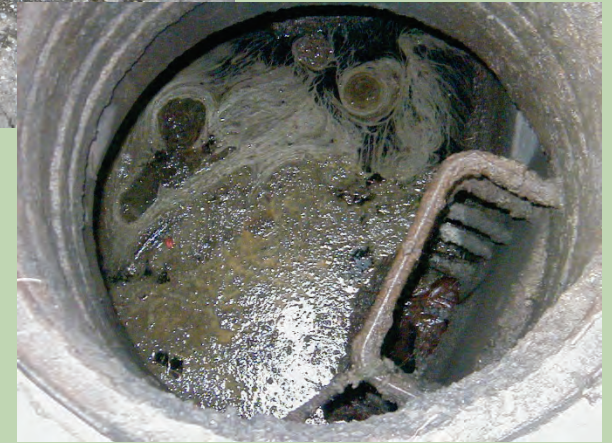
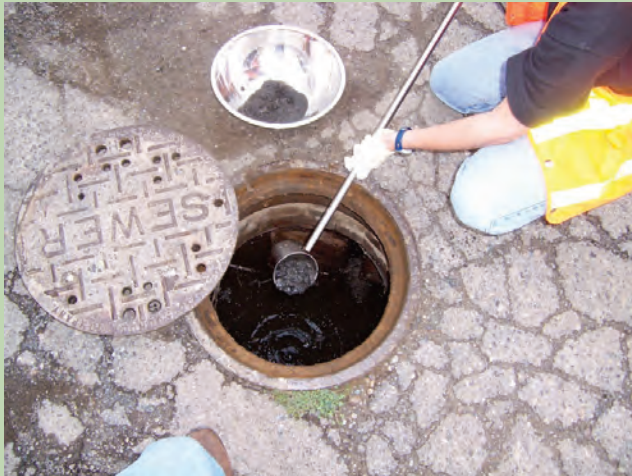
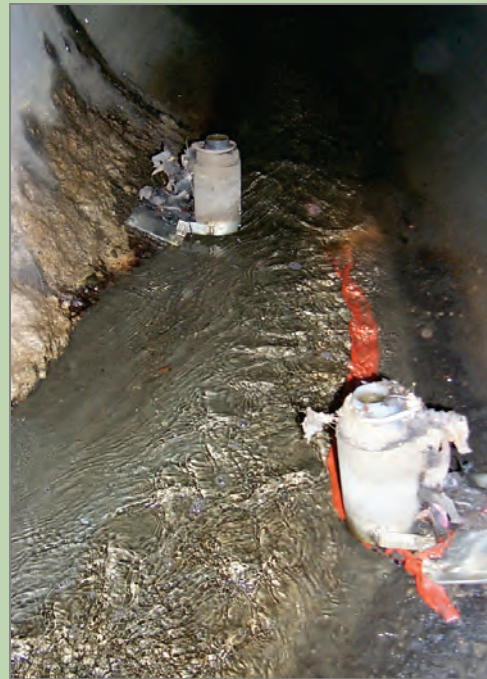
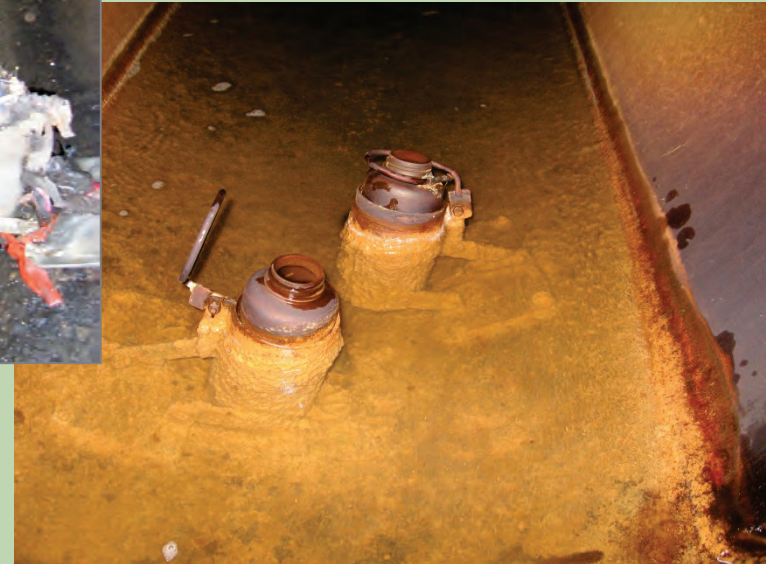
Source Samples

- Inline traps
- Inline grabs
- Onsite catch basins
- Right-of-way catch basins
- Street dirt and soil

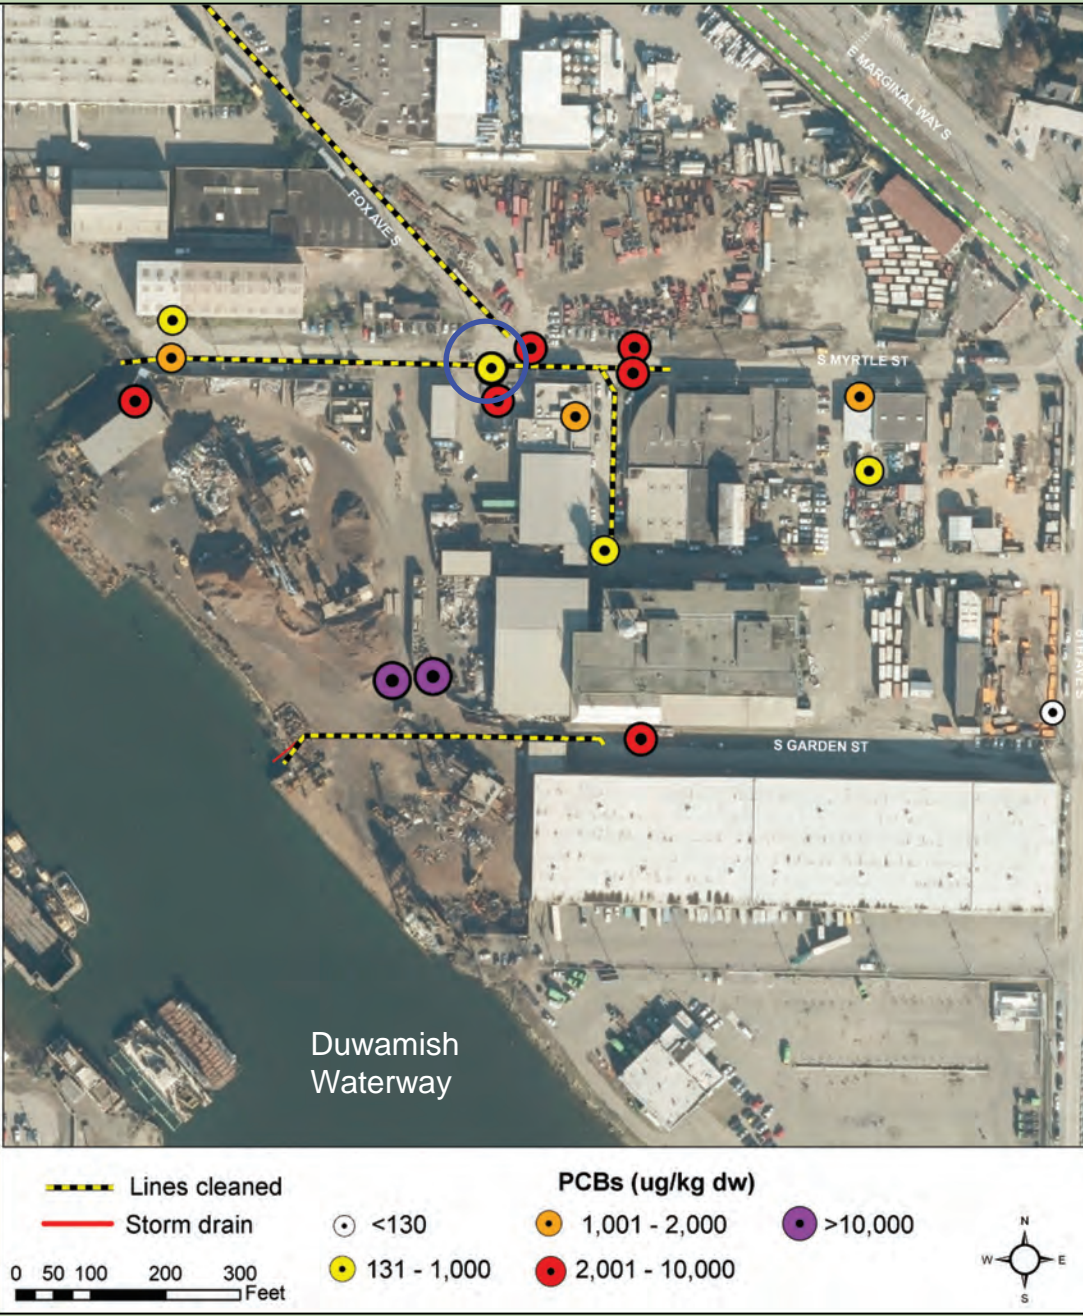
Metal Shredding Facility

- SPU cleans storm drains in 2009-2010
- PCBs elevated in CB adjacent to driveway entrance within 6 months
- CB cleaned several times, but PCBs remain elevated

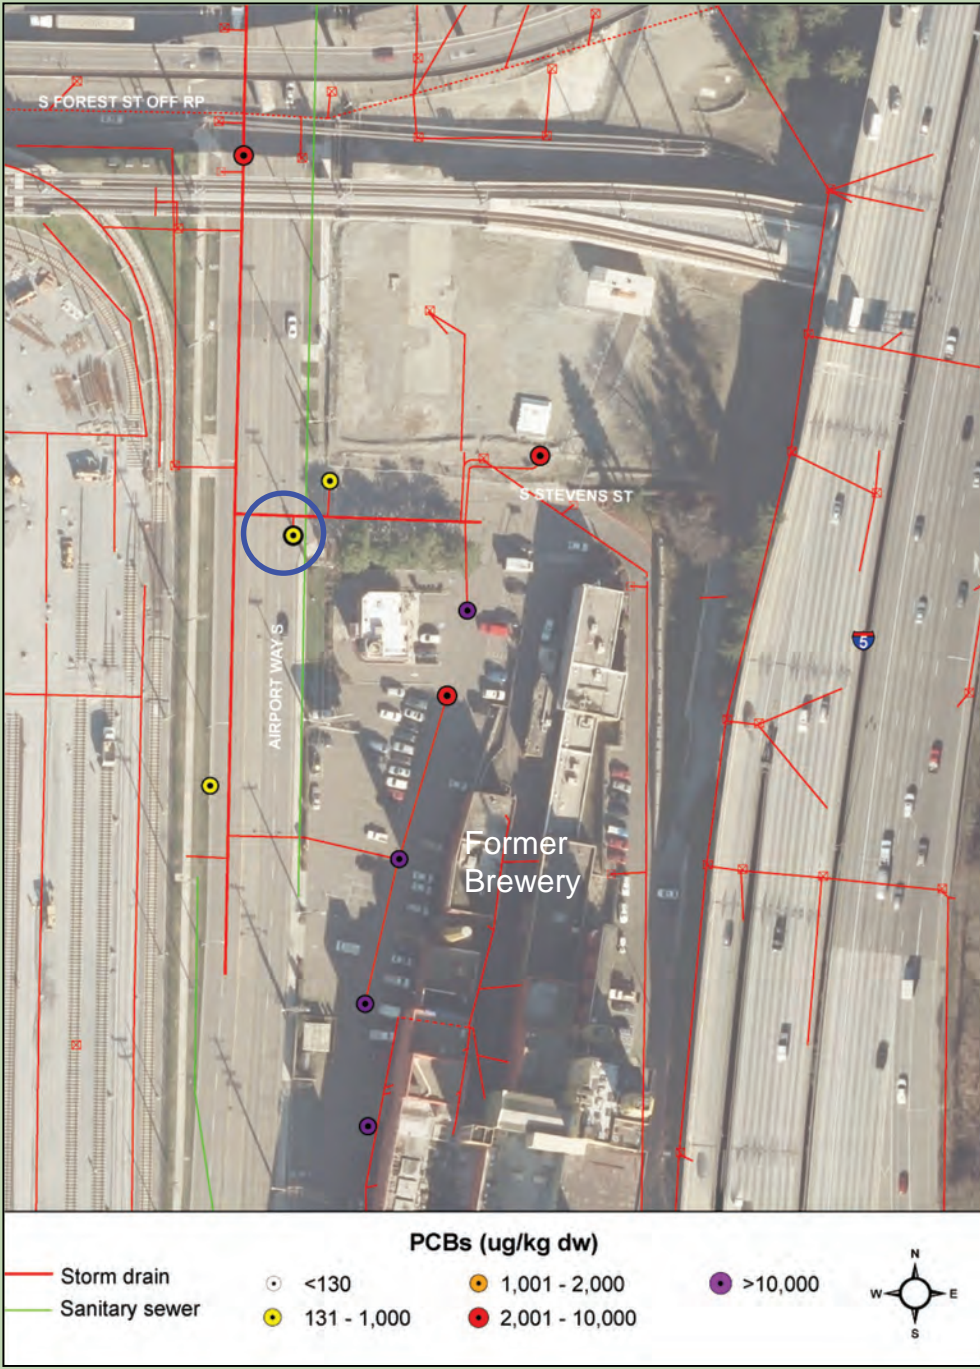
Old Brewery

PCBs in building paint

Source	PCBs (mg/kg dw)
Right-of-way CBs	0.2 - 10
Onsite CBs	2.6 - 189
Exterior building paint	0.8 – 321,000

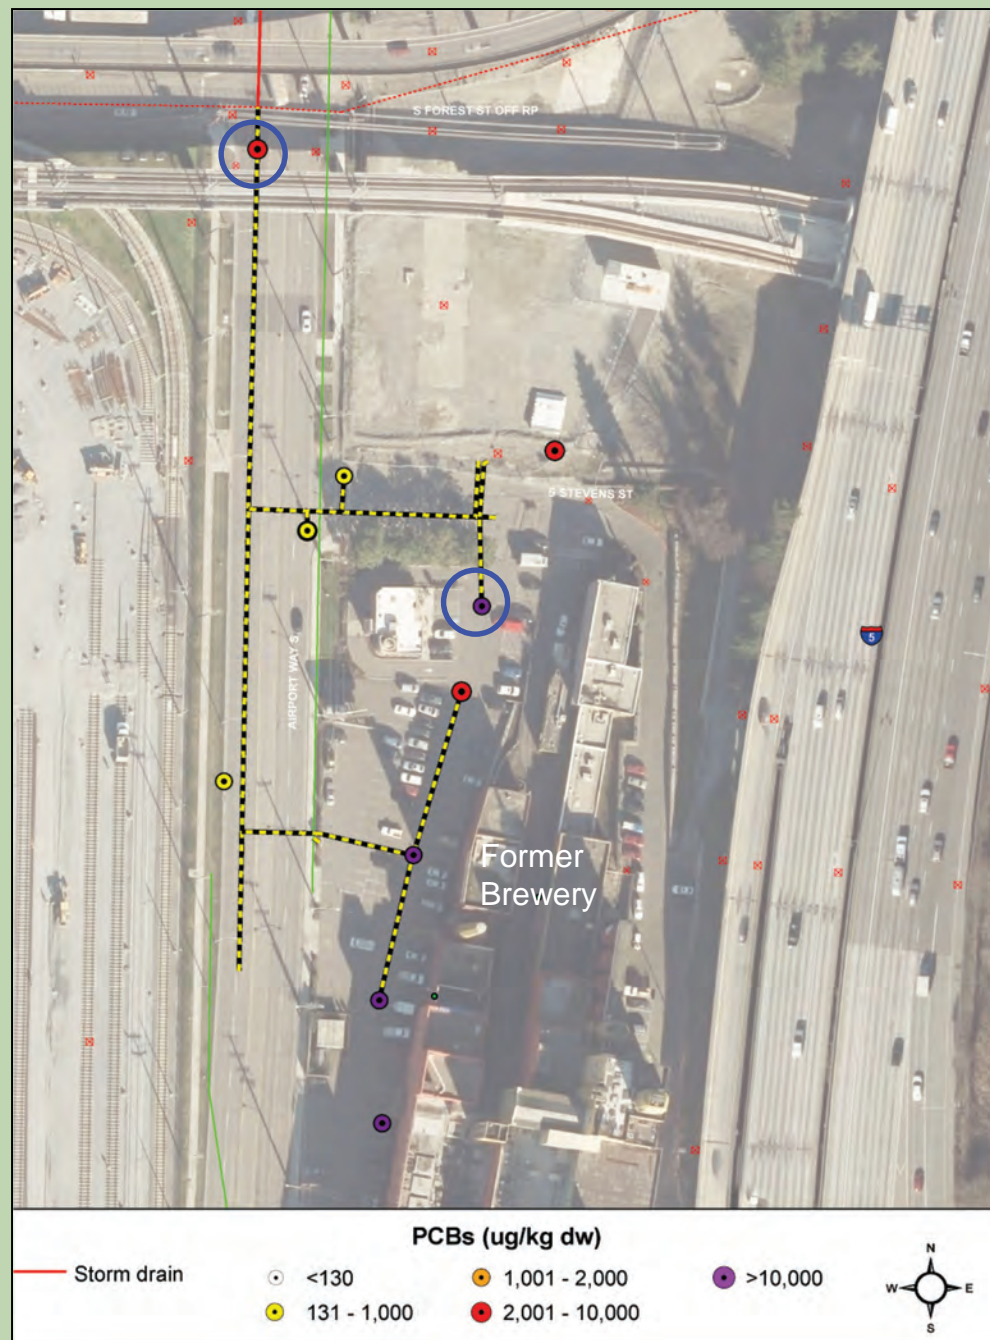
Old Brewery

PCBs in building paint

- 2004: 10 mg/kg PCBs in ROW catch basin
- 2008: SPU jets and cleans lines
- Owner installed filter fabric in CBs
- 2012: SPU re-samples lines
PCBs elevated (7.3 – 12.4 mg/kg)
- 2013: Rainier Commons jets and cleans lines again.
- 2014: 1st phase TSCA cleanup scheduled to start

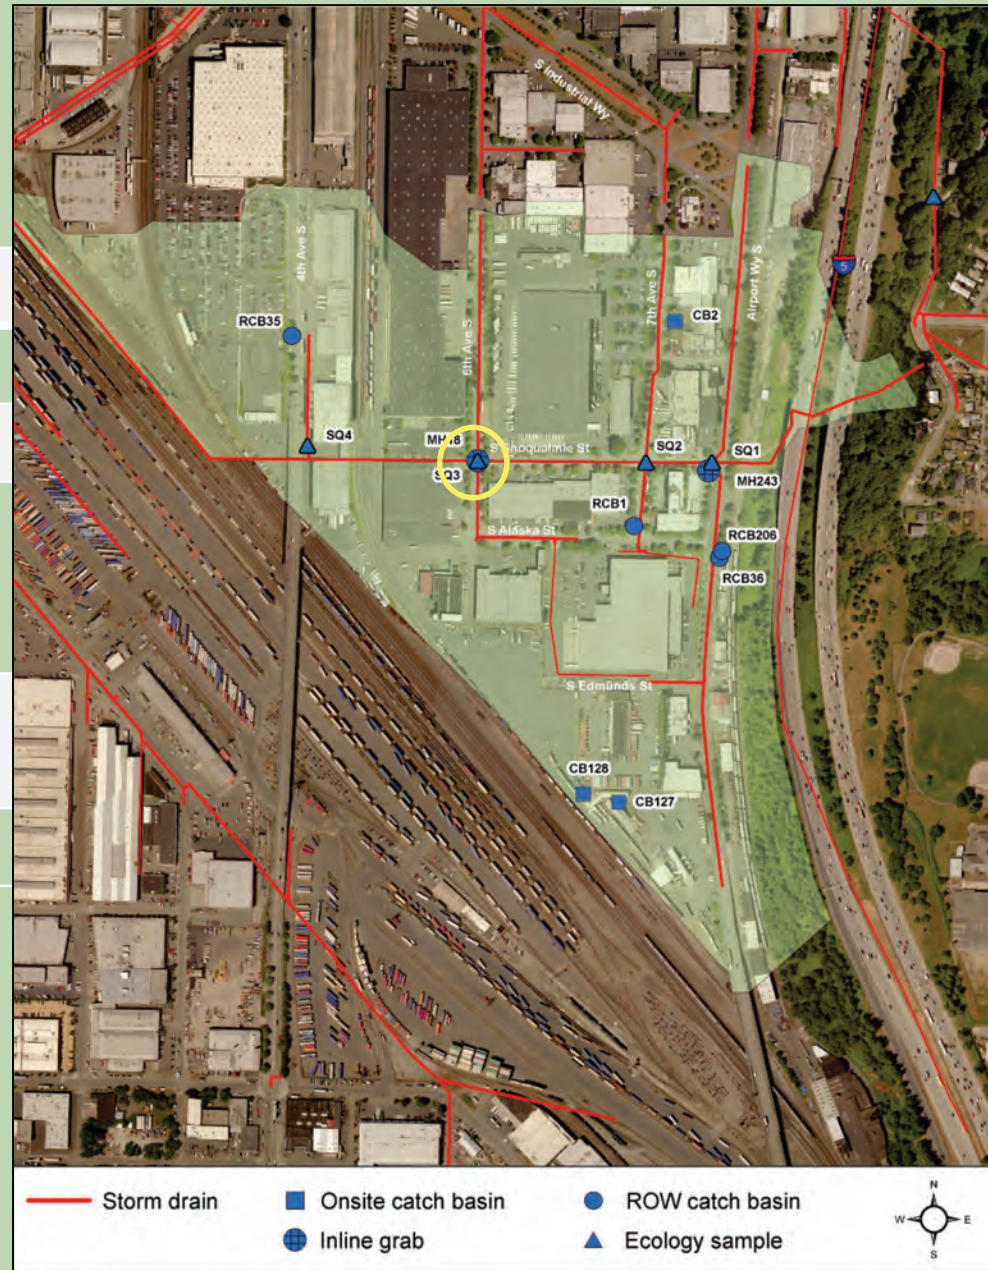
Diag-Snoq Basin

PCBs in MH18

Date	Action
2008-2009	Tracing for Hg
2010	Lines cleaned
2011	Ecology finds PCBs in base flow, filtered solids, sediment trap samples
2013	Elev PCBs (46 mg/kg dw) found in MH18
2014	More source tracing

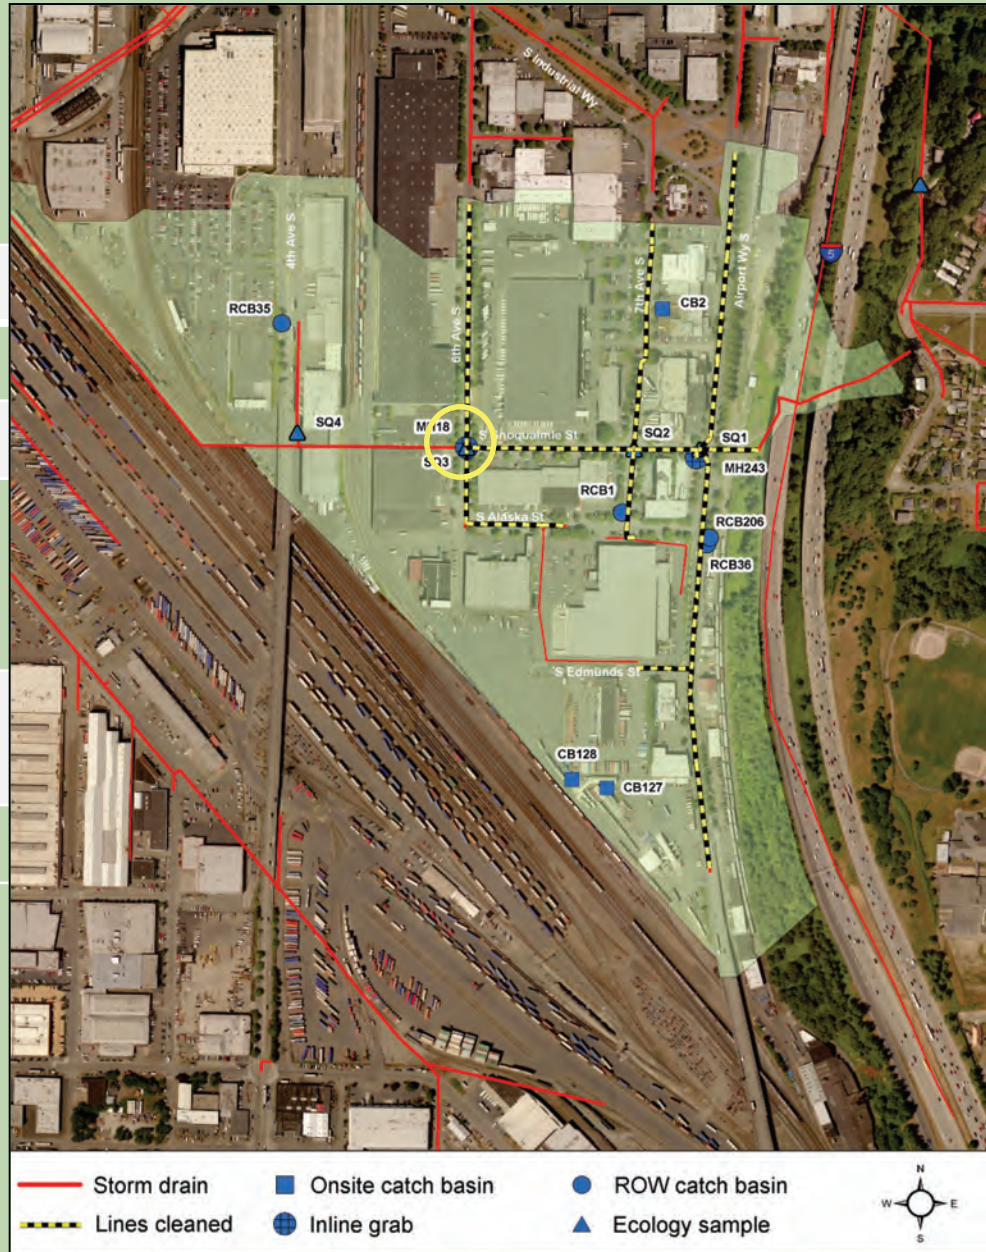
PCBs in MH18

Date	Action
2008-2009	Tracing for Hg
2010	Lines cleaned
2011	Ecology finds PCBs in base flow, filtered solids, sediment trap samples
2013	Elev PCBs (46 mg/kg dw) found in MH18
2014	More source tracing

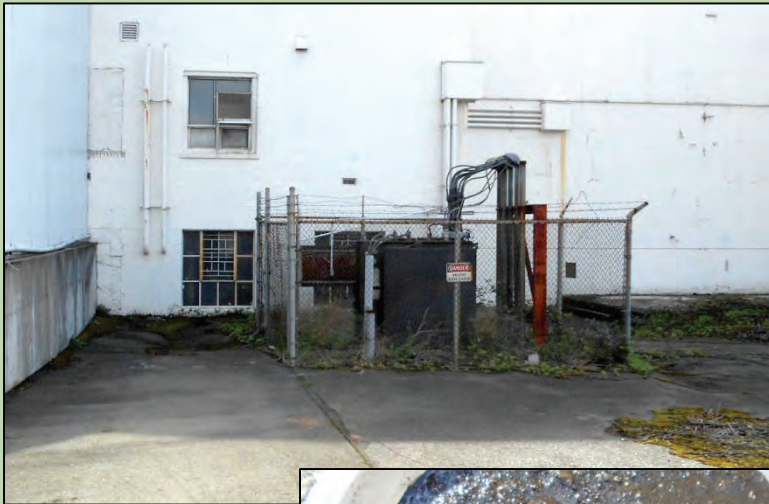
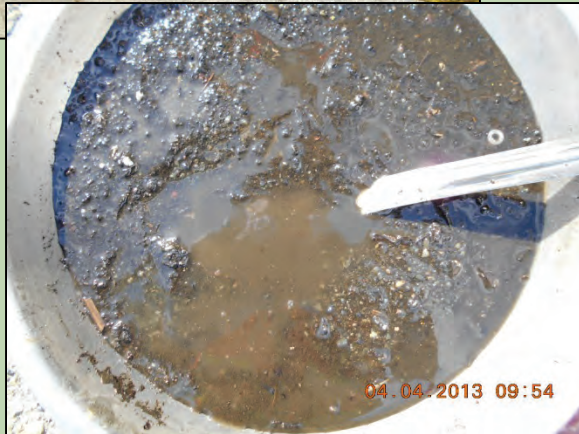
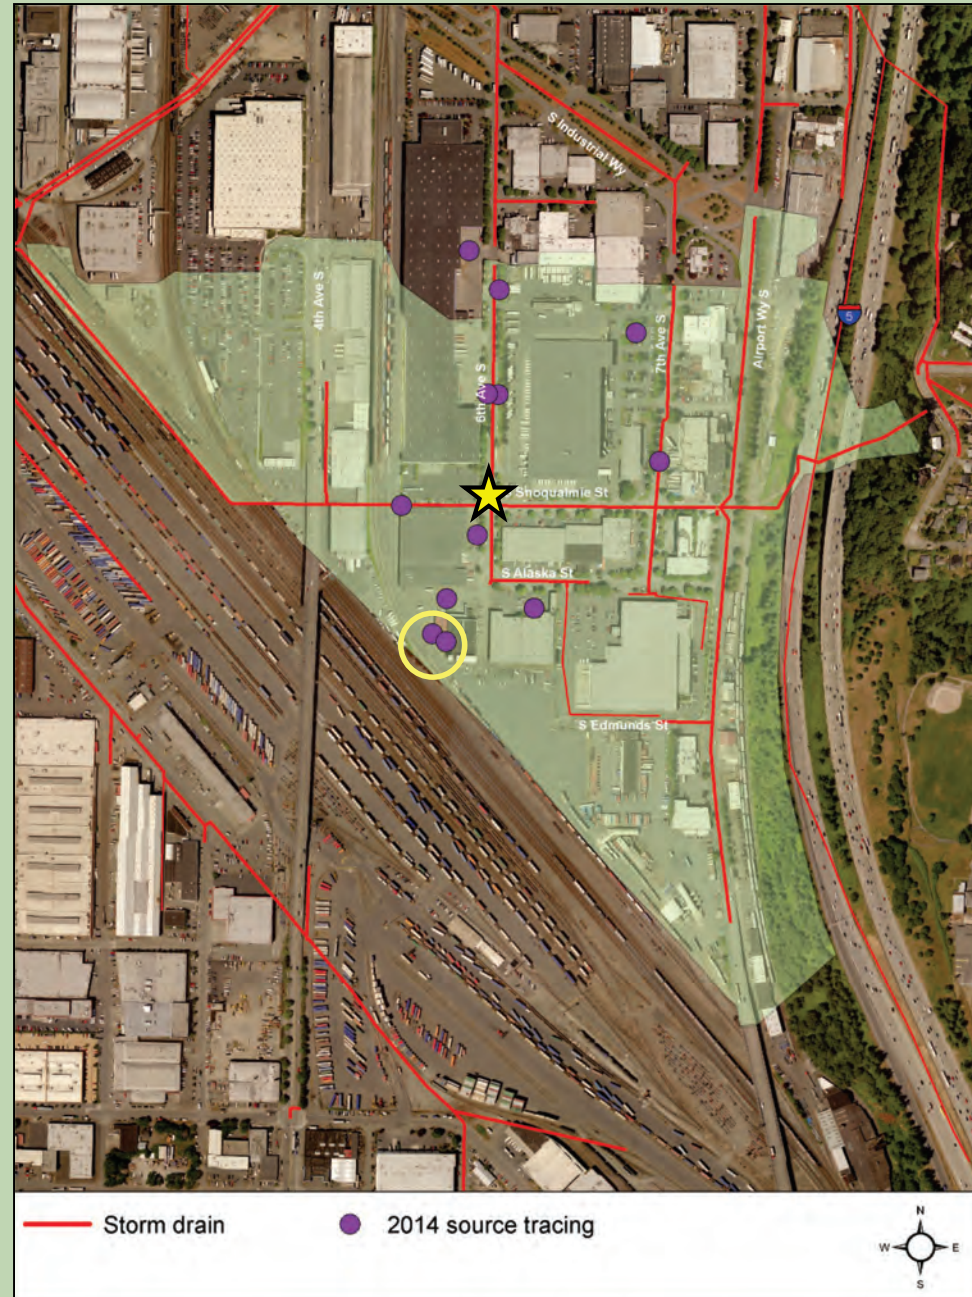
Diag-Snoq Basin

2014 Tracing

- 6 and 10 mg/kg in CBs near transformer
- Paint chips in CB
