## Elwha nearshore ecosystem restoration: dam removal and shoreline armor removal

# Elwha Nearshore Ecosystem Restoration: Dam Removal and Shoreline Armor Removal

Jamie Michel and Anne Shaffer, Coastal Watershed Institute; Chris Byrnes, Washington Department of Fish and Wildlife; Dave Parks, Washington Department of Natural Resources  
Salish Sea Ecosystem Conference 2018

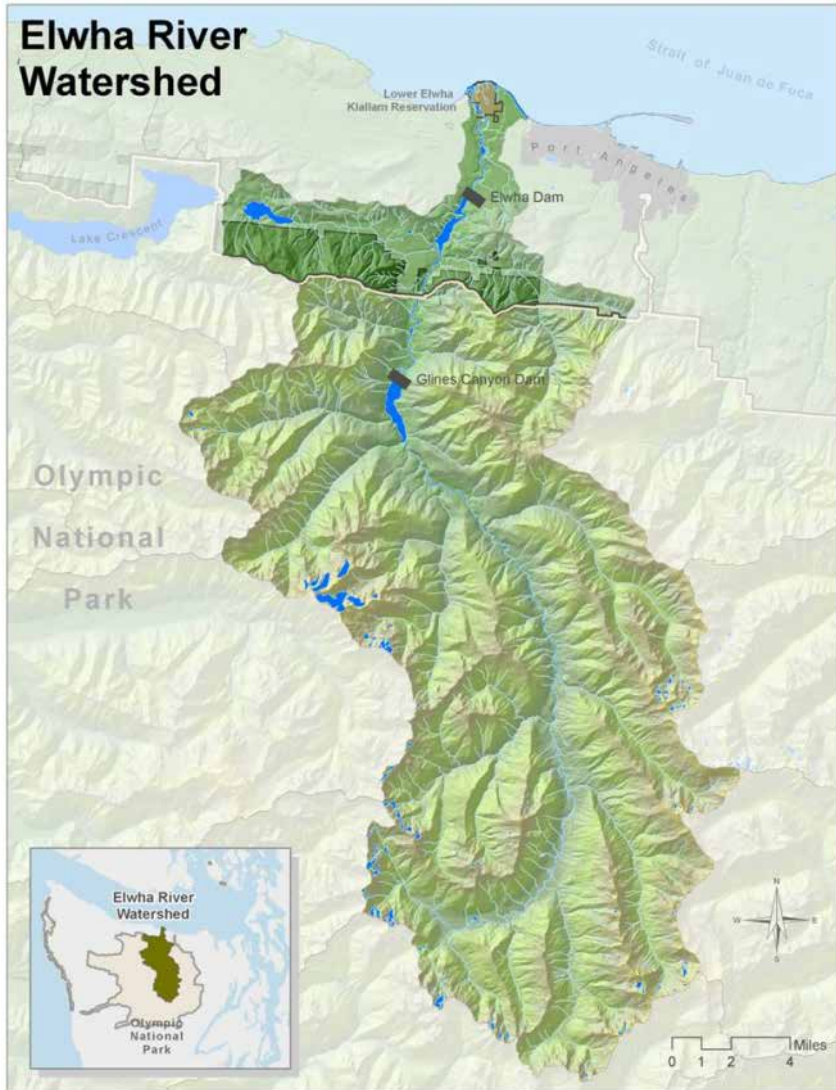
Former 105' tall Elwha Dam  
Removal Completed August 2012

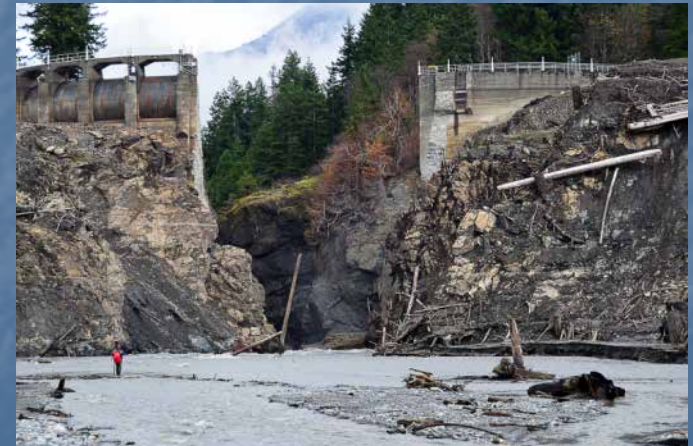
Former 210' tall Glines Canyon Dam  
Removal Completed August 2014

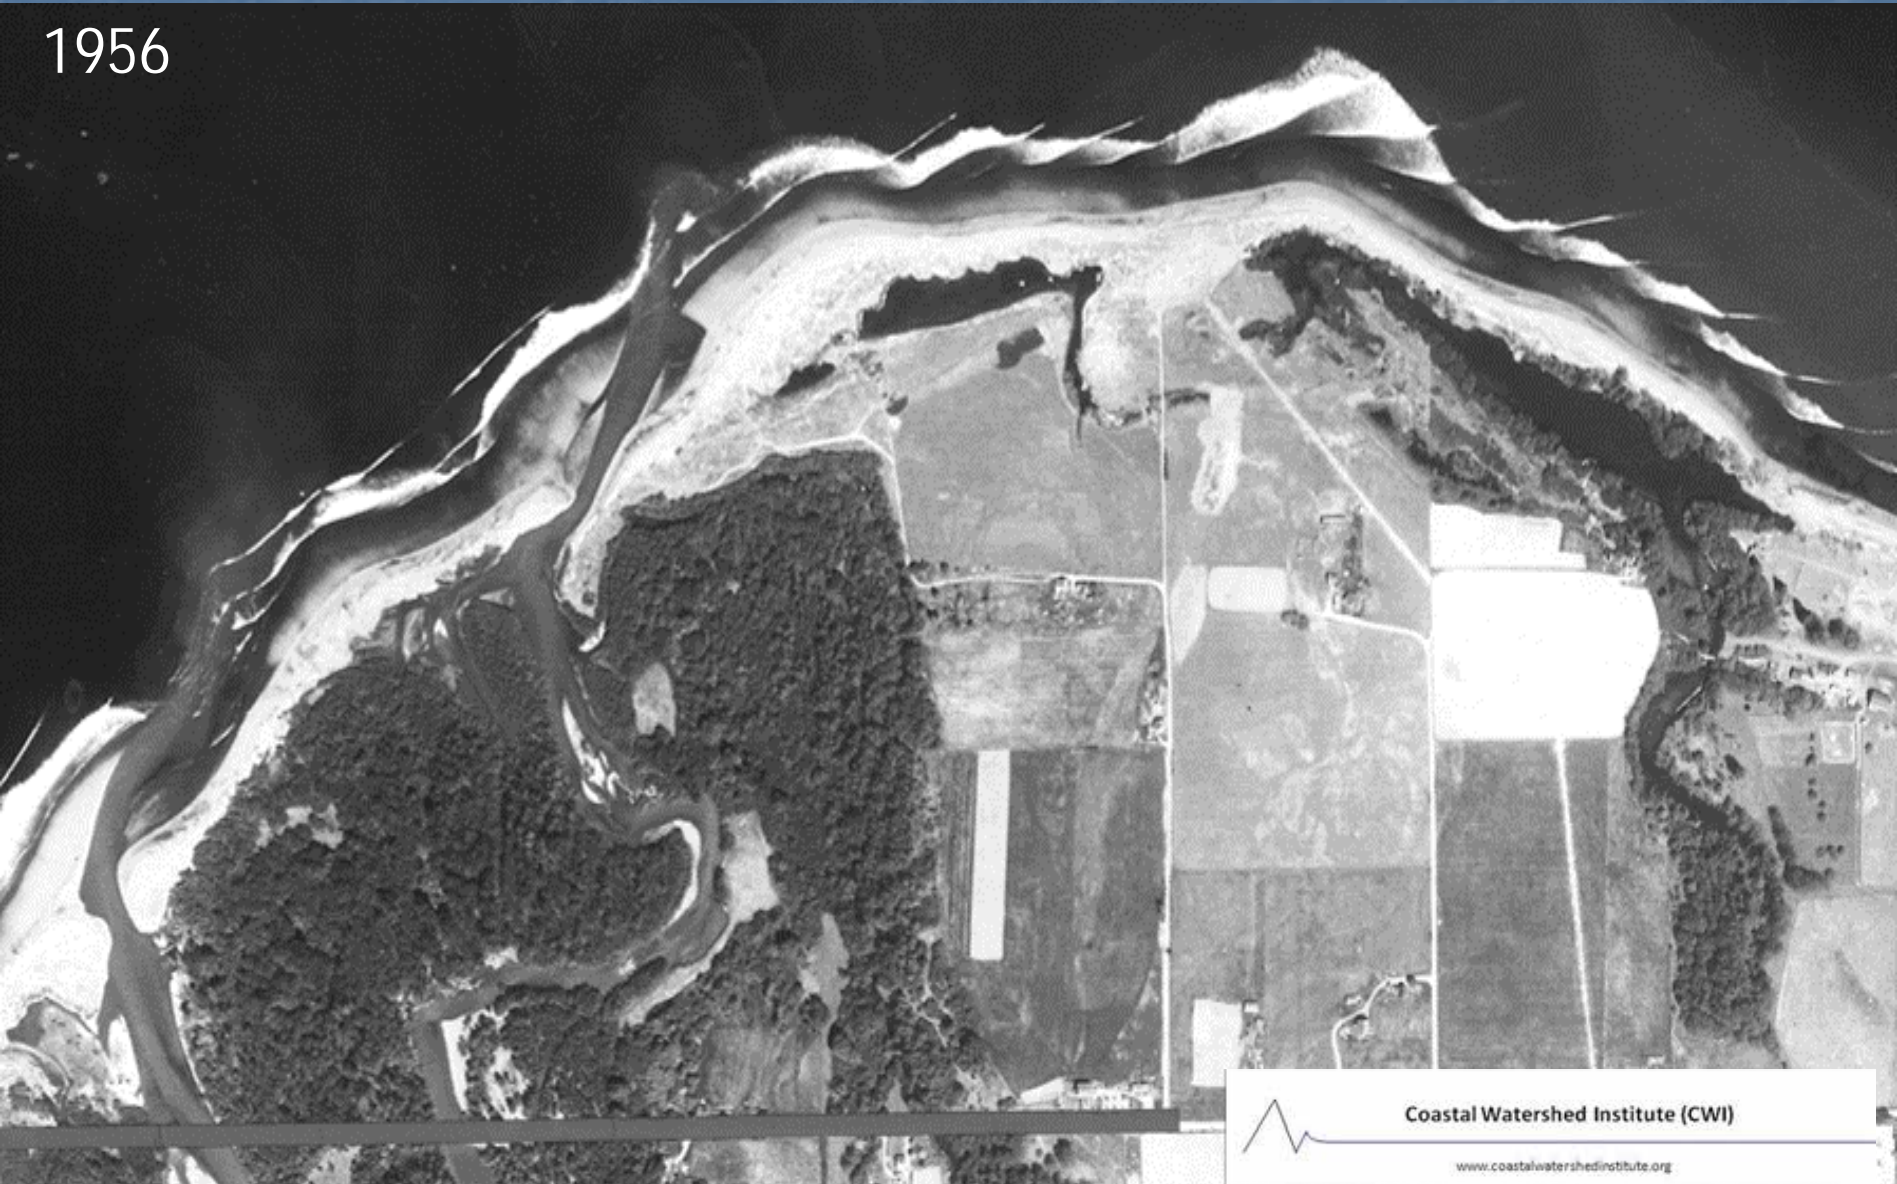
1956

# Sediment Starvation Exacerbates Erosion and Results in $\frac{3}{4}$ Mile of Armor

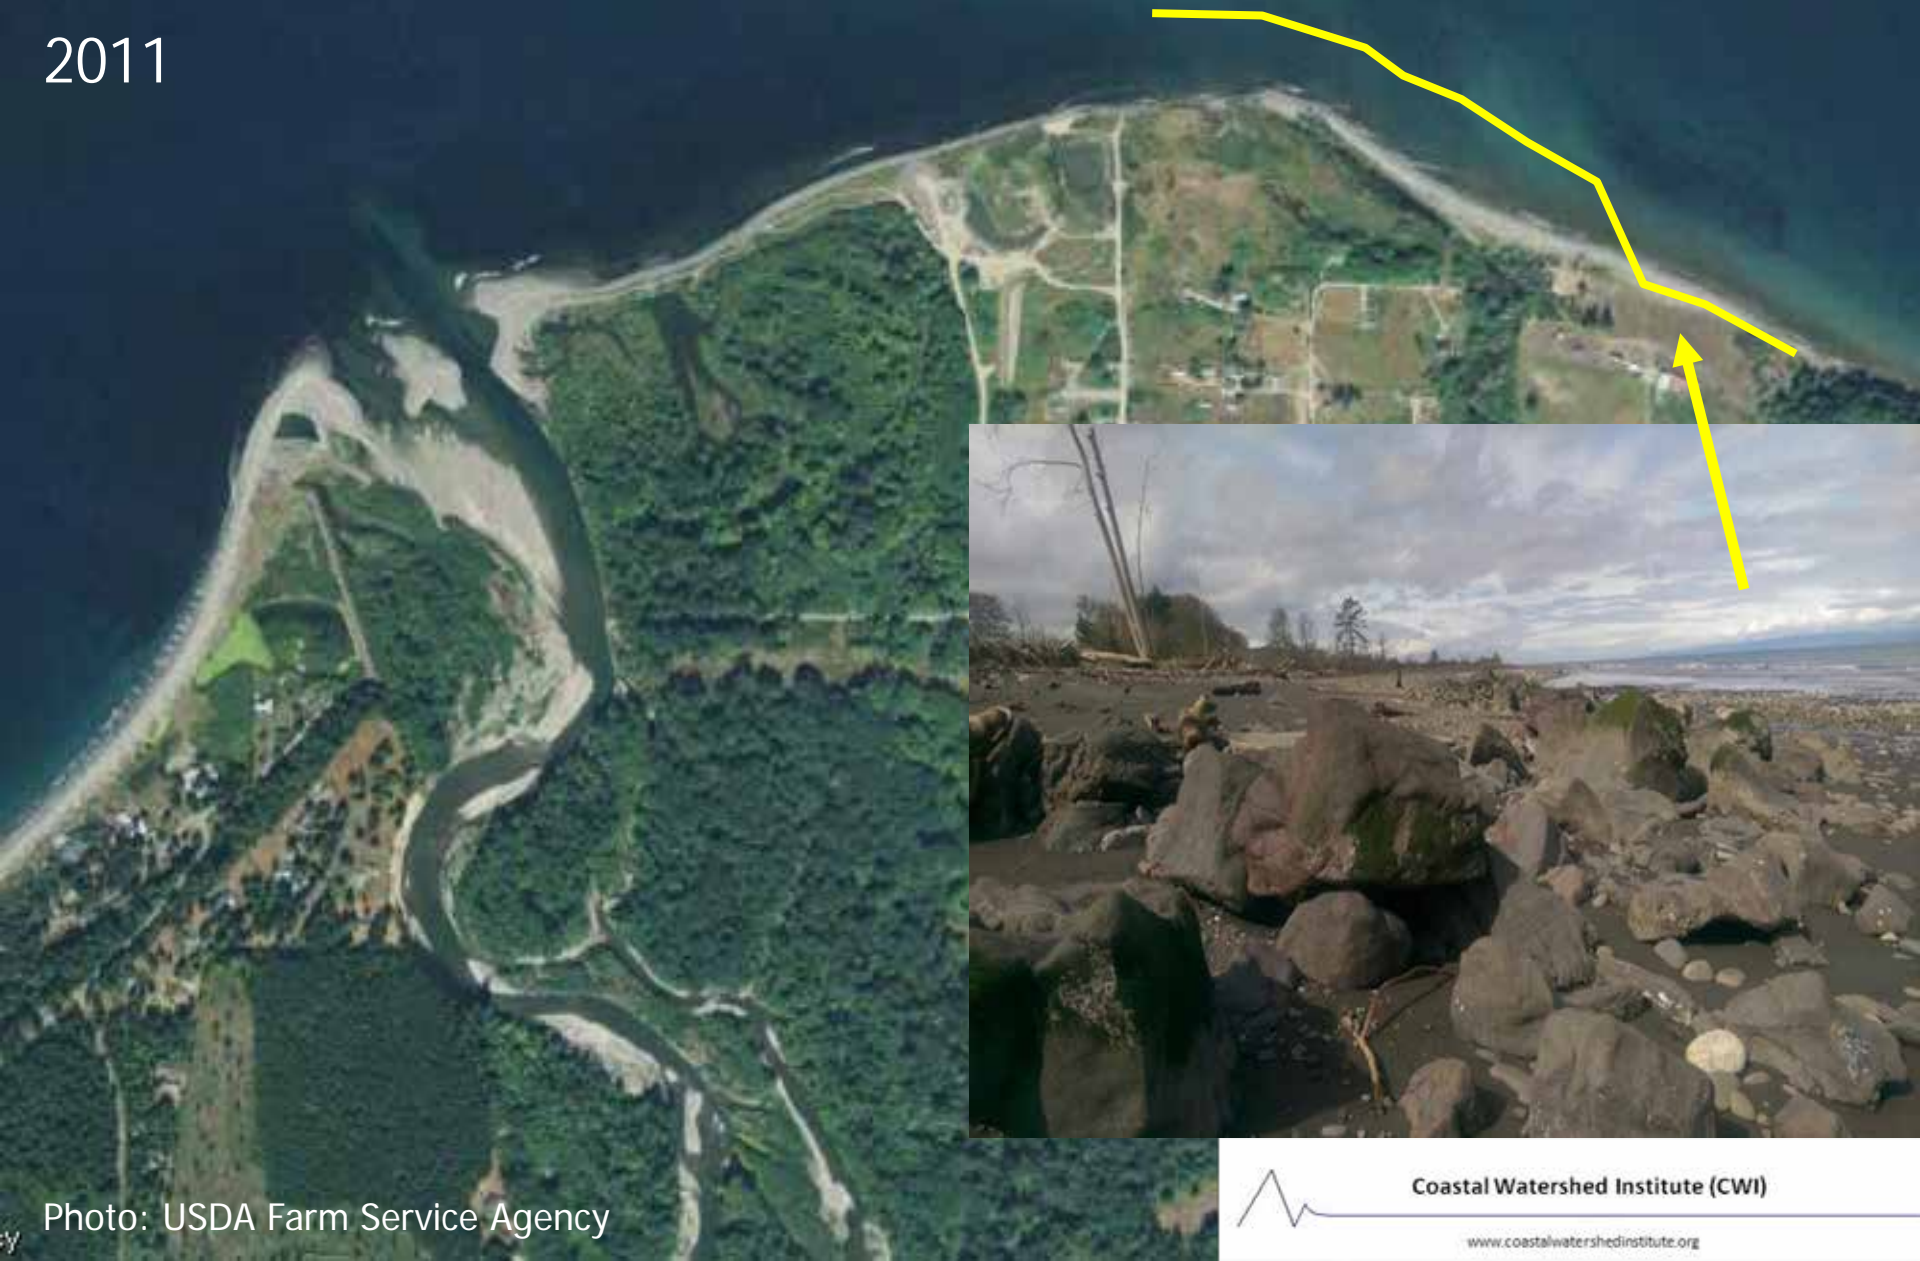
2011

# Continued Erosion Despite Armor

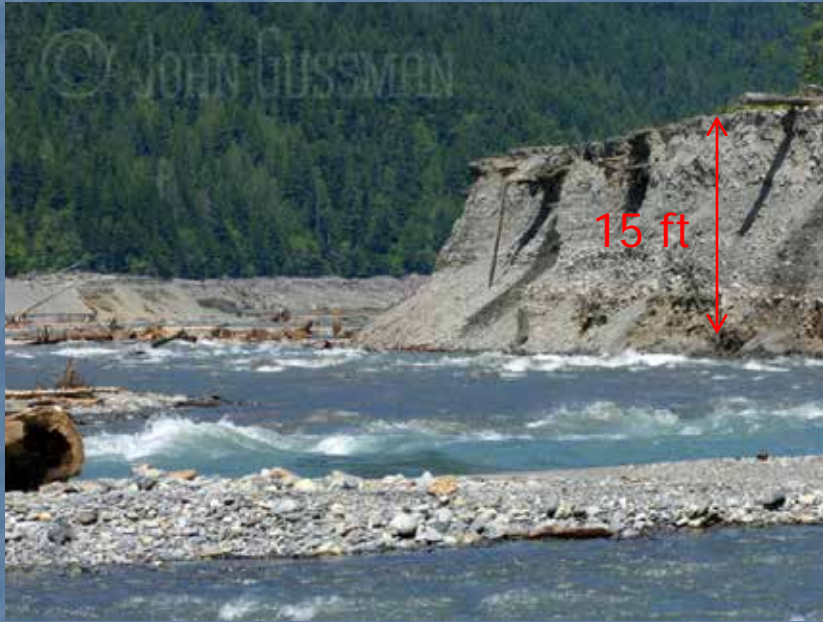
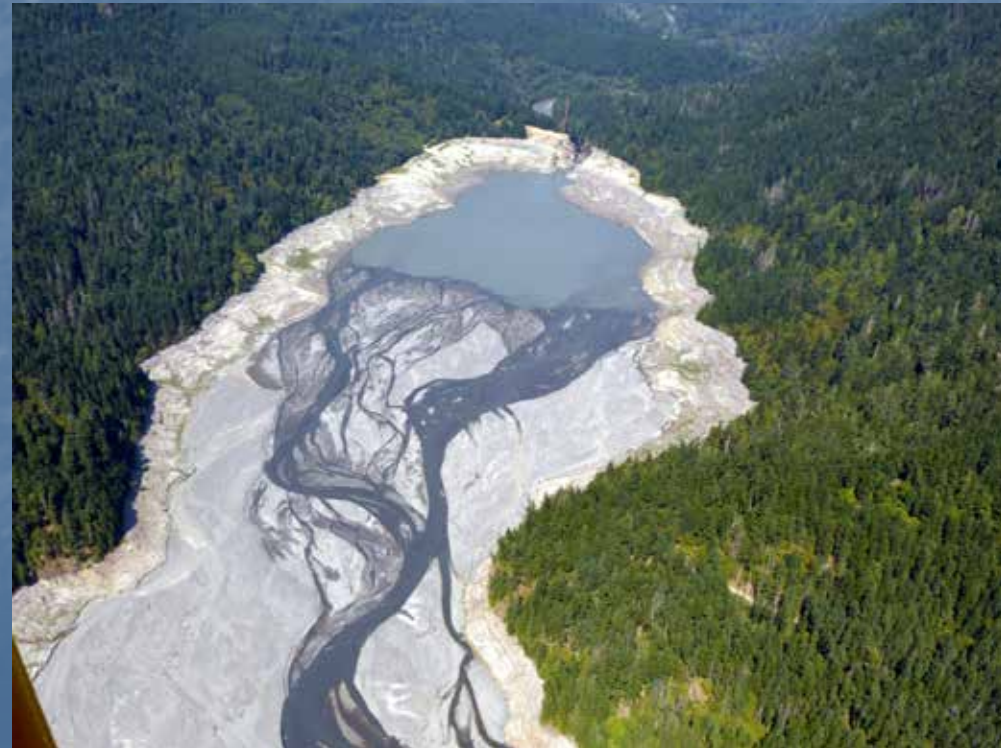
Lake Mills August 2012

Approximately 20,000,000 cubic meters of material behind dams\* - approximately 60% is sand/ silt, 40% is gravel/cobble

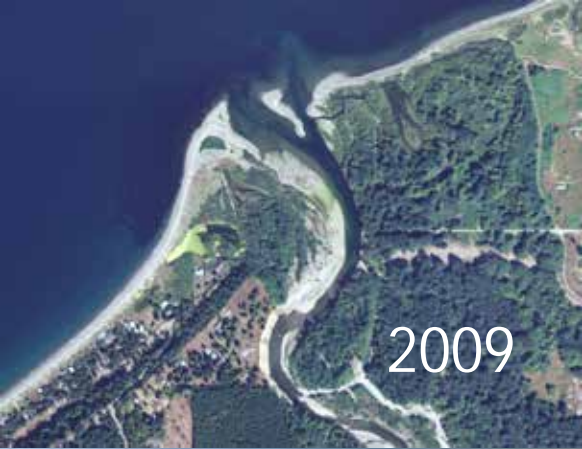
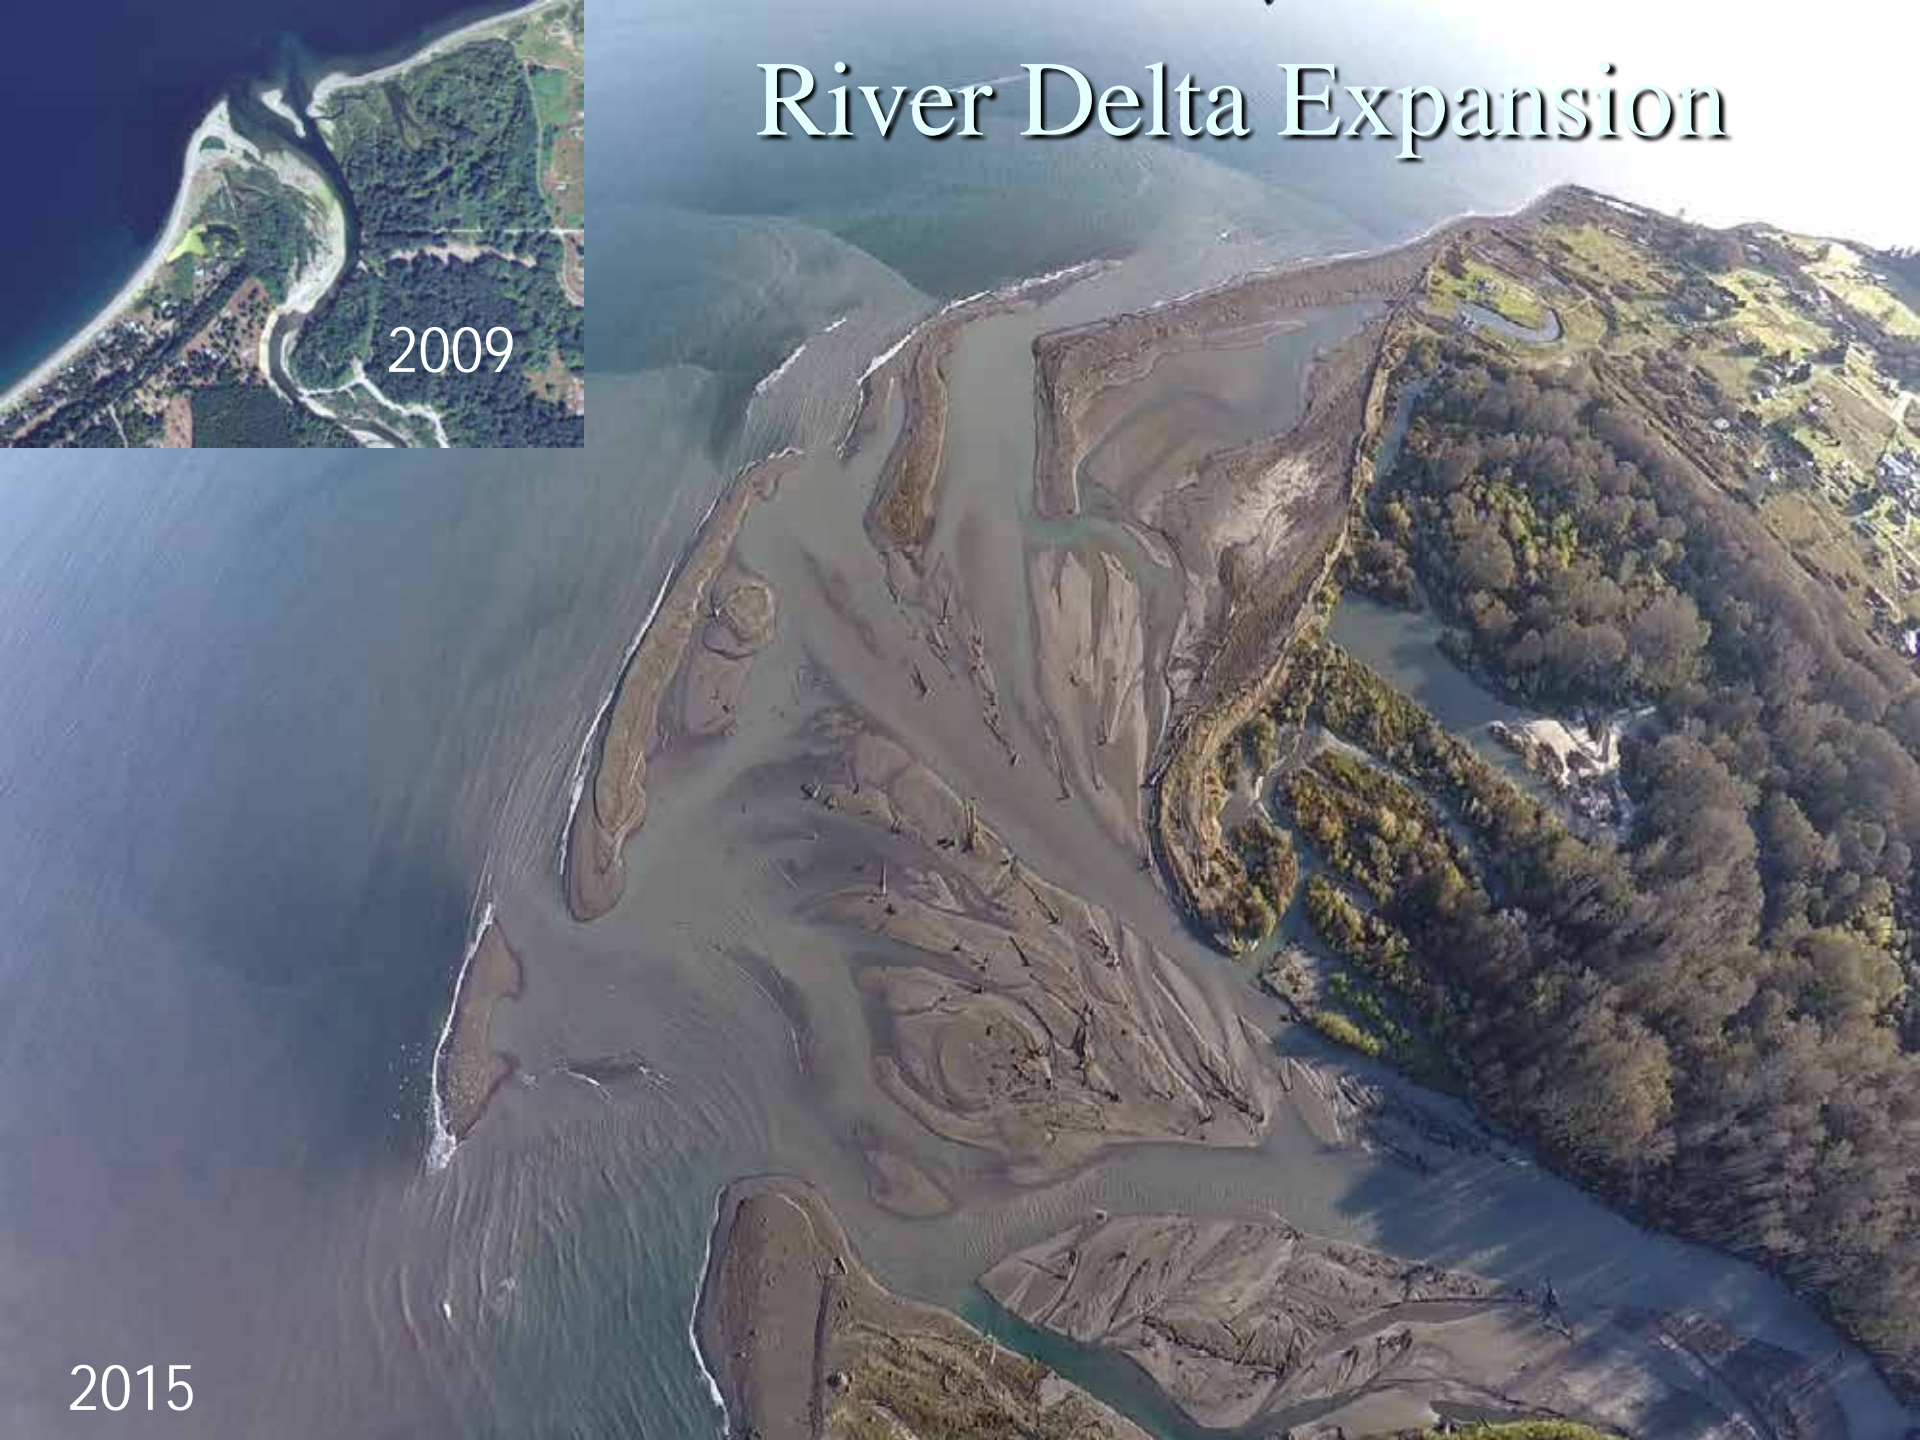
2009

# River Delta Expansion

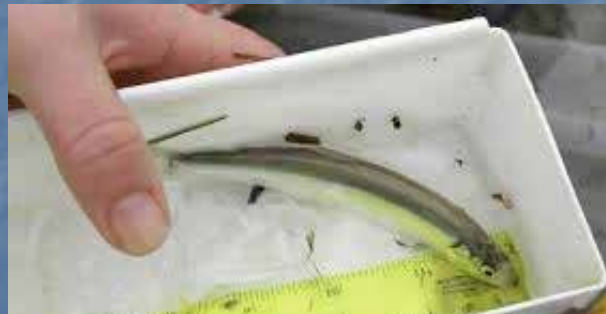
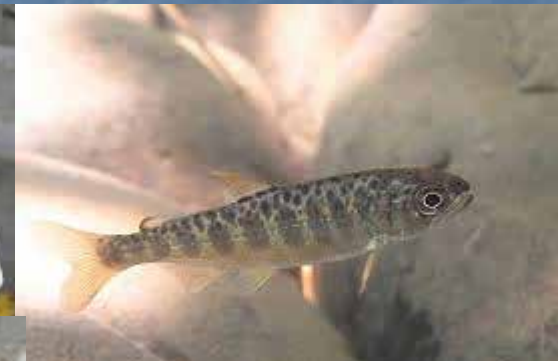
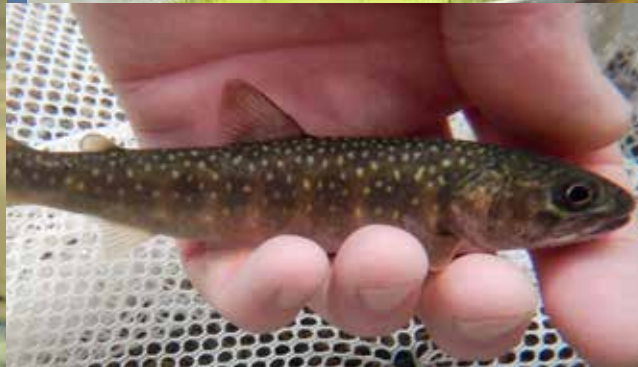
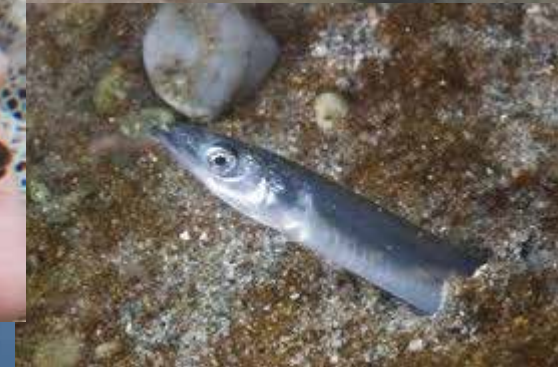
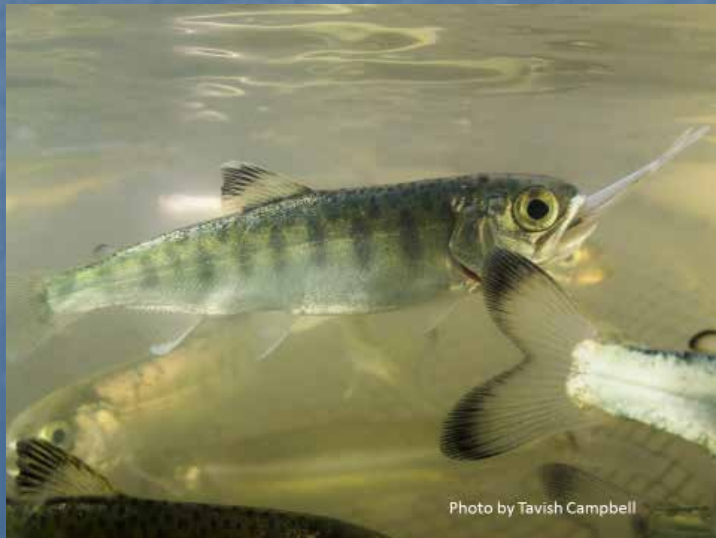
Chronic Sediment Starvation Results in Loss of ~20 acre Estuarine Lagoon

Shoreline transition from sand/gravel to cobble/boulder substrate

Derelict armor adversely impacts estuarine/nearshore dependent species

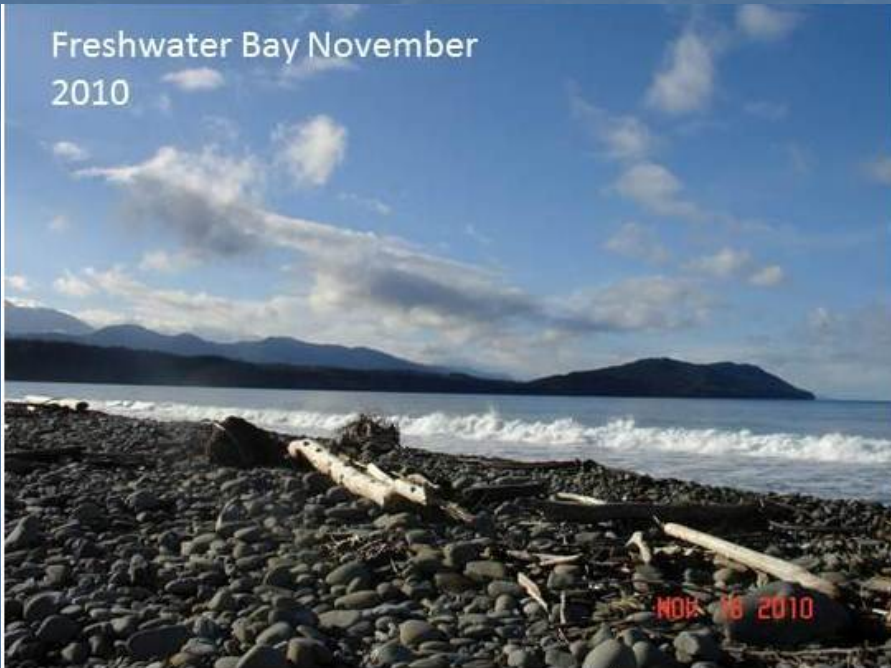
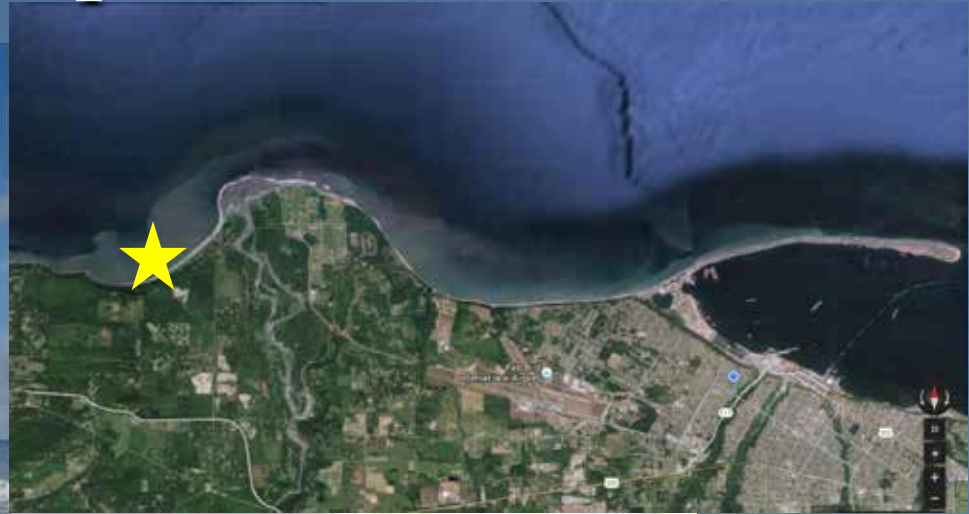
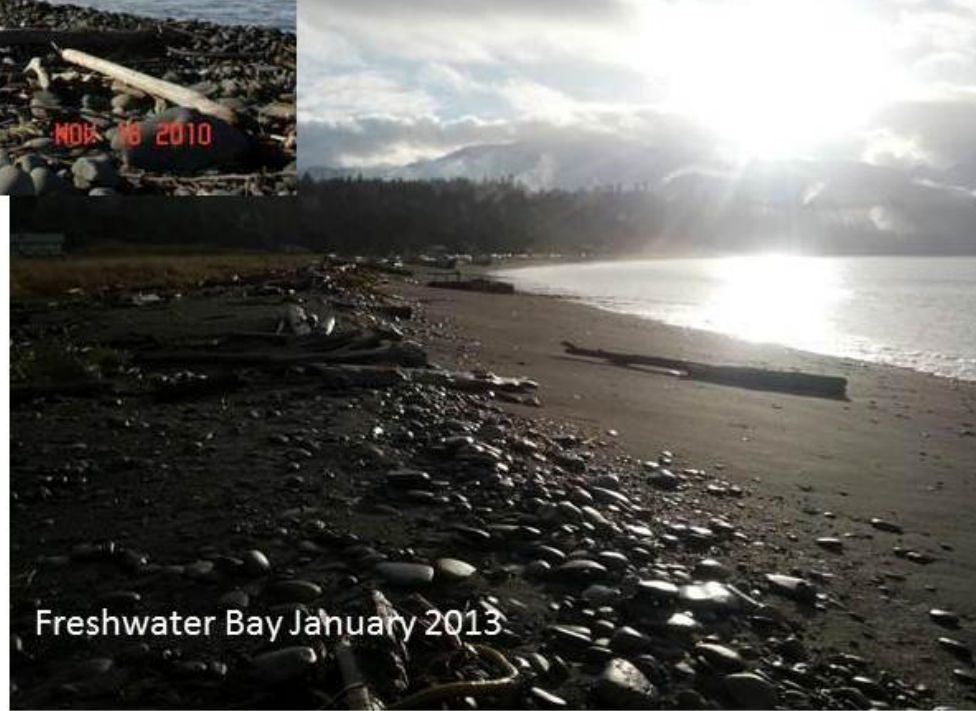
Freshwater Bay November  
2010

# Freshwater Bay Deposition

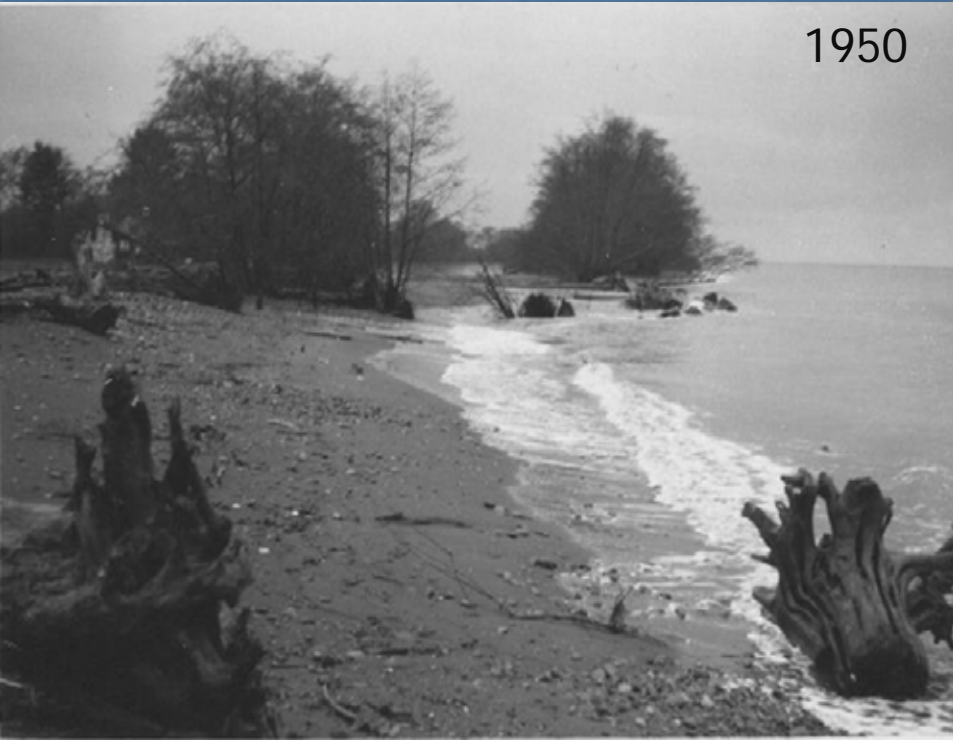
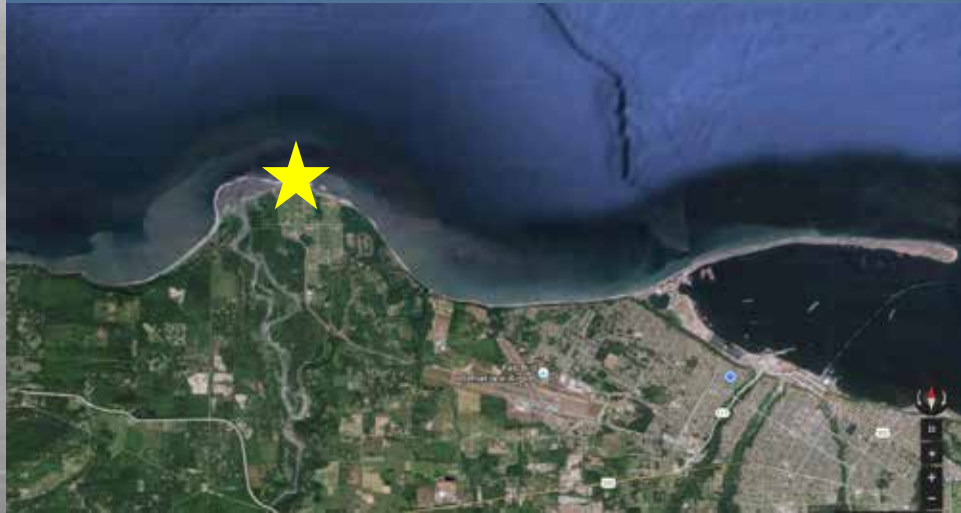
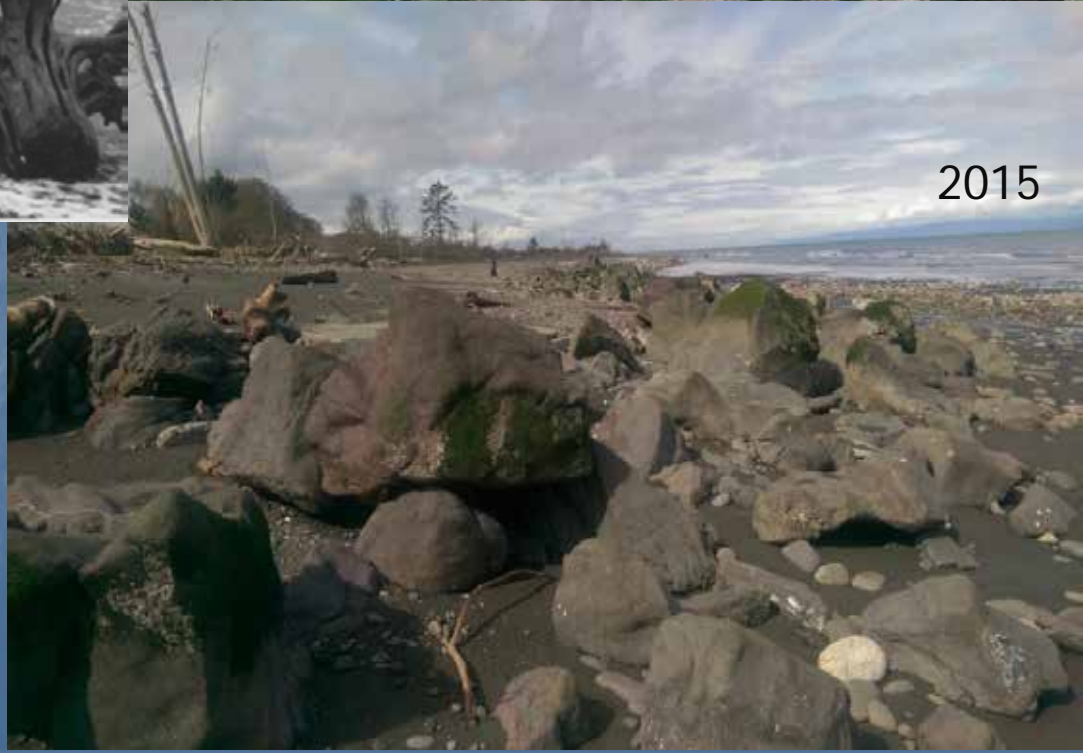
1950

# Beach Lake Erosion

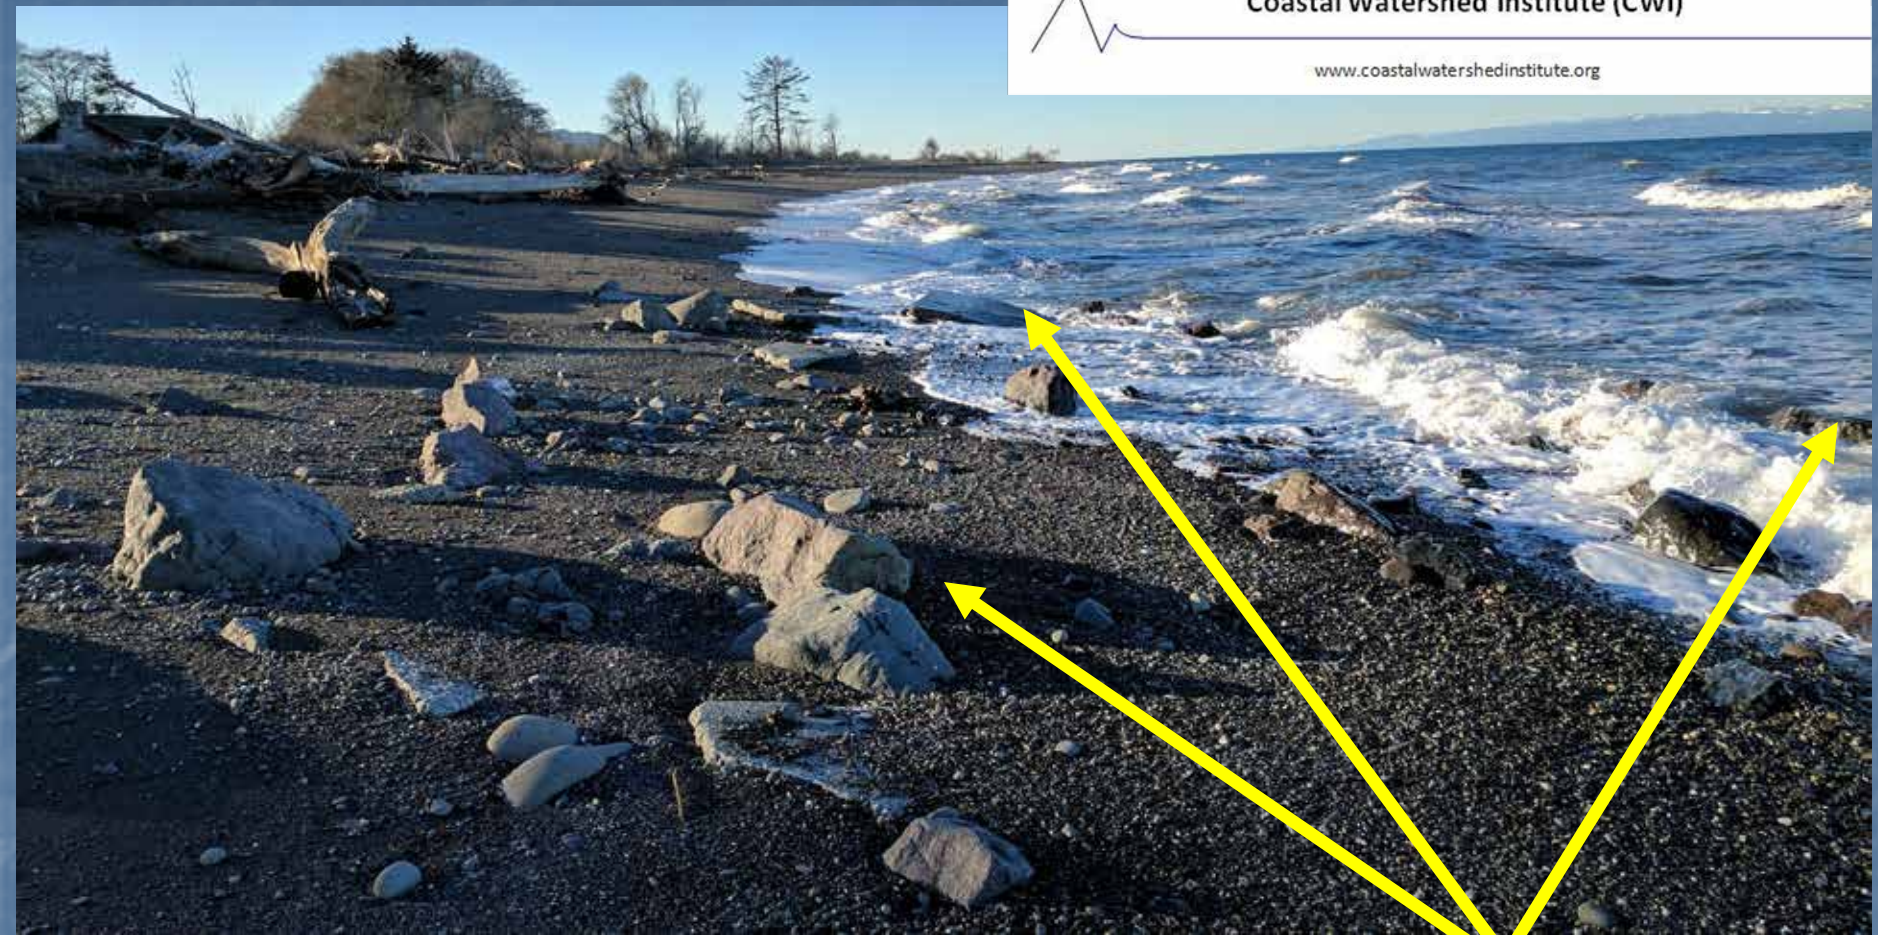
1/4/2017 (+4' MLLW Tide) Material Exposed After Winter Erosion. Note the armor and concrete panels on beach, but also the armor extending out to -2' MLLW. Project is permitted and funded for multiple phases of armor removal to continue to mobilize as armor emerges.
