Research into the cause of brackish marsh recession in the Fraser River estuary

Research into the Cause of Brackish Marsh Recession in the Fraser River Estuary

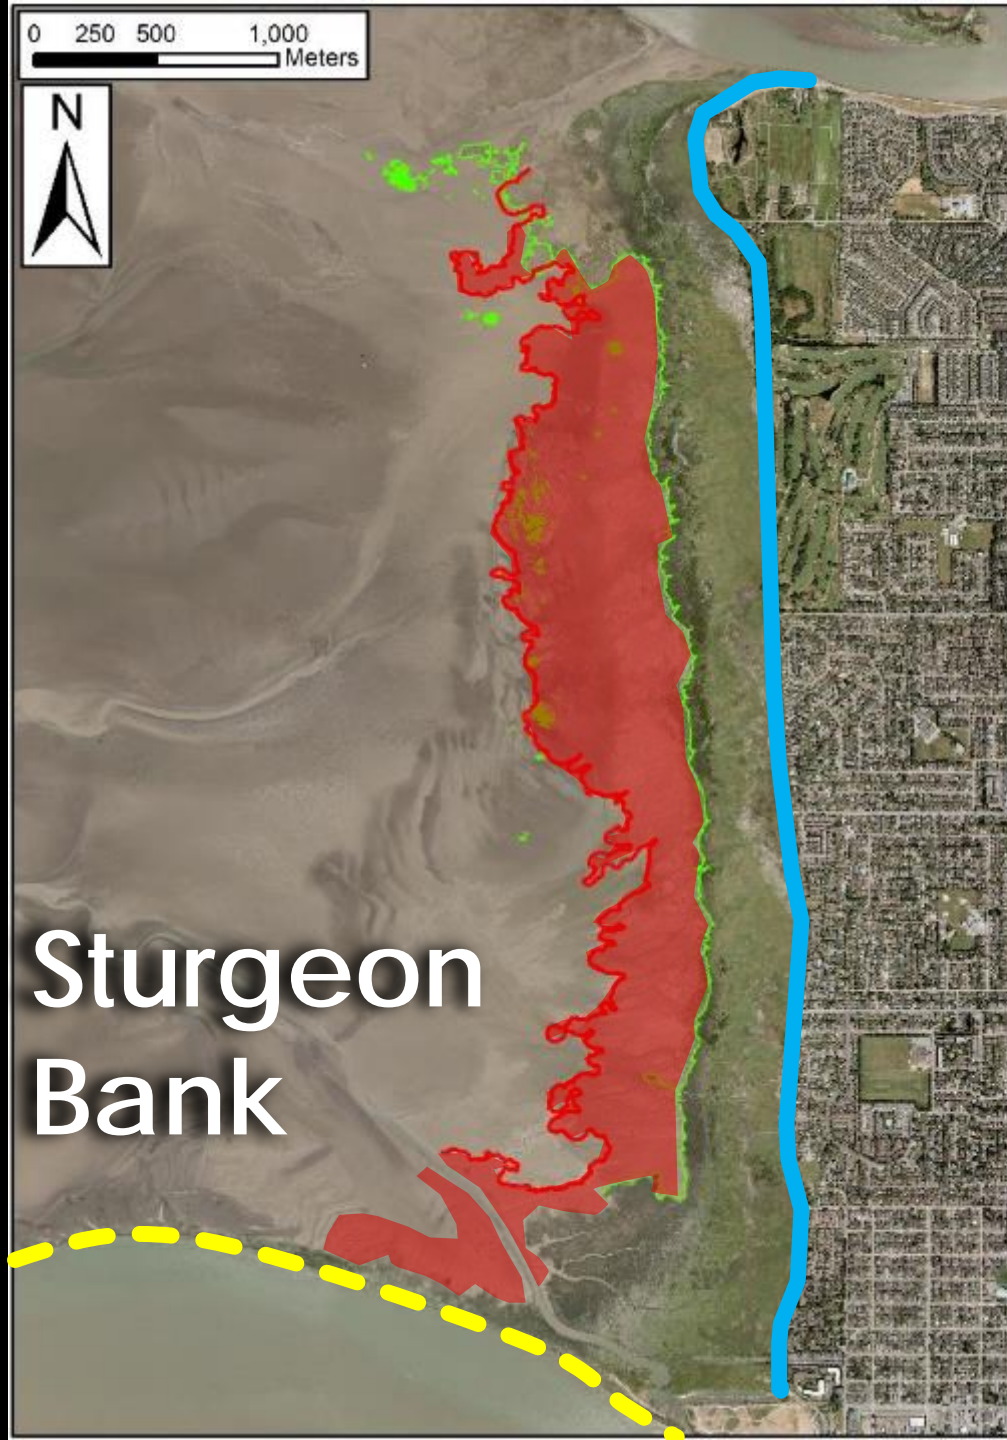
Marsh Leading Edge, Fraser River Delta 1989 to 2011

Grid	1989 Area (ha)	2011 Area (ha)	Change Area (%)	
Westminster Rd	26.8	22.8	-14.9	Sturgeon Bank
Steveston Rd	17.5	0.0	-100.0	
Outer Islands	21.0	19.5	-7.1	Westham Island
Reifel Refuge Inside	11.3	11.5	1.8	
Reifel Refuge Outside	25.0	22.5	-10.0	
Westham Island South	31.5	30.5	-3.2	
Brunswick Pt	37.8	23.3	-38.4	
Fraser River Delta	170.9	130.1	-23.9

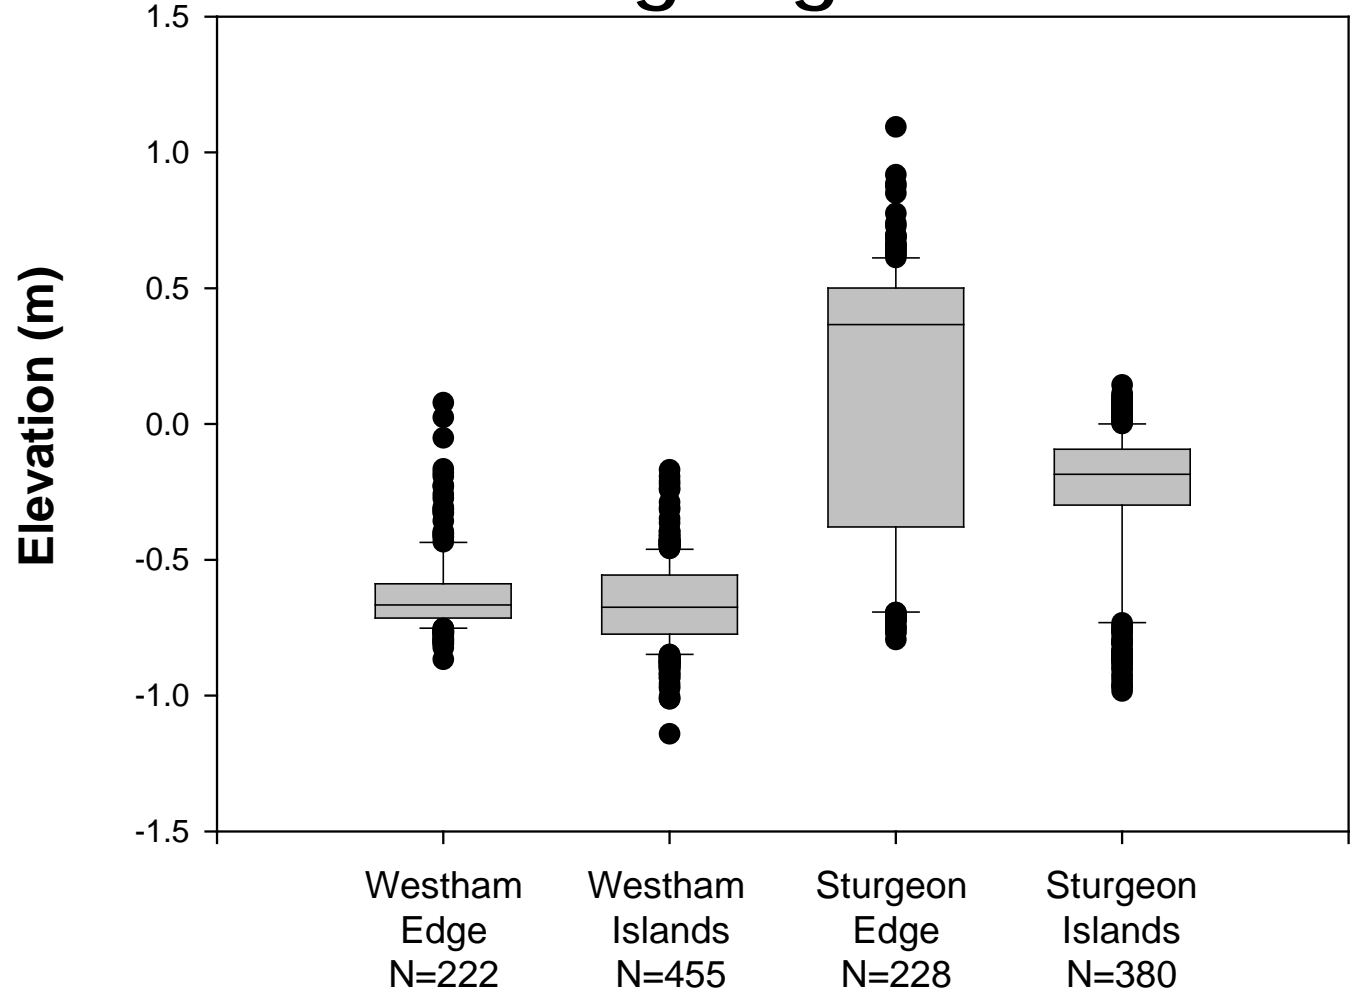
Elevation of Leading Edge and Islands

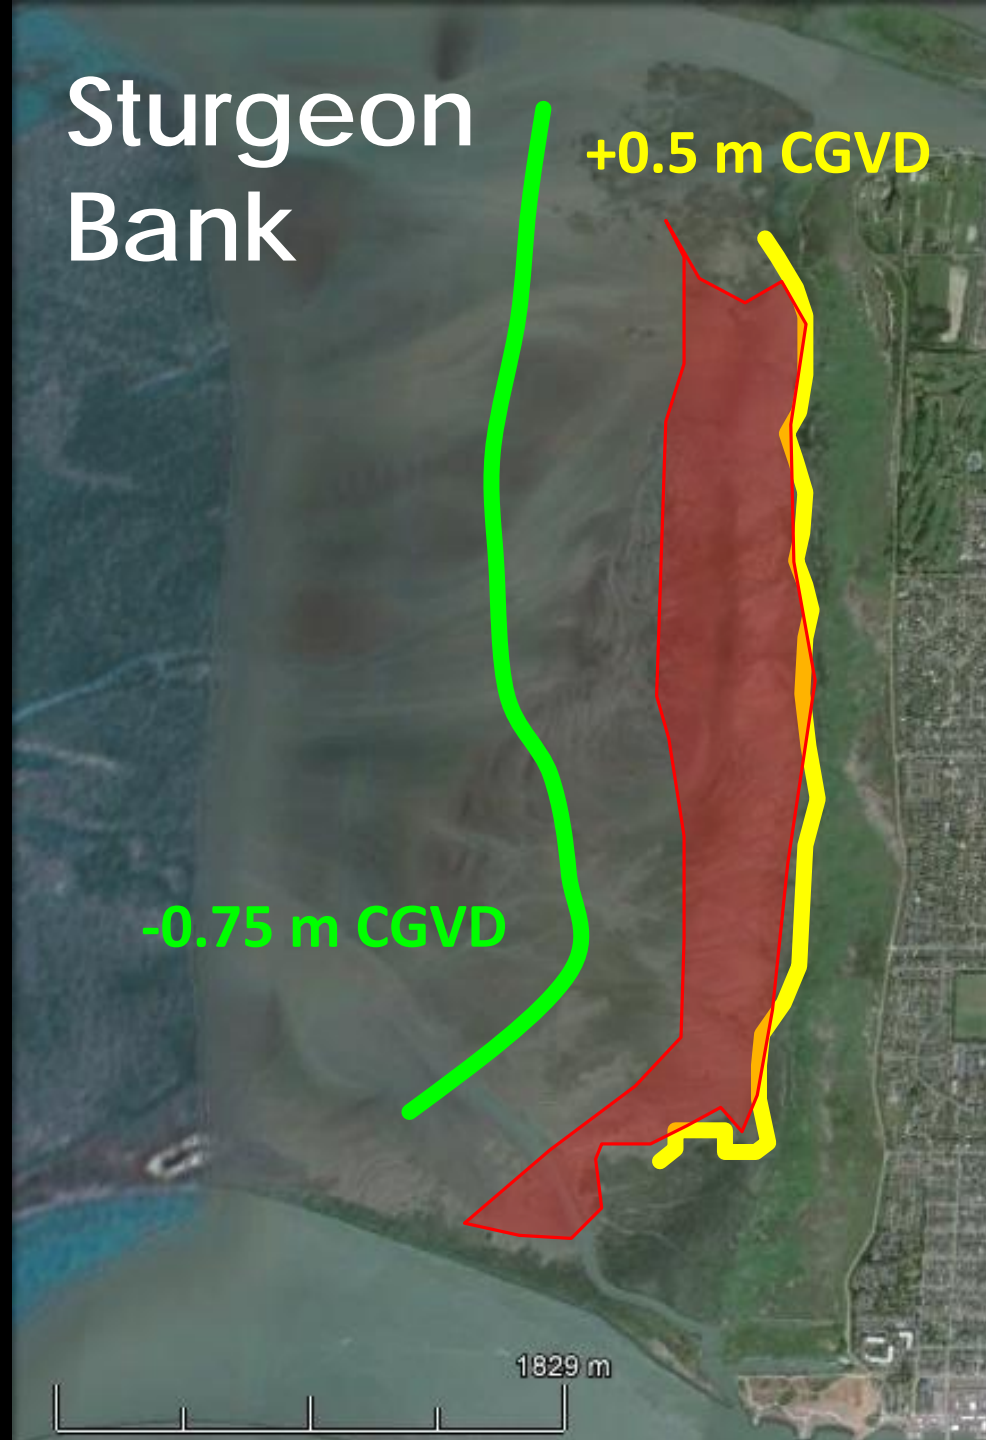
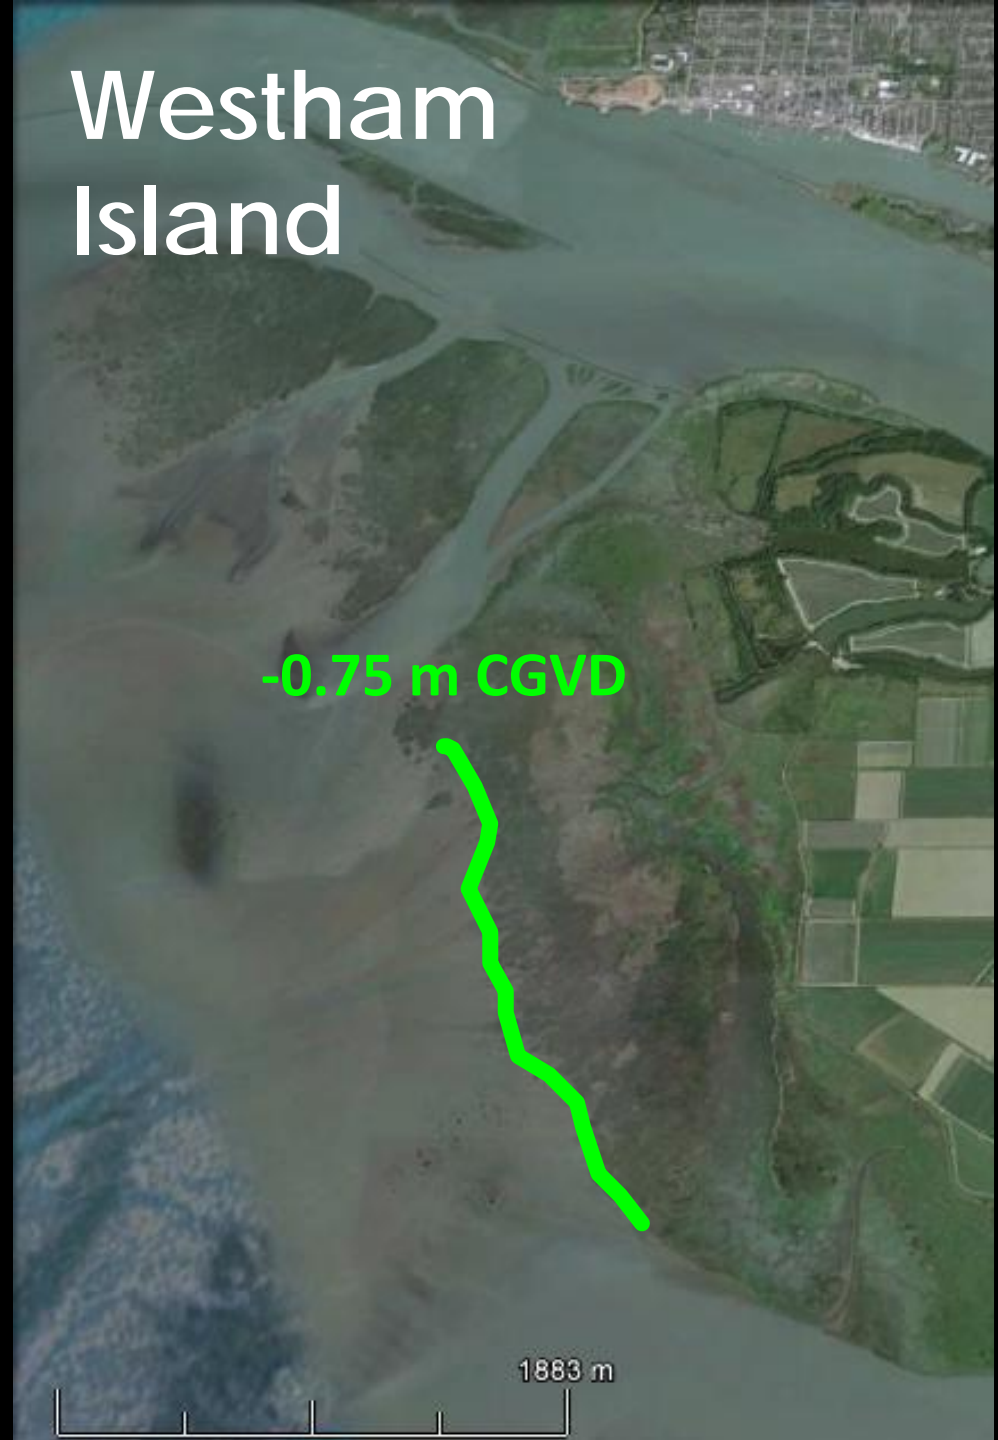
Sturgeon Bank

+0.5 m CGVD

-0.75 m CGVD

1829 m

Westham Island

1883 m

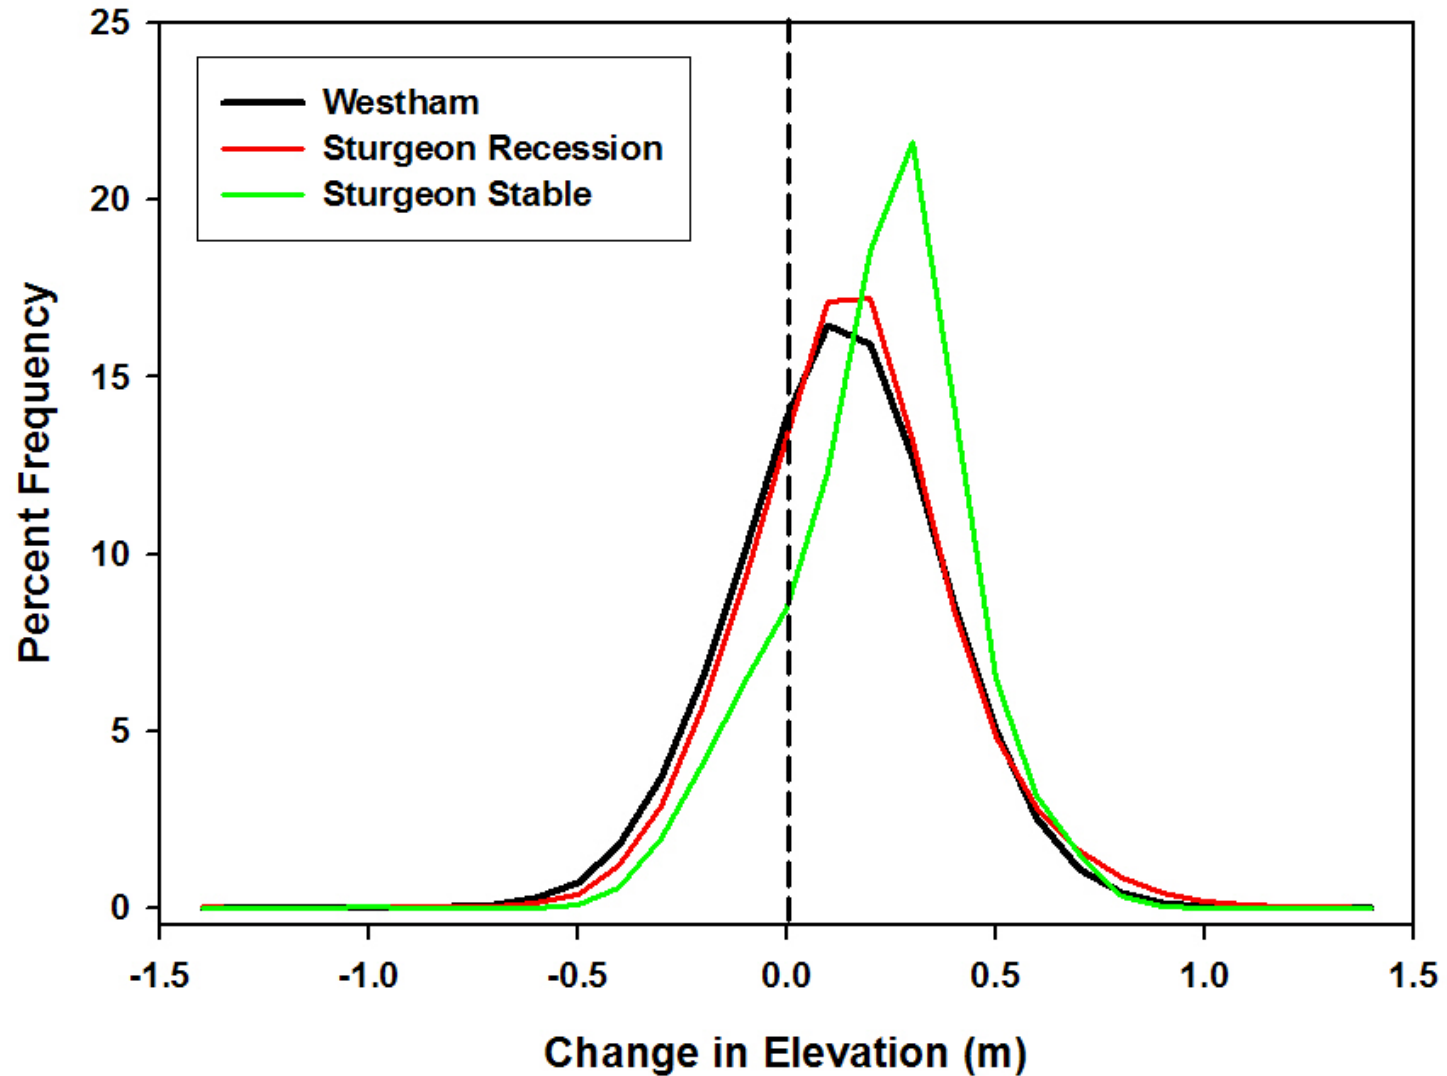
Change in Elevation from 2001 to 2013

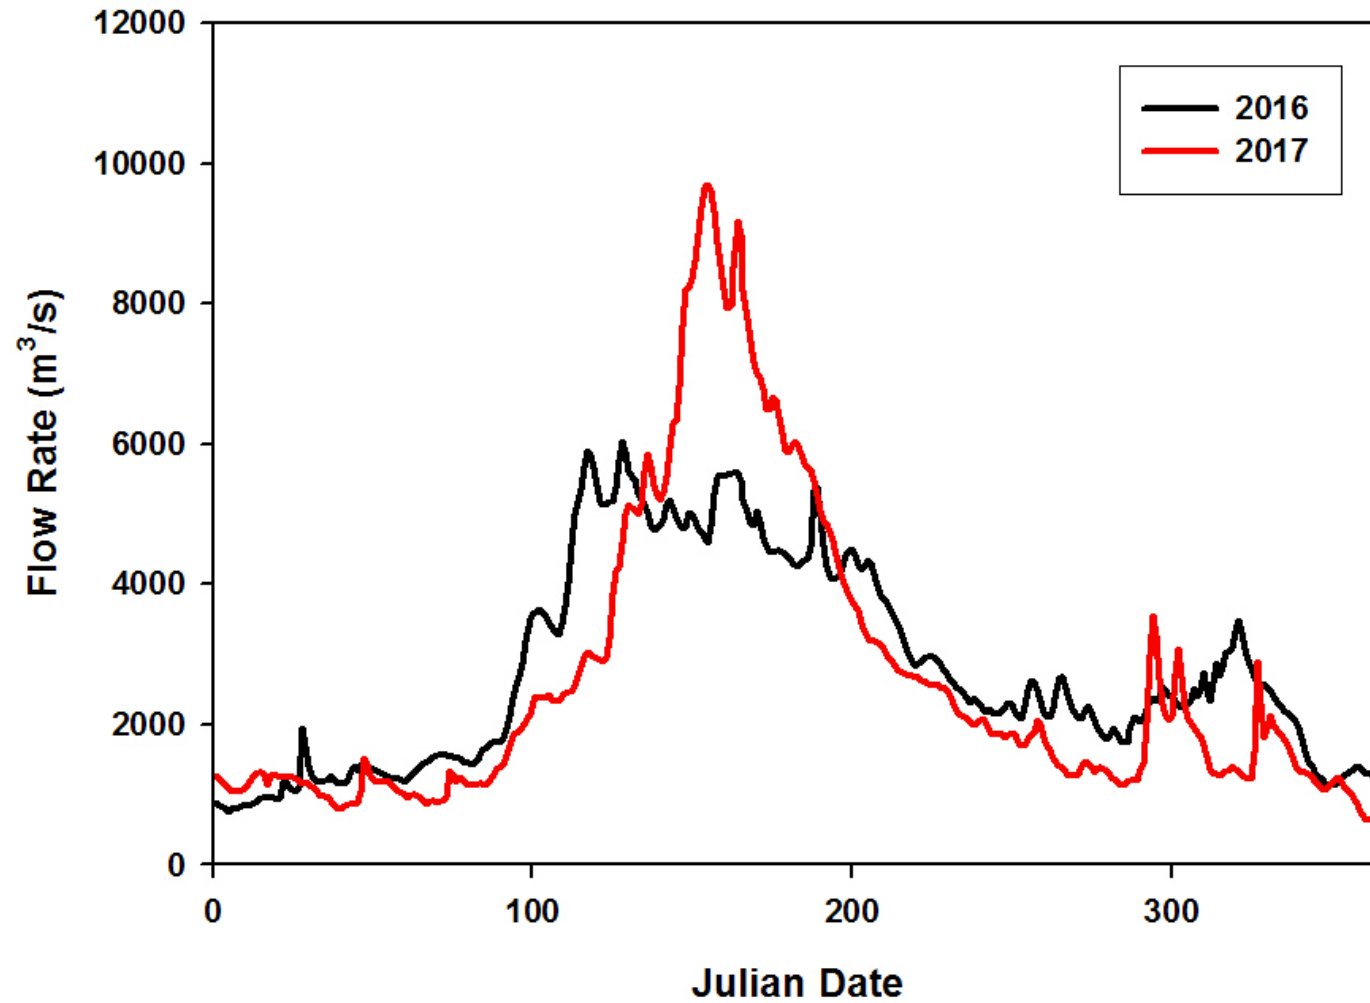
Fraser River Flow Rates at Hope

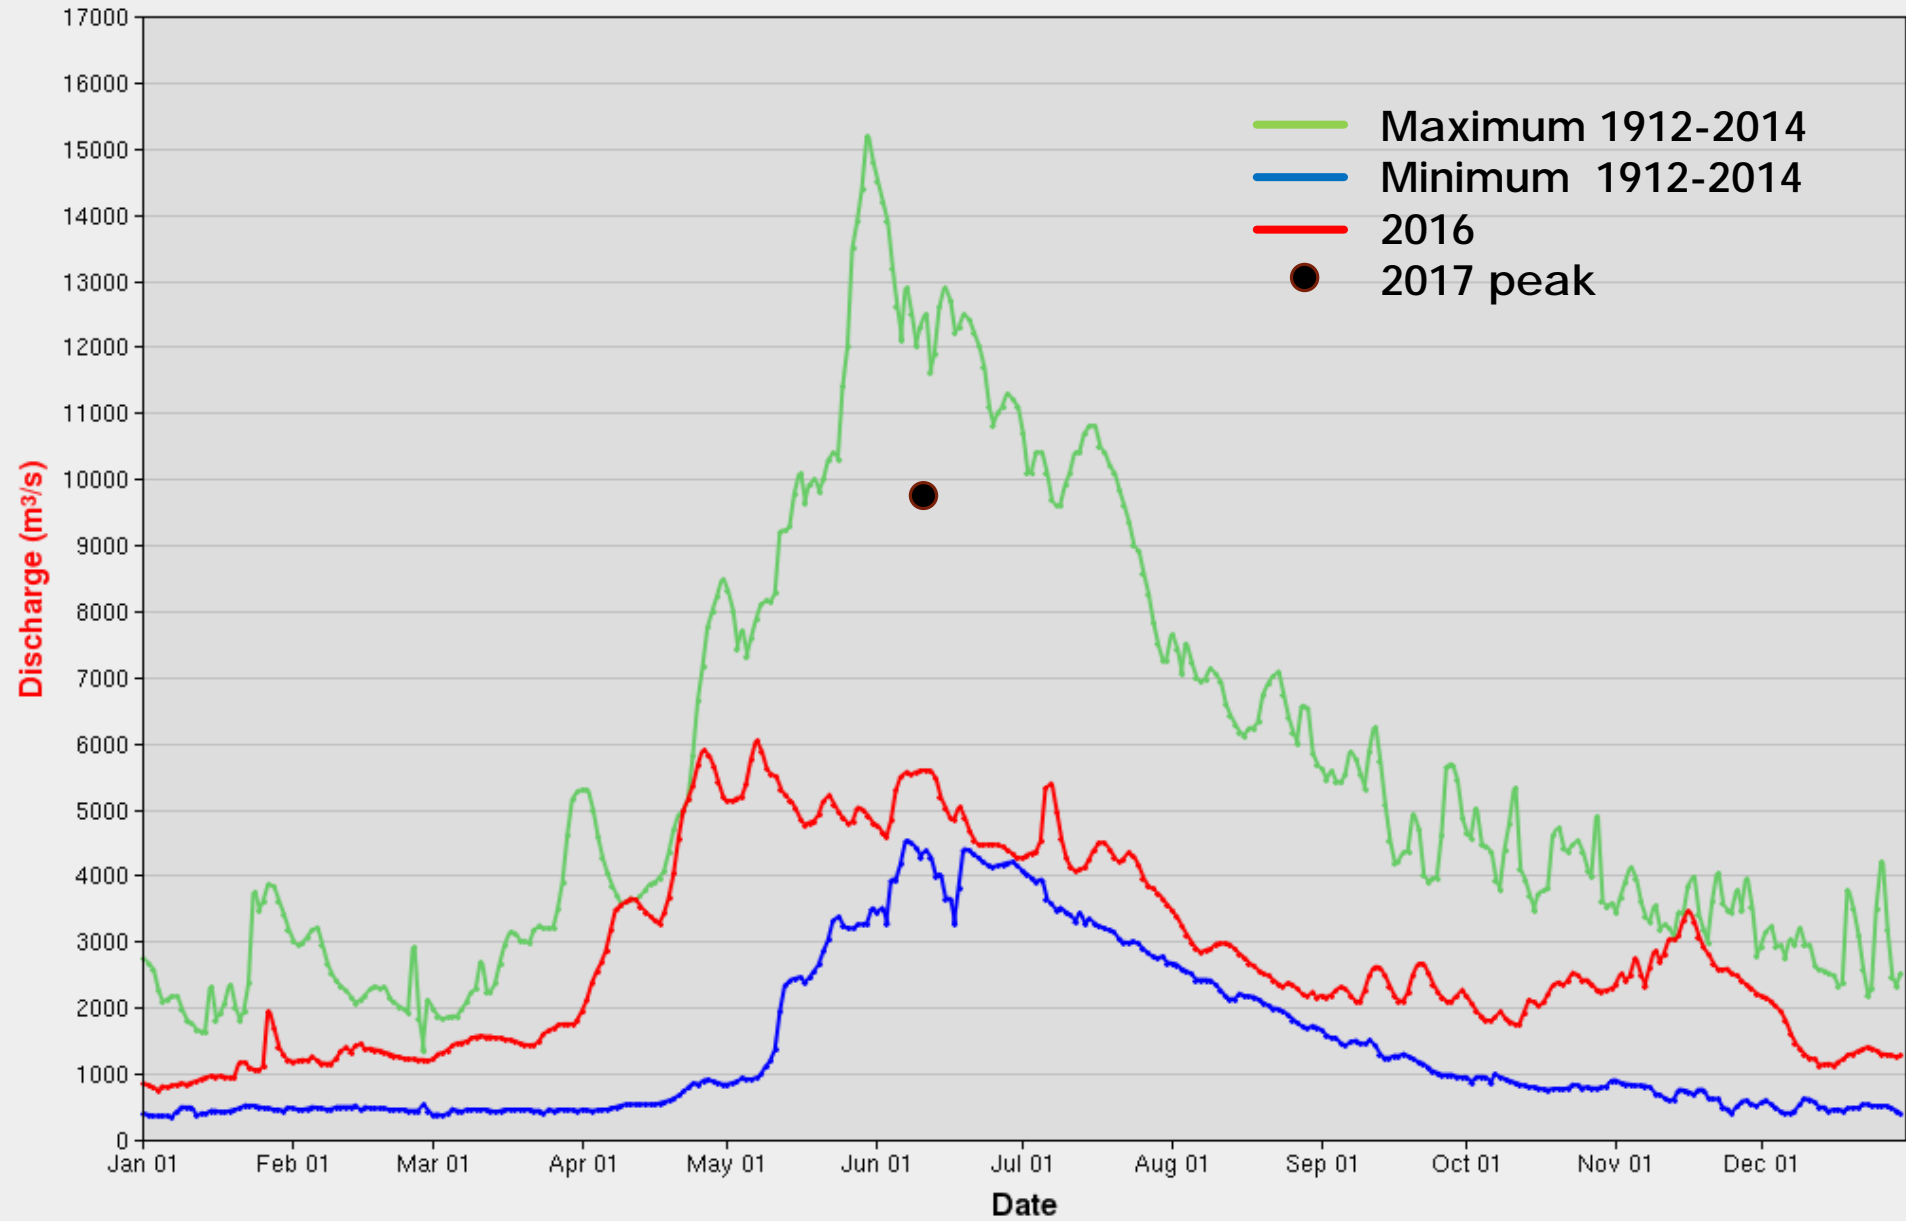
Fraser River Flow

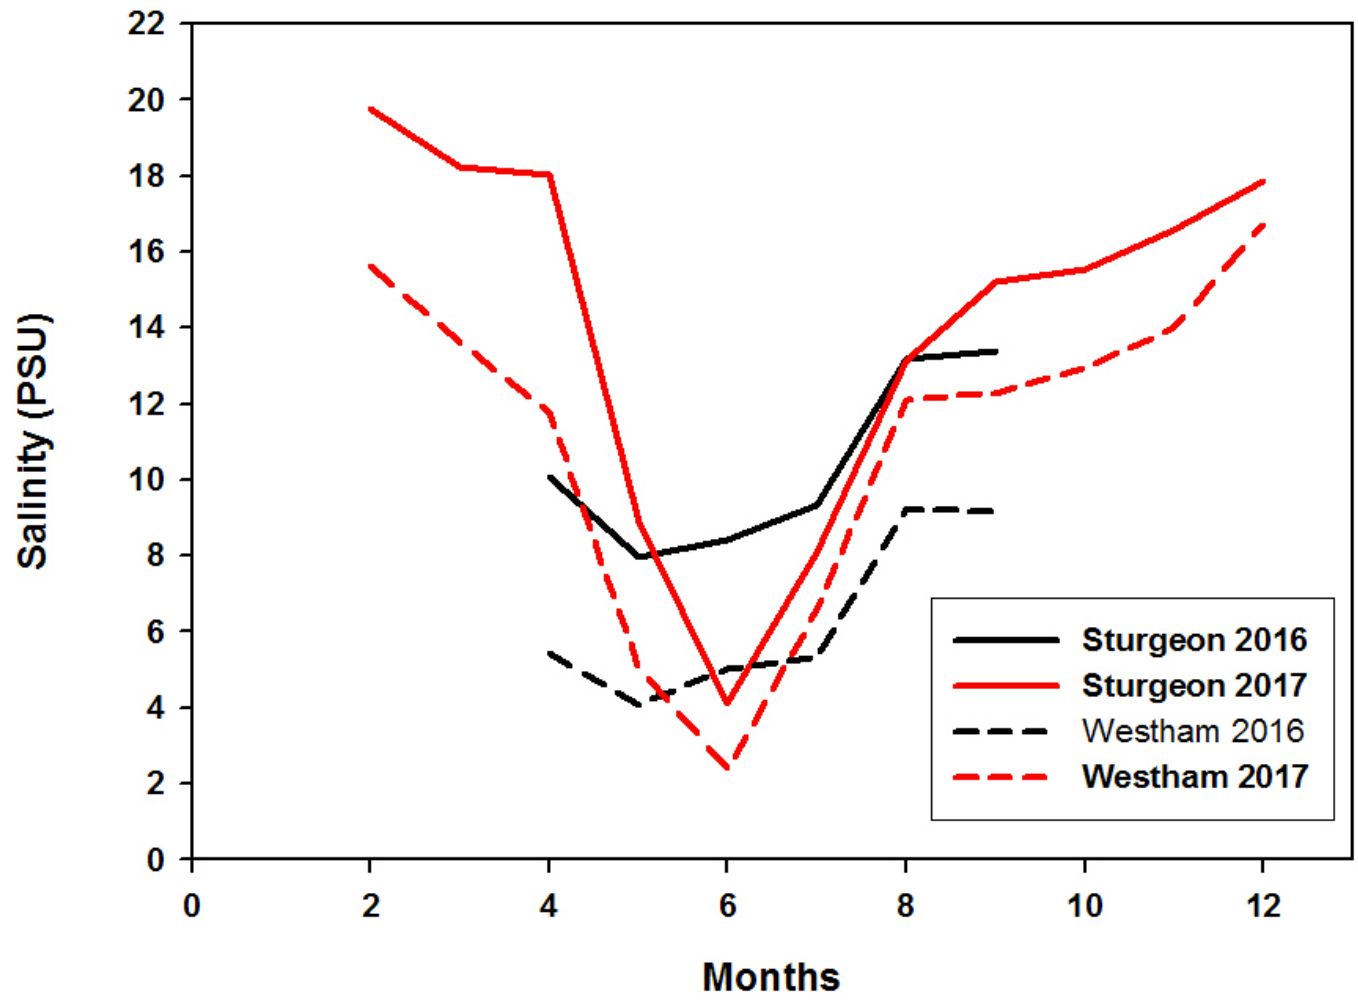
Mean Monthly Salinity

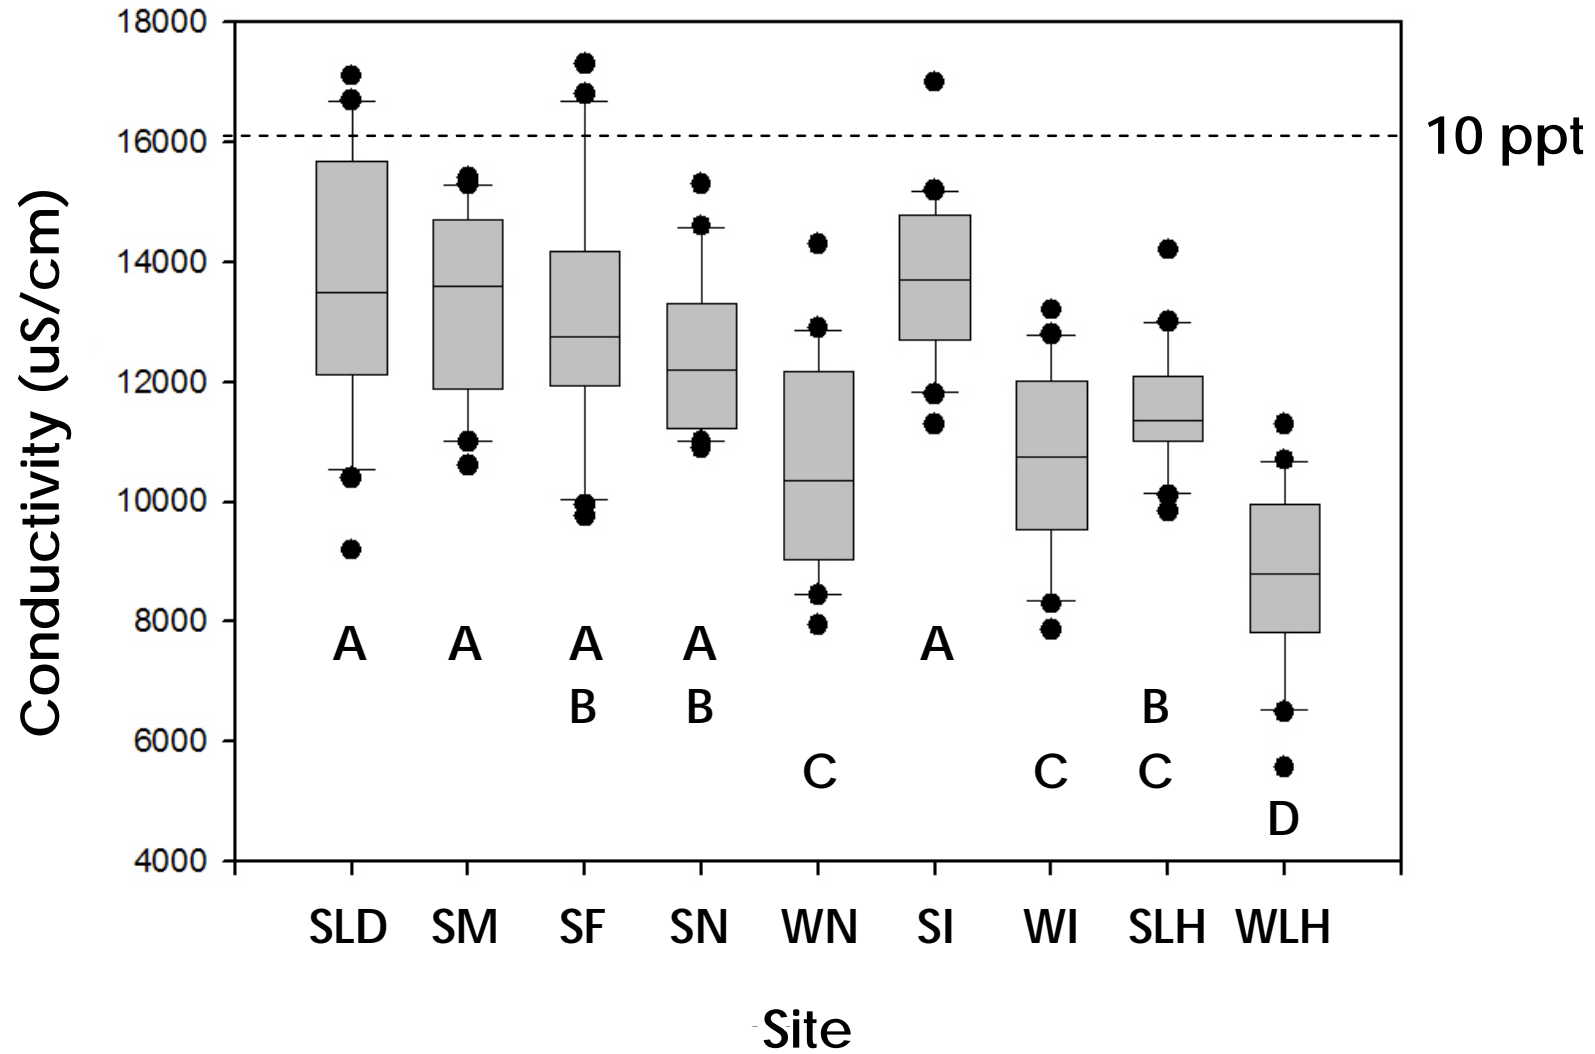
Soil Conductivity

N=20

Collected in 2016
