# Root Cause Analysis of Refinement Engineering for Automobile M

A Starred Paper

Master of Engineering Management

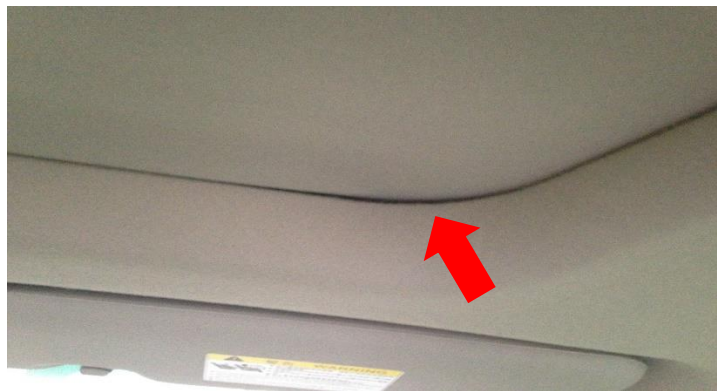
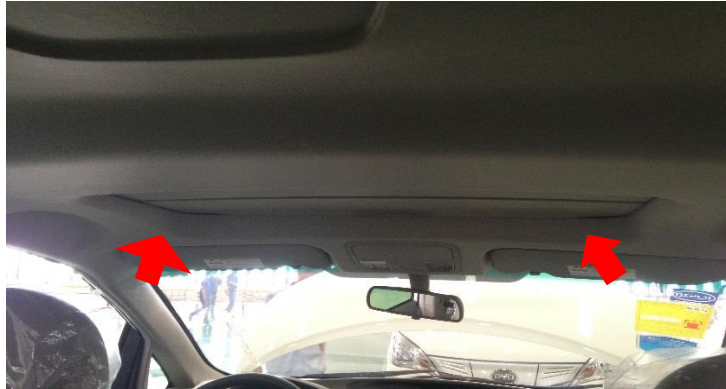
Figure 4: Gap between Skylight and Plafond

1. Photo introduction of parts related to the problem.
  - 1.1 The gap between the skylight and the plafond. The position showed as the red arrows in Figure 4 and Figure 5. When the skylight closed, the left and right edges of skylight could not cling to the plafond.

For the gap between skylight and plafond, the loose error range of plafond led to the problem. Skylight was assembly by welding plant and it was detected by measuring tool, so it had a higher accuracy than plafond. After detecting and analysis, the different altitude intercepts on the two sides of plafond was the cause of the problem. It was proved by rebuilding the plafond and mounting the connected part on plafond within a limited error range, and the gap was eliminated observably.

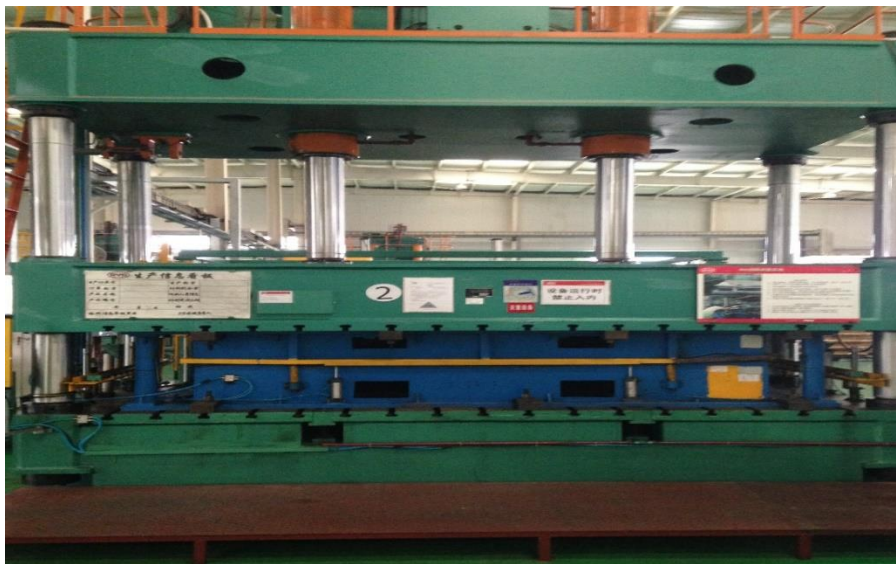
Figure 6: Production Machine of Plafond

1.2 Production process of skylight and plafond. Framework of skylight was assembly by other plant, and plafond was produced through stamping. The key component showed by red arrow on plafond connected to skylight was assembly manually. Showed as Figure 6 and Figure 7. Figure 8 showed the detecting mold of plafond. The lines on the mold were the standard of qualified plafond.

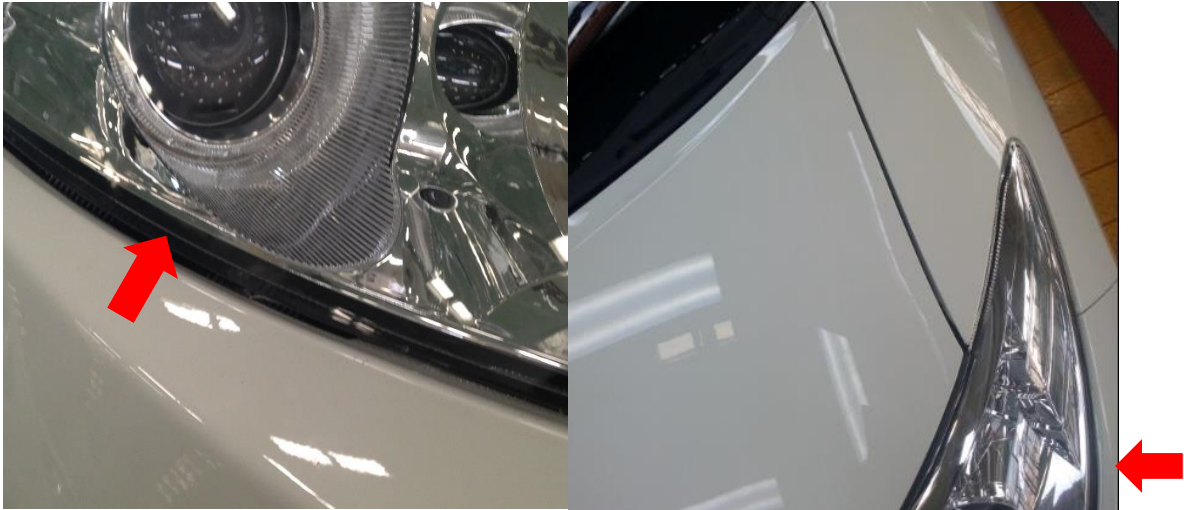
Figure 9: Gap between Lamp and Bumper

- 1.3 The gap between the front lamp and the bumper. Showed as red arrow in Figure 9.

To solve the problem on the lamp and the bumper, deformation experience and structure strengthening were the consideration of the material used in building the bumper. Meanwhile, analyzing car body was the main method to figure out the root cause. By reading the data of CMM detection and trail-producing, reason was confirmed. Because of the loose error range requirement, tolerance accumulation led to quality problem on final products.

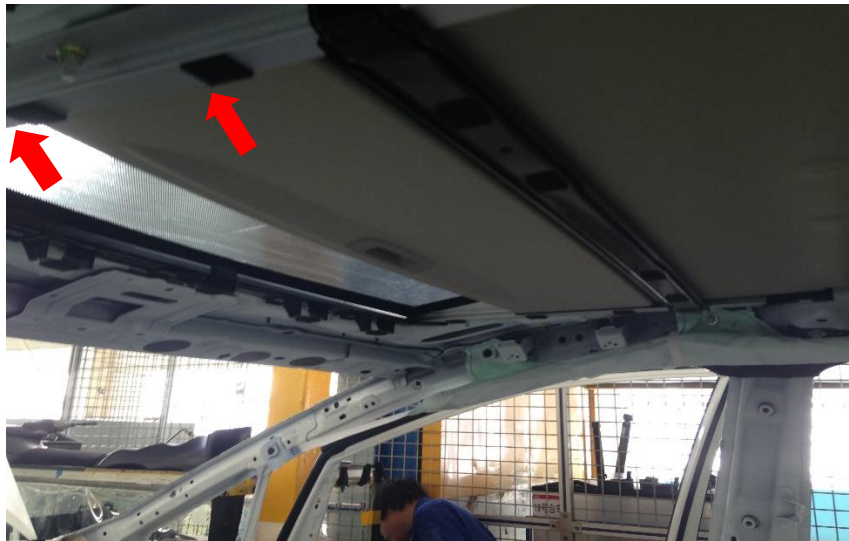
Figure 10: Connected Hasps on Skylight

- 1.4 Assembly of skylight. Figure 10 showed the moment before plafond mounted and the skylight had been installed. The positions of red arrows showed the hasps on skylight that connected to plafond.

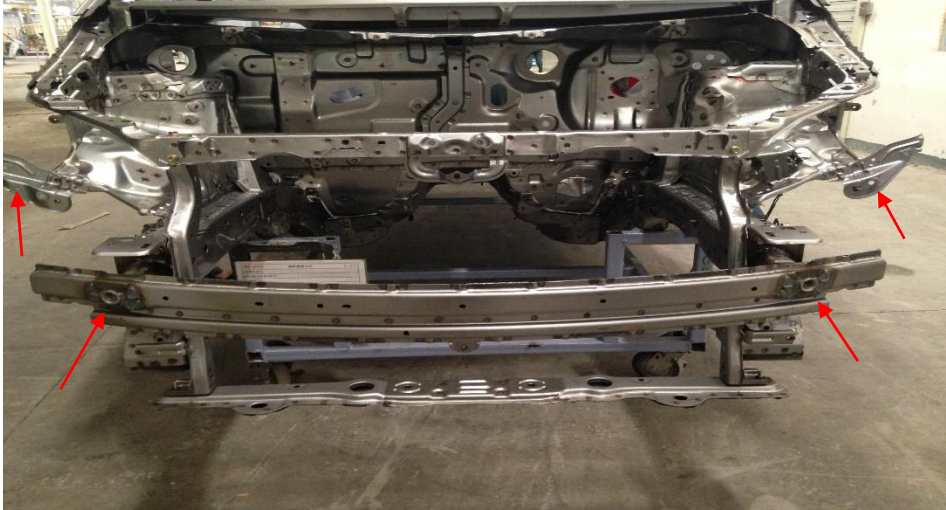
Figure 11: Part of Framework for Auto M

1.5 Framework of front side. In order to analyze the reason of gap between lamp and bumper, observing of bodywork frame is necessary. Red arrows in Figure 11 showed the important install position of lamp and bumper.

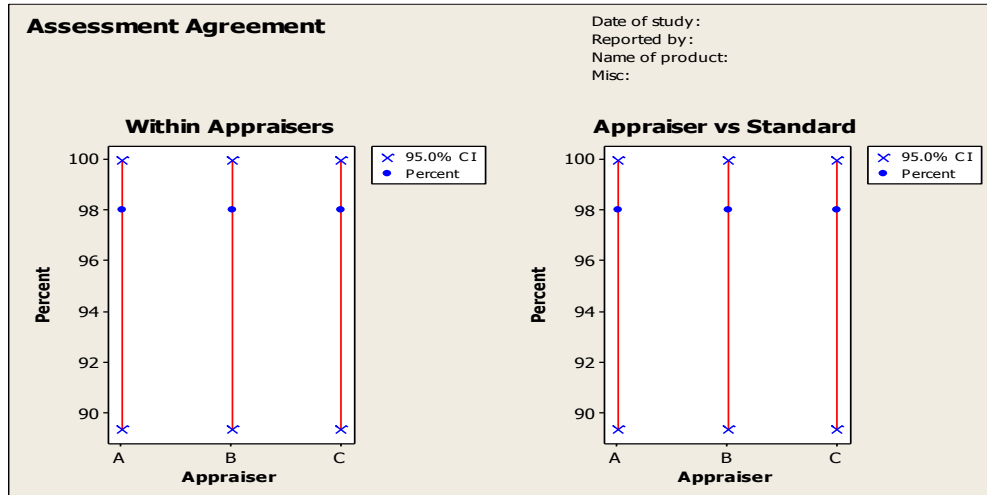
Figure 17: Assessment Agreement Analysis

1. Acceptability of plafond. Based on the production and detecting methods of plafond, Kappa test was used as MSA analysis for the plafond. After typing all data in Table 2 into Minitab and made attribute agreement analysis, figures and results provided for detecting.

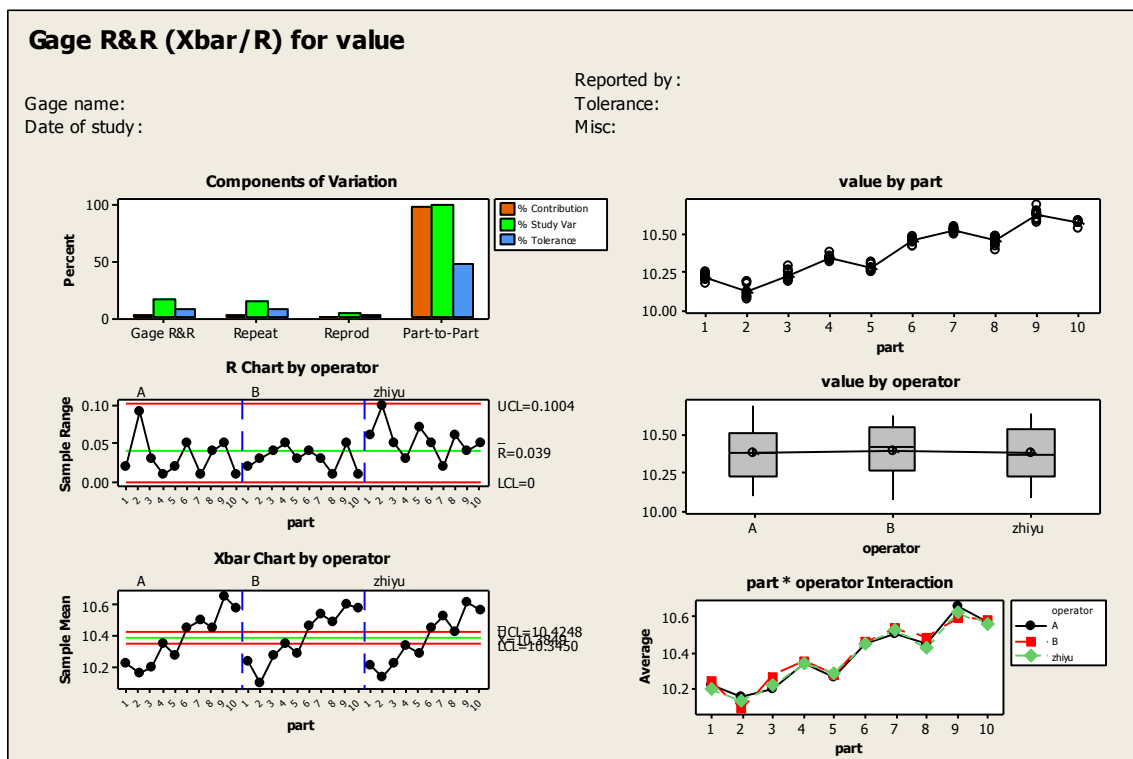
Figure 18: Gage R&R Analysis of Body Plant

2.1 Body plant. Using Minitab as the tool to analyze Gage R&R. After typing in the data in table 3, then chose Stat, Quality tools, Gage study, and then made Crossed Gage R&R study. Reading Figure 18 and Table 11 got from Minitab helped confirm the accuracy of the measurement system.

Normally the measurement system was acceptable if Gage R&R less than 10%, and 14.87% which was between 10% with 30% was also acceptable based on the requirement of auto plants.

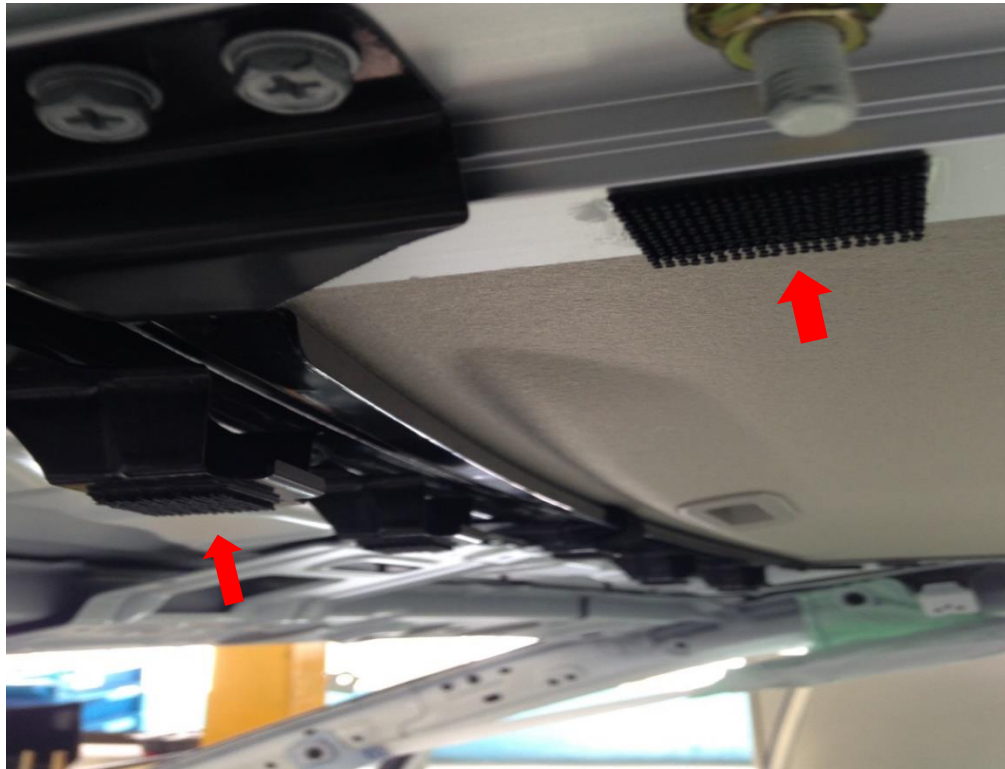
Figure 20: Connected Hasps on Skylight

- #### 3.1 Gap between skylight and plafond. After the basic measurement system analysis, the reason of flaws on skylight was seeking. As the assembly process of plafond and skylight, it was focusing on the connected hasp on plafond and skylight.

Comparing the characteristics of plafond and skylight, a higher error potential existed on plafond because of the production process. As a result, research on plafond was most important. The CMM detecting method of plafond showed as Figure 12 was a way to detect if the product qualified as design. After analysis by engineer, the altitude intercept of two hasps on plafond showed as red arrows in Figure 21 was acceptable.

plafond when the car assembled completely. After disassemble the plafond on the completed vehicle, engineer found the hasp on the right side did not stain the white pigment on skylight. By detecting the altitude intercept of key point and analyzed data, reason was figured out.

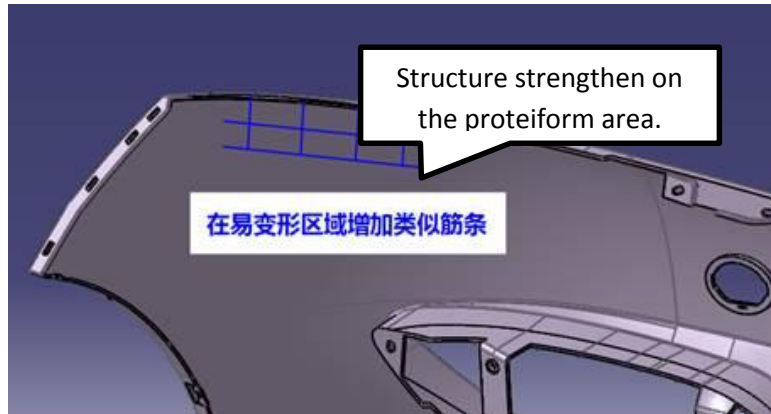
Figure 22: Structure Strengthen for Bumper

3.2.2 Structure strengthen. As the deformation might exist, engineer also made a plan of structure strengthen to seek the reason. In

Figure 22, blue lines showed the position need to be strengthened and trial-produce could show the result.
