## Calendar Year 2008 Report to the Rio Grande Compact Commission

U. S. Department of the Interior  
Bureau of Reclamation  
Albuquerque Area Office  
Albuquerque, New Mexico

March 2009

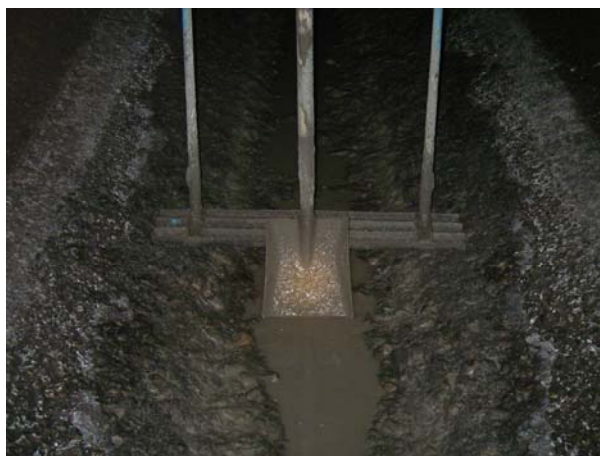
Photo 1. Azotea Tunnel prior to repair

Over time, rocks and sand diverted with high velocity spring flows cause abrasion and impact damage to the tunnel inverts. An Azotea Tunnel repair contract was awarded in September, 19, 2007 for the Phase II repair work. Notice to proceed was issued for the contract on October 17, 2007. The Contract was award to DLM Enterprises of Albuquerque New Mexico. The Contract consisted of repairing a total of 16,000 feet of tunnel invert from Stations 920+00 to 1080+00. Work consists of placing 400 cubic yards of concrete for tunnel invert repair. Work was completed on February 21, 2008. Budget and quantity estimates by the government engineer were within 2% of the actual expense and volume of concrete placed.

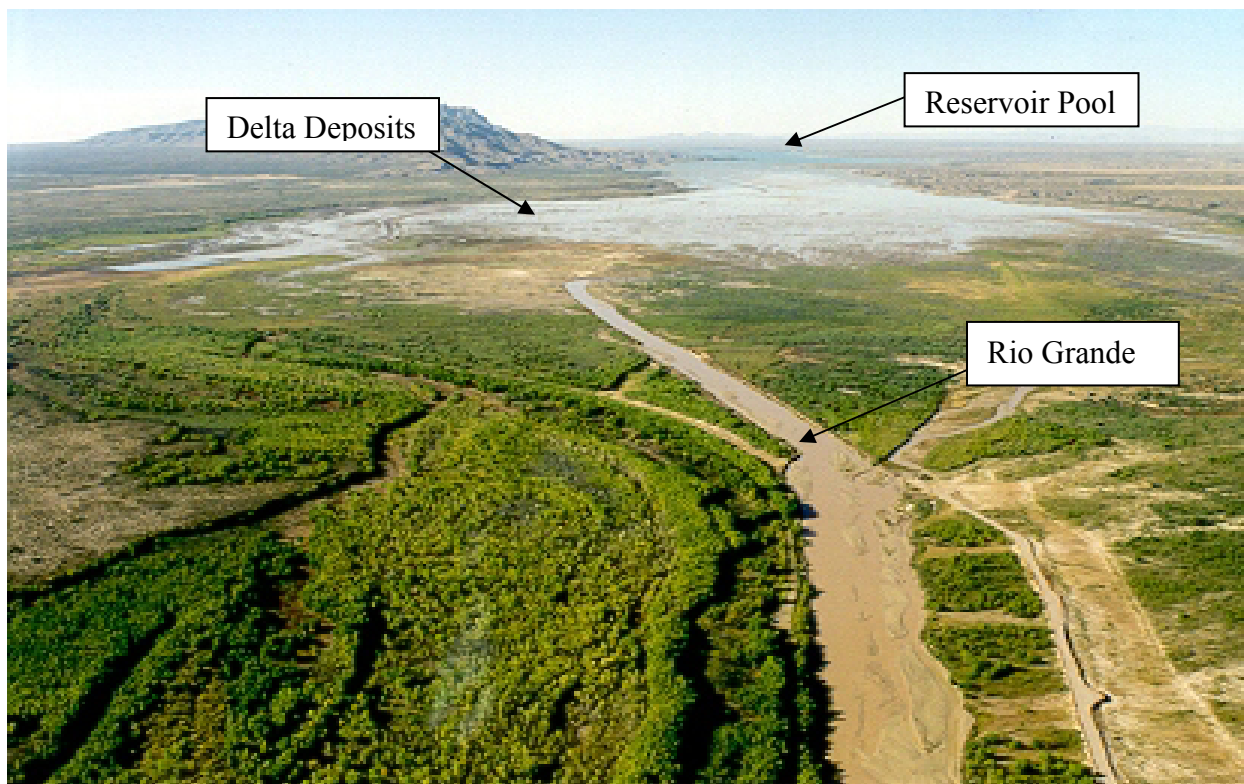
River disconnection has been an issue at the headwaters of Elephant Butte Reservoir since the early 1950s. The contributing factors for the occurrence of disconnection are many: the valley slope is very slight, the incoming sediment load is high, the clay deposits are highly cohesive, and vegetation growth is extremely aggressive. During drought periods when the reservoir pool decreases rapidly, all of these factors make it difficult for the river channel to maintain a connection with the reservoir pool (photo 1). The latest incidence of disconnection began in the late 1990s, and construction of the Temporary Channel began in 2000. The channel was constructed in three phases:

Photo 3. Headwaters of Elephant Butte Reservoir, prior to construction of the Temporary Channel (1998).

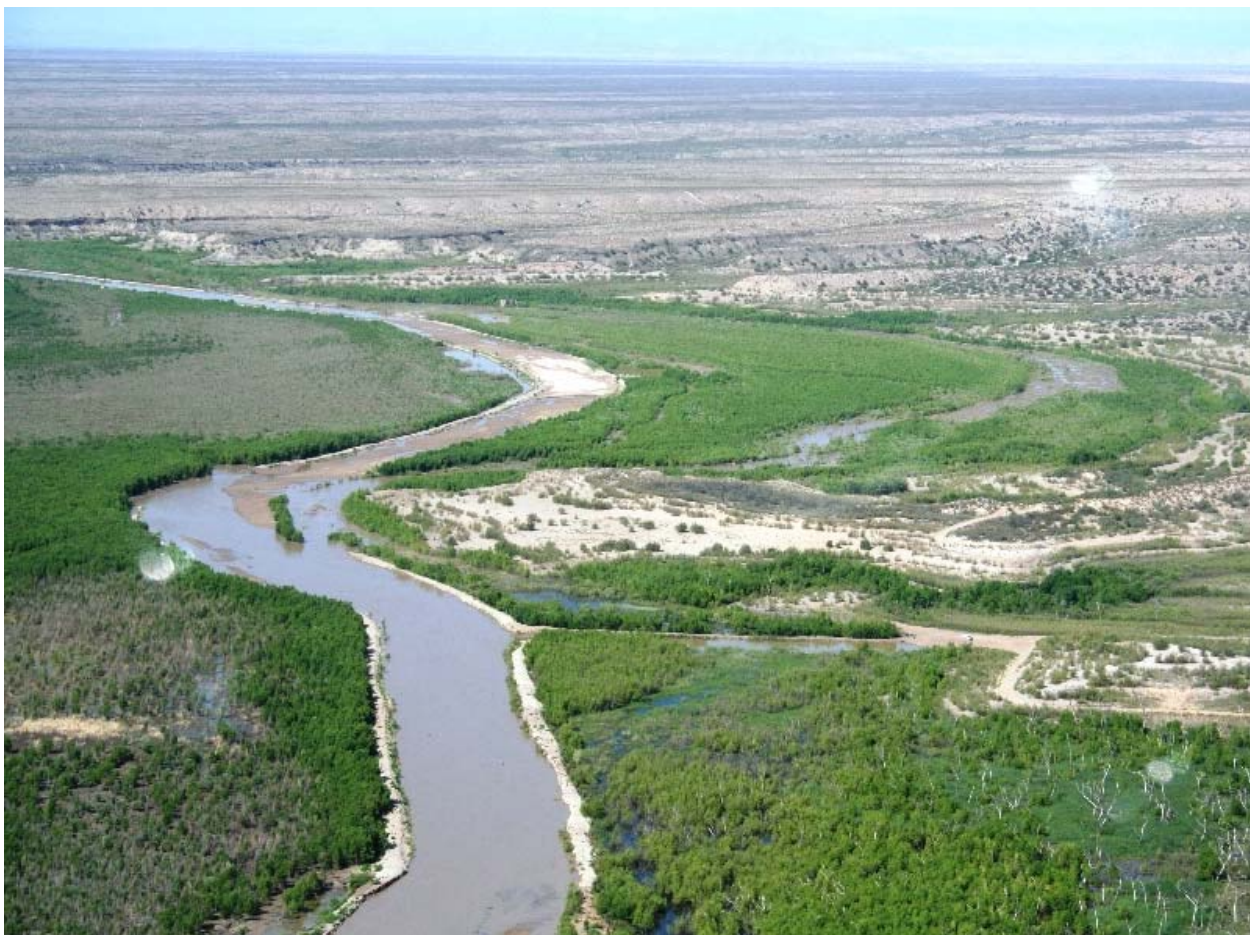
Photo 4. Temporary Channel sediment plug, looking downstream. Red Rock Staging Area is in the foreground (July 2008, Gonzales).

Reclamation crews also performed access road repairs and mowing of vegetation along the shoulders. Equipment maintenance and repairs, by the Socorro Field Division maintenance shop, also continued in 2008. The most significant repairs involved replacement of the wear plates and guides that secure the excavator tracks to the pontoons, completed in 2008.

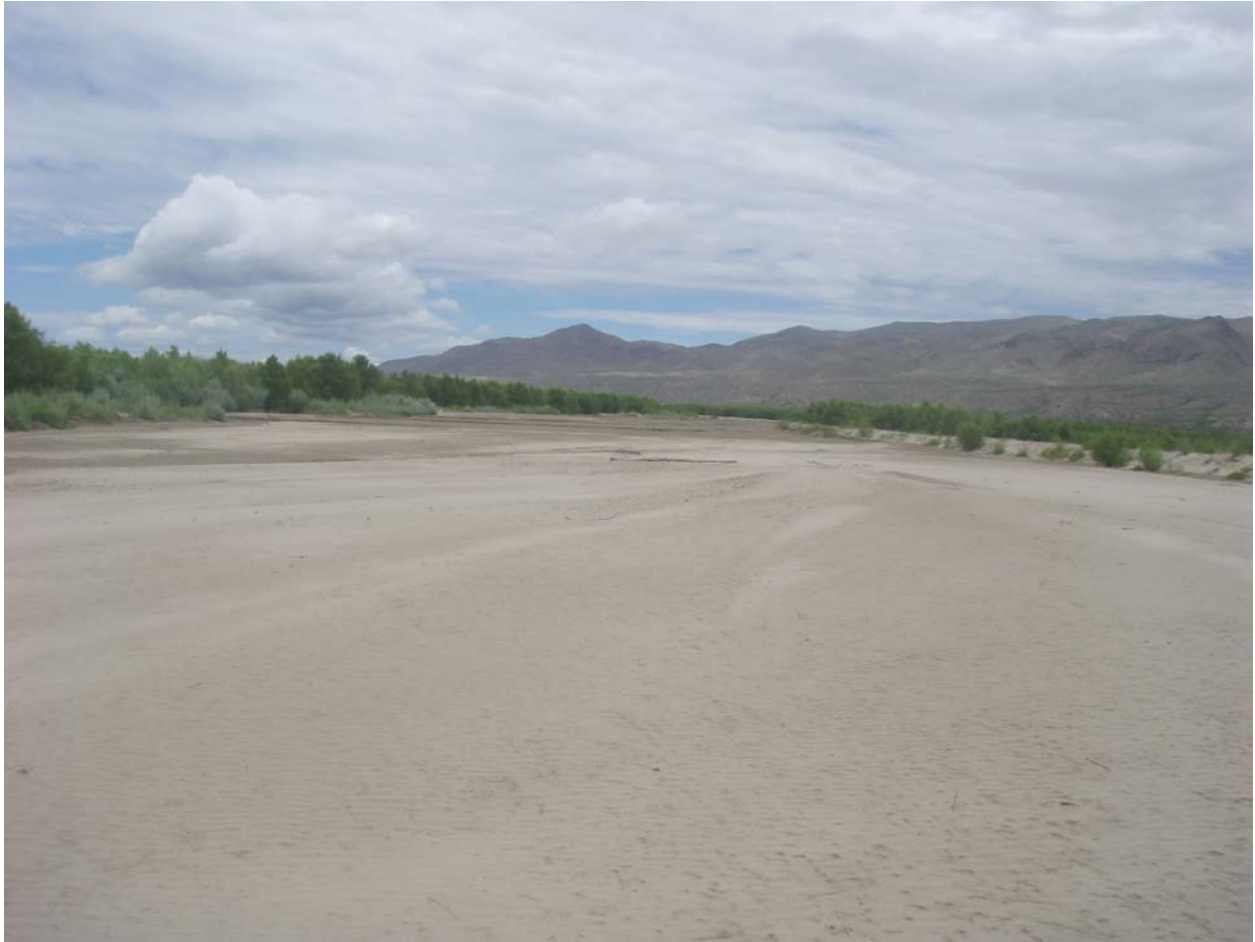
Photo 5. Temporary Channel sediment plug, looking upstream (July 2008, Rolland).

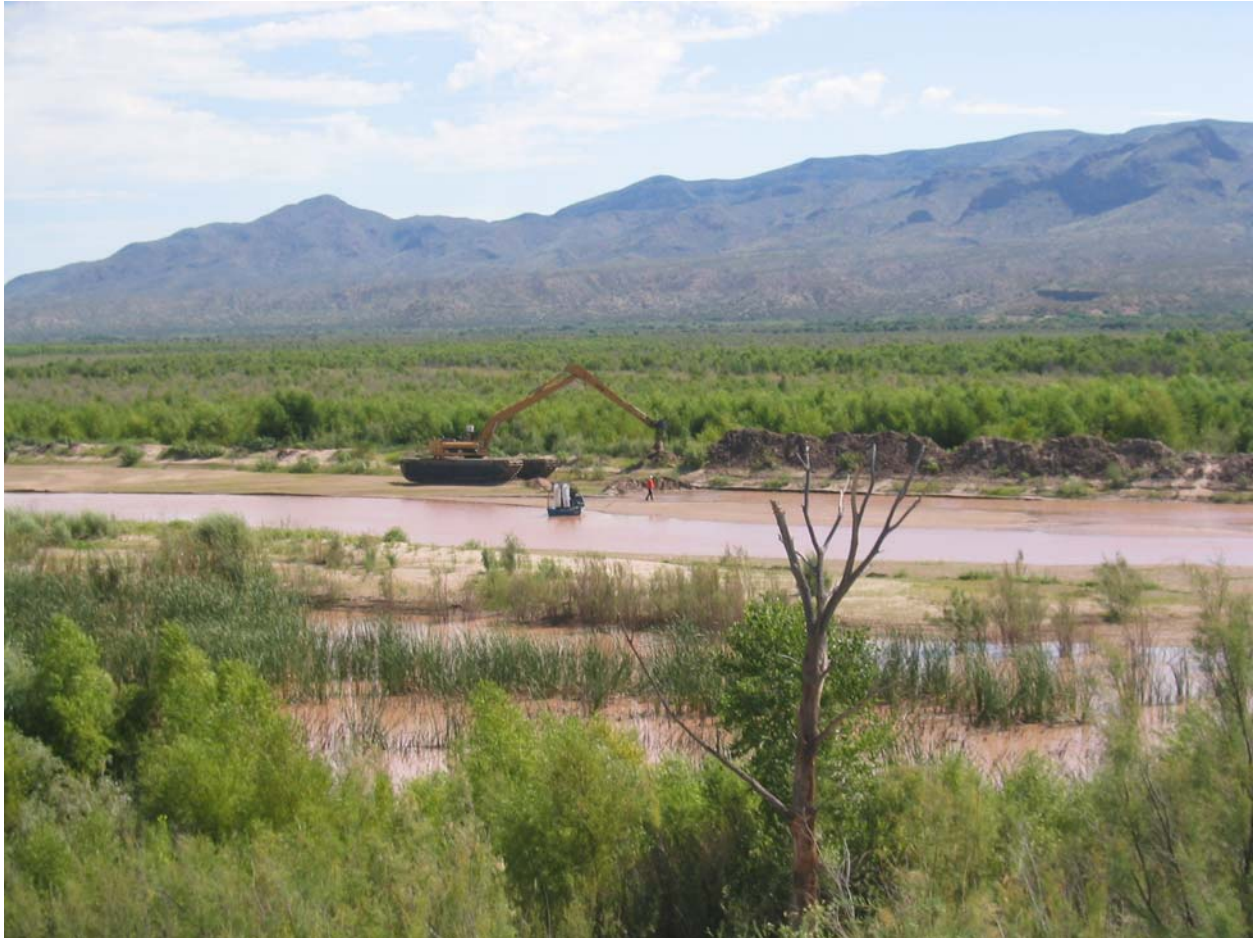
Photo 6. Amphibious excavator working on pilot channel through Temporary Channel sediment plug (September 2008, Weems).

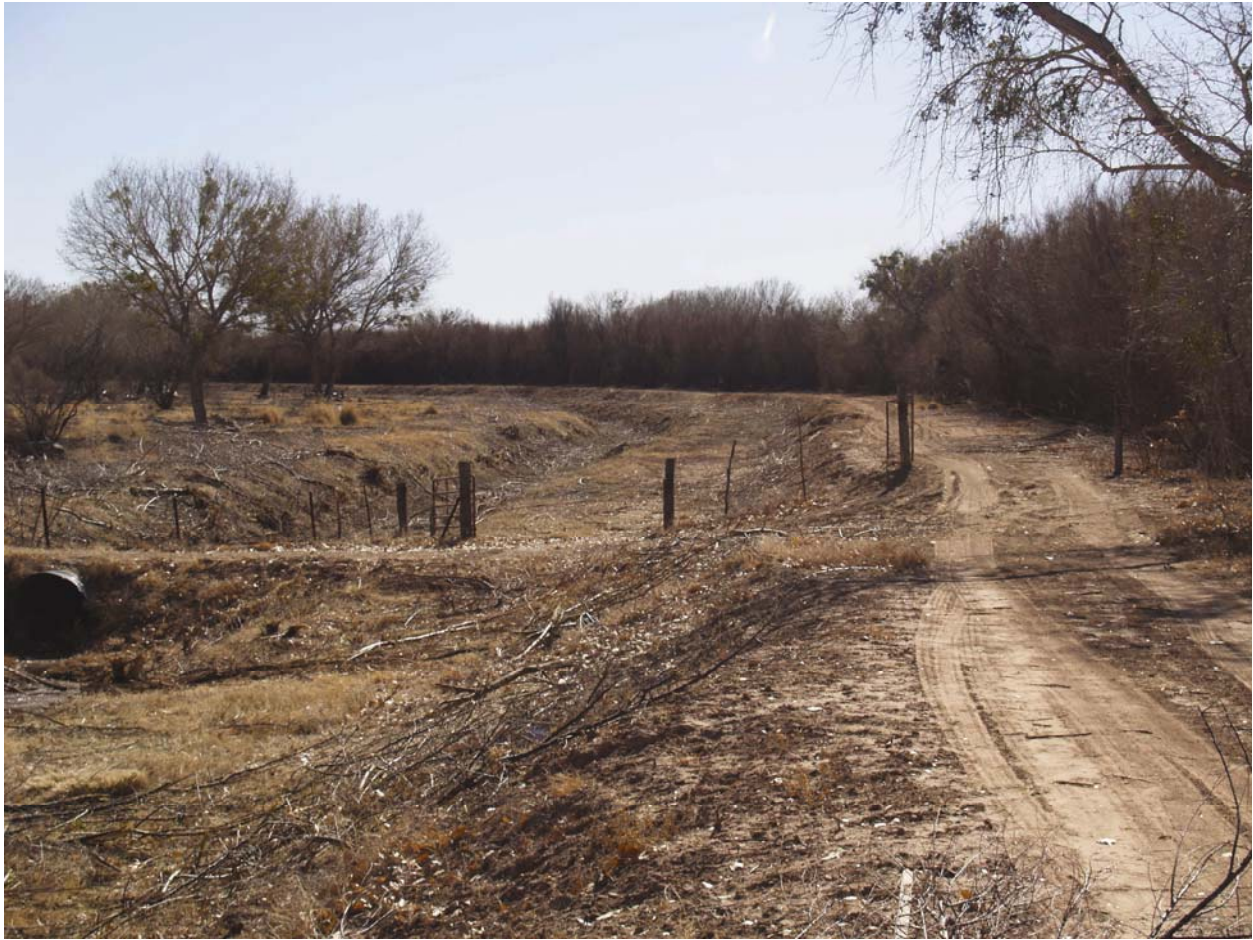
- **Escondida Drain:** In 2008 data collection, designs, and preparation of environmental compliance documents were completed for the Phase II work, which provides for vegetation control, and for reestablishing the outfall to the Rio Grande. Phase II work began in early January 2009, with mowing of the road shoulders and drain prism (Photo 5), and is scheduled for completion by September 2009. These drain improvements are funded on a cost share basis by NMISC and Reclamation.

Photo 7. Recently mowed Escondida Drain, looking south (January 2009, Everetts).

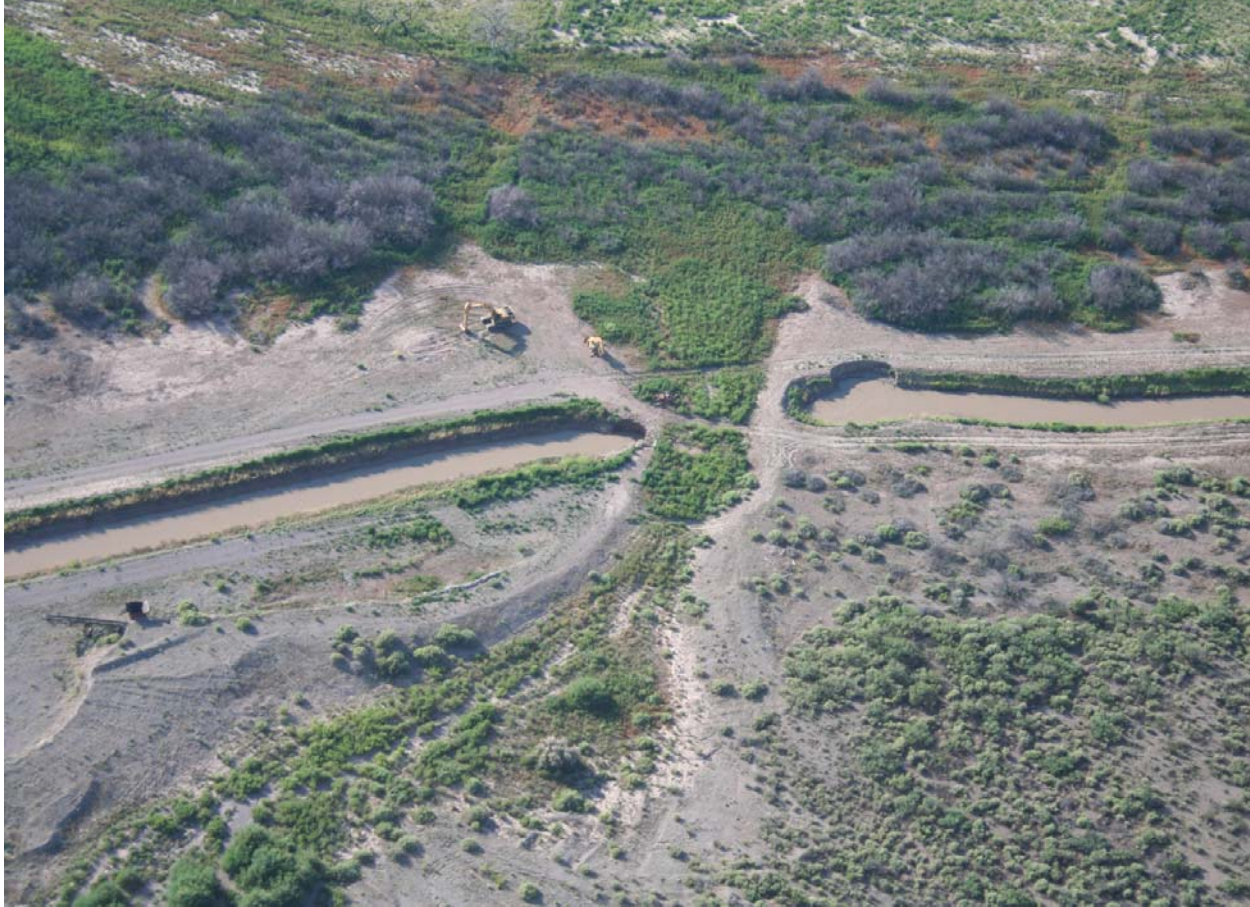
Photo 8. Collapsed culvert on Elmendorf Drain, looking east (July 2008, Gonzales).

- **Elmendorf Drain.** Reclamation completed designs and began preparation of environmental compliance documents for replacement of a collapsed culvert at an arroyo crossing of the drain, within the Bosque del Apache National Wildlife Refuge. Photo 6 shows the culvert shortly after the collapse began. The culvert continued to collapse and was eventually removed. The new culvert will be a 7-foot diameter reinforced concrete pipe (RCP), 200 lineal feet in length, and work is scheduled to begin in June 2009. The work will be accomplished cooperatively by NMISC, Reclamation, MRGESACP, and Bosque del Apache.

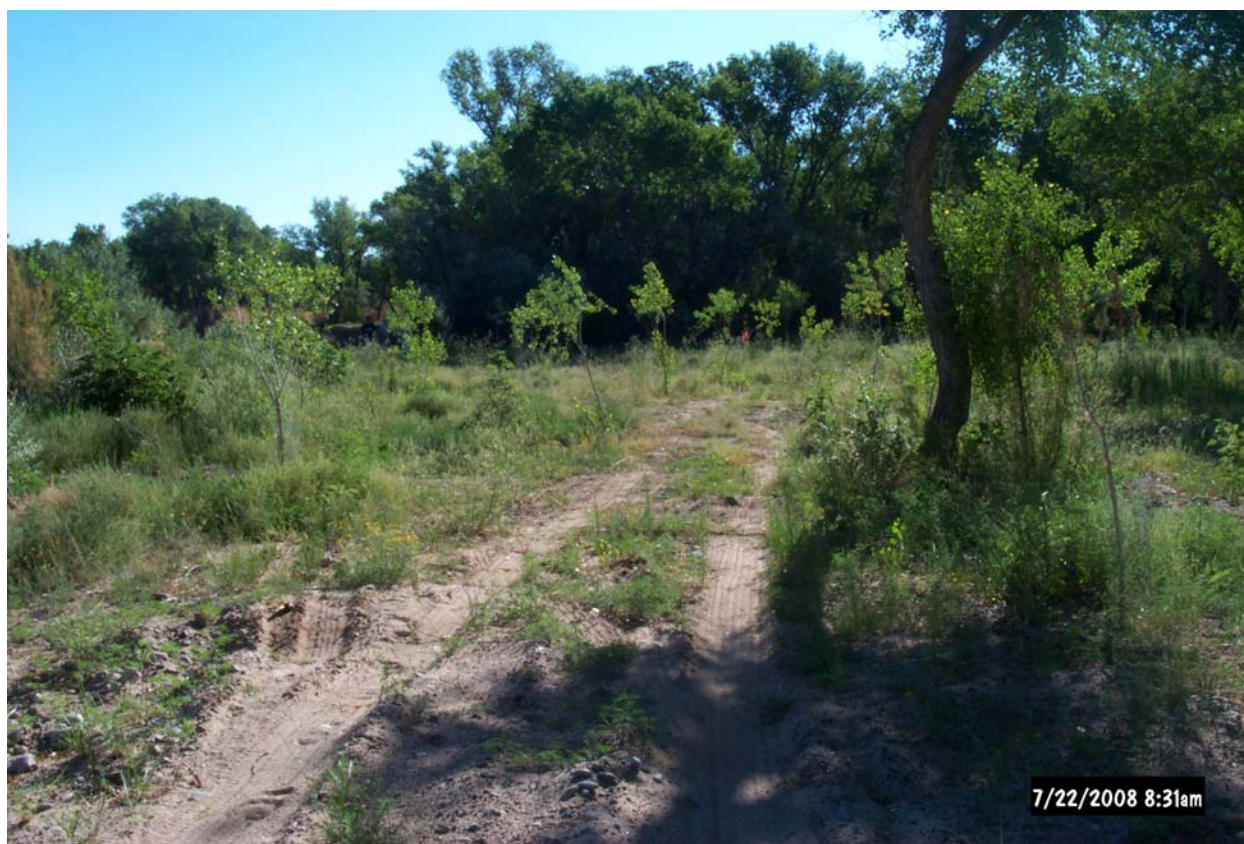
The primary concern at the San Ildefonso Pond priority site is that the east bank of the Rio Grande is very close to the berm surrounding the pond; the distance between the edge of the river channel and the toe of the berm is as little as 50 feet in some areas. Furthermore, the bend upstream of the pond has been observed to be eroding very actively during the spring runoff's of 2005, 2007, and 2008. Reclamation completed the construction of rock vanes to provide protection to the pond in 2007. In January of 2008 150 native cottonwood and black willow poles were delivered by Reclamation to the Pueblo of San Ildefonso. Under an agreement with Reclamation, the Pueblo planted these poles in the area disturbed by the construction project. A site visit in July 2008 found the majority of the planted poles doing well (Photo 7). While there is still a block of dense vegetation that provides substantial protection against flanking of the buried rock vanes, an optional plan is being developed to provide the necessary protection in the event the bend destabilizes the vegetation. This design plan would only be implemented if ongoing monitoring of the site reveals that the bend has moved to such a degree that additional flanking protection is necessary. Work on this design plan is in progress.

Photo 9. Poles planted around the buried rock vanes at San Ildefonso, viewed looking upstream. The active bend is upstream of the group of mature trees (July 2008, AuBuchon)

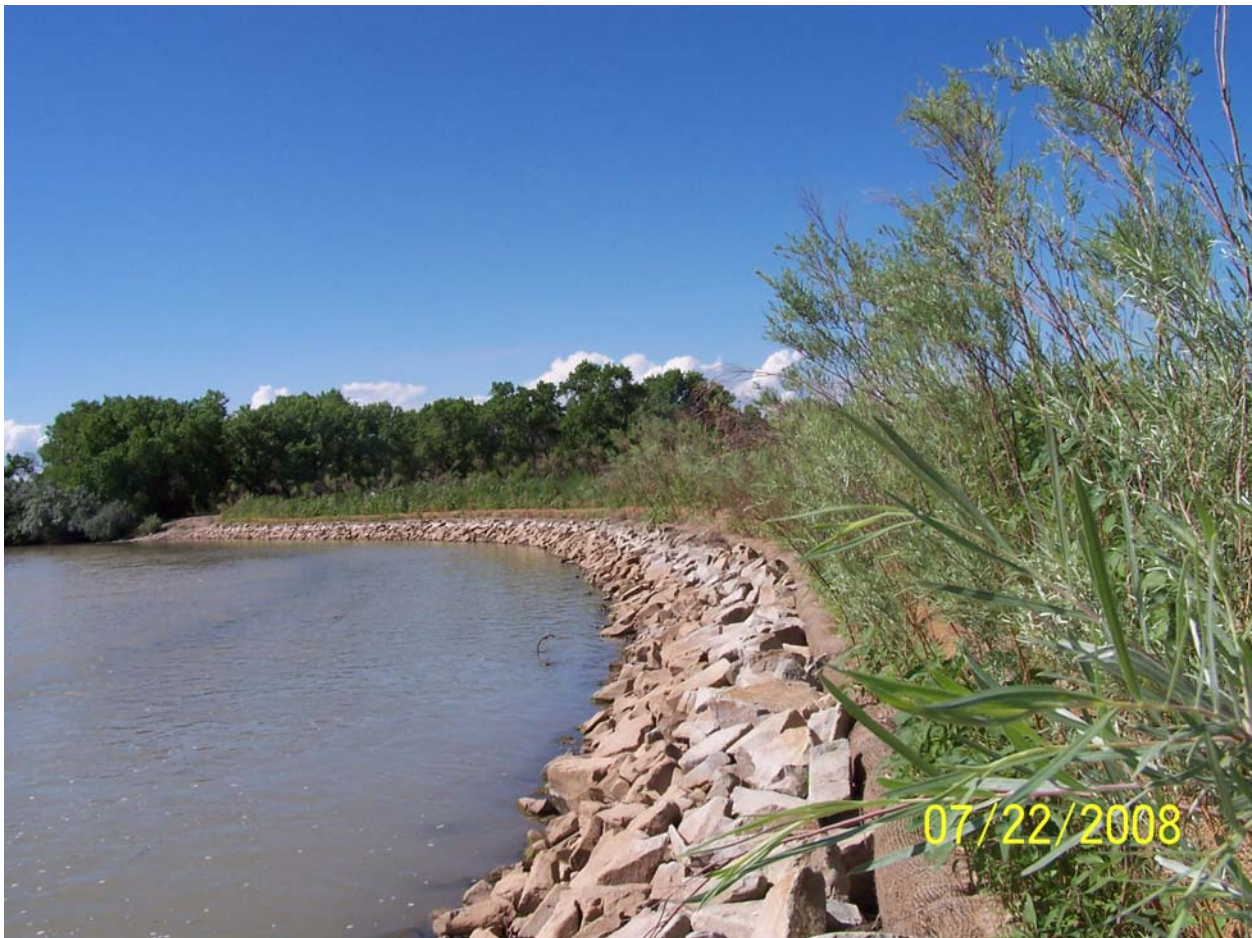
There are two priority sites on the Pueblo of Cochiti: one (at RM 231.3) is on the west side of the Rio Grande about 1 mile downstream of Cochiti Dam, and the other (at RM 228.9) is on the east side, about 3 miles downstream of the dam. At RM 231.3 (Photo 8), the west bank of the channel has migrated beyond the jetty jack line and is very close to a road and some agricultural fields. At RM 228.9 (Photo 9), the main channel is on the west side of a large island, and the secondary channel is on the east side. The secondary channel carries water year-round. The concern at this site is that the secondary channel was slowly, but steadily, migrating eastward toward the levee and riverside drain. Construction at both sites was completed during the summer of 2008. While poles were planted as part of the bioengineered bankline, additional planting is still required in the areas disturbed by construction activities. Sites reviews during and after the spring runoff, revealed that native vegetation was already returning to the site, so revegetation efforts at this site were postponed. Native species vegetation recruitment will be monitored during the 2009 growing season. In coordination with the Pueblo of Cochiti plans to restore native species vegetation will be prepared as necessary during the 2009 growing season.

Photo 10. Bankline protection on the Pueblo of Cochiti at RM 231.3 (July 2008, Baird)

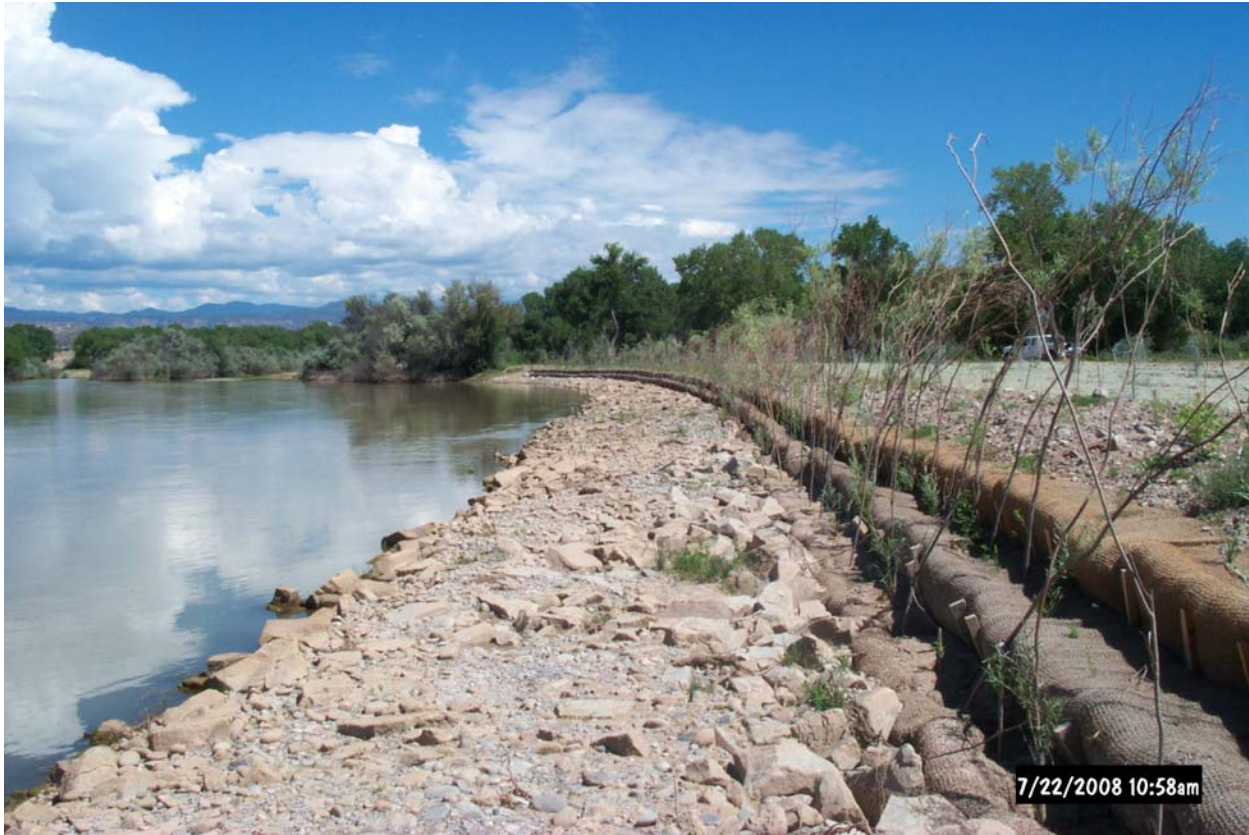
Photo 11. Bankline protection on the Pueblo of Cochiti at RM 228.9 (July 2008, AuBuchon)

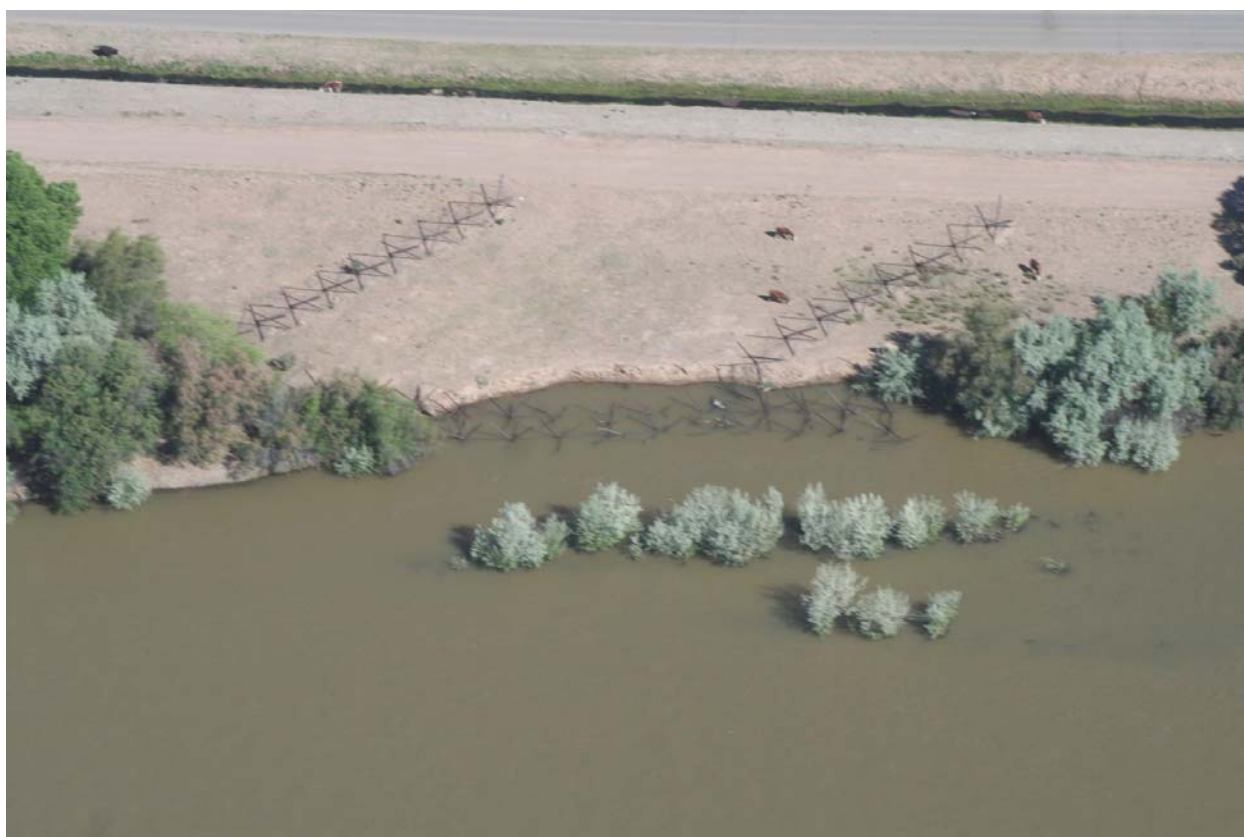
There are currently three priority sites on the reach of the Rio Grande passing through the Pueblo of Santo Domingo (RM 225.1, RM 224.6, and RM 223.9). At these sites, bankline erosion on the west side of the river is cause for concern because of the close proximity to the levee and riverside drain. Priority Site No. 2 (RM 224.6), which is across from the confluence of the Rio Galisteo, is shown in Photo 10. A Data Collection and Confidentiality Agreement was executed between the Santo Domingo Tribe and Reclamation in August 2007 to allow collection of design data for the three priority sites. Design data collection was completed in December 2007, and a geomorphic analysis was completed in May 2008. An evaluation of design alternatives for each of the sites was completed in December 2008 and selection of a preferred alternative for each of the sites is anticipated early in 2009.

Photo 12. Santo Domingo Priority Site No. 2 (RM 224.6), looking west (June 2008, Gonzales).

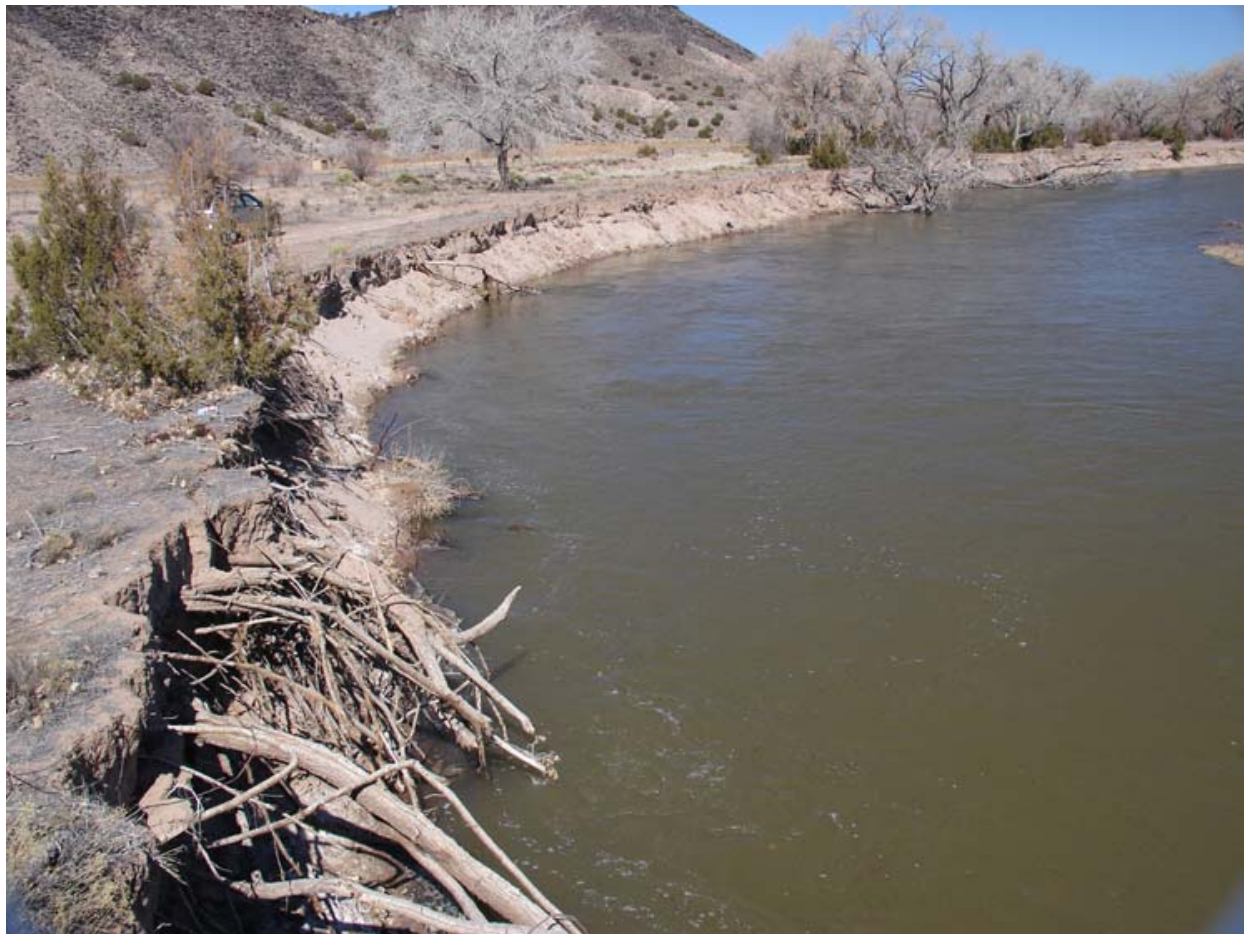
There are currently nine river maintenance priority sites on the Pueblo of San Felipe. Current conditions at these sites could lead to damage of levees, irrigation infrastructure, roads, and a residential area of the Pueblo. In late 2006, Reclamation obtained permission from the Pueblo to collect cross-section and bed material data for use in designs to address these sites. Hydrographic data was collected in spring 2007. A geomorphic analysis was completed in June 2008, and four sites were selected for initial consideration. Designs for these sites should be completed by March 2009, and construction is expected to begin in late 2009 or early 2010. Photo 11 shows the site at RM 213.4R.

Photo 13. Upstream view of eroding terrace at Priority Site 213.4R, San Felipe. Note the location of the levee about 60 feet west of the bank edge. (February 2008, Mussetter Engineering, Inc.)

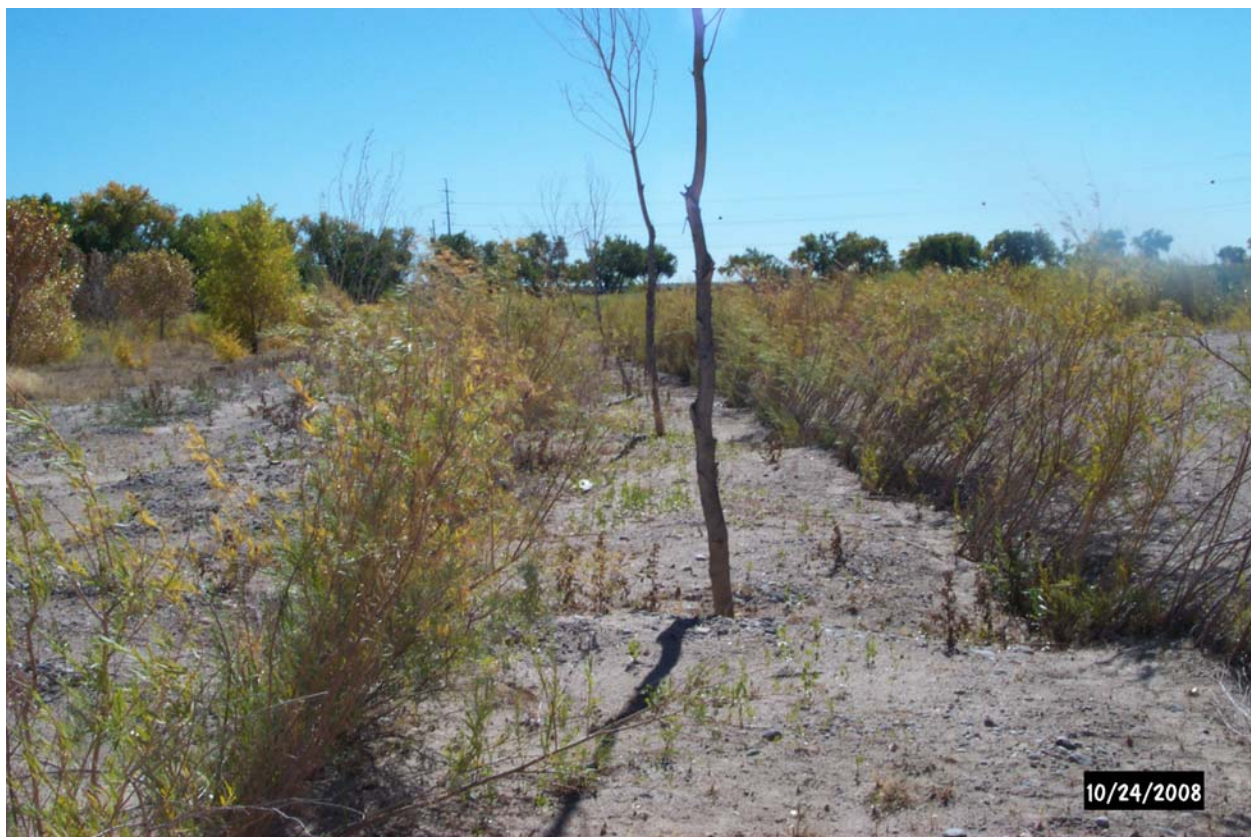
A large scale river maintenance project at Santa Ana Pueblo is nearly complete. The major features, river realignment and construction of a gradient restoration facility, are complete. The primary activity during 2005 was redistributing piles of excess sediment to facilitate their removal during the high spring flows; approximately 60,000 cubic yards of sediment was removed. In spring 2007, a line of riprap was installed at the upstream end of the gradient restoration facility, and a reinforced bankline at the Jemez River confluence was extended to protect against erosion. A willow trench was constructed by the Pueblo of Santa Ana in January 2008 according to a Reclamation design that would allow natural vegetation to provide ongoing protection of the east bank once the sediment spoil piles have been removed (Photo 12). Reclamation has developed designs to redistribute the remaining sediment spoil piles to best accomplish the project's goals. The sediment redistribution plan has permit approval, but due to the project construction load and water level restrictions the project is expected to be constructed in the summer of 2009. The overall project design requires average or higher spring runoff flows to develop features to their final configurations. Therefore, the duration of ongoing activities is dependent on hydrologic conditions.

Photo 14. Willow trench constructed by the Pueblo of Santa Ana in January 2008 (October 2008, AuBuchon)

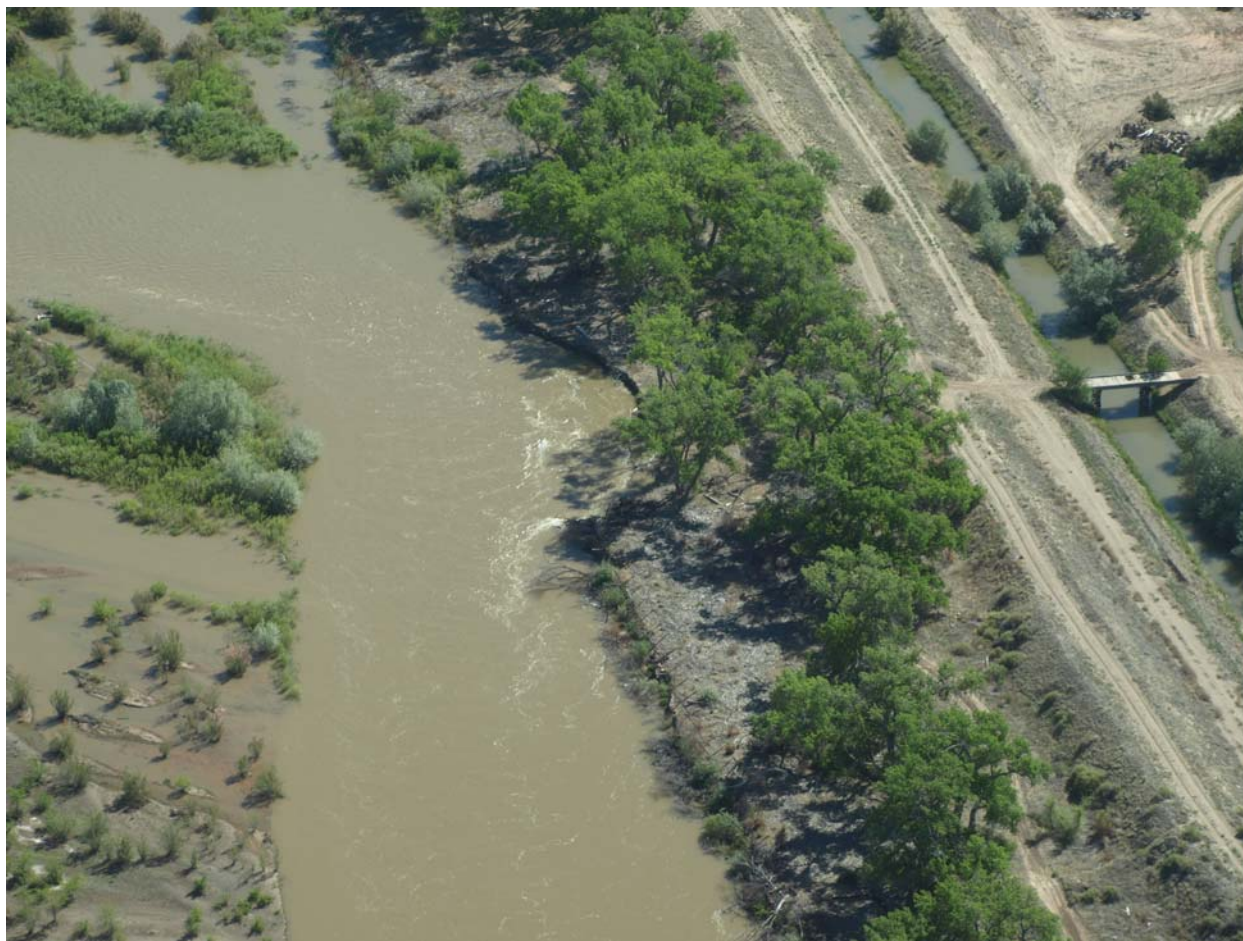
An additional priority site was added on the Pueblo of Santa Ana on the east bank of the Rio Grande, across from the Tamaya Resort special events tent, following the 2008 spring runoff (Photos 13 and 14). For many years, the bankline had been stable and had followed the jetty jack line. Prior to the 2008 runoff, the bankline had migrated beyond the jetty jack line; further erosion occurred during the 2008 runoff. The Pueblo of Santa Ana has repeatedly stated concern about conditions at the site. The Corps of Engineers is planning an island and bar lowering project in the area and project design work will be integrated with the Corps' plans. Due to the close proximity of the spoil levee and the amount of bankline erosion observed during 2008 this site was elevated to the status of a priority site. Reclamation is currently working with the Pueblo to of Santa Ana to develop a preferred protection strategy.

Photo 15. Aerial view looking upstream toward the bend erosion at the Santa Ana Tamaya site (June 2008, Padilla)

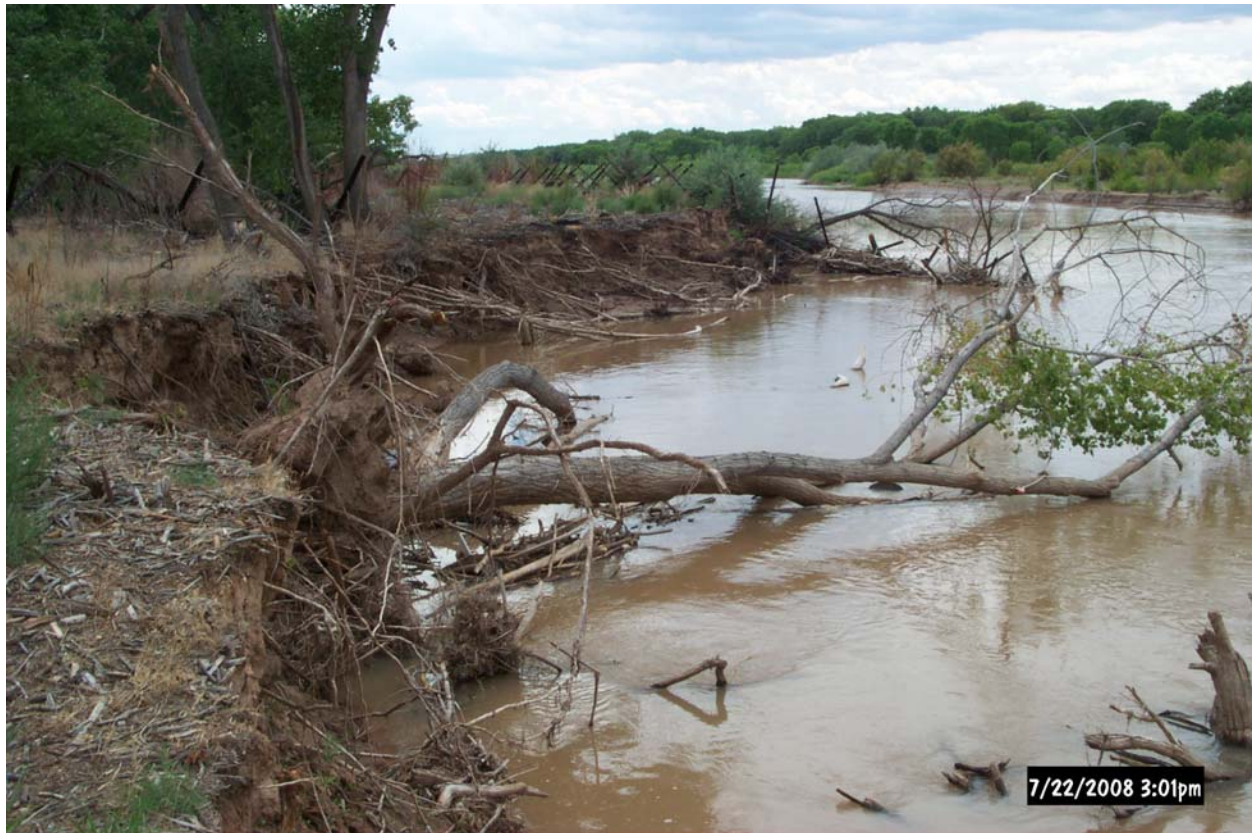
Photo 16. Looking downstream at the bend erosion at the Santa Ana Tamaya site (July 2008, AuBuchon)

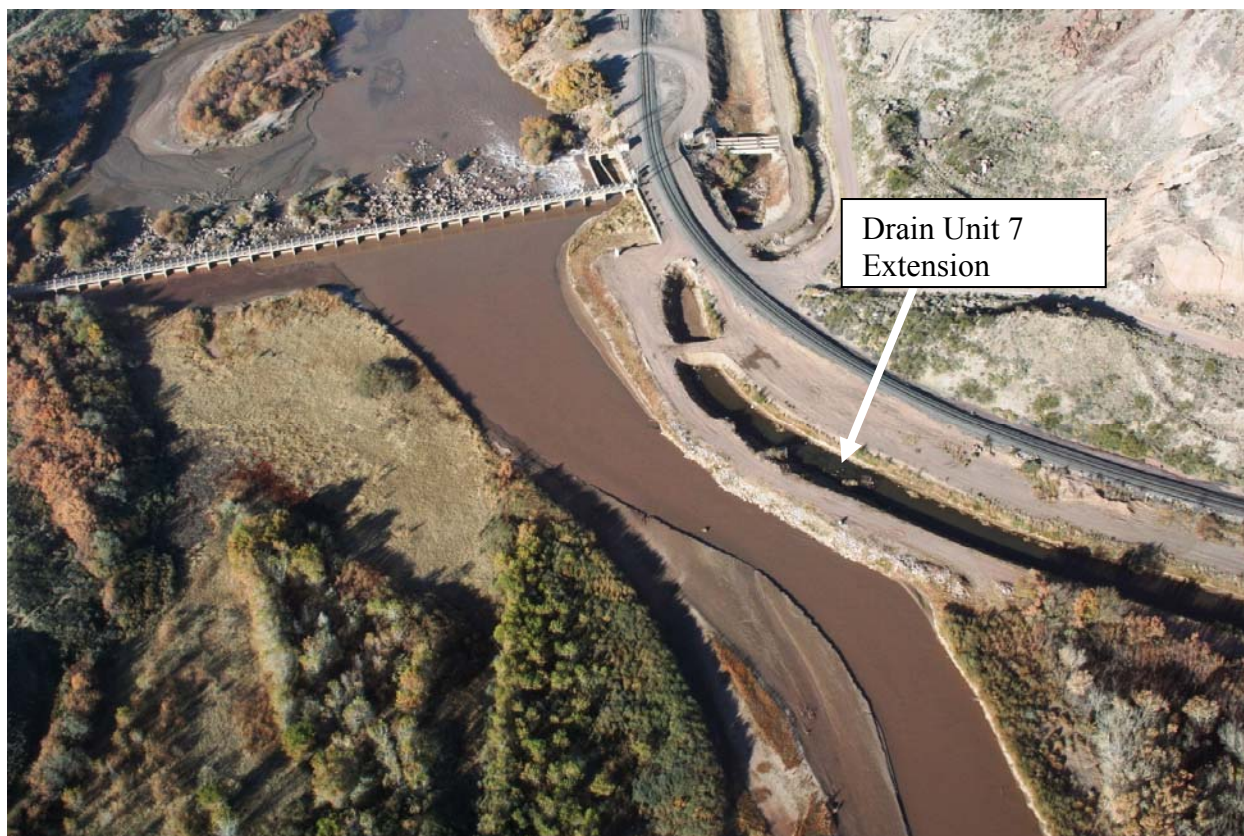
This priority site is located approximately 500 feet upstream of San Acacia Diversion Dam, on the west bank of the Rio Grande (Photo 15). The river is actively eroding the embankment of a spoil levee that protects the Drain Unit 7 Extension irrigation structure. Pre-emergency maintenance work was performed in May, 2005 to stabilize the eroding bankline. Riprap was placed along 200 feet of bankline at that time, but some of the riprap was displaced during the high flows of the 2006 monsoon season, and additional riprap was added prior to the 2007 spring runoff. A complete analysis of potential alternatives was completed in 2008, and placement of large gradation riprap for protection of the levee was determined to be the most appropriate solution for this site. Designs were completed in 2008 and construction is scheduled to begin in January 2009.

Photo 17. Drain Unit 7 Extension priority site, looking downstream toward San Acacia Diversion Dam (November 2008, Gonzales).

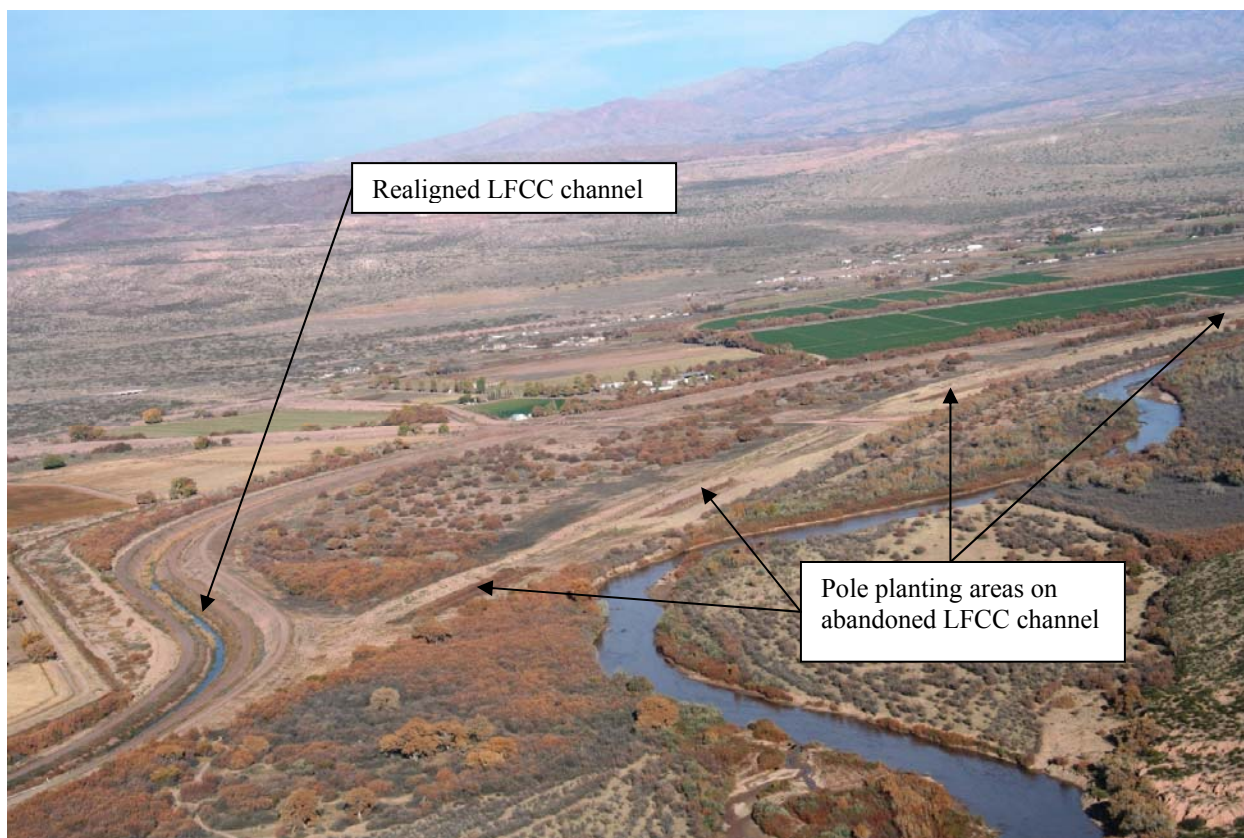
Reclamation completed earthwork at the River Mile 114 and 113 priority sites, approximately 2 miles downstream of San Acacia Diversion Dam. Channel incision, lateral channel migration, and bank erosion previously threatened the integrity of the levee system in this area. This project involved moving the levee and LFCC approximately 1,500 feet to the west, away from the river (Photo 16).

Major items of work included clearing and grubbing vegetation, excavating a new LFCC channel (approximately 10,800 feet), constructing a spoil levee adjacent to new LFCC channel, constructing a sheetpile grade control structure and a pipe crossing at San Lorenzo Arroyo, filing the existing LFCC channel, creating new potential floodplain between the new levee position and the channel, and planting cottonwood poles and other native species within the project area. The project is currently being monitored to document the amount of reseeding and weed control that is needed.

Photo 18. Looking upstream at the completed RM 114/113 construction (November 2008, Gonzales)

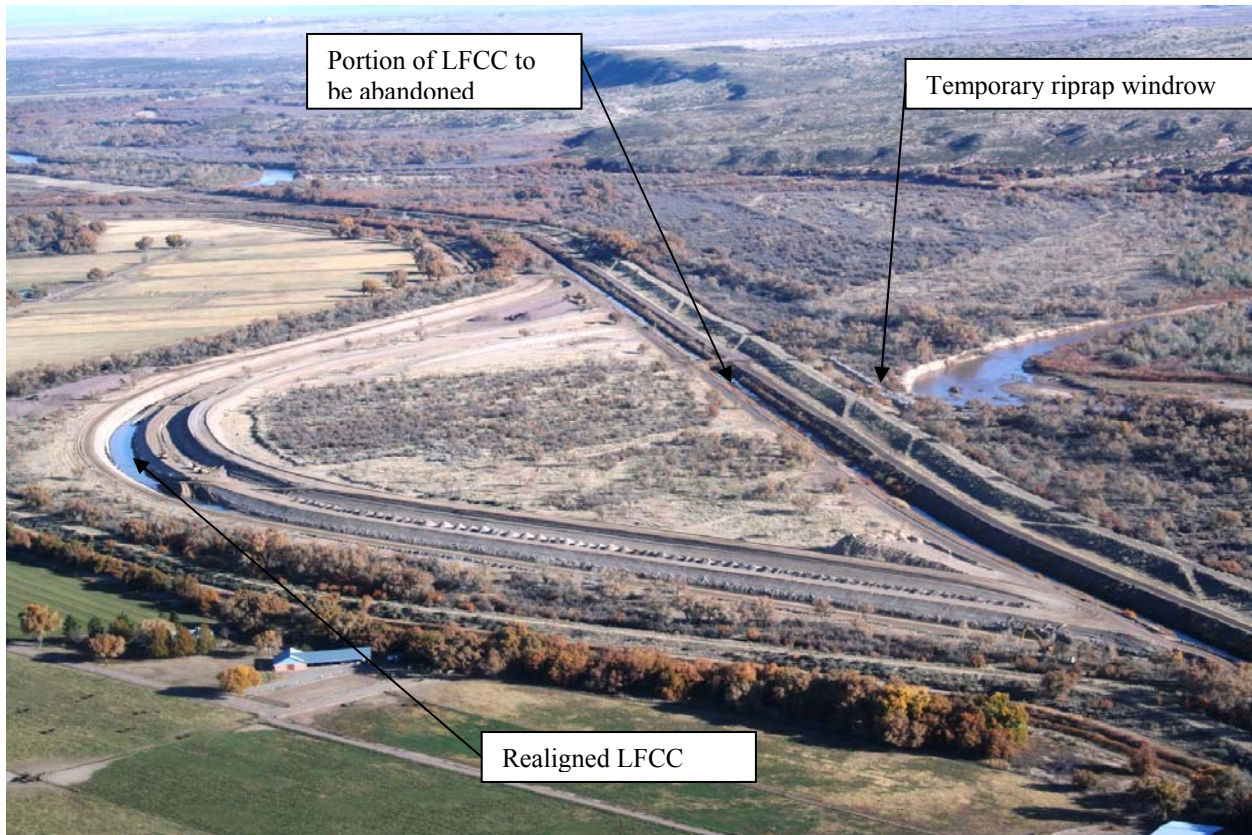
The San Acacia River Mile 111 priority site is located on the west side of the Rio Grande, approximately 5.5 miles downstream of the San Acacia Diversion Dam (Photo 17). The concern at this site is river channel migration and the fast rate of the bank erosion towards the levee which protects the Low Flow Conveyance Channel (LFCC). The construction of a levee setback project, similar in scope to the work performed at RM 114/113, was delayed for several years to allow a research project in the area to be completed. A self launching riprap windrow was placed in 2006 to provide temporary protection while awaiting the completion of the research project. Construction on the long term project began in April 2008. Construction is expected to be completed by the summer of 2009.

Photo 19. Looking upstream at the RM 111 construction (November 2008, Gonzales)
