## Calendar Year 2008 Report to the Rio Grande Compact Commission

U. S. Department of the Interior  
Bureau of Reclamation  
Albuquerque Area Office  
Albuquerque, New Mexico

March 2009

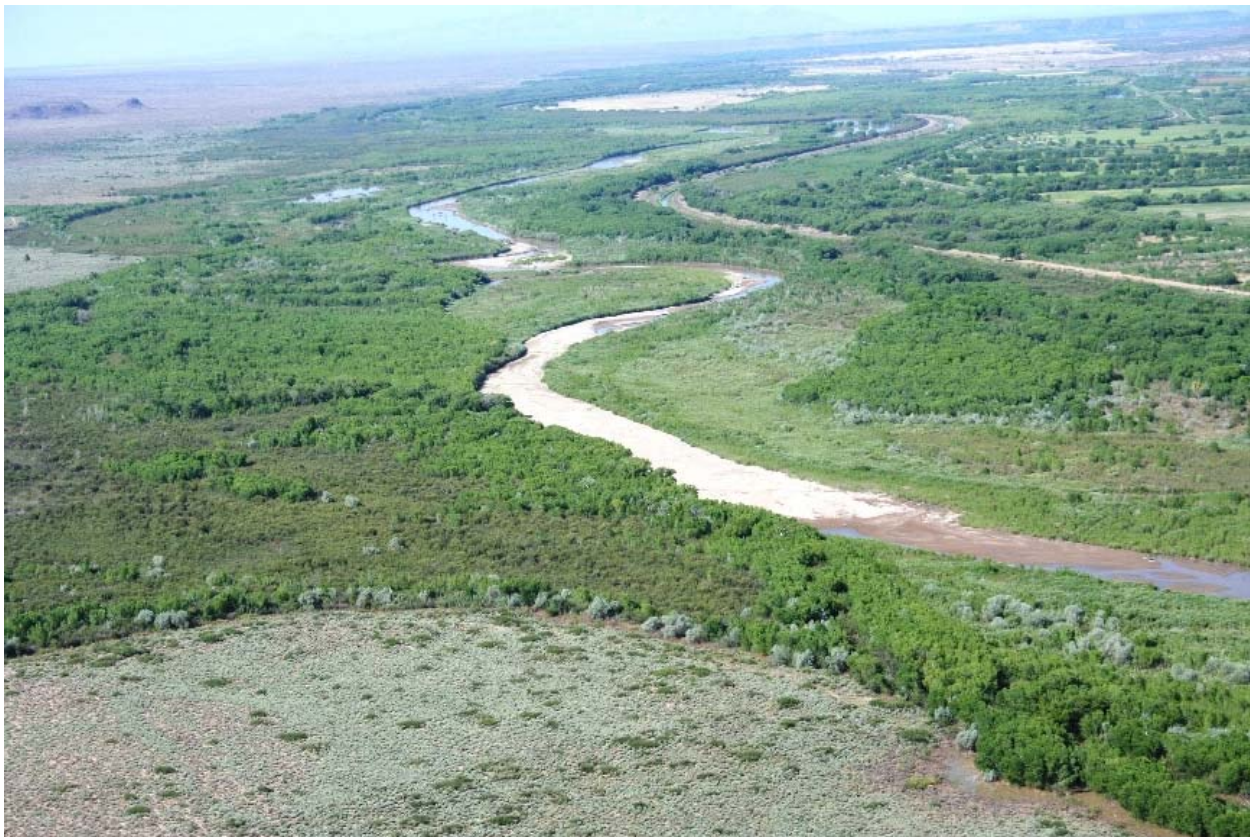
The plugged river channel caused a rise in water surface against the levee, and a portion of the levee was raised and widened during the runoff to alleviate concerns of levee failure due to overtopping and/or excessive seepage. After the runoff, Reclamation obtained environmental clearances for excavation of a pilot channel through the sediment plug, and NMISC funded the construction work. The pilot channel excavation began the end of September and was completed on October 21 (Photo 20). Reclamation has been closely monitoring the river since that time, including collection of several sets of survey data and aerial photography. So far the pilot channel is remaining open and the majority of river flows are confined to the main channel. However, due to sediment deposition in the channel over this general reach of the river, concerns remain regarding formation of future sediment plugs and Reclamation will continue to monitor the area closely, particularly as the spring runoff begins. Photo 21 shows how much the river has widened following the pilot channel excavation, leaving only two small sections of spoil berm.

Photo 21. Bosque del Apache sediment plug, facing downstream (July 2008, Gonzales).

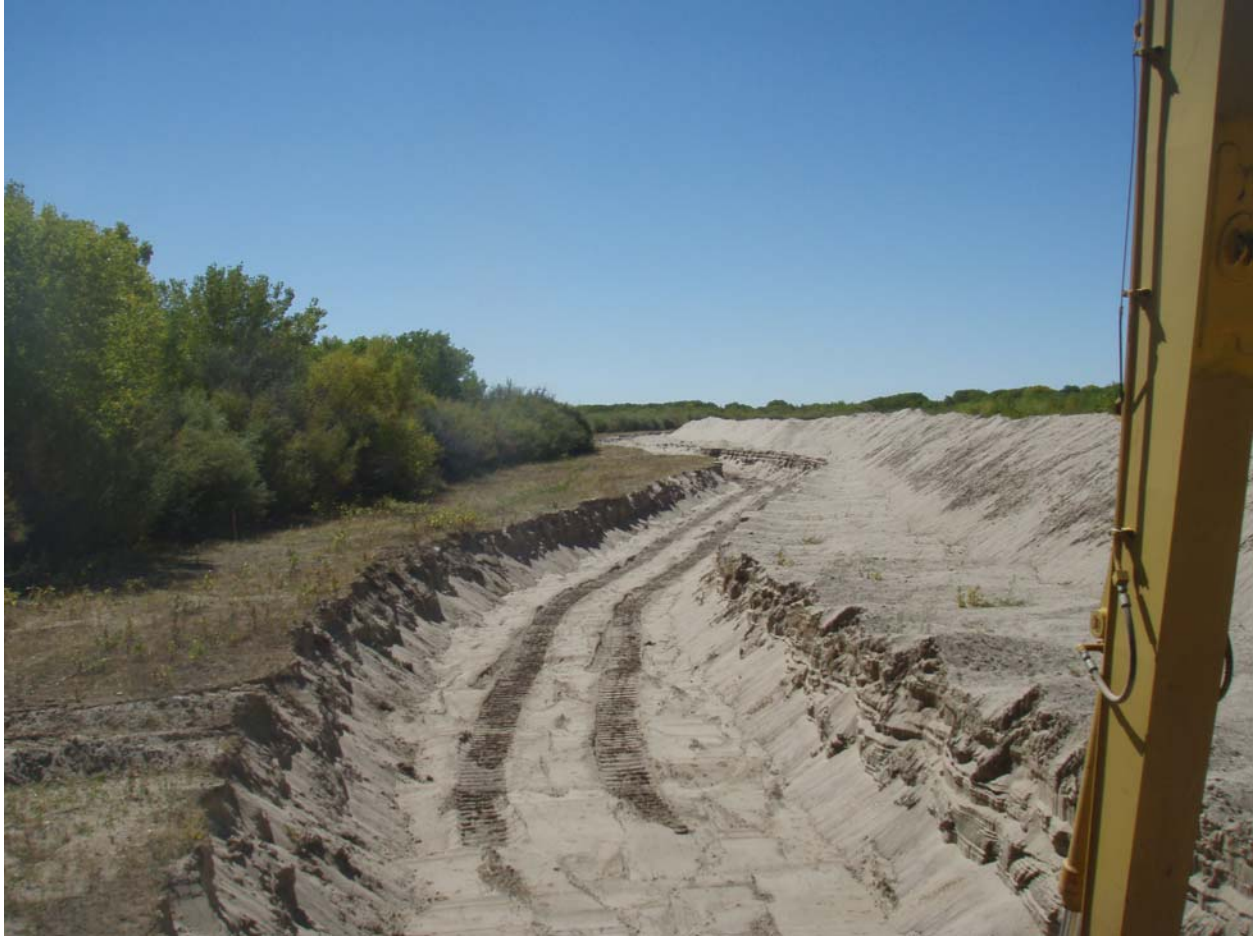
Photo 22. Bosque del Apache pilot channel excavation, looking downstream (October 2008, Rolland).

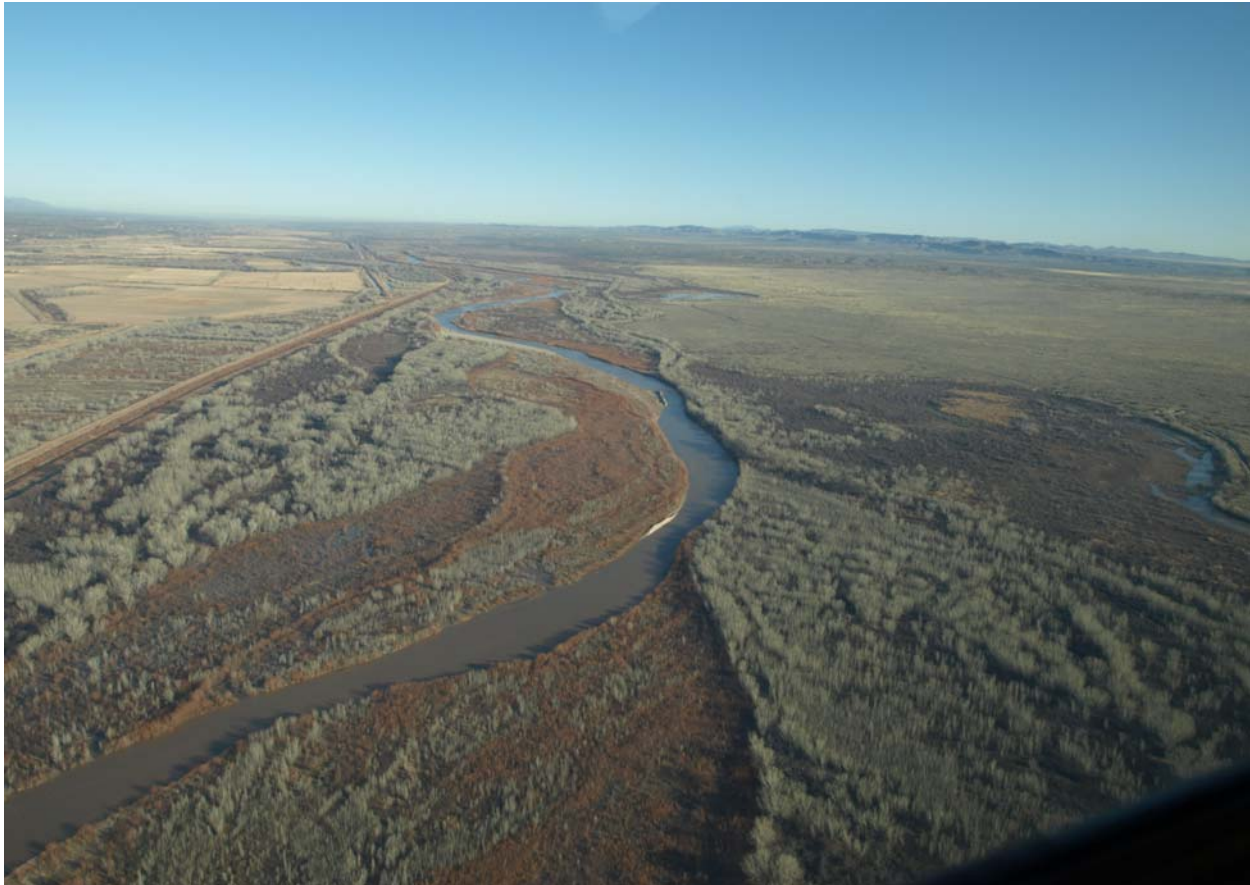
Photo 23. Recent photo of Bosque del Apache sediment plug area showing widening of the river since completion of pilot channel excavation. Taken from just south of the downstream end of the 2008 plug, looking upstream. (January 2009, Rolland)

Reclamation has also begun data collection for a thorough analysis of a reach of river extending from the San Antonio Bridge to the South Boundary of the BDANWR, to determine the risk for future sediment plug formation and, if applicable, to evaluate alternatives for a long-term solution.

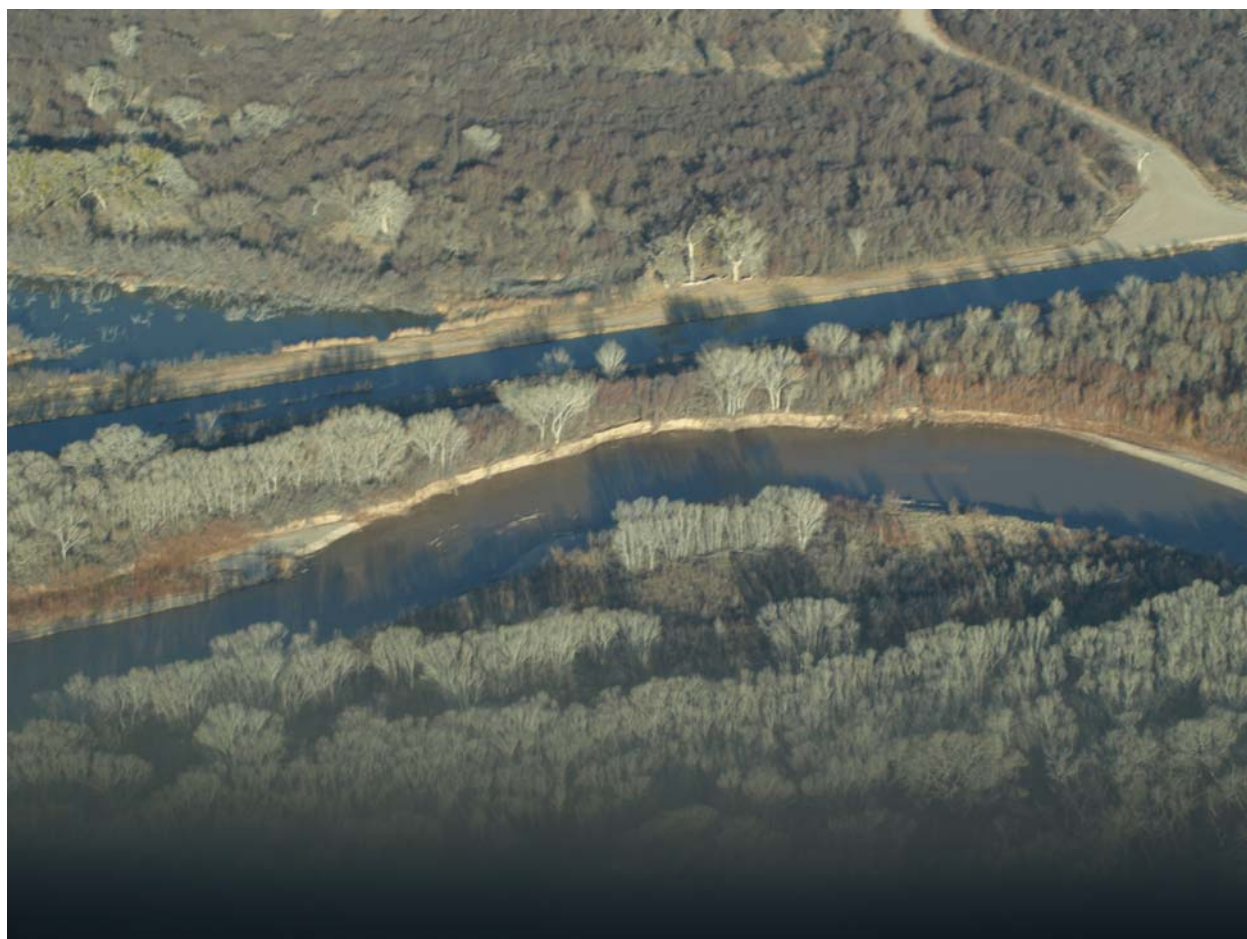
This site is located on the west bank of the Rio Grande, approximately 4.5 miles downstream from the San Marcial railroad bridge. It is also approximately 0.25 miles upstream of the Fort Craig Pump Site, where water is pumped from the LFCC to the river during the dry summer months. The active bankline is currently less than 100 feet from the San Marcial Levee (Photo 22), which protects the LFCC from the river. The levee road also provides the only access to 9.5 miles of the river downstream of this site, including the upper 3.5 miles of the Elephant Butte Temporary Channel.

The river bend at this site has been fairly stable in past years, but became active during the 2008 runoff, and was monitored very closely. There is considerable potential for more bankline erosion during the 2009 runoff, and the site will be monitored closely. Hydrographic data was collected for the site in 2007, and the alternative analysis process will begin in 2009.

Photo 24. Fort Craig Bend priority site, looking west (January 2009, Rolland).

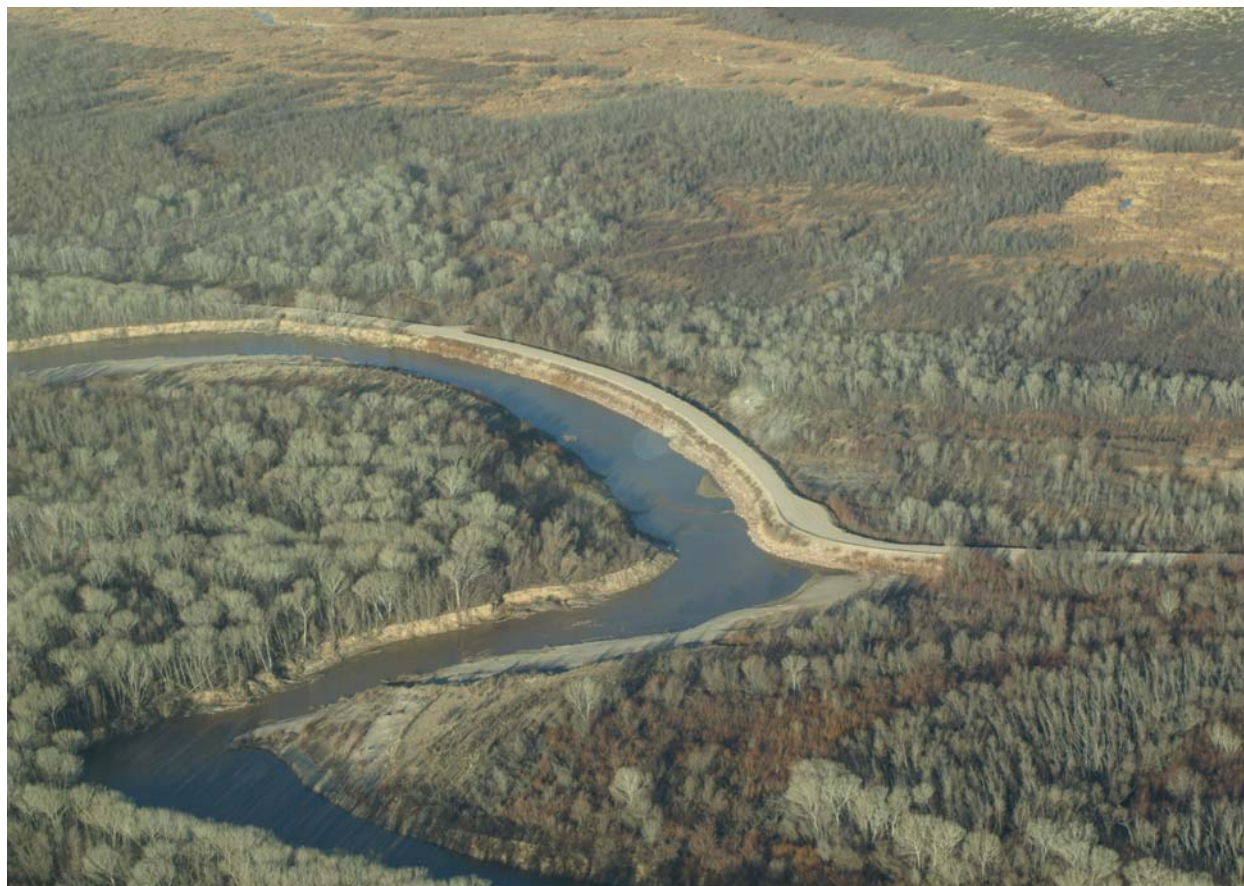
This site is located at River Mile 60, on the west bank of the Rio Grande, approximately 8.5 miles downstream from the San Marcial Railroad Bridge. The river makes a sharp bend to the west just upstream of the site, and then is forced to make another very abrupt bend to the south when it encounters a maintenance road embankment (Photo 23). The river then flows parallel to this road for a length of approximately 1,500 feet, with the right bank of the channel and left slope of the road embankment being one and the same. The road provides access to 5.5 miles of river downstream of the site, including the upper 3.5 miles of the Elephant Butte Temporary Channel.

The site has been an area of concern, but fairly stable, for many years but erosion has become more aggressive in the last few years due to river channel degradation through this reach. The upstream end of the site has been monitored closely in recent years because of a deep scour hole caused by the abrupt bend, and the possibility for undercutting of the riprap that protects the road embankment. However during the 2008 runoff the downstream end of the bend became an area of even greater concern, as the river is now eroding bankline in that area that is not protected with riprap. That erosion advanced to within 5 feet of the road embankment toward the end of the 2008 runoff, and the road was closed as a safety precaution for rest of the runoff. There is a high probability that at least a portion of the road will be destroyed during the 2009 runoff. The site will be monitored closely and the road will likely be closed again. Hydrographic data for this site was updated in 2007 and the alternative analysis process is currently in progress.

Photo 25. River Mile 60 priority site, looking southwest (January 2009, Rolland)

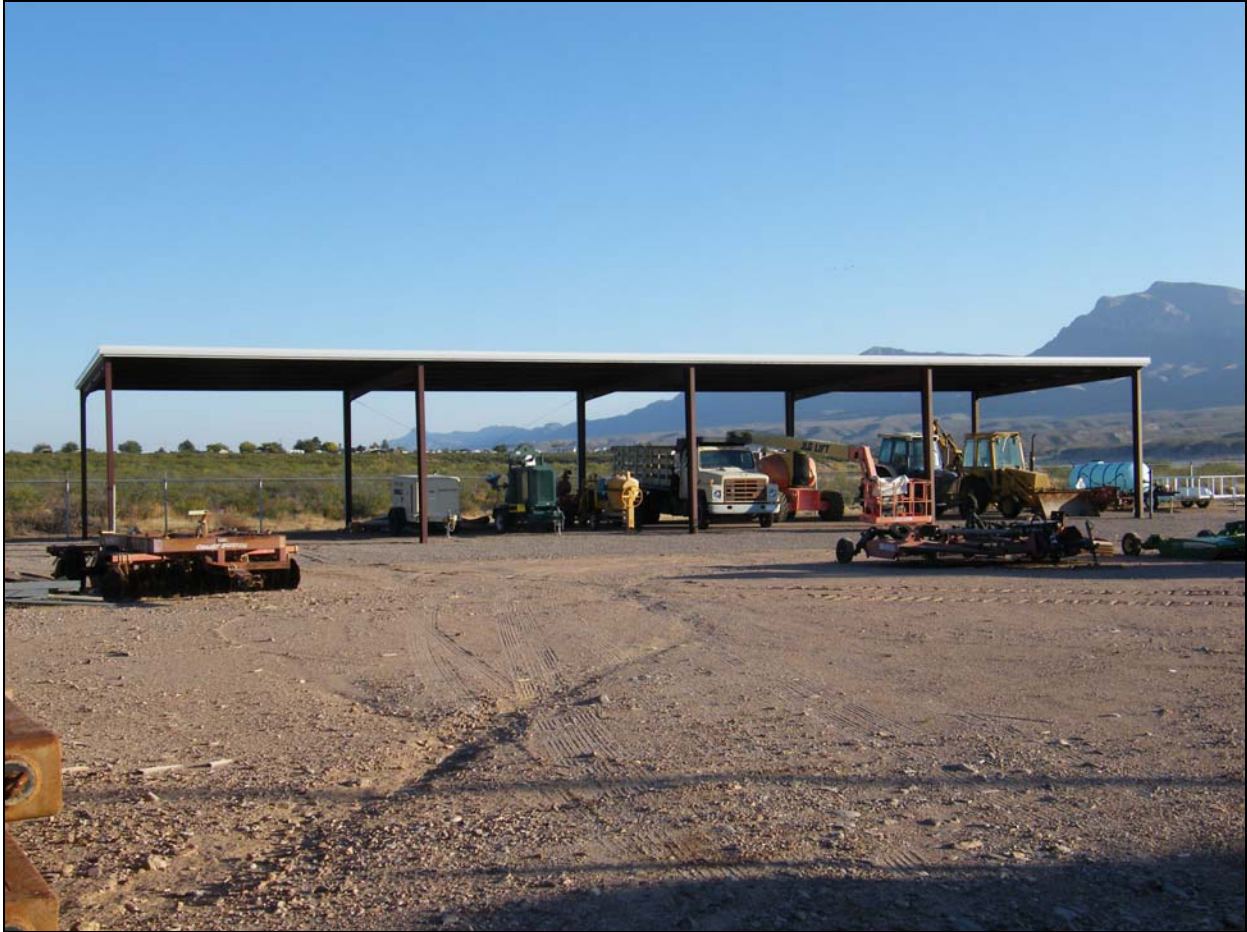
New equipment buildings were constructed one at Elephant Butte Dam and one at Caballo Dam. The hardware and design of the building was contracted to F&S Environmental. The parts were then delivered to the sites and left for the staff at Elephant Butte Field Division to complete. Foundation footings were designed by Lorenzo Arriaga and the site preparation and survey was done in house. The building was then built per the contract blue prints. The building had no side walls but did have a sloped roof to protect equipment from the hard summer months.

Photo 26 - New equipment cover at the Caballo Dam yard.

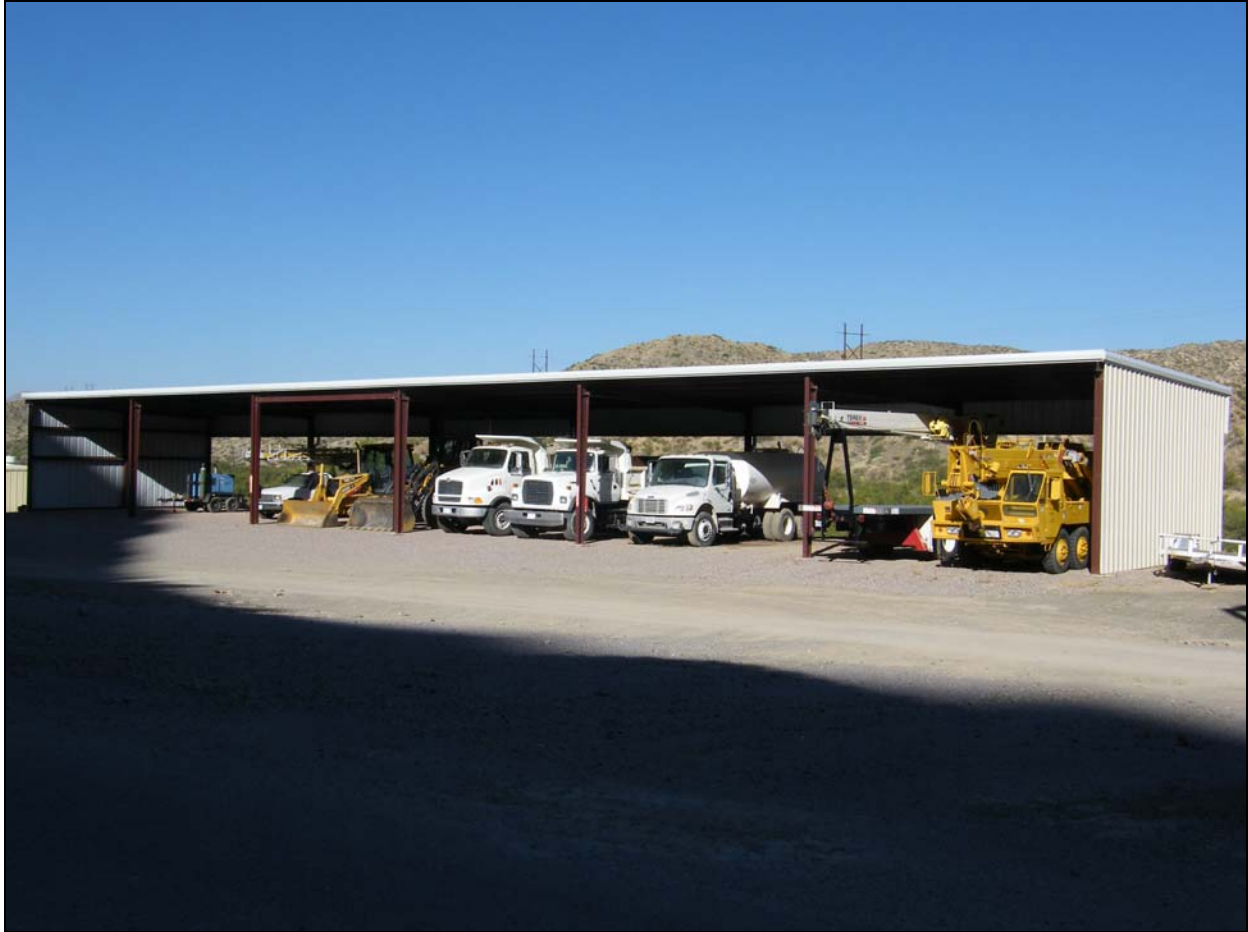
Photo 27 - New equipment cover at Elephant Butte Dam yard.

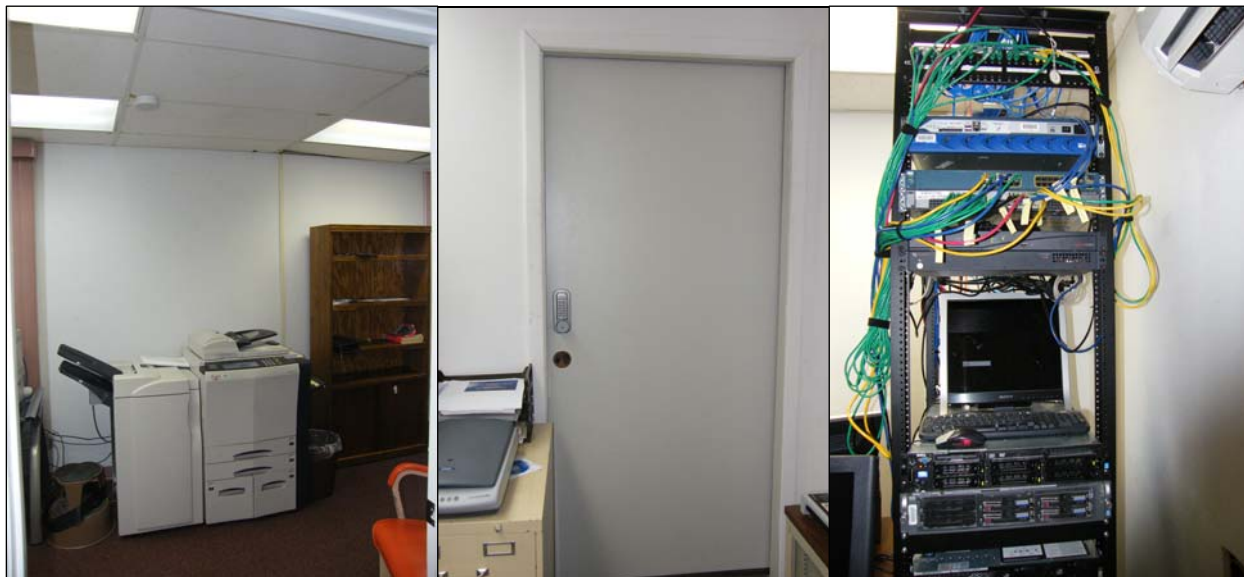
Elephant Butte Field Division's server was located in the copy room just encased in a cabinet with a lock on it. This took up a lot of area in the copy room and was not the most secure. A room for the server was constructed. New cooling system for that room and a security lock and server racks were all built into the room. The server now resides in this space and has been working well.

Photo 28 - Pictures showing old server location, new door access to server room, and the new servers on the racks up and running.

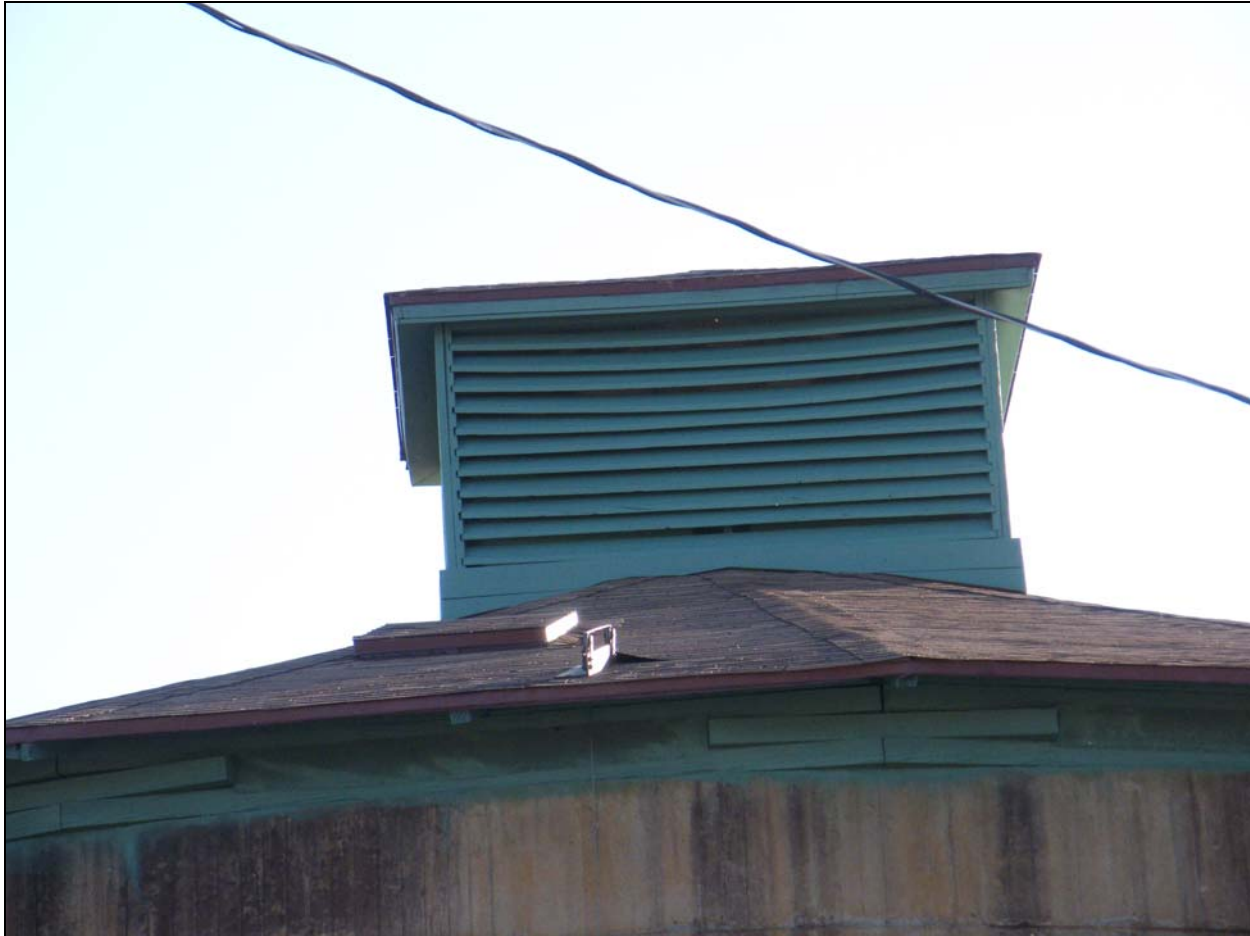
The water tank at Elephant Butte Field Division was recently lined with a fiberglass surface and this cleaned out the years of sediment and allowed the renovations needed. Valves were replaced and security lids for the valves were replaced as well. A closer look at the roof revealed that the shingles and siding needed rehab work. Even more investigation into the roof revealed that some of the trusses had major cracks and had deflected / sagged to the point that the structural integrity was compromised. The decision was made to replace the trusses that needed to be rather than repairing them. Then new plywood was applied and the entire roof re-shingled. The copula at the peak of the roof was repainted and repaired as necessary. The siding was also repainted. This project will extend the operating life of the water tank well into the future.

Photo 29 - Showing repainted vent box and redone roof as well as new access hatch.

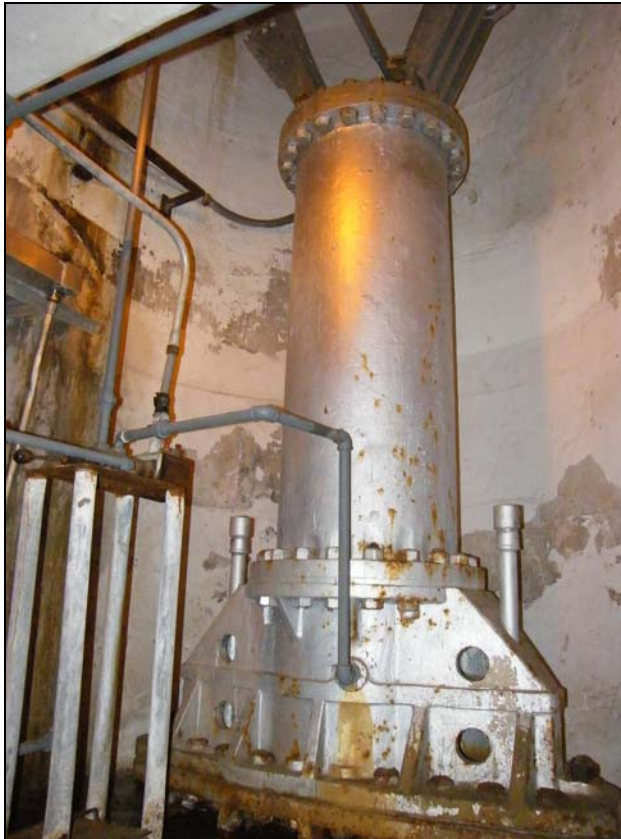
Photo 30 - Old penstock gate operator – water operated.

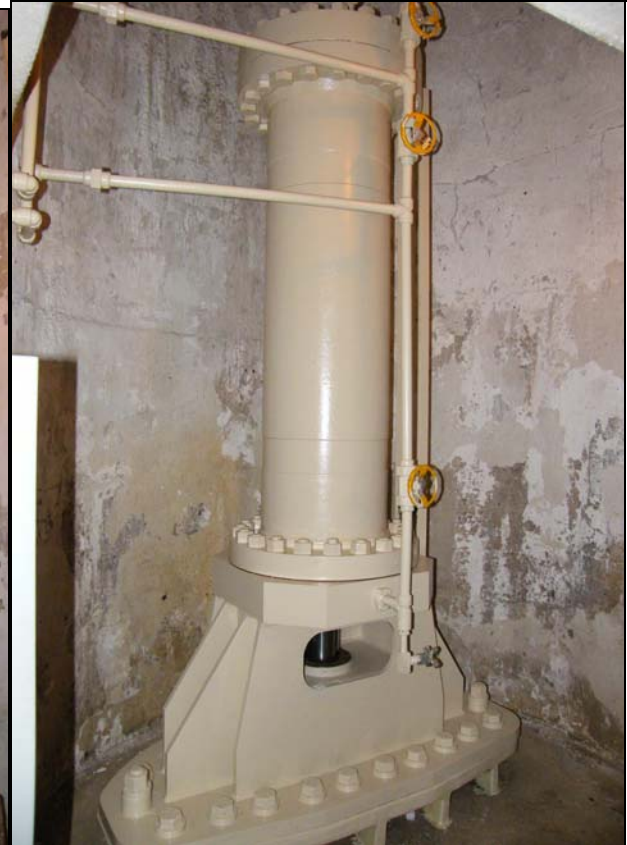
Photo 31 - New penstock gate operator - hydraulically operated.

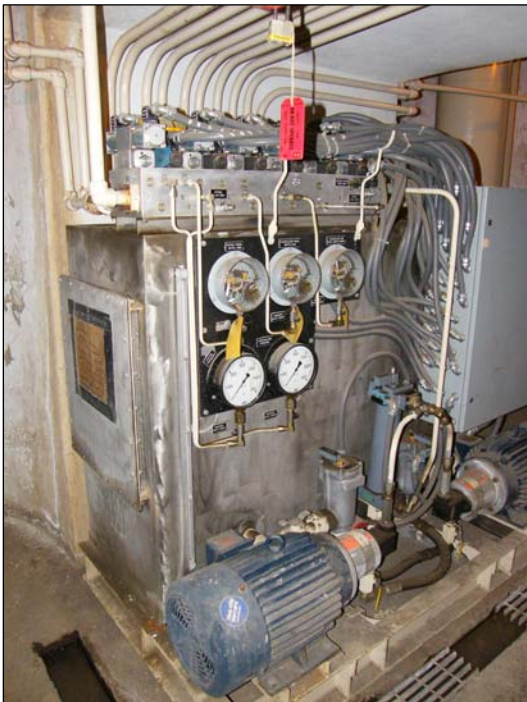
Photo 32 - Hydraulic Pump manifold.

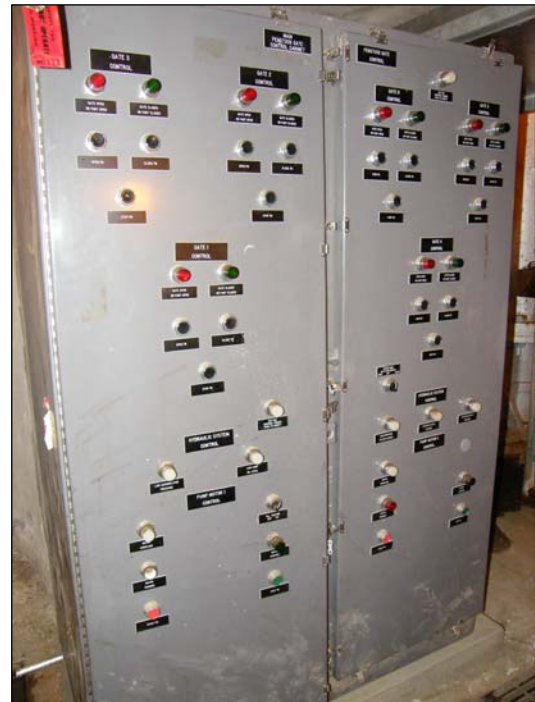
Photo 33 - Penstock control cabinet.

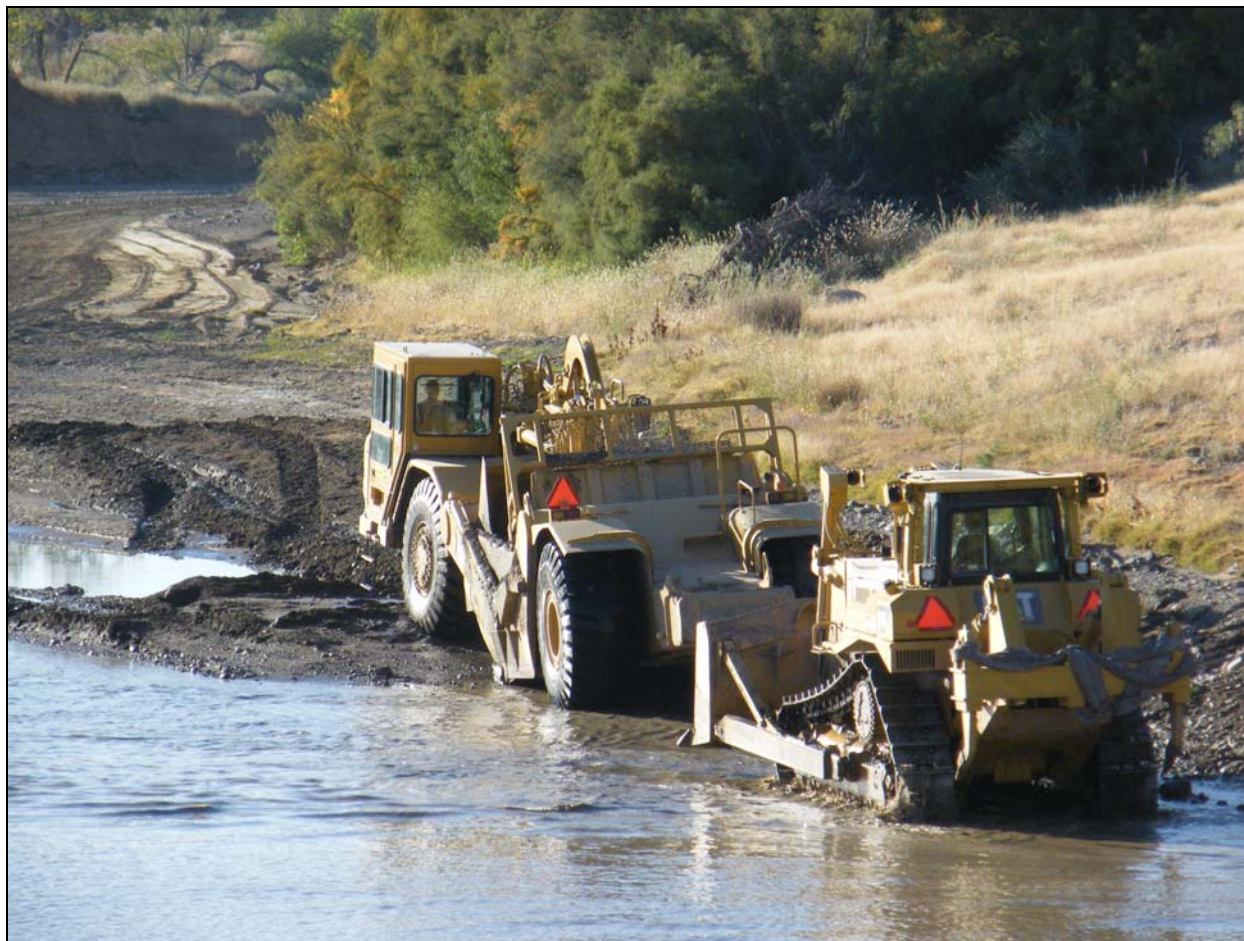
During the rainy season of this year (July, August and early September) Mescal Canyon and Cuchillo creek ran substantial amounts of sediment into the Rio Grande river channel. This in conjunction with the shut down of releases from Elephant Butte dam (early September) created large plugs in the river channel. This material had to be removed before releases from Elephant Butte dam could resume. The releases were to supply Caballo reservoir with adequate supply of water to release down to the irrigation districts. The plugs were removed to the point that the releases could easily pass through the channel. Numerous other smaller gravel and sediment plugs were removed in the reach below Cuchillo Creek and Hondo Arroyo at Williamsburg Bend were also removed. Total estimated material removed exceeded 15,000 cubic yards.

Photo 34 - River work and the Mescal Creek area.

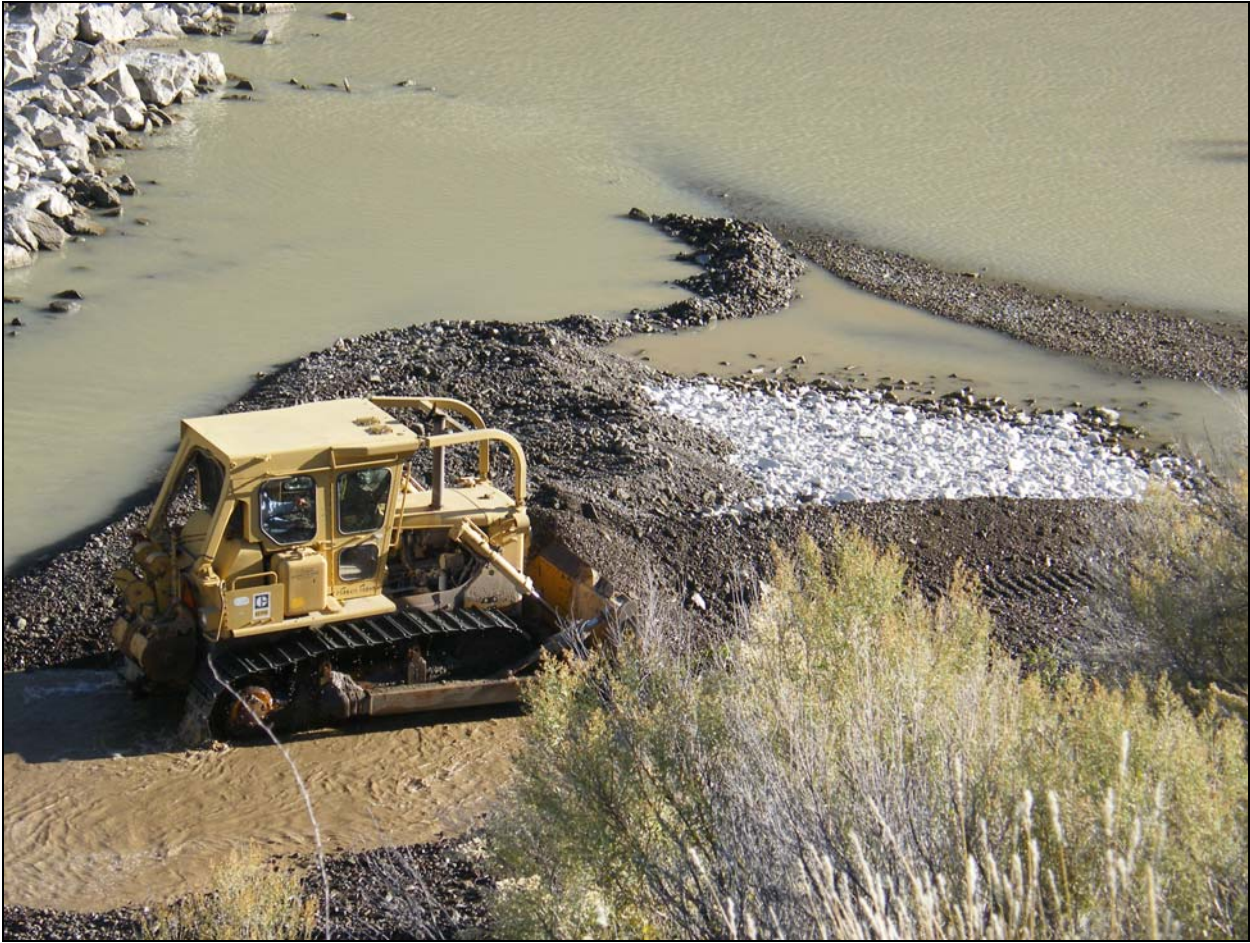
Photo 35 - River work near the tailbay to the Elephant Butte Dam.

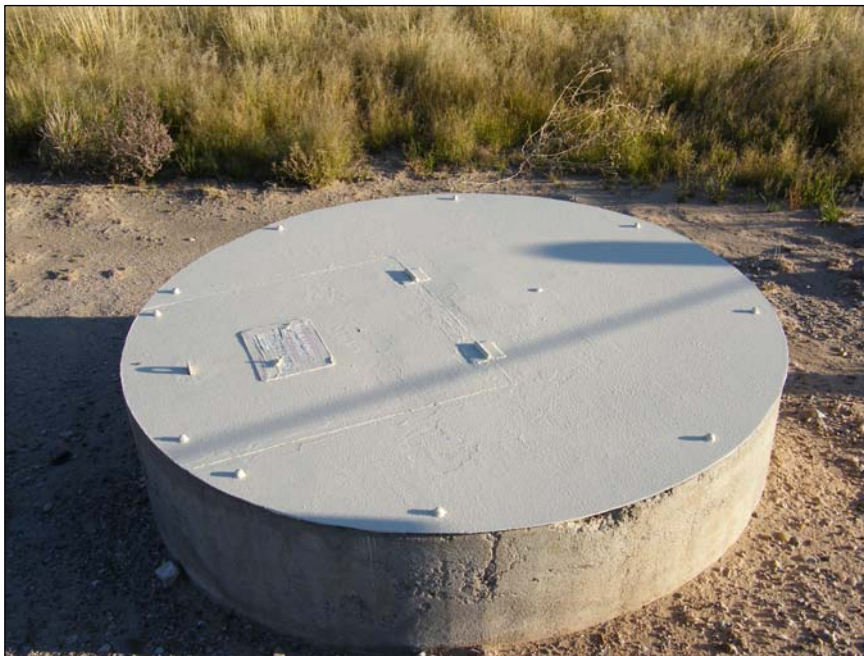
The toe drains a Caballo Dam have manhole access points throughout the downstream toe of the dam. These manholes are 5ft in diameter and ¼” thick. They are secured with 8 bolts and to access the toe drains for maintenance the entire lid had to be removed. This was very awkward the lid was heavy and presented pinches and potentially crushing of ones hands when handling the lid. The lid was redesigned with just a square lid that was cut into the existing 5ft cover. This lid is square and hinged and locked. This will allow maintenance of the drain system and reduce the possibility of injury to personnel.

Photo 36 - Modified manhole showing new access hatch.

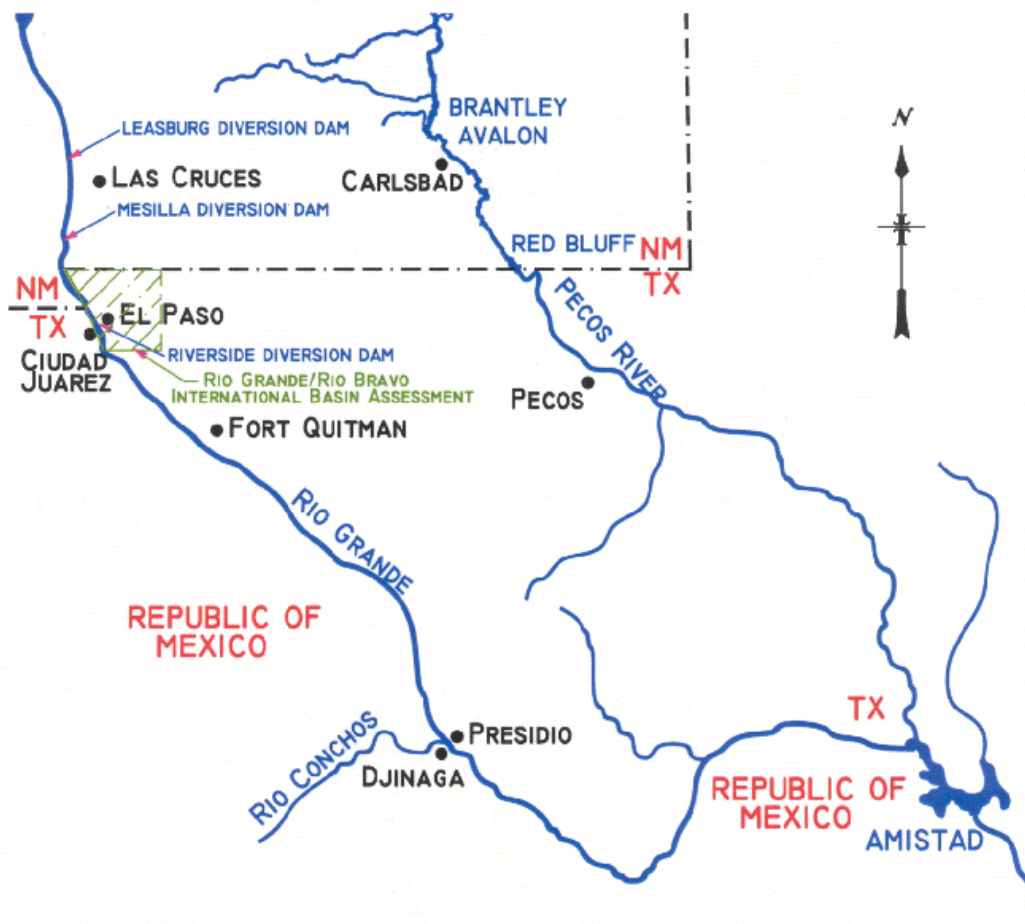
Figure 6: Area Map of the Rio Grande/Rio Bravo International Basin Assessment

Various groups have designated the subsections of the river differently. For the purposes of this assessment, the Lower Rio Grande / Rio Bravo is the Reach between El Paso, Texas and Amistad Reservoir. Major U.S. cities located along the Lower Rio Grande include El Paso, Laredo, Brownsville, and McAllen, Texas. Major Mexican cities along the Rio Grande are Juarez, Chihuahua, and Nuevo Laredo and Matamoros, Tamaulipas.
