Calendar Year 2010 Report to the Rio Grande Compact Commission

U. S. Department of the Interior
Bureau of Reclamation
Albuquerque Area Office
Albuquerque, New Mexico

March 2011

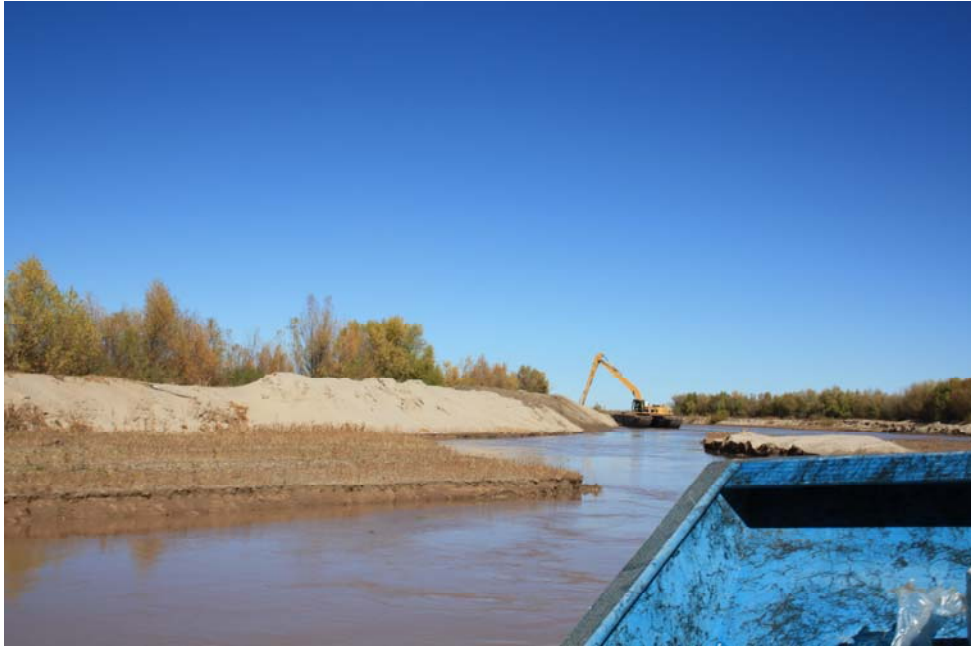
Photo 3: Amphibious excavator working on Breach B south of the Red Rock Staging Area (November 2010, Holste)

The Socorro Field Division began mobilization of equipment and access road maintenance on October 12, 2010. Dredging of the channel and berm repair began on October 25, 2010. Initial repairs of the larger outflow breaches were completed in early December 2010. However the repaired berms have not proven stable as they are composed of fine cohesionless sand. The Socorro Field Division monitors and repairs the berms, as they are continually eroding.

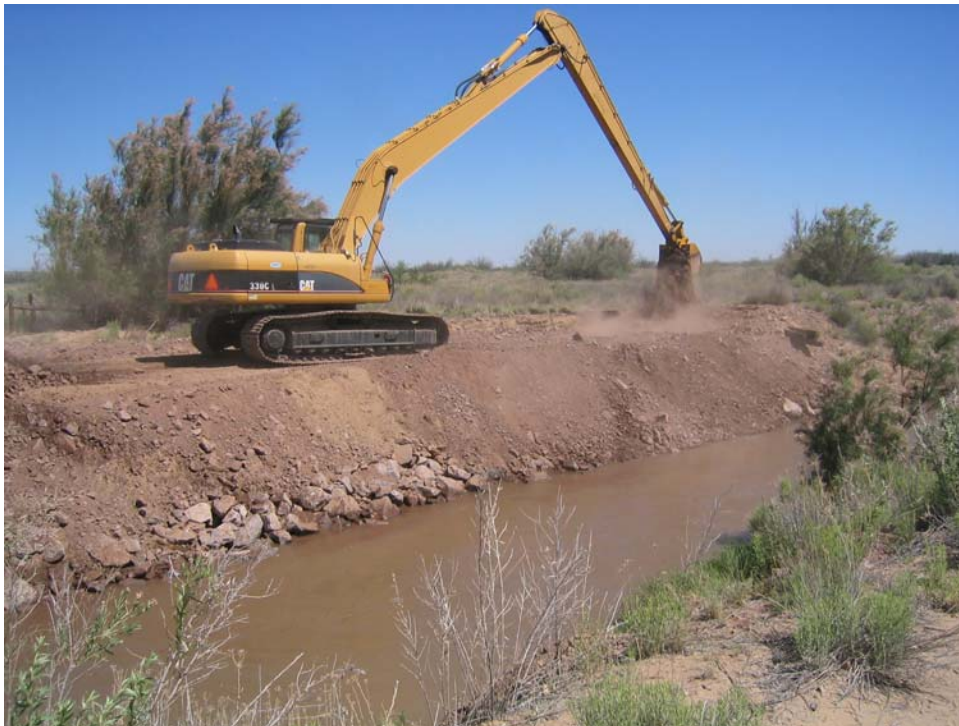
Photo 4: Reclamation construction crews repairing washout at Drain Unit 7 Extension, near the north end of the Ladd Gordon Waterfowl Complex (June 2010, Weems)

providing for the use of \$125,000 of Agreement funds for completion of critical safety rehabilitation work identified by Reclamation and NMISC. Work at Drain Unit 7 Extension began in late May 2010 and was completed in November. Repairs included fixing washouts in the access road and drain bankline, replacing the gate at the north end of the Ladd Gordon Waterfowl Complex, repair of an existing weir, and mowing and blading roads to improve accessibility. Reclamation provided inspection and administration for the work.

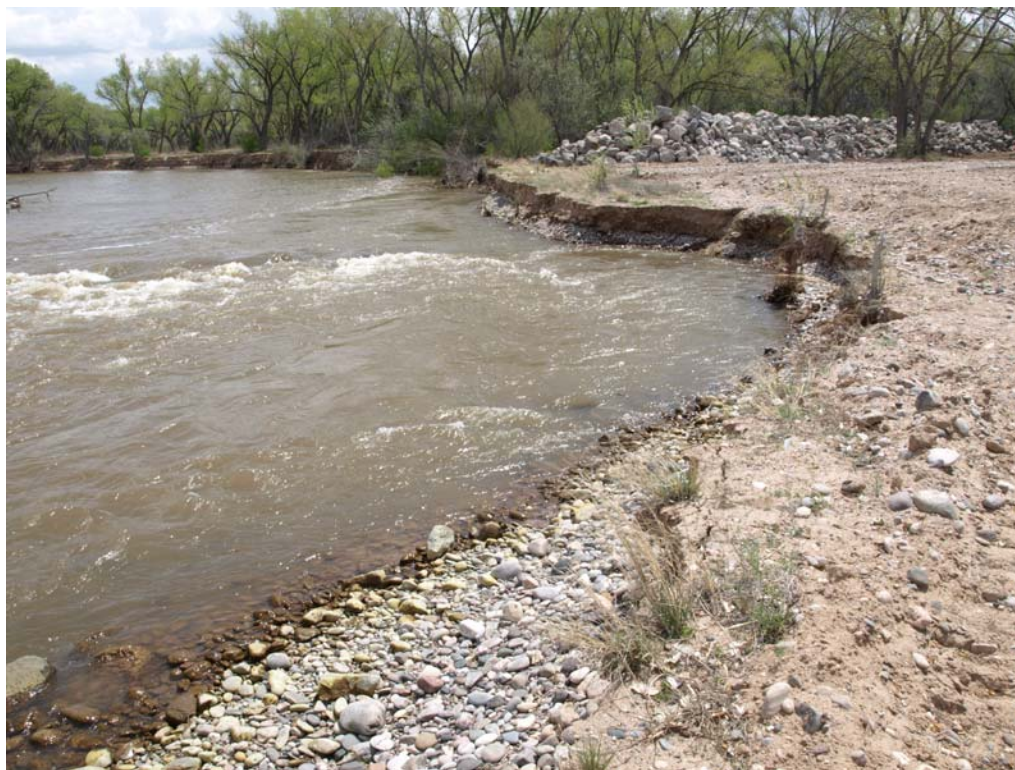
Photo 5: San Ildefonso bankline erosion and riprap windrow (May 2010, Holste)

This priority site is located at River Mile (RM) 259. In spring 2007, a river maintenance project was constructed by Reclamation's Socorro Field Division to provide protection for the San Ildefonso fishing pond. Eight buried rock vanes were placed with this project and were intended to become functional as bankline erosion progressed. To further stabilize the site, Reclamation worked with the Pueblo de San Ildefonso to plant 150 cottonwood and Gooding's willow poles throughout the project site during the winter of 2008. A line of dense vegetation north of the project site provided additional protection to the pond through recent spring runoffs (2005, 2007, and 2008), despite the active bank erosion seen on the bend immediately upstream of the pond. During the spring runoff of 2009, however, the channel eroded through this line of dense vegetation, resulting in the loss of about 80 feet of bankline in portions of the previously constructed project area.

This bank erosion exposed and threatened to flank three of the buried rock vanes. Reclamation worked with the Pueblo de San Ildefonso to construct a temporary solution prior to the 2010 spring runoff. The project consisted of two design components: a buried trench riprap revetment and a riprap windrow. The trench riprap revetment has a length of 205 feet with an alignment approximately parallel to the river. The riprap windrow ties into the upstream end of the trench riprap and extends for a distance of 180 feet with an alignment on top of the existing diagonal rock vane (Photo 5). Approximately 2,200 cubic yards of rock was installed with a nominal diameter of 24 inches. This temporary protection provides flanking protection and additional bankline stabilization for the previously placed rock vanes, allowing time for the development and permitting of a longer term solution.

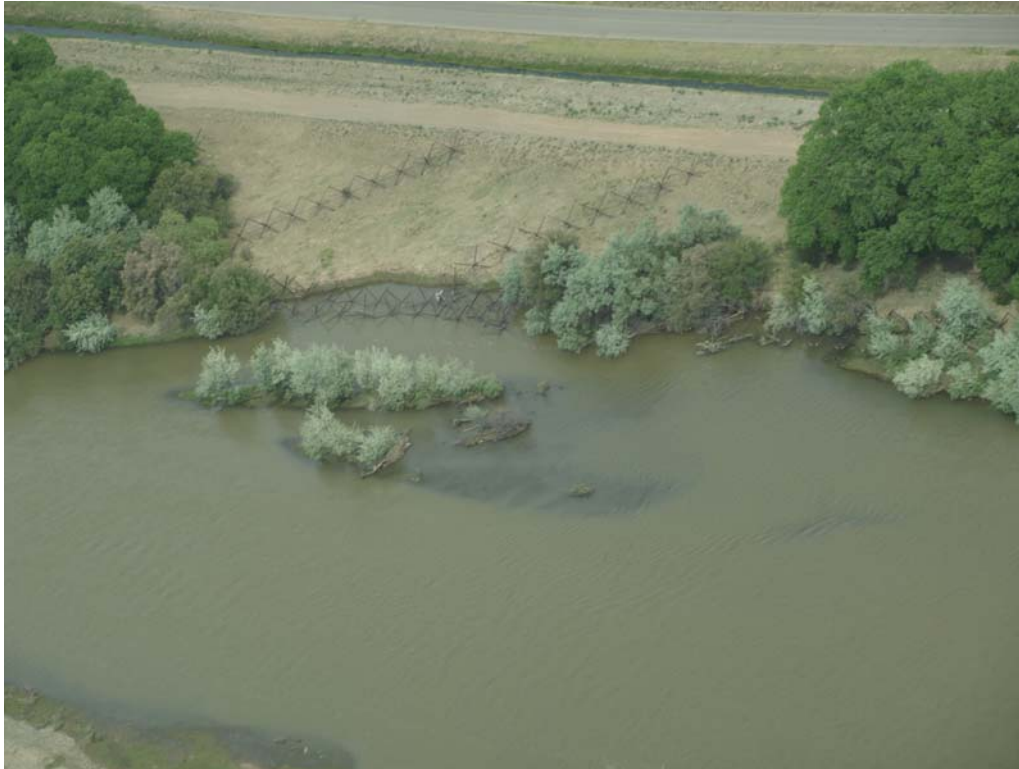
Photo 6: Kewa Pueblo RM 224.6 Priority Site (June 2010, Benoit)

There are currently three priority sites on the reach of the Rio Grande passing through Santo Domingo Tribe lands (RM 225.1, RM 224.6, and RM 223.9). At these sites, bankline erosion on the west side of the river is cause for concern because of the close proximity to the levee and riverside drain. RM 224.6, which is across from the confluence of the Rio Galisteo, is shown in Photo 6, and RM 223.9 is shown in Photo 7. A Data Collection and Confidentiality Agreement was executed between the Santo Domingo Tribe and Reclamation in August 2007 to allow collection of design data for the three priority sites. Reclamation is currently working with the Santo Domingo Tribe to reach consensus on a final design.

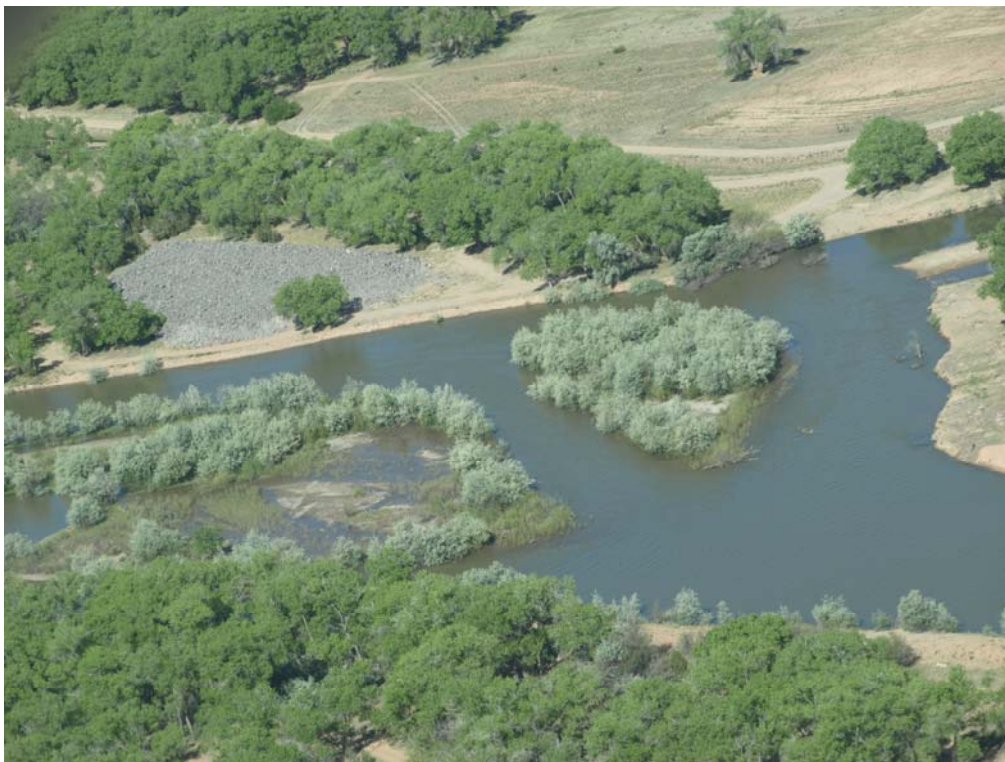
Photo 7: Kewa Pueblo RM 223.9 Priority Site, looking west (May 2010, Benoit)

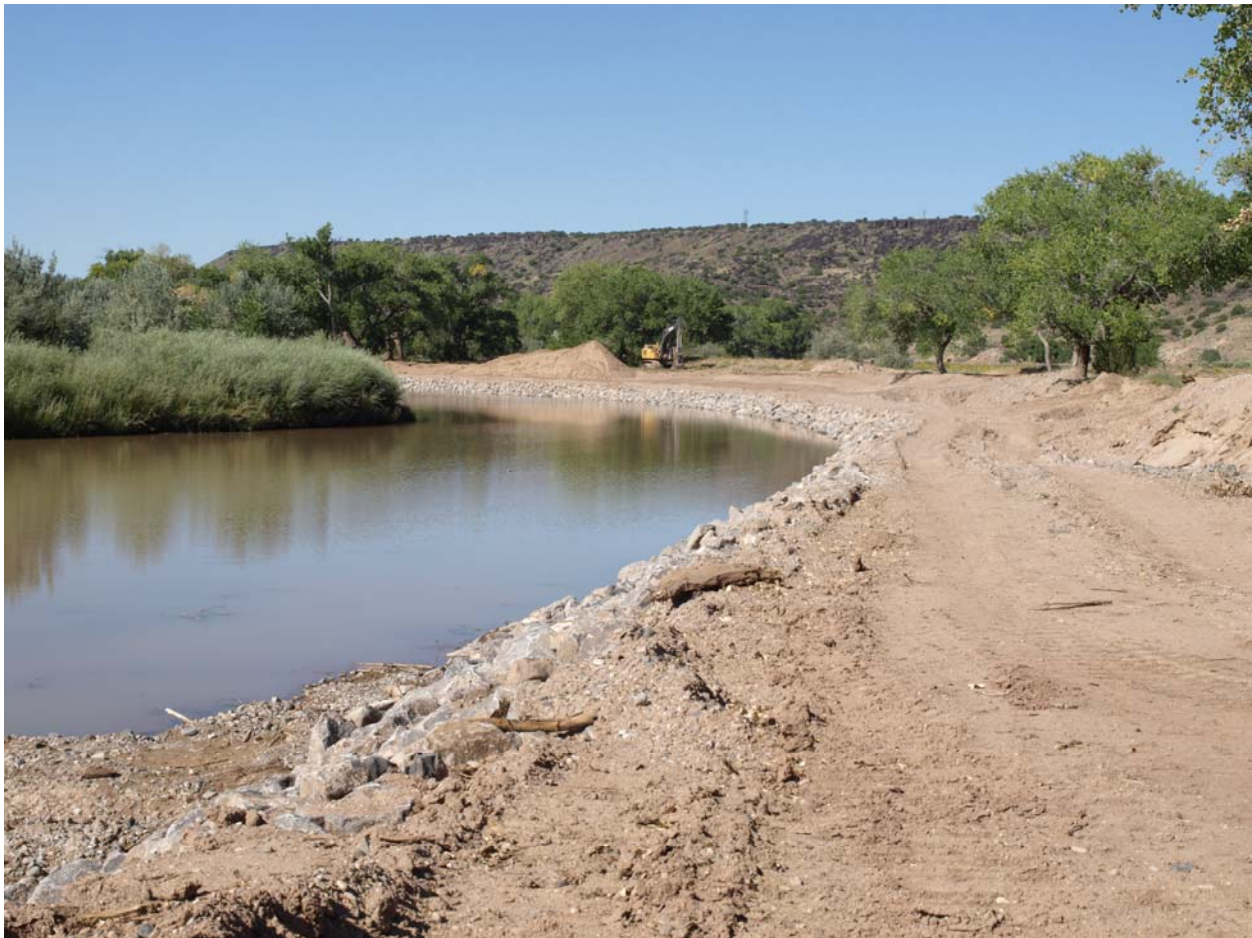
Photo 8: Rock toe placement at Priority Site 213.4, San Felipe (September 2010, AuBuchon)

There are currently nine river maintenance priority sites on the Pueblo of San Felipe. Current conditions at these sites could lead to damage of levees, irrigation infrastructure, roads, and a residential area of the Pueblo. In late 2006, Reclamation obtained permission from the Pueblo to collect cross-section and bed material data for use in designs to address these sites. Construction commenced at four of these sites in 2010, with two expected to be completed by April 2011. Photo 8 shows the site at RM 213.4.

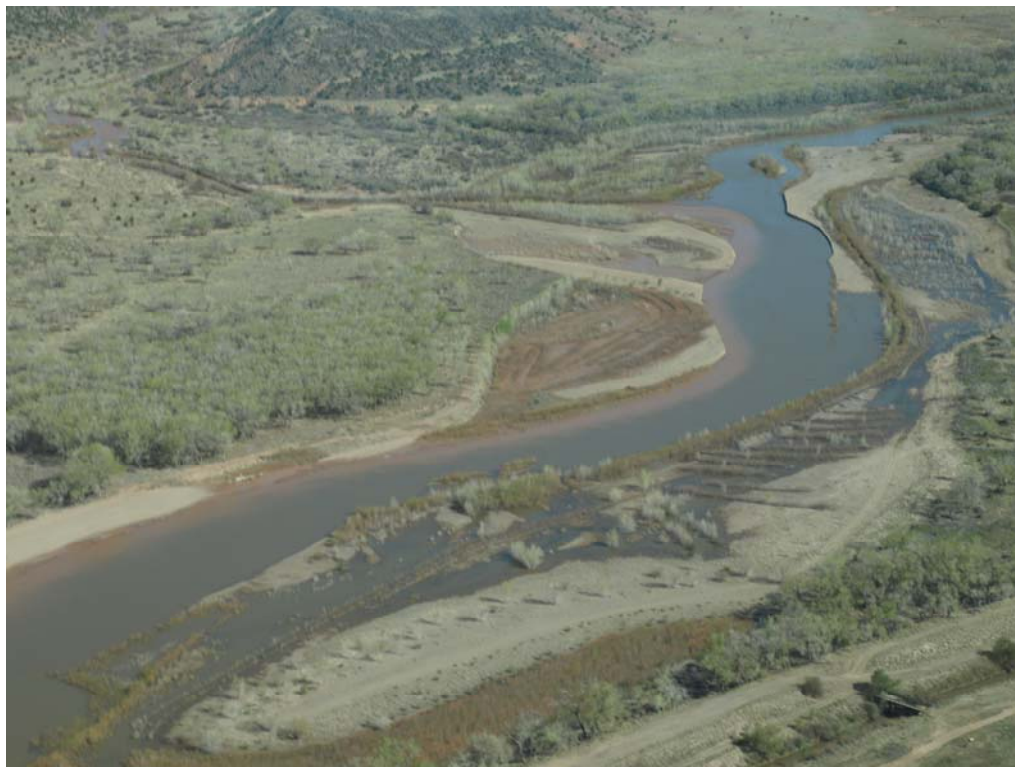
Photo 9: Looking upstream at location of sediment spoil pile on the Pueblo of Santa Ana after sediment has been removed. Flow in the Rio Grande is approximately 3000 cfs (April 2010, Holste)

The 2010 spring runoff saw increased inundation in the project area (Photo 9), and also new bank erosion on the eastern bank upstream of gradient restoration facility. A planned solution to protect the bank and prevent flanking of the gradient restoration facility is underway and is expected to be completed in 2011.

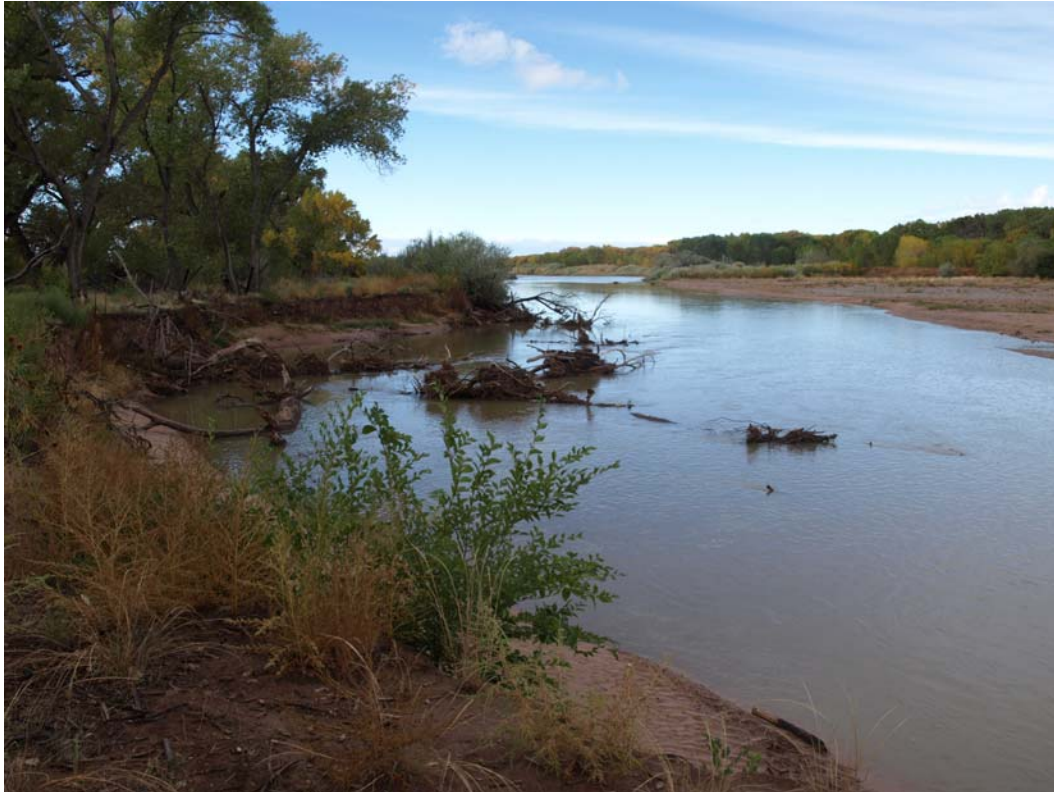
Photo 10: Looking downstream at the bend erosion at the Santa Ana RM 205.8 priority site (October 2010, AuBuchon)

An additional priority site was added within the Pueblo of Santa Ana, on the east bank of the Rio Grande across from the Tamaya Resort special events tent, following the 2008 spring runoff. For many years, the bankline had been stable and followed the jetty jack line. Prior to the 2008 runoff, the bankline migrated beyond the jetty jack line; further erosion occurred during the 2008 spring runoff.

Due to the close proximity of the spoil levee and the amount of bankline erosion observed during 2008, this site was elevated to the status of a priority site. The Corps of Engineers, through their Section 1135 project authority, undertook an island and bar lowering project on the Rio Grande through the Pueblo of Santa Ana, a portion of which was adjacent to this priority site (Photo 10). Observations from the 2009 and 2010 spring runoff indicate that this project helped reduce the active bank erosion at this site by increasing the conveyance capacity at high flows (Photo 11). Reclamation is currently working with the Pueblo of Santa Ana to implement an Information Sharing Agreement and develop a preferred protection strategy.

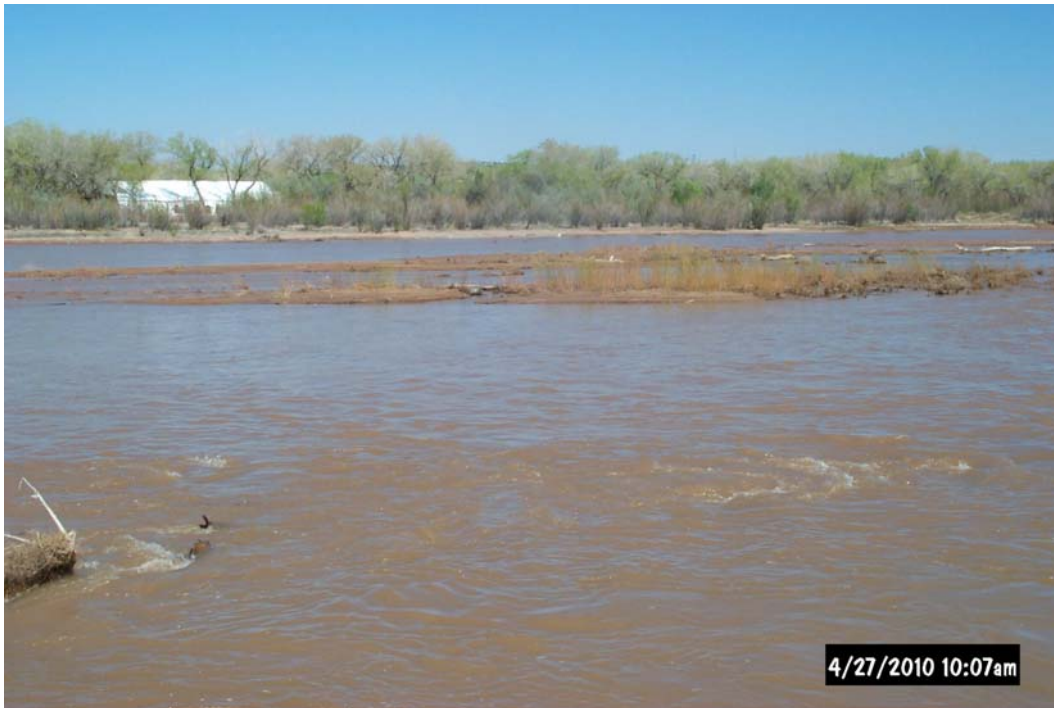
Photo 11: Increased wetted width at higher flows (approximate river flow is 2800 cfs) from the Corps of Engineers' bar lowering at the Pueblo of Santa Ana across from the Santa Ana RM 205.8 priority site (April 2010, AuBuchon)

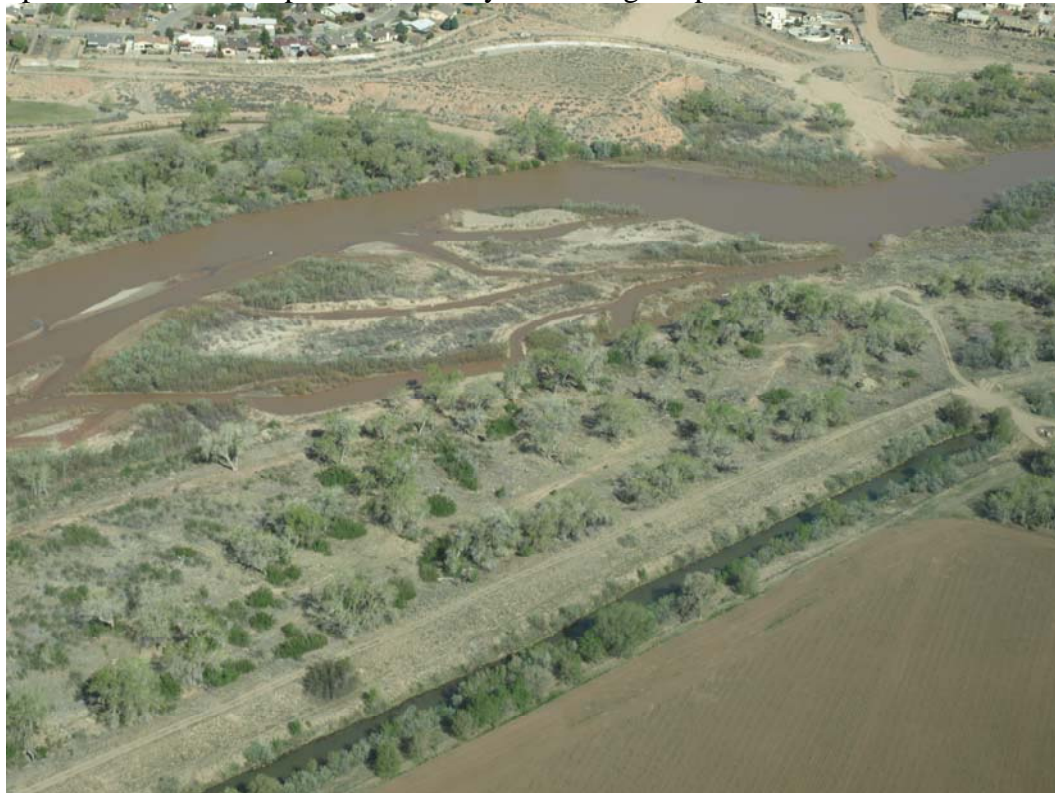
Photo 12: Looking west at Corrales Siphon river maintenance site location during spring runoff. Note high flow channels cut in bar by Pueblo of Sandia. Flow in the Rio Grande is approximately 3000 cfs. (April 2010, Holste)

However, in early 2008, Reclamation became aware that the inverted siphon consists mostly of a wood pipeline that was constructed in the 1930s. Because of concerns about the stability of the wood pipeline when subjected to the loading and vibration of construction equipment, vibration testing and video examination of the pipe were performed. While the video was inconclusive, the vibration testing indicated that equipment should stay approximately 50 feet from the pipe to avoid damaging it. In addition, conditions at the site have changed, as deposited sediment and high flow side channels cut in the bar on the opposite bank by the Pueblo of Sandia have alleviated some of the pressure at the higher discharges (Photo 12).

Reclamation has downgraded the status of this project to a monitored site but is currently considering techniques that would not impact the siphon, but would help to further stabilize the upstream sediment deposition, thereby increasing the protection on the undercut bank.

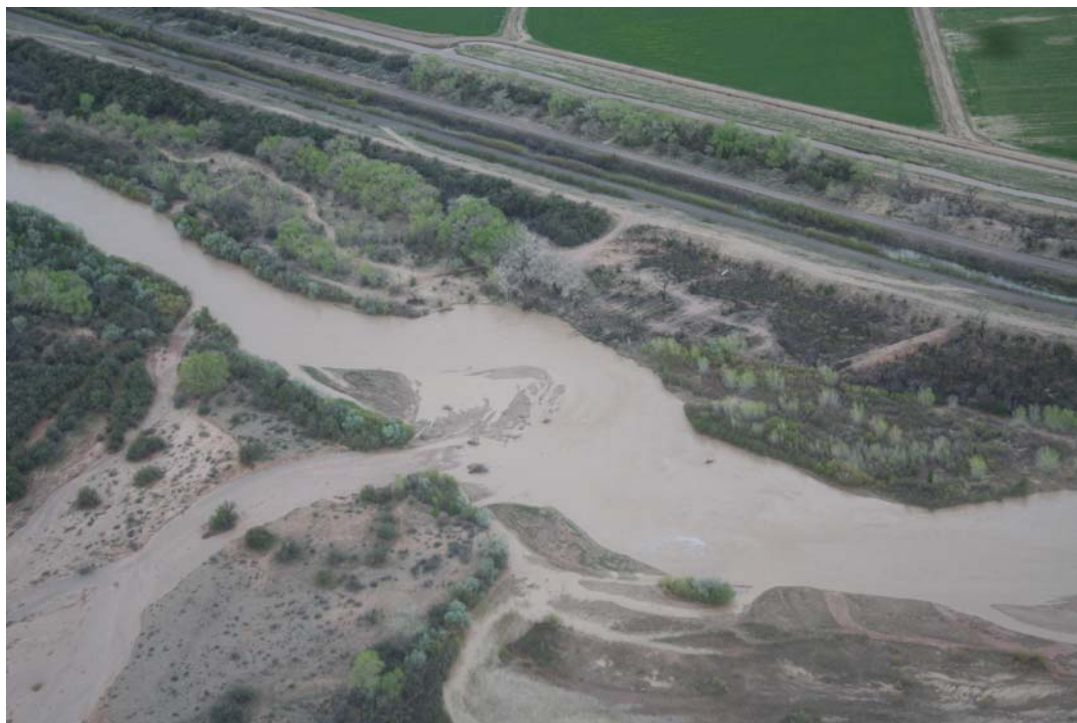
Photo 13: Aerial photograph of the Arroyo de las Cañas (April 2010, Gonzales)

This river maintenance site is located at RM 95.5 (Photo 13) on the west bank of the Rio Grande, upstream of Arroyo de las Cañas. When the site was identified in 2005, the bankline was less than 100 feet from the levee toe, and the thalweg was along the outside of the bend nearest the levee. While the bankline was eroded during the 2005 runoff, subsequent years (2006 and 2007) saw extensive deposition at this site. Spring runoff conditions in 2008 and 2009, along with a fire that burned a majority of the vegetation in the area in the early part of 2009, have again raised concerns that this site may be susceptible to erosion, although no additional erosion was observed through the 2010 spring runoff. This site has been downgraded to monitored site status. Proactive bank stabilization of depositional features is being evaluated to see if it could reduce the risk of further erosion.

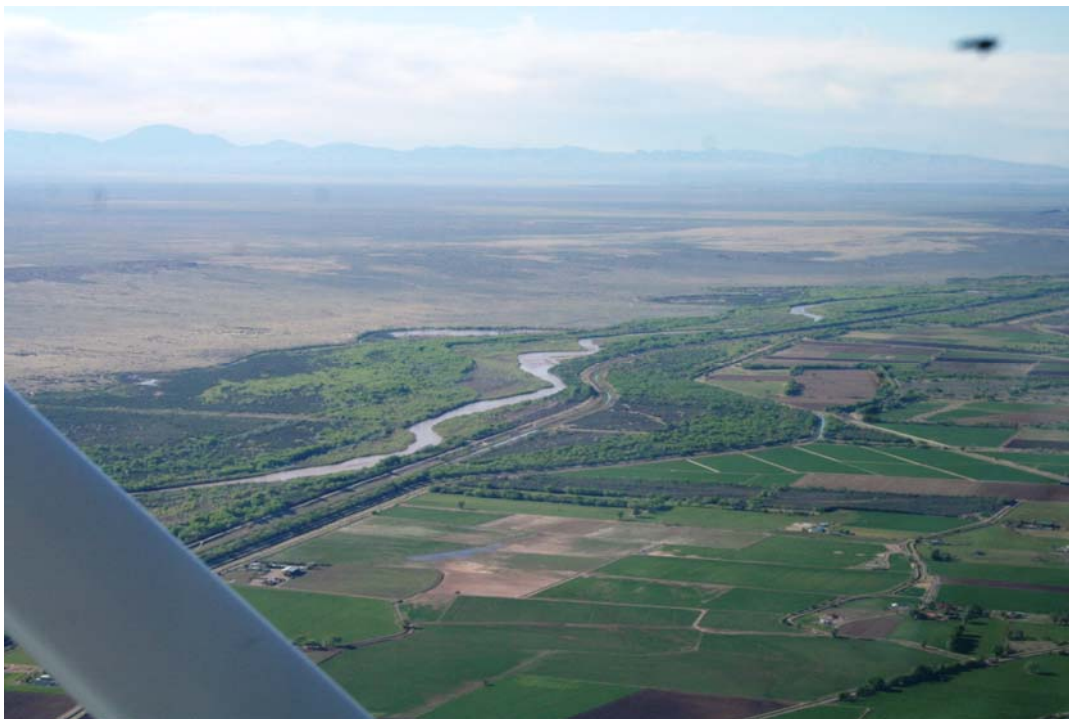
Photo 14: The reach of river currently considered most prone to sediment plug formation, taken from just north of the North Boundary BDANWR, looking south (April 2010, Gonzales)

Reclamation continues to monitor the 2008 sediment plug area, and has analyzed sediment plug potential in the general reach of river from RM 89 (2 miles upstream of the U.S. Highway 380 Bridge) to RM 80. A geomorphic assessment and hydraulic and sediment-continuity analyses report for this reach was completed in February 2010. In addition to assessing sediment plug potential, the report identified specific areas most vulnerable to plug formation and measures that may prevent future plug formation. Evaluation of alternatives for addressing sediment plugs is in progress, and Reclamation will monitor river conditions and runoff projections during 2011. The area thought to currently have the greatest potential for sediment plug formation is shown in Photo 14.

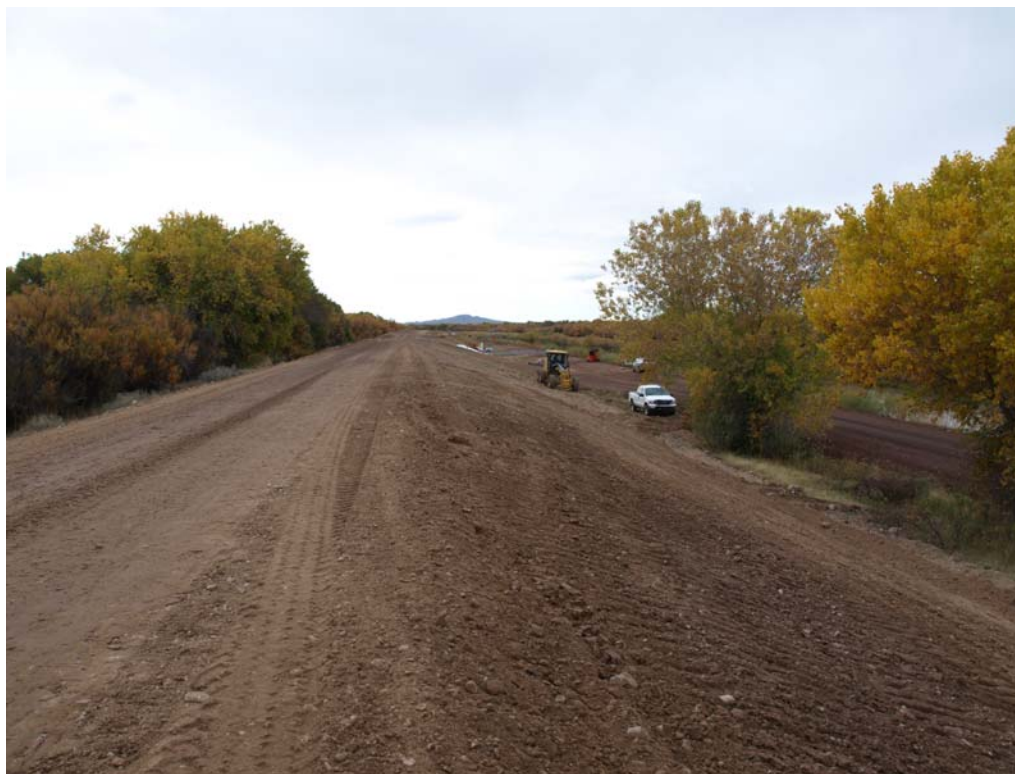
Photo 15: A completed section of the 2009 Bosque del Apache Levee ARRA improvements (October 2009, Rolland)

In 2009, Reclamation requested American Recovery and Reinvestment Act (ARRA) funds for improvements to the levee, and received \$2 million. The improvements included raising low areas and widening narrow areas within a three mile stretch of levee where conditions are of greatest concern. This work was awarded to Stoven Construction, Inc., by a task order under the 2009 Simplified Acquisition of Basic Engineering Requirements (SABER) contract. Contract work included loading and hauling Government-furnished borrow material from the Valverde borrow site to the levee. Reclamation's Socorro Field Division shaped the material on the levee after it was dumped by the contractor.

Because of schedule limitations imposed by the BDANWR due to migratory bird season, construction for this project was divided into two periods of performance. The first period ran from October 26, 2009, to November 10, 2009, and provided approximately 52,200 tons (33,700 cubic yards) of material on the levee (Photo 15). The second period went from March 1, 2010, to March 26, 2010, and added approximately 83,300 tons (53,800 cubic yards) of material. The total quantity of material hauled and added to the levee is estimated to be 135,500 tons (87,500 cubic yards). The Reclamation crew is currently working on a 1.2 mile portion of the levee north of BDANWR (Photo 16). Initial material placement to bring the top of the levee to width and grade took place from August 16, 2010, to October 7, 2010. Work will resume in spring 2011 to widen the base of the levee.

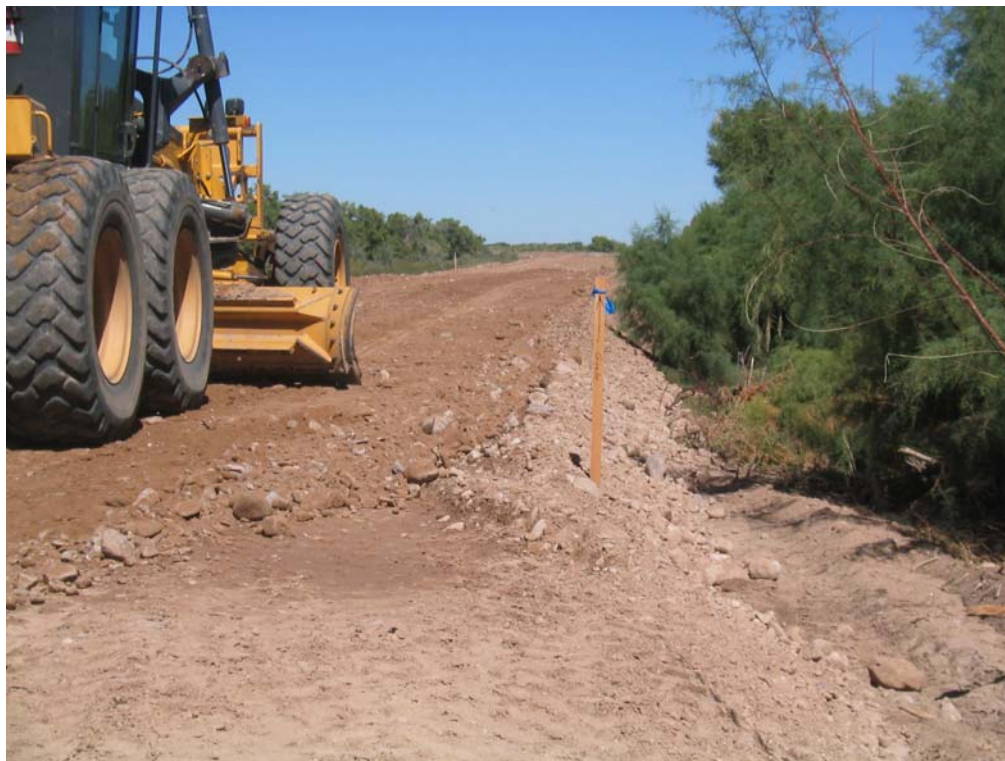
Photo 16: Levee raising north of BDANWR (September 2010, Weems)

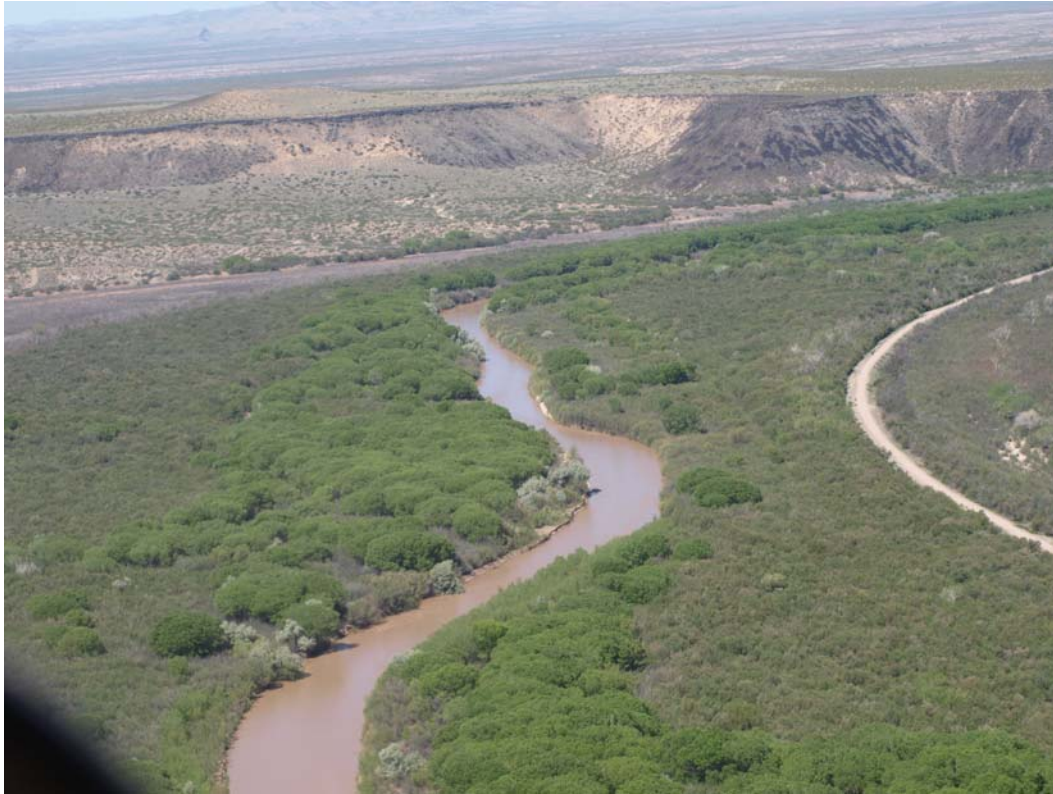
Photo 17: Vicinity of 2005 Tiffany Sediment Plug (May 2010, Padilla)

During the 2005 spring runoff, a sediment plug formed in the vicinity of RM 70 (approximately 1.5 miles upstream of the San Marcial railroad bridge), and then grew in the upstream direction to a length of over 3 miles. In a joint effort between NMISC and Reclamation, the plug was removed in 2005. Reclamation has continued to monitor this site closely, and has evaluated alternatives for solutions to the problem. However, a recent evaluation indicates that channel bed lowering in this reach of the river (Photo 17) in the last few years has increased the channel capacity and therefore lowered the risk for formation of another sediment plug at this site. Reclamation may eventually implement a project for channel work to reduce the probability of future plugs in this area, but it has become a lower priority due to the recent bed lowering.

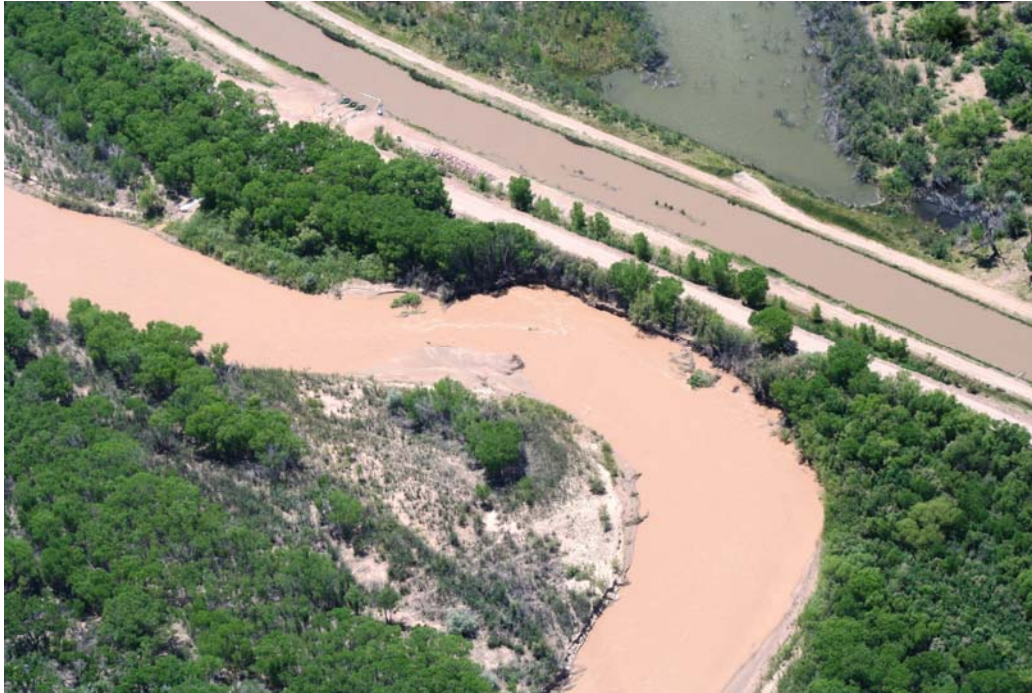
Photo 18: Fort Craig Bend priority site, looking southwest (May 2010, Gonzales)

The river bend at this site has been fairly stable in past years, but became active during the 2008 runoff, with even more erosion activity during the 2009 runoff. The upper portion of the bend was stable during the 2010 runoff, but the erosion continued to progress downstream, with almost 50 feet of bankline lost at one location. A riprap windrow has been designed to provide short term protection and is anticipated to be placed between the top of bank and the levee toe during spring 2011.

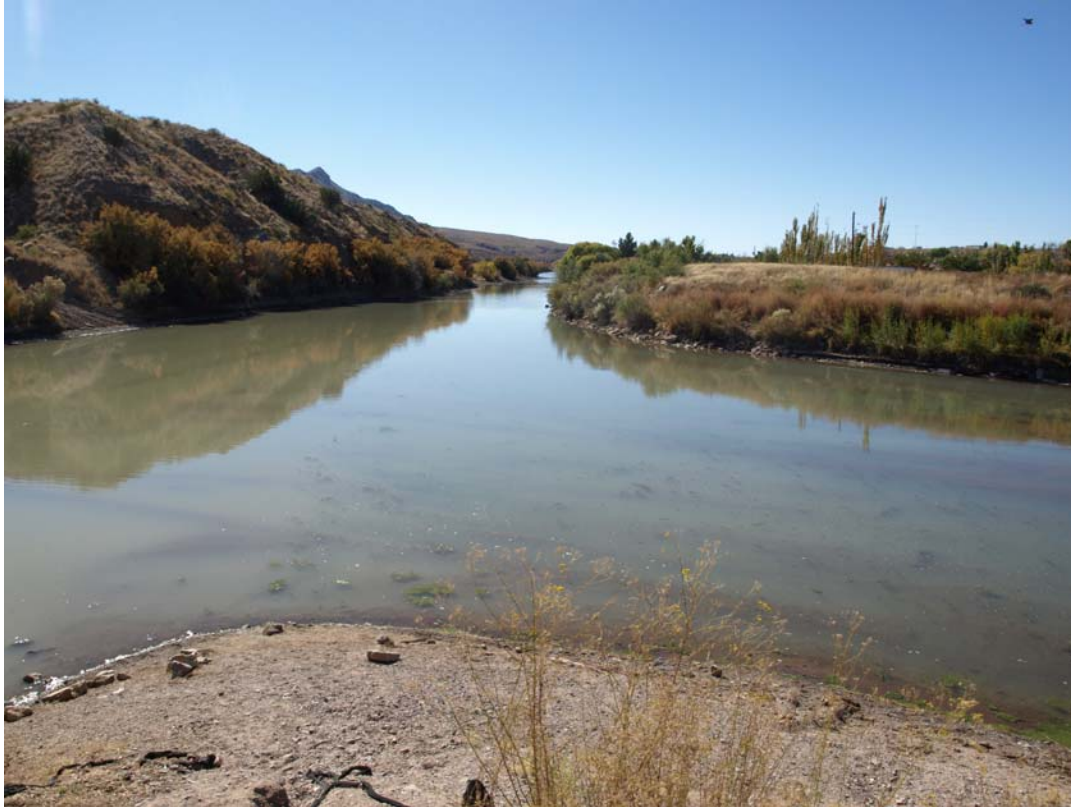
Photo 19: Rio Grande and Cuchilla Negro Creek confluence after sediment excavation (November 2010, AuBuchon)

Sediment excavation was performed in 2010 at arroyo mouths (Photo 19) and various reaches of the river channel, with a total volume of 9,900 cubic yards removed.

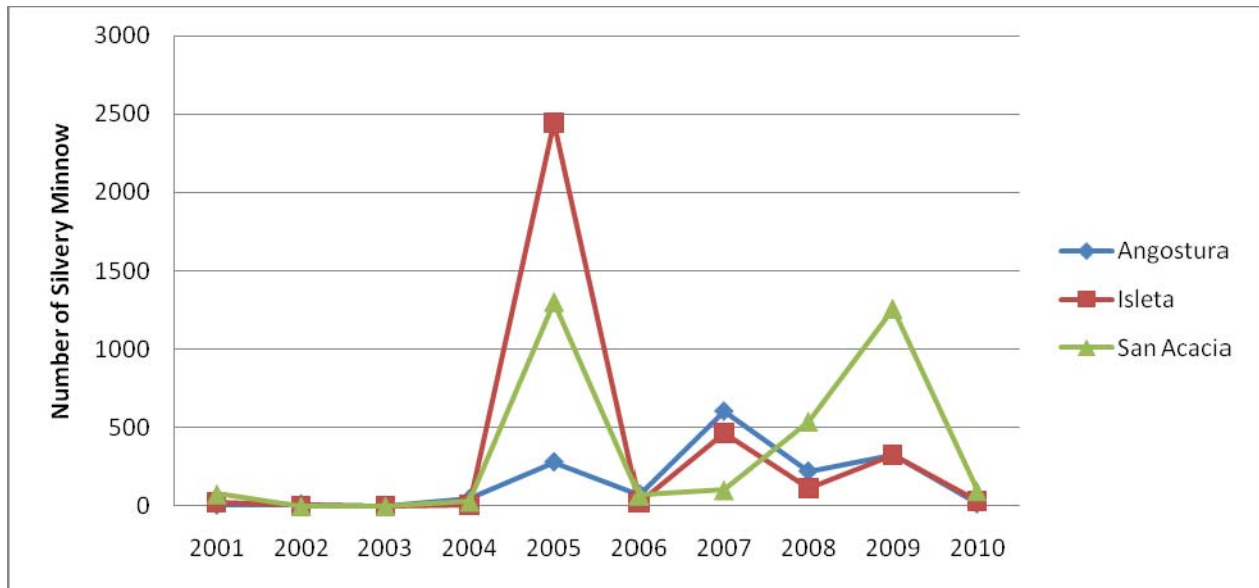
Figure 5: Total Number of Rio Grande Silvery Minnow Captured in October Population Monitoring Surveys

Figure 5 shows silvery minnow population monitoring trends from 2001 through 2010, based on annual October population monitoring contracted through the Program. This monitoring is conducted using seining by habitat and has been the consistent method used for over ten years. The silvery minnow population has fluctuated since 2003. Despite spring runoff being enhanced by a planned Cochiti overbanking deviation and effective post-runoff water management, population appears to have experienced reduced recruitment success in 2010 in all reaches. This apparent decline may be due to a combination of habitat loss and crowding within existing habitats during periods of low flow accompanied by drying, however, further studies may be necessary to determine the actual cause. Table 10 shows the total numbers of silvery minnow captured and the number of sample sites (in parentheses), by reach, during October surveys between 2001 and 2010.
