Calendar Year 2012 Report to the Rio Grande Compact Commission

U. S. Department of the Interior
Bureau of Reclamation
Albuquerque Area Office
Albuquerque, New Mexico

March 2013

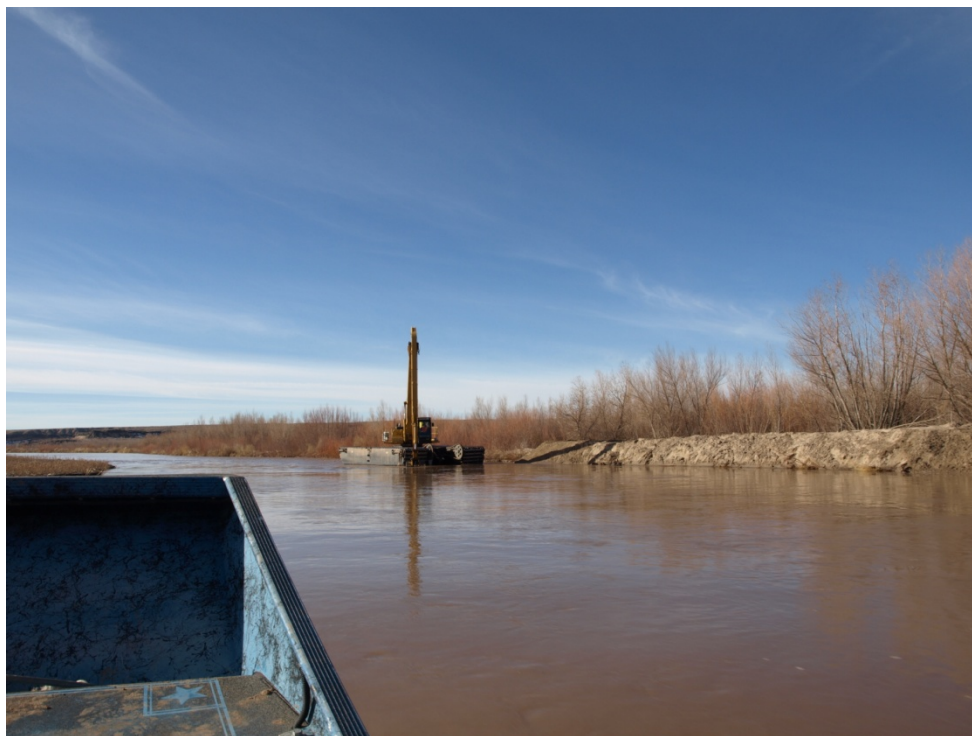
Photo 1: Amphibious excavator working on west berm of the Temporary Channel (January 2012, Casuga)

The maintenance work performed along the Temporary Channel in 2012 extended from RM 46 north to RM 54. Given the drought conditions in 2012 and a low peak runoff, the Temp Channel did not experience any breaches during the year. There were, however, significant sections along the channel where the banks had narrowed considerably from vegetation encroachment and bank sloughing. General maintenance of banks along the length of channel was done to increase the width of the banks. The bank widths were increased on the channel side, so the overall footprint of the Temporary Channel did not increase. Maintenance work consisted of the removing sediment deposits within channel and placing the removed material on the channel banks to increase width.

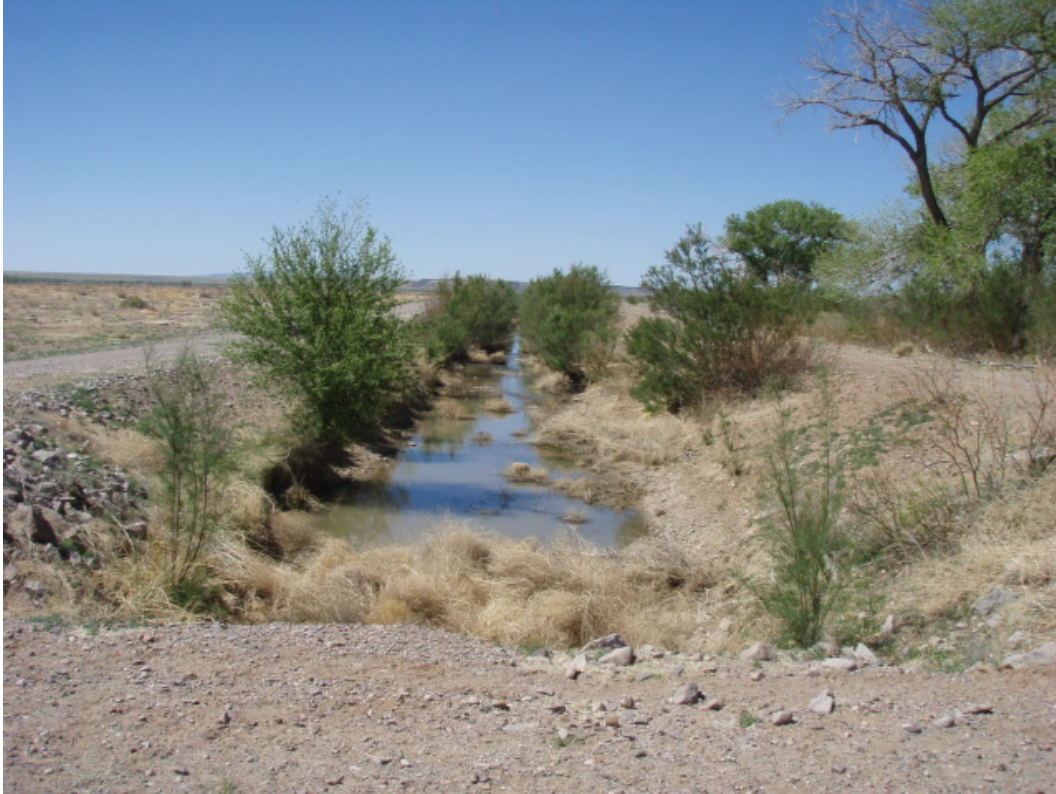
Photo 2: Elmendorf Drain, south branch before maintenance (April 2012, Grogan)

- Elmendorf Drain, south branch. Maintenance work was completed in August and September 2012. Work items included mowing overgrown vegetation along the drain channel banks, removing aquatic vegetation from the wetted drain channel, removing sediment in the drain in areas where it has accumulated to form shallow or island areas, grading the service road on both sides of the drain, and diverting flow from the east branch to the south branch to wash away tumbleweed blockages.

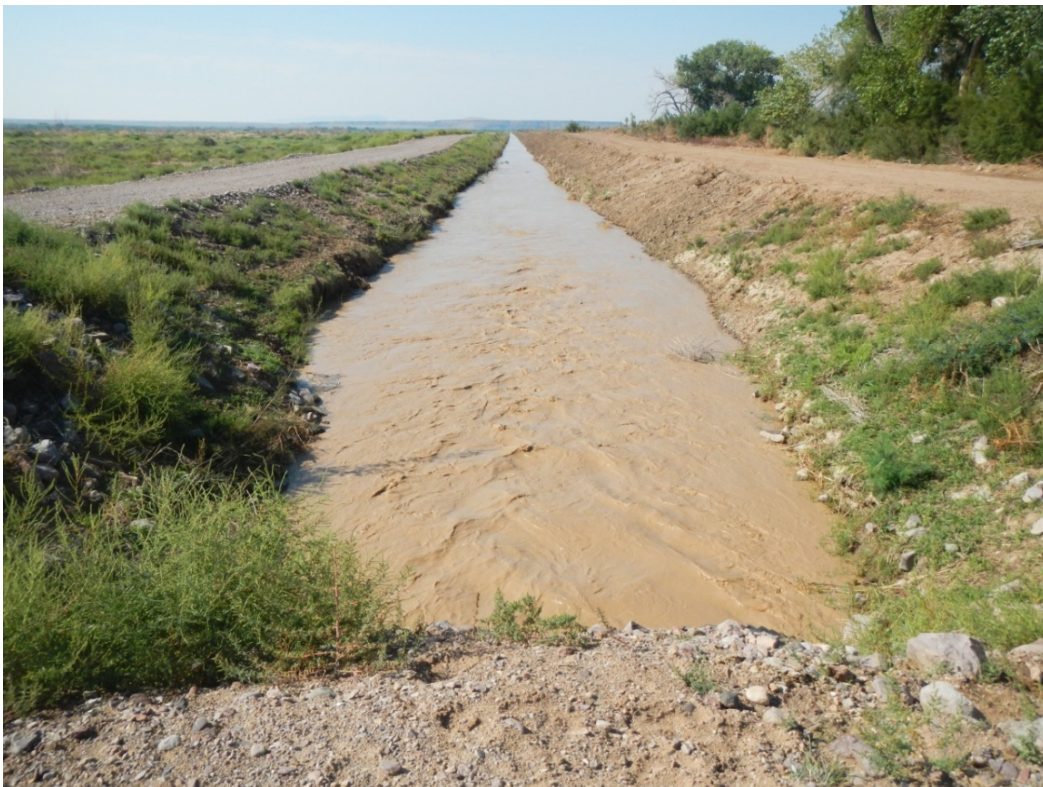
Photo 3: Elmendorf Drain, south branch after maintenance completed (April 2012, Grogan)

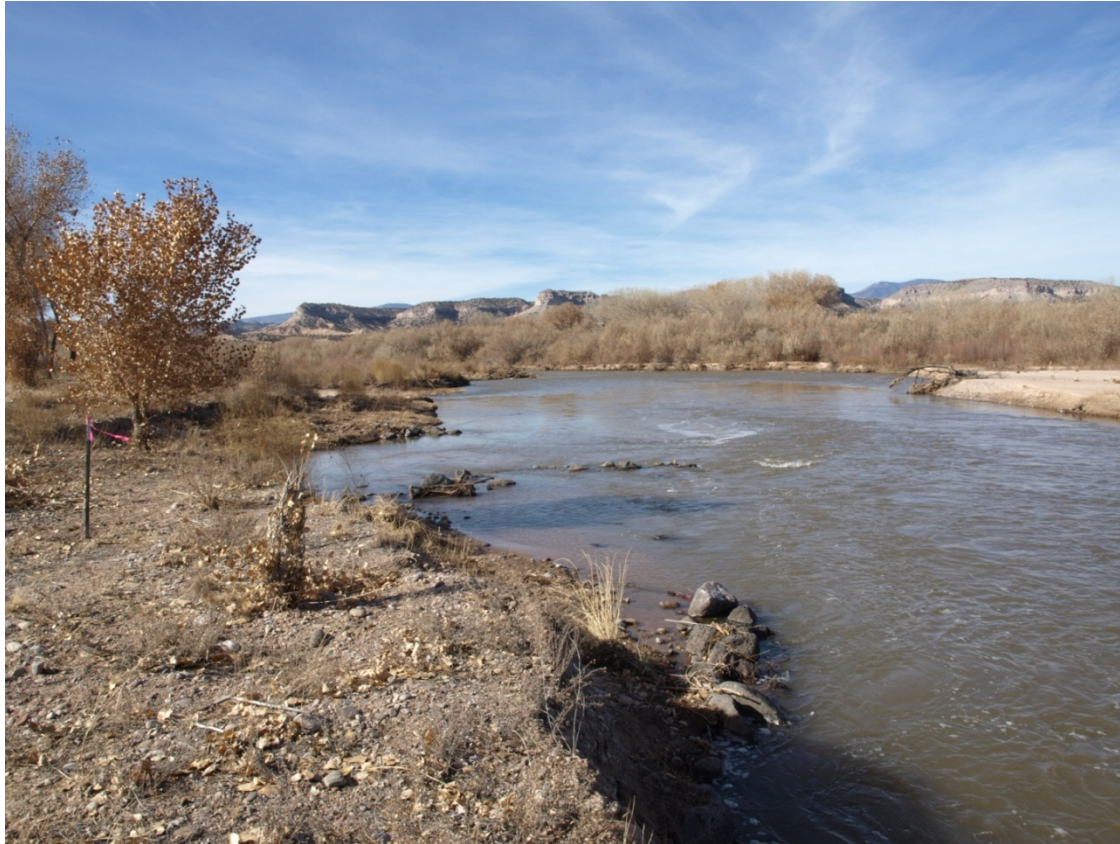
Photo 4: San Ildefonso bankline erosion, showing exposed rock vanes (December 2012, AuBuchon)

This priority site is located at River Mile (RM) 259. In spring 2007, a river maintenance project was constructed by Reclamation's Socorro Field Division to provide protection for the San Ildefonso fishing pond. During the spring runoff of 2009, the channel eroded through a line of dense vegetation planted as part of the project. This erosion resulted in the loss of up to 75 feet of bankline upstream of the previous project area. This bank erosion exposed and threatened to flank three of the buried rock vanes (Photo 4). Reclamation worked with the Pueblo de San Ildefonso to construct a temporary solution prior to the 2010 spring runoff. The project consisted of a buried trench riprap revetment and a riprap windrow. This 2010 temporary protection work allowed for the development and permitting of a longer term solution.

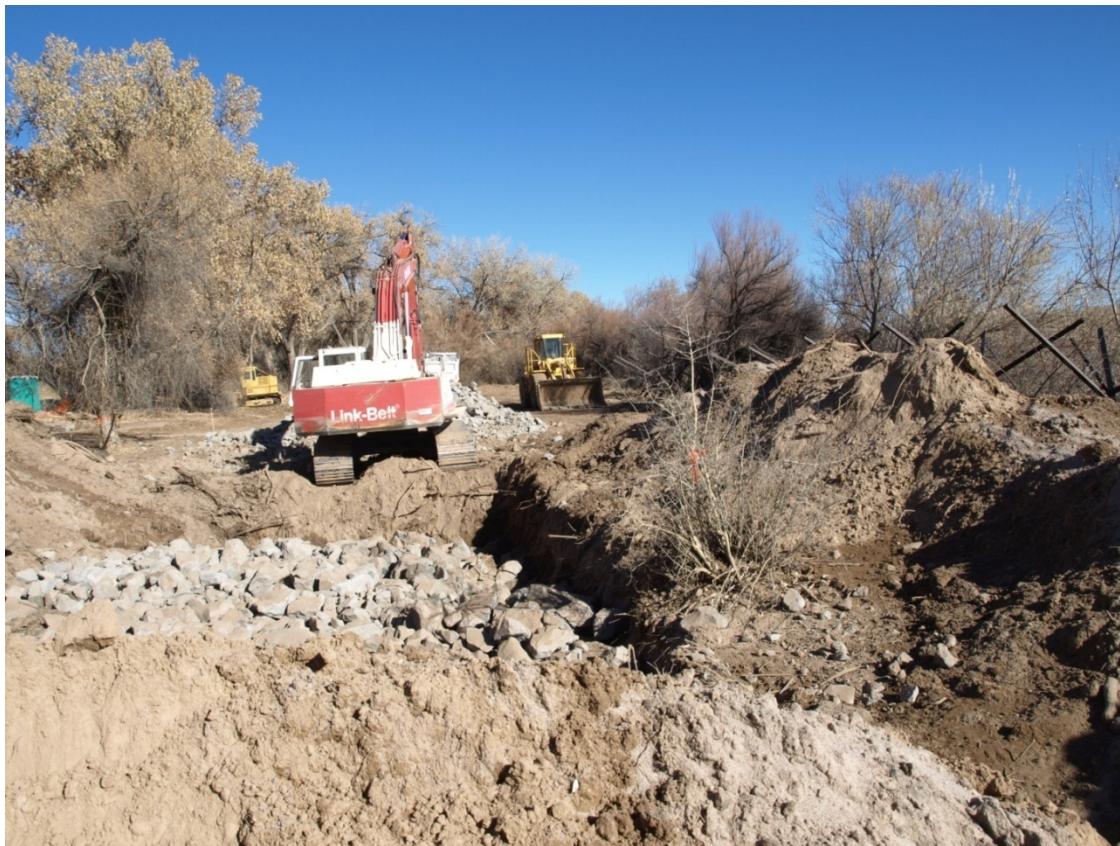
Photo 5: Santo Domingo Pueblo RM 225.1, placing self launching riprap (December 2012, AuBuchon)

The three project sites were divided into two phases, RM 225.1 will be completed in Phase 1, and RM 224.6 and RM 223.9 will be completed together at a later time as part of Phase 2. Detailed designs, construction drawings, a project description, and environmental compliance for RM 225.1 were completed in September 2012. Construction began on this site in October 2012 and is expected to be completed in January 2013. A picture of the construction at this site is shown in Photo 5. The project description for RM 224.6 and RM 223.9 was completed in the

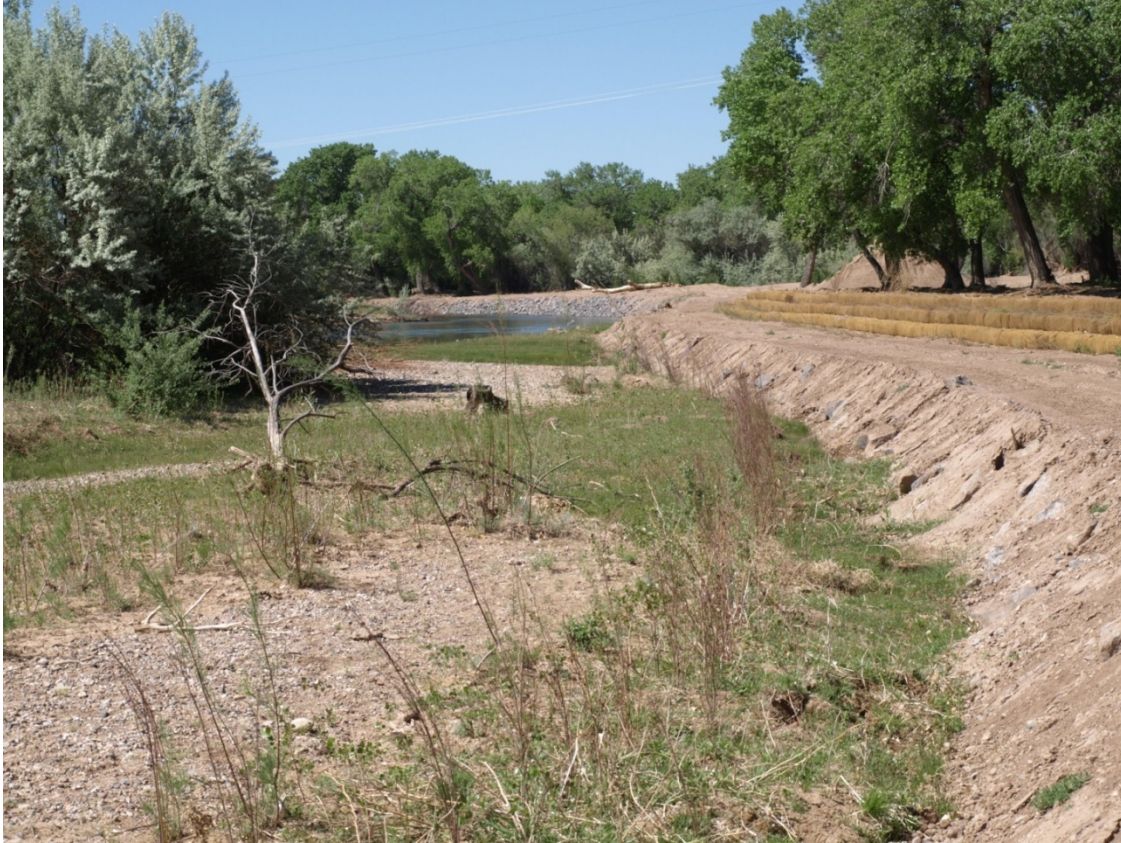
Photo 6: Coyote willow whips, rock toe, and Bio-D blocks at Priority Site RM 212.0 (May 2012, Walton)

Construction was completed at two sites, RM 213.4 and RM 213.7, in 2011. A third site, RM 212, was completed in early 2012 (see Photo 6). Current conditions at the unprotected sites could lead to damage of levees, irrigation infrastructure, roads, and a residential area of the Pueblo. Construction on RM 215.5 began in July 2012 and should be completed in March 2013. For the remaining six sites, Reclamation worked with the Pueblo of San Felipe and selected preferred alternatives in October 2012 for the designs at each of these sites. Design work at these sites is currently being pursued. Construction drawings and project descriptions are expected in the first half of 2013. Environmental compliance is anticipated at the end of 2013, with an anticipated start of construction in early 2014.

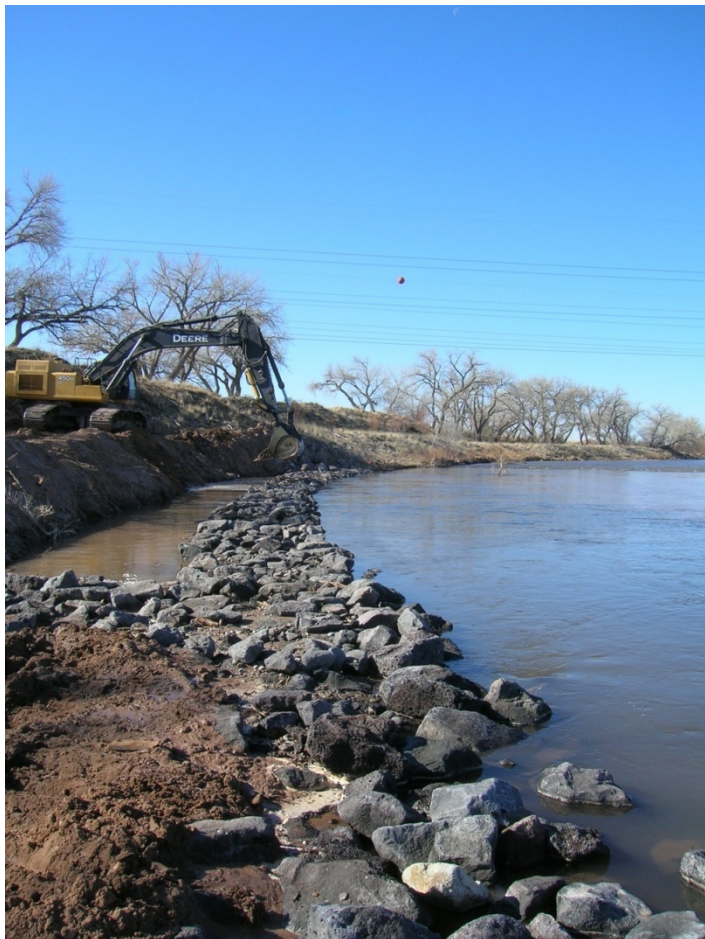
Photo 7: 2012 construction on the LFSTP with tiebacks (March 2012, Mims)

In 2005, Reclamation lowered the elevation of backwater areas to facilitate inundation at higher discharges. In 2008 additional flanking protection was added on the west side of the installed GRF and along bioengineering bankline protection along the Jemez River. Another backwater area on the west side was also added at this time. In 2009, bendway weirs were placed in the eroding bend upstream of the GRF and the remaining sediment spoil piles were removed, allowing increased inundation of the floodplain. In 2012, construction of a longitudinal fill stone toe (LFSTP) with tiebacks was initiated to provide flanking protection on the east side of the installed GRF (see Photo 8). Construction of the LFSTP began in February 2012 and was completed in April 2012. Re-vegetation with native vegetation was accomplished at all of these sites through a P.L. 93-638 contract in place with the Pueblo of Santa Ana.

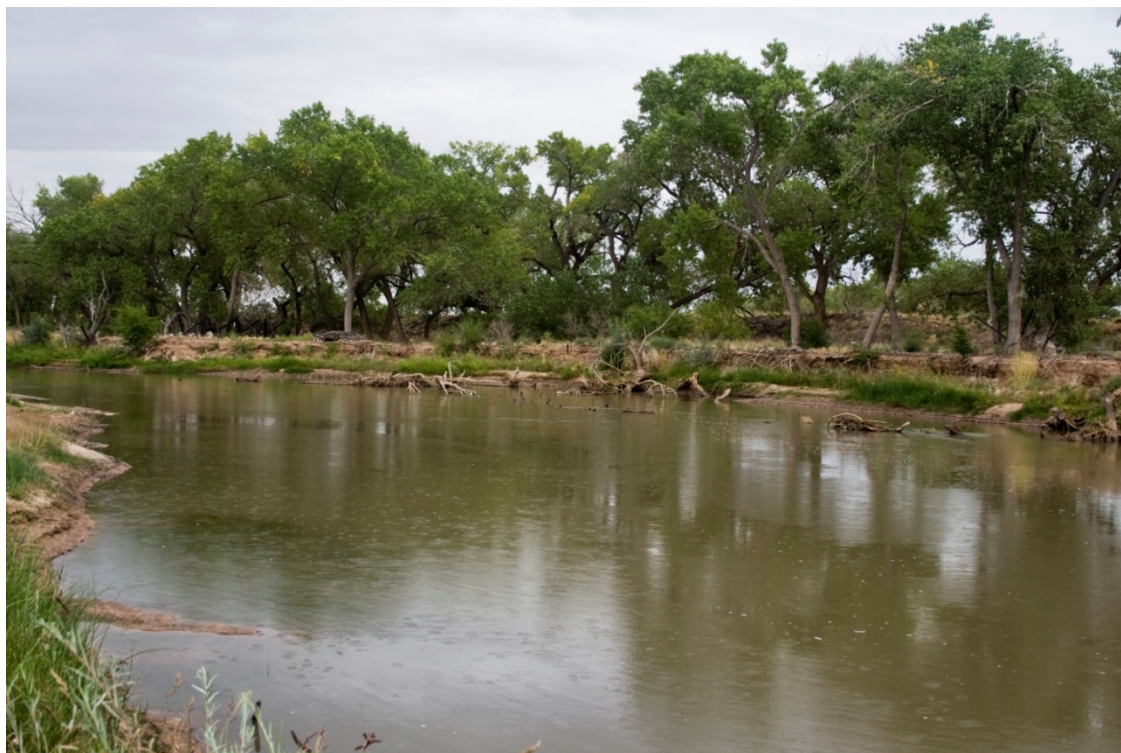
Photo 8: Santa Ana RM 205.8 priority site (September 2012, Nemeth)

This site is within the Pueblo of Santa Ana, on the east bank of the Rio Grande across from the Tamaya Resort special events tent (see Photo 8). An island and bar lowering project, undertaken by the Corps of Engineers through their Section 1135 project authority, has helped reduce the active bank erosion at this site by reducing outer bank velocities and shear stresses at high flows. Reclamation has worked with the Pueblo of Santa Ana to develop a preferred alternative to provide protection at this site. A Public Law 93-638 contract was initiated with the Pueblo of Santa Ana in 2010 to facilitate the collection of design data, pursue the geomorphic and hydraulic analyses at this site, develop suitable alternatives, and produce final designs. A preferred alternative was selected at this site in May 2012. Final designs are expected in January 2013, along with a project description. Environmental compliance and maintenance construction are anticipated in the fall of 2013.

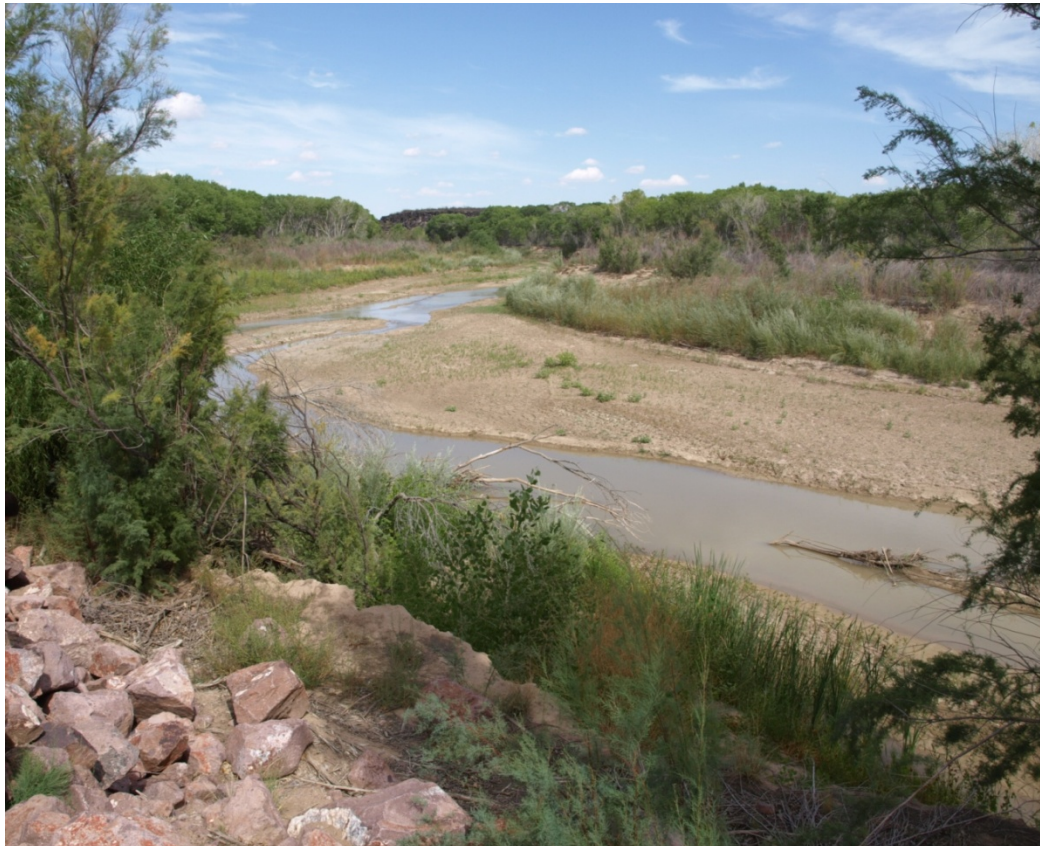
Photo 9: Fort Craig Bend, looking upstream with riprap window in left corner (September 2012, Holste)

Reclamation continues to monitor the bank erosion at this site. Due to the current drought conditions, the 2012 runoff was not sufficient to cause the temporary riprap windrow constructed in March of 2011 to launch. It is anticipated that given a normal spring runoff or large thunderstorm monsoonal event that the material protecting the levee will be launched. The riprap window is an interim measure at this location and should withstand the design event of 7700 cfs or approximately two to three seasons of normal spring runoff. Reclamation is starting a long term evaluation of potential reach-based strategies for the river and LFCC for the reach between Ft. Craig and RM 60.

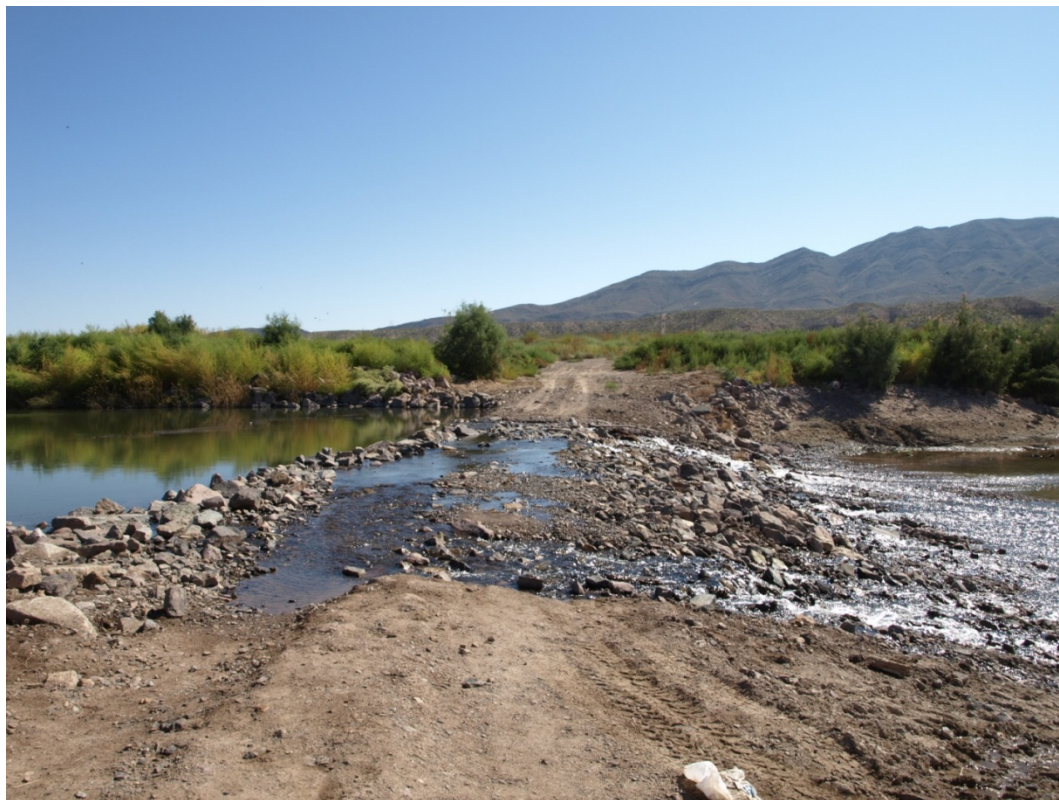
Photo 10: Temporary dike installation on the Rio Grande (October 2012, AuBuchon)

Photo 10 shows the temporary dike installed for 2012.

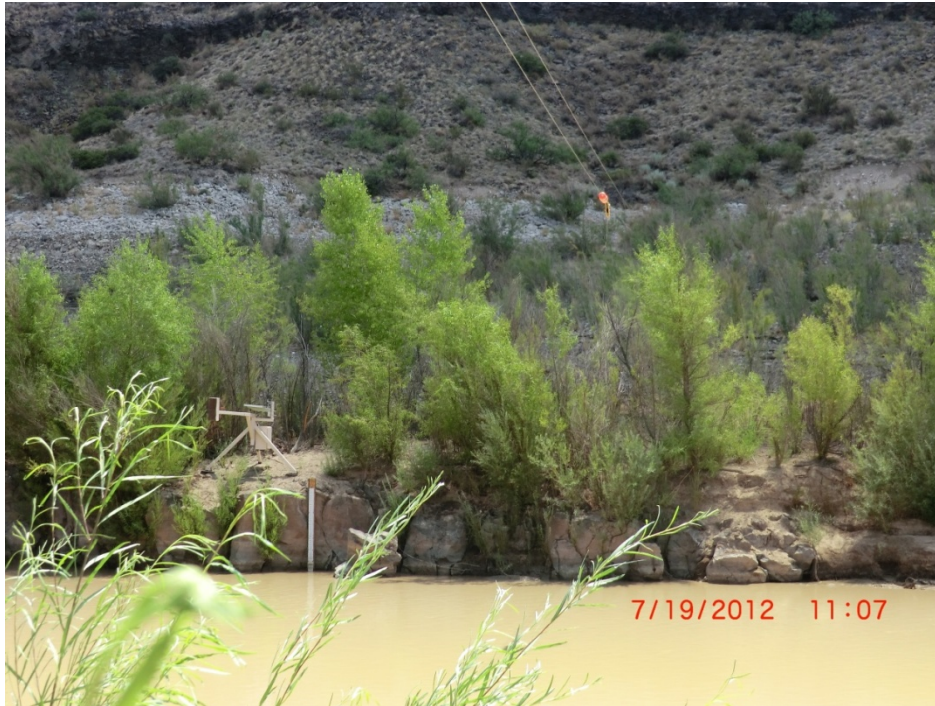
Photo 11: New USGS Gage located within the Narrows of Elephant Butte Reservoir (Ryan 2012)

In 2012 Reclamation funded the development of a new USGS gauging station located at the Elephant Butte Temporary Channel just north of rangeline EB-53 in the Reservoir Narrows. The next upstream gauging station along the Rio Grande is located at San Marcial, approximately 30 river miles upstream of the active reservoir pool. The surface water gauge is approximately 6.5 river miles upstream of the current reservoir pool stage. Reclamation is currently doing a hydrologic analysis for the water delivery benefits derived from Temporary Channel maintenance between the San Marcial and Narrows gauges.

Installation of the new gauging facility was done by the USGS. Reclamation provided support through funding, vegetation clearing, and environmental compliance. Construction was completed May of 2012.
