## Calendar Year 2017 Report to the Rio Grande Compact Commission

U. S. Department of the Interior  
Bureau of Reclamation  
Albuquerque Area Office  
Albuquerque, New Mexico

March 2018

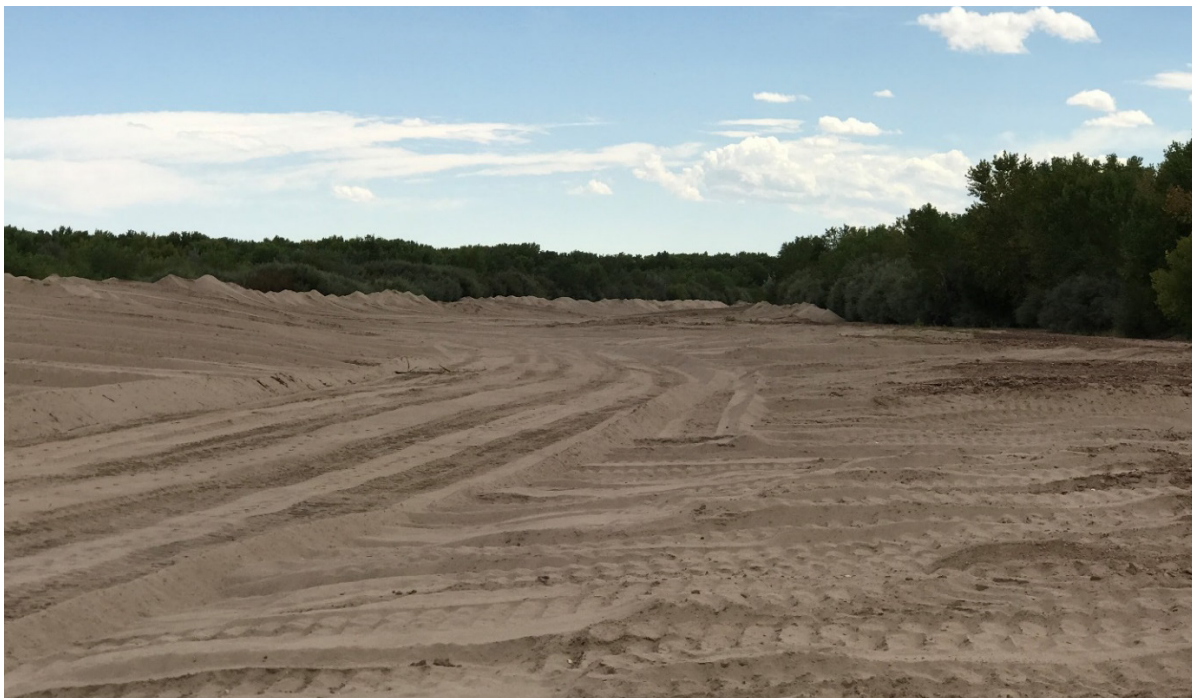
Photo 1: Bosque del Apache Sediment Plug Removal (Vollmer, August 2017)

A sediment plug formed within the Bosque del Apache National Wildlife Refuge (BDANWR) in April 2017 during runoff. It completely blocked the river channel, forcing flows into both the east and west overbank. NEPA compliance was completed in late August 2017, and plans were prepared to remove the plug. Crews from the Socorro Field Division (SFD) mobilized at the end of August, and began opening a channel through the three mile long plug. Work was confined to the reach without flycatcher and cuckoo habitat through the end of August. After the Labor Day weekend, SFD began channel work in the area with flycatcher and cuckoo habitat. Work progressed quickly, and was completed on September 15, 2017. Equipment was out of the area by September 20, 2017.

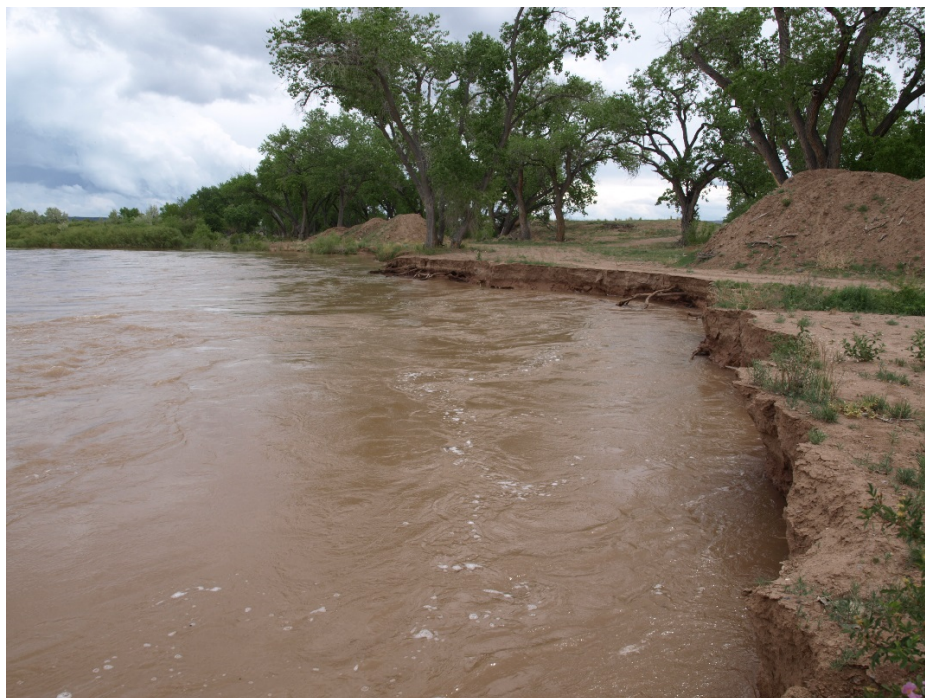
Photo 2: Santa Ana RM 205.8, looking upstream at flow over bendway weir field during the 2017 spring runoff (Herrington, May 2017)

This site is within the Pueblo of Santa Ana, on the east bank of the Rio Grande across from the Tamaya Resort special events tent. Nine bendway weirs and a low elevation floodplain were constructed in 2014. The Pueblo of Santa Ana, through a PL 93-638 contract, planted vegetation at this site in early 2015. During the spring runoff in 2015, erosion at the site threatened the project. An interim adaptive maintenance solution was completed in January 2016 to provide protection while a longer term solution was investigated. The site experienced additional bank erosion during the 2017 runoff, however, the temporary controls placed in 2016 minimized the extent of the lateral bank migration.

The longer term investigation includes evaluating the specific geomorphic and hydraulic conditions that led to the unexpected bank erosion in 2015. The geomorphic assessment was completed in 2017. The hydraulic analysis is expected to be completed in 2018. This investigation may result in the recommendation of additional adaptive maintenance steps as part of a permanent repair project. Reclamation, the Pueblo of Santa Ana, and the University of New Mexico are in the third year of a five-year collaborative research effort at this project site. The research is investigating the effects of bendway weirs on primary producer organisms, specifically targeting those known to be food sources for the silvery minnow.

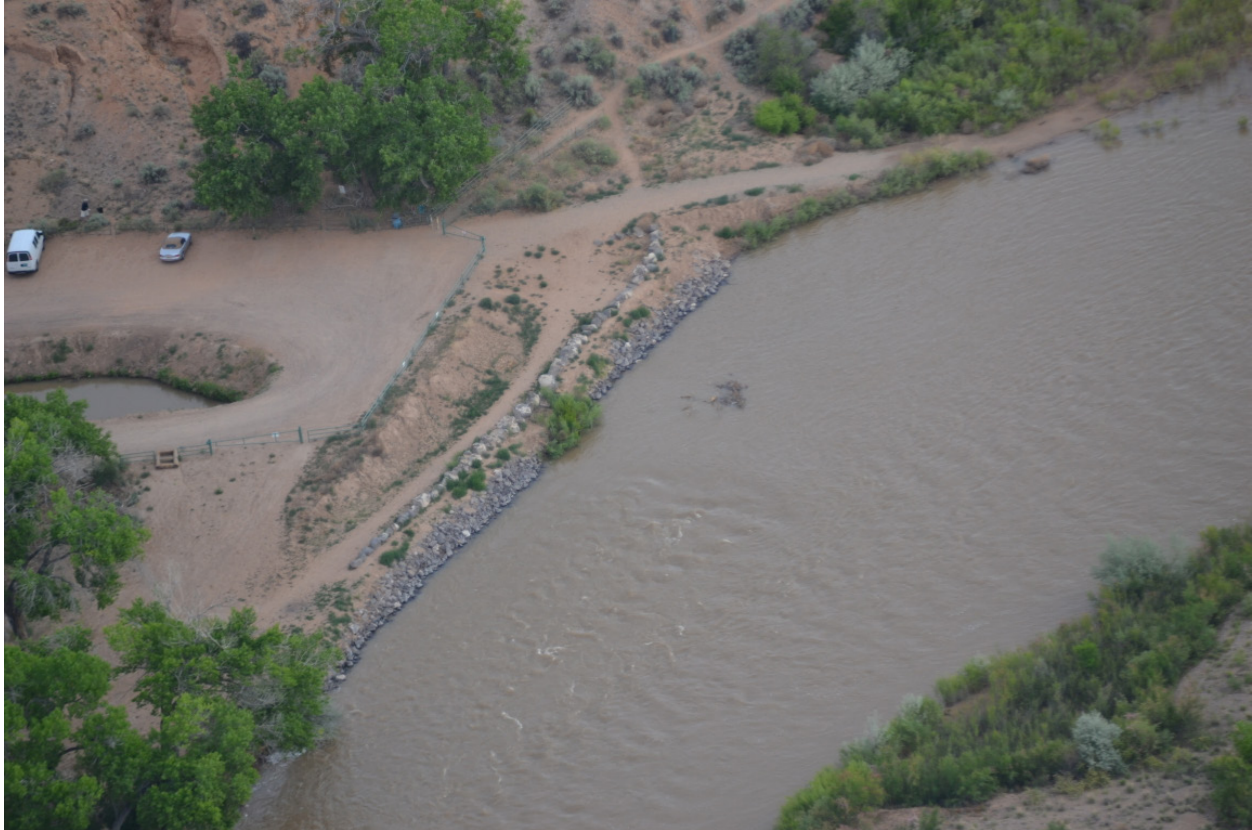
Photo 5: Aerial view of Corrales Siphon (Padilla, May 2017)

The Corrales Siphon is located in Corrales, New Mexico, just north of Albuquerque, at RM 199.7 and about 700 feet downstream of the Arroyo de la Barranca confluence. The siphon was constructed in the early 1930s by the MRGCD to provide irrigation water to the Corrales Main Canal. During river reconnaissance in 2012, Reclamation discovered that degradation in the area had exposed the siphon, exposing it to the current. MRGCD requested emergency technical assistance and construction support from Reclamation to temporarily protect the siphon during the 2016 runoff.

Reclamation and MRGCD collaborated on a short term project that placed riprap in the scour hole downstream of the exposed siphon from the western bankline. This riprap material was placed on the river bed to a depth of approximately 6 feet for a length of about 50 feet downstream of the siphon and a width of about 75 feet across the river channel from the bankline toe. Riprap was also placed upstream and downstream of the siphon along the west bankline. Approximately 1,800 cubic yards of riprap were placed for the project. MRGCD is planning to repair the wood stave siphon, and address the continued threat from erosion and degradation.

Annual monitoring on the ground and from the air continues. The scour hole and exposed part of the siphon have moved away from the western bank, toward center of the river channel. New developments caused by geomorphic responses to the temporary repair will continue to be monitored by Reclamation.

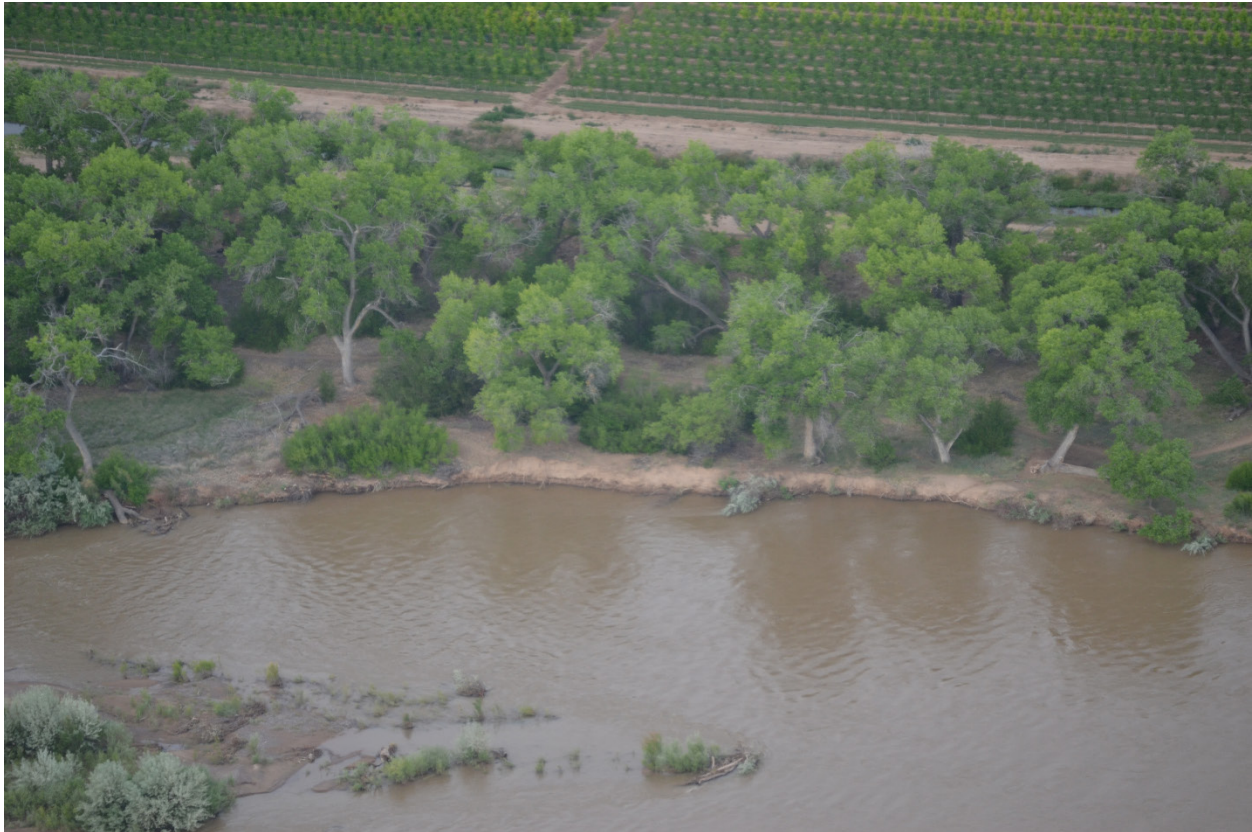
Photo 6: Bank erosion at River Mile 199 (Padilla, May 2017)

In spring 2017 Reclamation identified a new erosion site near RM 199, in the Corrales area. This site is on the west side of the river, and the active bankline is approximately 120 feet from the west levee toe. There are no river cross sections in the vicinity. Brushing and surveying to establish a new rangeline at this location is planned for 2018. This site's bankline had not been surveyed before, so the amount of erosion resulting from the 2017 runoff cannot be quantified. The reach planning effort between Highway 550 Bridge to Montañño Bridge will provide a detailed geomorphic and hydraulic study of the reach and sub-reaches that will help evaluate erosion at RM 199 in context of the overall reach needs.

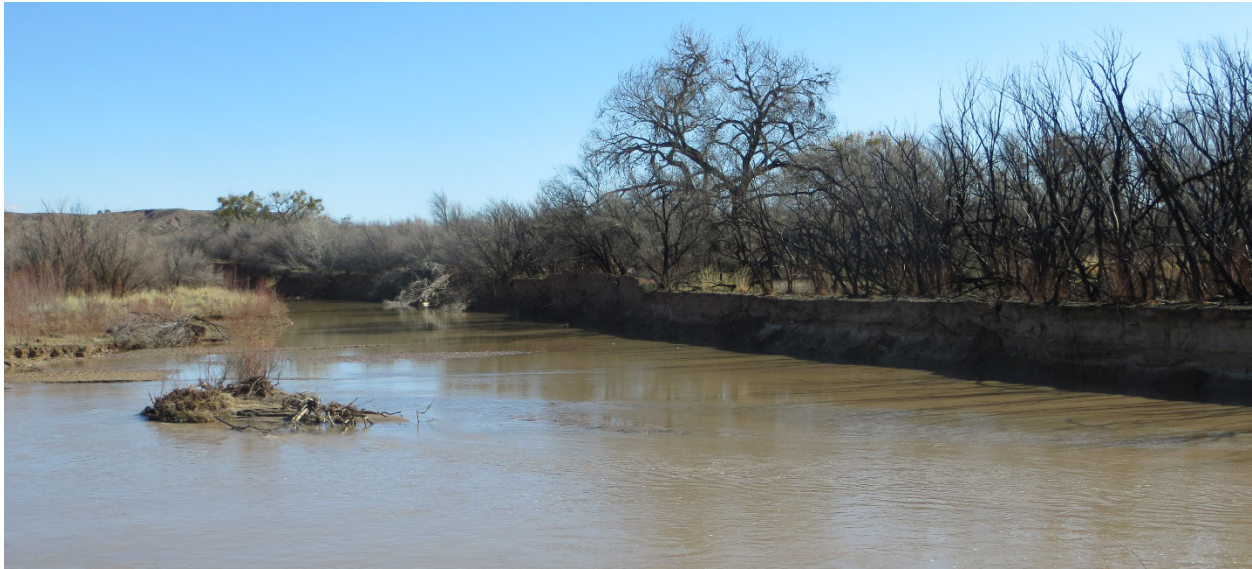
Photo 7: Burned trees and cut bank on Arroyo de la Parida, looking up arroyo from confluence with Rio Grande (Bui, February 2017)

The habitat restoration sites in the Escondida burn scar include lowering the Arroyo de la Parida delta and an abandoned side channel. Approximately 1.8 acres of the arroyo delta will be lowered to the 300 cfs inundation design level. Cut banks will also be sloped to encourage growth of riparian vegetation.

The side channel work is intended to create a flow-through channel at 2,000 cfs. An additional three outlets will be added along the side channel, which along with the original inlet and outlet,

will function as backwaters at the 300 cfs inundation design level.

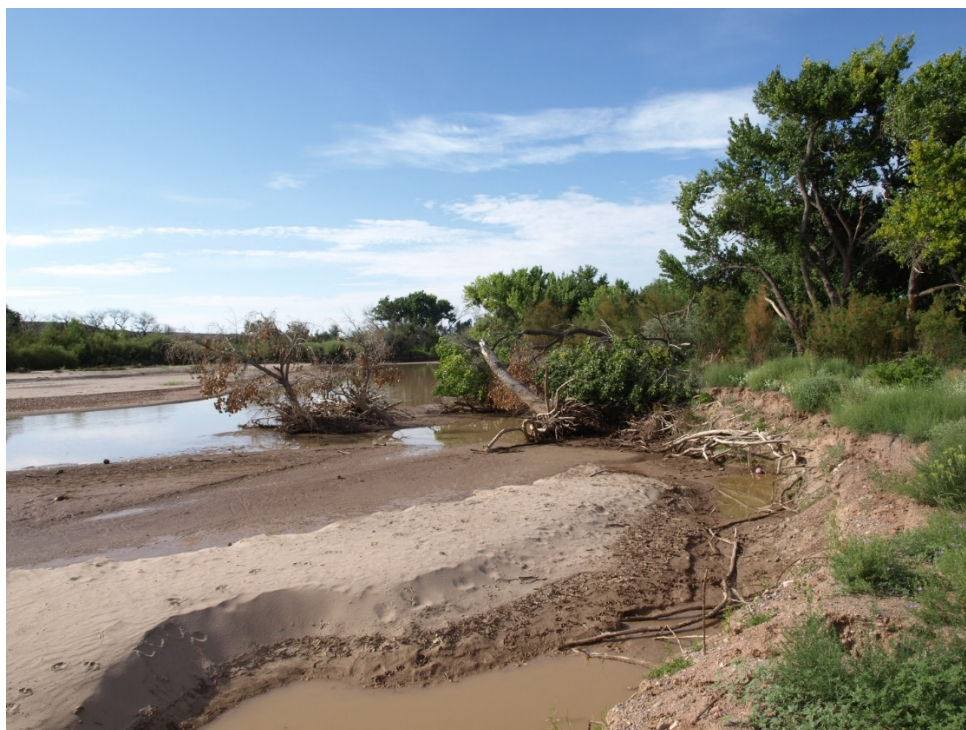
Photo 8: Bank erosion and deposition at Arroyo de las Cañas and Rio Grande confluence (AuBuchon, August 2017)

The Arroyo de las Cañas site is located upstream of the Arroyo de las Cañas confluence, between RM 96 and 95, south of Socorro, NM. The Rio Grande is close to the west spoil levee for the LFCC through this reach, with a potential for damage to the spoil levee from lateral erosion of the river. In 2005, significant bank erosion was observed at this site and plans were initiated for constructing a river maintenance project. The project was ready for construction when the 2008 spring snowmelt runoff moved the river's alignment away from the spoil levee. This reduced the probability of damage to the spoil levee and a decision was made to monitor the area to see if future work would be warranted.

Reclamation completed a geomorphic assessment of this area in 2016. A contingency response

plan was also developed in 2016, had spring monitoring observed signs of a potential failure. In 2017, the USACE completed a levee construction project adjacent to the Arroyo de las Cañas site. Reclamation reviewed the USACE levee design and found that the design riprap size, quantity, and protection length was more than adequate to also address Reclamation's river maintenance concerns there. Reclamation will conduct a reach evaluation in the area in 2018. It should help identify potential river projects that minimize the need for river maintenance action and/or improve habitat value.

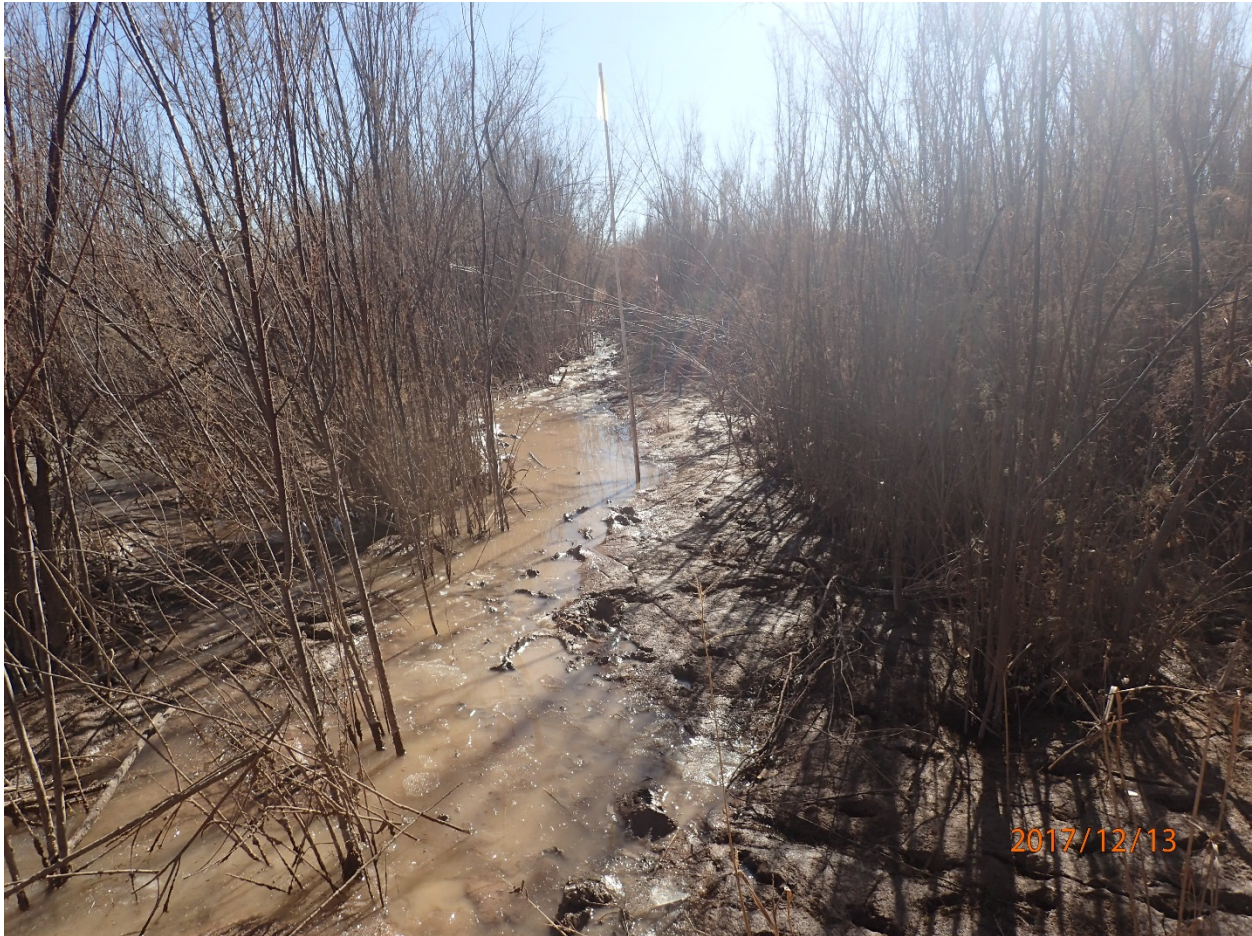
Photo 9: Looking south along northern portion of the BDA pilot realignment project. Flagging is on proposed centerline (Holste, December 2017)

During the 2008 and 2017 spring runoffs, a sediment plug formed in the main channel of the Rio Grande at RM 81, located within the BDANWR. In 2014, a multi-agency project team began to pursue a realignment to the east of the current channel that would address river maintenance concerns near the 2008 and 2017 sediment plugs. The overall realignment project will involve two river segments, about 4.5 miles and 2.5 miles in length, that reconnect with the current channel. In 2016, Reclamation decided to construct the southern portion first to learn lessons from the observed channel response of the smaller realignment section before beginning work on the longer northern realignment. The southern realignment portion was termed the BDA Pilot Realignment Project.

Designs were completed on the BDA Pilot Realignment Project in 2017. Environmental approvals allowed mowing to begin in January 2018. NEPA and Clean Water Act compliance for the entire project is underway and is expected to be received by summer 2018. Construction is contingent on field conditions, but should be completed in 2018 or 2019.

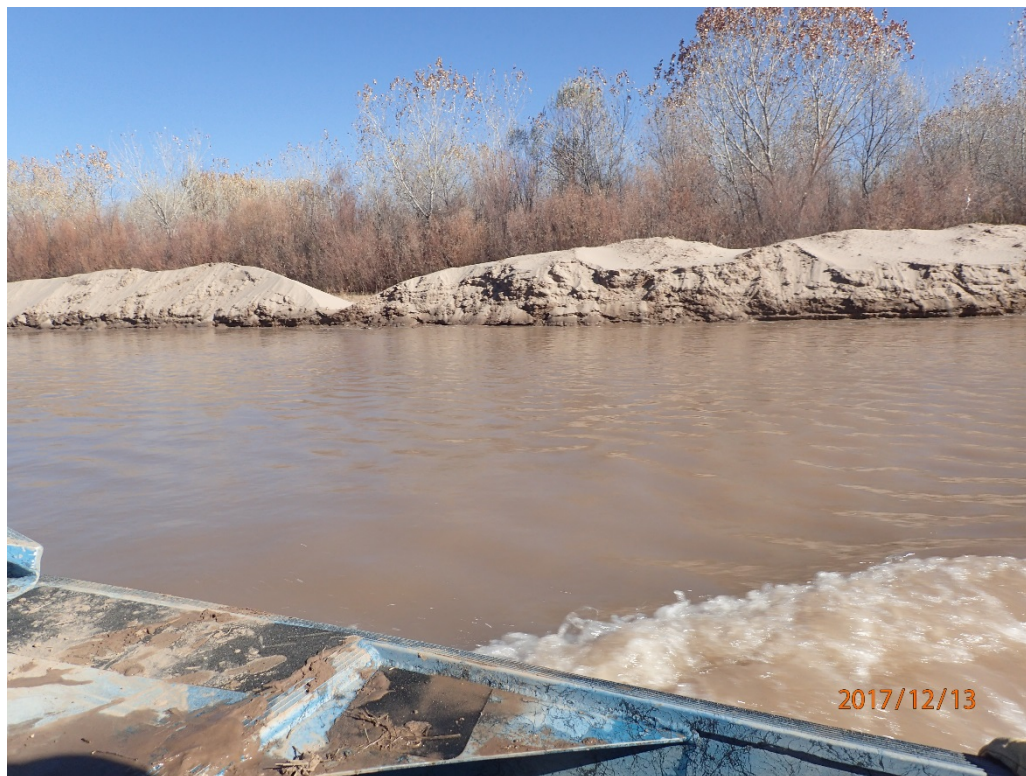
Photo 10: Looking east at spoil berm from 2017 pilot channel through the sediment plug. Spoil piles are actively eroding (Holste, December 2017).

During the 2017 spring runoff, a sediment plug formed in the main channel of the Rio Grande at RM 81 within the BDANWR. Reclamation initiated work on a pilot channel through the plugged area in August 2017. It was completed in September 2017. The 2017 pilot channel had a similar 25 foot bottom width as the previous pilot channel constructed after the 2008 sediment plug. Observations of the pilot channel in fall 2017 indicated that the river was removing spoil material adjacent to it.

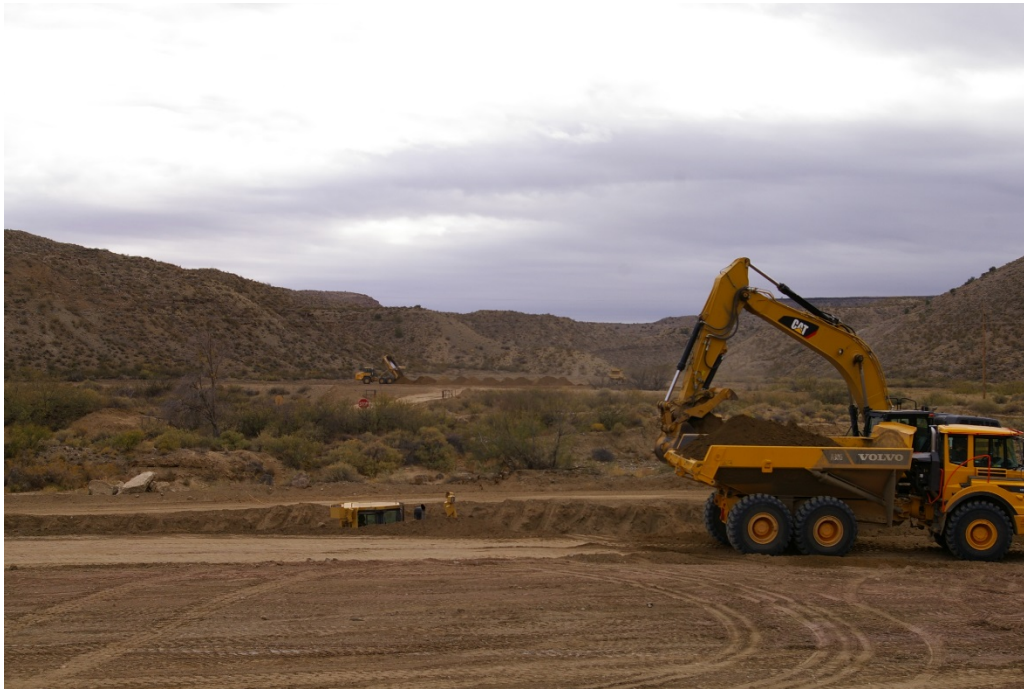
Photo 11: Relocation of previously stockpiled sediment (foreground) away from active arroyo (background), looking up Mescal Arroyo near Rio Grande confluence (Harris, December 2017)

confluence can create channel capacity concerns and influence water operations and power generation. Geomorphic and hydraulic modeling analyses of this tributary led to the formation of a multi-disciplinary team to assess potential options at the Mescal Arroyo and Rio Grande confluence that would minimize the future maintenance. The team formulated potential alternatives in 2016, and completed a final alternative analysis report in 2017.

The preferred alternative seeks to change past sediment spoil management practices that exacerbated the deposition problem at the confluence. The spoil within the active channel of the Mescal Arroyo will be moved (this work was started in 2017), resulting in a wider channel confluence that will allow deposition to occur above the Rio Grande confluence. A new location has been identified for the excavated spoil material that would cause less impinging flow conditions on the sediment piles from the arroyo. A grade control structure is also proposed to help stabilize the arroyo bed and prevent future head-cutting up the arroyo that would generate additional sediment. Design for this alternative is expected in 2018.
