### Modal Analysis and Vibration Test of NASA MSFC Shaker Table

**Modal Analysis and Vibration Test of Shaker Table**

To: ET40 Vibrations Team  
From: Brian Mincks  
Subject: Modal Analysis and Vibration of UD T4000-H Shaker

# **Unholtz-Dickie T4000A Modal Analysis & Vibration Test**

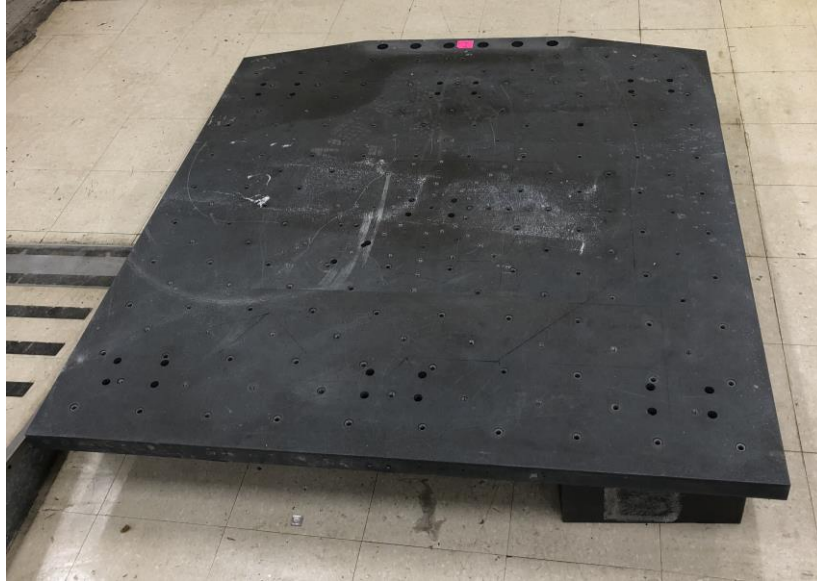
To simulate the free-free boundary condition, the shaker is setup on foam blocks. Simple, checkout tests revealed the first structural mode was more than ten times that of the first rigid body mode signifying the free-free simulation is valid [1]. Figure 2 shows this setup of the shaker table on foam.

**Figure 2** Free-Free test setup

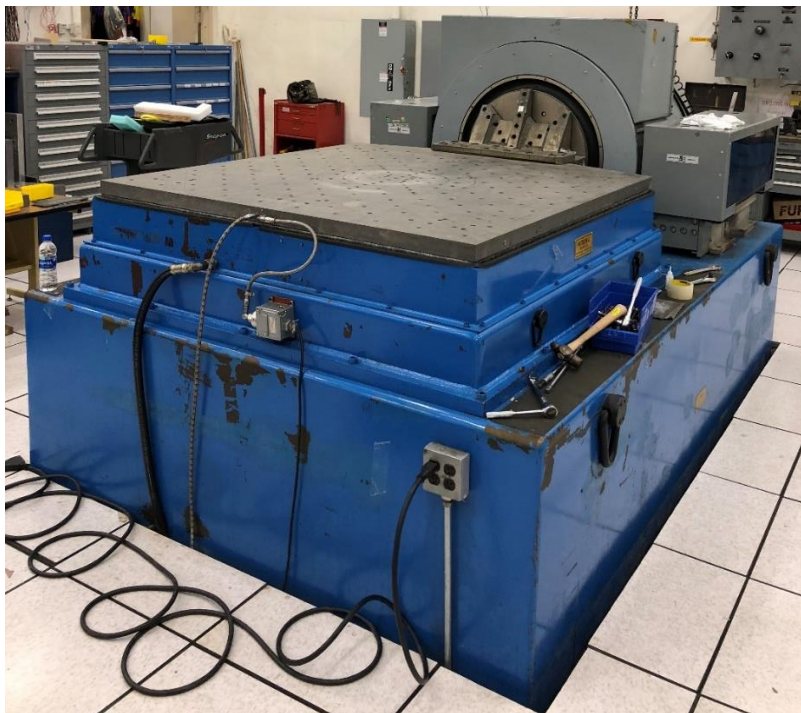
To simulate a free-fixed boundary condition, the table is left on the shaker. Lubricating oil that flows during shaker operation is pumped in between the table and its support structure to create the free boundary condition. The shaker is left locked to fix the other end. Figure 3 shows the free-fixed configuration.

**Figure 3** Free-fixed test setup

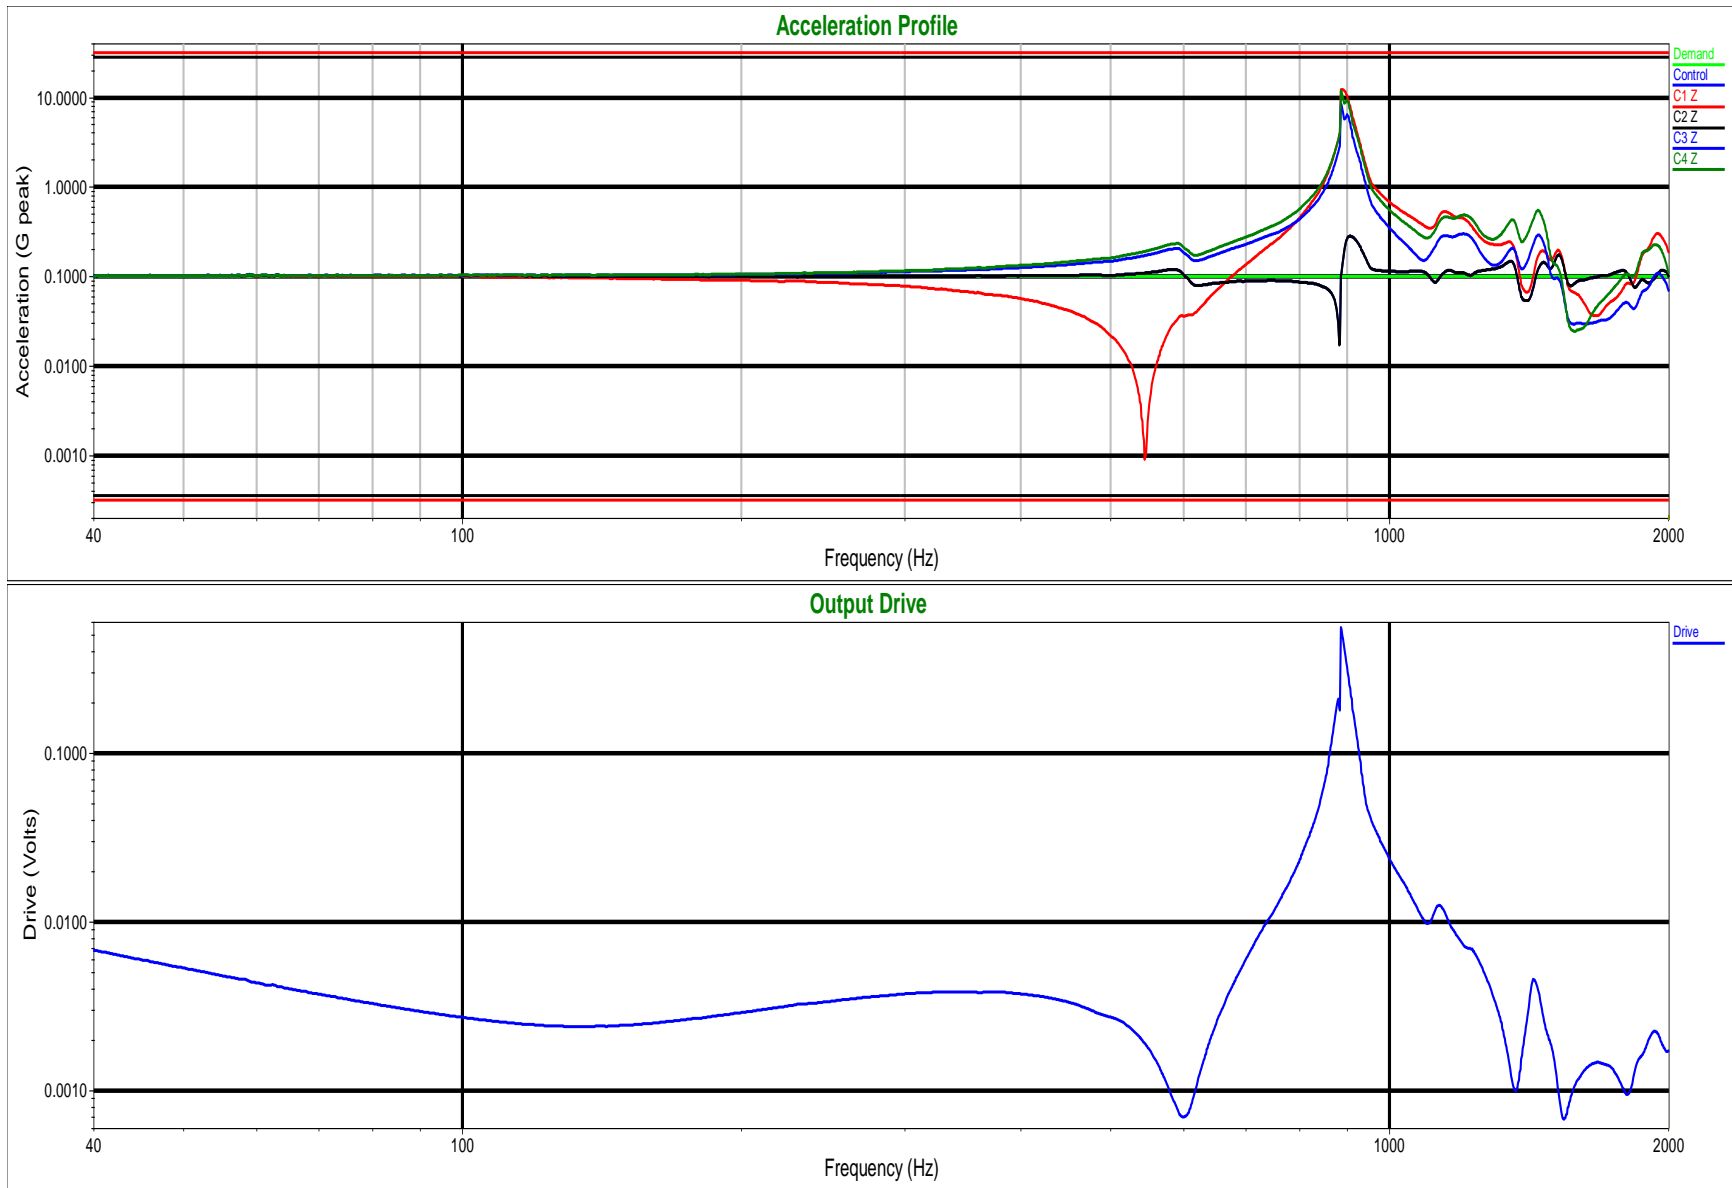
Figure 13 shows the vibration profile controlling at P1. Figure 14 shows the vibration profile controlling at P2. Figure 15 shows the acceleration profile controlling at P3. Figure 16 shows the vibration profile controlling at P4. All of the acceleration profiles are exported directly from VibrationView

**Figure 14** Vibration profile controlling at P2
